Building and Timber Pest Inspection Report

Inspection Date: Fri, 16 Jan 2026

Property Address: 52 St Leonard Cres, Elizabeth Downs SA
5113, Australia

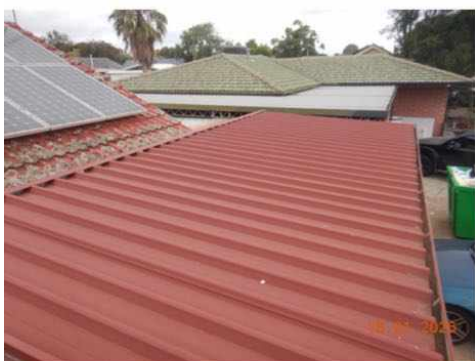
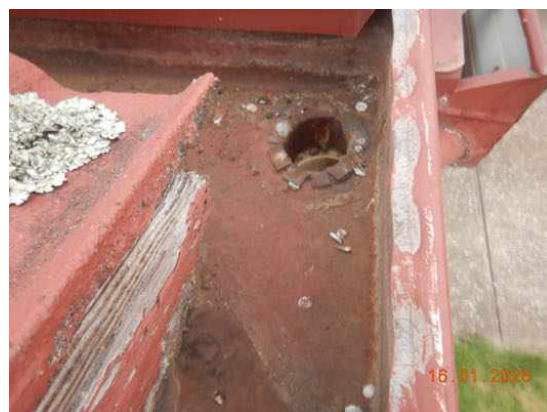
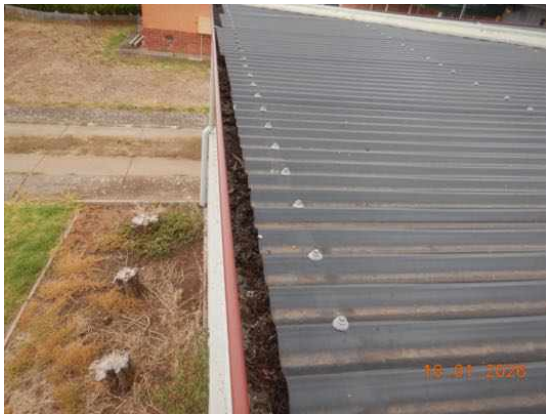
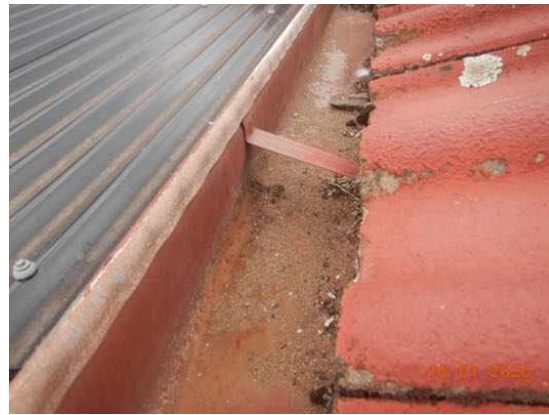
Building: Building 1
Location: Roof Exterior
Finding: Roof plumbing - Rusted or corroded
Information: The roof plumbing has areas of rust and corrosion. It is suspected that this has been caused by blockages, resulting in pooling or standing water, that have prematurely rusted elements of the roof plumbing and or general old age.

Rusted roof plumbing will generally develop holes and leaks that can affect other building elements with poor drainage of storm water.

Poorly drained roof areas will also lead to damp conditions surrounding the base perimeter of the building which, if left unmanaged, can lead to a range of secondary building defects.

Repair and/or replacement of rusted roof plumbing is highly required in order to reinstate the roof drainage system to a fully operational level.

To further maintain these areas, gutters should be cleaned frequently, allowing the avoidance of any partial blockages.

A licensed plumber or specialist roof restoration company should be appointed to undertake these works. It is advised that such works be completed as soon as possible to prevent any further damage and deterioration.

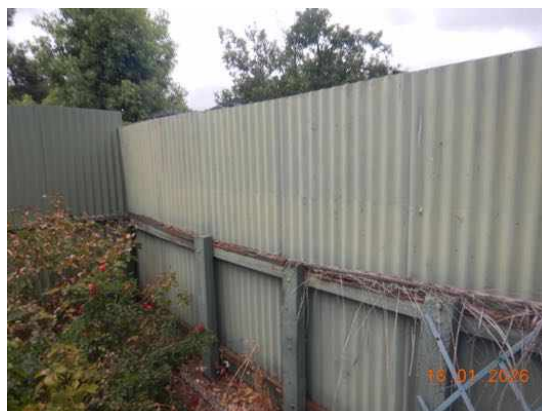
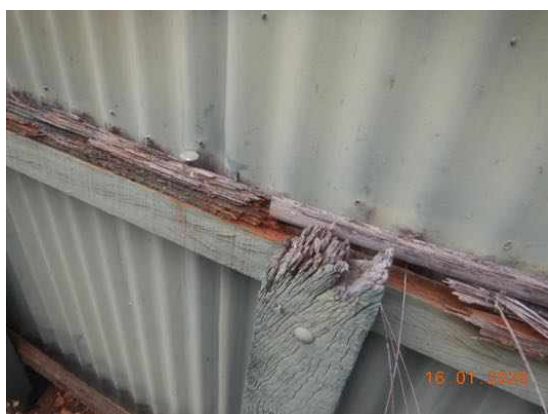
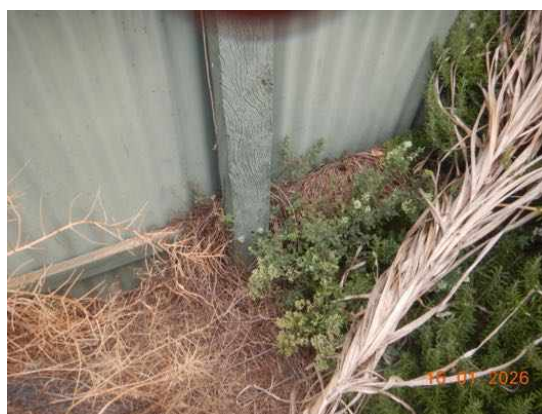
Finding 3.01

Building: Building 1
Location: Yard - Back
Finding: Fencing - Deteriorated
Information: It was noted at the time of inspection that sections of the fencing throughout the property have deteriorated. Typically fencing deteriorates due to age and or wear, rot and or rust which is generally expected for a structure of this age, due to prolonged

exposure to weather conditions. Sometimes inadequate installation or maintenance can be to blame.

If left unattended, it is likely that further damage will occur. It is suspected that repair of several elements of the fencing may be required however replacement may be a consideration of the client also.

A licensed fencing contractor should be appointed to provide further advice and perform rectification works as necessary.

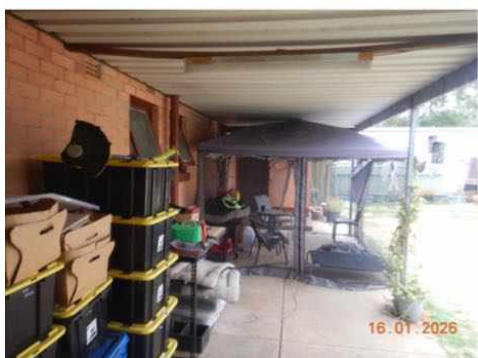
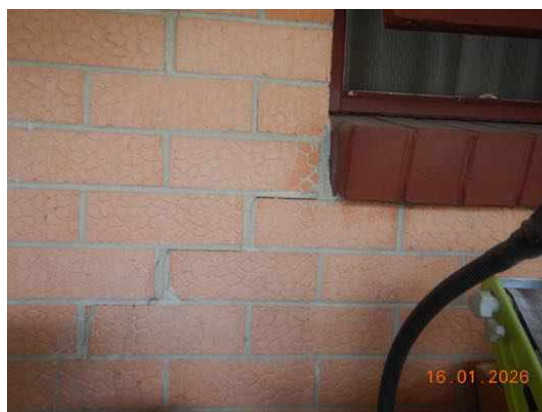
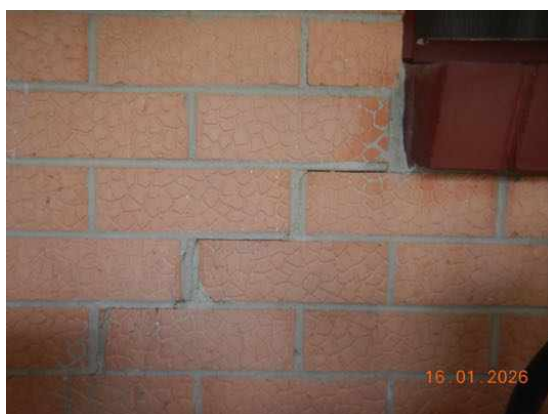
Finding 3.02

Building:	Building 1
Location:	Exterior walls - rear
Finding:	Brickwork - Step cracking
Information:	Step cracking was identified to the brickwork in this area at the time of inspection. Step cracking, which is similar to other forms of cracking, has a variety of possible causes. However, the most common is the subsidence of adjacent footings.

Step cracking is a relatively common defect, and is most likely to occur adjacent to windows, doors and other openings. Mortar failure in the gaps between affected bricks indicates the stresses and tensions affecting the wall.

Where step cracking is extensive or severe, the client is advised to consult a structural

engineer. Minor step cracking can be used as a warning sign to address factors causing stress to the wall, which can include the effect of surrounding trees, water leaks, soil erosion, or even the presence of reactive soils in the surrounding area.

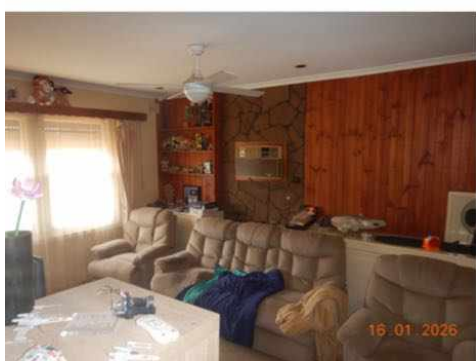
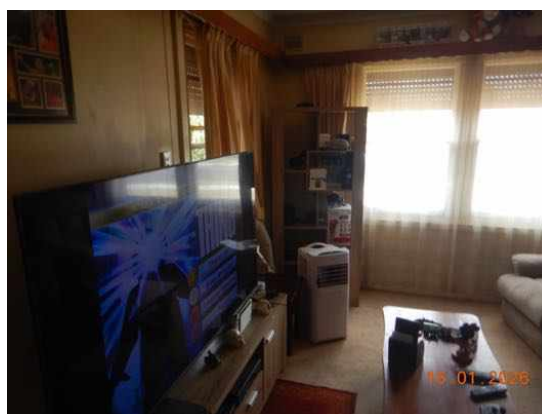
Windows provide ventilation to the adjoining area and should be at a fully operational level to ensure user comfort. Restricted function of the window may also pose as a potential safety hazard if required for emergency egress from the building.

Where windows have been painted shut the seal of the paint needs to be broken. This is generally done by breaking the seal of the paint and then maintaining the sash tracks clearing and lubricating them with silicone. Remedial paint work will likely be required and can be completed along with the rest of the remedial works necessary by a general handyman.

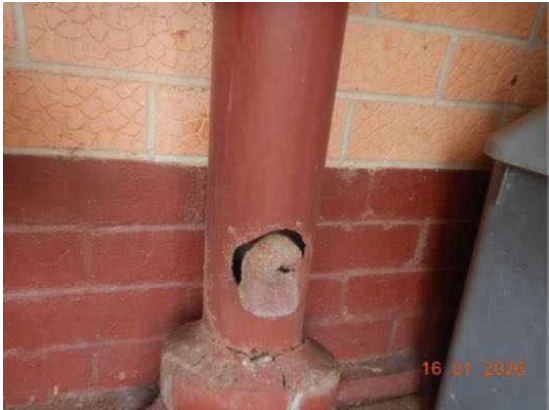
Building: Building 1
 Location: All Areas
 Finding: Minor defects present
 Information: There were several age and maintenance related defects evident to the dwelling at the

time of inspection. These defects include but are not limited to

- Plumbing vent is damaged
- Blistering paint to rear porch ceiling
- Shed door damaged
- Several fine cracks to internal tiling.

Appropriate licensed trades people could be appointed to make repairs at the discretion of the client.

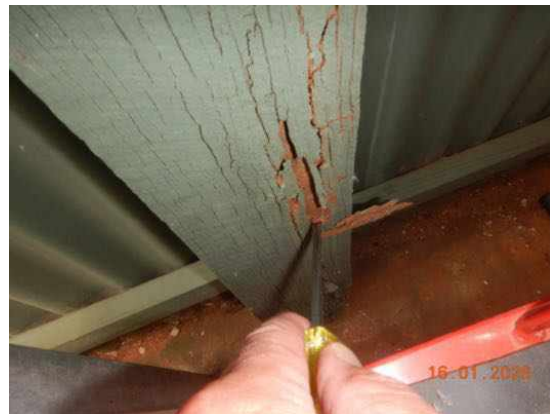
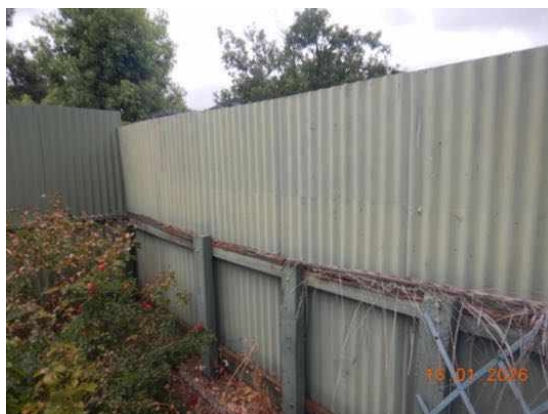
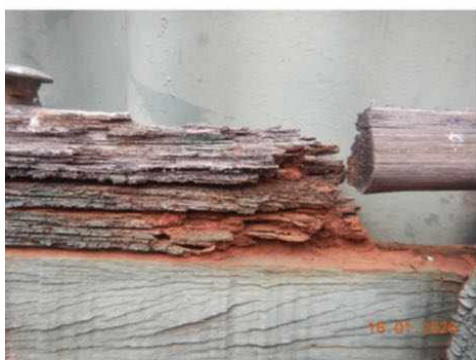
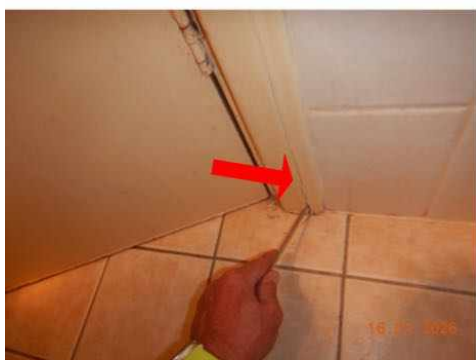
Building: Building 1
Location: Yard - Back
Finding: Evidence of termite damage - minor
Information: Despite no live termite or timber pest activity being indicated, previous termite damage was found to have affected the fencing and also the door frame to the bathroom.

This damage is considered to be inactive and is minor in nature.

It is advised that the area be visually inspected frequently to ensure that the condition of affected building materials does not worsen. At the time of inspection, damage is not structural and is only considered to be superficial.

A building contractor may be appointed to provide a further invasive inspection if further damage is evident.

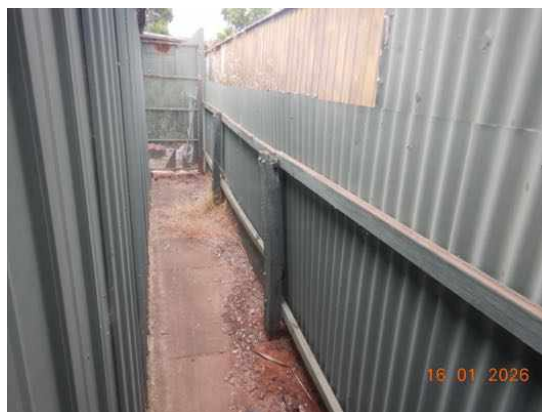
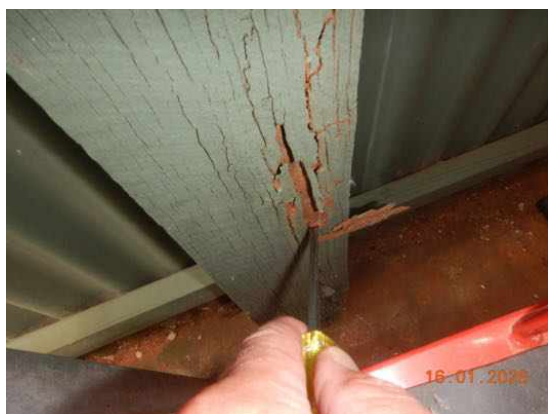
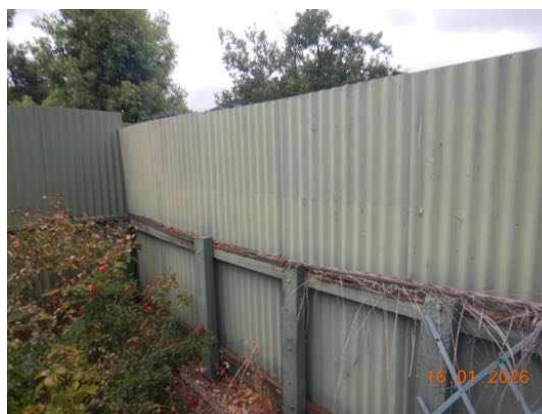
Finding 6.01

Building:	Building 1
Location:	All External Areas
Finding:	Untreated or non-durable timbers in a hazardous environment
Information:	To reduce the risk of timber pest attack it is essential that timber used in a hazardous environment (e.g. in direct contact with the ground or frequently exposed to damp conditions) is of sufficient durability and/or is adequately preservative treated. Additionally any timber lying around or timber stumps should be removed.

Untreated timbers in direct contact with the ground are likely to develop severe wood rot and/or fungal decay if left unattended creating attraction for subterranean termites to infest the timbers from surrounding areas.

If untreated or non-durable timbers are found to be in a hazardous environment it is highly advised that replacement of these building elements be performed as soon as possible to aid the protection of the property against termite / timber pest attack. Failing this close monitoring is recommended in an attempt to identify termite infestation at an early stage.

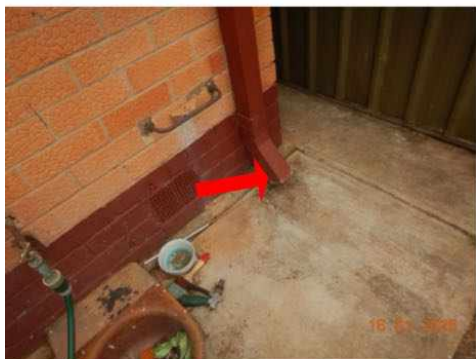
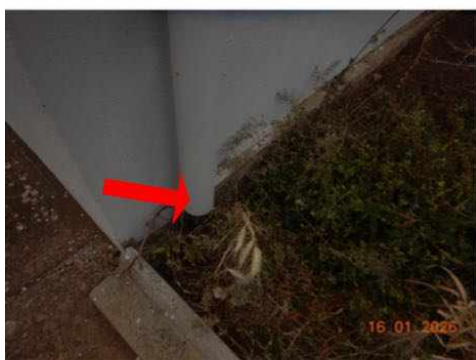
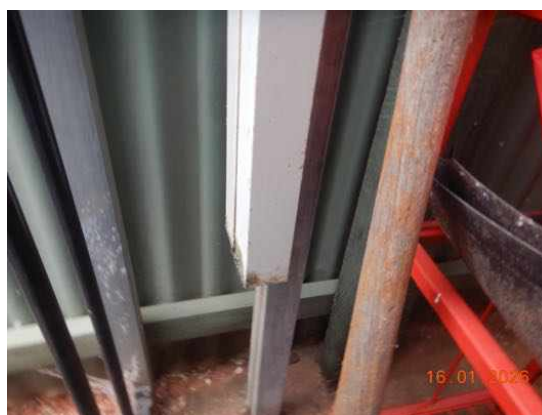
Finding 6.02

Building:	Building 1
Location:	All External Areas
Finding:	Stormwater drain - Not connected or leaking
Information:	The roof plumbing is not adequately connected to stormwater drainage or is leaking in several areas on the site. This issue negatively impacts the functional capacity of the roof plumbing.

Where roof plumbing doesn't drain adequately, the area at the base perimeter can become excessively damp, potentially creating an environment that is susceptible to rust and corrosion of surrounding building elements, as well as attracting termites and other pests.

It is highly recommended that a plumber be appointed to further inspect the area and to install or repair drainage equipment where necessary.

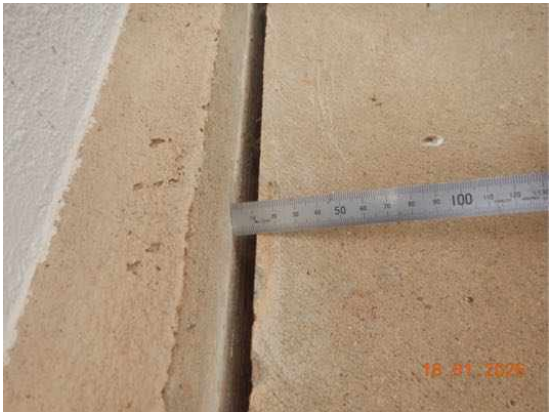
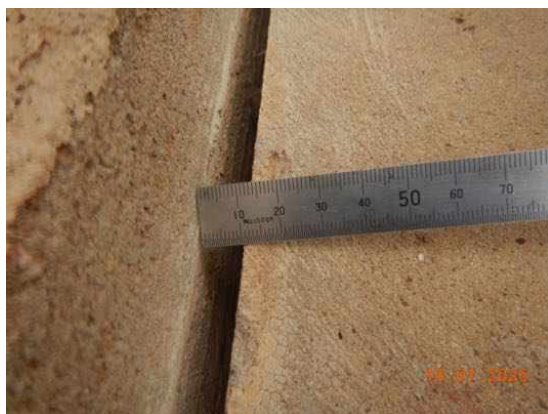
With reactive clay soils, it is extremely important to ensure that all stormwater flows including roof and ground flows are contained and continually maintained.

A licensed builder may be required to Fill the gap between the pavement and the buildings which is recommended in the short term to prevent unwanted moisture accessing the foundation.

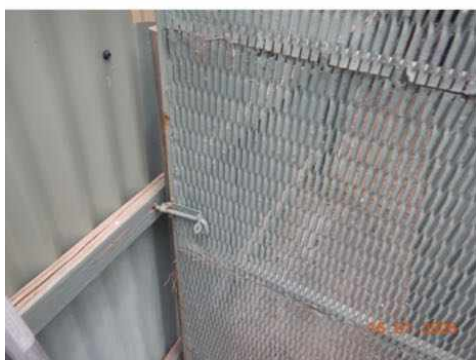
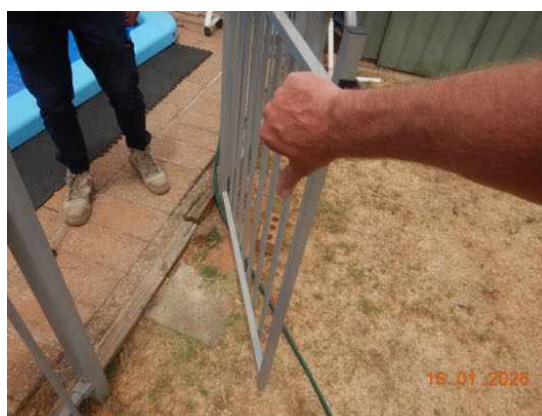
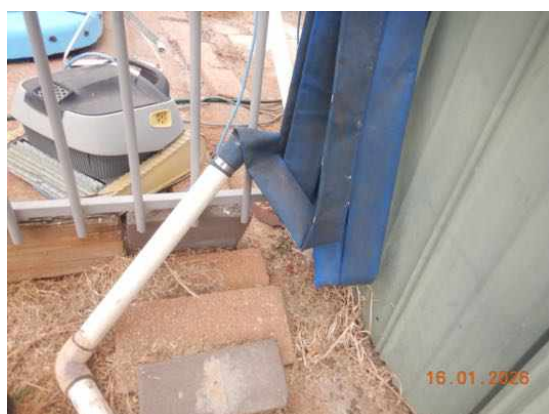
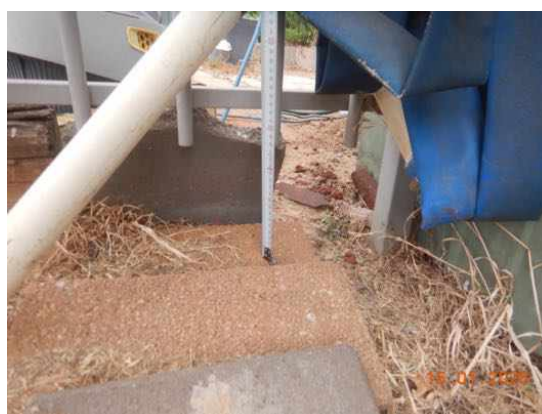
Building: Building 1
 Location: Yard - Back
 Finding: Pool fencing - Inspection required
 Information: It is suspected that areas of the pool fencing do not to comply with Australian Standards and do not appear to be safe. Assessment of the pool area is required.

Please note that this inspection does not cover pool fencing and other pool fittings and fixtures. It is highly advised that a specialist be appointed to inspect the pool and surrounding area and provide advice on rectification works that may be required.

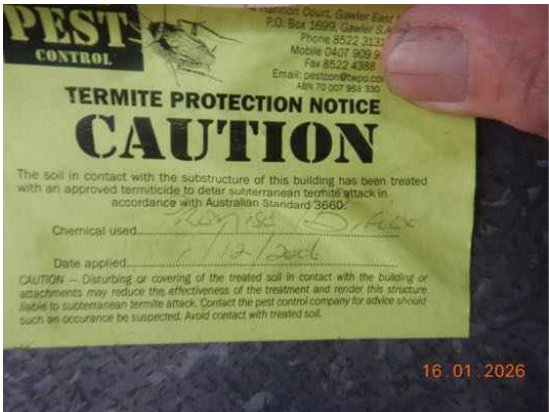
Building:	Building 1
Location:	All External Areas
Finding:	Evidence of a chemical treated zone barrier was identified - drill and inject
Information:	During inspection of the property, it was noted that works to install a chemical treated zone barrier had previously been completed. A chemical treated zone barrier is likely to ensure effective protection against termites.

Drill and inject holes were evident and found at approximately 350mm centres. This indicates that the treatment was done many years ago and would likely be outdated.

We strongly recommend annual inspections of the barrier and surrounding areas as there are several factors that can lead to deterioration of the barrier and decrease its effectiveness.
