Building and Timber Pest Inspection Report

Inspection Date: Wed, 4 Mar 2026

Property Address: 6 Walsh Cres, North Nowra NSW 2541,
Australia

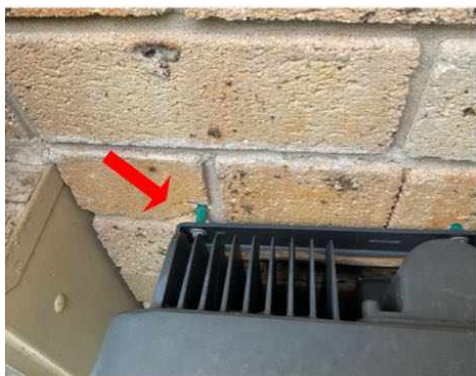
Building: Building 1
Location: Pictured area
Finding: Solar control box loose
Information: The solar control board is falling off the wall and could cause an electrical safety issue

if not immediately rectified.

An electrician would be the trade responsible for rectification of this box before it falls off the wall and creates electrical safety issues.

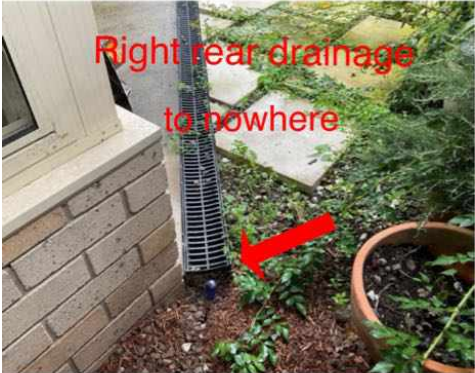
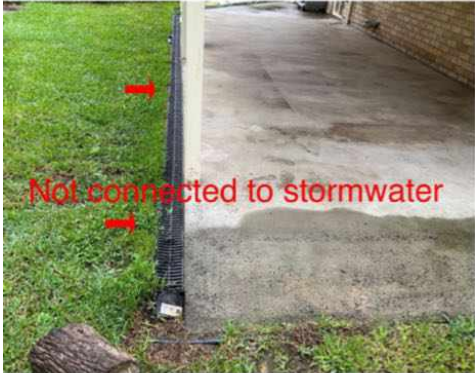
Finding 2.01

Building:	Building 1
Location:	Many pictured walls and subfloor areas
Finding:	Site drainage - Inadequate
Information:	The site drainage in many areas was found to be totally inadequate at the time of inspection, creating potential for subsequent water damage to associated building elements.

New strip drains have been added to the rear garage and rear house but they do not appear to be connected to drainage rendering them pointless. Rainwater is entering the subfloor and 80% + of the subfloor appears damp with many areas mouldy. These damp conditions are causing rising damp to subfloor walls and this damp appears to be starting above the floor in many house walls. This is thought to also cause the step cracking found in the brickwork. This moisture is promoting tree roots growing in the subfloor.

Where site drainage is inadequate, installation of an Agricultural (Aggie) Drain is required. A qualified plumber should be appointed to further inspect the property and perform any remedial works or provide a quote before purchase. Secondary defects are already occurring and this damp may affect the structural stability of subfloor walls

in the future.

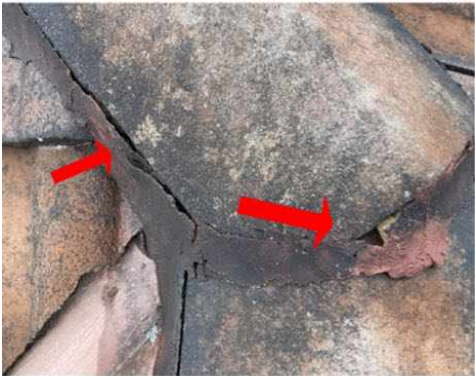
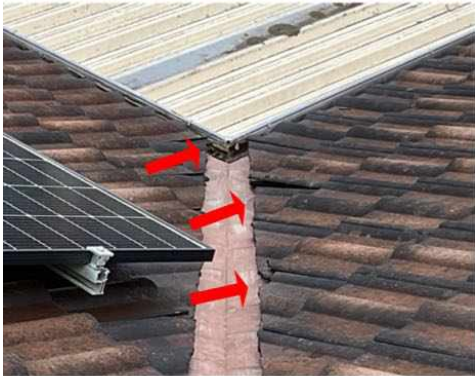
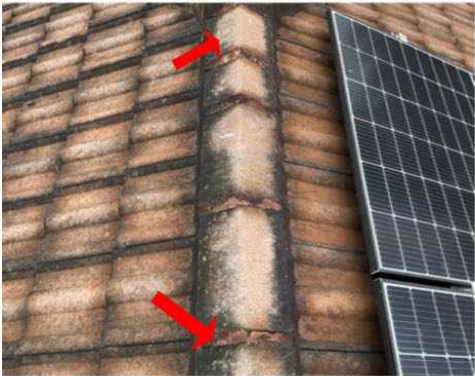
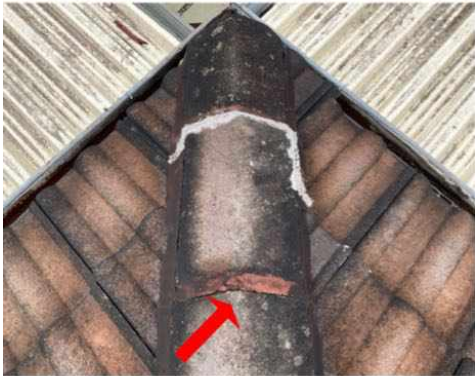
Building: Building 2
Location: Roof Exterior
Finding: Roof tiles - Weathered
Information: Upon inspection of the exterior roofing, the majority of the ridge capping roof tiles were considered to be in a poor condition.

Isolated areas of mortar have come loose and cracking is also present. Re-pointing and re-sealing is urgently required to help preserve and extend the life span of the tiles.

Where left unmanaged, deteriorating roof tiles are likely to lead to a number of secondary defects, including minor water leaks and weather exposure to internal roofing structures.

Consultation with a roofing contractor is highly advised to gain advice on cost of remedial works that are required before purchase. Remedial works are likely to increase the longevity of the exterior roofing structure.

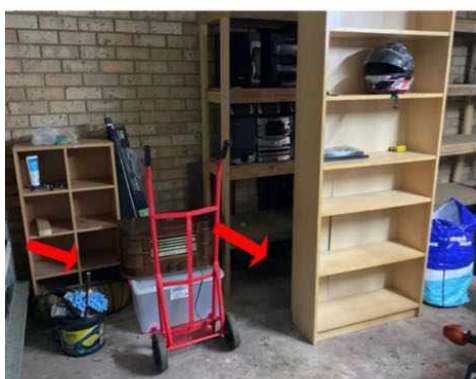
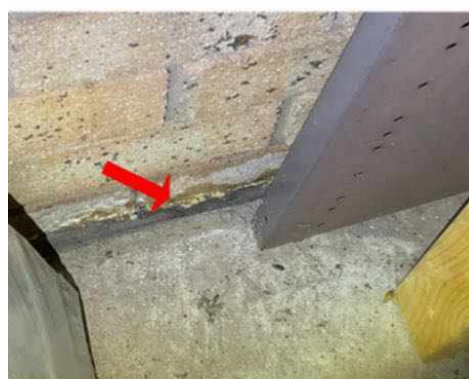
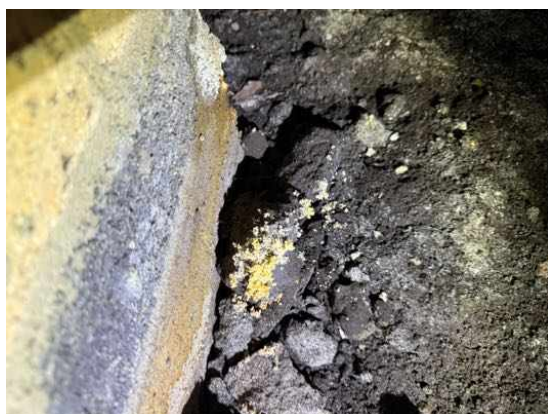
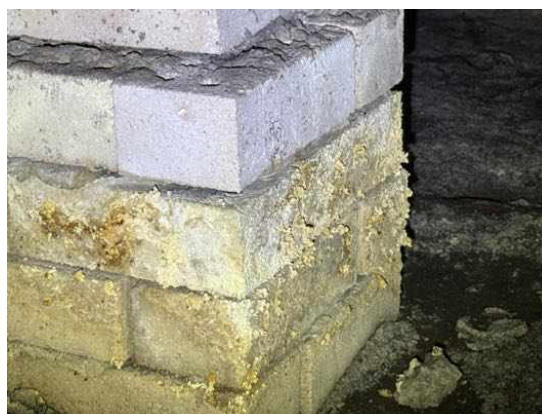
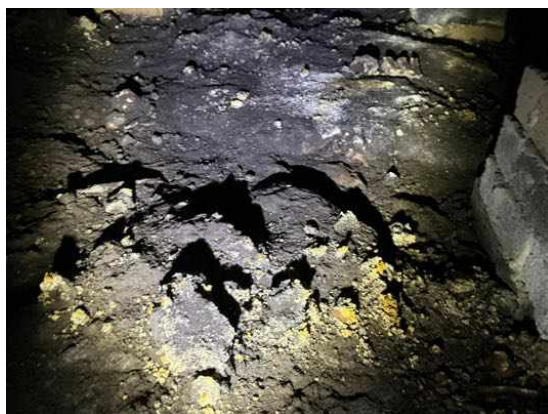
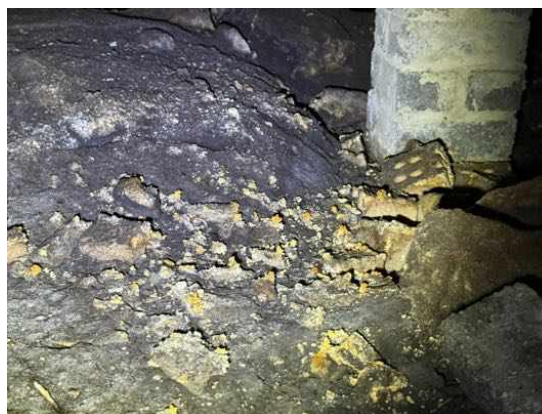
Finding 3.03

Building: Building 1
Location: Subfloor and garage
Finding: Mould - Present in subfloor and garage
Information: Where evidence of extensive mould growth was noted, there may be environmental, biological or health issues associated with the report. A specialist inspection by a suitably qualified environmental health inspector is warranted, where mould is extensive or where any queries regarding air quality spores or other related issues apply.

Subfloor mould is generally caused by moisture ingress, lack of external drainage, lack of adequate ventilation and subfloor debris present. These issues need rectification

to stop mould development. Any mould found during the inspection should be cleaned immediately by a cleaning contractor or the homeowner as applicable.

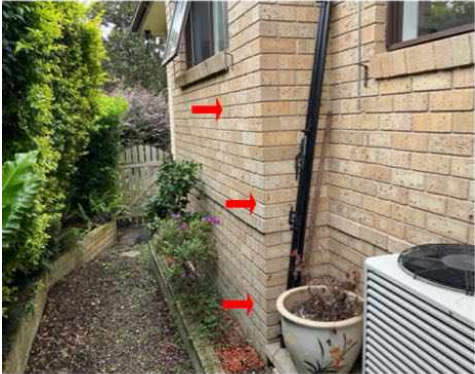
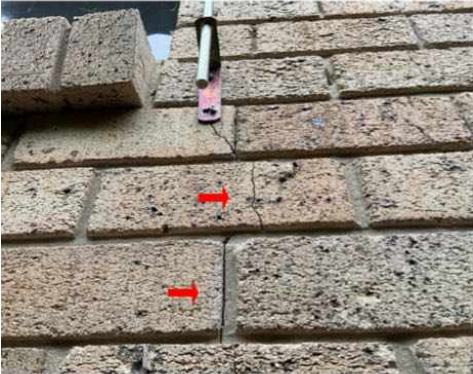
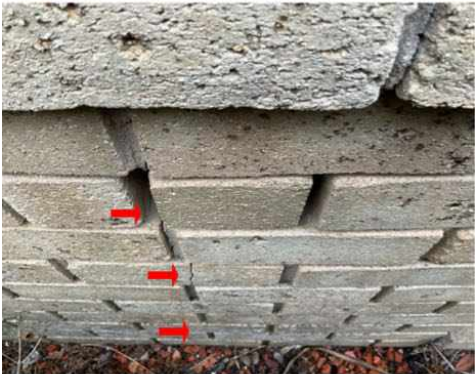
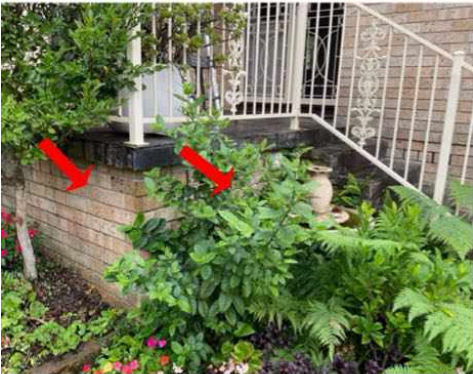
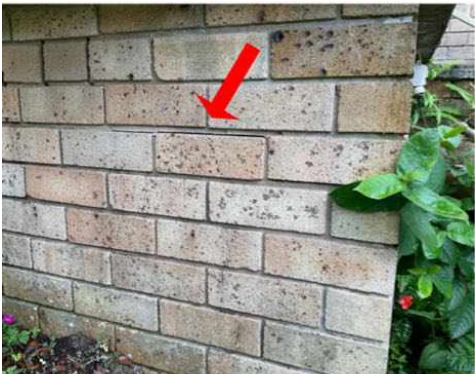
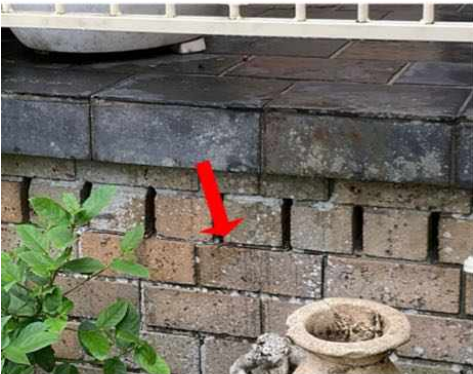
Finding 3.04

Building:	Building 1
Location:	Exterior walls - right & front
Finding:	Step cracking to brickwork (minor)
Information:	Step cracking was identified to the brickwork in this area at the time of inspection. Step cracking, which is similar to other forms of cracking, has a variety of possible causes. However, the most common is the subsidence of adjacent footings.

Step cracking is a relatively common defect, and is most likely to occur adjacent to windows, doors and other openings. Mortar failure in the gaps between affected bricks indicates the stresses and tensions affecting the wall.

Where step cracking is extensive or severe, the client is advised to consult a structural engineer. This minor step cracking can be used as a warning sign to address factors causing stress to the wall, which can include the effect of surrounding trees, water leaks, soil erosion, or even the presence of reactive soils in the surrounding area.

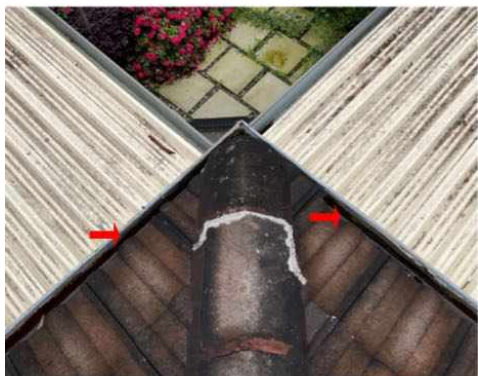
Finding 3.05

Building:	Building 1
Location:	Roof Exterior
Finding:	Roof plumbing - Rusted or corroded
Information:	The roof plumbing has areas of rust and corrosion. It is suspected that this has been caused by blockages, resulting in pooling or standing water, that have prematurely rusted elements of the roof plumbing.

Rusted roof plumbing will generally develop holes and leaks that can affect other building elements with poor drainage of storm water. Poorly drained roof areas will also lead to damp conditions surrounding the base perimeter of the building which, if left unmanaged, can lead to a range of secondary building defects.

Repair and/or replacement of rusted roof plumbing is highly required in order to reinstate the roof drainage system to a fully operational level. To further maintain these areas, gutters should be cleaned frequently, allowing the avoidance of any partial blockages.

A licensed plumber or specialist roof restoration company should be appointed to undertake these works. It is advised that such works be completed as soon as possible to prevent any further damage and deterioration.

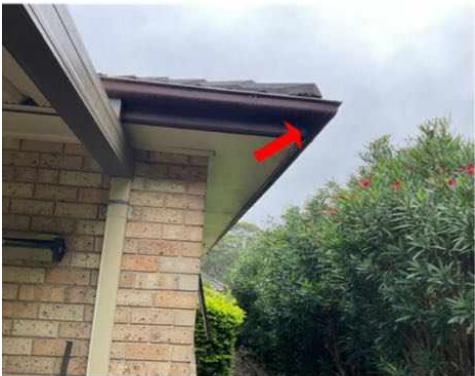
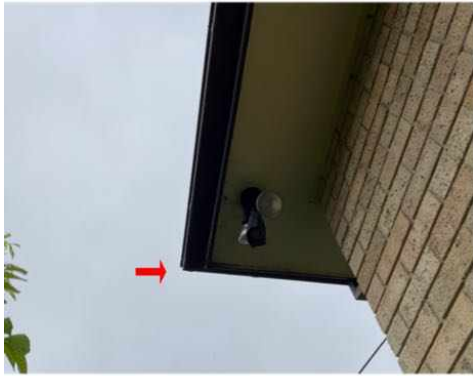
Finding 3.06

Building: Building 1
Location: Exterior gutters
Finding: Water leak - downpipe
Information: Many water leak were found to gutter areas. These leaks are ongoing and hence require urgent action.

Regardless of the location, even minor leaks that are left unmanaged can lead to serious damage of associated building elements.

It is highly advised that the cause of these leaks (likely to be the rusted gutters) be identified and resolved immediately by a roof plumber to prevent any further damage. Depending on the extent of the damage previously sustained, replacement of many gutters may be required.

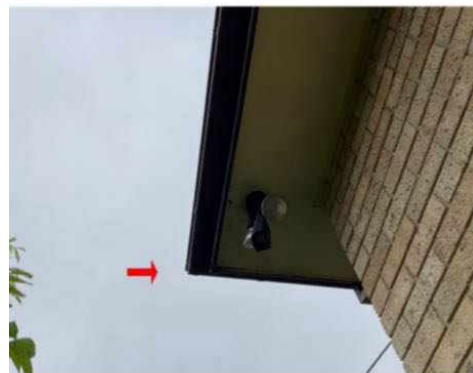
Finding 3.07

Building:	Building 1
Location:	Pictured areas
Finding:	Wood rot
Information:	Some fascia shows evidence of wood rot. Wood rot, also known as Fungal Decay, occurs when timbers and other cellulose building materials are exposed to damp conditions on an ongoing basis. This could be the result of exposure to weathering over a prolonged period of time, or the attraction of excessive moisture from other abutting building materials.

Early intervention and regular maintenance, particularly of exterior timbers, will prolong the useful life of these building elements. Prior to any works being performed, the cause of the moisture that has created the visible wood rot should be identified and addressed in a suitable manner. Replacement of affected timbers may then be a necessary step in protecting surrounding building elements from such deterioration.

A qualified carpenter or registered builder may also be required to replace affected building materials.

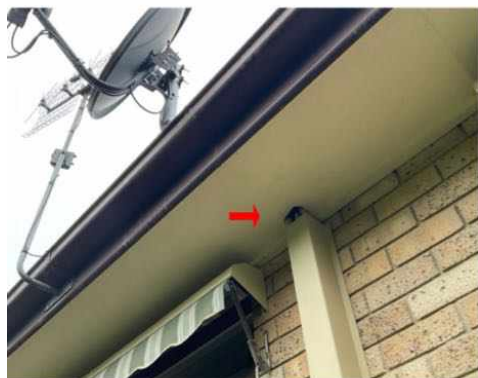
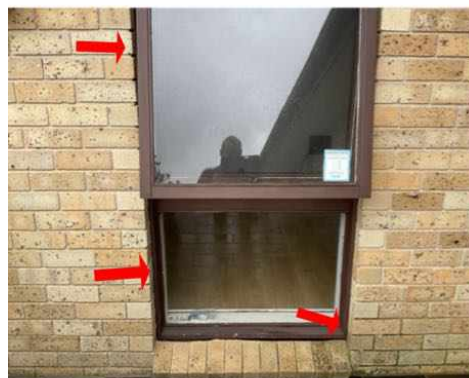
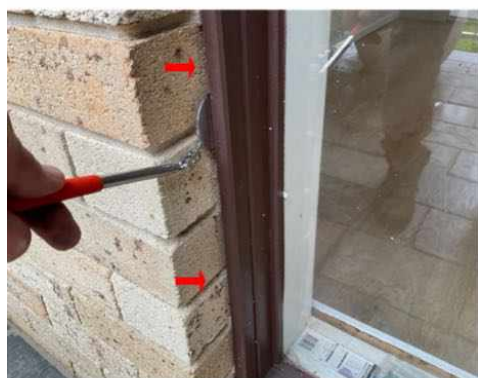
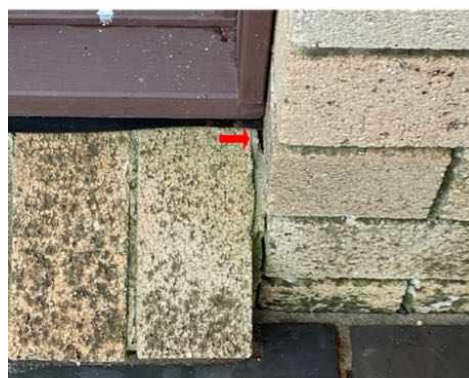
Building: Building 1
 Location: Exterior front wall
 Finding: Sealant (external) - missing
 Information: It was noted on inspection that areas of external sealant was missing to small areas of the external front wall. Some walls were hidden behind trees.

Flexible sealants should be applied to these affected areas to prevent any subsequent water damage that is likely to occur.

A sealant specialist or skilled handy person should be appointed to complete these works as soon as possible

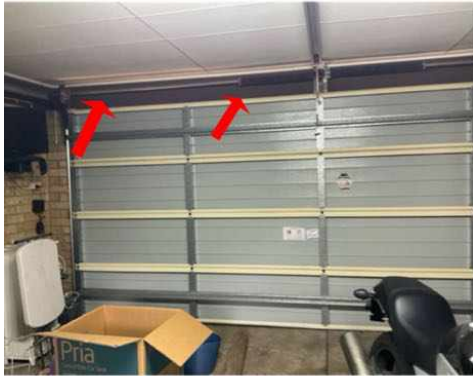
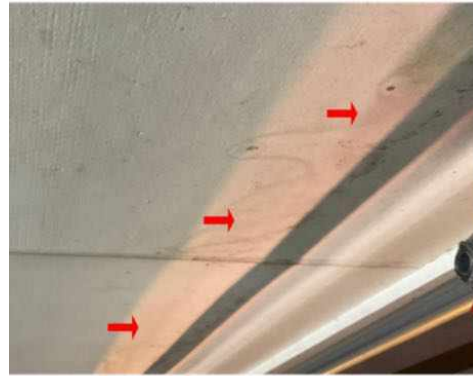
Finding 3.11

Building:	Building 1
Location:	Garage
Finding:	Ceiling - Water stained
Information:	Water staining to ceiling linings in this front garage area was evident at the time of inspection. Water staining indicates that surfaces have been exposed to excessive moisture over time. The minerals and other elements in the water lead to staining, which may graduate to corrosion and deterioration if left unmanaged.

While mostly an appearance defect, water staining can be indicative of more serious defects, which may be currently concealed by interior ceilings.

Where water staining is active, a licensed plumber must be consulted to identify the cause of the staining and to provide advice on any reparation works that may be required. Replacement of any damaged structures is advised.

Conversely, where water staining is old and inactive, affected building materials may be repaired or replaced at client discretion.

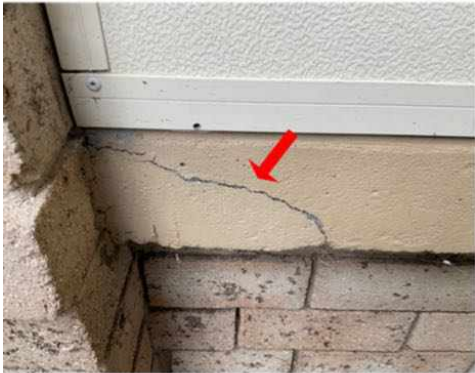
Building:	Building 1
Location:	Rear verandah
Finding:	Crack in concrete slab - Category 1
Information:	A crack coded as Category 1 was identified in this slab. A Category 1 crack is described as a fine but noticeable crack, with the slab at an otherwise reasonable level. To be considered Category 1, the approximate width of the crack is less than 1.0mm, or a less than 10mm change in offset when a 3m straight edge is placed over the defect.

Category 1 cracks should be monitored for a period of 12 months. At the end of the monitoring period, identified cracks that are rated greater than Category 2 are considered defects, and require rectification.

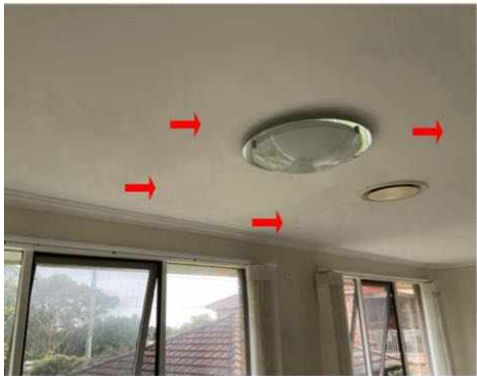
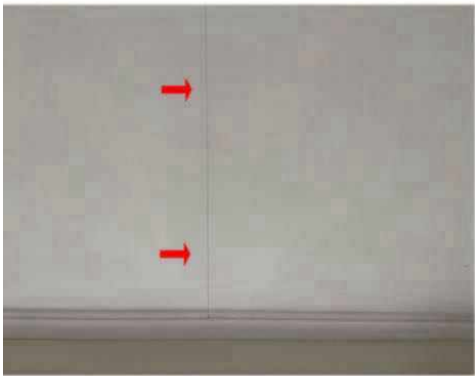
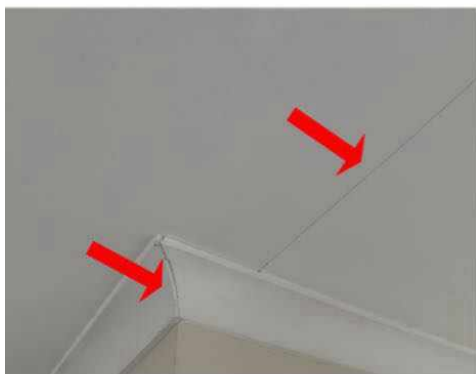
Finding 3.14

Building: Building 1
Location: Lounge Room & kitchen
Finding: Cracking - Damage Category 1 - Fine (up to 1mm)
Information: Although fine cracks are quite noticeable, they are often only considered to be an appearance defect, and usually do not indicate any structural damage. Generally, the cause of a fine crack is indicative of a separation between building materials and finishes (e.g. paint, plaster, etc.) along joins.

Cracking of this nature can generally be repaired with minor sanding, filling and/or repainting. Such works should be performed by a qualified painter or a general handyman.

Monitoring of all cracking should be conducted frequently. Always contact a building inspector should cracks widen, lengthen, or become more numerous.

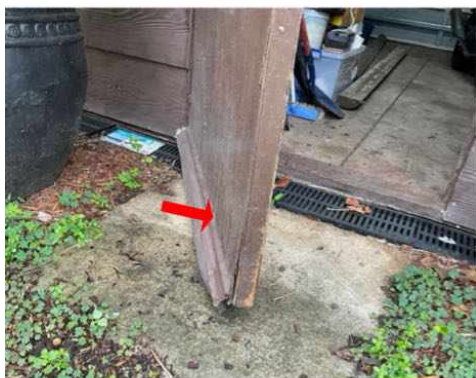
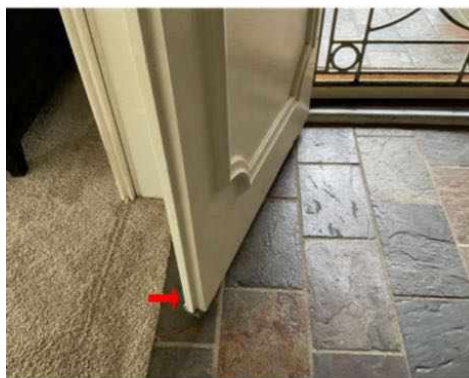
1. The garage and front doors are delaminating and may need replacement in 3-5 years. 4 other doors and the kitchen window are binding requiring adjustment.
2. Some skirting is unfinished
3. The roof fan and one window has broken or loose parts.

A carpenter would be the trade responsible for rectification of these areas when convenient.

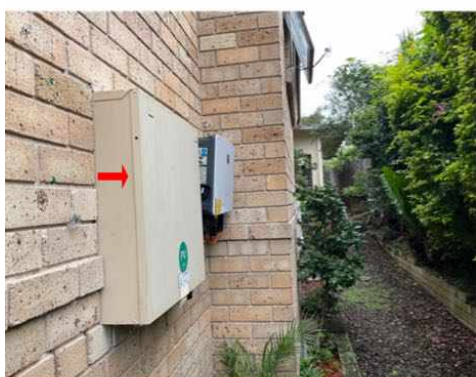
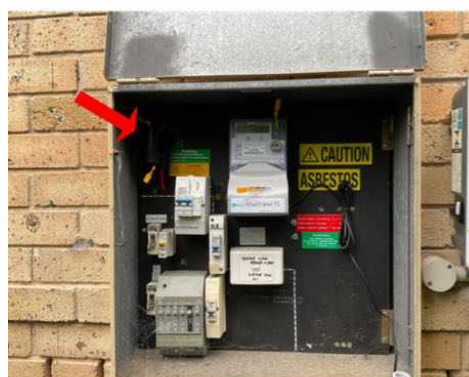
A durable notice should be placed in the switchboard unit to indicate current termite barriers. At the time of inspection, no durable notice was evident and it appeared as though no chemical termite management system has been installed, with no evidence to suggest preventative works taking place since the property was built.

The client may consider gaining further advice from a pest controller as to the costs and procedures involved with a 'chemical' application. It is recommended that obtaining such advice be a short-term priority.

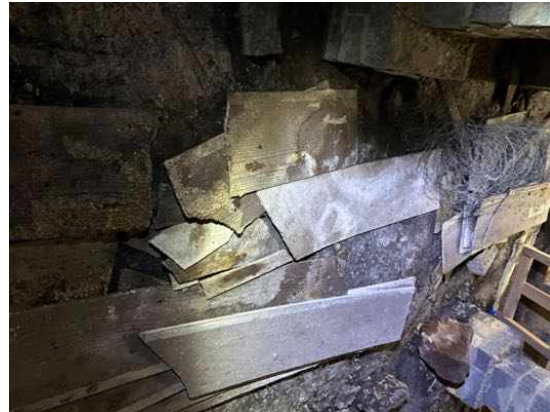
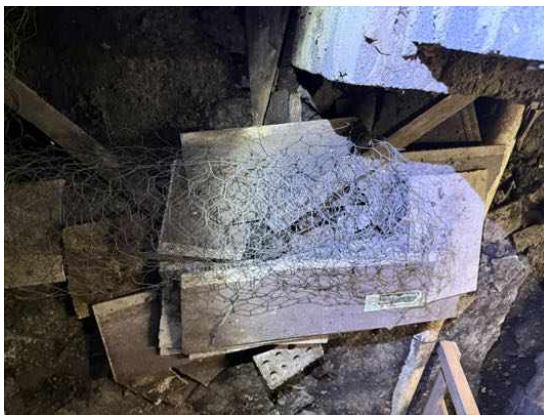
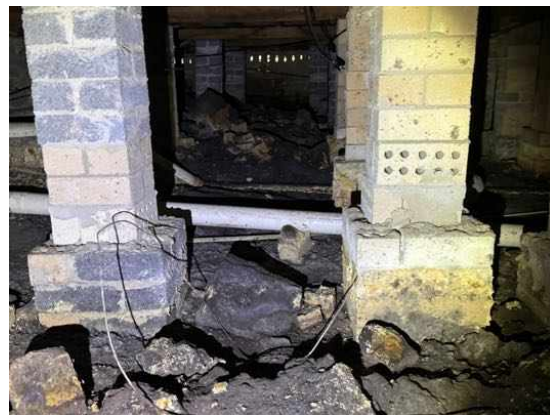
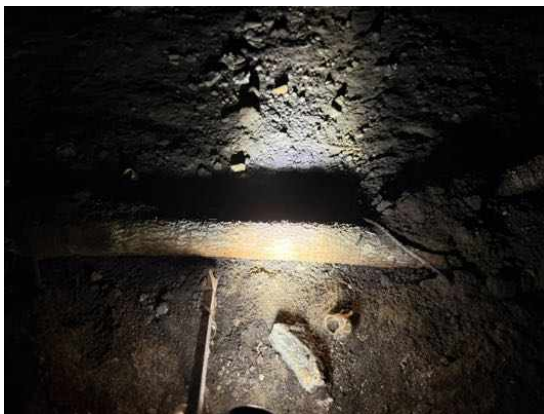
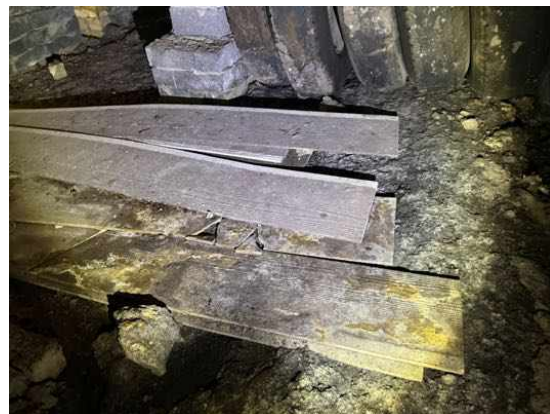
Finding 6.02

Building:	Building 1
Location:	All Subfloor Areas
Finding:	Subfloor - Debris and tree roots growing
Information:	An array of debris and some tree roots were found in the subfloor area at the time of inspection. Debris in this area restricts subfloor ventilation and creates potential for concealed pest entry. Stored timbers and other materials may also make the area susceptible to termite activity and wood rot.

ALL Debris in the subfloor should be removed prior to purchase. Depending on the location and amount of debris and stored items, the homeowner may elect to

undertake this task. Alternatively there are a large number of rubbish removal subcontractors that could undertake these works.

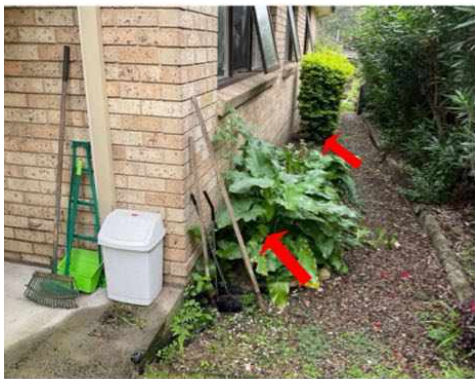
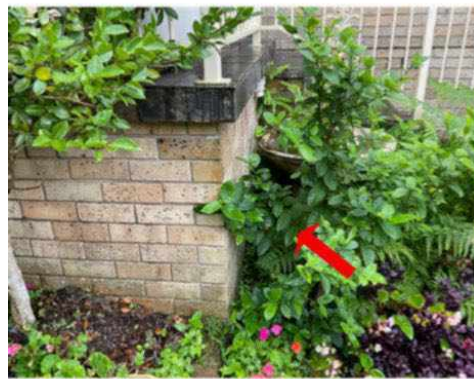
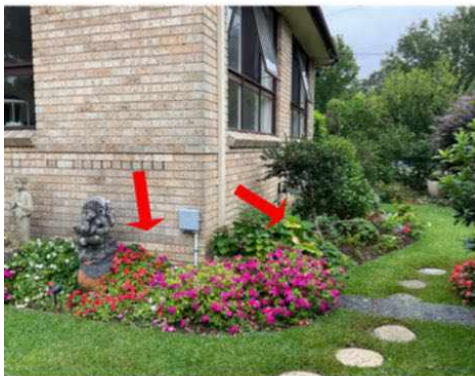
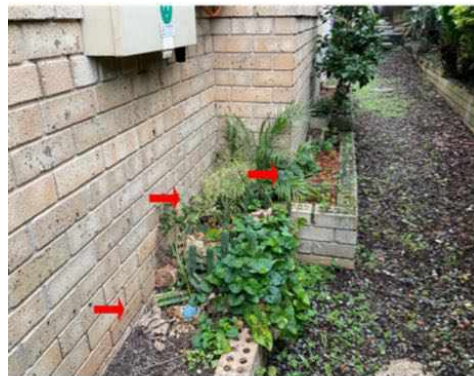
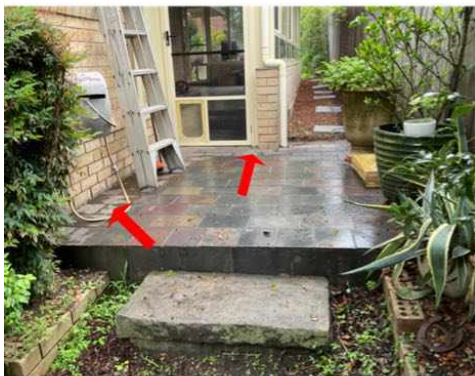
Finding 6.03

Building:	Building 1
Location:	Yard - front
Finding:	Bridging - Vegetation and decking
Information:	Where vegetation and decking obstructs inspection of building elements, also known as bridging as it provides a bridging point for the access of termites, full inspection can not be achieved. Consequently moisture or dampness may be present and the areas becomes conducive to termite activity. Plants and decks against or very close to

The removal and replanting of plant species that do not provide "cover" or cutting back of existing vegetation and leaving a small gap between decking and the building walls will assist greatly in preventing Bridging from occurring.

The removal of any such stored building or plant materials that may be conducive to termite activity should be carried out as soon as possible and arrange re inspection to minimize the risk of termite attack.

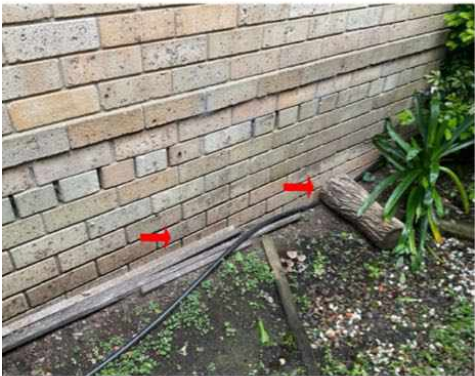
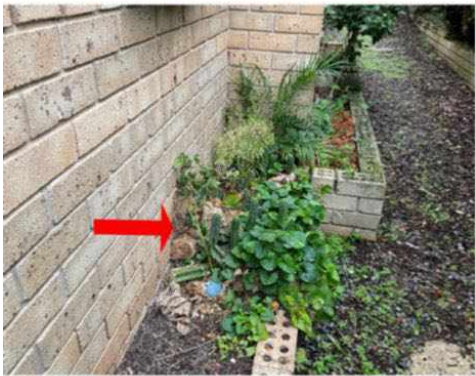
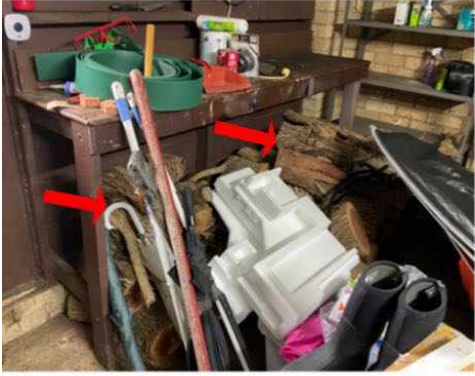
Finding 6.04

Building: Building 1
Location: Many areas including garage and subfloor
Finding: Timber in contact with the ground
Information: Any timbers in direct ground contact provide opportunity for concealed termite entry and are likely to be subject to premature rot and decay as the soil retains moisture or damp conditions against the timbers.

Removal of all waste timber that is in direct contact with ground is highly advised. This timber is promoting mould and wood rot and is very attractive to termites.

Frequent pest inspections are advised to readily identify any termite activity in these areas.

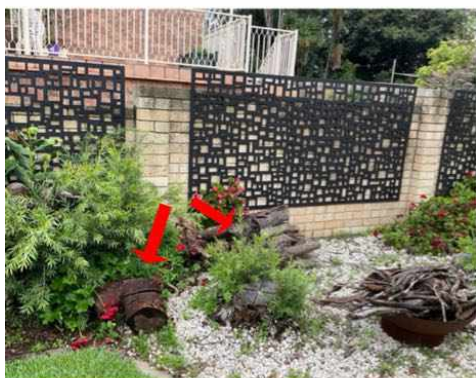
Finding 6.05

Building:	Building 1
Location:	Pictured yard area
Finding:	Tree stumps - left in ground
Information:	Tree stumps left in ground provide opportunity for termite attack as they are likely to be subject to rot and decay providing an attractive food source. Treatment and/or Removal of the stump is highly recommended. A pest controller and tree removalist should be engaged to perform such works.

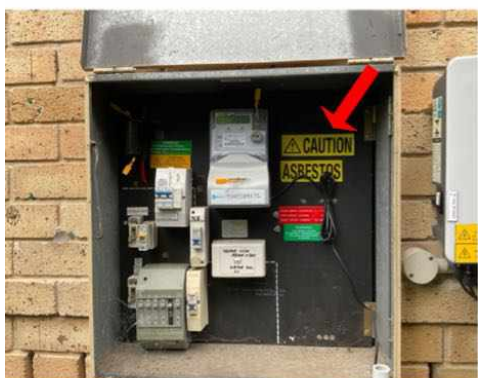
Building: Building 1
 Location: Some areas
 Finding: Asbestos - Suspected ACM Identified on Site
 Information: Reporting on Asbestos is outside the Scope of this Report. This suspected defect is highlighted as a caution only. We suspect, based on our experience in the building

In the interim, the client is advised to act with caution, especially when considering any damage to building materials general wear and tear renovations extensions demolition and general maintenance activities due to the suspected presence of Asbestos.
