Building and Timber Pest Inspection Report

Inspection Date: Thu, 12 Mar 2026

Property Address: 10/25 St Just Ct, Golden Grove SA 5125, Australia

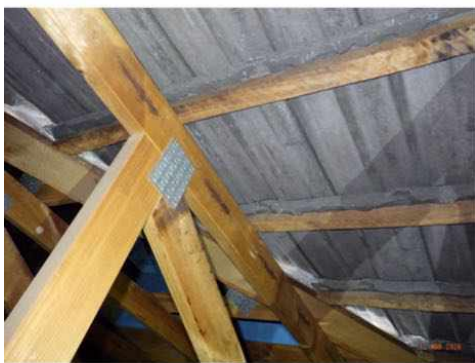
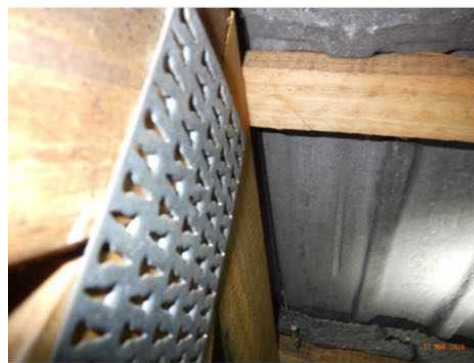
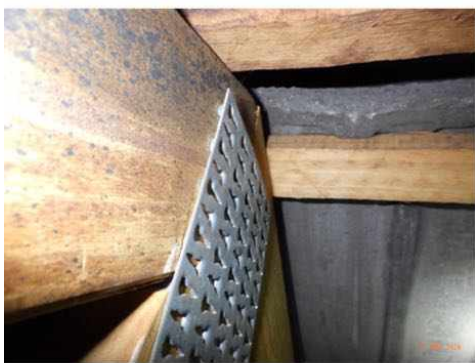
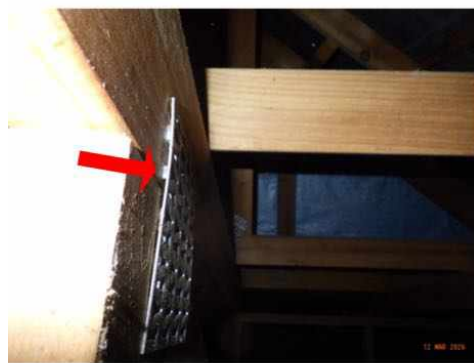
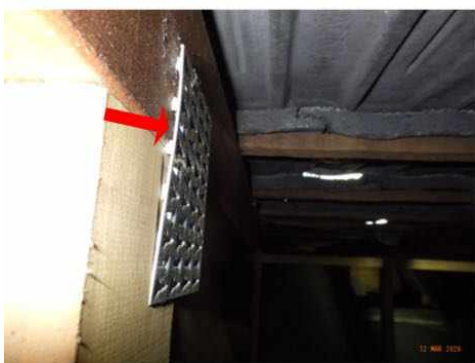
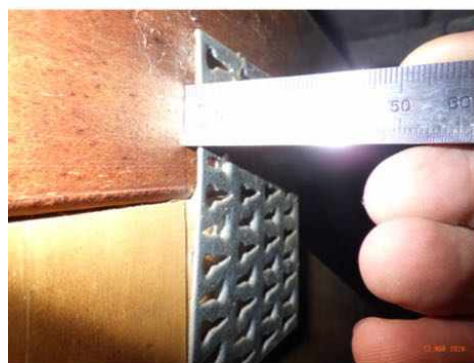
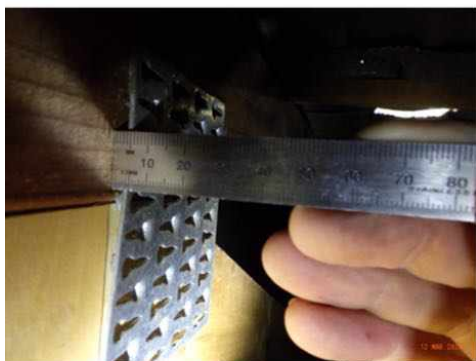
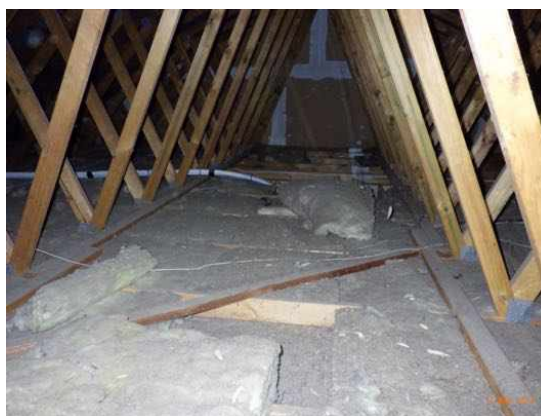
Finding 2.01

This could be due to one or more of several reasons including faulty nail plates, varying moisture levels, and slight movement of timber elements. Secondary defects can be created, ranging from damage to ceiling linings through to structural failure.

The issue appears to be effecting approximately >20 areas with minimal back out evident ,4mm and as such, repair is possible.

A structural engineer would be required to provide recommendations to be carried out by a licensed builder ASAP to prevent any further deterioration and to prevent a hazard being created.

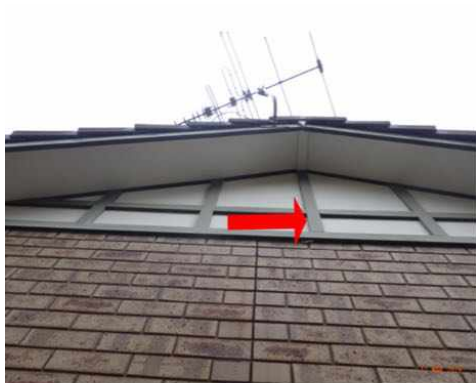
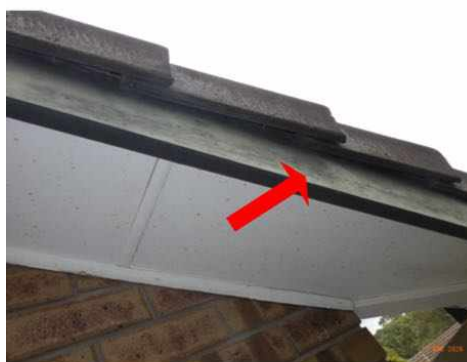
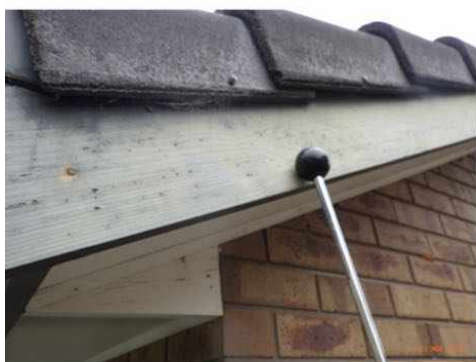
Finding 3.01

Building:	Building 1
Location:	Roof Exterior
Finding:	External painting deteriorated
Information:	Some of the external paintwork to the side of the dwelling including but not limited to fascias and other external fitments have been neglected and require attention to prepare and re-paint.

Whilst incomplete or missing paint finish is generally an appearance defect, it can also lead to the development of secondary building defects over time. Incomplete areas of paint finish expose the area to moisture, potentially accelerating the deterioration of underlying building materials.

Degraded paint finishes should be sanded back, filled, leveled and painted, as applicable. Where inadequate or missing paint protection has led to the deterioration of the associated building element, repair and/or replacement of this building element may be required.

A painting contractor should be appointed as soon as possible to perform necessary works to aid the appearance of the affected area and to ensure the area is protected against further deterioration. Alternatively, the homeowner following manufacturer instructions may perform these works.

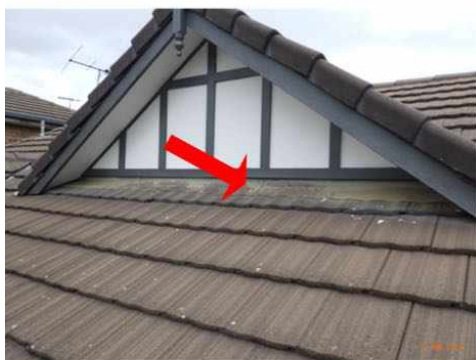
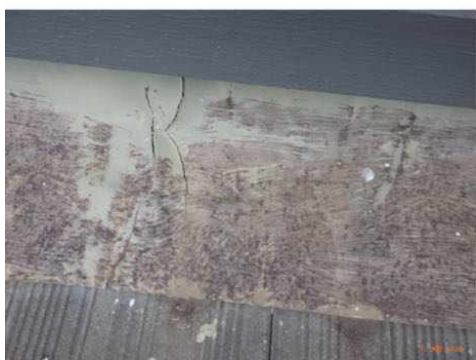
Finding 3.02

Building:	Building 1
Location:	Roof Exterior
Finding:	Roof plumbing - Flashing cracked
Information:	Water leaks generally occur when a particular area of the property is not weather or water tight. Cracks were evident to the lead roof flashings at the time of inspection.

Regardless of the location, if left unmanaged, even minor leaks can lead to serious damage of associated building elements, potentially resulting in the need for replacement of building materials. Damage to ceilings, wood rot, mould and other hazards, such as electrical hazards, may also arise if left unmanaged.

The cause of the water leak should be identified and addressed immediately to prevent further damage. The water leak should be resolved prior to any repairs of the damaged area, which may require localised replacement of building materials and refinishing.

Further inspection by a qualified carpenter or licensed plumber is advised to adequately rectify the potential leak.

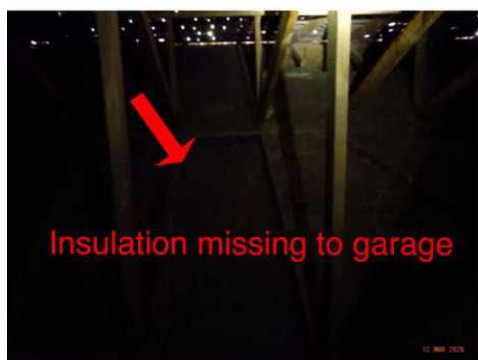
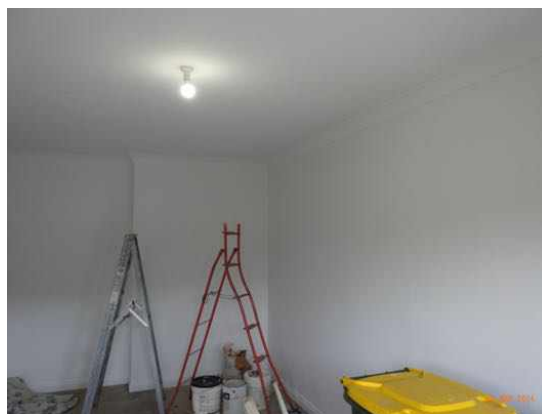
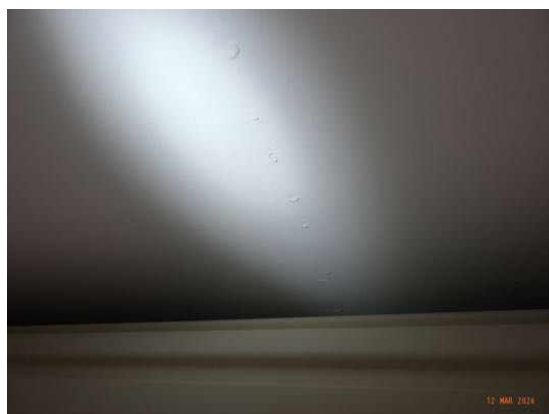
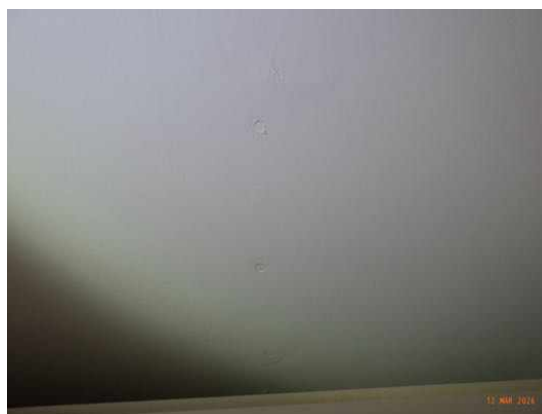
Finding 3.03

Information: A very common defect found in garages is that the ceiling can sag over time, due to their lack of insulation and or their susceptibility to moisture. Condensation builds up in the roof and rests on the plasterboard softening it somewhat which makes it more likely to sag and release from its fixing points. Moisture evaporating from cars can also contribute to this issue.

It appears that the sag has been repaired recently with many screws evident through the paint. A timber batten can be screwed to the ceiling just before the roller door to ensure that no sagging occurs in the future.

We also recommend that you insulate your garage. The ceiling appears to have a recent coat of paint.

A licensed building insulation installer could be appointed to carry out these works at the discretion of the client.

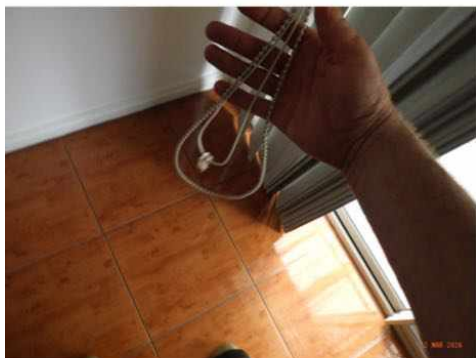
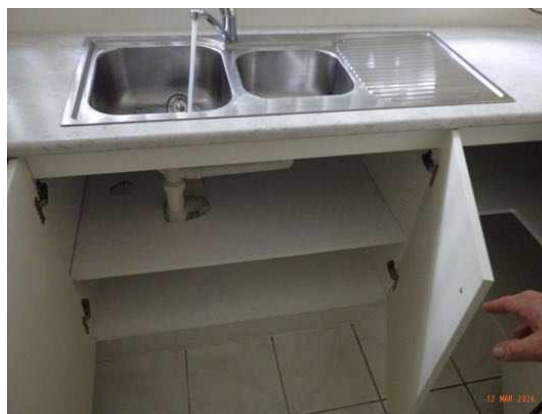
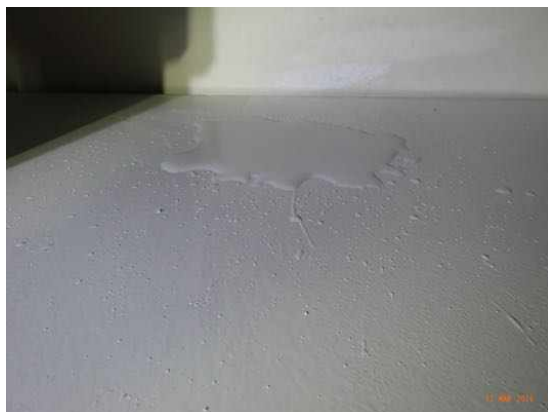
Finding 3.04

Building:	Building 1
Location:	All Areas
Finding:	Minor defects present
Information:	Minor defects were evident throughout the dwelling at the time of inspection, which are consistent with normal wear and tear and considered appropriate for a property of this age.

These defects are typical of ongoing material ageing, settlement, and general use over time, and include, but are not limited to:

- Blind cords not fixed to walls
- Small leak to kitchen mixer

While these defects are not considered structurally significant at present, they should be addressed as part of routine and ongoing property maintenance to prevent further deterioration. Repairs and maintenance works should be carried out by appropriately licensed and qualified tradespeople to ensure the continued serviceability and longevity of the dwelling.

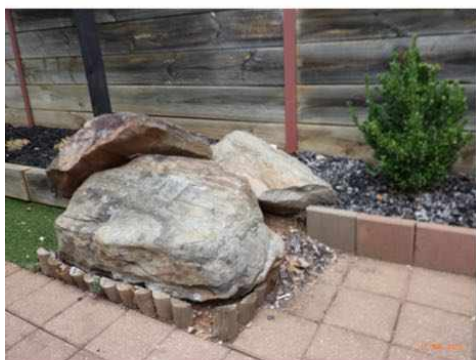
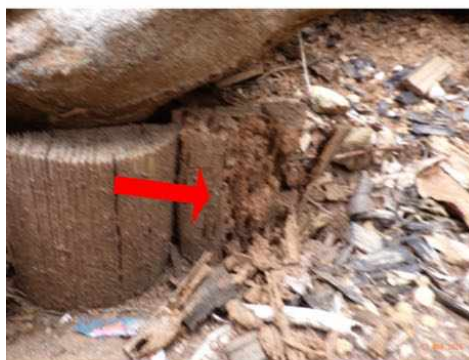
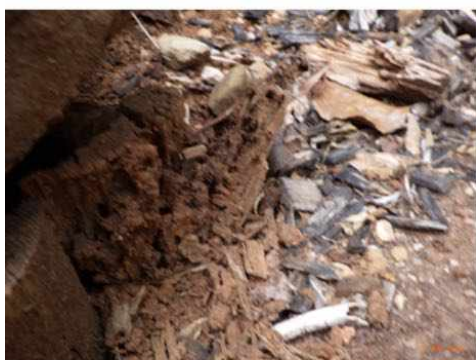
Building: Building 1
 Location: Yard - Back
 Finding: Evidence of termite damage - minor
 Information: Despite no live termite or timber pest activity being indicated, previous termite damage was found to have affected this area. This damage is considered to be inactive and is minor in nature.

It is advised that the area be visually inspected frequently to ensure that the condition of affected building materials does not worsen. At the time of inspection, damage is not structural and is only considered to be superficial.

A building contractor may be appointed to provide a further invasive inspection if further damage is evident.

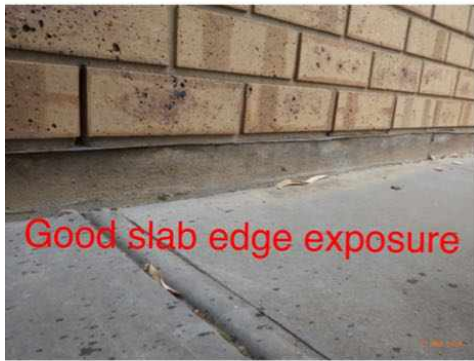
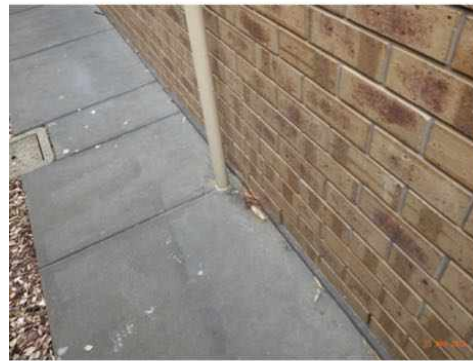
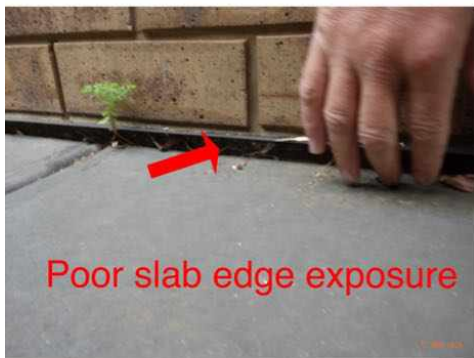
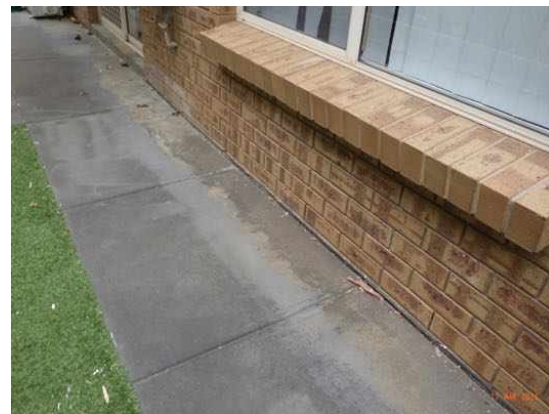
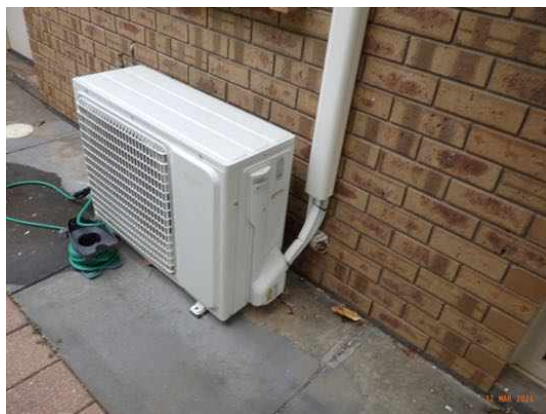
Finding 6.01

If the slab edge is not properly exposed there is a high risk of concealed termite attack which your inspector will likely not be able to see. Sometimes, in order to determine the type of slab, a suitably qualified person such as an architect or builder may be required to consult construction plans.

Where the slab edge cannot be properly inspected, it is highly recommended that termite or timber pest inspections be carried out every 6-12 months to aid protection of the property against infestation and termite treatment advice is followed closely.

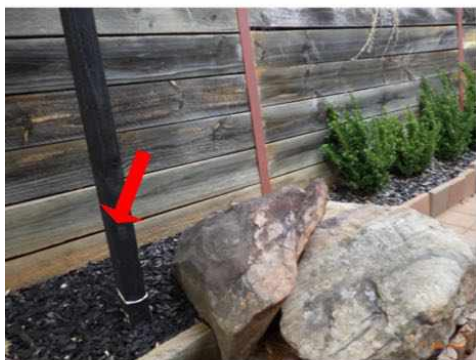
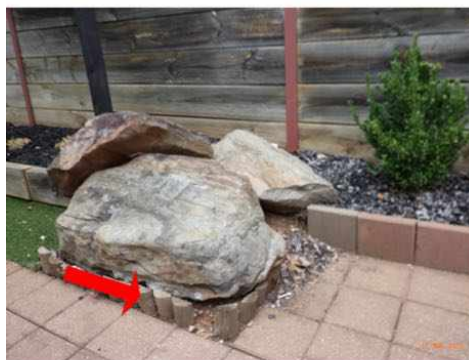
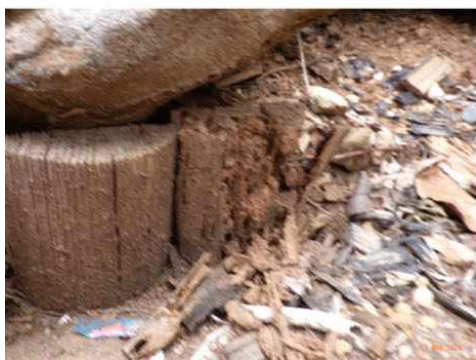
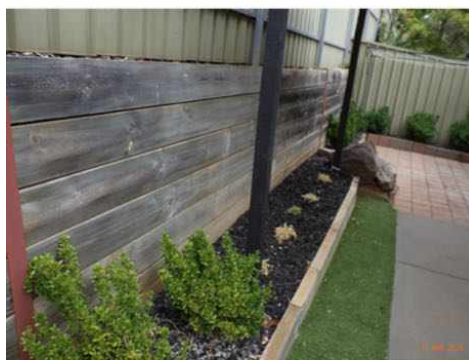
Finding 6.02

Building: Building 1
 Location: Yard - Back
 Finding: Untreated or non-durable timbers in a hazardous environment
 Information: To reduce the risk of timber pest attack it is essential that timber used in a hazardous environment (e.g. in direct contact with the ground or frequently exposed to damp conditions) is of sufficient durability and/or is adequately preservative treated. Additionally any timber lying around or timber stumps should be removed.

Untreated timbers in direct contact with the ground are likely to develop severe wood rot and/or fungal decay if left unattended creating attraction for subterranean termites

to infest the timbers from surrounding areas.

If untreated or non-durable timbers are found to be in a hazardous environment it is highly advised that replacement of these building elements be performed as soon as possible to aid the protection of the property against termite / timber pest attack. Failing this close monitoring is recommended in an attempt to identify termite infestation at an early stage.

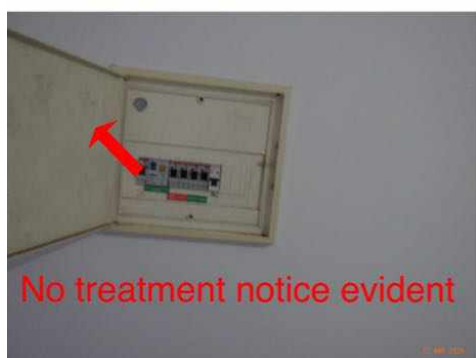
Finding 6.03

Building:	Building 1
Location:	All Areas
Finding:	Termite Management System - no evidence of a chemical installation
Information:	The application of a post-construction chemical termite barrier is highly recommended for all properties, particularly if live termite activity has been found on the site previously. Such barriers are highly effective in preventing termite attack on any timber building elements throughout the property.

At the time of inspection, it appeared as though no termite management system has been installed, with no evidence to suggest preventative works taking place.

The client may consider gaining further advice from a pest controller as to the costs and procedures involved with this application. It is recommended that obtaining such advice be a short-term priority.

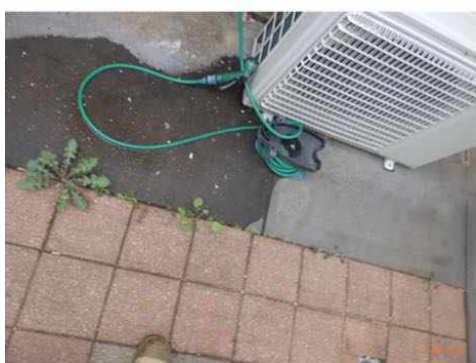
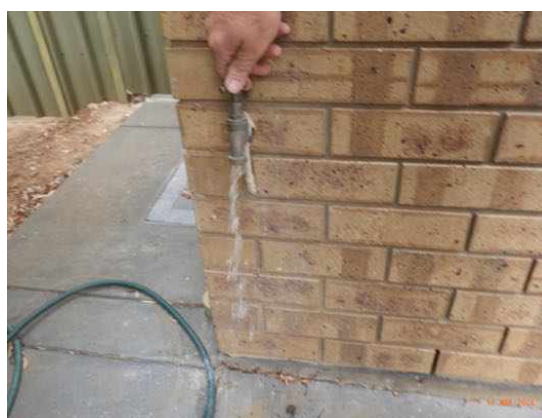
Finding 6.04

Building:	Building 1
Location:	All External Areas
Finding:	Air conditioner and or external tap - No drainage
Information:	Moisture around the perimeter of the building should be minimised to ensure that the area is kept dry and stable which in turn reduces the risk of water damage and termite infestation.

There appears to be no drainage points set up to the air conditioning unit, and or the external tap. While this is not a legal requirement it is recommended to reduce the risk of moisture related issues and the creation of an environment conducive to termite activity.

It is recommended that a licensed plumber be appointed to set up drainage in order to prevent such an environment from being created.

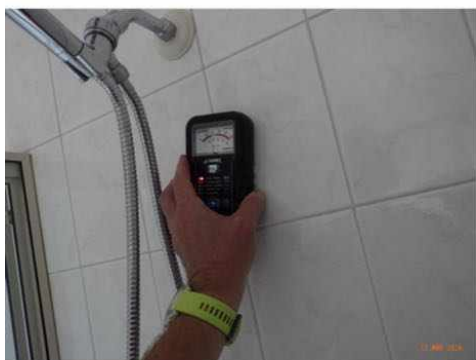
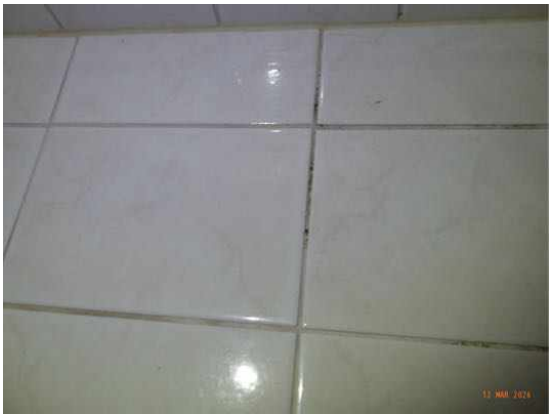
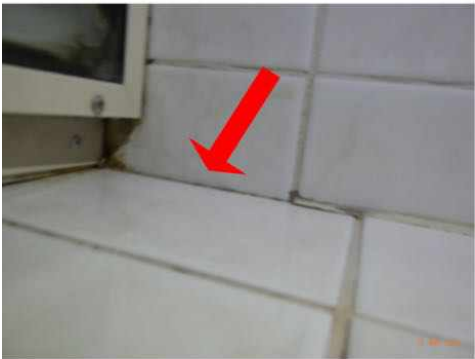
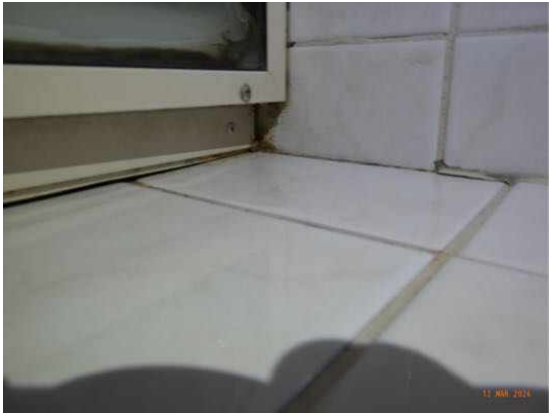
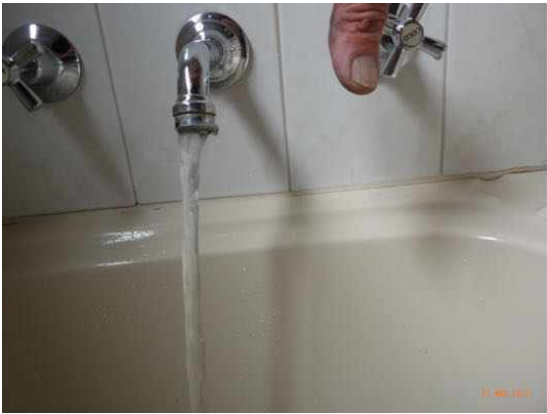
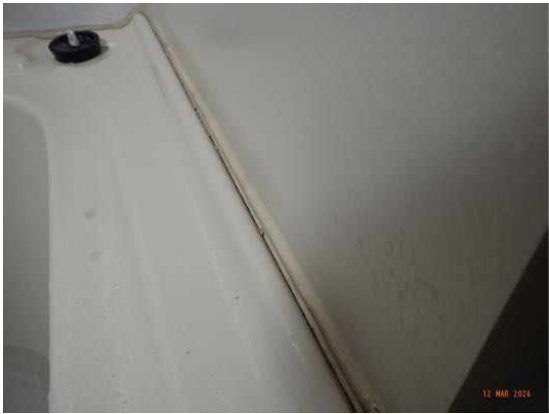
Finding 6.05

Building: Building 1
Location: Bathroom
Finding: Sealant and grouting - Regular maintenance
Information: It was noted on inspection that sealant and grout has small areas of deterioration evident to the shower alcove at the time of inspection. There are also very fine cracks to 2 floor tiles to the shower.

Silicone and grout generally need repair at least every 5 years and as such close monitoring should be carried out in the future after repairs are carried out.

Different materials and floor areas move at different rates, generally causing cracking to grout or sealant at this point. A flexible sealant is required to allow for expected expansion and contraction, while keeping the joint water tight and protective of all associated building materials.

Flexible and mould resistant materials should be applied to affected areas to prevent any subsequent water damage that is likely to occur. Regular maintenance and replacement of damage or missing or damaged sealant and grout is highly recommended to the wet areas, as this is a regular wear and tear defect. Sealant and grouting in areas that come into regular contact with water should be maintained for the long term care of your property.

A sealant specialist or tiling contractor should be appointed to complete these works as soon as possible
