Building and Timber Pest Inspection Report

Inspection Date: Wed, 25 Mar 2026

Property Address: 2/464 Victoria St, Brunswick West VIC 3055, Australia

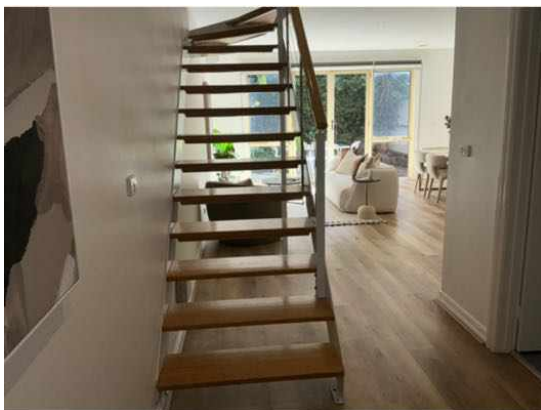
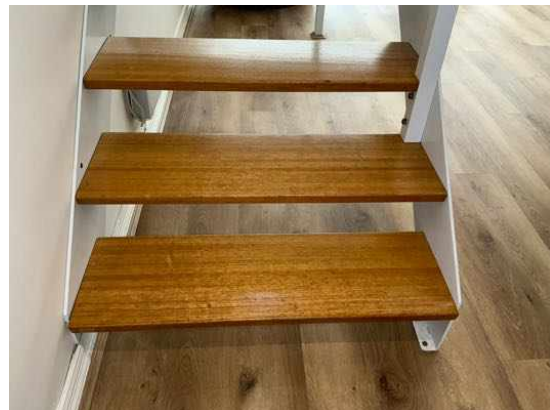
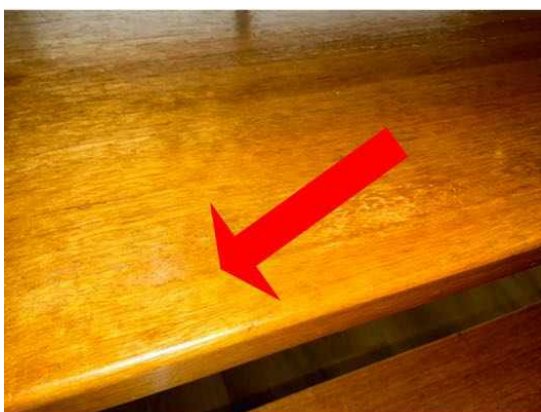
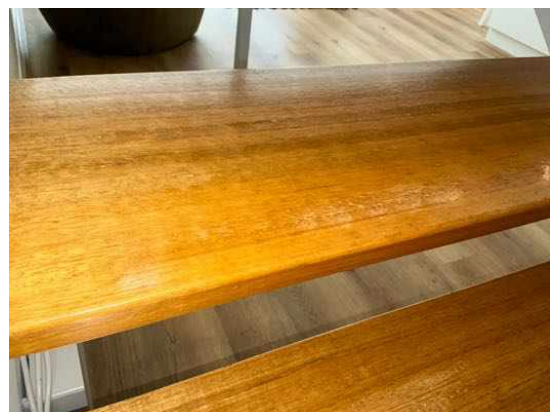
Finding 1.01

Building: Main Building
Location: Stairs - Internal
Finding: Stairs slippery finish
Information: It was observed that the polished timber stairs were finished in a coating that has no slip index rating and appears to be quite smooth

Polished timber stairs should be finished in an appropriate non-nonslip coating with a rough surface finish. Alternatively the stairs should be fitted with nonslip nosing to the treads or a non-slip tape to the stair treads

A general handyman or painting contractor should review as soon as possible.

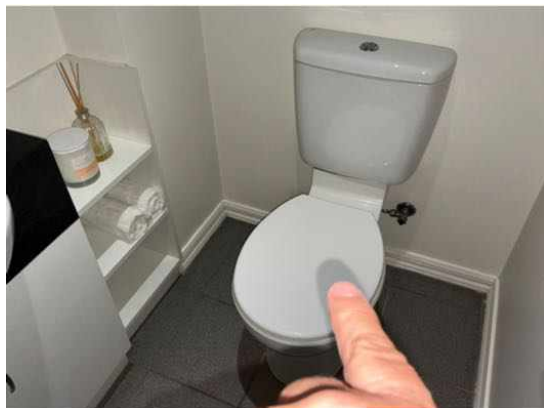
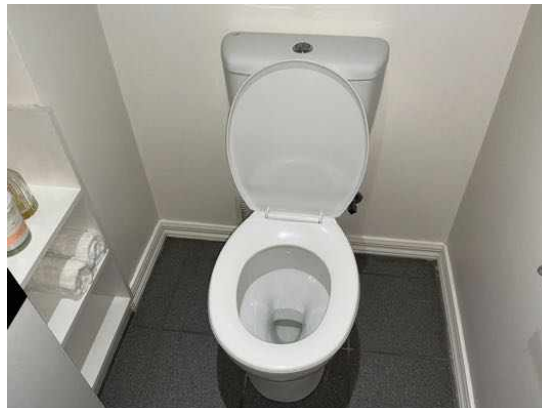
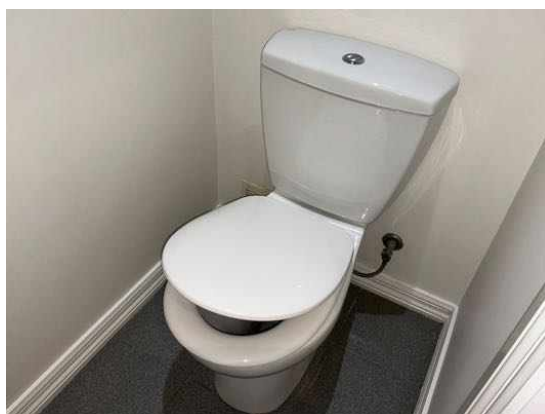
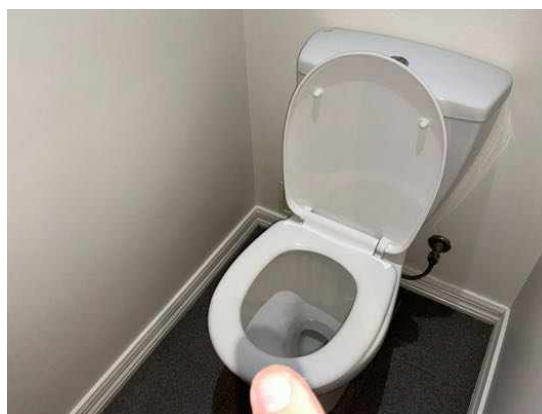
Finding 1.02

Building: Main Building
Location: Both WC seats
Finding: Toilet seat loose

Information: It was observed that the toilet seat was loose and unstable.

Loose seats can cause fall injury to persons while in use and lead to serious injury

A licensed sanitary plumber should be engaged to review prior to use

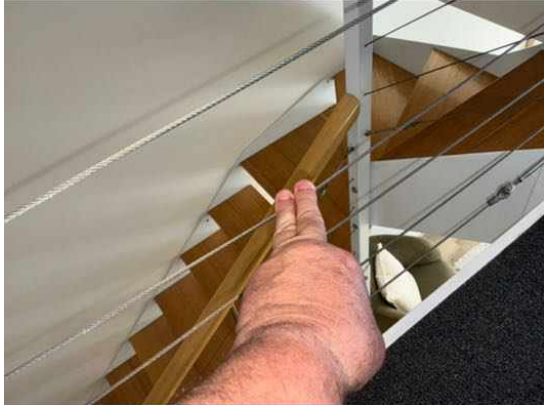
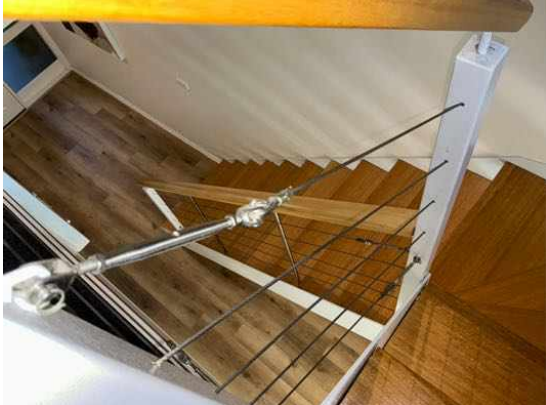
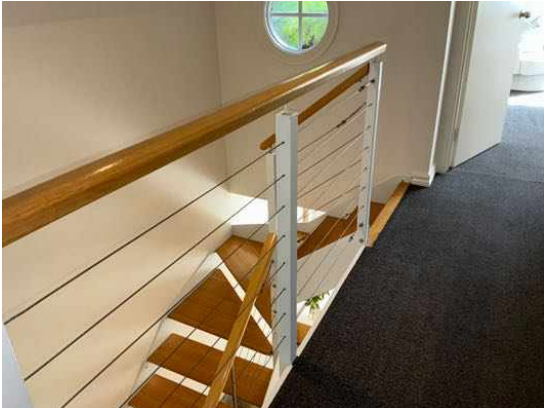
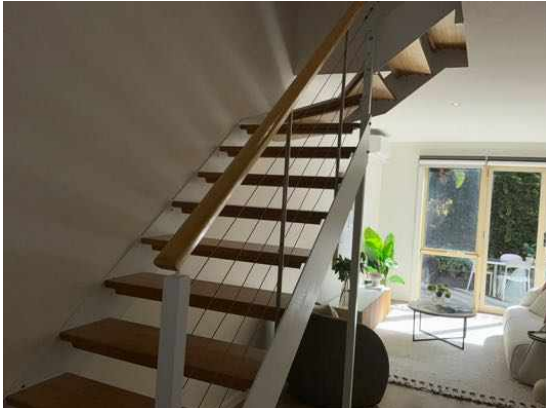
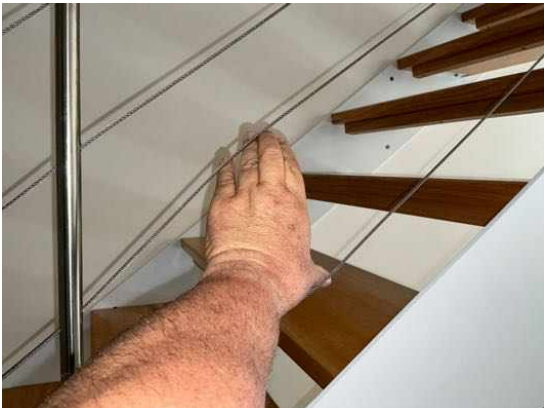
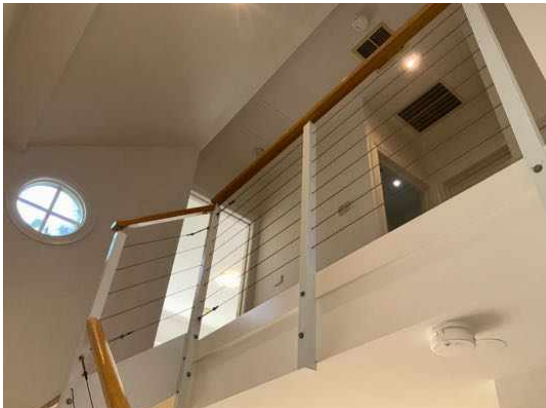
Finding 1.03

Building: Main Building

Location: Stairs - Internal

Finding: Balustrade - Suspected Non-Compliance

Information: The balustrade wires were measured and found to be less than the present building regulation requirement. The gaps between the balustrade cladding or wires were found to be greater than the present building regulation requirement of 125mm.

As with all constructions, compliance for a particular dwelling need only meet the regulations of the build date and not necessarily future changes to specific building regulations.

Some changes to the building regulations are made to ensure the safety of all inhabitants and balustrades are definitely one of those crucial regulations.

This defect creates a potential safety hazard and should be rectified as soon as possible to ensure the safety of the area and to meet present building standards and

regulations.

A registered builder should be contacted to discuss possible rectification solutions.

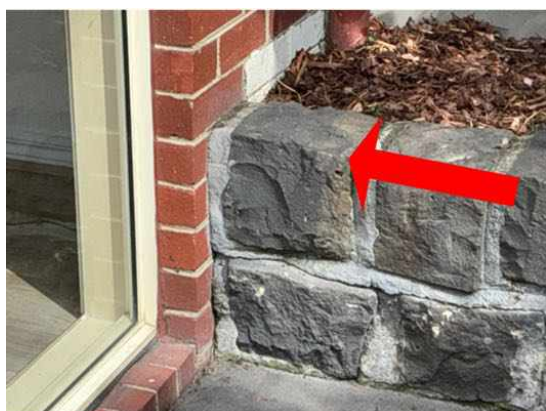
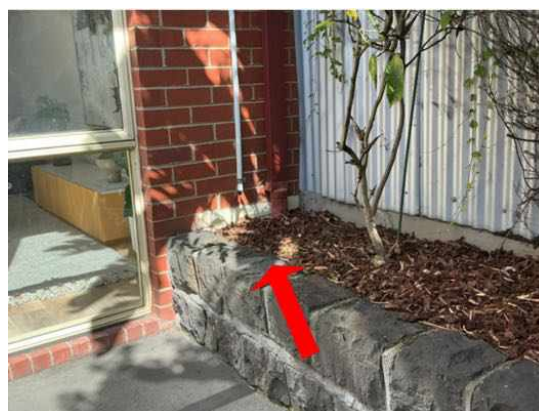
Finding 2.01

Building: Main Building
Location: Yard - Back
Finding: Retaining/brick veneer wall - Defective

Information: The brick veneer wall on the rear elevation was found to be retaining and defective at the time of inspection. Generally, defective retaining walls are caused by poor original design or material use. However, deteriorated retaining walls may also be a result of substandard construction, poor site drainage or unmanaged stormwater flows.

Significant repair and replacement should be expected. Where brick veneer walls are considered retaining walls, a structural engineer / surveyor should be consulted regarding required remedial works. Otherwise, a landscaper or retaining wall installer may be appointed to repair, replace or modify the wall and make it for purpose as soon as possible

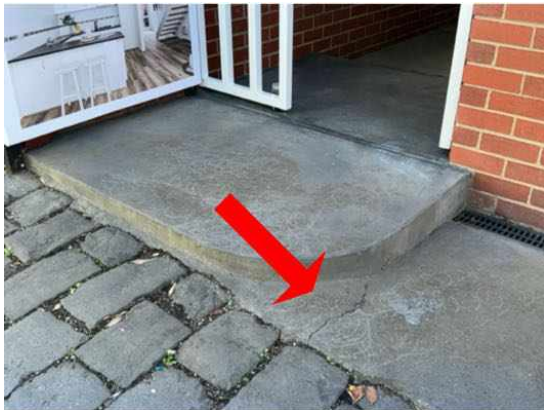
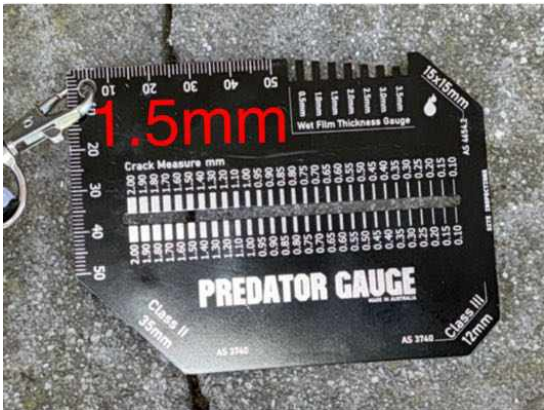
Finding 3.01

Building: Main Building

Location: Driveway

Finding: Cracking - Damage Category 2 - Noticeable (up to 5mm)

Information: Noticeable cracks are a common occurrence as a result of many primary defects. Such causes may include age, general wear and tear, expected building movement, general expansion/contraction of building materials in different weather conditions, and/or minor failings in the installation or application of building materials.

Noticeable cracks may result in minor sticking or jamming of associated doors and windows, which require easement. However, noticeable cracks are easily filled and repaired. A plasterer can be consulted to install an expansion joint at this point to allow for this movement during different weather conditions.

Monitoring of all cracking should be conducted frequently. Always contact a building inspector should cracks widen, lengthen, or become more numerous. Additionally, your building inspector should also be contacted if associated building elements such as doors and windows become more difficult to operate over time.

Relevant tradespeople, such as carpenters, painters and plasterers, should be

appointed to perform remedial works, as deemed necessary.

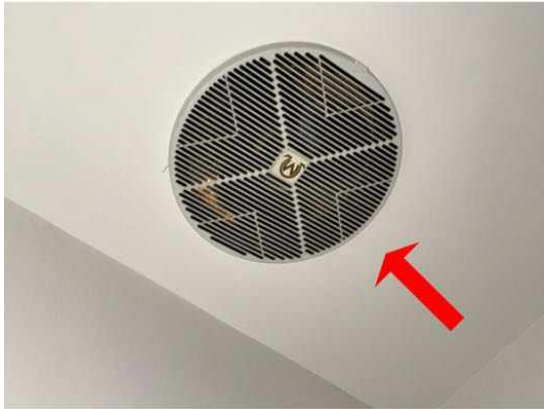
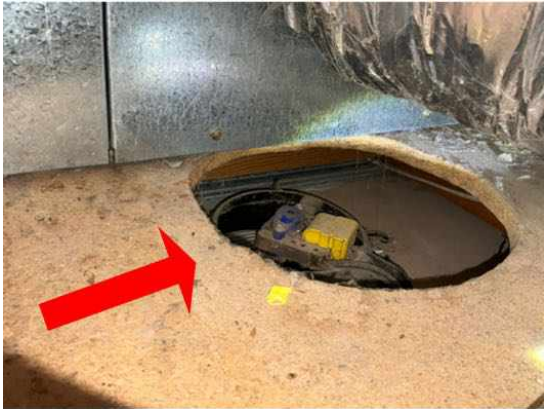
Finding 3.02

Building: Main Building
 Location: Roof Void
 Finding: Exhaust fans to bathrooms not ducted NH
 Information: It was observed that the exhaust fans in the roof space are not directed to an external source. The roof space does not provide adequate ventilation due to installation obstructing the fans and no external ducting or roof vents being provided.

Bathroom exhaust fans provide a means of egress for moisture steam vapour to exit the building. Excessive moisture in bathrooms could lead to conducive conditions for mould growth and premature deterioration of other building elements.

A licenced plumber should be engaged to review at the owners discretion.

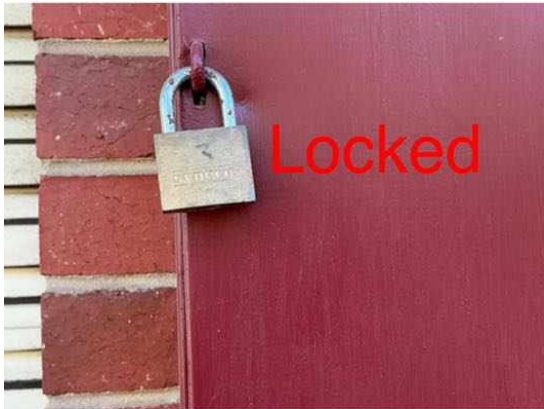
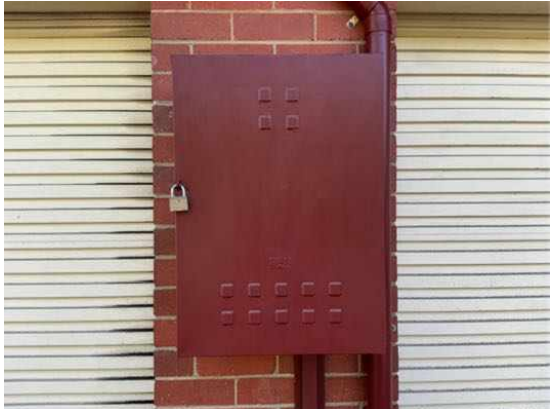
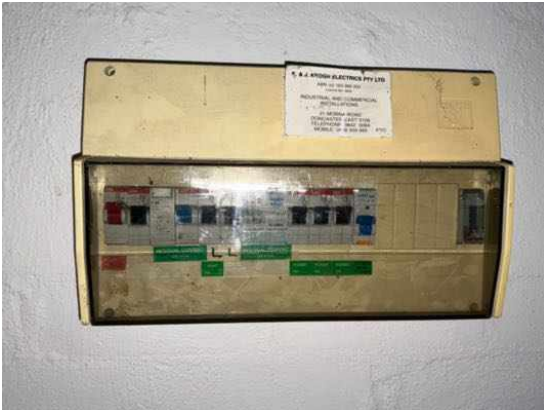
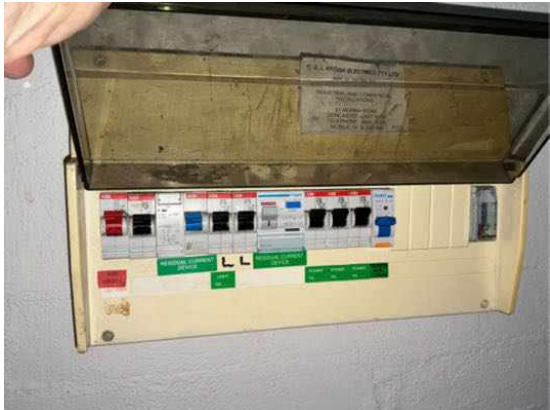
Finding 6.01

Building: Main Building
 Location: Meter Box
 Finding: Termite Management System - no evidence of a chemical installation
 Information: The application of a post-construction chemical termite barrier is highly recommended for all properties, particularly if live termite activity has been found on the site previously. Such barriers are highly effective in preventing termite attack on any timber building elements throughout the property.

A durable notice should be placed in the switchboard unit to indicate current termite barriers. At the time of inspection, it appeared as though no termite management system has been installed, with no evidence to suggest preventative works taking place.

The client may consider gaining further advice from a pest controller as to the costs and procedures involved with this application. It is recommended that obtaining such advice be a short-term priority.

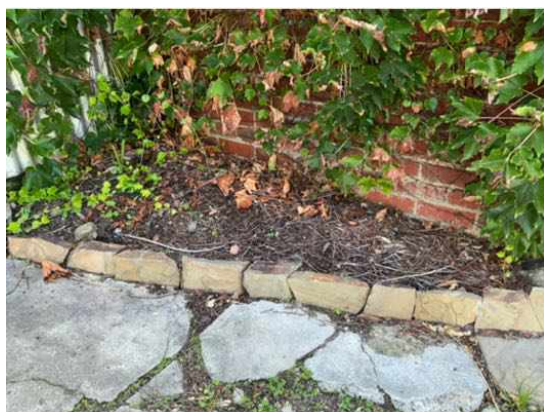
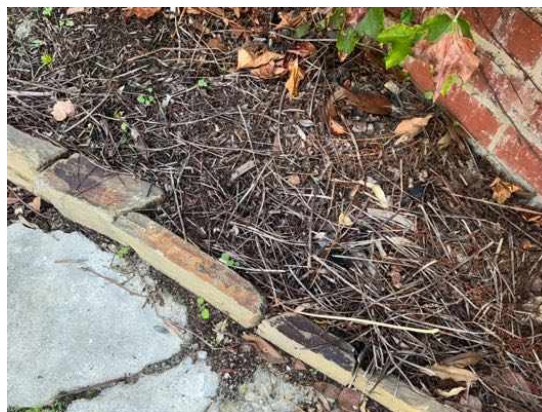
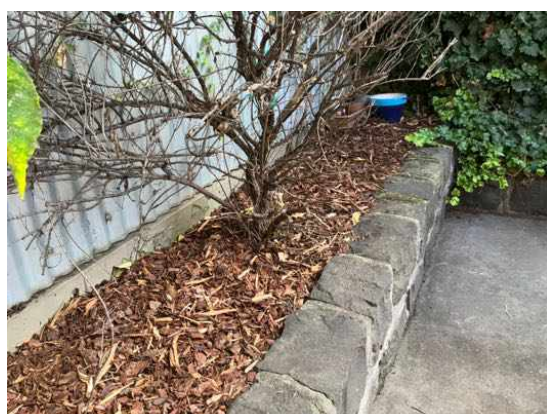
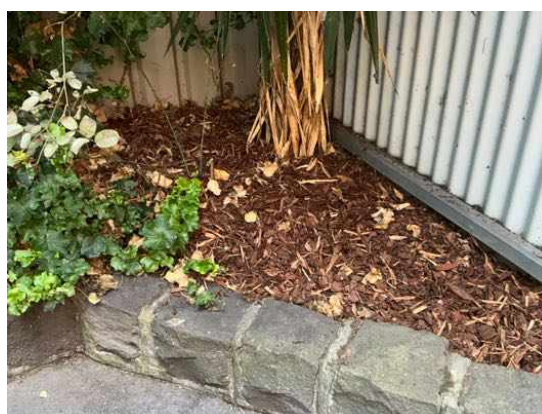
Finding 6.02

Building:	Main Building
Location:	All External Areas
Finding:	Garden Beds - Conditions Conducive to Termites
Information:	Garden beds were found to be evident in the garden area. These garden beds can include untreated timber, and with a combination of moisture from watering hosing can make conditions conducive to termite activity and termite ingress.

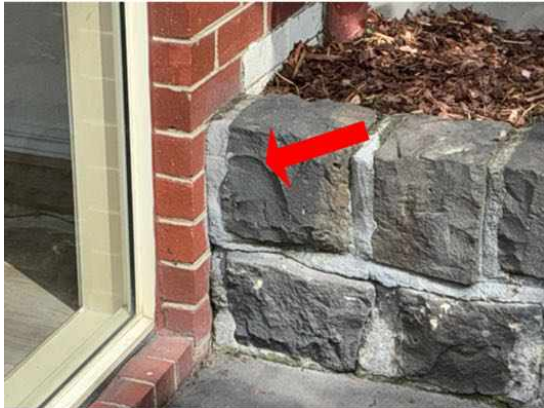
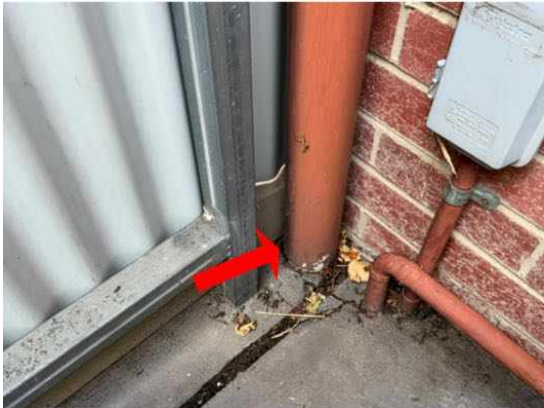
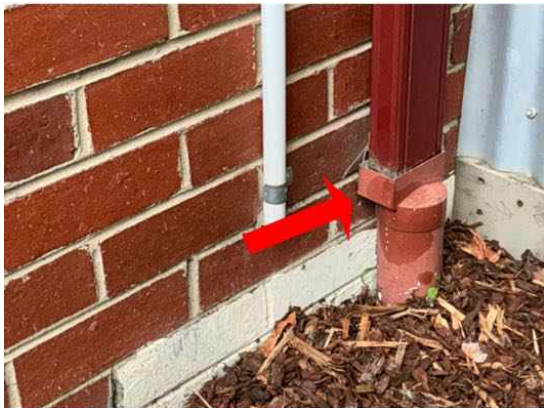
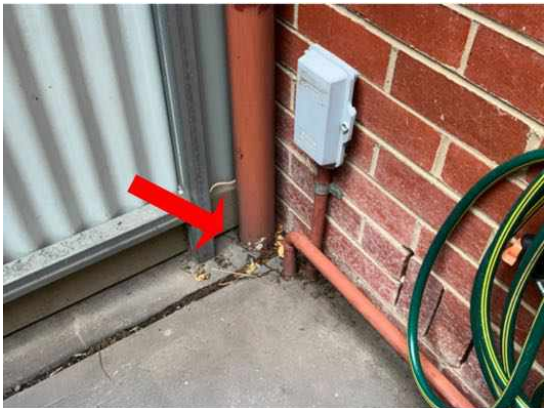
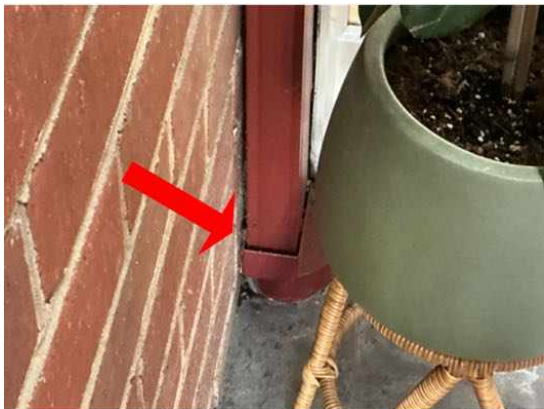
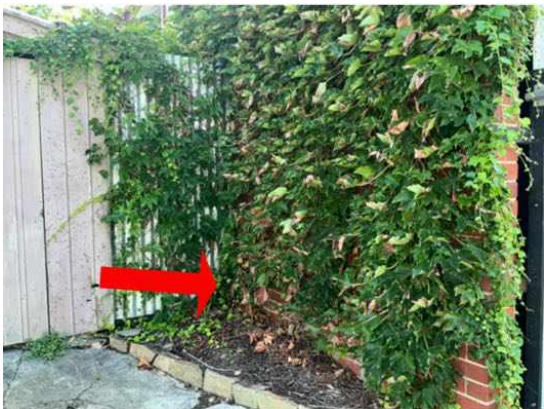
Finding 6.04

It is important for internal flooring to be raised above adjacent external ground levels. Where external ground levels are above internal flooring water pooling and subsequent internal flooding is likely to occur which may attract termite activity to the internal area.

It is highly advised that a landscaper or paver be appointed to lower external grounds that are raised above adjacent internal flooring. Alternatively if external grounds and internal flooring is level installation of a raised door sill may be appropriate in preventing any water pooling in the area.

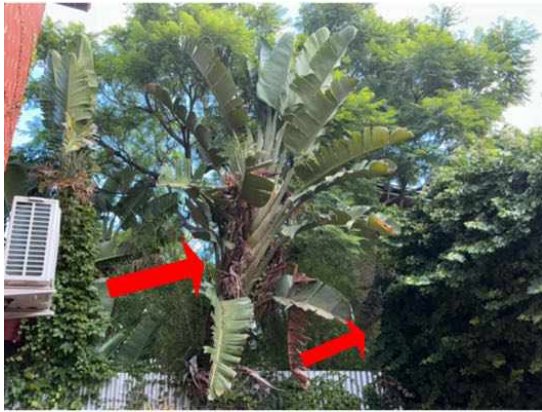
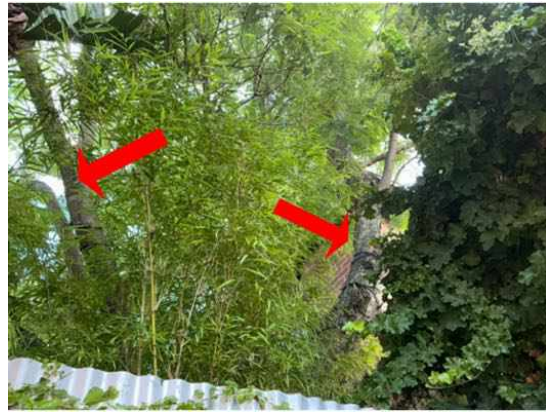
Finding 6.05

Building: Main Building
 Location: All External Areas
 Finding: Trees/large/termite
 Information: It was observed that there were several large trees next to or nearby the building.

The trees have the potential to provide conducive conditions for termite infestation

It is recommended that periodic 12 monthly inspections by a registered pest control contractor be undertaken and further reinstatement of outdated termite barriers as

soon as possible.

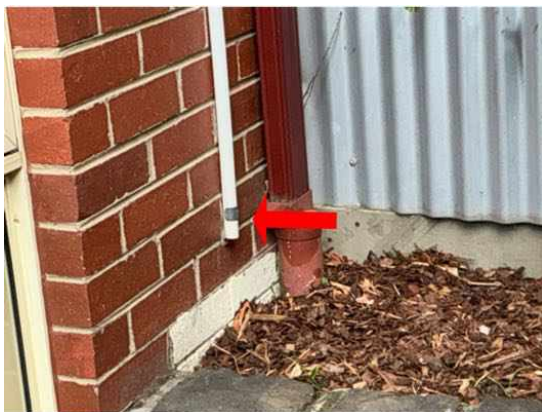
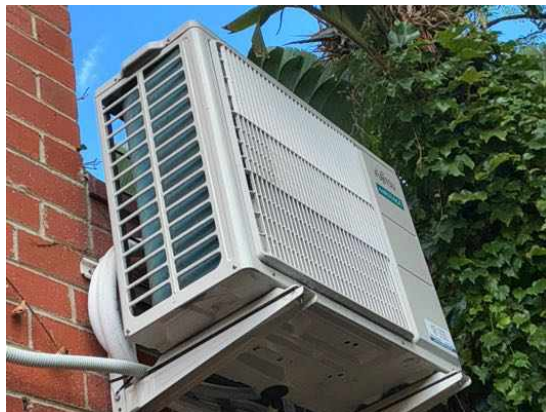
Finding 6.06

Building:	Main Building
Location:	Exterior walls - rear
Finding:	Air conditioner condenser pipe not connected
Information:	The A/C Condenser overflows were found to be disconnected from the stormwater system and is creating excessive moisture to the surrounding area.

Such leaking creates an environment which is conducive to an array of defects including water damage to associated building materials and the attraction of termites or timber pest infestation.

A Licensed plumber should be engaged to review as soon as possible

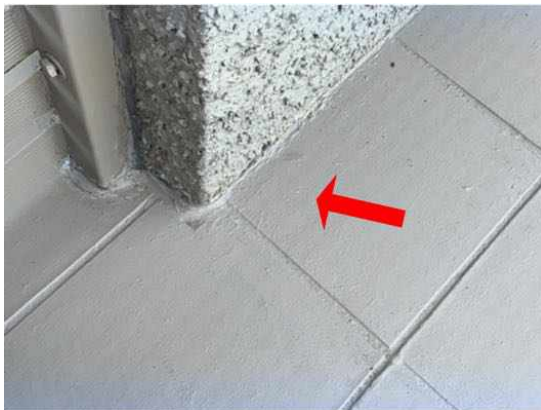
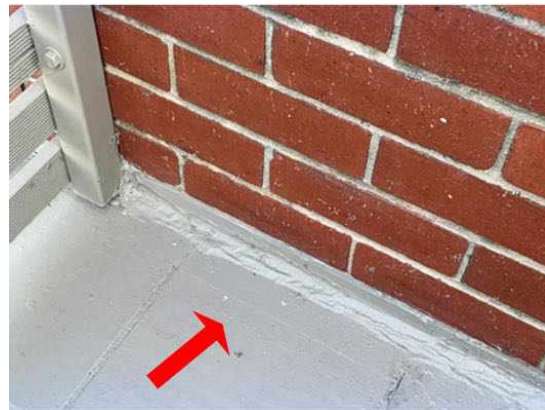
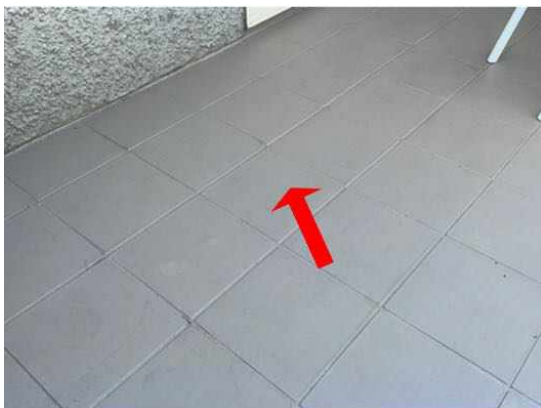
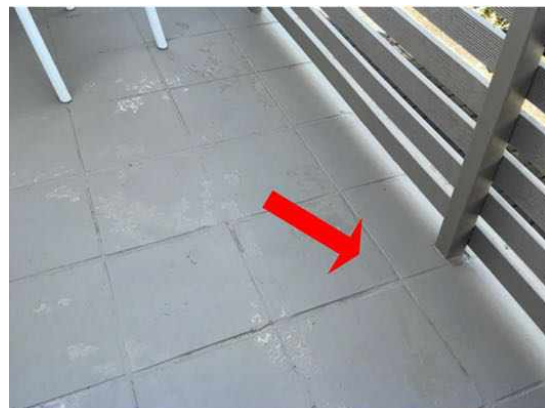
Noted Item

Building: Main Building
 Location: Balcony
 Finding: Balcony tiles/painted
 Information: It was observed at the time of the inspection that the floor tiles to the balcony have been painted/sealed. It is unknown if the tiles have been sealed to repair a previous water leak or if they have been sealed to provide a more pleasing aesthetic appeal.

No evidence of leaking moisture was found however it is recommended that this area be monitored for any moisture ingress that may occur. Should the floor tiles have been previously repaired and sealed.
