Building and Timber Pest Inspection Report

Inspection Date: Thu, 29 Jan 2026

Property Address: 1A Keysor Rd, Pagewood NSW 2035,
Australia

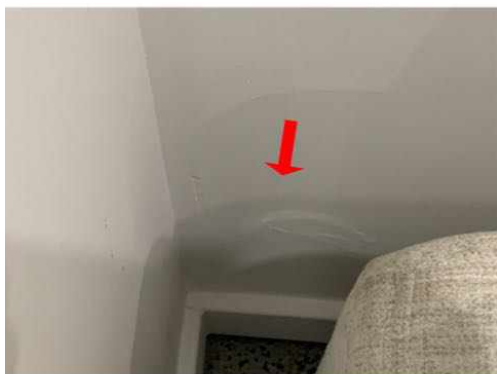
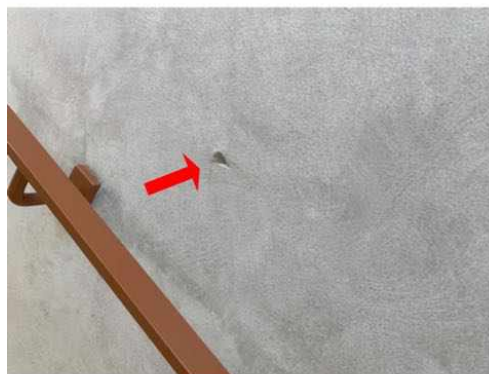
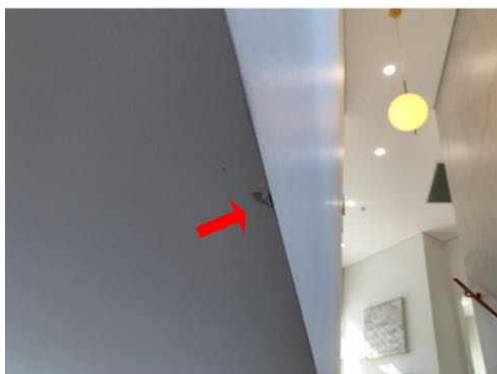
Building: Main Building
Location: Garage / Stairs
Finding: Wall lining - Damaged
Information: Breakage occurs generally when the building materials have either aged and decayed, or as a result of damage (accidental or deliberate).

Repair and/or replacement of broken elements is advised to ensure that additional secondary defects do not arise as a consequence. Such works are necessary, as all building elements play a key role in the operation and function of the overall structure and its performance.

A relevant tradesperson should be appointed to repair or replace the affected building element prior to any subsequent damage being caused.

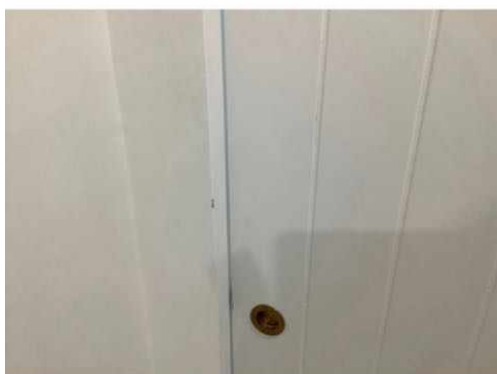
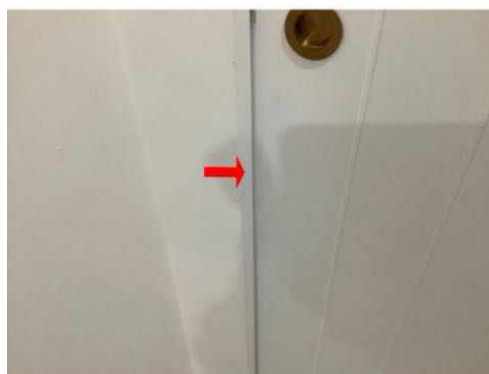
Finding 3.02

Building:	Main Building
Location:	Laundry
Finding:	Sliding Door - Stiff to slide (Note: Not closing fully)
Information:	The sliding door in this area was jammed and difficult to slide along the associated tracks at the time of the inspection. Restricted function of the affected door may pose as a potential safety hazard if required for emergency egress from the building.

Generally, factors such as general age of the building element and a lack of maintenance are the usual causes for this type of defect.

Replacement of door hardware or tracks may be required, as well as minor repairs and cleaning. A registered builder or general handy person will be required to repair the affected doors.

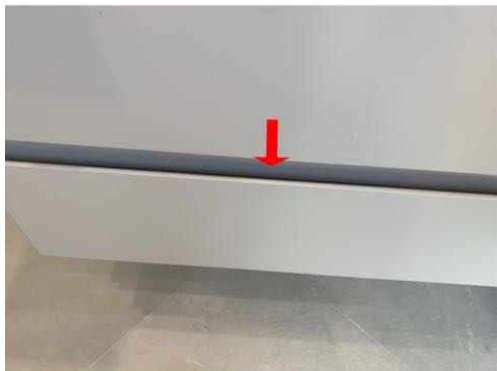
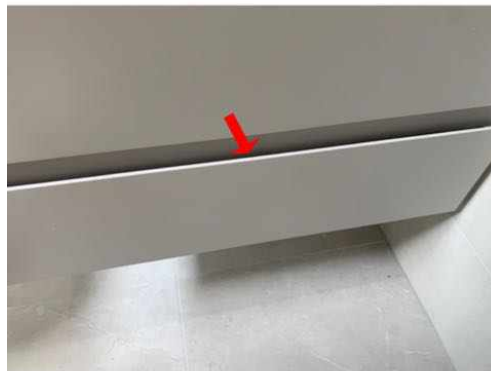
Finding 3.03

Building:	
Location:	Ensuites x2
Finding:	Built-in drawers - soft close
Information:	It is observed that some of the built-in drawers soft close function was not operating as intended.

The nominated project built-in contractor should be directed to rectify and adjust accordingly to operate as designed.

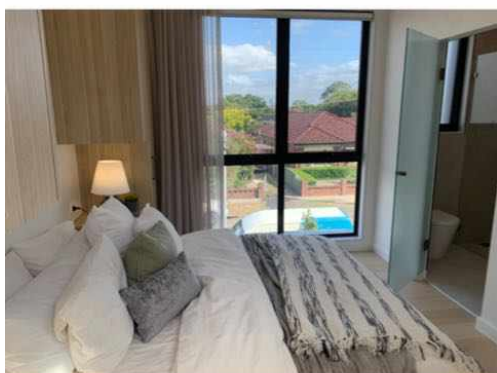
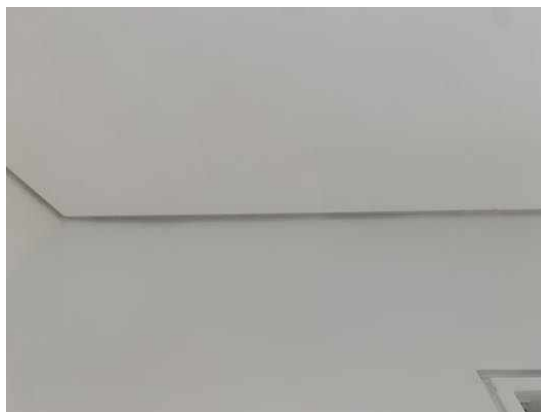
Finding 3.04

Building:	Main Building
Location:	Bedroom
Finding:	Ceiling Lining / Wall Angle Cracking - Damage Category 1 - Fine (up to 1mm)
Information:	Although fine cracks are quite noticeable, they are often only considered to be an appearance defect, and usually do not indicate any structural damage. Generally, the cause of a fine crack is indicative of a separation between building materials and finishes (e.g. paint, plaster, etc.) along joints.

Cracking of this nature can generally be repaired with minor sanding, filling and/or repainting. Such works should be performed by a qualified painter or a general handyman.

Monitoring of all cracking should be conducted frequently. Always contact a building inspector should cracks widen, lengthen, or become more numerous.

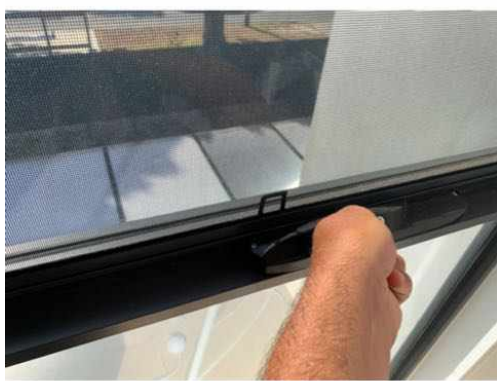
Finding 3.05

Location: Lounge Room 2
 Finding: Window - Stiff to operate / jammed
 Information: The window in this area was jammed and difficult to operate at the time of the inspection. Windows provide ventilation to the adjoining area and should be at a fully operational level to ensure user comfort. Restricted function of the window may also pose as a potential safety hazard if required for emergency egress from the building.

Generally, factors such as general age of the building element and a lack of maintenance are the usual causes for this type of defect.

Replacement of window hardware or frame may be required, as well as minor repairs and cleaning. A registered builder or general handy person will be required to repair the window.

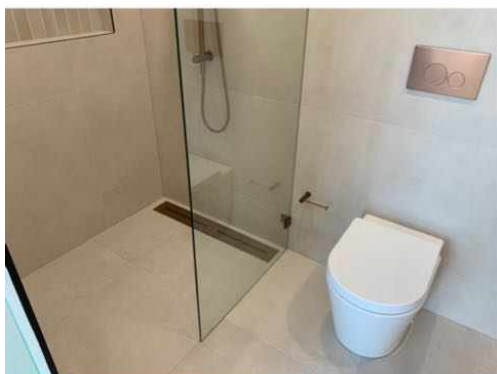
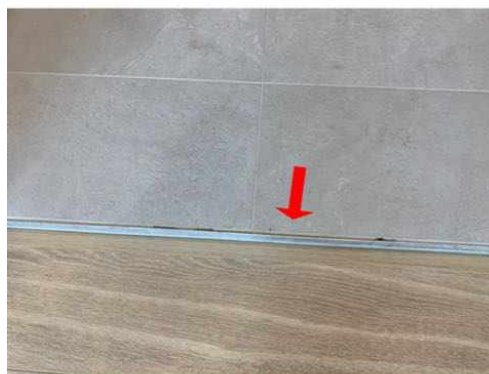
Finding 3.06

Building: Main Building
 Location: Ensuite - Master
 Finding: Grout - Missing
 Information: Grout is missing in this area. Grout is used to protect gaps and crevices in building materials to ensure that they are water-tight and prevent water penetration to the associated structures.

Where grout is missing, a tiling contractor should be appointed immediately to apply grout and re-apply any silicone where necessary. Failure to do so is likely to lead to water damage to the surrounding area.

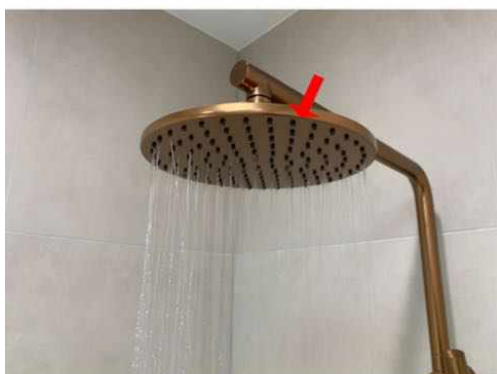
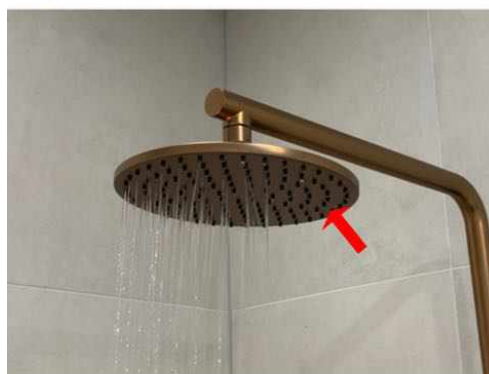
Finding 3.07

Building:	Main Building
Location:	Ensuite / Bathroom
Finding:	Shower head - Not operating (water not coming out of all nozzles)
Information:	Non-operational items should be addressed to ensure that the full function of the building structure is available. Where some building elements are not operating as intended, it is possible that secondary building defects could arise due to their non-operation.

Repair and/or replacement of the faulty building element is recommended. It is highly recommended that the relevant tradesperson be engaged to perform any necessary works.

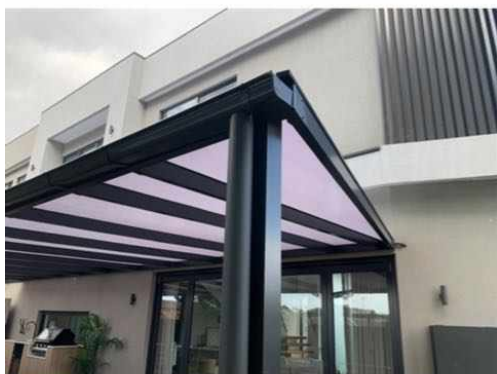
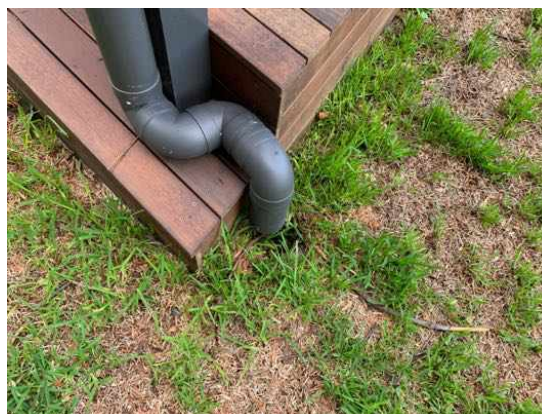
Building:	Main Building
Location:	Pergola
Finding:	Site drainage - Inadequate
Information:	The site drainage in this area was found to be inadequate at the time of inspection, creating potential for subsequent water damage to associated building elements.

It is important that water does not lie against the base of walls; surrounding paths and ground levels should be sloped to drain water away from walls. Downpipes should not discharge stormwater onto lower walls or plinths. Stormwater should be carried away by large, regularly cleaned drains. Ground levels may need to be lowered to expose a buried DPC.

Where site drainage is inadequate, installation of an Agricultural (Aggie) Drain may be required. A qualified plumber should be appointed to further inspect the property and perform any remedial works as necessary. Water damage and secondary defects are likely to occur if left unmanaged.

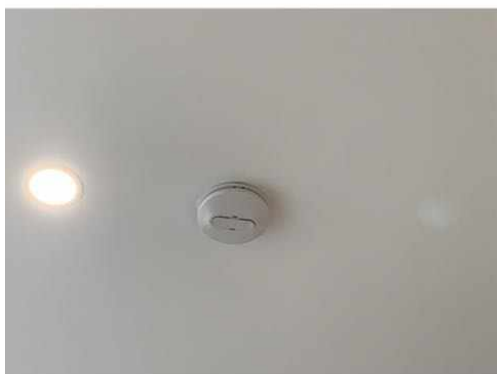
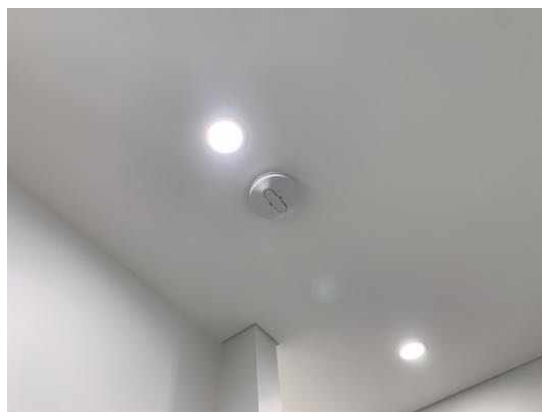
Please note that this defect is highlighted as a caution only. We suspect, based on our experience in the building industry, that the absence of smoke detectors, or their poor condition, should be addressed as a matter of urgency to improve occupant safety.

Note: The smoke alarms were not tested at the time of inspection, however, appeared to be operational.

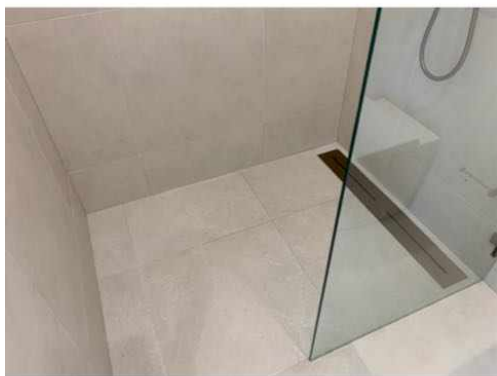
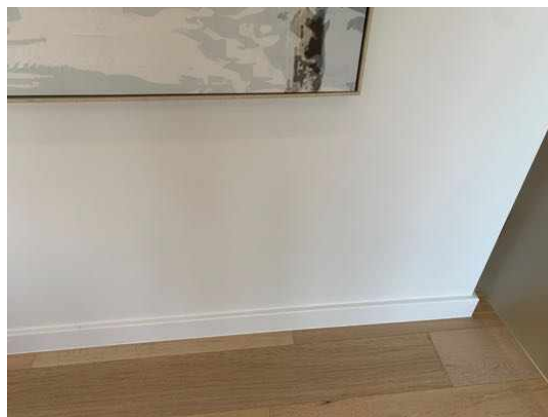
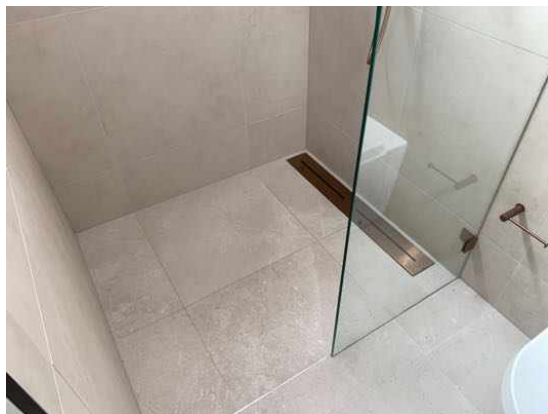
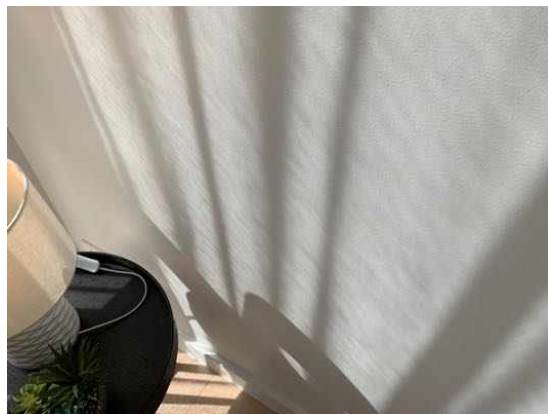
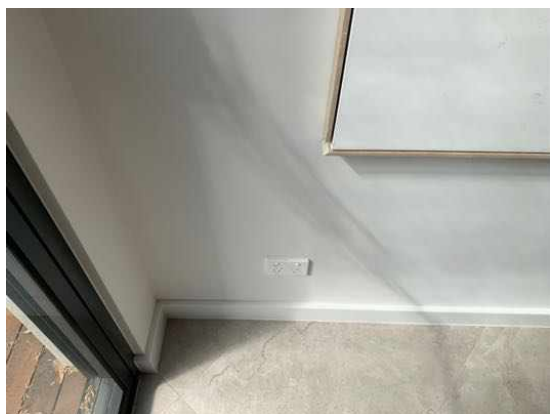
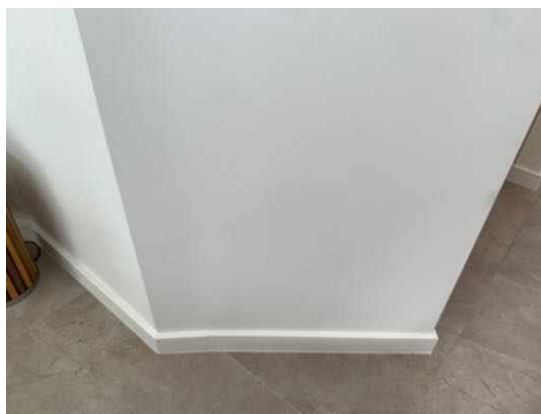
Building: Main Building
 Location: Hallway / Bedroom / Ground Floor Walls
 Finding: Moisture Readings - No Damp Detected

During the inspection a moisture meter was used to measure and evaluate the presence of damp to the rear of the shower recess walls (where possible) and the lower ground floor walls.

The moisture readings indicated either no damp or moisture readings that were in an acceptable range for the material being measured (ie masonry / platerboard).

Note: The upper level bathroom / ensuite were back to back, therefore, no moisture reading could be taken due to the wall tiling on each side of the wall.

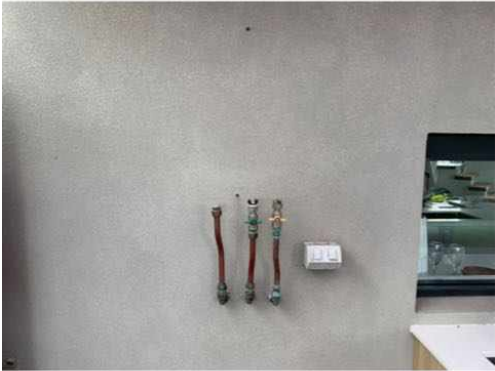
Building:	Main Building
Location:	Exterior walls - front
Finding:	Installation - Gas hot water unit incomplete (Note: On new builds gas hot water units are generally installed just prior to settlement)
Information:	The installation of this building element appears to be incomplete. Generally substandard repairs or installation are related to poor workmanship, the use of inappropriate materials, or a failure to complete installation to a suitable standard.

Where installation is substandard and/or incomplete, the client should contact the responsible trade to undertake rectification. Unfinished and substandard building works are likely to degrade more quickly and may create potential for secondary defects to associated building elements.

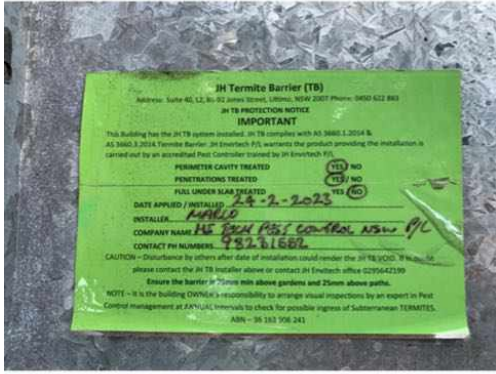
Where a Termite Management System has been identified you should refer to the type of barrier date of installation warranty conditions and any documentation provided by a builder or past owner. Consult the company who installed the barrier to confirm whether the system is still under warranty.

Most chemical termite management systems expire and require replenishment and all physical systems are primarily designed to prevent concealed entry.
