Building and Timber Pest Inspection Report

Inspection Date: Wed, 11 Mar 2026

Property Address: 2/65 Gladstone St, Newport NSW 2106,
Australia

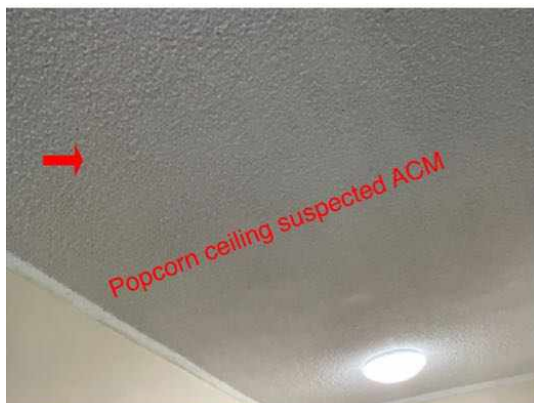
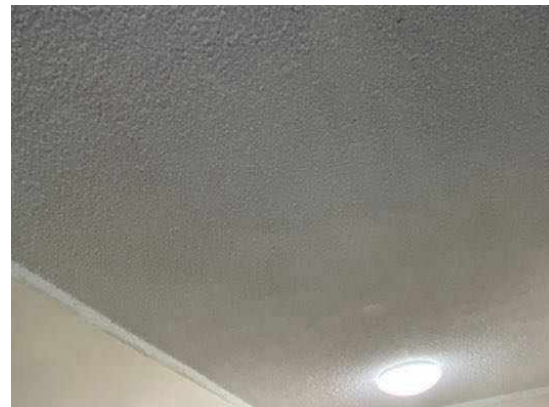
Finding 1.01

Building:	Main Building
Location:	All Areas
Finding:	Asbestos - Suspected ACM Identified on Site
Information:	Reporting on Asbestos is outside the Scope of this Report. This suspected defect is highlighted as a caution only. We suspect, based on our experience in the building industry, that there is a higher risk of the identified building element containing asbestos.

As Asbestos Reporting is outside the scope of this report, we advise that you consider a separate Asbestos Inspection and Condition Audit, which can include the taking of samples for definitive confirmation of the presence of Asbestos.

In the interim, the client is advised to act with caution, especially when considering any damage to building materials general wear and tear renovations extensions demolition and general maintenance activities due to the suspected presence of Asbestos.

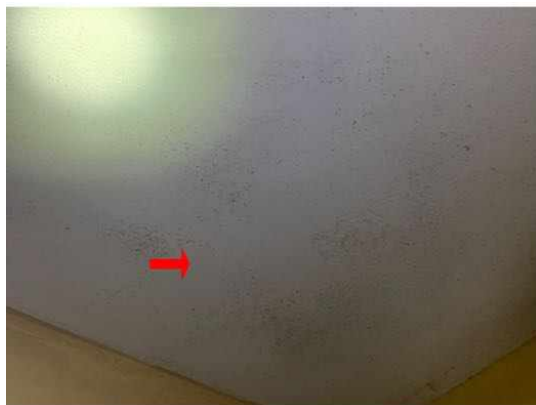
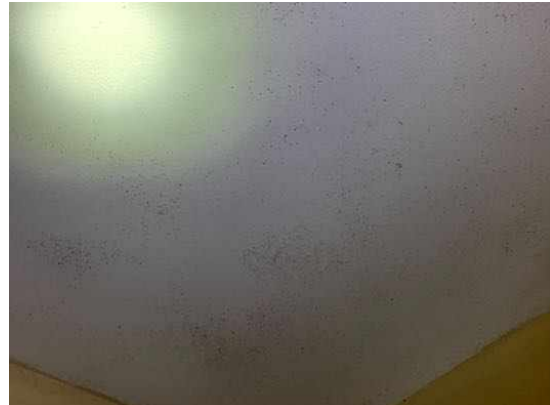
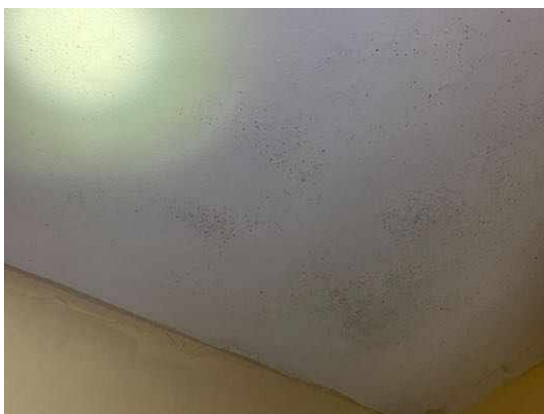
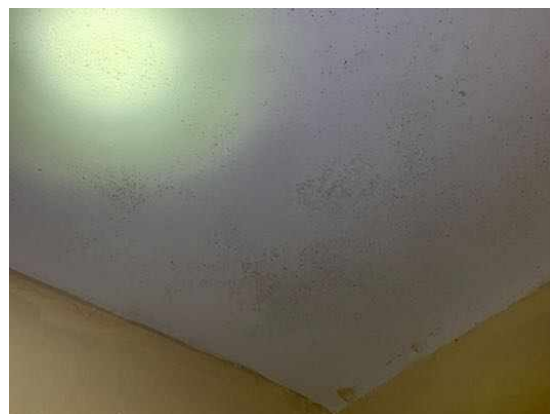
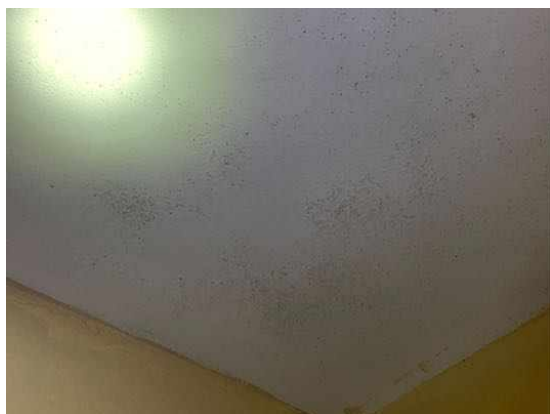
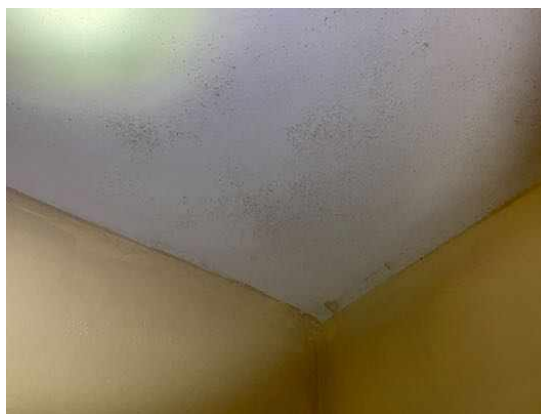
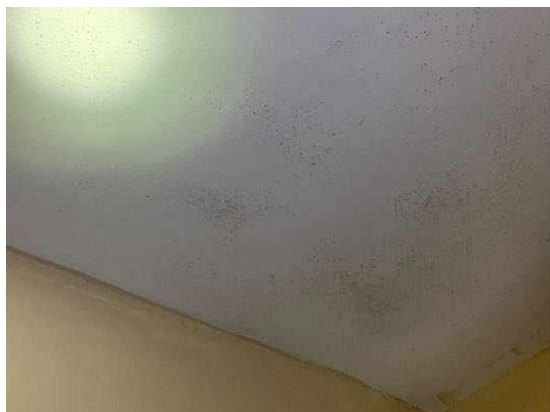
Finding 1.02

Building:	Main Building
Location:	Bathroom
Finding:	Mould - Present
Information:	Mold growth is present throughout the property, primarily due to inadequate ventilation. Poor airflow and moisture accumulation within the house have created ideal conditions for mold to thrive.

- ****Health Hazards****: Mold growth can pose serious health risks to occupants,

particularly those with allergies, asthma, or other respiratory conditions. Prolonged exposure to mold spores can cause respiratory issues, skin irritation, and other allergic reactions.

- **Structural Damage**: Mold can degrade building materials over time, leading to rot and weakening of the structural components such as timber, drywall, and insulation, which can result in costly repairs.

- **Decreased Property Value**: The presence of mold can significantly reduce the value of the property, as it indicates underlying moisture and ventilation issues that need addressing.

A licensed mold remediation specialist should be engaged to remove the mold and treat affected areas. In addition, a ventilation expert or builder should assess and improve the house's ventilation system, possibly installing exhaust fans, vents, or mechanical ventilation systems to ensure adequate airflow and prevent future mold growth.

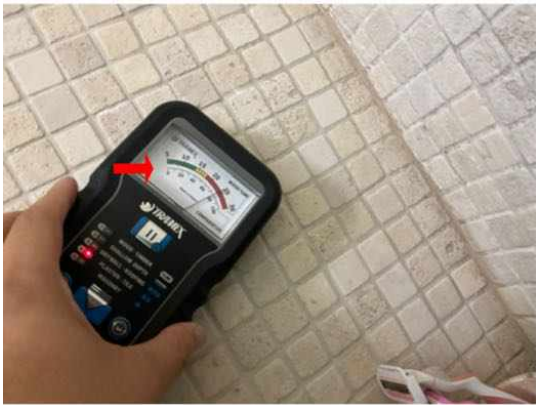
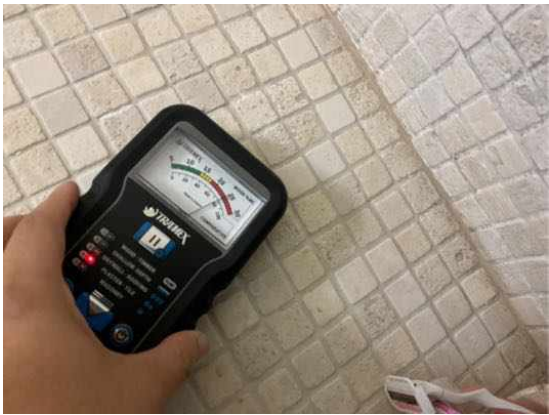
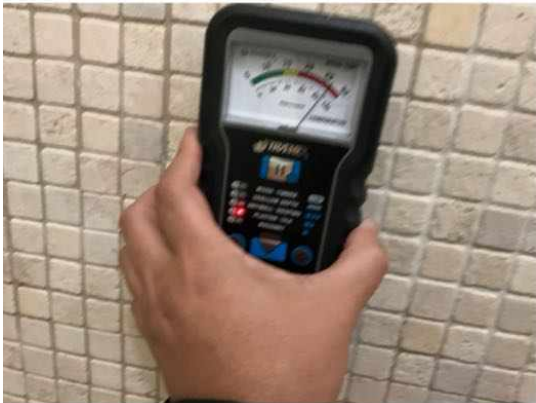
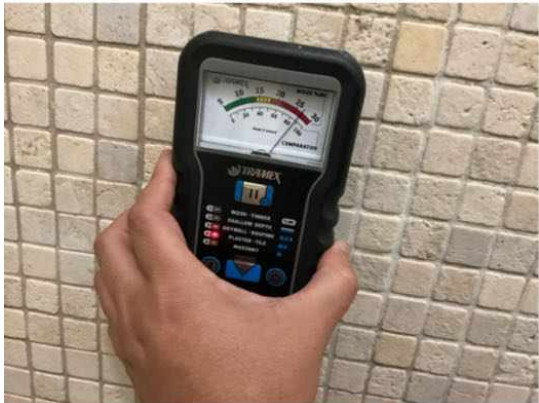
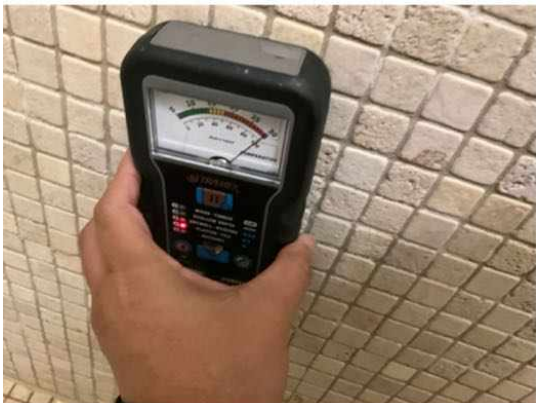
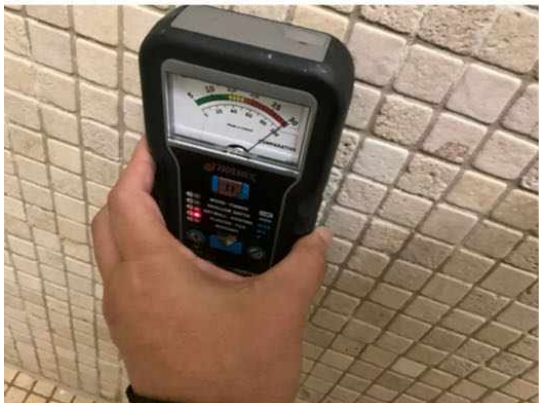
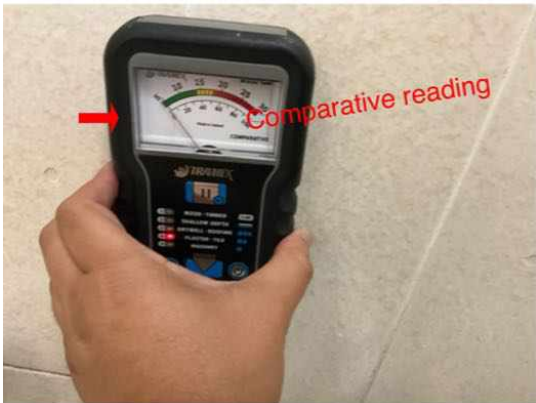
Finding 2.01

Building:	Main Building
Location:	Bathroom
Finding:	Evidence of excessive moisture was present at the time of inspection
Information:	Excessive moisture is present behind the bathroom tiles, indicating a potential water leakage issue within the wall.

The prolonged presence of moisture can lead to mold growth, deteriorate the structure, and create an environment conducive to health hazards. Additionally, it may compromise the adhesive holding the tiles, leading to their detachment.

A licensed plumber or a qualified contractor specializing in water damage remediation should investigate the source of the moisture, fix any leaks, and address the damage. Additionally, replacing affected tiles and ensuring proper waterproofing are crucial to preventing future issues.

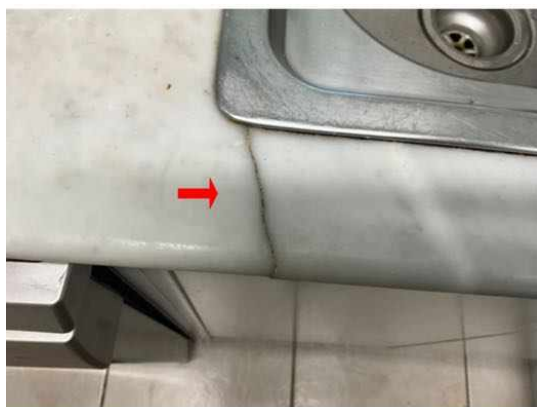
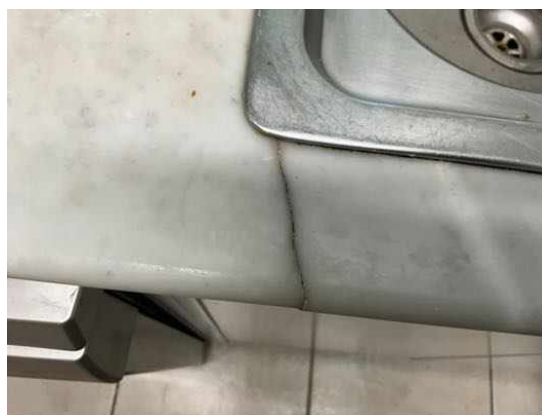
Finding 3.02

Location: Kitchen
Finding: Kitchen benchtop - crack fine

Information: A crack has been identified in the kitchen benchtop, compromising its structural integrity and aesthetic appeal.

1. Safety Hazard: The crack may widen over time, leading to potential injuries from sharp edges or structural instability.
2. Hygiene Concerns: The crack can harbor bacteria, mold, and other contaminants, posing a risk to food safety and hygiene.
3. Damage to Surrounding Areas: Water or other liquids may seep into the crack, causing damage to the underlying cabinets, flooring, or walls.

A qualified contractor or carpenter specializing in countertop repair or replacement should address the issue promptly. Depending on the severity of the crack, repair options may include filling the crack with epoxy or resin, reinforcing the benchtop, or replacing the entire countertop.

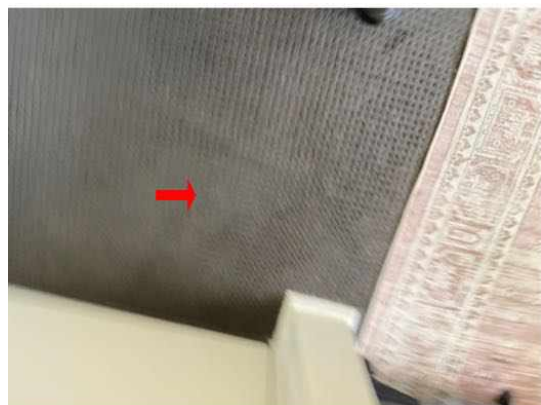
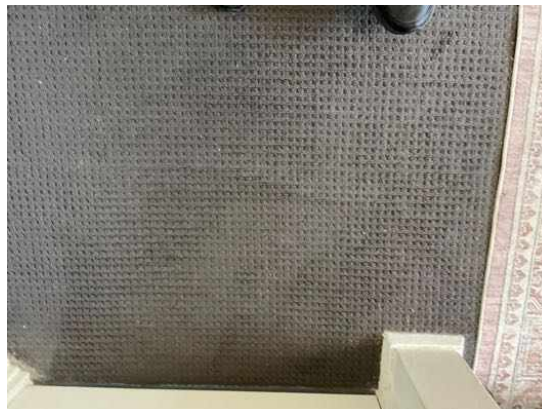
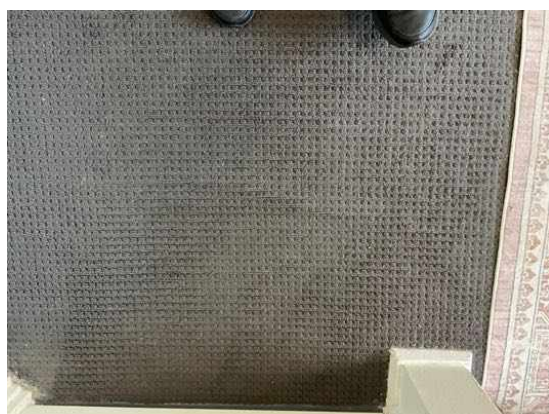
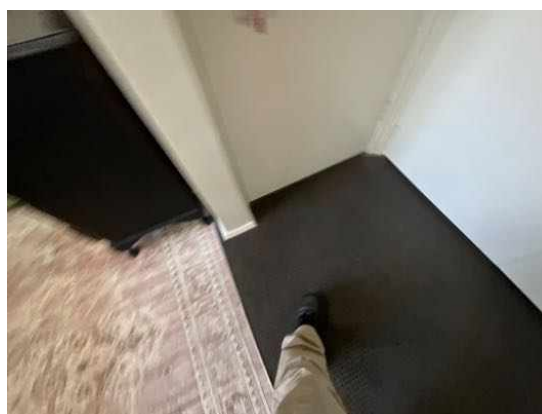
Finding 3.03

Finding: carpet exhibits visible signs of aging

comfort, potential tripping hazards due to frayed edges, and a negative impact on indoor air quality if fibers begin to degrade and release particles into the air.

Professional carpet cleaning and restoration services can address issues such as deep cleaning to rejuvenate colors, repairing frayed edges, and restoring fibers. Additionally, replacing the carpets entirely may be necessary in severe cases of aging or damage beyond repair.

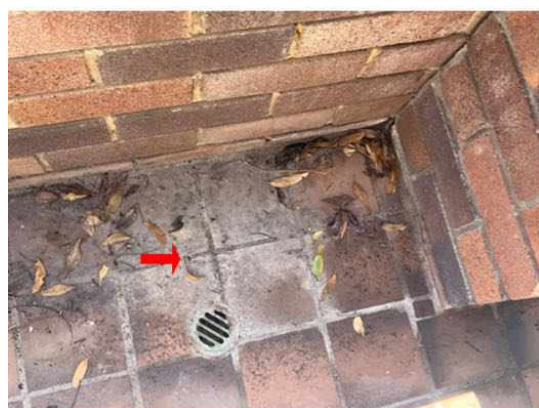
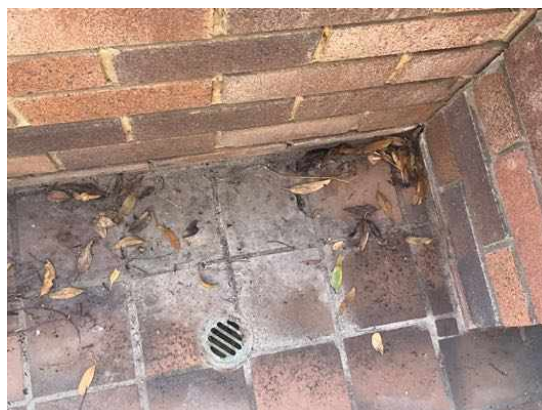
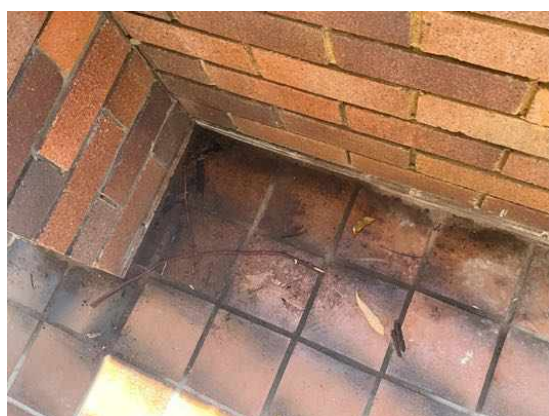
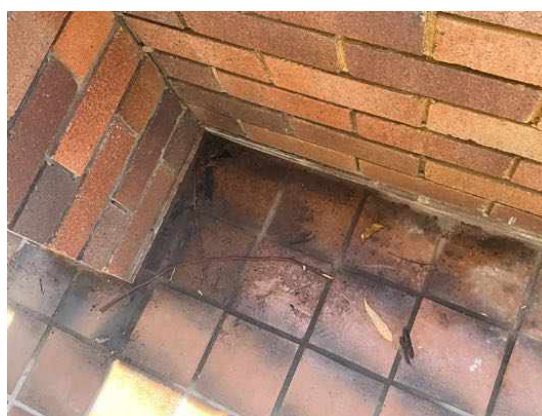
Finding 3.04

Finding: Water staining

Information: Water staining was evident in this area at the time of inspection. Water staining indicates that surfaces have been exposed to excessive moisture over time. The minerals and other elements in the water lead to staining, which may graduate to corrosion and deterioration if left unmanaged.

While mostly an appearance defect, water staining can be indicative of more serious defects, which may be currently concealed by other building elements.

Where water staining is active, a licensed plumber must be consulted to identify the

cause of the staining and to provide advice on any reparation works that may be required. Replacement of any broken or damaged structures is advised.

Conversely, where water staining is old and inactive, affected building materials may be repaired or replaced at client discretion. A qualified carpenter or registered builder may be appointed to perform these works.

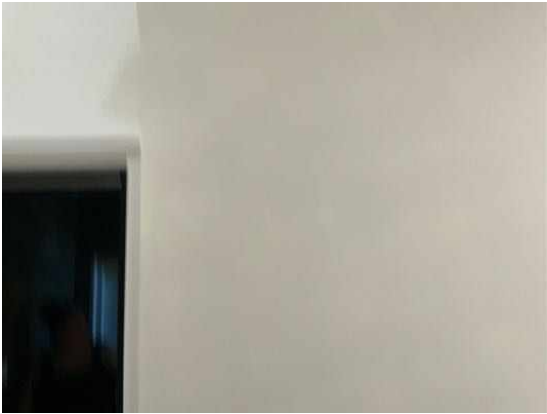
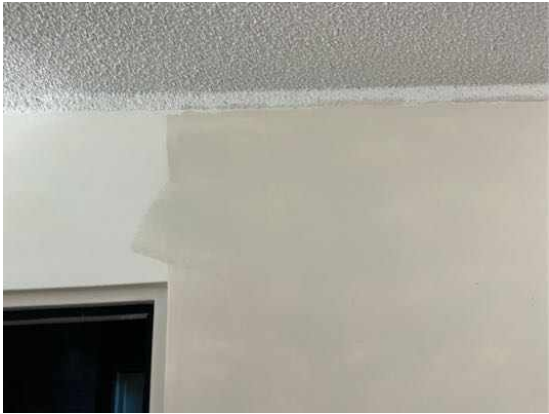
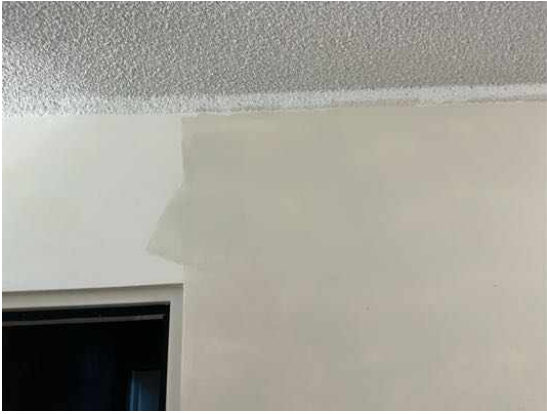
Finding 3.05

Building:	Main Building
Location:	All Areas
Finding:	Paint - Substandard
Information:	Areas were identified where the surface finish of the painting is substandard and this is considered a defect.

Any irregularity in the surface which is visible from a normal viewing position is considered a defect. Marks may also be a result of fault by other tradespeople throughout the construction process.

Defective surface finish of paintwork is marked with an arrow to the below photos in the following locations.

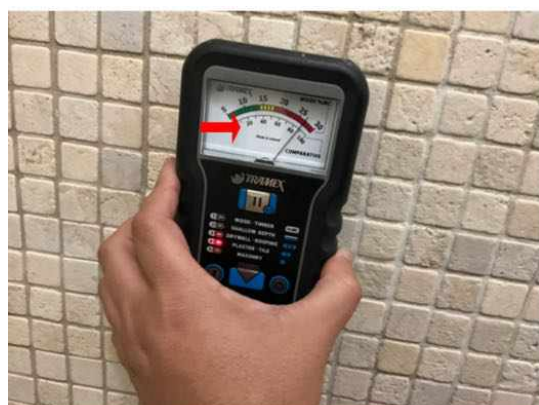
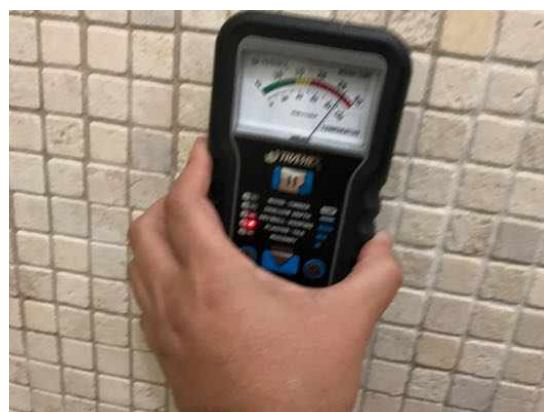
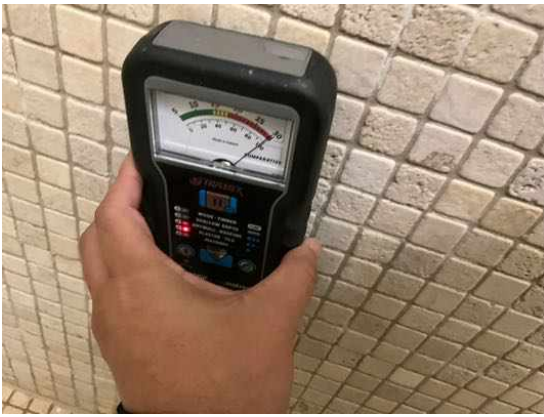
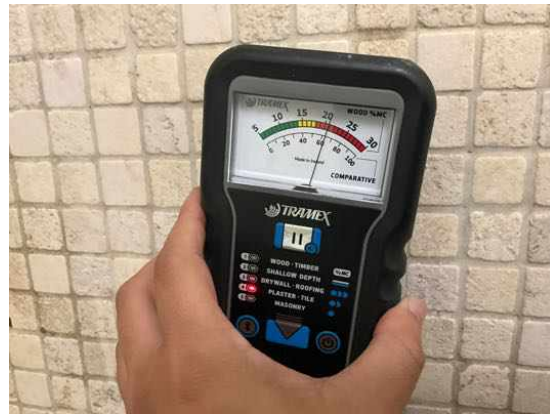
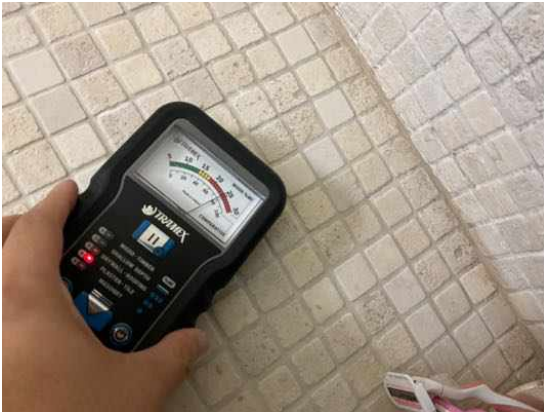
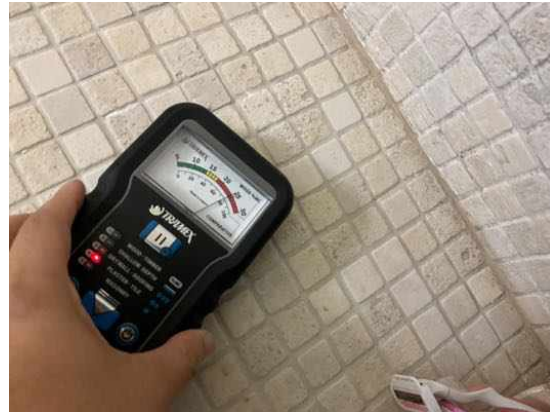
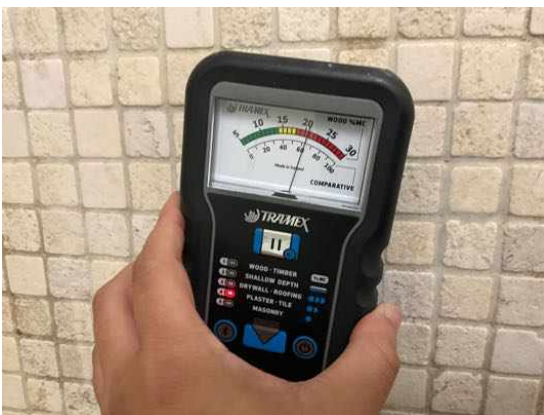
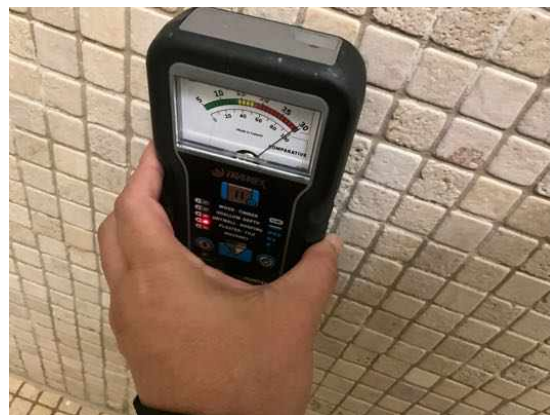
Finding 6.01

Building:	Main Building
Location:	Bathroom
Finding:	Excessive moisture - Conducive to Timber pest
Information:	Excessive moisture can attract termites and produce conditions that promote fungal growth and wood decay.

Excessive moisture is generally caused by deteriorated inadequate or missing roof drainage leaking plumbing pipes or fixtures poorly plumbed HWS overflows or condenser units and poor site drainage.

Prior to any remedial works being performed a qualified plumber should be appointed to further inspect the property and to identify the cause of the excessive moisture. Works to remove affected building elements may then be necessary and should be performed by an appropriate tradesperson.

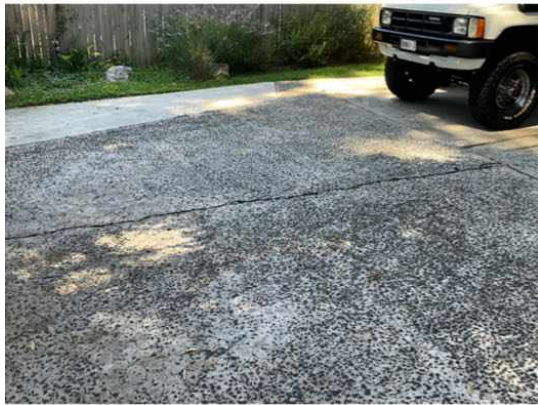
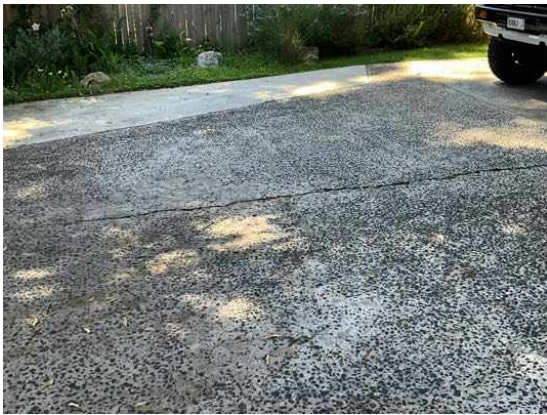
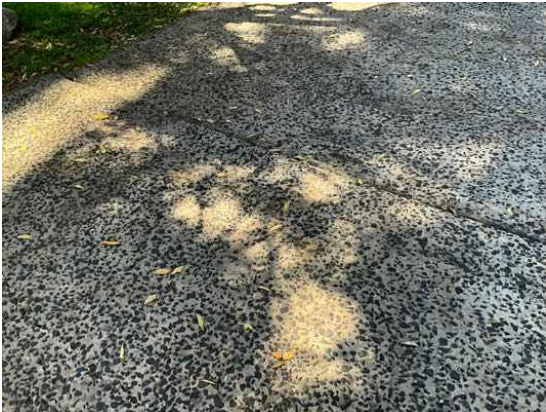
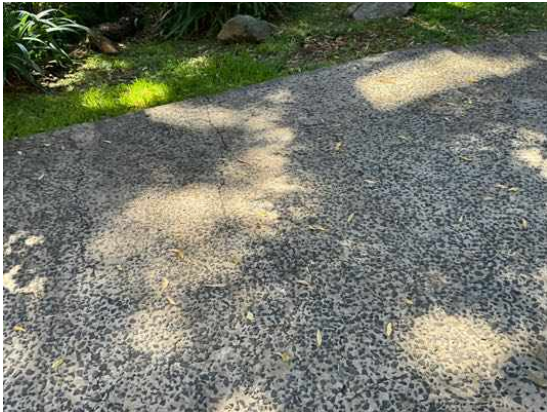
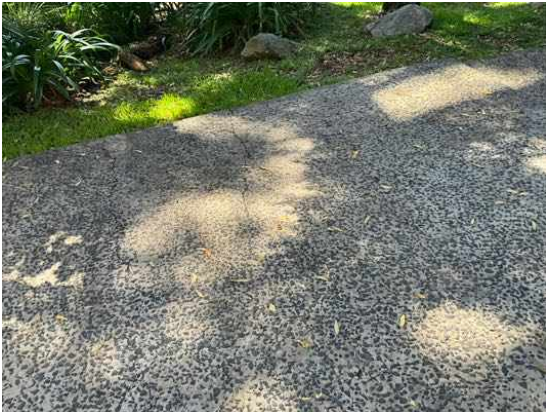
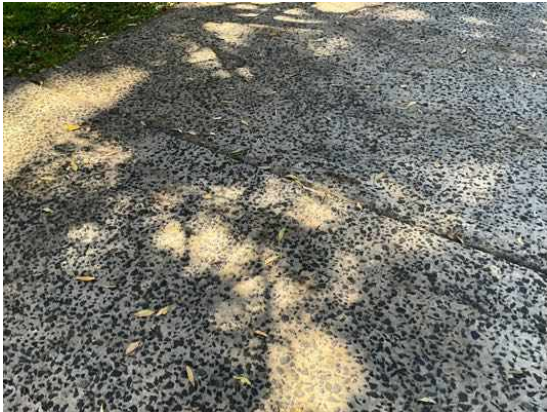
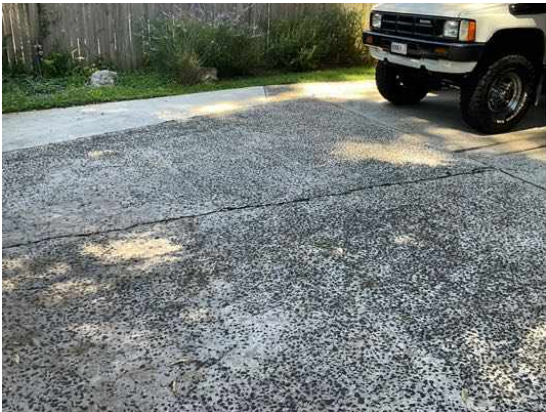
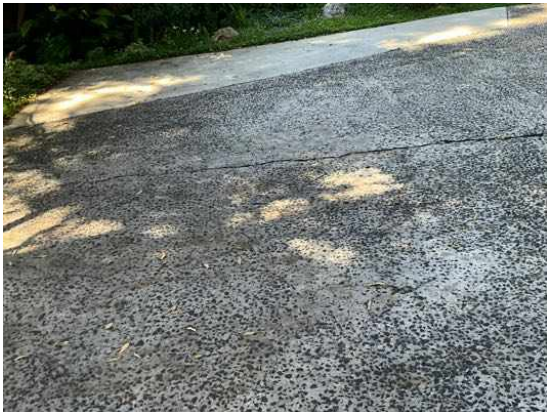
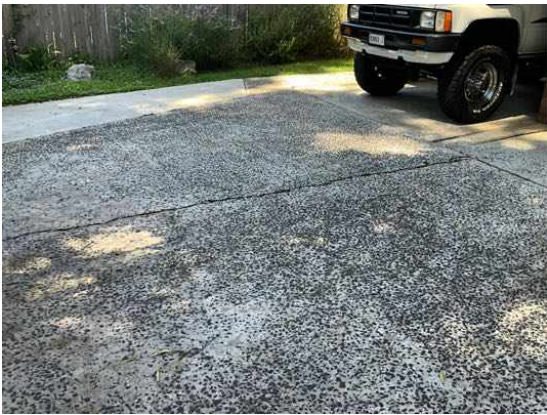
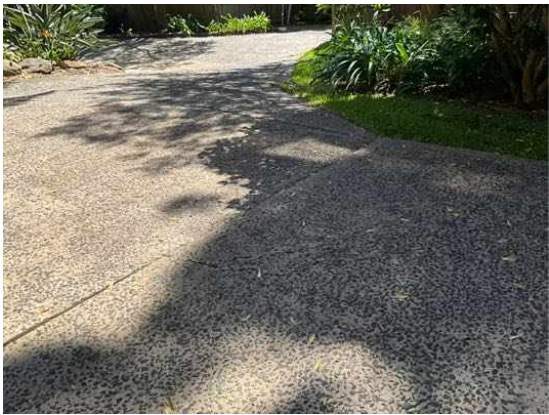
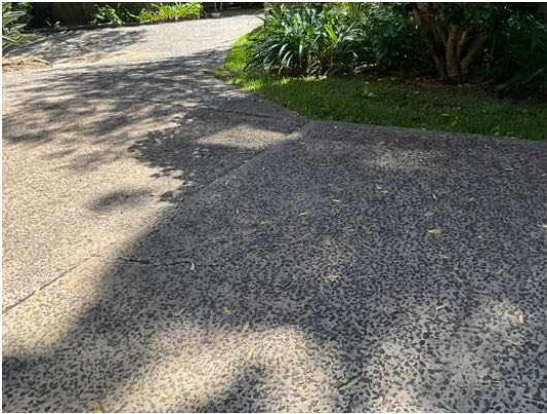
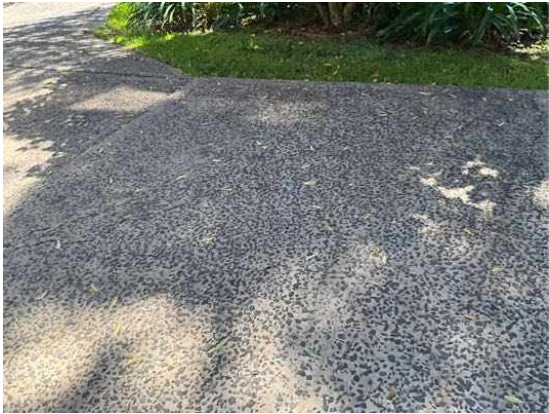
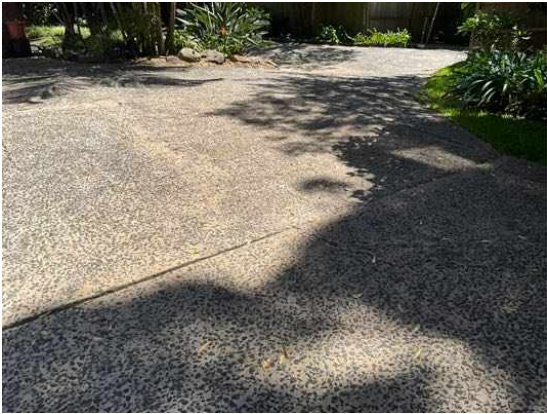
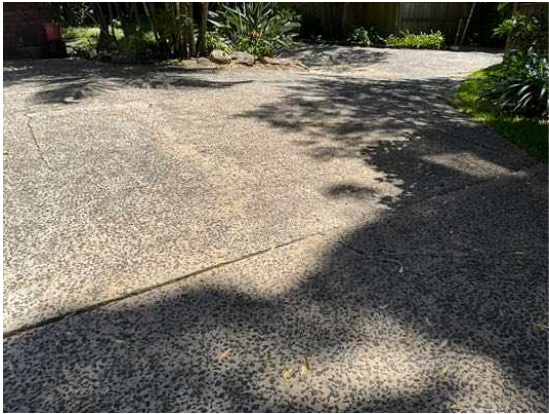
Building: Main Building
 Location: All Areas
 Finding: Noticeable Cracking in Concrete Slab
 Information: Noticeable cracking has been observed in the concrete slab, failing to meet the required construction and quality standards.

- Cracks are visible on the surface and may extend through the depth of the slab.
- Evidence of improper curing or inadequate reinforcement leading to cracking.

- Compromised structural integrity of the slab, potentially leading to failure under load.
- Water ingress through cracks, causing corrosion of reinforcement and further weakening the structure.
- Potential trip hazards and aesthetic issues, reducing the overall value and safety of the property.
- Increased maintenance and repair costs due to ongoing deterioration.

- A structural engineer should be engaged to assess the extent of the cracking and recommend appropriate repair methods.
- A licensed contractor or concrete repair specialist should carry out the recommended repairs under the guidance of the structural engineer.

A detailed inspection should be conducted post-repair to confirm compliance with the required standards and to ensure that the structural integrity of the concrete slab has been restored.
