Building and Timber Pest Inspection Report

Inspection Date: Mon, 2 Mar 2026

Property Address: 1/14 Xenia St, Pimpama QLD 4209,
Australia

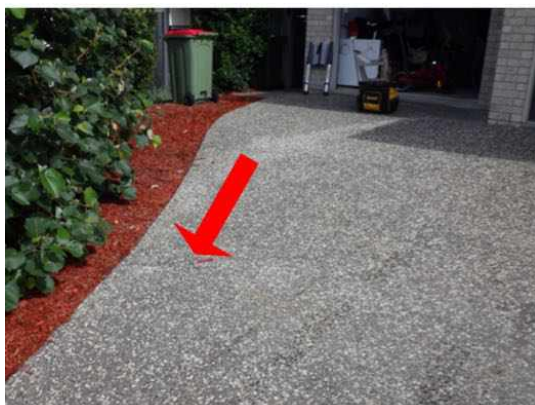
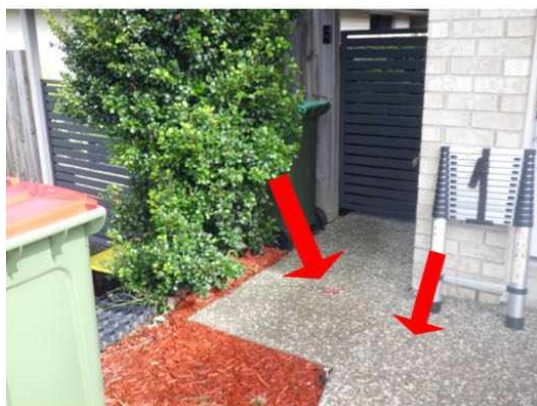
Building: Main Building
Location: Driveway > Ground Level
Finding: Cracking in concrete slab - Category 1
Information: Cracking coded as Category 1 was identified in the driveway and footpaths concrete slab (as per example photos). A Category 1 crack is described as a fine but noticeable crack, with the slab at an otherwise reasonable level.

To be considered Category 1, the approximate width of the crack is less than 1.0mm, or a less than 10mm change in offset when a 3m straight edge is placed over the defect.

Category 1 cracks should be monitored for a period of 12 months. At the end of the monitoring period, identified cracks that are rated greater than Category 2 are considered defects, and require rectification.

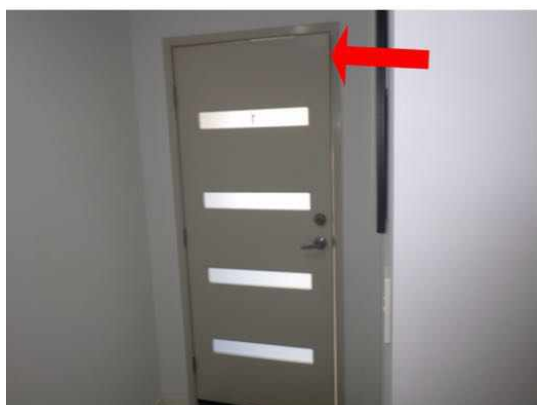
Finding 3.02

Building: Main Building
 Location: Entry > Front
 Finding: Door - Binding/Jamming
 Information: Binding and/or jamming of the entry door on the door frame was evident during standard operation. This defect inhibits the functionality of affected door as well as creating potential for secondary defects to associated building elements, such as damage to the door framing.

A door that binds to the associated door frame or sill may have several causes, such as poor installation of the door or deteriorated hinges.

A qualified carpenter or general handyperson could be appointed to perform minor rectification works at client discretion.

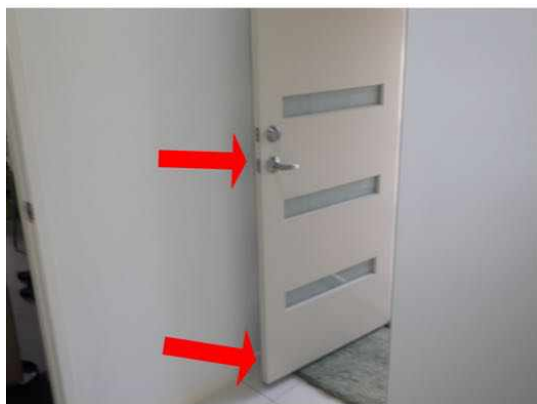
Finding 3.03

Building: Main Building
 Location: Entry > Front Right
 Finding: Door stop - Missing
 Information: The entry door stop is missing or is inadequate to stop the door handle from impacting the wall.

Re-installation or replacement of the door stop is advised to prevent any subsequent damage to the wall linings or associated structures.

A general handyman may be appointed to perform these works at client discretion.

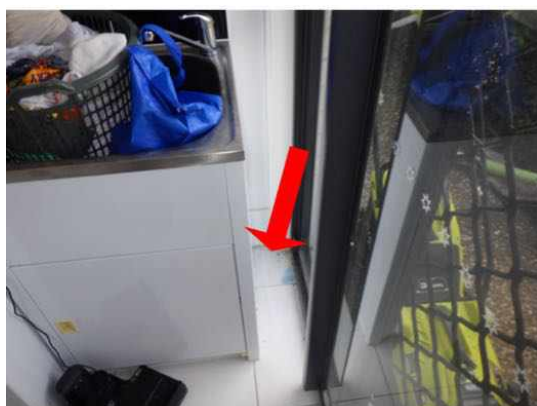
Finding 3.04

Finding: Tile - Cracked

Information: A cracked tile to the laundry floor area was identified at the time of inspection. Such defects are generally caused by impact. Cracked or broken tiled areas may also be a direct result of poor workmanship during the construction process.

A tiling contractor could be appointed to perform repair works at the clients discretion.

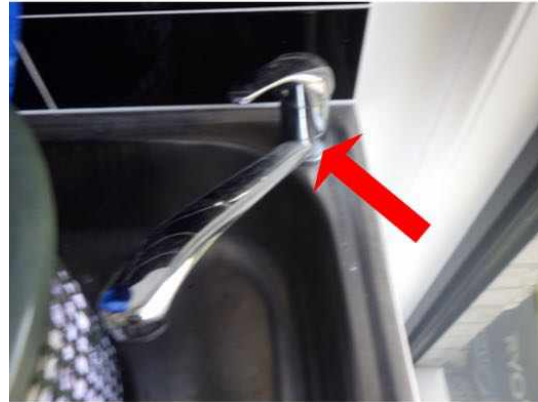
Finding 3.05

Finding: Tap - Loose

Information: The tap in the laundry area has not been installed correctly, or has deteriorated with age, and is consequently loose. This tap being loose creates potential for water leaks

and subsequent water damage to the surrounding area.

Where taps or spouts are loose, a qualified plumber should be appointed to re-fix the plumbing fitting.

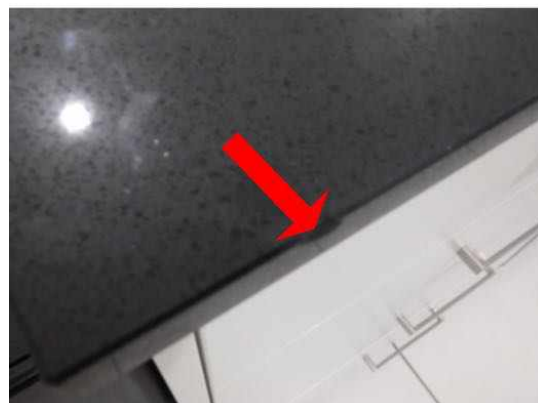
Finding 3.06

Building: Main Building
 Location: Kitchen > Front Left
 Finding: Chipping - Kitchen bench top.
 Information: At the time of inspection there was a small chip to the front edge of the kitchen bench manufactured stone top.

While such chipping may be noticeable in some cases, it is quite common and does not indicate any structural damage.

Chipping of this nature can generally be repaired with minor sanding, filling and/or polishing. Such works should be performed by a qualified stone mason.

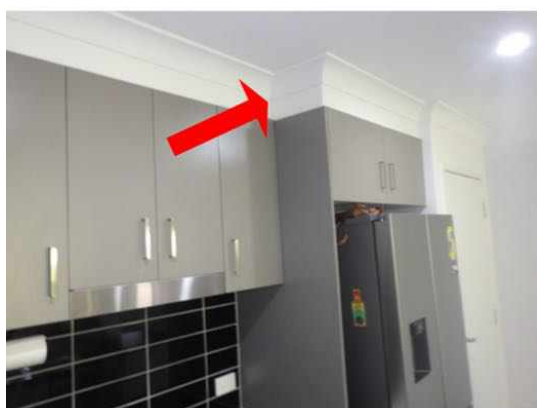
Finding 3.07

Building: Main Building
 Location: Kitchen > Centre Right

Finding: Cracking - Wall
 Information: There is cracking to an area of the wall lining or cabinetry bulkhead in the kitchen area.

The cracking appears minor in nature and is generally only ever an appearance defect. While such cracking may be noticeable in some cases, it is quite common and does not indicate any structural damage.

Cracking of this nature can generally be repaired with minor sanding, filling and/or repainting. Such works should be performed by a qualified painter or a general handyman.

Monitoring of all cracking should be conducted frequently. Always contact a building inspector should cracks widen, lengthen, or become more numerous.

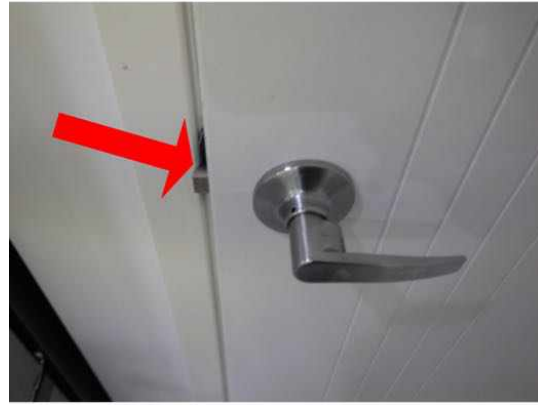
Finding 3.08

Building: Main Building
 Location: Pantry - Walk In > Front
 Finding: Door - Not latching
 Information: The door to the walk in pantry was found to be not latching at the time of inspection. Breakage occurs generally when the building materials have aged and decayed.

A qualified carpenter or general handyman could be appointed to adjust the door handle striker plate at the client's discretion.

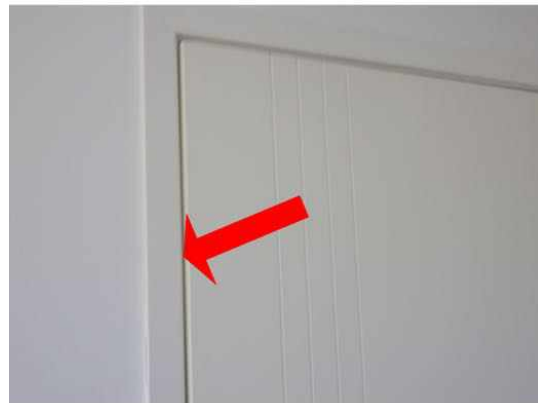
Finding 3.09

Building:	Main Building
Location:	Bedroom 3 > Front
Finding:	Door - Binding/Jamming
Information:	Binding and/or jamming of the bedroom 3 door on the door frame was evident during standard operation. This defect inhibits the functionality of affected door as well as creating potential for secondary defects to associated building elements, such as damage to the door framing.

A door that binds to the associated door frame or sill may have several causes, such as poor installation of the door or deteriorated hinges.

A qualified carpenter or general handyperson could be appointed to perform minor rectification works at client discretion.

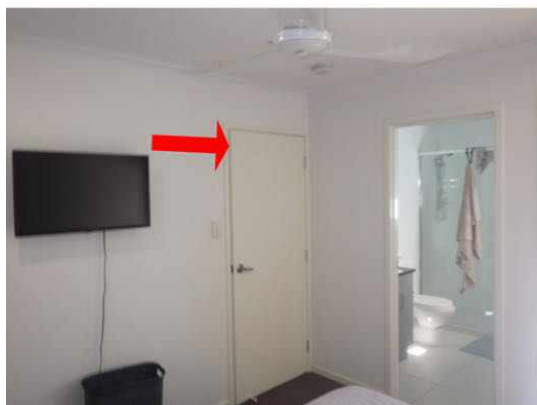
Finding 3.10

Building:	Main Building
Location:	Bedroom - Master > Front
Finding:	Door - Binding/Jamming
Information:	Binding and/or jamming of the main bedroom door on the door frame was evident during standard operation. This defect inhibits the functionality of affected door as well

as creating potential for secondary defects to associated building elements, such as damage to the door framing.

A door that binds to the associated door frame or sill may have several causes, such as poor installation of the door or deteriorated hinges.

A qualified carpenter or general handyperson could be appointed to perform minor rectification works at client discretion.

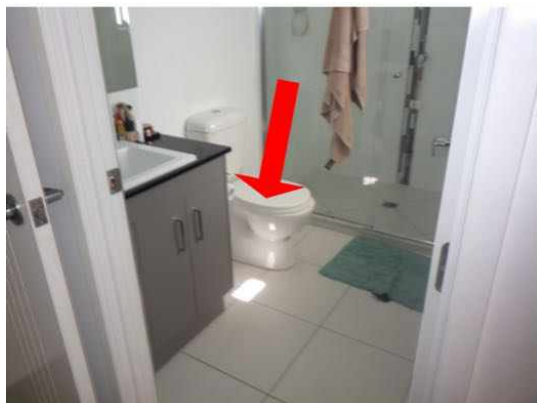
Finding 3.11

Building:	Main Building
Location:	Ensuite > Centre Left
Finding:	Toilet seat - Loose
Information:	The ensuite toilet seat was found to be loose at the time of inspection. It is suspected that this defect has developed due to general wear and tear.

If left unmanaged, the toilet seat could deteriorate further, leading to destabilisation and the potential for water leaks to the toilet pan area.

It is recommended that the seat be repaired by a licensed plumbing or general handyman.

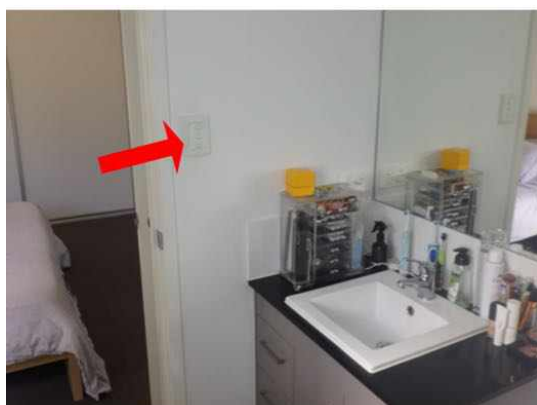
Finding 3.12

Building: Main Building
 Location: Ensuite > Front Left
 Finding: Light Switch
 Information: At the time of inspection the light switch in the ensuite area showed signs of cracking to the cover plate.

A licensed electrician or general handyman could be engaged to replace the light switch cover plate.

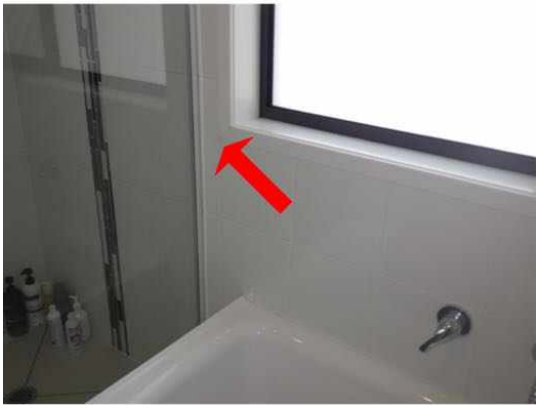
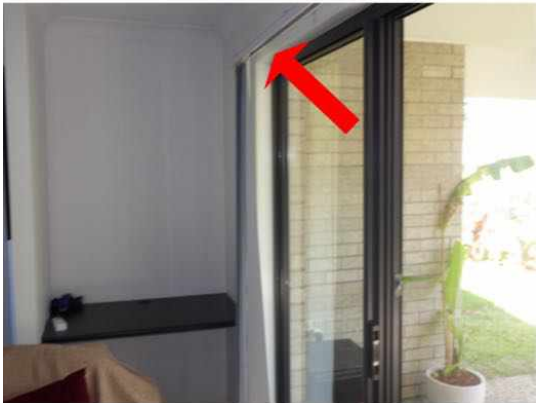
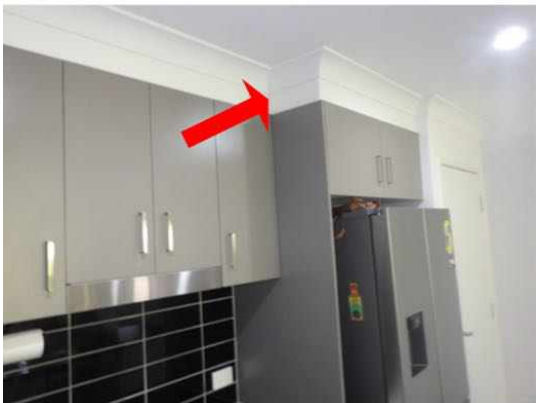
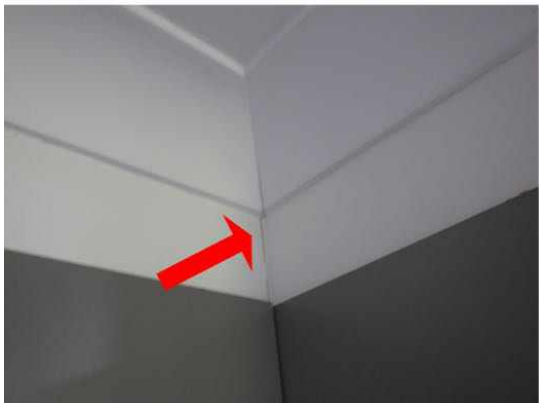
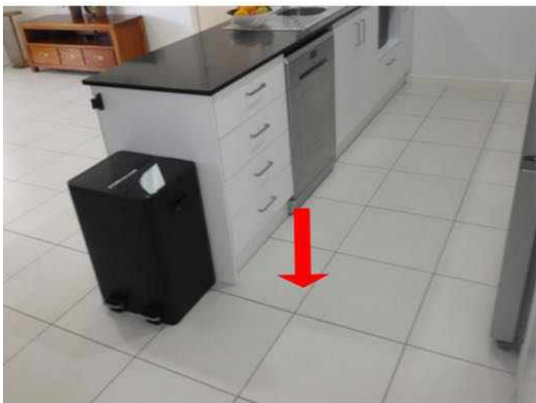
Finding 3.13

Building: Main Building
 Location: Internal Areas > Existing
 Finding: Wear and Tear
 Information: At the time of inspection the building interior showed signs of minor cracking and/or scuffing to floors, walls, ceilings and cornices (as per example photos).

The level of damage appears consistent with general deterioration and/or wear and tear.

The relevant trades people or a general handyman could be engaged to undertake repair work at the clients discretion.

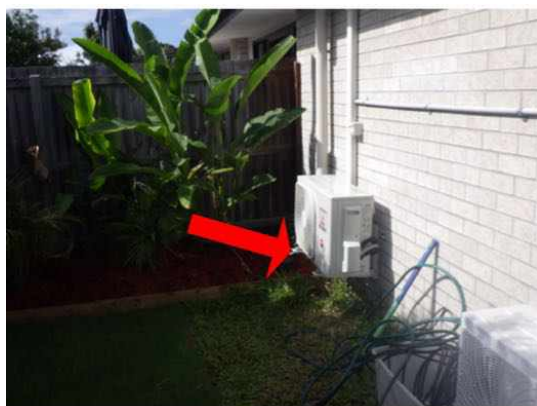
Finding 6.01

Building:	Main Building
Location:	Exterior walls - right side > Centre Right
Finding:	Overflow - Not plumbed for drainage
Information:	The air conditioning unit overflow is not plumbed or connected to suitable drainage, which can result in the surrounding area becoming excessively damp. These damp conditions can lead to secondary defects such as rot, rust or corrosion of associated building elements, the formation of fungal decay, or even the creation of potential slip hazards. When coupled with poor site drainage, pooling of water may also attract termite activity to this area. It is highly recommended that a qualified plumber be appointed to install adequate drainage to the overflow. These works will ensure that the area remains dry and free of any secondary defects.

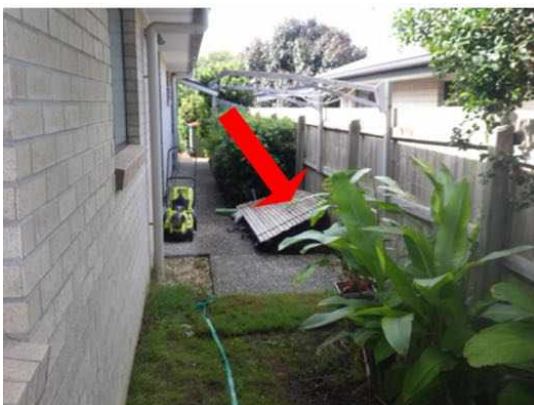
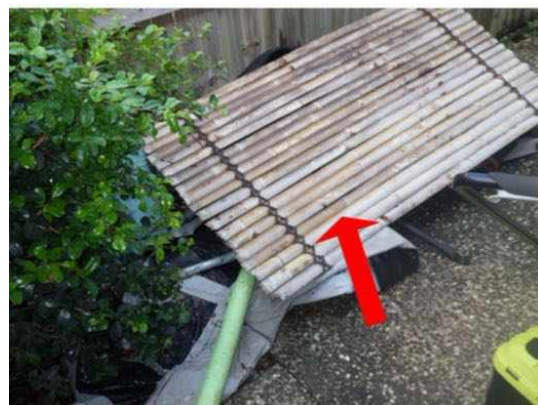
These stored items severely limit full inspection of the area and may conceal timber termite pest and or vermin activity.

It is highly recommended the items are removed to allow for complete inspection of the area.

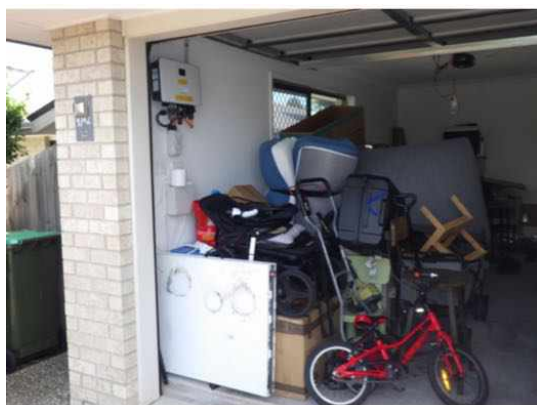
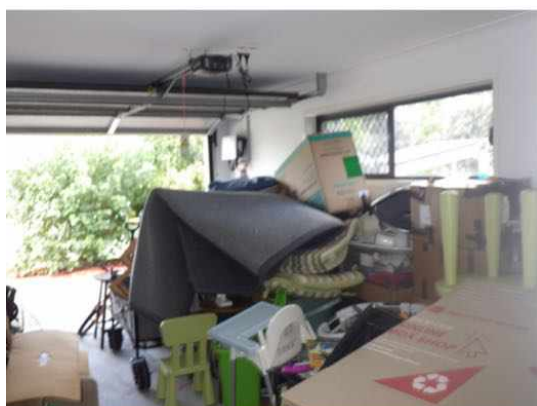
Finding 6.04

Building: Main Building
Location: Garage > All Areas
Finding: Stored Items
Information: At the time of inspection there was furniture, personal and stored items against internal walls in areas of the garage area inspected.

These stored items severely limit full inspection of the area and may conceal timber termite pest and or vermin activity.

It is highly recommended the items are removed to allow for complete inspection of the area.

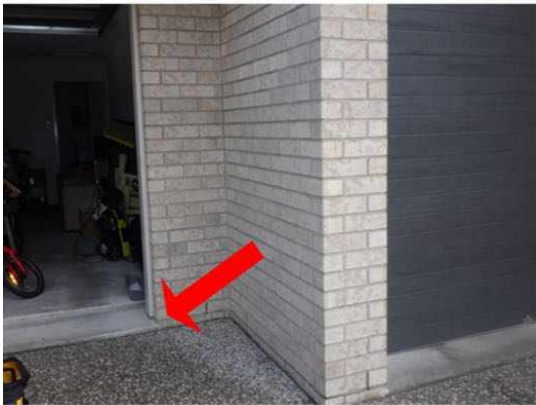
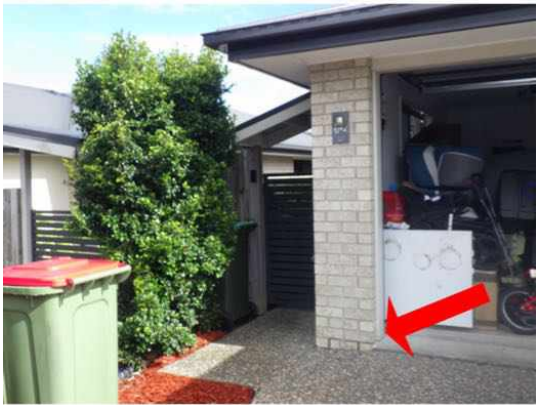
In this instance evidence of a previously installed physical barrier was observed, along with a durable notice inside the electrical meter box. This system requires regular annual inspections.

No evidence of regular or annual inspections was found.

Where a Termite Management System has been identified you should refer to the type of barrier date of installation warranty conditions and any documentation provided by a builder or past owner.
