# Building and Timber Pest Inspection Report

Inspection Date: Mon, 16 Mar 2026

Property Address: 5A Dellwood Ave, Earlwood NSW 2206,  
Australia

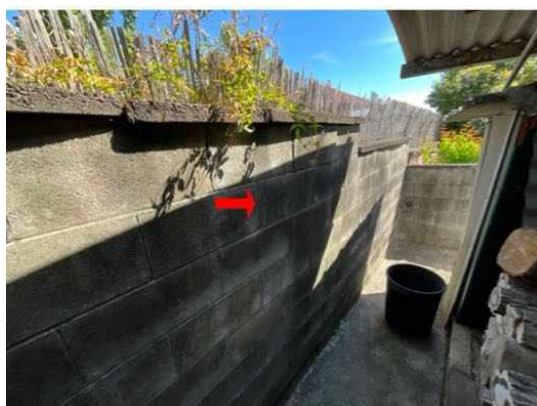
Building:	Yard
Location:	Exterior walls
Finding:	Blockwork - Cracking noticeable
Information:	There were several cracks and or crack repairs evident to external blockwork.

Noticeable cracks are a common occurrence in external blockwork and are a likely result of age expected building movement, general expansion, and/or contraction of building materials in different weather conditions.

It is highly advised that a qualified bricklayer be appointed to provide necessary works to cracked brickwork to prevent any further damage.

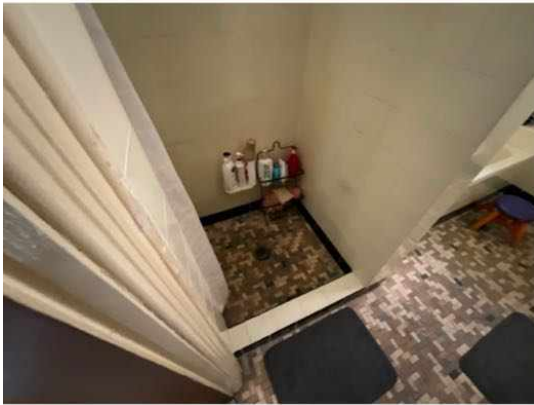
#### Finding 2.01

Building:	Main Building
Location:	Bathroom
Finding:	Water proofing - Failed
Information:	The waterproofing membrane in this area appears to have failed. Generally this could occur from substandard installation or through damage from physical force.

The failure of the waterproofing membrane system be it in a bathroom, balcony or basement can lead to severe consequences and costly repair. Waterproofing is an essential part of any construction in a wet environment and its installation should be truly sustainable. Unfortunately, despite the best intentions, failures tend to occur.

It is advised that a builder be appointed to see what necessary works are required.

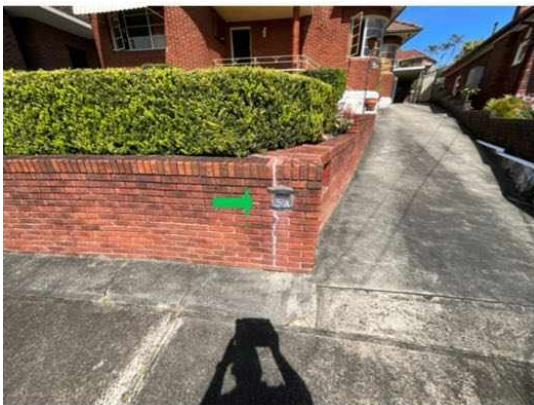
### Finding 3.01

Building:	Yard
Location:	Exterior walls
Finding:	Brickwork - Cracking noticeable
Information:	There were several cracks and or crack repairs evident to external brickwork.

Noticeable cracks are a common occurrence in external brickwork and are a likely result of age expected building movement, general expansion, and/or contraction of building materials in different weather conditions.

It is highly advised that a qualified bricklayer be appointed to provide necessary works to cracked brickwork to prevent any further damage.

Always monitor these cracks and contact a building inspector should cracks widen, lengthen, or become more numerous.

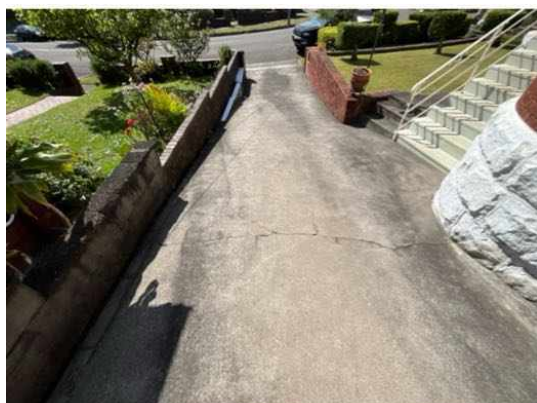
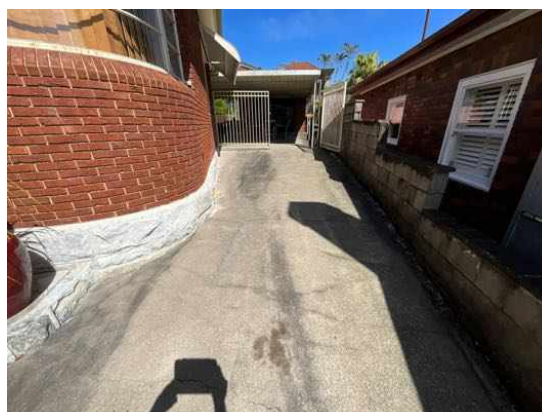
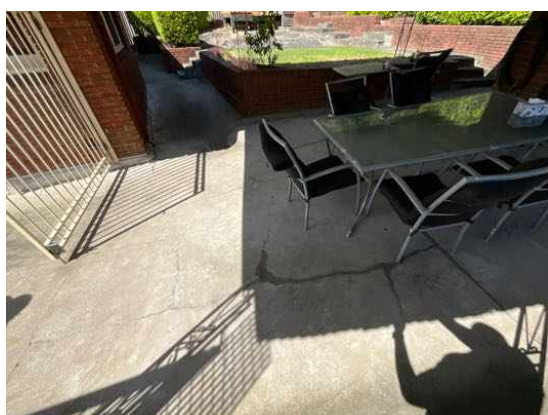
### Finding 3.02

Building:	Yard
Location:	Pathway
Finding:	Cracking - External Concrete Paving Damage Category 1 - Fine (less than 2mm)
Information:	Fine cracks were identified in external concrete paving. Although fine cracks are quite noticeable, they are often only considered to be an appearance defect, and usually do not indicate any structural damage. To be considered a Category 1 or fine crack, the crack is found to be less than 2mm in width.

Generally the cause of a hairline crack in existing concrete paving such as driveways and pathways is indicative of the expansion and contraction of the concrete. Such causes are generally due to environmental factors, such as moisture levels, weather conditions, root systems of nearby trees or the soil types on which they are laid.

Fine cracks may also be due to poor original installation of the concrete. Factors such as poor compaction of the sub surface and/or inadequate reinforcing of the slab may create cracking and other secondary defects.

Monitoring of all cracking should be conducted frequently. Always contact a building inspector should cracks widen, lengthen, or become more numerous.

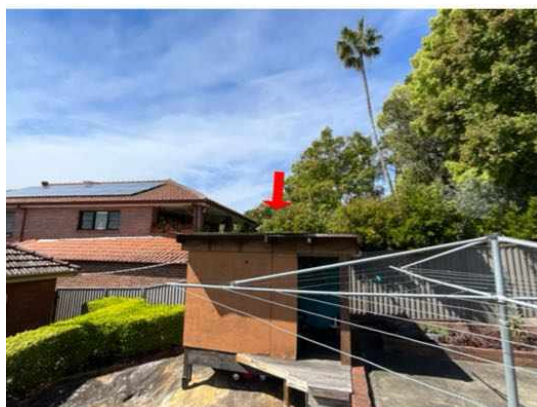
### Finding 3.03

Location:	Shed
Finding:	Roof sheets - Rusted
Information:	Metal roofs generally comprise numerous individual sheets, which join and overlap. These intersections are particularly prone to lift at the edge and consequently rust at these points.

Upon inspection of the exterior roofing structure, evidence of rust to these sections was identified.

A roofing contractor should be appointed to assess the damage to the roofing sheets and to perform remedial works as necessary.

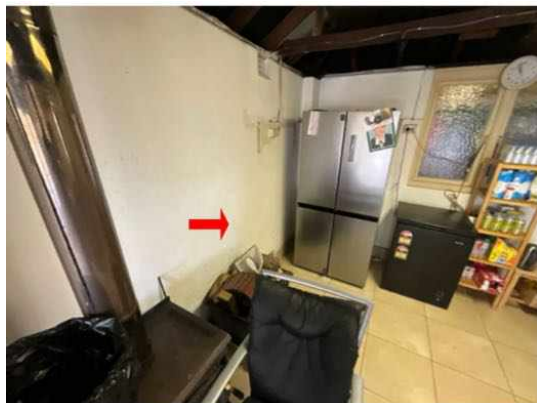
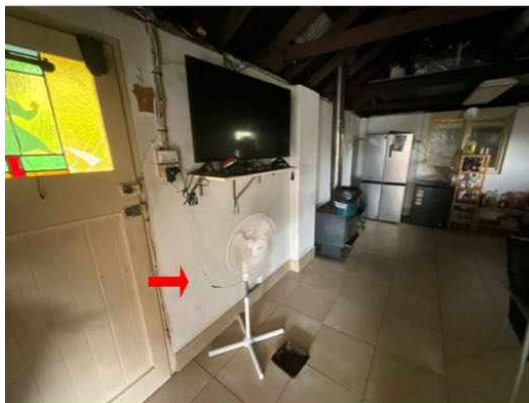
### Finding 3.04

Building:	Garage
Location:	Garage
Finding:	Interior walls - Lateral damp
Information:	Lateral penetrating damp refers to the sideways movement of moisture. The implications of unmanaged damp range from mould fungi growth, wood rot and decaying building materials, to finishes including lifting, bubbling, peeling and staining of paint, plaster and wallpaper.

Consultation with a damp proofing contractor is advised to address the cause of the damp and to perform remedial works as necessary.

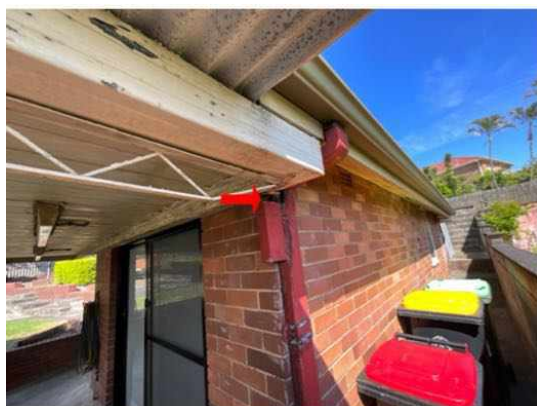
### Finding 3.05

Building:	Garage
Location:	Roof Exterior
Finding:	Roof plumbing - Rusted or corroded
Information:	The roof plumbing has areas of rust and corrosion. It is suspected that this has been caused by blockages, resulting in pooling or standing water, that have prematurely rusted elements of the roof plumbing.

Rusted roof plumbing will generally develop holes and leaks that can affect other building elements with poor drainage of storm water. Poorly drained roof areas will also lead to damp conditions surrounding the base perimeter of the building which, if left unmanaged, can lead to a range of secondary building defects.

Repair and/or replacement of rusted roof plumbing is highly required in order to reinstate the roof drainage system to a fully operational level. To further maintain these areas, gutters should be cleaned frequently, allowing the avoidance of any partial blockages.

A licensed plumber or specialist roof restoration company should be appointed to undertake these works.

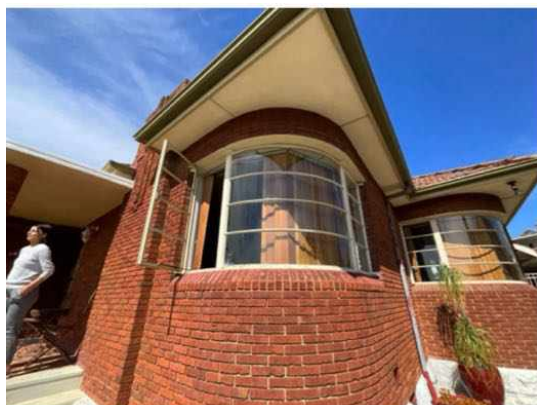
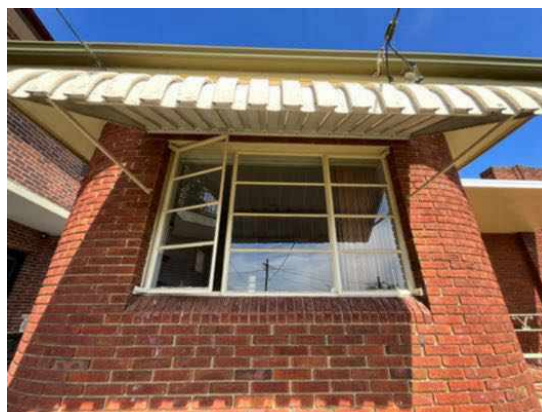
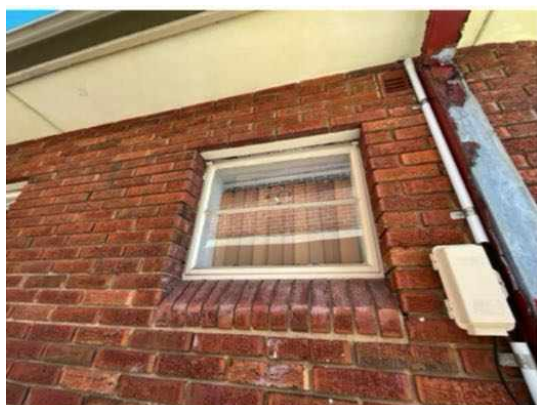
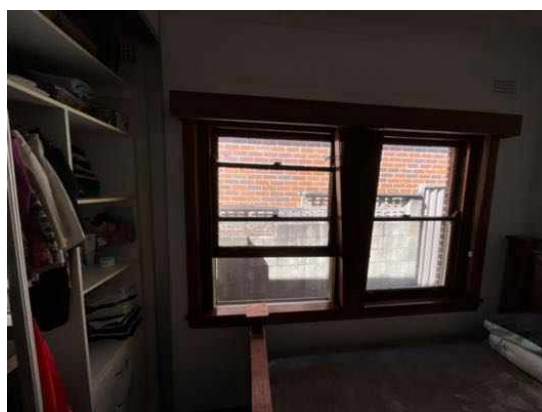
### Finding 3.06

Building:	Main Building
Location:	Window
Finding:	Glass - Cracked
Information:	Cracks were identified in the glass in this area. Cracking in glass is generally the result of impact damage, and is likely to develop further when left unmanaged.

A qualified glazier is required to repair the glass.

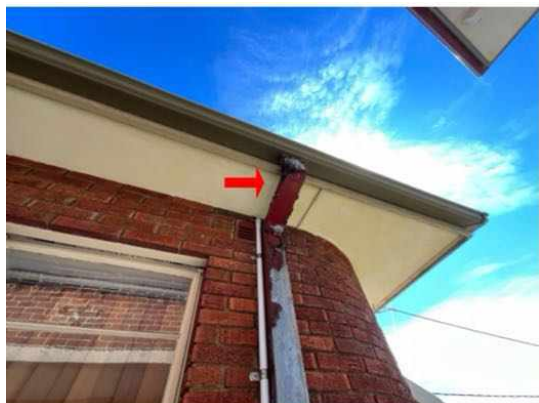
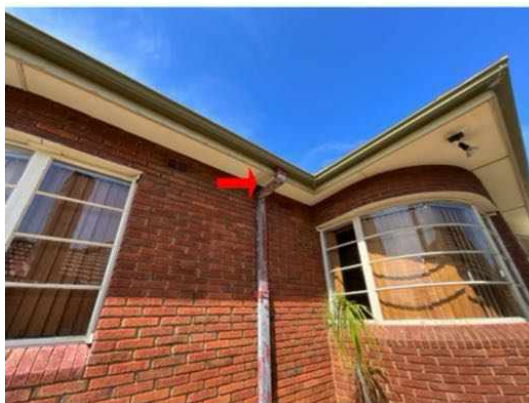
### Finding 3.07

Building:	Main Building
Location:	Roof Exterior
Finding:	Roof plumbing - Rusted or corroded
Information:	The roof plumbing has areas of rust and corrosion. It is suspected that this has been caused by blockages, resulting in pooling or standing water, that have prematurely rusted elements of the roof plumbing.

Rusted roof plumbing will generally develop holes and leaks that can affect other building elements with poor drainage of storm water. Poorly drained roof areas will also lead to damp conditions surrounding the base perimeter of the building which, if left unmanaged, can lead to a range of secondary building defects.

Repair and/or replacement of rusted roof plumbing is highly required in order to

reinstate the roof drainage system to a fully operational level. To further maintain these areas, gutters should be cleaned frequently, allowing the avoidance of any partial blockages.

A licensed plumber or specialist roof restoration company should be appointed to undertake these works.

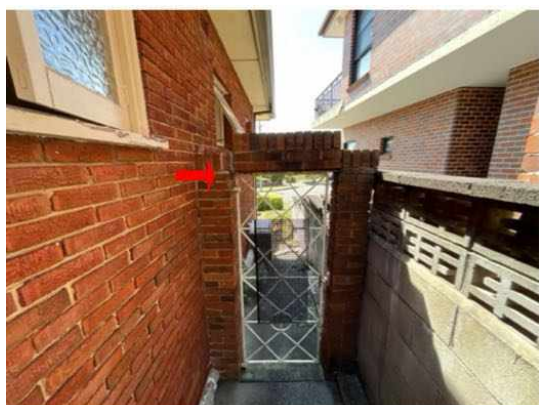
### Finding 3.08

Building:	Main Building
Location:	Exterior walls
Finding:	Lintel - Rusted or corroded
Information:	This building element shows evidence of rusting and corrosion, which is likely to have developed as a result of excessive exposure to moisture and or inadequate coatings.

As surface rust provides no protection to the underlying iron, the deteriorating condition is likely to worsen if not addressed in the short-term future.

I recommend appointing a bricklayer to see what necessary works are required.

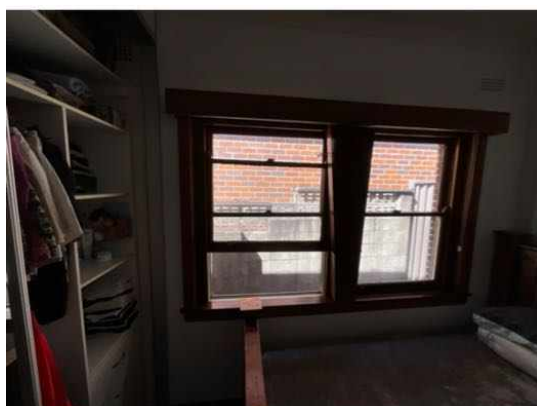
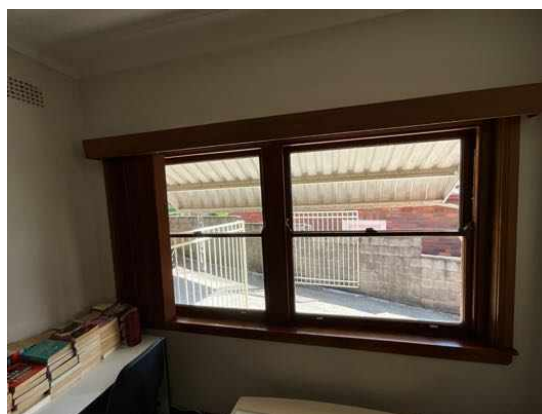
### Finding 3.09

Building:	Main Building
Location:	Window
Finding:	Windows - Sash cords missing
Information:	Sashes are the moveable panes of windows that primarily slide vertically over each other to expose one half of the window area. Each sash is provided with springs balances and/or compression weather-stripping, which act to hold the window in place in one position.

Repairing or replacing sash cords involves some work and is often best completed by an experienced carpenter or specialist window restorer. It is advised that such works be completed to improve the operational state of the affected window.

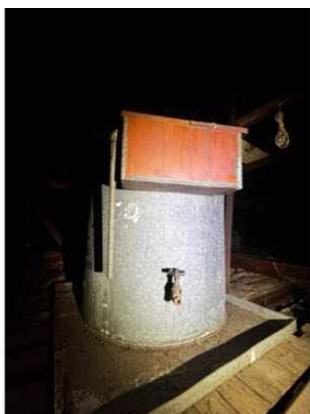
### Finding 3.10

Building:	Main Building
Location:	Roof Void
Finding:	Gravity-Fed HWS - Disconnected
Information:	It was noted at the time of inspection that a disconnected gravity-fed hot water system (HWS) remains in this area.

I recommend appointing a plumber to see what necessary works are required to remove the unit from the area.

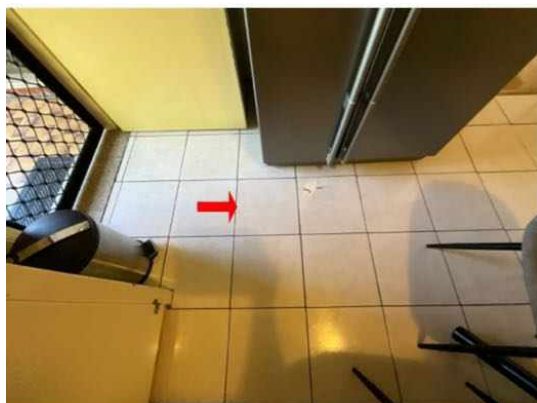
### Finding 3.11

Building:	Main Building
Location:	Kitchen
Finding:	Tile - Cracked or damaged
Information:	Cracking was evident to the tiling in this area at the time of inspection.

I recommend appointing a tiling contractor to see what necessary works are required to replace any damaged tiles.

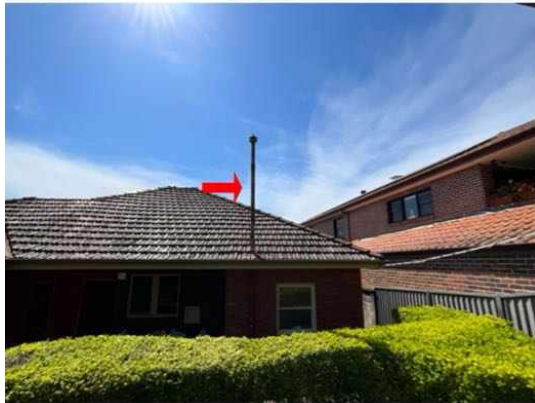
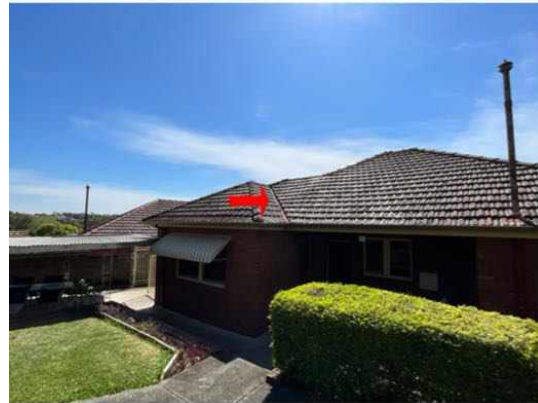
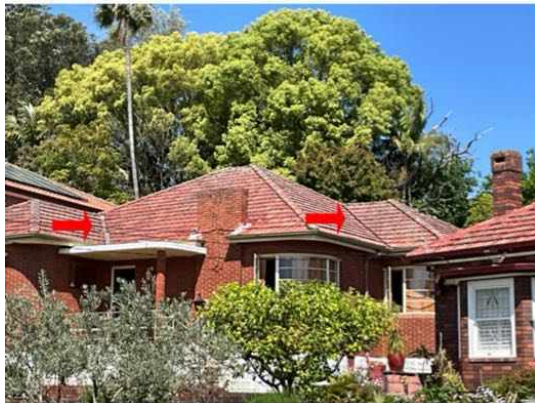
### Finding 3.12

Building:	Main Building
Location:	Roof Exterior
Finding:	Building element - Rusted or corroded
Information:	This building element shows evidence of rusting and corrosion, which is likely to have developed as a result of excessive exposure to moisture and or inadequate coatings.

As surface rust provides no protection to the underlying iron, the deteriorating condition is likely to worsen if not addressed in the short-term future.

Rusting and corrosion should be managed by ideally removing or limiting the affected surface from exposure to moisture.

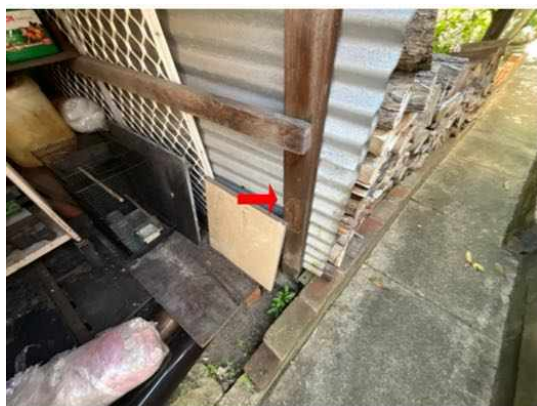
Building:	Yard
Location:	Shed
Finding:	Termite - damage identified
Information:	Despite no live termite or timbered pest activity being indicated, termite damage was found to have affected this area.

A building contractor should be appointed to provide a further invasive inspection and to see what necessary works are required.

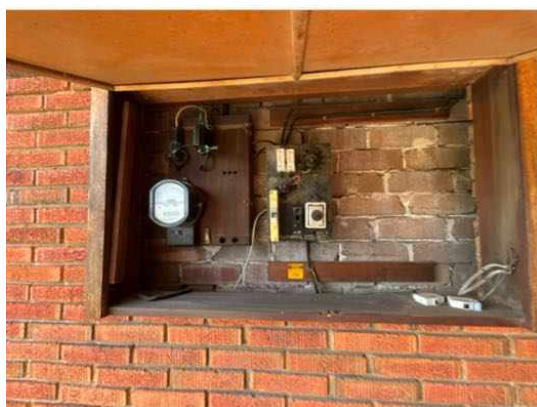
### Finding 6.01

Building:	Main Building
Location:	All Areas
Finding:	Termite Management System - no evidence of a chemical installation
Information:	The application of a post-construction chemical termite barrier is highly recommended for all properties, particularly if live termite activity has been found on the site previously. Such barriers are highly effective in preventing termite attack on any timber building elements throughout the property.

A durable notice should be placed in the switchboard unit to indicate current termite barriers. At the time of inspection, it appeared as though no termite management system has been installed, with no evidence to suggest preventative works taking place.

The client may consider gaining further advice from a pest controller as to the costs and procedures involved with this application. It is recommended that obtaining such advice be a short-term priority.

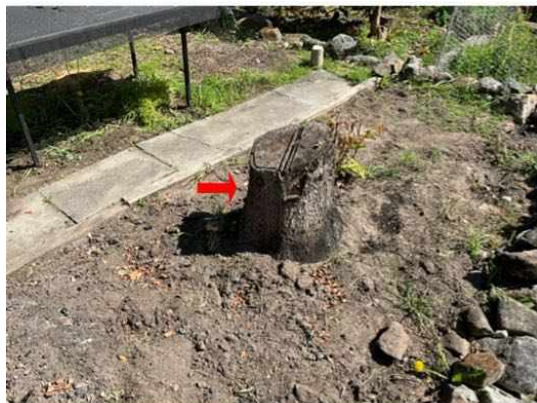
### Finding 6.02

Building: Yard  
Location: Yard - Back  
Finding: Tree Stump  
Information: There was a tree stump located in this area of the property.

I would highly recommend removal of the tree stump as this heightens the risk of a termite infestation at the property.

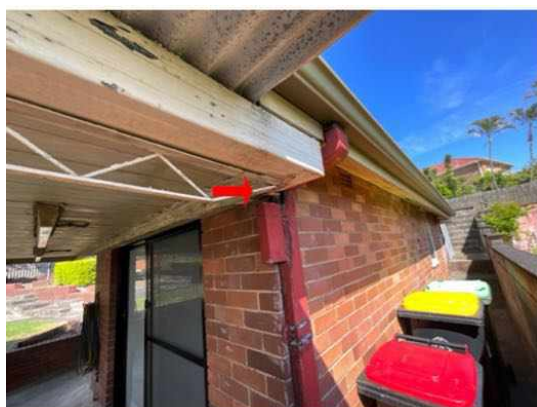
### Finding 6.03

Building: Garage  
Location: Roof Exterior  
Finding: Excessive moisture - identified  
Information: Excessive moisture can attract termites and produce conditions that promote fungal growth and wood decay.

Prior to any remedial works being performed a qualified plumber should be appointed to further inspect the property and to identify the cause of the excessive moisture.

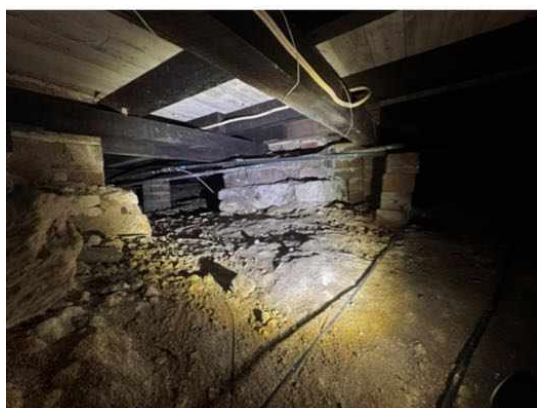
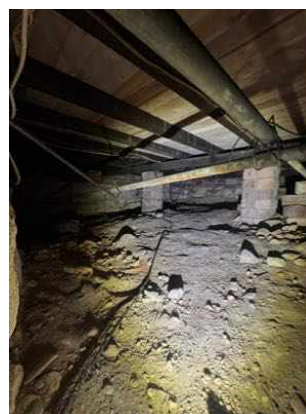
### Finding 6.04

Building: Main Building  
Location: Subfloor

**Finding:** Subfloor - Lack of ventilation  
**Information:** It was noted at the time of inspection that the subfloor area lacks adequate ventilation. Ventilation can be restricted by a variety of minor defects, including obstructions in the subfloor space, a lack of vents or a low clearance.

A well ventilated subfloor aids in maintaining dry conditions, preventing secondary damage such as wood rot and pest activity, as well as preventing the development of mould and mildew (which can lead to respiratory safety hazards for occupants).

The client may also consider mechanical ventilation (powered fans) to improve subfloor airflow.
