# Building and Timber Pest Inspection Report

Inspection Date: Tue, 24 Feb 2026

Property Address: 56 Dalton Rd, St Ives Chase NSW 2075, Australia

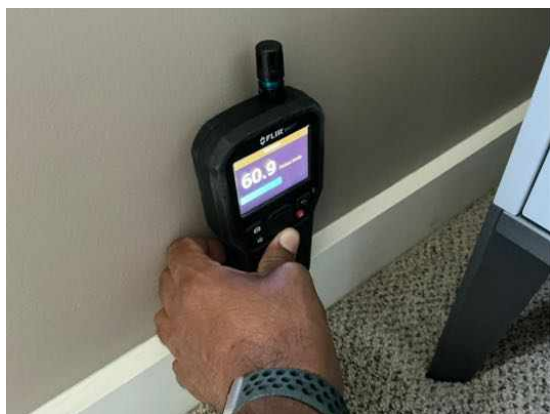
Building:	Main Building
Location:	Bedroom 1
Finding:	Damp - Rising
Information:	At the time of inspection, rising damp was identified within the property. This condition results from the upward movement of moisture through porous building materials, such as bricks, sandstone, or mortar, via capillary action. A damp-proof course (DPC), an impermeable barrier installed at the base of walls above ground level during construction, is typically used to prevent rising damp. However, the absence, deterioration, or bridging of the DPC can compromise its effectiveness, specially in older buildings, leading to moisture ingress. Inadequate site drainage, which allows water to accumulate around the foundation, is a common contributing factor to this issue.

It is strongly recommended that the client engage a qualified damp-proofing specialist for remedial actions. Additionally, consulting a qualified plumber or drainage specialist

to assess and improve site drainage is advised to mitigate further risks. Monitoring the condition for 12 months is essential to evaluate its status and prevent potential recurrence or further damage.

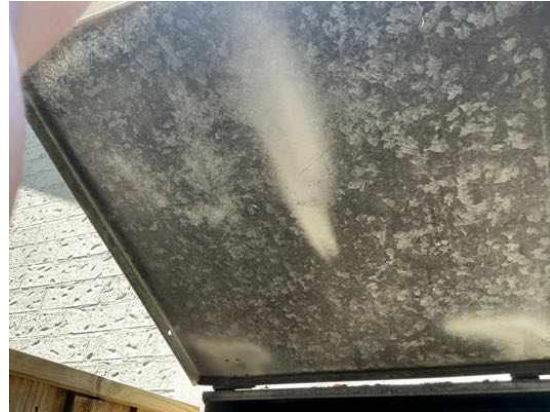
Building:	Main Building
Location:	Meter Box
Finding:	Termite Management System - No Evidence of Installation
Information:	The application of a post-construction chemical termite barrier is strongly recommended for all properties, especially if there has been any history of live termite activity on-site. These barriers are highly effective in protecting timber building elements throughout the property by preventing termite attacks. It is also advisable to install a durable notice within the switchboard unit, indicating the presence of any termite barriers for future reference.

During the inspection, there was no indication that a termite management system had been installed, nor was there any evidence to suggest that preventative measures had previously been undertaken. The client is encouraged to seek further advice from a licensed pest controller regarding the costs and procedures involved in the application of a termite barrier. Prioritizing this step in the short term is strongly advised to ensure long-term protection.

Additionally, the client may want to consult with the vendor to determine whether regular Timber Pest inspections, as per AS4349.3 or AS 3660.2, have been conducted in the past. This will provide further insights into any past termite management practices and help inform the appropriate course of action.

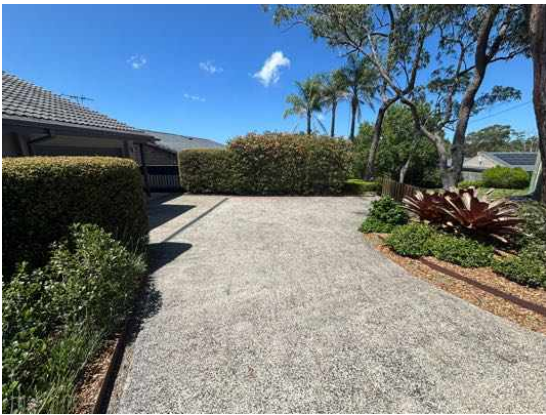
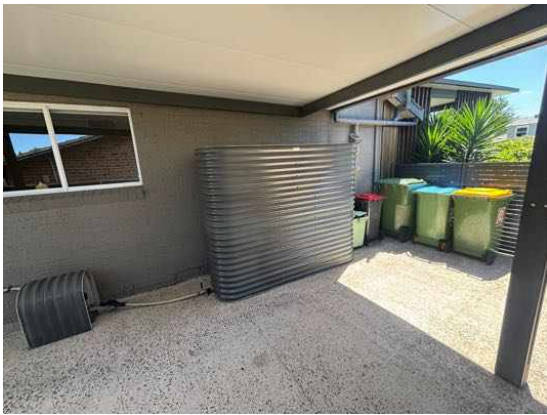
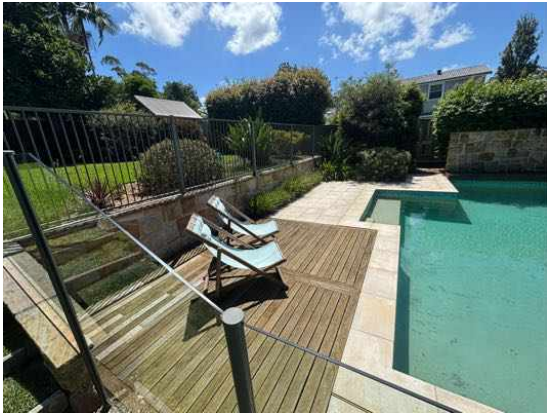
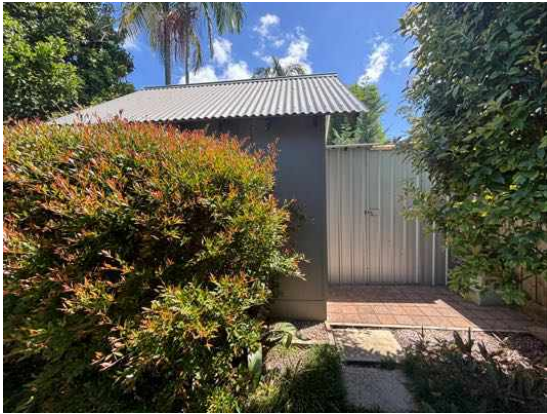
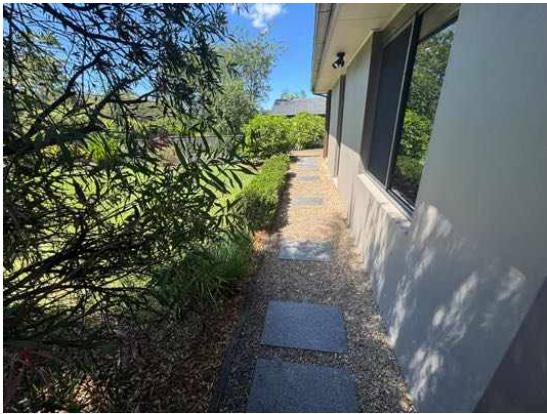
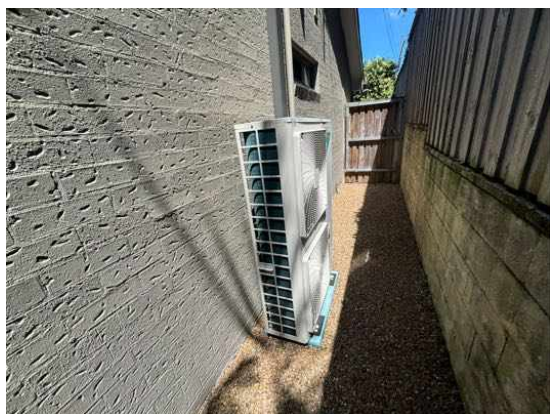
**Building:** Main Building  
**Location:** All External Areas  
**Finding:** Obstructions and Limitations - External Areas  
**Information:** The attached photographs provide a visual representation of the obstructions and limitations that impeded a full inspection of the external areas of the property at the time of assessment. These obstructions, which may include vegetation, stored items, debris, or other physical barriers, can obscure potential defects and prevent a thorough evaluation of the property's condition. Obstructions of this nature can conceal a wide range of issues, such as structural damage, water ingress, pest infestations, or deteriorating building materials, which may not be visible during the initial inspection.

It is essential that these obstructions be cleared to allow for a comprehensive inspection of the external areas. Removing these barriers will enable a more accurate assessment of the property's condition and allow any hidden defects to be identified and addressed promptly. Failure to do so could result in undetected issues worsening over time, potentially leading to more costly repairs in the future.

Therefore, it is strongly recommended that the obstructions be removed and a re-inspection be scheduled once the affected areas are made fully accessible. This will ensure a complete evaluation of the property's exterior and provide the client with a clear understanding of any potential issues that may have been concealed during the initial inspection.

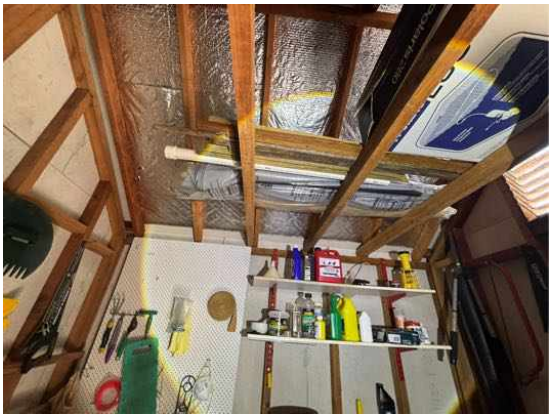
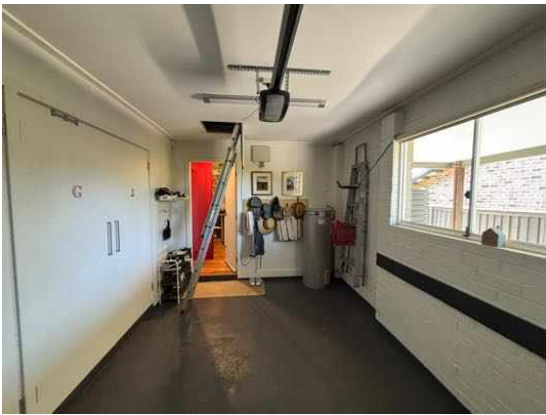
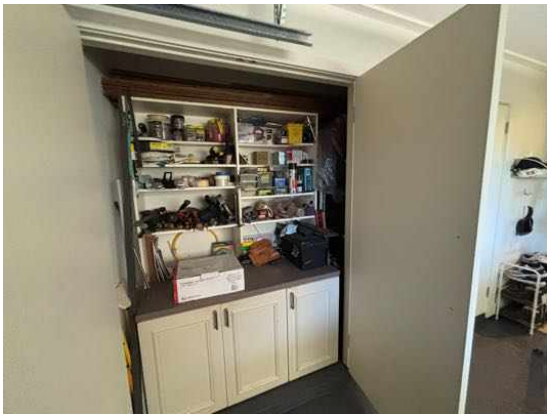
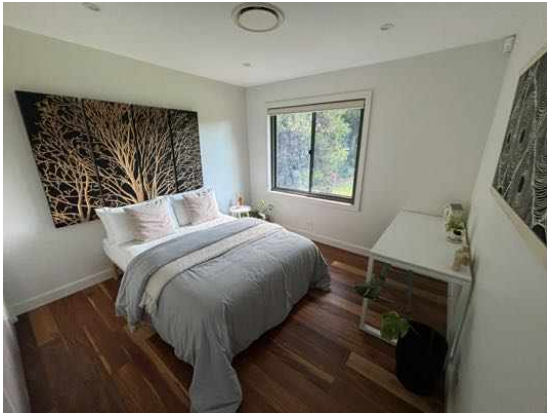
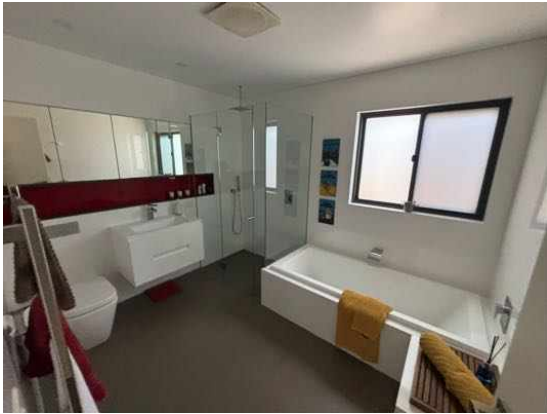
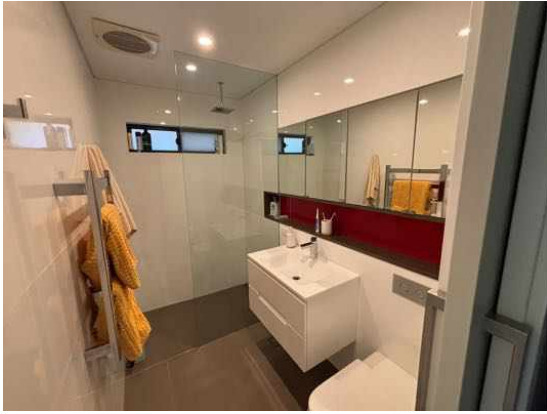
Information: The accompanying photographs provide clear evidence of the obstructions and limitations that restricted a comprehensive inspection of the internal areas of the property at the time of assessment. These obstructions, which may include furniture, personal belongings, stored items, or structural elements such as wall coverings and built-ins, significantly hindered the ability to thoroughly evaluate these areas. It is important to note that such obstructions can potentially conceal a wide array of defects, ranging from hidden structural damage, water leaks, pest infestations, or electrical issues, to deteriorating materials that may not be visible during the initial inspection.

The presence of these impediments means that critical areas of the property were not accessible, and therefore, any underlying defects that may affect the integrity and safety of the property could remain undetected. These hidden defects, if left unaddressed, could worsen over time and may result in costly repairs or pose potential safety hazards to the occupants.

It is highly recommended that all obstructions be cleared to facilitate a complete and thorough inspection of the internal areas. Once the obstructions have been removed and full access is available, a re-inspection should be carried out to ensure that any previously concealed issues can be properly identified and rectified. This follow-up inspection will provide a more accurate assessment of the property's internal condition and help the client make informed decisions about any necessary repairs or maintenance.

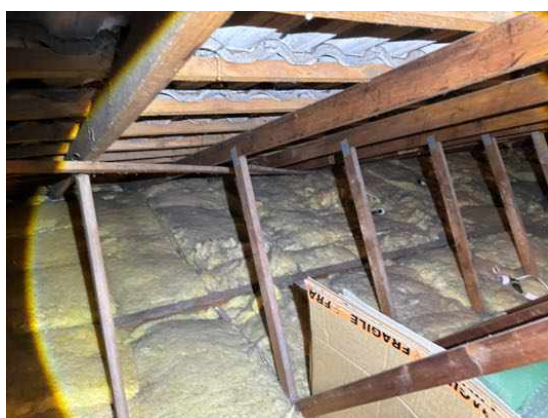
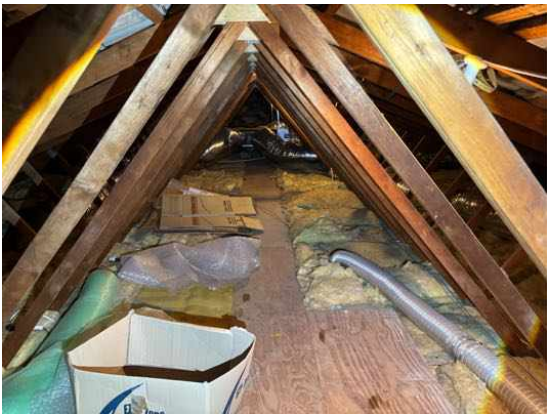
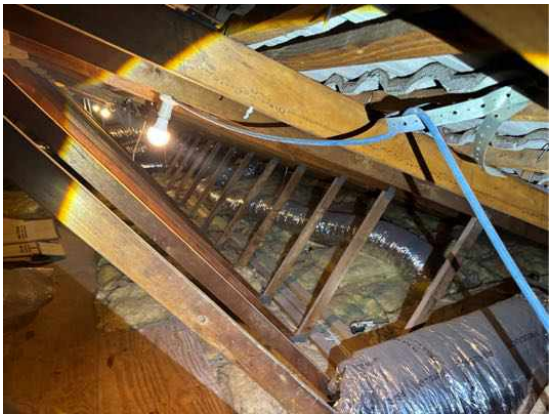
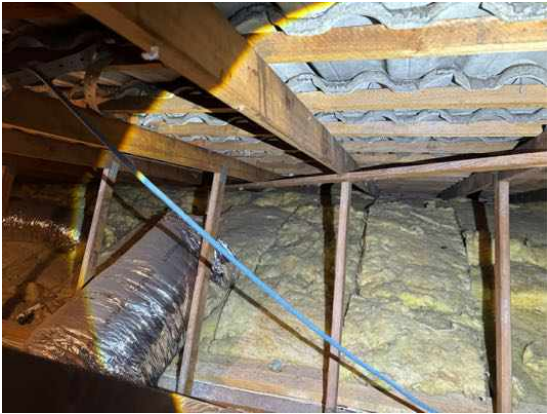
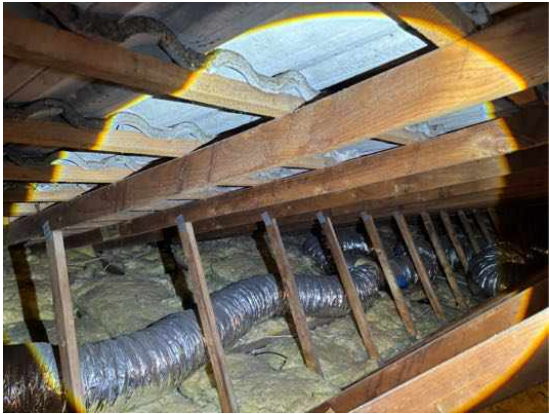
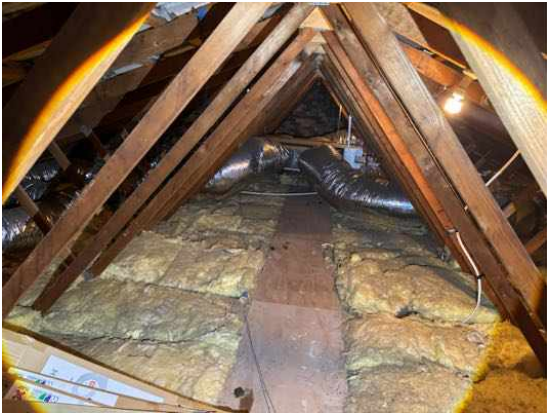
Building: Main Building  
Location: Roof Void  
Finding: Obstructions, Limitations, and General Roof Space Condition  
Information: The photographs provided document both the general condition and the obstructions and limitations that were present in the roof cavity of the main building at the time of inspection. These obstructions—such as insulation materials, stored items, structural elements, or electrical wiring—restricted safe and adequate access to key areas within the roof space. As a result, a comprehensive inspection of all components could not be completed.

Obstructions of this nature may conceal a variety of potential defects, including damaged framing, compromised insulation, evidence of moisture ingress, pest activity, or electrical hazards. While no major issues were observed in the visible areas, the presence of these limitations means that some defects may remain undetected.

It is recommended that these barriers be removed or repositioned to facilitate full and safe access to the roof space. Once clear, a follow-up inspection should be conducted to allow for a thorough assessment of all concealed areas. This will help ensure that the condition of the roof cavity is accurately evaluated and any hidden issues are appropriately identified and addressed.

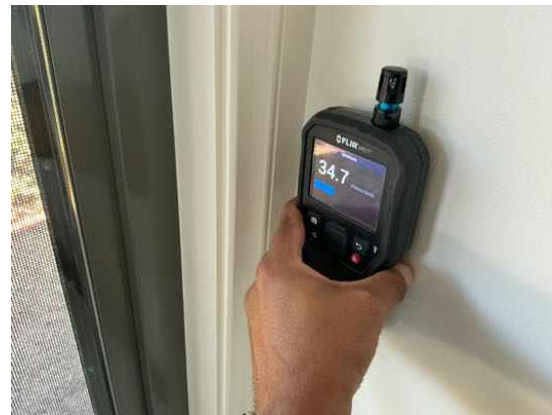
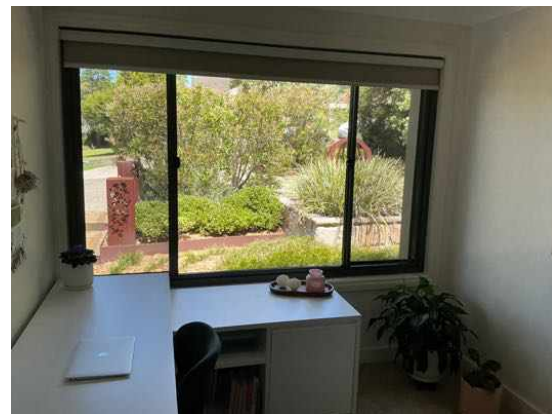
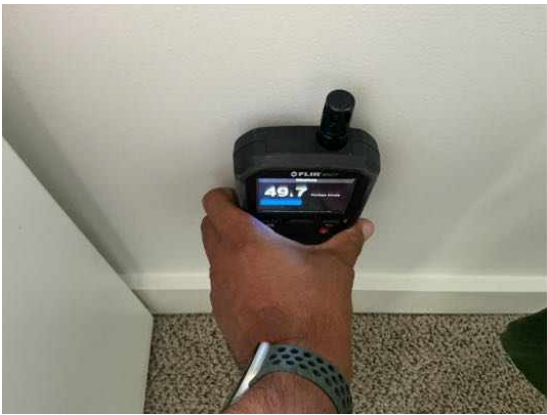
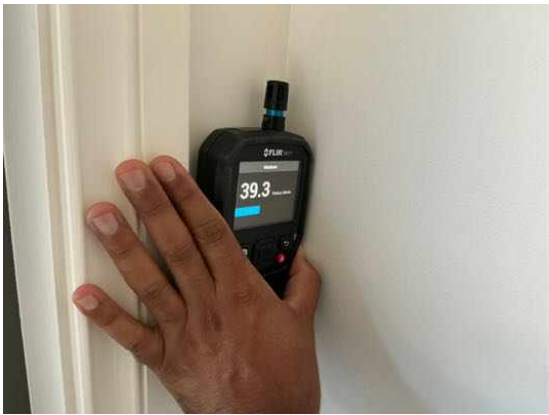
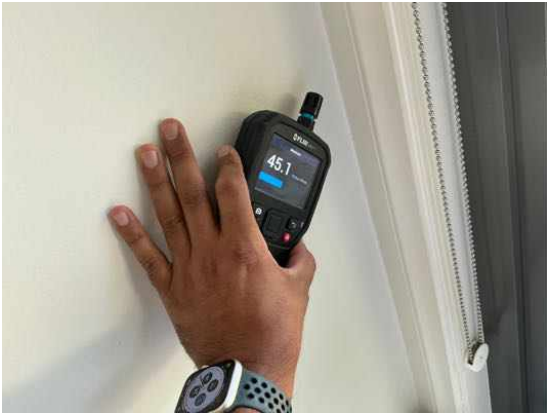
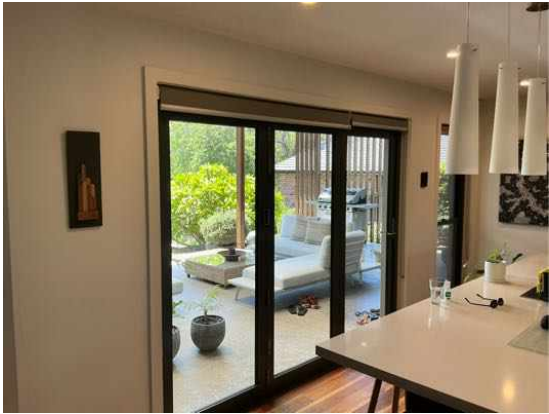
Building: Main Building  
Location: All Areas  
Finding: Additional Photos - Moisture Meter Readings  
Information: Additional moisture meter reading photos have been provided for the property to offer further clarity on areas tested during the inspection. These photos are intended to give a visual reference for the specific locations where moisture levels were measured. These readings were taken at the time of the inspection to assess any potential moisture-related issues within the property. Any defects related to moisture that were identified during the inspection have been separately mentioned in the defect statements within the report.

It is important for the client to understand that moisture levels can fluctuate over time due to various factors, including changes in weather, humidity, and environmental conditions. While the readings reflect the property's moisture levels during the inspection, they may not represent future conditions, and increased moisture could lead to issues such as dampness, mould growth, or deterioration of building materials if left unmonitored.

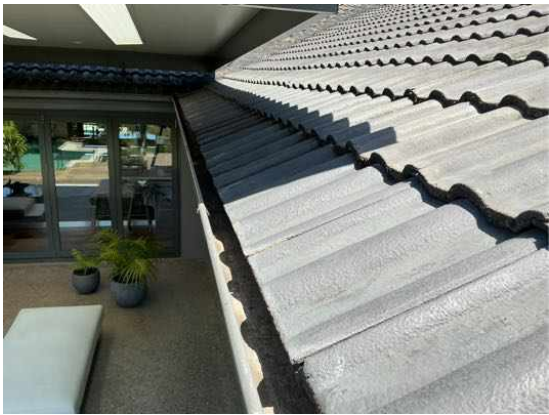
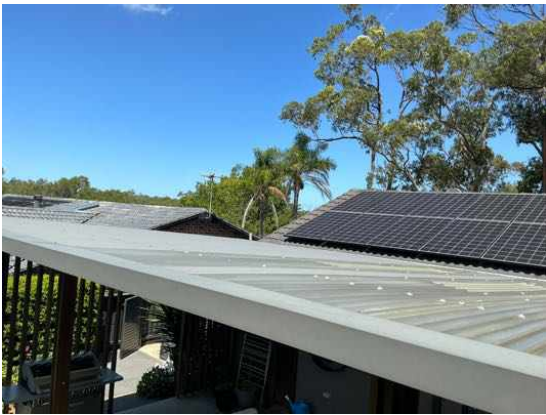
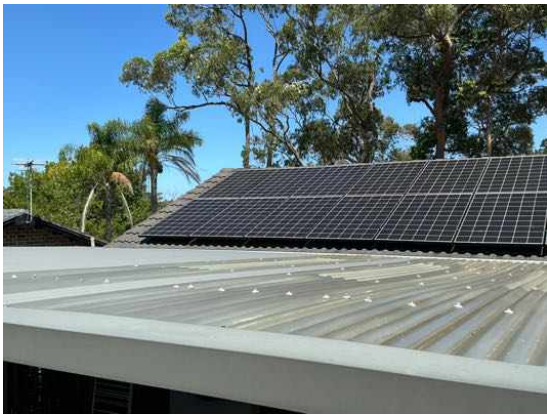
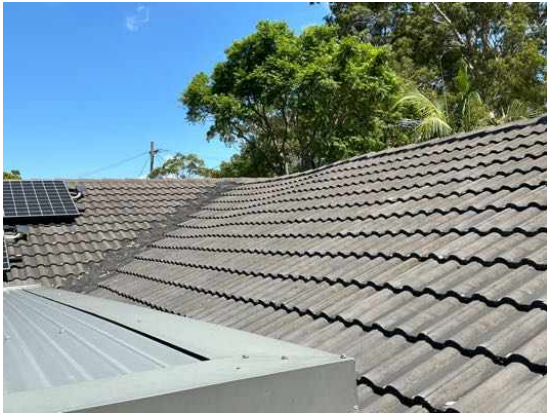
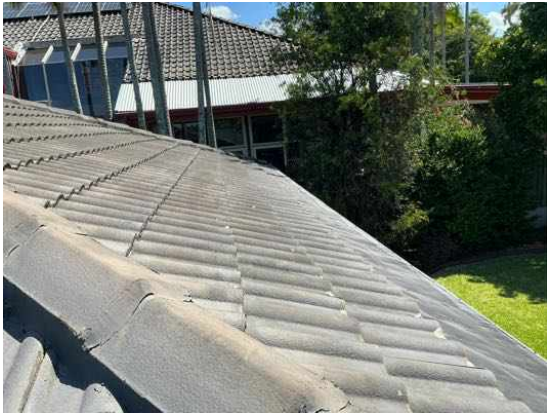
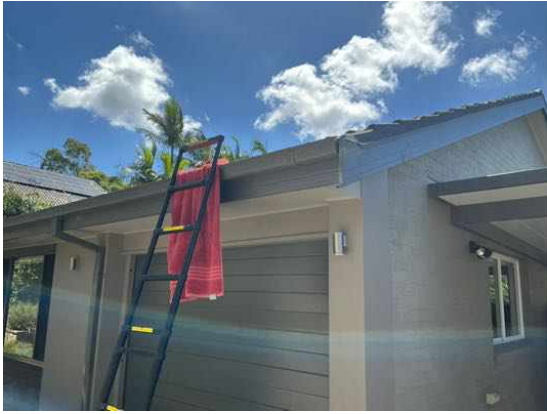
Information: As part of the information provided, please note that the attached roof photos represent the condition of the roof at the time of inspection. These photos are for visual reference only and do not constitute a detailed roofing assessment. Any defects or issues identified with the roof are mentioned separately in the defect statements. It is strongly recommended that the client engage a qualified roofer to conduct a thorough inspection of the roof, ensuring that any potential issues, such as leaks, structural integrity, or wear and tear, are properly identified and addressed.

Additionally, the condition of the roof may change over time due to weather, natural wear, or other unforeseen factors. Regular maintenance and inspections by a licensed professional are advised to ensure the roof remains in good condition and to avoid costly repairs in the future. The information provided in these photos should be considered a snapshot of the roof's condition during the time of inspection and not a guarantee of its future performance.
