Building and Timber Pest Inspection Report

Inspection Date: Fri, 27 Feb 2026

Property Address: 703/8 Ebsworth St, Zetland NSW 2017,
Australia

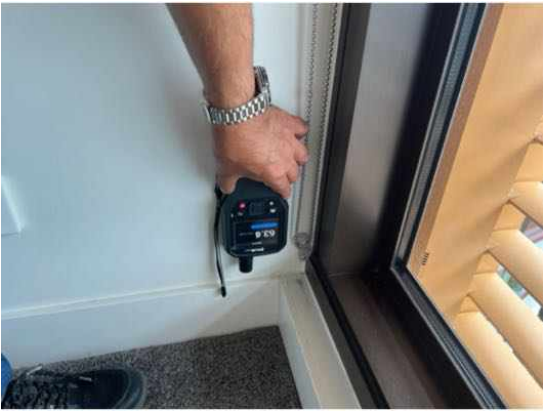
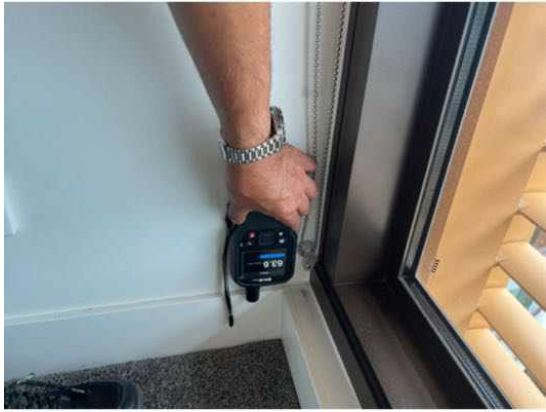
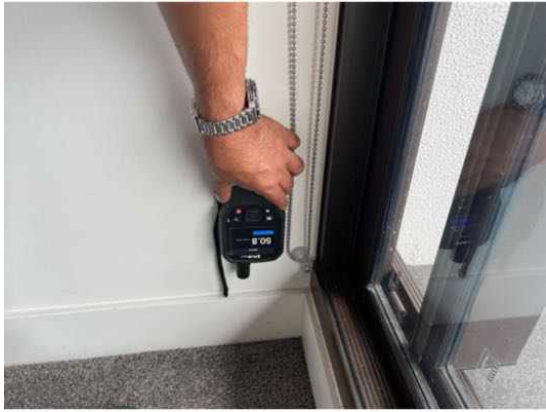
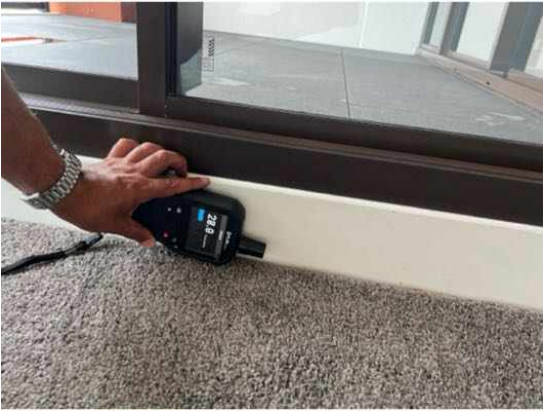
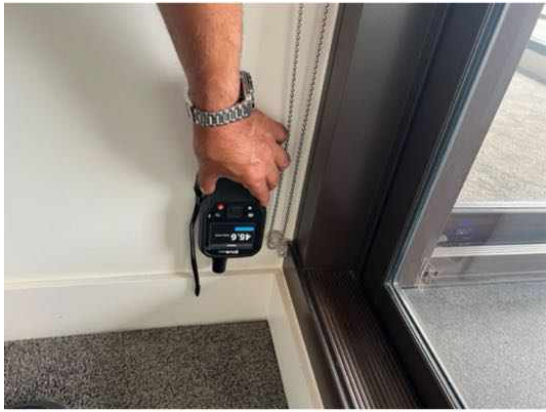
Finding 3.01

Building:	Main Building
Location:	All Internal Areas - Near skirting door and windows (Bedroom , lounge)
Finding:	Elevated Moisture Skirting and bedroom/lounge window wall
Information:	Elevated moisture readings were recorded to wall and skirting areas adjacent to sliding doors and window openings. The distribution of readings suggests possible moisture ingress associated with external door and window assemblies or balcony threshold detailing. No visible deterioration was noted at the time of inspection. Due to the non-invasive nature of the inspection, the precise source could not be determined at the time, however, further investigation by a suitably qualified contractor is recommended to assess external sealing, flashing and waterproofing integrity.

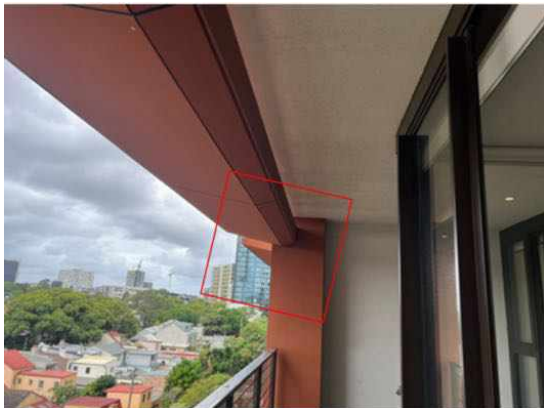
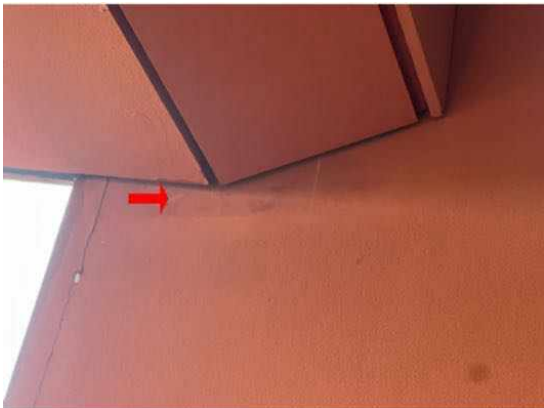
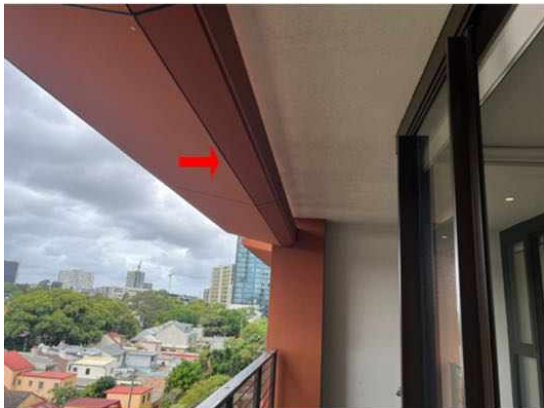
Finding 3.02

Building: Main Building
Location: Balcony
Finding: Elevated Moisture and minor deterioration - Strata
Information: Slightly elevated moisture levels were detected on balcony exterior cladding wall. There was visible signs of paint bubbling and minor deterioration along with water droplets in the bulk head. Further invasive investigation by a licensed plumber or waterproofing specialist is recommended to confirm the source and extent of water ingress. As this relates to a multi-residential building, the source of water ingress may involve common property, a suitably qualified waterproofing contractor is recommended to determine cause, responsibility, and scope if required.

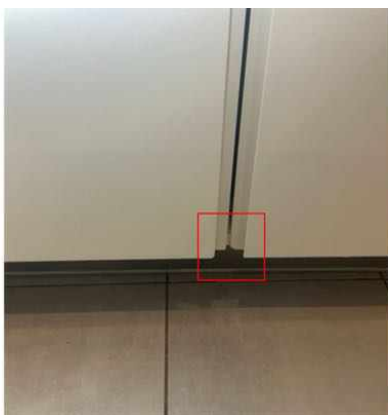
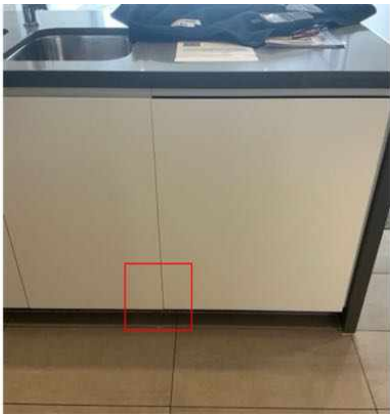
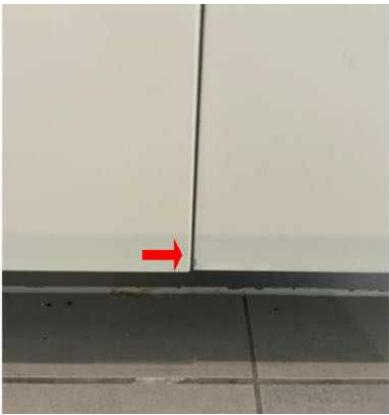
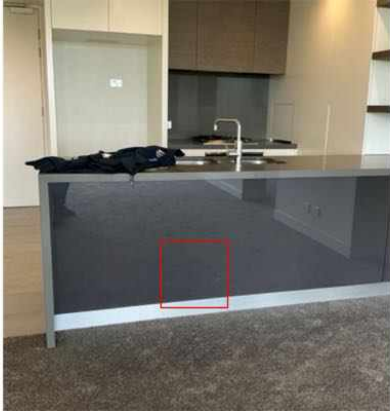
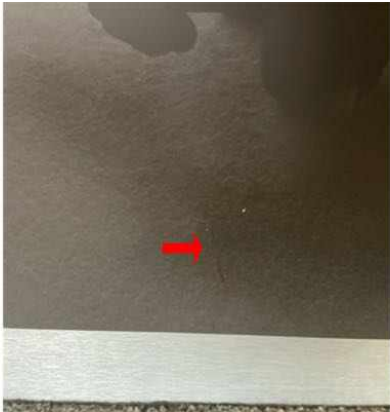
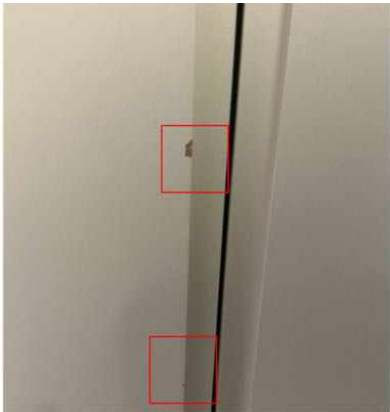
Building:	Main Building
Location:	All Internal Areas
Finding:	Building element - Damaged - Cupboard chipping kitchen/Hallway , bedroom built in chipping , plaster damaged master bedroom/lounge , loose towel rail ensuite
Information:	Breakage occurs generally when the building materials have either aged and decayed, or as a result of damage (accidental or deliberate).

Repair and/or replacement of broken elements is advised to ensure that additional secondary defects do not arise as a consequence. Such works are necessary, as all building elements play a key role in the operation and function of the overall structure and its performance.

A relevant tradesperson should be appointed to repair or replace the affected building element prior to any subsequent damage being caused.

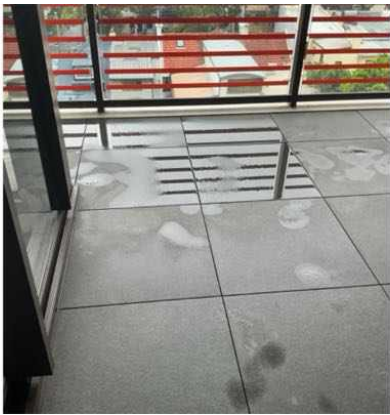
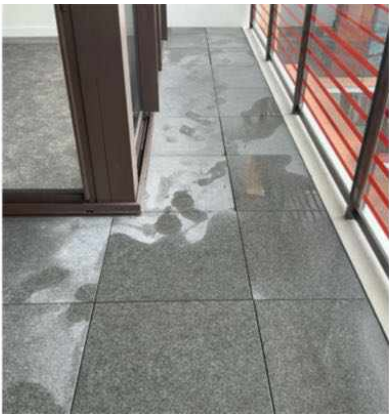
Finding 3.06

Building: Main Building
Location: Balcony
Finding: Water Ponding
Information: The pavers showed evidence of minor water ponding during rain events. Prolonged exposure to standing water can accelerate deterioration or slip hazards if not maintained. Regular monitoring and timely maintenance is recommended to ensure safety and durability.

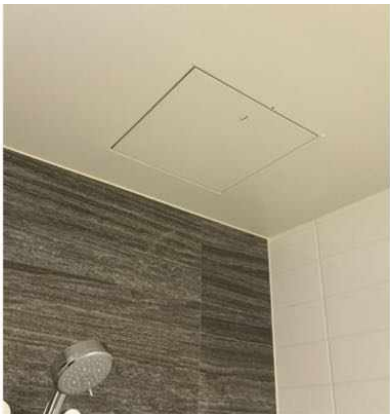
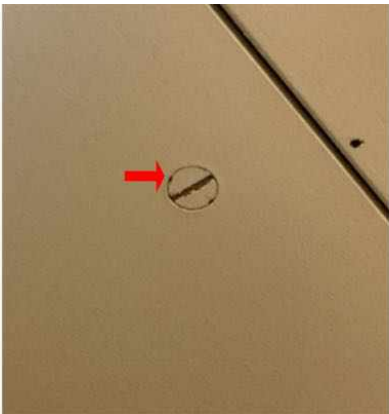
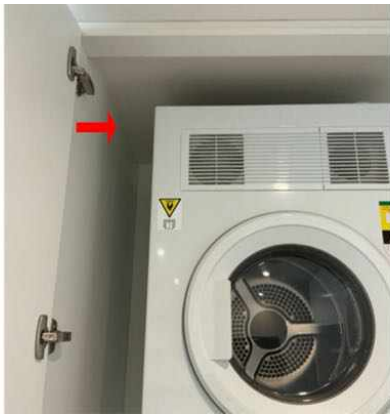
Finding 3.07

Building: Main Building
Location: Bathroom, Laundry
Finding: Water Staining - Humidity or Ventilation
Information: The ceiling surface shows peeling paint and water staining on the walls faint commonly consistent with humidity-related staining, often found in bathroom or wet areas with insufficient ventilation. While there is no visible sagging or major water damage, the pattern suggests prolonged moisture exposure, possibly due to steam accumulation or minor condensation issues. According to AS 4349.1–2007 (Appendix C), this would be classified as a minor defect unless further deterioration or active leaks are found. Recommend improving mechanical or natural ventilation, cleaning the surface with mould treatment, and monitoring for recurrence.

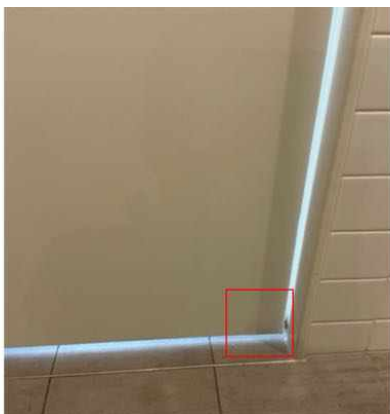
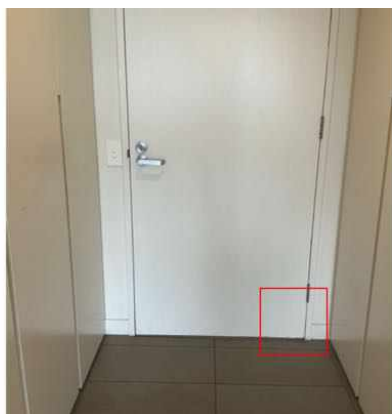
Finding 3.08

Building:	Main Building
Location:	Bathroom, Main door
Finding:	Delamination of timbers
Information:	Delamination is one means by which composite materials (e.g. layered timber composites) may fail over time. In laminated materials, repeated cyclic stresses may lead to the formation of mini-structures of separate layers, with significant loss of mechanical toughness. Water penetration or the presence of excessive moisture also generally contributes to delamination.

Where building materials have become delaminated, they lose their structural strength, and are likely to have a variety of appearance and serviceability defects as a result.

Delamination of timbers may be repaired where the area affected is minor and/or easily accessible, by gluing and screwing layers back together. However, this is an interim repair, and where delamination has occurred, the client should plan for the replacement of affected timbers sooner than would otherwise be expected.

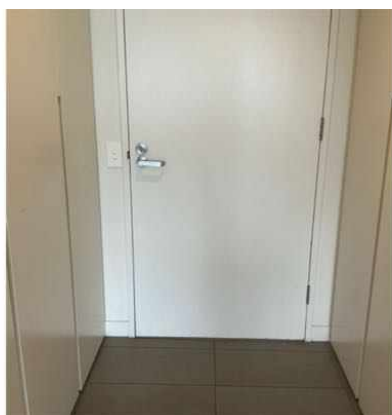
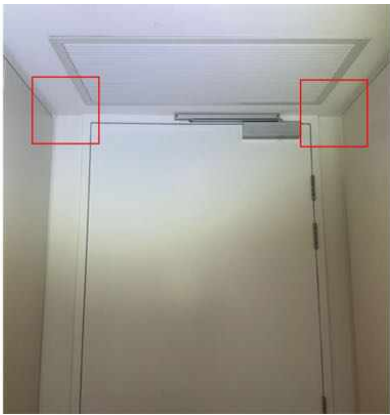
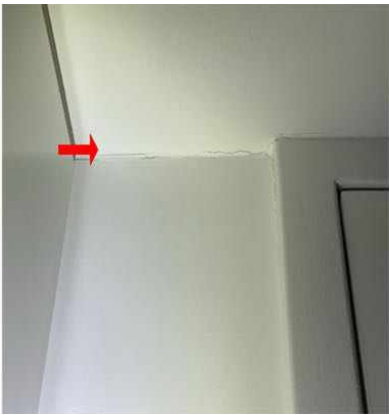
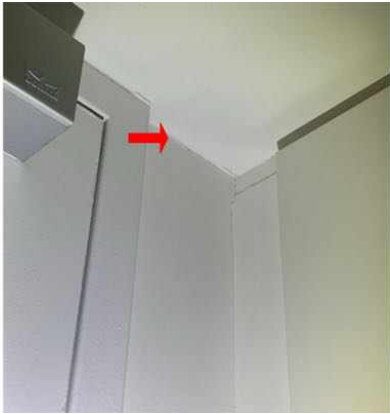
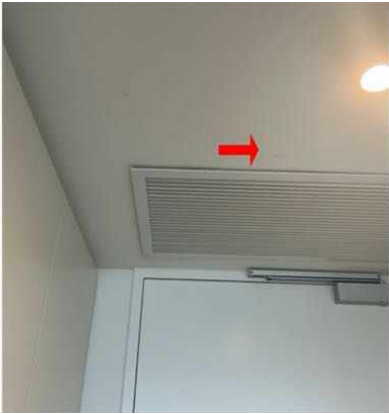
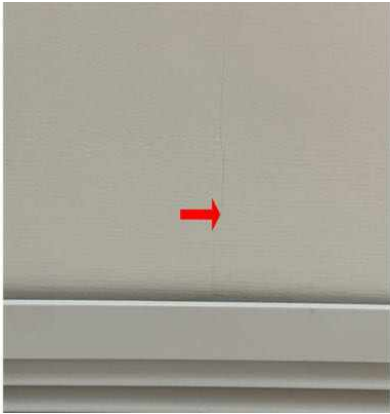
Finding 3.09

Building:	Main Building
Location:	All Internal Areas
Finding:	Paint finish and hairline cracking to some areas
Information:	The paint finish in this area was identified as being incomplete at the time of inspection including some hairline minor cracking.

Whilst incomplete or missing paint finish is generally an appearance defect, it can also lead to the development of secondary building defects over time. Incomplete areas of paint finish expose the area to moisture, potentially accelerating the deterioration of underlying building materials.

Incomplete paint finishes should be sanded back, filled, leveled and painted, as applicable. Where inadequate or missing paint protection has led to the deterioration of the associated building element, repair and/or replacement of this building element may be required.

A painting contractor should be appointed as soon as possible to perform necessary works to aid the appearance of the affected area and to ensure the area is protected against further deterioration. Alternatively, the homeowner following manufacturer instructions may perform these works.

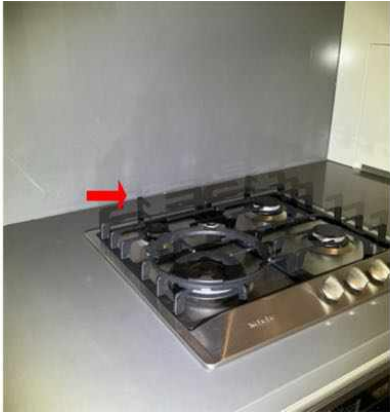
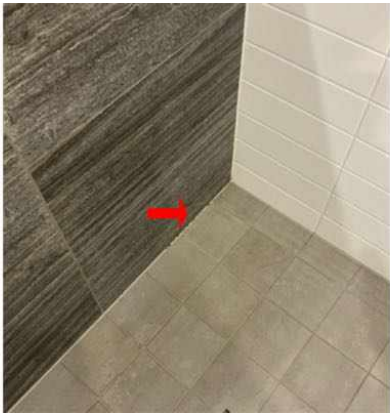
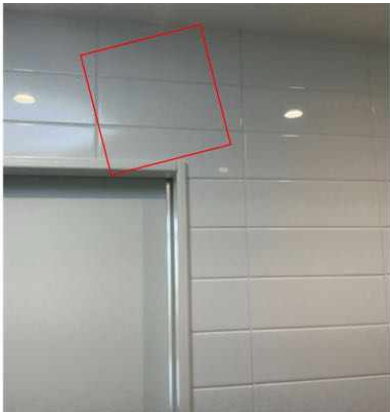
Finding 3.10

Building:	Main Building
Location:	All Internal Areas
Finding:	Sealant and grouting - Missing or degraded
Information:	It was noted on inspection that sealant or grout is degraded. There is also evidence of poor workmanship and excessive use of sealant. Silicone should never be used as a first line of defence against waterproofing. Further inspection by a licensed waterproofing contractor is highly recommended.

Different materials and floor areas move at different rates, generally causing cracking to grout or sealant at this point. A flexible sealant is required to allow for expected expansion and contraction, while keeping the joint water tight and protective of all associated building materials.

There appears to be excessive mould to the sealant and grout which will likely require scraping out and replacement.

Flexible and mould resistant materials should be applied to affected areas to prevent any subsequent water damage that is likely to occur. Regular maintenance and replacement of damage or missing or damaged sealant and grout is highly recommended to the wet areas, as this is a regular wear and tear defect. Sealant and grouting in areas that come into regular contact with water should be maintained for the long term care of your property.

A sealant specialist or tiling contractor should be appointed to complete these works as soon as possible

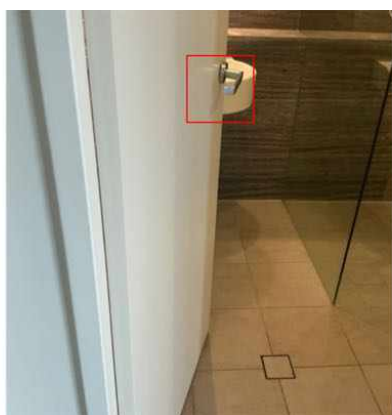
Finding 3.11

Building: Main Building
Location: Bathroom
Finding: Door - Broken handle
Information: The door handle in this area was found to be broken at the time of inspection. Breakage occurs generally when the building materials have aged and decayed, but may be indicative of impact damage (accidental or deliberate).

Repair and/or replacement of the broken door handle is advised to improve the operational state of the associated door.

A qualified carpenter or general handyman should be appointed to repair/replace the door handle at the client's discretion.

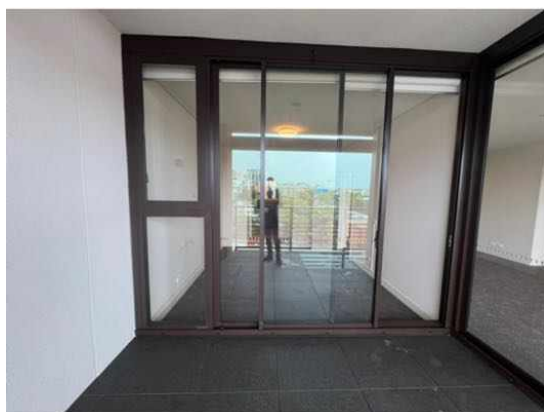
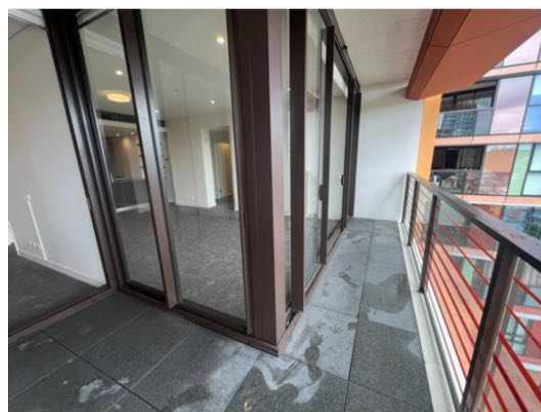
Noted Item

Building:	Main Building
Location:	All External Areas
Finding:	Pedestal Paver System - Balcony
Information:	The balcony appears to incorporate a raised pedestal paver system. Minor movement of individual pavers can be characteristic of this system, however, any excessive rocking or instability should be assessed and adjusted to ensure even support and minimise trip hazards. Ongoing maintenance of pedestal alignment and drainage beneath the pavers is recommended.
