# Building and Timber Pest Inspection Report

Inspection Date: Wed, 11 Mar 2026

Property Address: 3/64 Hazel Grove, Ridgehaven SA 5097,  
Australia

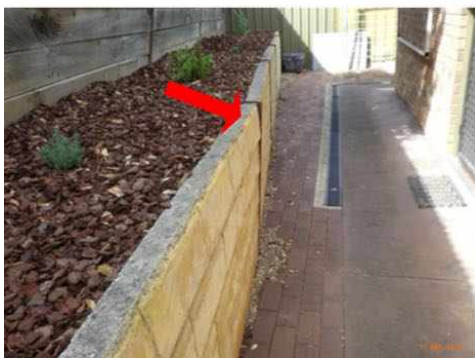
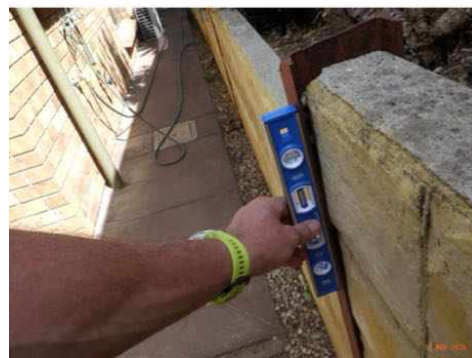
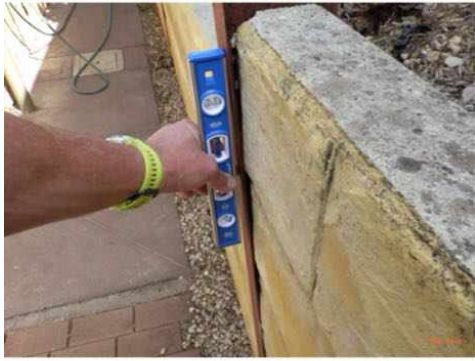
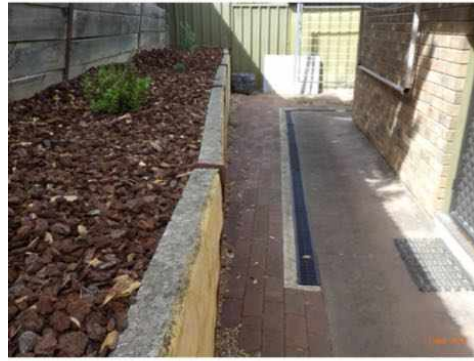
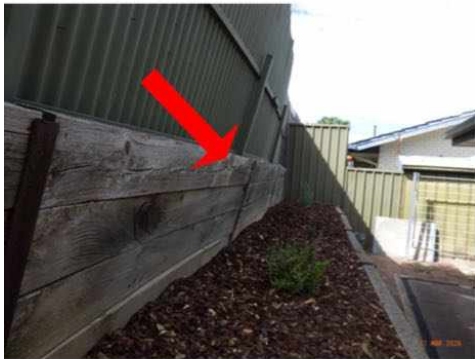
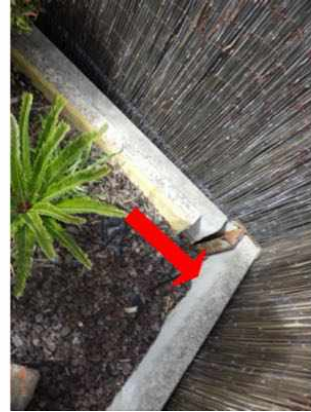
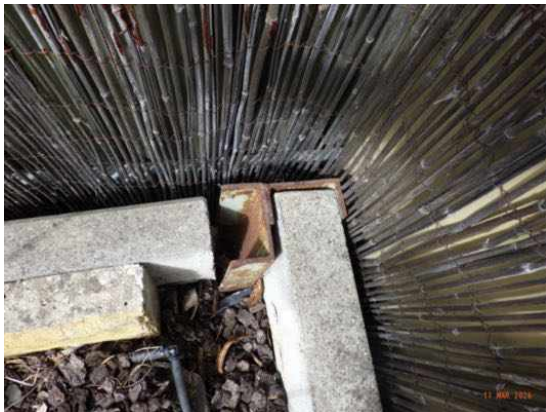
#### Finding 3.01

Location: Yard - Back

Finding: Retaining wall - Defective

Information: Several retaining walls were found to be defective at the time of inspection. Generally, defective retaining walls are caused by poor original design or material use. However, deteriorated retaining walls may also be a result of substandard construction, poor site drainage or unmanaged stormwater flows.

If left unmanaged, the retaining wall may become a safety hazard if it continues to destabilise. Where retaining walls further rot and decay, an environment is created that is conducive to termite and pest infestation.

Significant repair and replacement should be expected. Where retaining walls are considered structural walls, a structural engineer / surveyor should be consulted regarding required remedial works. Otherwise, a landscaper or retaining wall installer may be appointed to repair or replace the wall, at the discretion of the client.

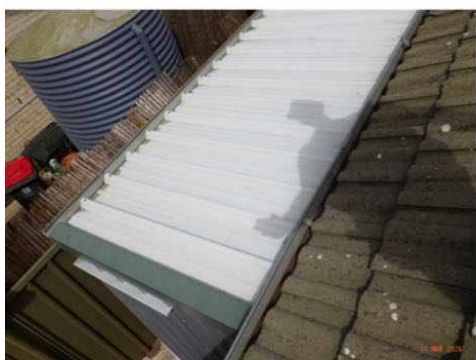
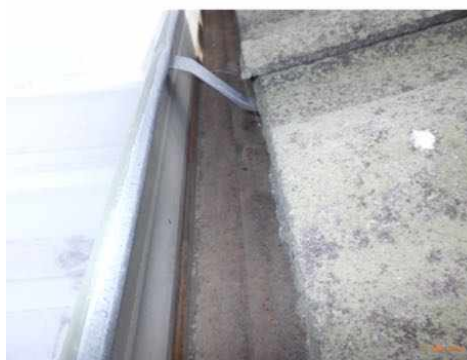
### Finding 3.02

Building:	Building 1
Location:	Roof Exterior
Finding:	Roof plumbing - Rusted or corroded
Information:	The roof plumbing has areas of rust and corrosion. It is suspected that this has been caused by blockages, resulting in pooling or standing water, that have prematurely rusted elements of the roof plumbing. Some guttering has been replaced and surface rust is evident elsewhere.

Rusted roof plumbing will generally develop holes and leaks that can affect other building elements with poor drainage of storm water.

Poorly drained roof areas will also lead to damp conditions surrounding the base perimeter of the building which, if left unmanaged, can lead to a range of secondary building defects.

Repair and/or replacement of rusted roof plumbing is highly required in order to reinstate the roof drainage system to a fully operational level.

To further maintain these areas, gutters should be cleaned frequently, allowing the avoidance of any partial blockages.

A licensed plumber or specialist roof restoration company should be appointed to undertake these works if leaks become evident.

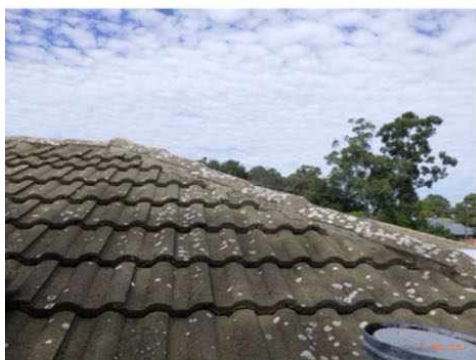
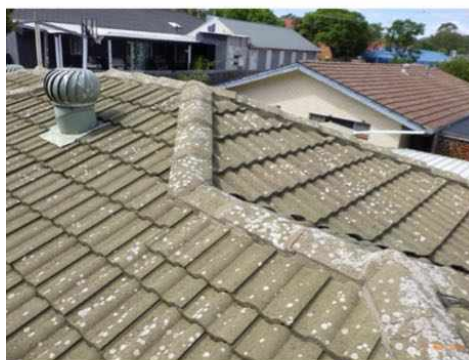
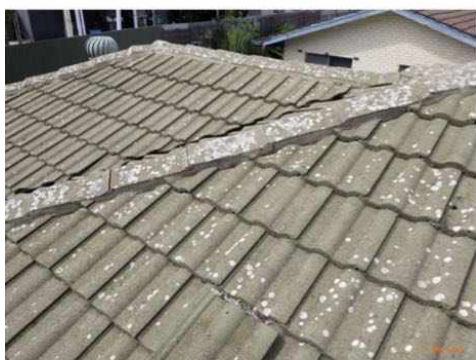
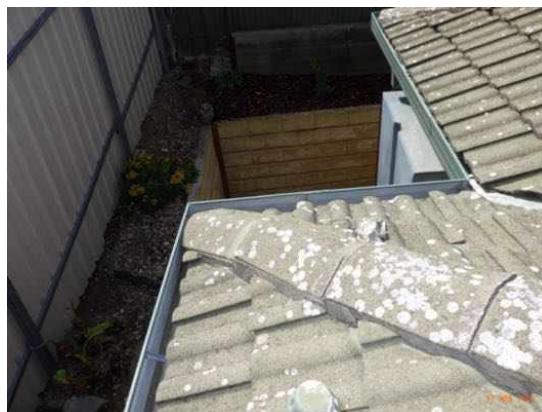
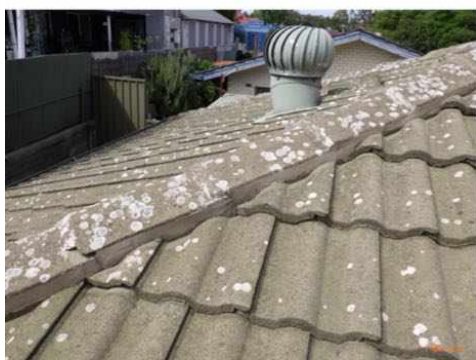
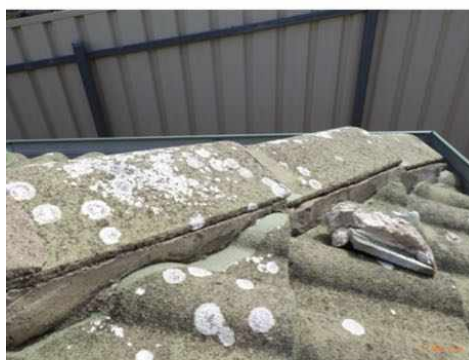
### Finding 3.03

Building:	Building 1
Location:	Roof Exterior
Finding:	Mortar - Deterioration
Information:	Mortar, or 'bedding', is the material which fills joins and intersections between tiles and other building elements on the exterior roof covering, such as gable ends, hip capping and valleys. Upon inspection of the exterior roof, it was noted that sections of the mortar show varying levels of deterioration.

Mortar generally deteriorates as a result of frequent exposure to weather conditions over a prolonged period of time. Mortar that is deteriorating may allow water ingress into the roof void, putting associated building elements and roofing structures at risk of water damage.

Deteriorated mortar also detracts from the functionality of roof tiles and other roofing elements, potentially decreasing weather tightness and roof drainage.

Mortar deterioration can be attended to by a handyperson where areas of deterioration are localised and easily accessible. Otherwise, consultation with a roofing contractor is advised where greater works are required.

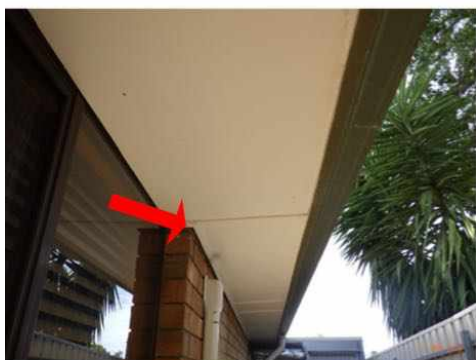
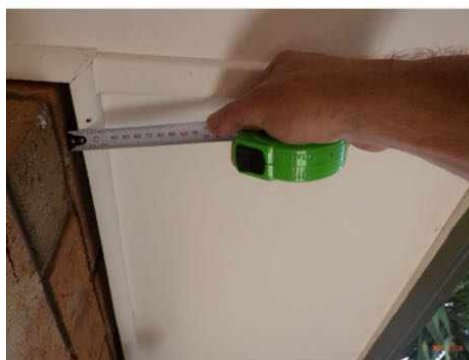
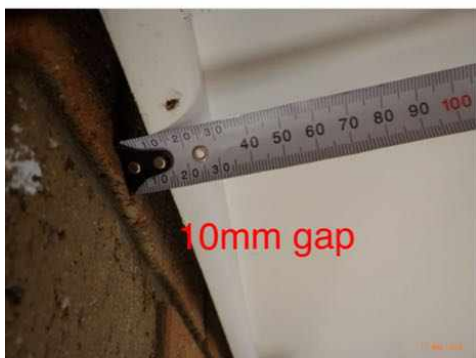
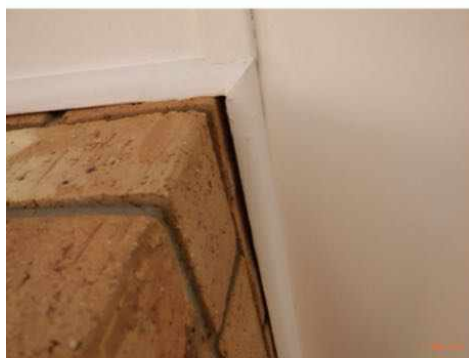
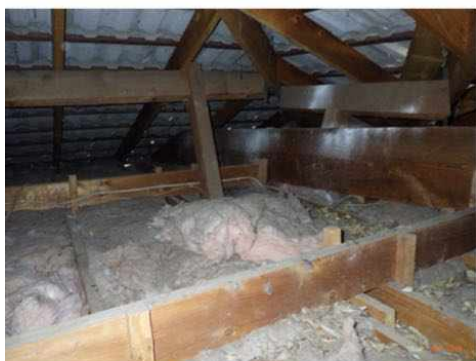
### Finding 3.04

Building:	Building 1
Location:	Roof Void
Finding:	Sagging roof - Roof spread - Minor 10mm
Information:	<p>The roofing structure was found to be sagging at the time of inspection. This is evidenced by gaps in the eaves linings/ quads of approximately 10mm at several areas of the roof at the time of inspection. It is likely that this defect has occurred over a long period of time and as such monitoring the area is recommended.</p> <p>Secondary defects occurring from roof spread range from deteriorated ridge capping mortar to general sag evident across the roof line.</p>

There are several likely contributing factors for this damage including but not limited to

- settling of the roof members
- Lack of common rafters to the central section of roof.

This defect is a common defect with tiled pitched roofs and as such monitoring the area is recommended. Should further sag become apparent then the area should be inspected by a registered structural engineer to provide remedial advice to be carried out by a licensed builder

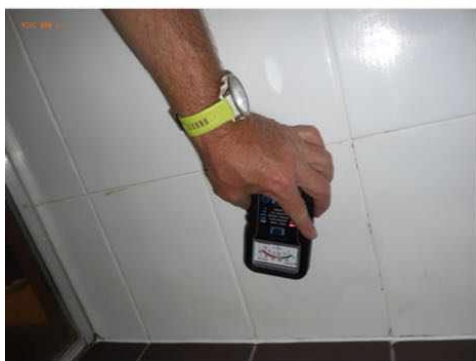
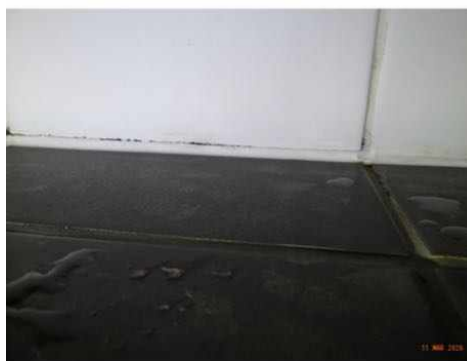
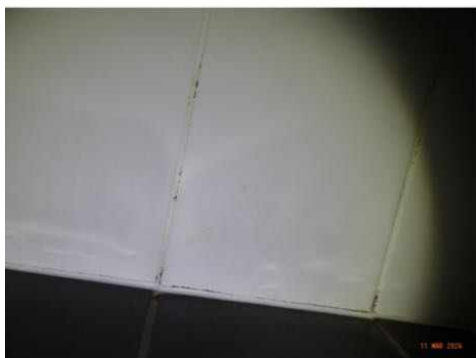
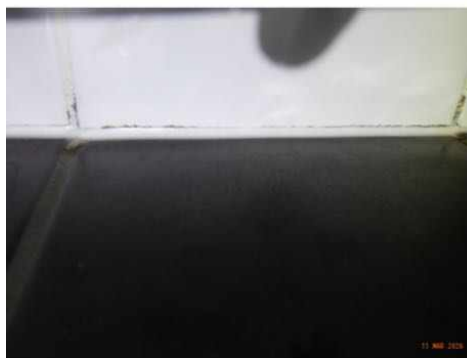
### Finding 3.05

Building: Building 1  
Location: Bathroom  
Finding: Sealant and grouting - Regular maintenance  
Information: It was noted on inspection that sealant and grout has small areas of deterioration evident to the shower alcove at the time of inspection.

Silicone and grout generally need repair at least every 5 years and as such close monitoring should be carried out in the future after repairs are carried out.

Different materials and floor areas move at different rates, generally causing cracking to grout or sealant at this point. A flexible sealant is required to allow for expected expansion and contraction, while keeping the joint water tight and protective of all associated building materials.

Flexible and mould resistant materials should be applied to affected areas to prevent any subsequent water damage that is likely to occur. Regular maintenance and replacement of damage or missing or damaged sealant and grout is highly recommended to the wet areas, as this is a regular wear and tear defect. Sealant and grouting in areas that come into regular contact with water should be maintained for the long term care of your property.

A sealant specialist or tiling contractor should be appointed to complete these works as soon as possible

Repairing the sealant and grout in the short term is recommended.

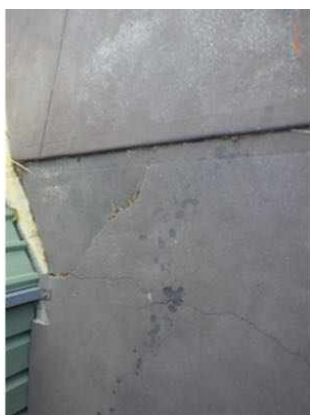
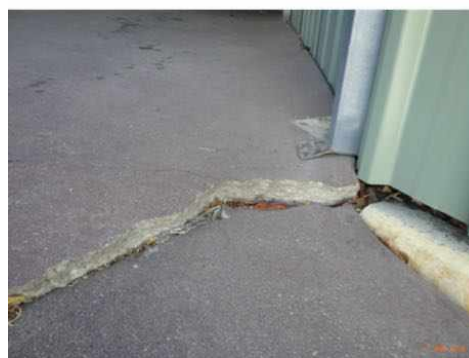
### Finding 3.06

Building:	Building 1
Location:	All Areas
Finding:	Minor defects present
Information:	Minor defects were evident throughout the dwelling at the time of inspection, which are consistent with normal wear and tear and considered appropriate for a property of this age.

These defects are typical of ongoing material ageing, settlement, and general use over time, and include, but are not limited to:

- Cracking to carport concrete

While these defects are not considered structurally significant at present, they should be addressed as part of routine and ongoing property maintenance to prevent further deterioration. Repairs and maintenance works should be carried out by appropriately licensed and qualified tradespeople to ensure the continued serviceability and longevity of the dwelling.

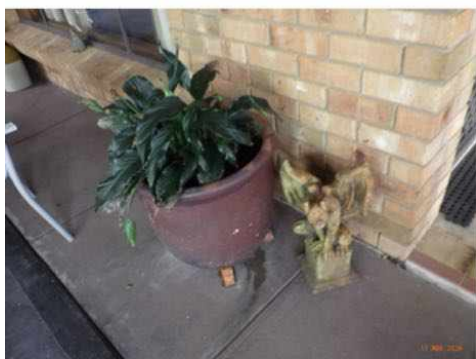
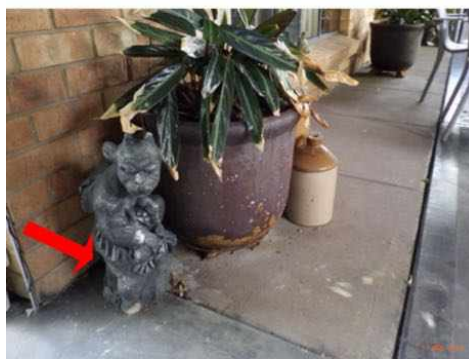
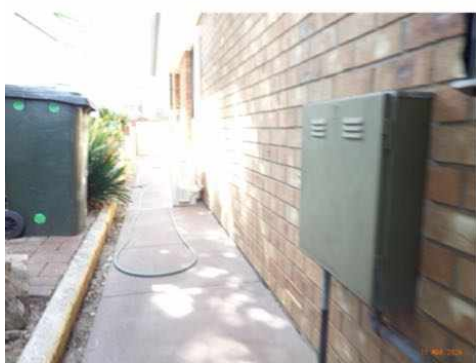
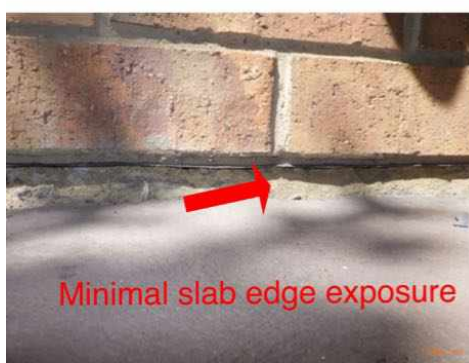
### Finding 6.01

Location: All External Areas  
 Finding: Slab Edge - Exposure  
 Information: An inspection zone of at least 75mm in relation to the exposed slab edge, between the bottom brick and the perimeter pavement, is required. This inspection zone should be maintained in order to force termites into the open where they can be detected more readily during regular inspections. The slab edge should not be concealed by anything that may prevent inspection of the area, including render, landscaping, soil, turf, paving, concrete cladding or other structures.

If the slab edge is not properly exposed there is a high risk of concealed termite attack which your inspector will likely not be able to see. Sometimes, in order to determine the type of slab, a suitably qualified person such as an architect or builder may be required to consult construction plans.

Where the slab edge cannot be properly inspected, it is highly recommended that termite or timber pest inspections be carried out every 6-12 months to aid protection of the property against infestation and termite treatment advice is followed closely.

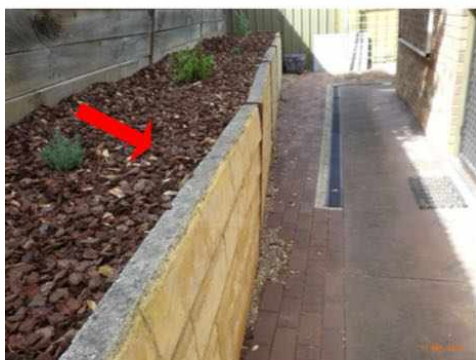
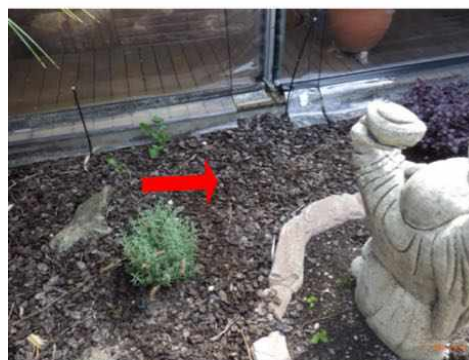
## Finding 6.02

Building: Building 1  
 Location: All External Areas  
 Finding: Untreated or non-durable timbers in a hazardous environment

Information: To reduce the risk of timber pest attack it is essential that timber used in a hazardous environment (e.g. in direct contact with the ground or frequently exposed to damp conditions) is of sufficient durability and/or is adequately preservative treated. Additionally any timber lying around or timber stumps should be removed.

Untreated timbers in direct contact with the ground are likely to develop severe wood rot and/or fungal decay if left unattended creating attraction for subterranean termites to infest the timbers from surrounding areas.

If untreated or non-durable timbers are found to be in a hazardous environment it is highly advised that replacement of these building elements be performed as soon as possible to aid the protection of the property against termite / timber pest attack. Failing this close monitoring is recommended in an attempt to identify termite infestation at an early stage.

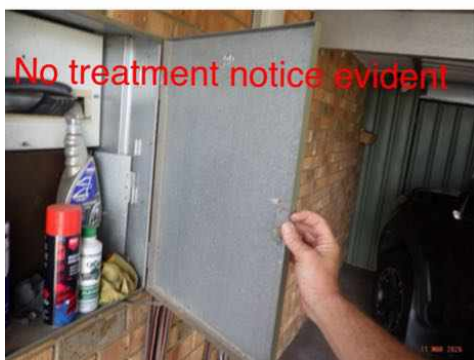
### Finding 6.03

Building: Building 1  
 Location: All Areas  
 Finding: Termite Management System - no evidence of a chemical installation  
 Information: The application of a post-construction chemical termite barrier is highly recommended for all properties, particularly if live termite activity has been found on the site previously. Such barriers are highly effective in preventing termite attack on any timber building elements throughout the property.

At the time of inspection, it appeared as though no termite management system has been installed, with no evidence to suggest preventative works taking place.

A durable notice should be placed in the switchboard unit to indicate current termite barriers.

The client may consider gaining further advice from a pest controller as to the costs and procedures involved with this application. It is recommended that obtaining such advice be a short-term priority.

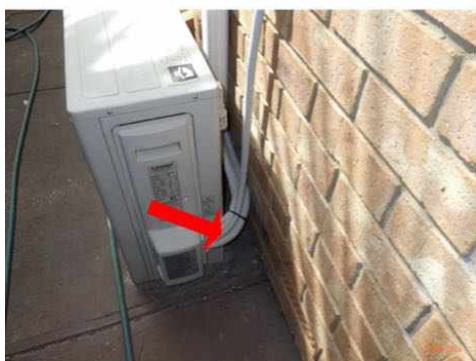
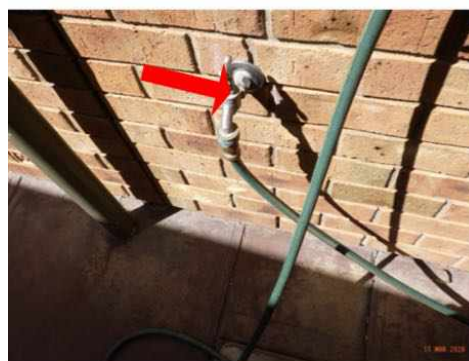
### Finding 6.04

Building:	Building 1
Location:	All External Areas
Finding:	Air conditioner and or external tap - No drainage
Information:	Moisture around the perimeter of the building should be minimised to ensure that the area is kept dry and stable which in turn reduces the risk of water damage and termite infestation.

There appears to be no drainage points set up to the air conditioning unit, and or the external tap. While this is not a legal requirement it is recommended to reduce the risk of moisture related issues and the creation of an environment conducive to termite activity.

It is recommended that a licensed plumber be appointed to set up drainage in order to prevent such an environment from being created.

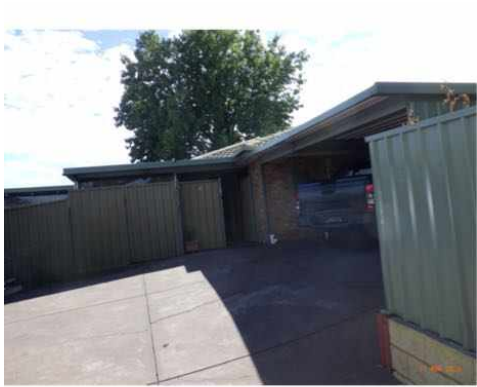
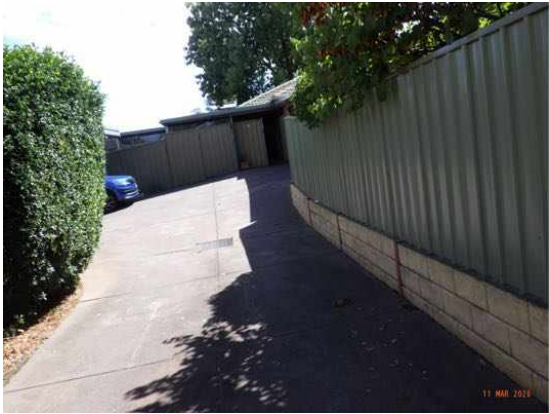
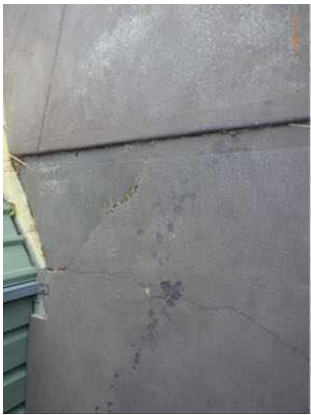
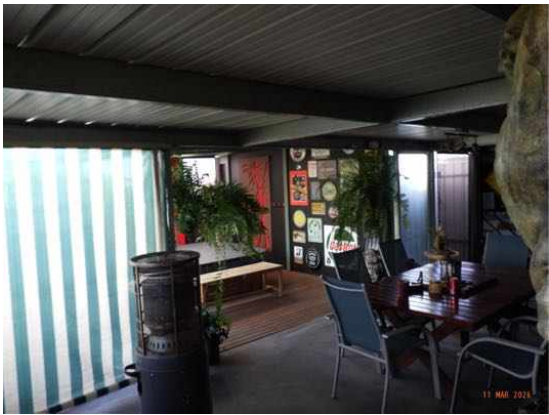
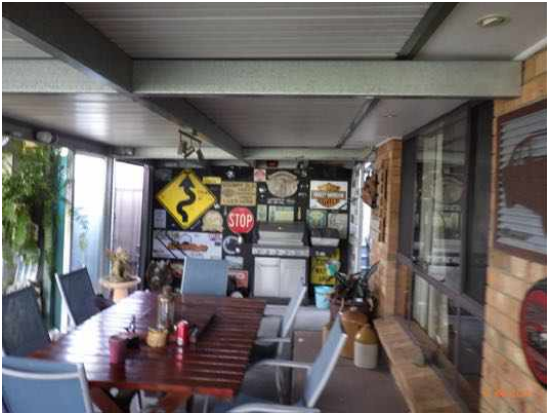
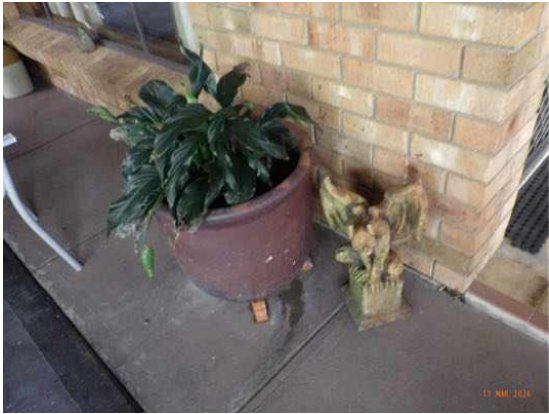
**Noted Item**

Building: Building 1  
Location: All Areas  
Finding: Additional Photos - Obstructions and Limitations  
Information:

These photographs are an indication of the obstructions and limitations which impeded full inspection of the property at the time of inspection. These obstructions can hide an array of defects and should be removed to allow full inspection to be carried out.
