Building Inspection Report

Inspection Date: Tue, 24 Mar 2026

Property Address: 1407/112 Talavera Rd Macquarie Park,
NSW 2113.

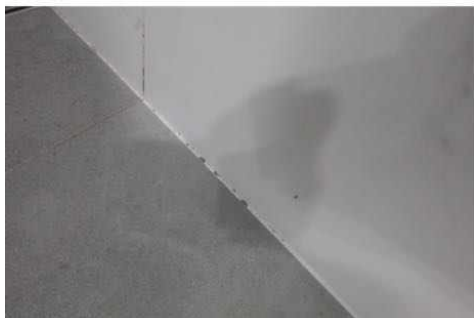
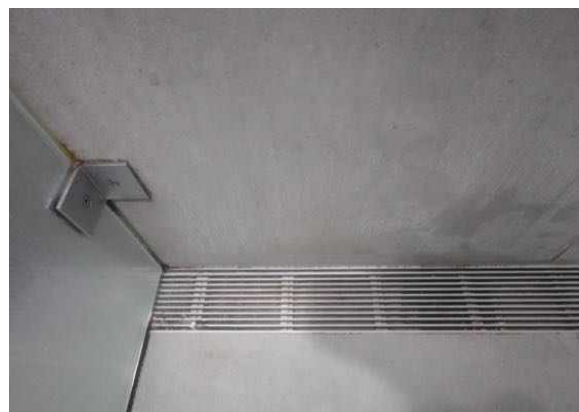
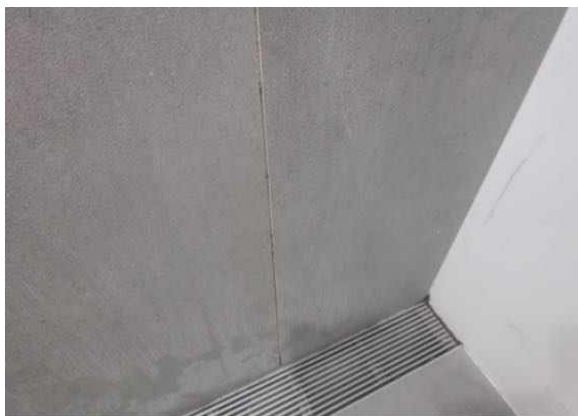
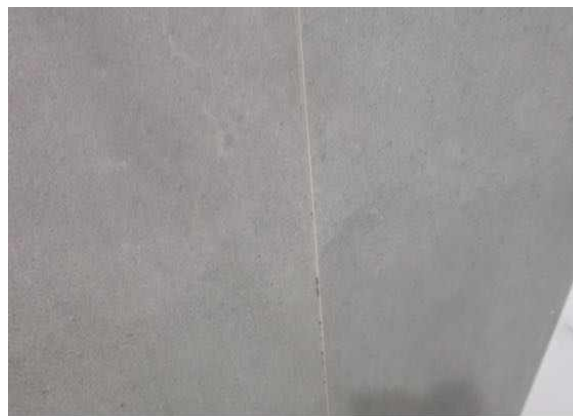
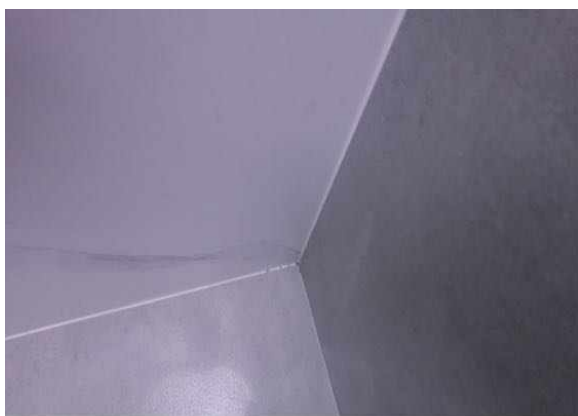
Defects 3.01

Building: Main Building
Location: Bathroom
Finding: Sealant and grouting - Inadequate
Information: It was noted on inspection that sealant or grout is degraded to several wet areas. Different materials and floor areas move at different rates, generally causing cracking to grout or sealant at this point.

A flexible sealant is required to allow for expected expansion and contraction, while keeping the joint water tight and protective of all associated building materials.

Flexible and mould resistant materials should be applied to affected areas to prevent any subsequent water damage that is likely to occur. Regular maintenance and replacement of damage or missing or damaged sealant and grout is highly recommended to the wet areas, as this is a regular wear and tear defect

A licensed sealant specialist /licensed tiling contractor should be appointed to complete these works as soon as possible.

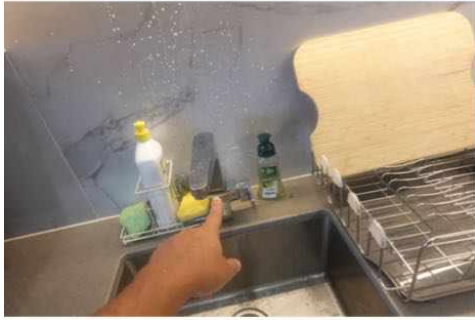
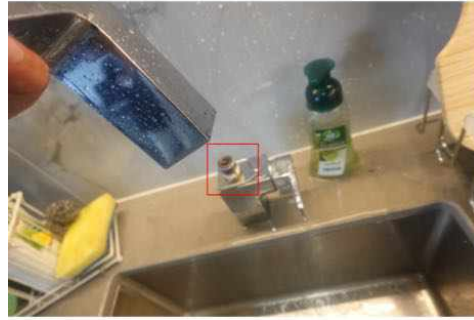
Defects 3.02

Location: Kitchen

Finding: Tap - Loose

Information: The tap in this area has not been installed correctly, or has deteriorated with age, and is consequently loose.

This tap being loose creates potential for water leaks and subsequent water damage to the surrounding area.

Where taps or spouts are loose, a licensed plumber should be appointed to re-fix the plumbing fitting.

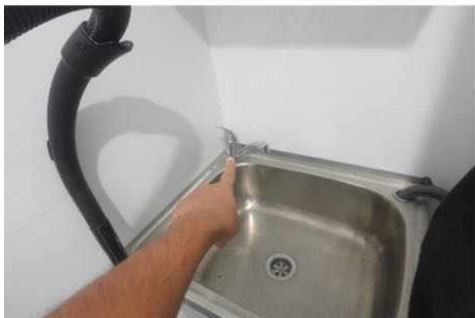
Defects 3.03

Location: Laundry

Finding: Hot water not working

Information: It was noted that the hot water on laundry sink was not working at the time of inspection.

It is advised to engage a licensed plumber to carry out necessary rectification.

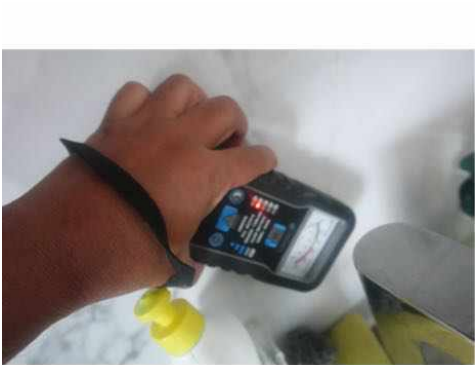
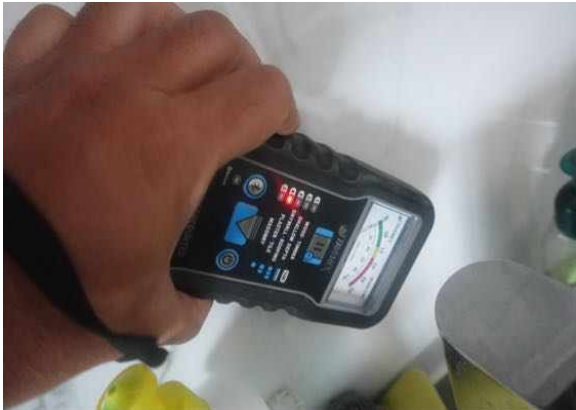
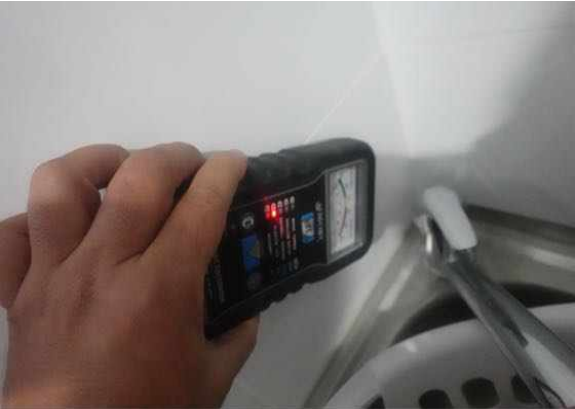
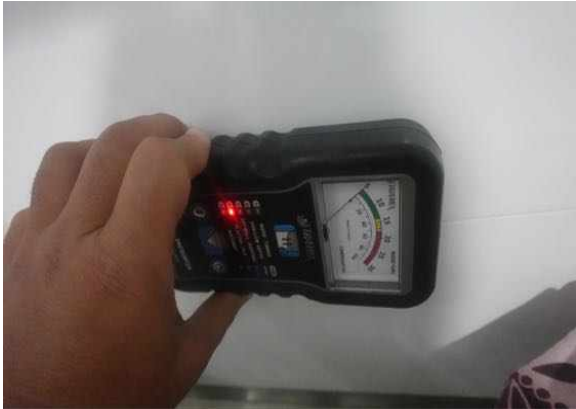
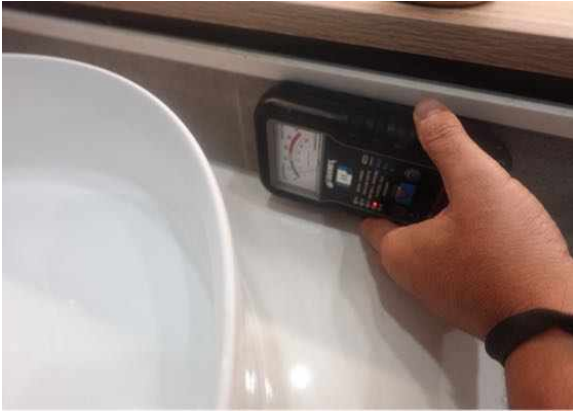
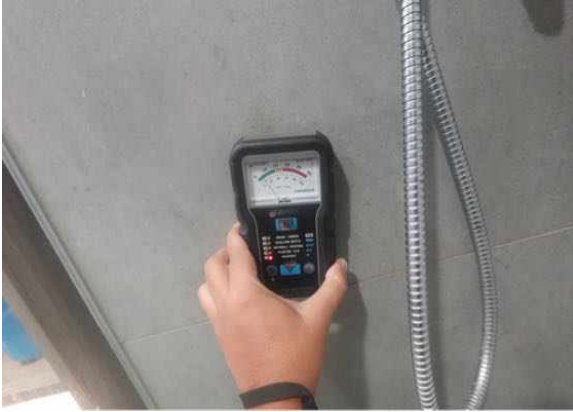
Building: Main Building
Location:
Finding: Moisture check
Information: During inspection, moisture meter was used and no high moisture detected at the time of inspection.

Please note if the wet areas have not been used for some time, moisture readings would not vary significantly and this can lead to erroneous results.

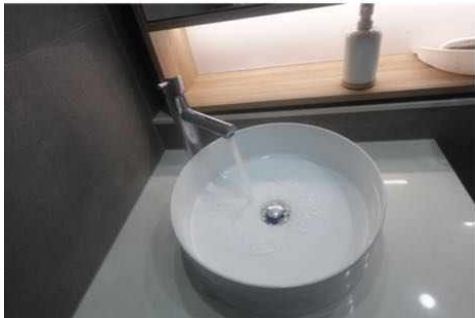
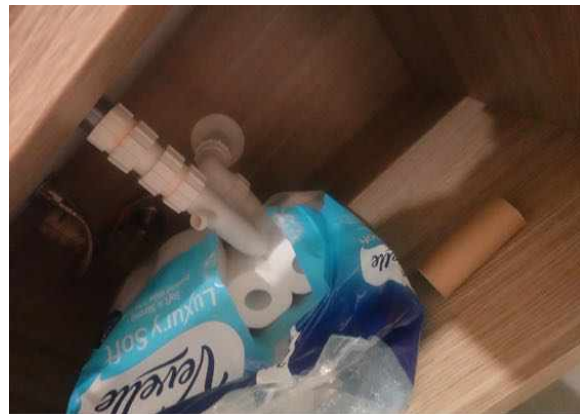
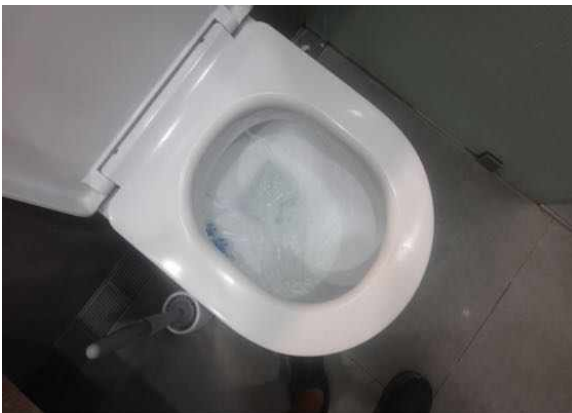
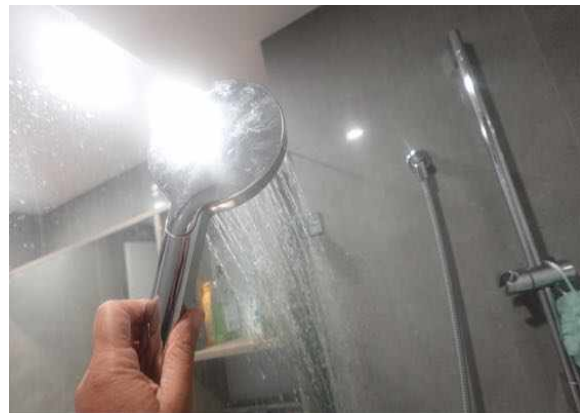
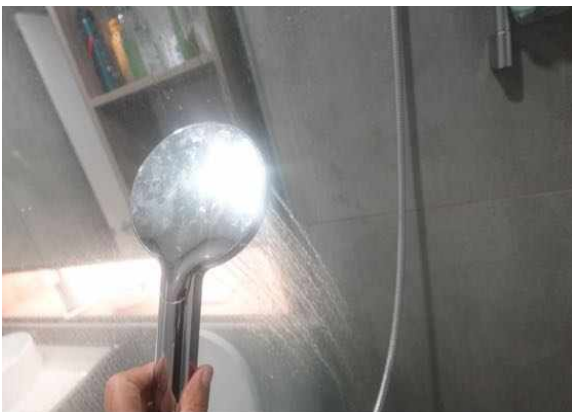
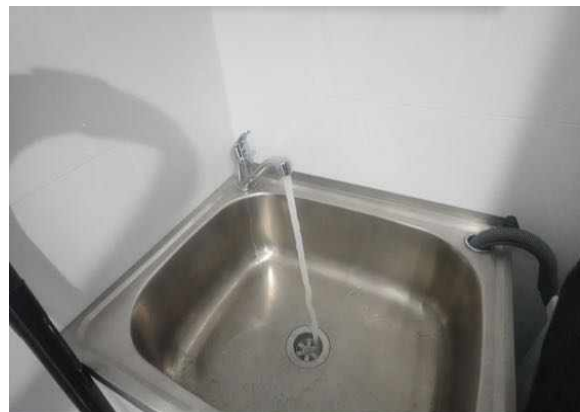
Building: Main Building
 Location: All internal areas
 Finding: Taps, toilets and sinks tested : Visual only
 Information: Taps, drainage and toilets were checked for water flow and drainage was checked for leakage.

Unless identified in a separate defect, no remedial work appears to be required on these items at the time of the inspection.

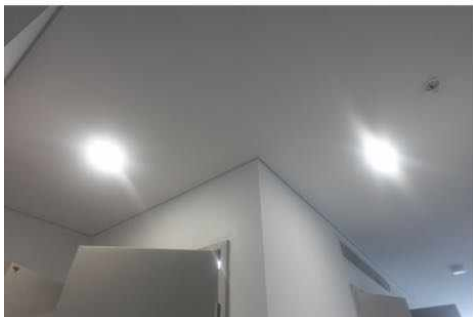
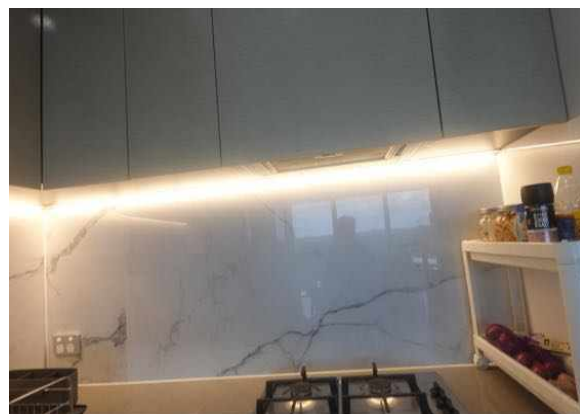
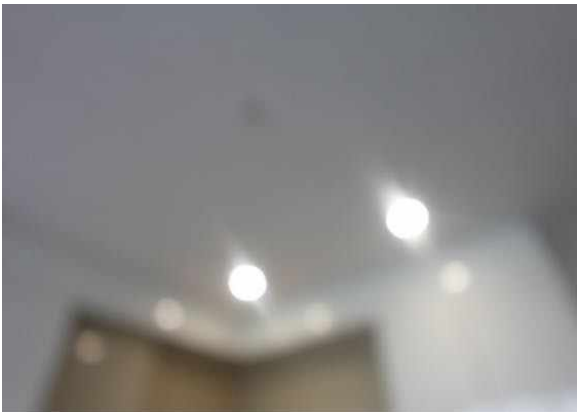
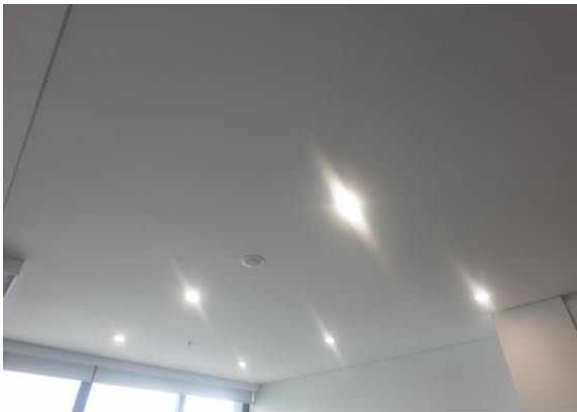
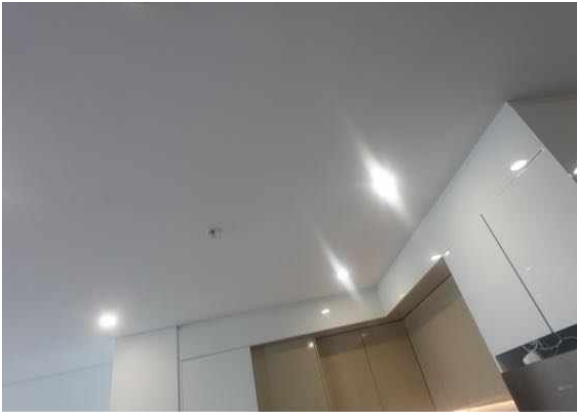
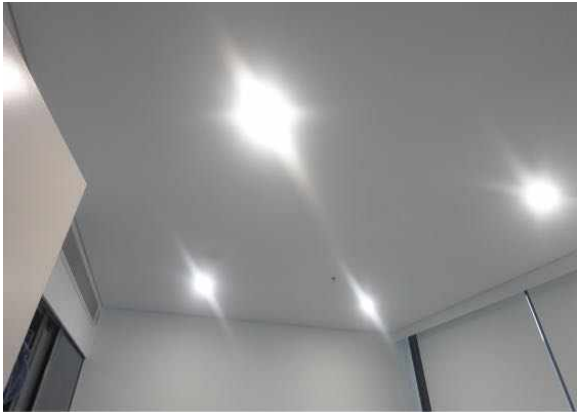
Building:	Main Building
Location:	All Lights
Finding:	Electrical switches and light tested : Visual only
Information:	Electrical inspections are outside the scope of the building inspection and must be conducted by a Licensed and registered Trades person.

It is highly recommended that the client makes arrangements to have the electrical checked by a licensed tradesperson to ensure that they are working safely and efficiently.
