Building and Timber Pest Inspection Report

Inspection Date: Sat, 7 Mar 2026

Property Address: 40C Stoney Creek Rd, Bexley NSW 2207,
Australia

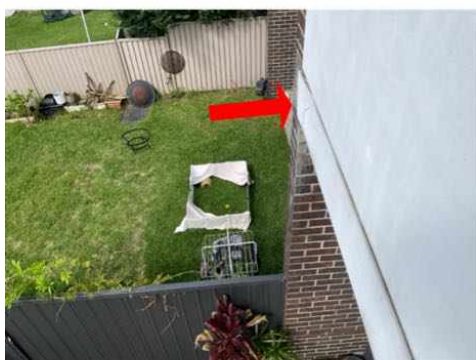
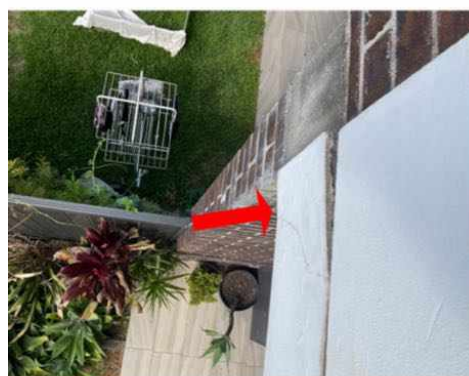
Building:	Building 1
Location:	Exterior balcony cladding
Finding:	Cladding loose and damaged
Information:	Evidence of damage was identified to the right rear balcony wall corner was found where the cladding has cracking damage and may fall at any time.

This cladding should be removed immediately incase it falls and injures nearby persons.

A renderer or licensed builder would be the trade responsible for rectification of this wall area.

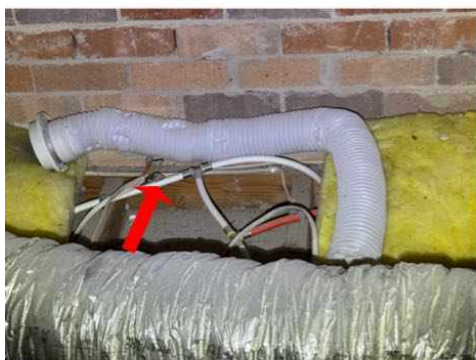
Finding 1.02

Building:	Building 1
Location:	Roof Cavity - Front and rear
Finding:	Electrical cables missing a junction boxes
Information:	The electrical fittings in these roof areas were found to be missing a junction boxes at the time of inspection.

These pictured missing fittings and loose cables expose electrical works, and may create a safety hazard if there is potential contact with persons in the area.

A Licensed electrician should be appointed to rectify these areas immediately.

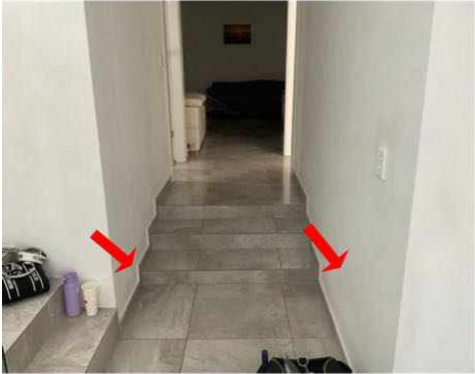
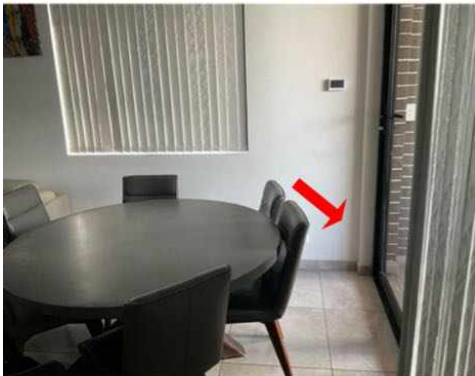
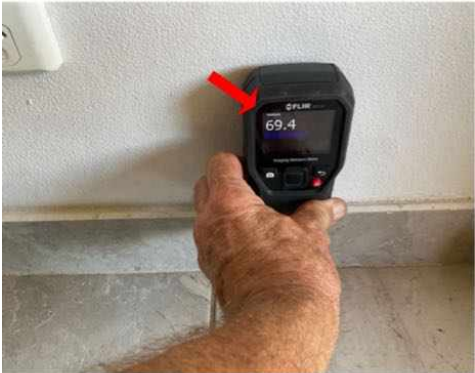
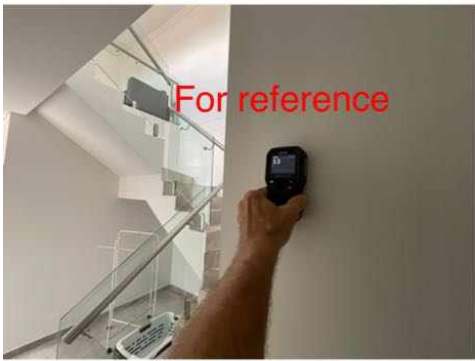
Finding 2.01

Moisture readings of 100 and 69.4 were recorded along with paint damage either side of the central hall area. Staining was also visible under the stairs.

Moisture readings of 1 and 3.3 were recorded above the damaged areas for reference, indicating the damage appeared to be coming from the slab.

The first step in addressing rising damp is to diagnose the cause. The identified cause should be addressed first before addressing the appearance and other defects which have resulted from the rising damp. If the original cause is not resolved, further cases of damp are likely to ensue, resulting in secondary defects.

Consultation with a qualified plumber is advised immediately to identify the cause of the damp and perform remedial works as required.

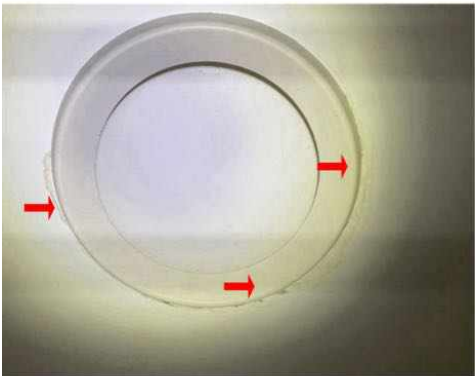
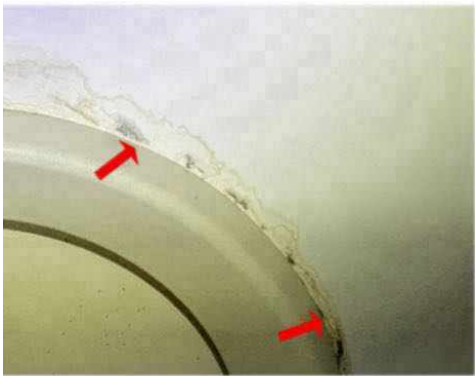
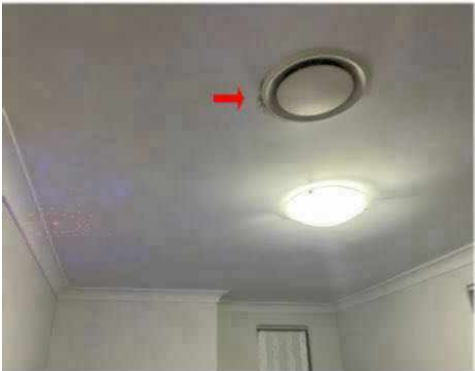
Finding 2.02

Building: Building 1
Location: Roof Cavity - all upper areas
Finding: Air Conditioning Condensation Damage to Ceilings
Information: Evidence of damage to internal ceilings was observed and is consistent with air-conditioning condensation issues. The mould resulting from these damp conditions may affect the health of the occupants. Moisture was found to be dripping off many areas of the main AC unit, pipe and ducting in the roof void. Moisture staining and deterioration indicate that condensate is not being adequately drained or managed, which may be due to blocked or incorrectly installed condensate drains, insufficient insulation to pipework, or unit malfunction. Ongoing moisture exposure has lead to ceiling damage, mould developing and deterioration of building materials.

A licensed air-conditioning contractor should inspect the system, rectify the cause of the condensation, and ensure condensate is correctly discharged. Affected ceiling linings should be repaired or replaced once the moisture issue has been resolved.

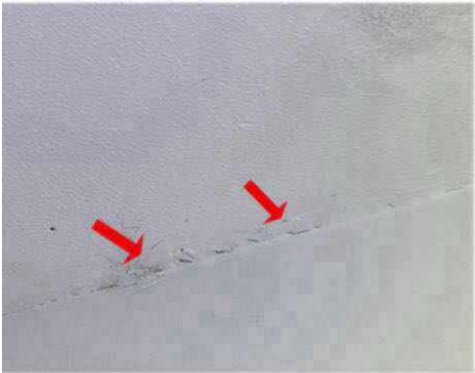
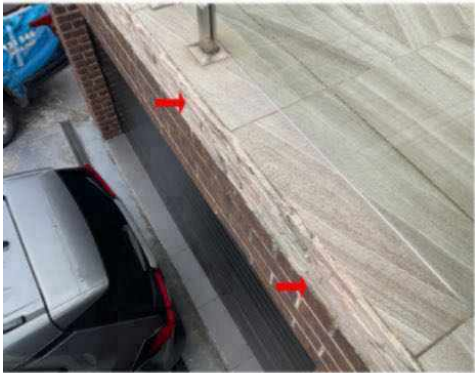
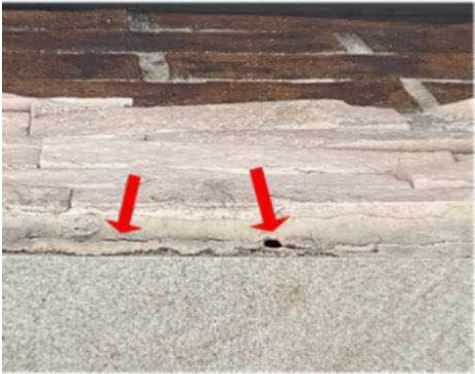
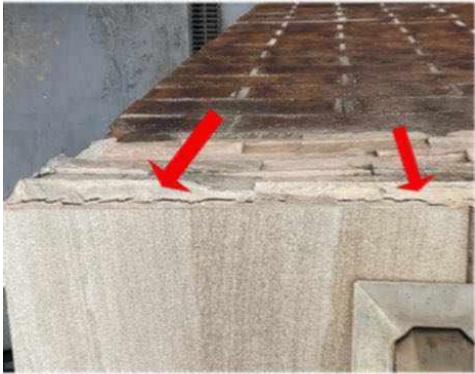
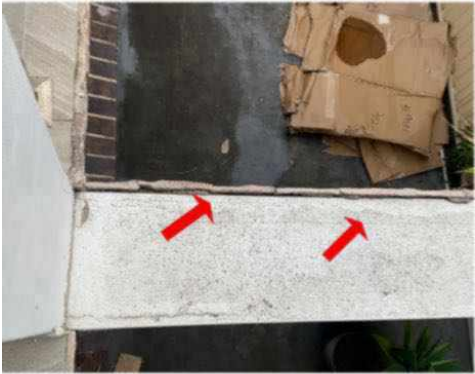
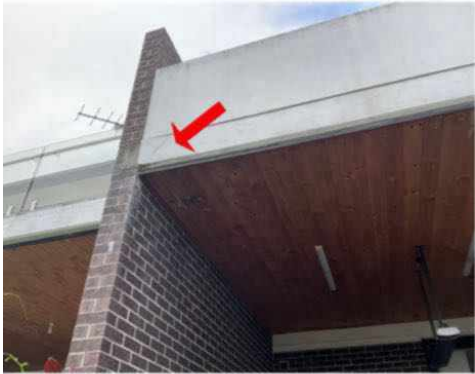
Finding 2.03

Building: Building 1
 Location: Balconies
 Finding: Waterproofing of balconies
 Information: On inspection of the front and rear balconies, it appeared as though the waterproofing has failed. Staining, bubbling and cracking paint was evident in many areas. As water is ingressing through these concrete balconies, there is a risk of concrete cancer developing where the metal reinforcing in the concrete starts to rust, then expand and break apart the concrete. This is listed as a major defect in this report as it is highly likely that it will lead to further damage over time.

On the rear balcony, water appears to be leaking through the balcony damaging the wooding ceiling cladding and rear wall render (see safety defects - loose cladding)

All elevated balconies, stairs and landings need urgent attention to stop further damage.

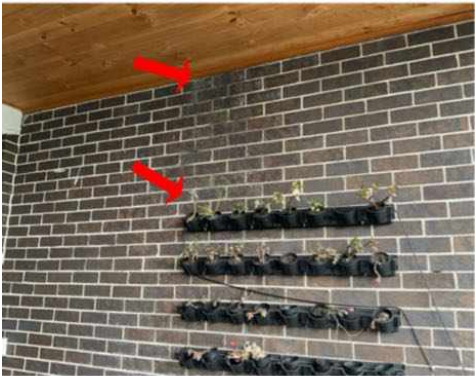
Finding 2.04

Building: Building 1
Location: Pictured rear left pergola wall
Finding: Flashing missing
Information: The roof flashing was missing on the left rear wall at the time of inspection. A channel exists in the rear brickwork for water to pool and create further damage to adjoining walls.

Regardless of the location, if left unmanaged, even minor leaks can lead to serious damage of associated building elements, potentially resulting in the need for replacement of building materials. Here, water is entering the internal left pergola wall. Damage to wall mortar, timber pergola ceiling and wood rot may also arise if this missing flashing is left unmanaged.

A roofing contractor should be engaged to install this missing flashing as soon as possible. This should have been installed before handover by the builder.

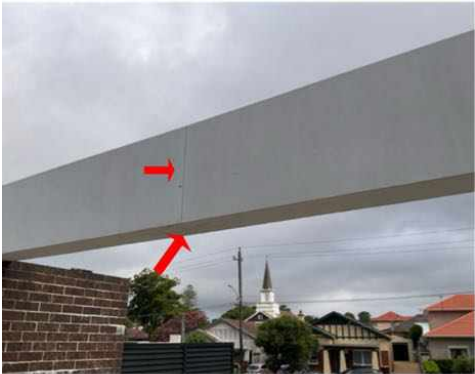
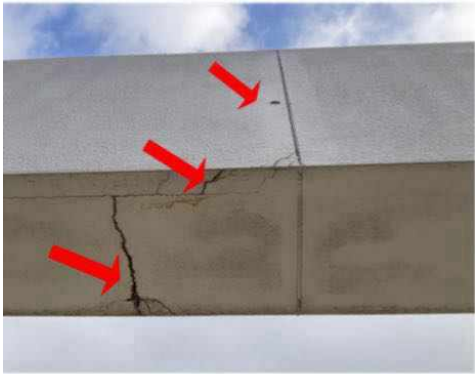
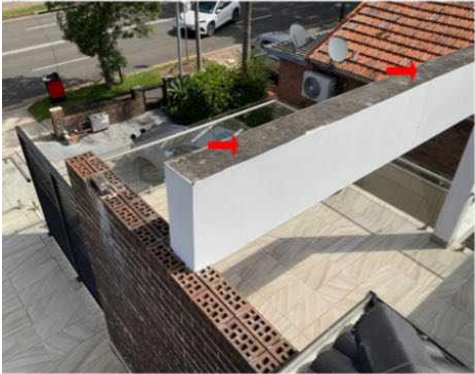
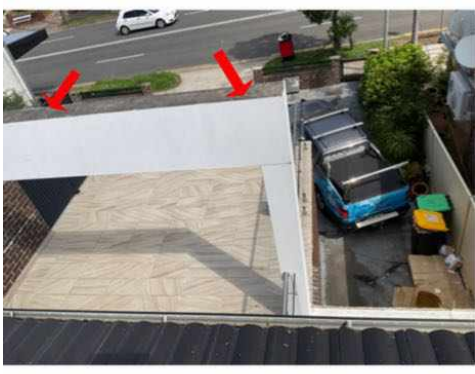
Finding 3.01

Building: Building 1
Location: Balcony structure
Finding: Structural engineers evaluation required
Information: It was noted on inspection that areas of external sealant was missing causing damage to this structure.

If water ingress continues, structural damage may occur and this structure may fail. It was advised the neighbours similar structure collapsed.

This structure is not sealed on the upper surface and cracked on the vertical and underside surfaces. Flexible sealants and protective paint is required immediately to stop damage from rainwater ingress.

Flexible sealants should be applied to these affected areas to prevent any subsequent water damage that is likely to occur.

A sealant specialist should be appointed to complete these works immediately and a structural engineer should assess this structures stability.

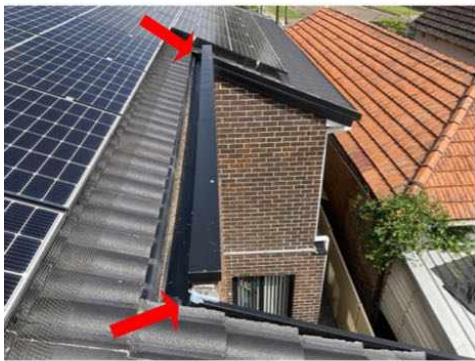
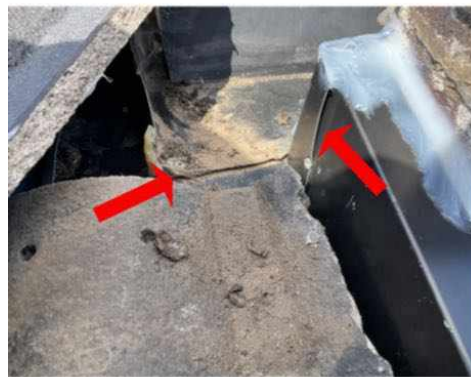
Finding: Roof sealant (external) - missing
Information: It was noted on inspection that areas of external sealant was missing to small areas of the left upper middle roof.

It is not clear whether this missing sealant or the adjacent gutter being overwhelmed in large rain events is causing the mould and wall damage in the adjoining internal wardrobe.

Flexible sealants or flashings should be applied to these affected areas to prevent any subsequent water damage that is likely to occur.

A sealant specialist or roofing contractor should be appointed to complete these works as soon as possible. Adjacent roof tiles may be required to be removed to access these areas. If damage continues in the adjacent wardrobe after these repairs, the other possible sources of moisture need to be further investigated.

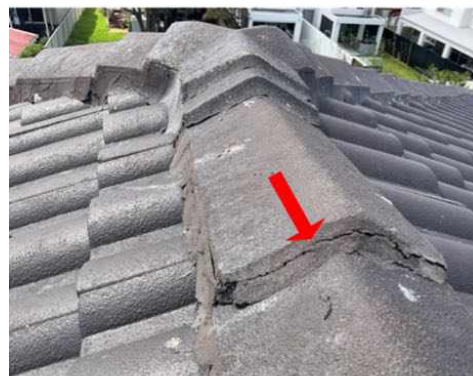
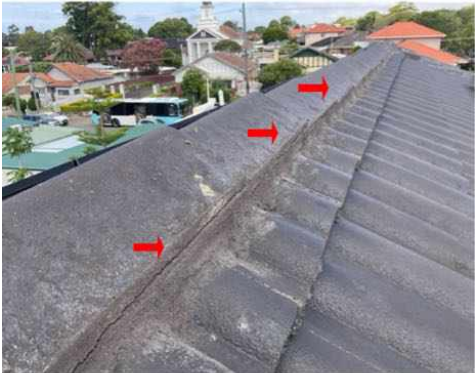
Finding 3.05

Building:	Building 1
Location:	Roof Exterior
Finding:	Roof tiles - weathered
Information:	Upon inspection of the exterior roofing, the majority of roof tiles were considered to be in a good condition. While weathering of the tiles is consistent with the age of the property, maintenance works are required.

Isolated areas of mortar show minor cracking is present. Re-pointing and re-sealing the may be considered as an interim solution by the client to help preserve and extend the life span of the tiles. Where left unmanaged, deteriorating roof mortar and tiles are likely to lead to a number of secondary defects, including minor water leaks and weather exposure to internal roofing structures.

Consultation with a roofing contractor is highly advised to gain advice on cost of remedial works that may be required in the short to medium term. Remedial works are likely to increase the longevity of the exterior roofing structure.

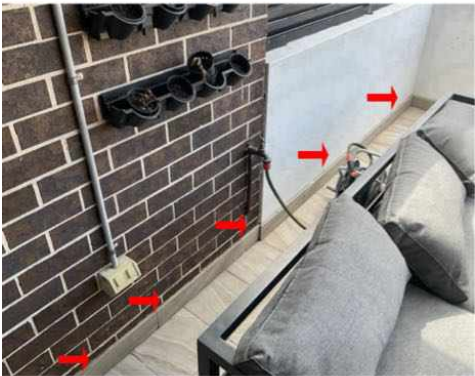
Finding 3.06

Building: Building 1
Location: Exterior balcony
Finding: Sealant (external) - missing
Information: It was noted on inspection that areas of external sealant was missing to many front and rear balcony areas.

A flexible sealant is required to protect the associated building materials from rainwater ingress. Excessive moisture was found in many garage areas and moisture damage was found on the underside of the rear balcony.

Flexible sealants should be applied to these affected balcony areas to prevent any subsequent water damage that is likely to occur. Both the front cladding sealant and rear balcony sealant appear to be very substandard.

A sealant specialist or should be appointed to complete these works as soon as possible to stop the water damage that's occurring to the lower areas.

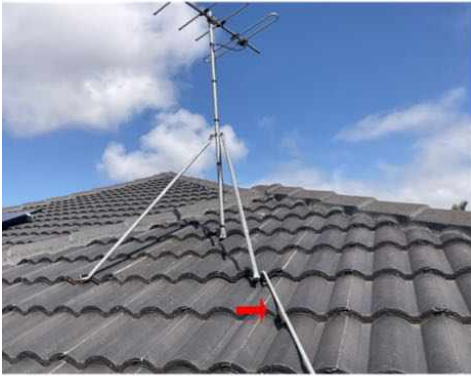
Finding 3.07

Building: Building 1
Location: Roof Exterior
Finding: Aerial damaged
Information: Evidence of damage was identified to the TV aerial on the roof. It has broken and loose parts. An aerial contractor can repair this damage when convenient.

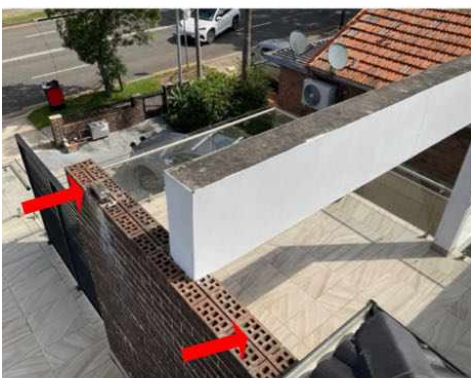
Finding 3.08

Building:	Building 1
Location:	Balcony dividing wall
Finding:	Incomplete / Substandard construction
Information:	This front dividing wall is not sealed from rain ingress.. The garage architrave also shows large gaps.

The front brickwork should be a header course or flashing installed in this external area. This has lead to efflorescence staining of this wall and may lead to further defects if left unmanaged. The left rear wall is also not flashed allowing water to pool and run down the internal balcony wall (see the major defect of flashing missing).

Where a building element is installed in such as way that it fails to achieve the required minimum standard or level of finish, the builder should have rectified the defect to stop further damage occurring.

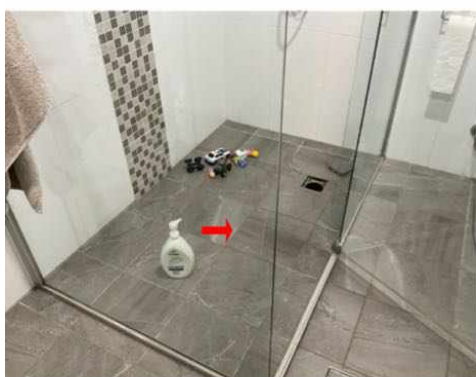
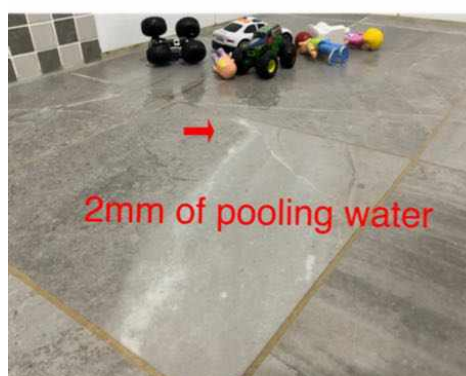
Finding 3.10

Building:	Building 1
Location:	Bathroom - downstairs
Finding:	Bathroom tiling - Insufficient fall
Information:	There is an insufficient fall in the shower tiling , which means that the angle of the tiling is inadequate for the shower to drain away. This is resulting in pooling of water in the area, creating the potential for water damage to nearby areas. This is likely to lead to premature sealant / grout degradation if not repaired. Adjustment by a tiling contractor is required as soon as possible to prevent any further damage to the area.

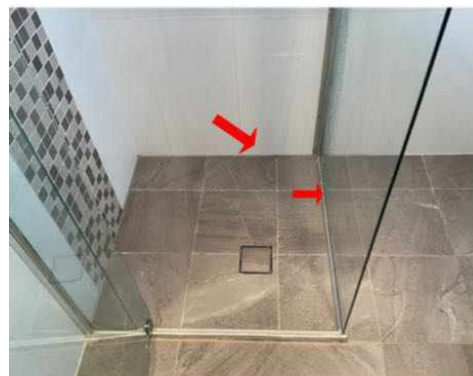
Building:	Building 1
Location:	bathroom and other areas
Finding:	Sealant and grouting - Missing or damaged
Information:	It was noted on inspection that sealant or grout is degraded to these pictured areas.

Different materials and floor areas move at different rates, generally causing cracking to grout or sealant at this point. A flexible sealant is required to allow for expected expansion and contraction, while keeping the joint water tight and protective of all associated building materials.

Flexible and mould resistant materials should be applied to affected areas to prevent any subsequent water damage that is likely to occur. Regular maintenance and replacement of damage or missing or damaged sealant and grout is highly recommended to the wet areas, as this is a regular wear and tear defect. Sealant and grouting in areas that come into regular contact with water should be maintained for the long term care of your property.

A sealant specialist or tiling contractor should be appointed to complete these works as soon as possible

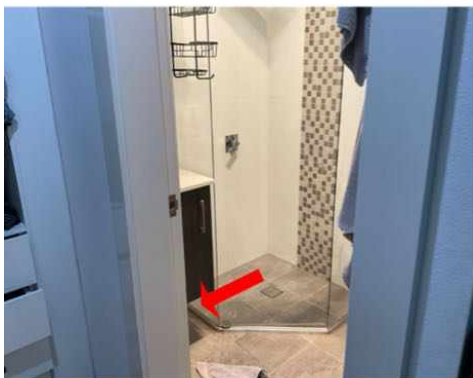
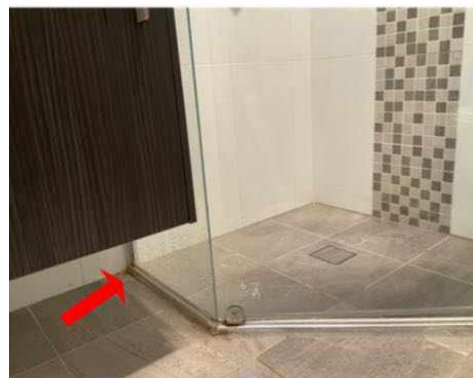
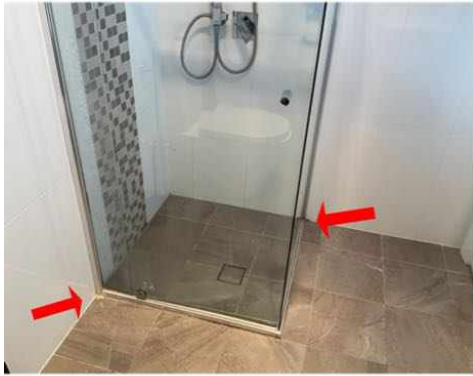
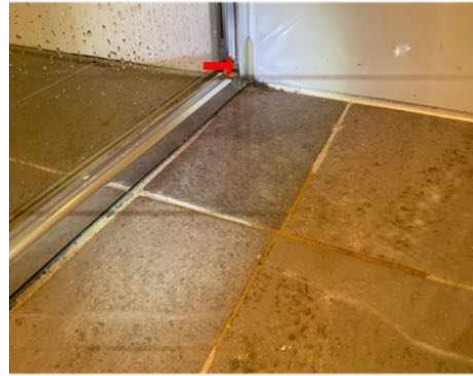
Finding 3.13

Finding: Shower screens - Leaking

Information: Leaking was evident to two shower screens at the time of inspection. It is suspected that the leaking has occurred as a result missing sealant. Leaking from the showers, where left unattended, is likely to lead to water damage to adjoining flooring and walls. Such damage can lead to water damage and necessitate extensive remedial works being required. Active water leaks may also create an environment that is susceptible to the formation and development of mould.

Appointment of a sealant expert is required to repair or replace this missing sealant. Such works should be performed as soon as possible to ensure that no further damage occurs.

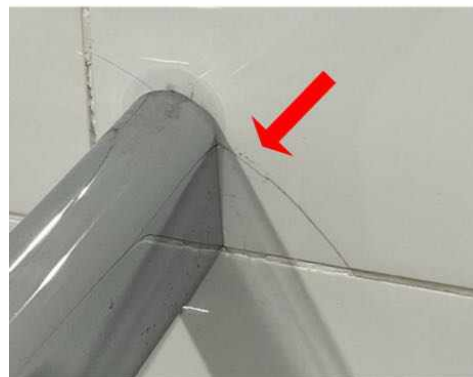
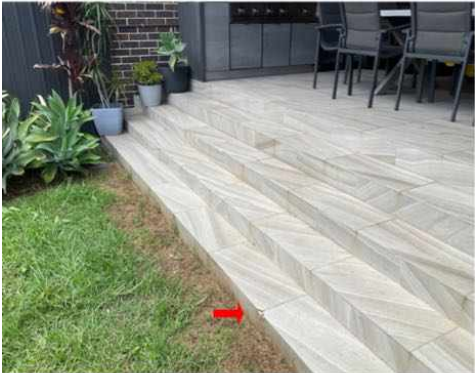
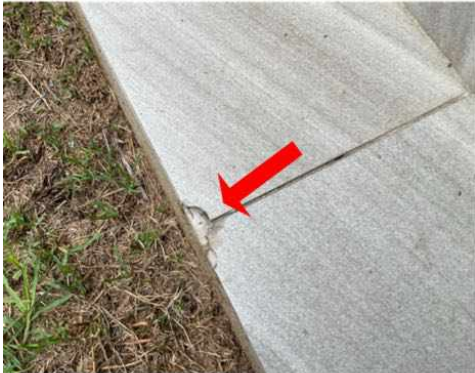
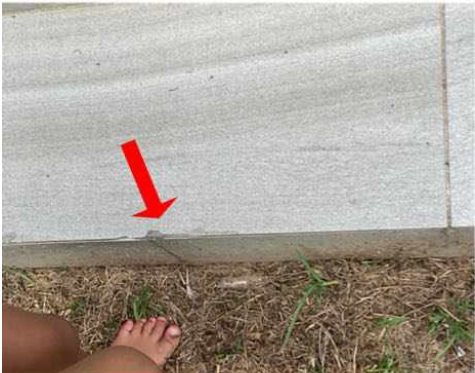
Finding 3.14

Building:	Building 1
Location:	Balcony and Bathroom
Finding:	Tiles cracked
Information:	Cracked tiles were evident in these pictured areas at the time of inspection. It is suspected that this cracking has occurred as a result of minor settlement and impact damage.

Cracked tiles throughout the household detract from the overall appearance of the affected areas. In wet areas of kitchens and bathrooms, it can lead to water damage of adjoining walls and floors.

Replacement of cracked tiles is recommended as soon as possible. A tiling contractor may be appointed to perform these works. Where cracks become more numerous, contact a licensed building inspector for further investigation.

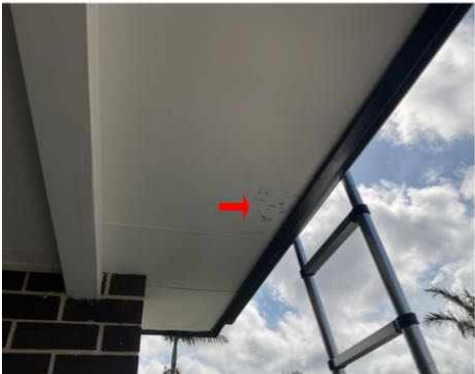
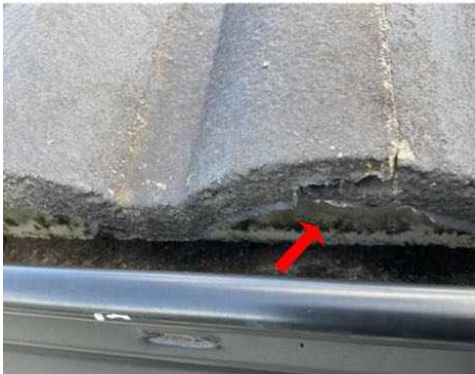
Finding 3.15

Building: Building 1
Location: Upper left and rear eaves
Finding: Mould - Present
Information:

Where evidence of mould growth was noted in the eaves, it is suspected the size of the gutters is insufficient in heavy rain events. It is thought rainwater is overflowing back into these eave areas during these events. It is recommended to consult a roofing contractor for further advice. No roof tile damage was evident in these areas of mould.

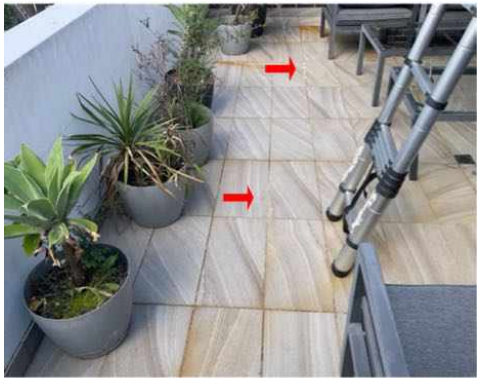
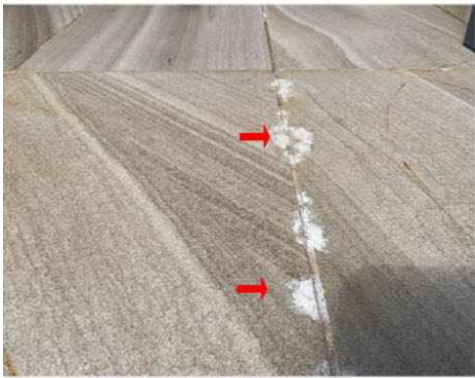
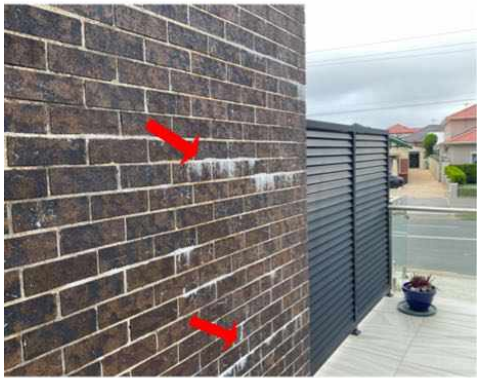
Finding 3.16

Building: Building 1
Location: Balcony's
Finding: Decks and balconies - Calcification or efflorescence
Information: Calcification or efflorescence caused by water coming from a deck or balcony that occurs on walls below or beside the deck or balcony, or that appears in the mortar joints of the deck or balcony tiling, may be considered a defect if it is due to defective or missing flashings, membrane, a damp proof course DPC or faulty design and needs to be investigated to identify the cause. Activities of others, such as owners watering plants, may also contribute to the efflorescence, which may not be attributed to the work of the builder.

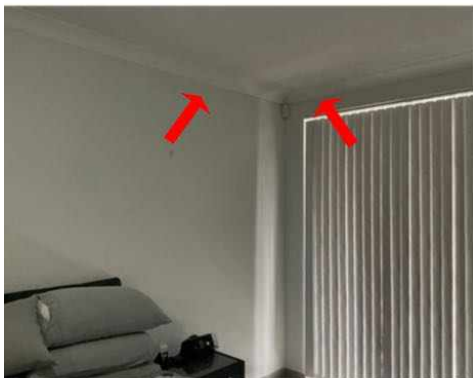
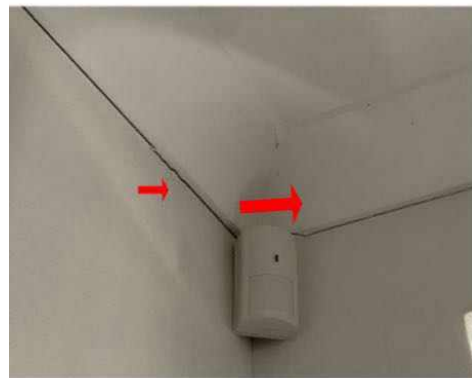
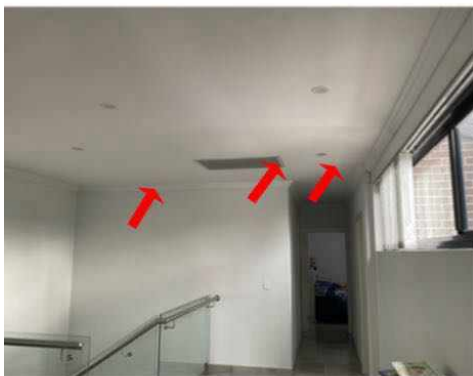
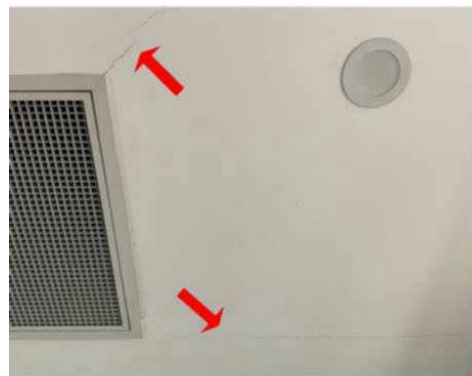
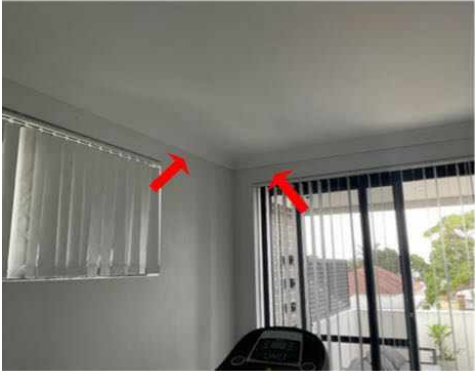
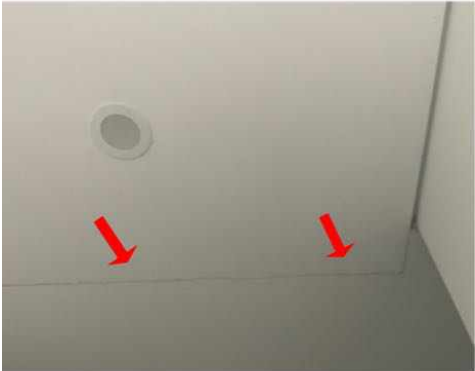
Finding 3.17

Building:	Building 1
Location:	Some areas
Finding:	Cracking - Damage Category 1 - Fine (up to 1mm)
Information:	Although fine cracks are quite noticeable, they are often only considered to be an appearance defect, and usually do not indicate any structural damage. Generally, the cause of a fine crack is indicative of a separation between building materials and finishes (e.g. paint, plaster, etc.) along joins.

Cracking of this nature can generally be repaired with minor sanding, filling and/or repainting. Such works should be performed by a qualified painter or a general handyman.

Monitoring of all cracking should be conducted frequently. Always contact a building inspector should cracks widen, lengthen, or become more numerous.

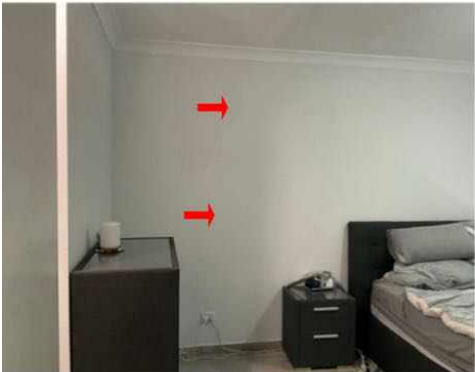
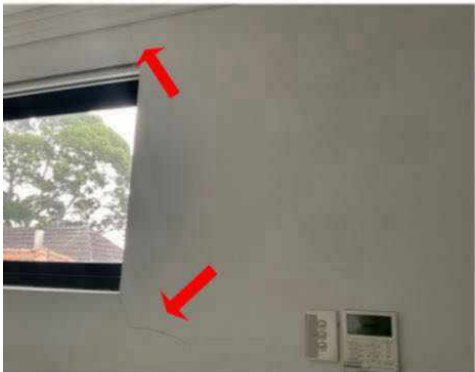
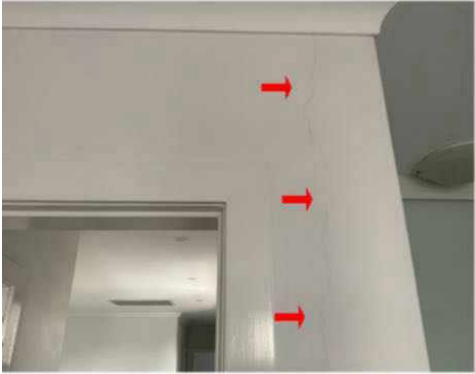
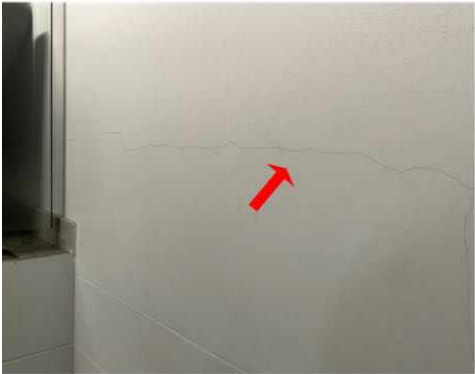
Finding 3.18

Building: Building 1
Location: Many rooms
Finding: Cracks to internal render - Category 1
Information: It has been observed that many areas of cracking to internal rendered surfaces has occurred. The degree of damage falls within Category 1, described as fine cracks that do not need repair and which are less than 1.0mm in width limit. (See also step cracking defect)

Damage of this category is not considered a defect for rectification. Always contact your building inspector should cracks widen, lengthen, or become more numerous.

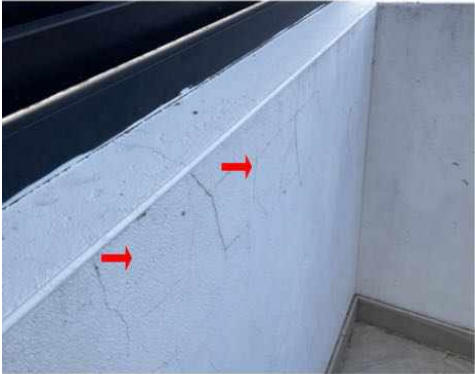
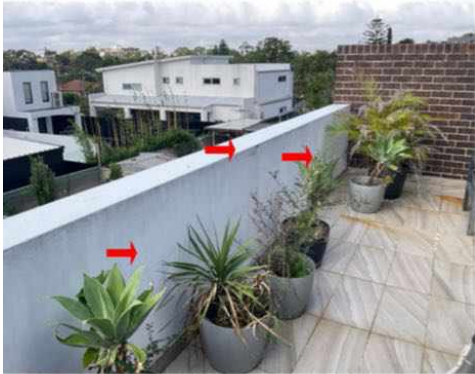
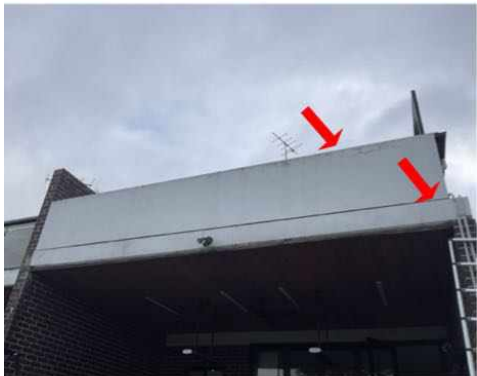
Finding 3.19

Building: Building 1
Location: Many internal and external areas
Finding: Render (external) cracking.
Information: It has been observed that cracking to some external rendered surfaces. The degree of damage is described as “slight” noticeable cracks which are easily filled. Cracking of this size are generally less than 5mm in width.

Always contact your building inspector should cracks widen, lengthen, or become more numerous.

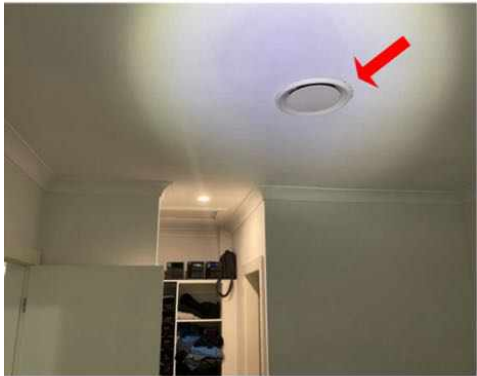
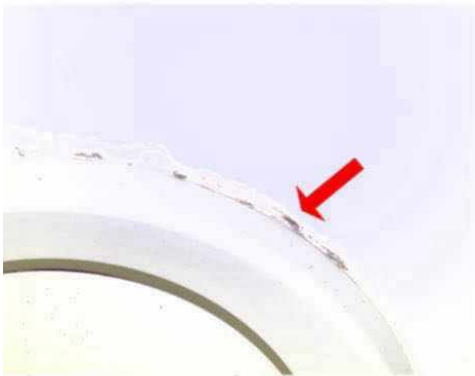
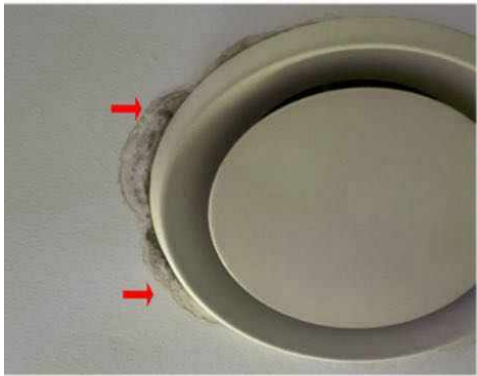
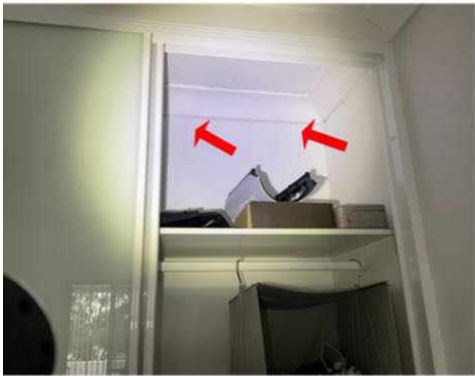
Finding 3.20

Building: Building 1
Location: Exterior balcony eaves
Finding: Mould - Present to internal ceilings
Information: Where evidence of mould growth was noted to many ceilings, there may be environmental, biological or health issues associated with the report.

See air conditioning condensation and external sealant defects in this report.
