Building and Timber Pest Inspection Report VR

Inspection Date: Thu, 5 Feb 2026

Property Address: 8 Moyston Ct, Thornlands QLD 4164,
Australia

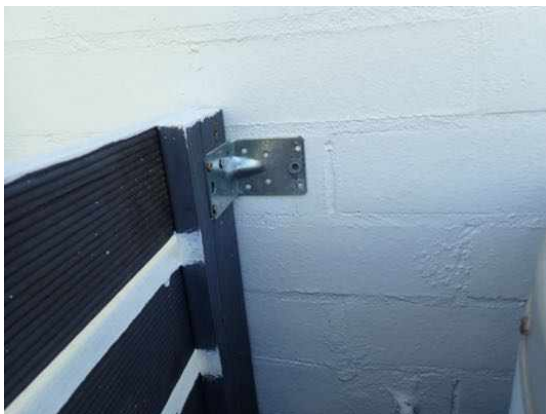
Finding 3.04

Building:	Main Building
Location:	Exterior walls - right side > Centre Right
Finding:	Hot water unit to close to wall.
Information:	The electrical hot water unit has been installed too close to the external wall and enclosed in a fixed timber screen that restricts inspection for termite activity and general servicing. This is conducive to termite activity, and it is recommended it be moved away from the wall to create a visual barrier for inspection purposes. A plumbing contractor could complete this task.

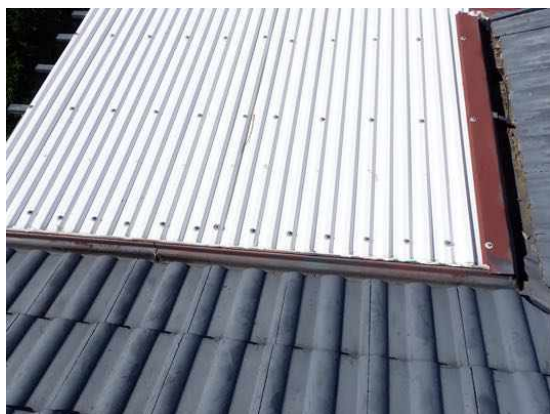
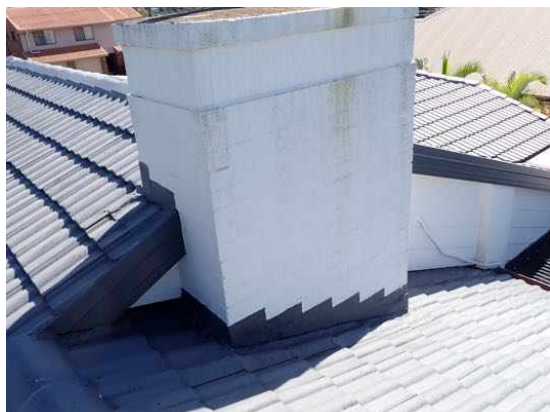
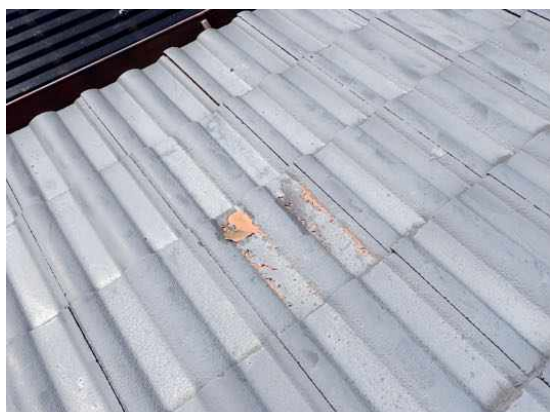
Finding 3.05

Building: Main Building
Location: Roof Exterior > All Areas
Finding: Roof Condition
Information:

The concrete tiled roof on this building appears to have been fully serviced and re coated in the past many years, and is in fair condition at the time of this inspection.

Isolated areas of the painted tile surfaces are showing signs of minor environmental deterioration, and should be recoated to reduce the risk of further deterioration occurring.

A handyman can complete this job.

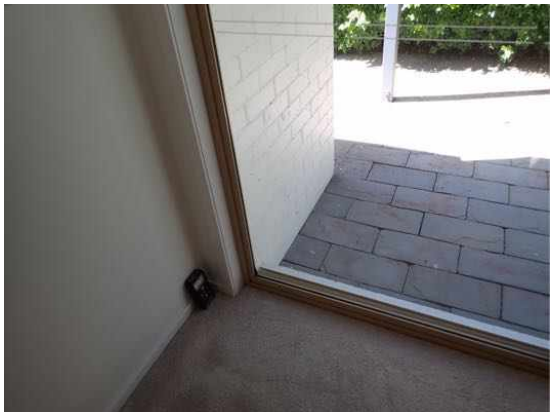
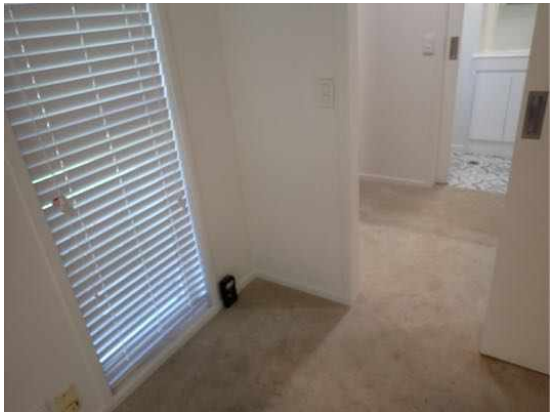
Building: Main Building
 Location: Bedroom - Master > Front Right
 Finding: moisture meter readings
 Information: There was a slightly high moisture meter reading of 22 % in the master bedroom front right side entry wall area that backs onto the master bedroom ensuite shower area at the time of this inspection. This can be caused by water ingress into the wall cavity from external sources or a possible plumbing leak . Wet areas can also have a potential failure to the water proofing membrane causing potential water issues. A licensed plumbing contractor or waterproofing contractor should inspect this area and report .

This area should be closely monitored for any changes .

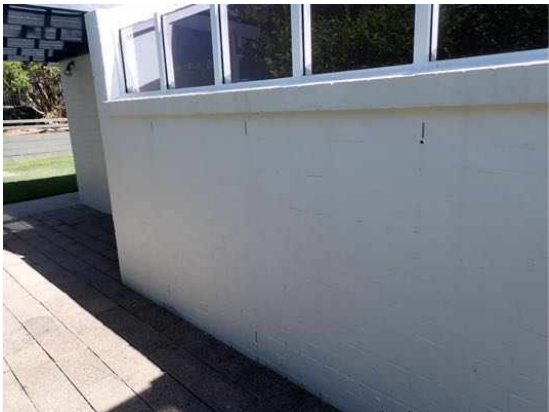
Finding 6.02

Building:	Main Building
Location:	Exterior walls > All Areas
Finding:	Slab Edge - Exposure
Information:	Masonry wall weep holes throughout areas of this building were found to be blocked or below finished natural ground or paving levels .

If the slab edge or weep hole line is not properly exposed there is a high risk of termite attack. Sometimes, in order to determine the type of slab, a suitably qualified person such as an architect or builder may be required to consult the construction plans.

Where the slab edge or weep hole line cannot be properly inspected, it is highly recommended that termite or timber pest inspections be carried out every 6-12 months to aid protection of the property against infestation.
