Building and Timber Pest Inspection Report

Inspection Date: Wed, 11 Mar 2026

Property Address: 10/6 Mary St, Wiley Park NSW 2195,
Australia

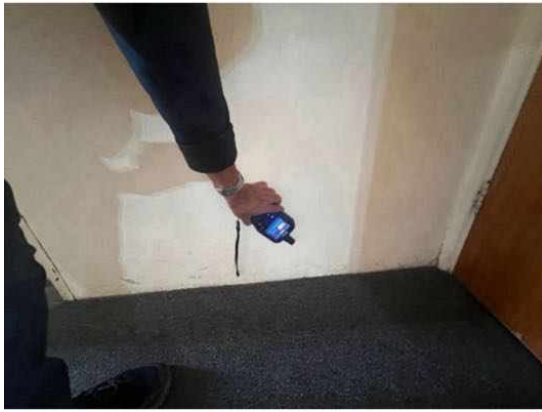
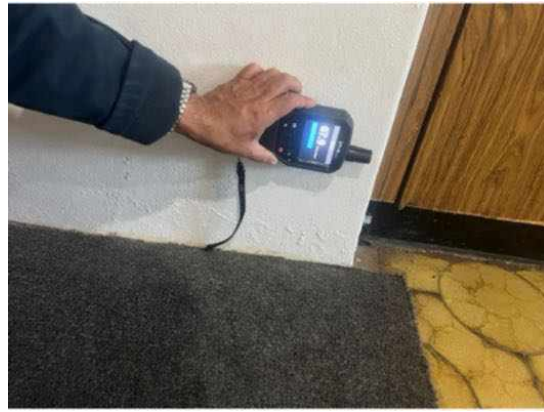
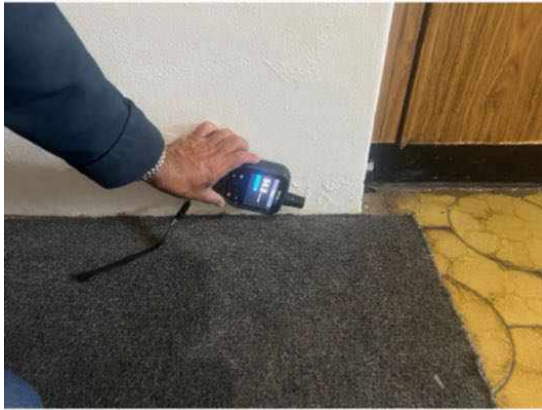
Building: Main Building
Location: Bathroom (back of kitchen)
Finding: Elevated Moisture Bathroom & Back of shower with deterioration
Information: Elevated moisture levels were detected to tiled surfaces in bathroom/shower areas. This may be due to porous or missing grout, cracked tiles or recent use, however the possibility of waterproofing membrane failure or plumbing leaks cannot be excluded. Persistent moisture ingress can lead to concealed damage, including timber rot and mould growth. Further investigation by a licensed plumber and/or waterproofing contractor is recommended as soon as possible. The back of shower area also showed elevated moisture with visible deterioration evident at the time of inspection.

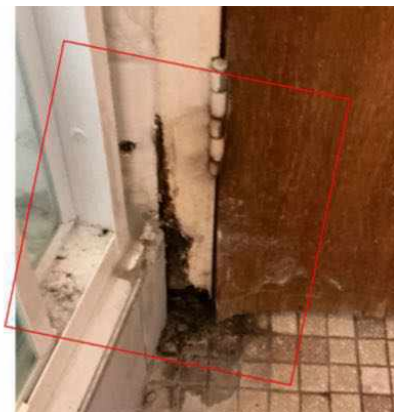
Finding 2.02

Finding: Wet-Area Door Jambs – Moisture Staining / Decay

Information: moisture staining and deterioration were observed at the base of the wet-area door jamb and architraves. This is commonly due to water splashing or moisture tracking from the bathroom floor into adjacent joinery or inadequate waterproof transition at the bathroom threshold.

Further inspection by a licensed waterproofing contractor is recommended to verify exact cause and remedial measures

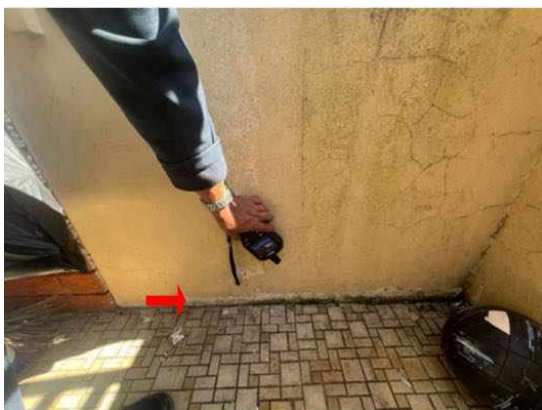
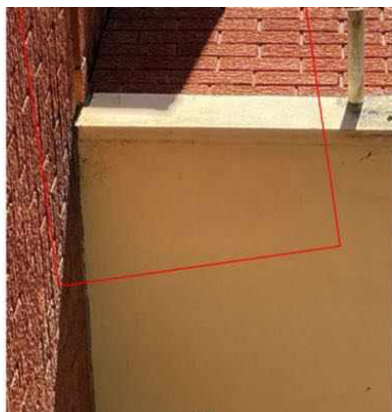
Finding 2.03

Finding: Balcony Elevated Moisture - Strata

Information: Elevated moisture was recorded at the base of the balcony wall and tiles, with associated staining consistent with water exposure under balcony soffit. While no internal damage was visible at the time of inspection, balconies in multi-unit dwellings are high-risk areas for waterproofing failure, which can lead to leaks into adjoining units and significant rectification costs. Further investigation by a licensed waterproofing contractor is strongly recommended.

Depending on the strata plan, this area may form part of the common property, in which case remedial responsibility may rest with the owners corporation (strata). Purchasers should seek clarification from the strata manager and legal adviser prior to purchase.

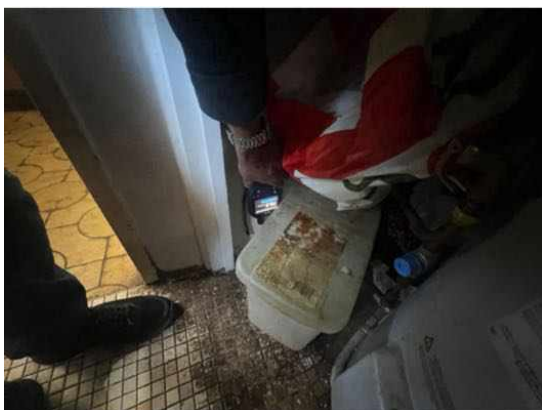
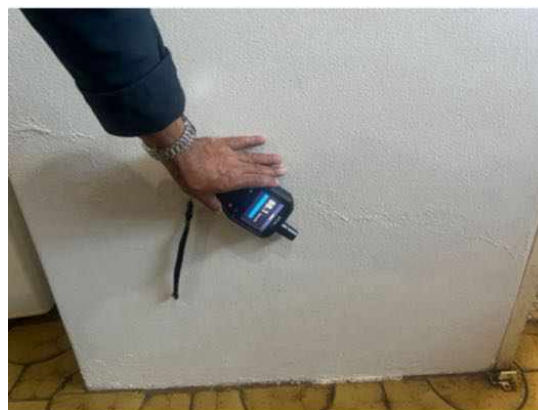
Finding 3.01

Building:	Main Building
Location:	All Internal Areas
Finding:	Painted surface - Bubbling & elevated moisture - Further investigation required
Information:	Sections of paint in this area was found to have bubbled and deteriorated. Paint bubbling is generally an indication of excessive moisture in the area, that is currently hidden by the painted surface.

The presence of excessive moisture can have major implications on associated building elements if left unattended. While only seemingly minor at this stage, the damage cannot be determined due to the paint obstructing any further inspection of the damage.

It is highly advised that the affected paint be cleaned to allow a further, more invasive inspection by a licensed plumber. Failure to act on this defect may necessitate major works in the future.

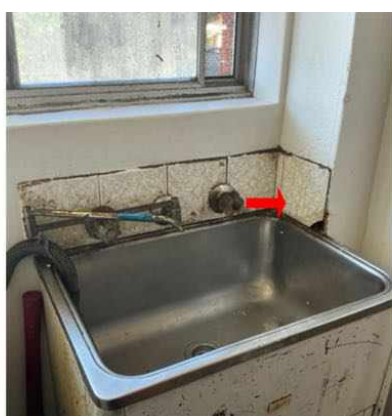
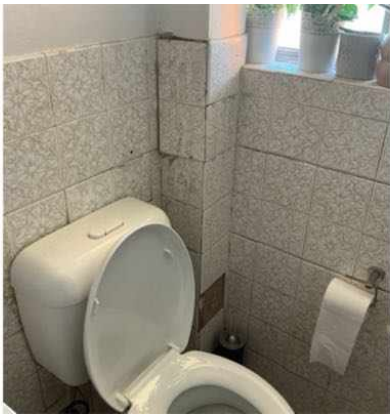
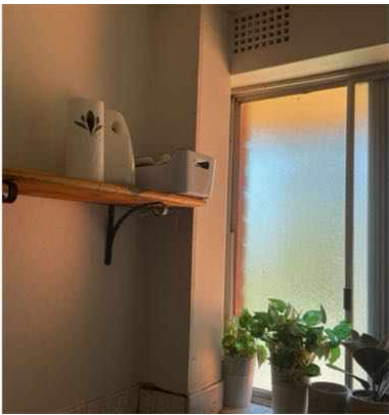
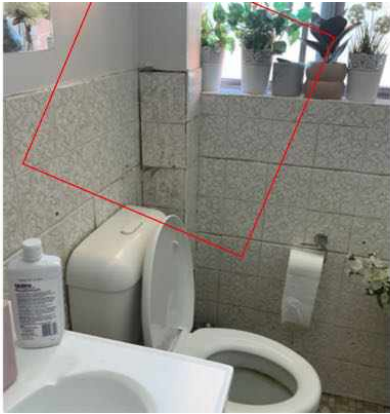
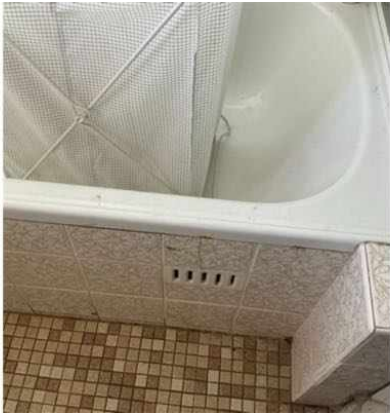
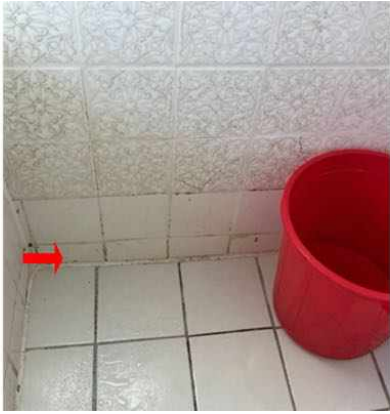
Finding 3.02

Building:	Main Building
Location:	All Internal Areas
Finding:	Tiles - Cracked or damaged
Information:	Cracking was evident to the tiling in this area at the time of inspection. While the cracking appears to be minor, this area is frequently exposed to water, allowing potential for water penetration into adjoining sections of walls or flooring.

If left unmanaged, water penetration to these areas may lead to subsequent water damage, which is likely necessitate repair work to affected building elements.

A tiling contractor should be appointed to ensure that no further water damage occurs. The re-application of silicone and grouting throughout remaining tile work is also advised, to further protect the area against water penetration.

Where water penetration has led to water damage, appointment of a relevant tradesperson may be required to repair damaged building elements.

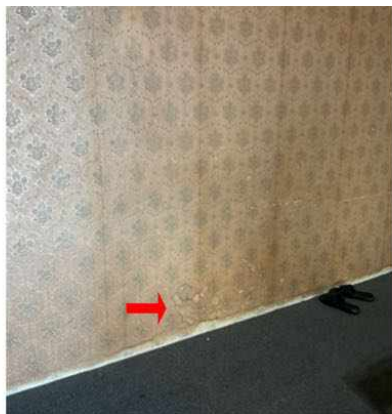
Finding 3.03

Building:	Main Building
Location:	All Internal Areas - Lounge
Finding:	Water staining
Information:	Water staining was evident in this area at the time of inspection. Water staining indicates that surfaces have been exposed to excessive moisture over time. The minerals and other elements in the water lead to staining, which may graduate to corrosion and deterioration if left unmanaged.

While mostly an appearance defect, water staining can be indicative of more serious defects, which may be currently concealed by other building elements.

Where water staining is active, a licensed plumber must be consulted to identify the cause of the staining and to provide advice on any reparation works that may be required. Replacement of any broken or damaged structures is advised.

Conversely, where water staining is old and inactive, affected building materials may be repaired or replaced at client discretion. A qualified carpenter or registered builder may be appointed to perform these works.

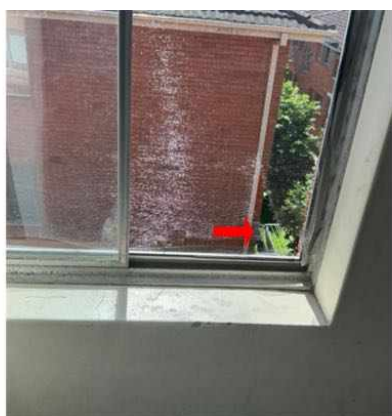
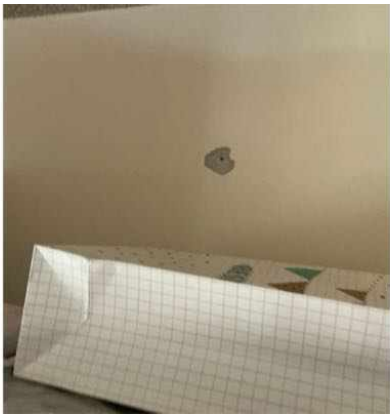
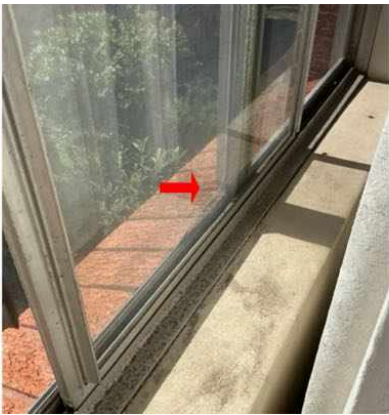
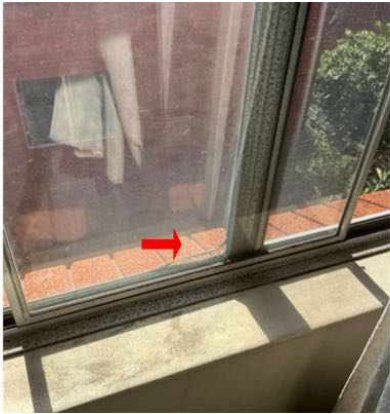
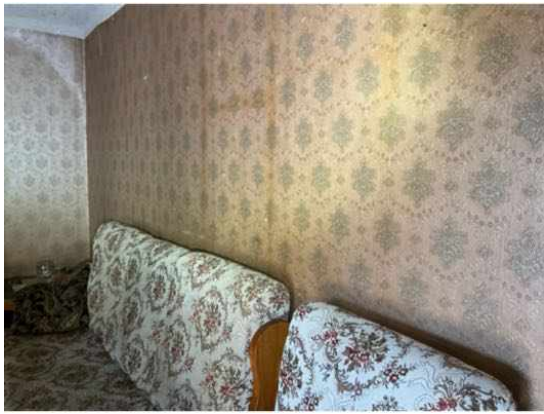
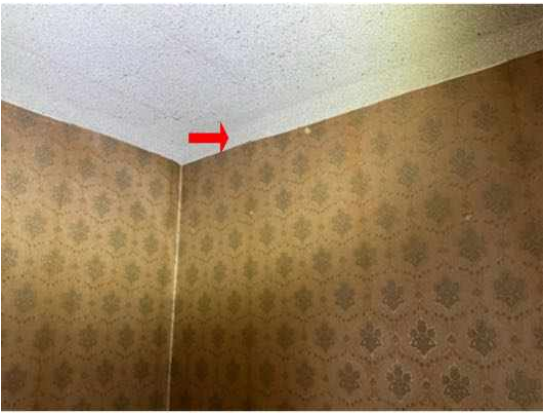
Finding 3.04

Building:	Main Building
Location:	All Internal Areas
Finding:	Building element - Damaged - Wall paper damaged , fly screen damaged , window seal damaged (Possible moisture ingress)
Information:	Breakage occurs generally when the building materials have either aged and decayed, or as a result of damage (accidental or deliberate).

Repair and/or replacement of broken elements is advised to ensure that additional secondary defects do not arise as a consequence. Such works are necessary, as all building elements play a key role in the operation and function of the overall structure and its performance.

A relevant tradesperson should be appointed to repair or replace the affected building element prior to any subsequent damage being caused.

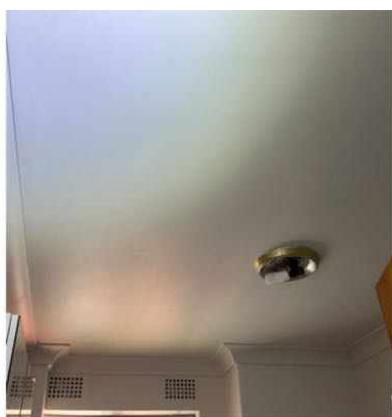
Finding 3.05

Building:	Main Building
Location:	All Internal Areas - bathroom
Finding:	Building element - Missing - No ventilation
Information:	Although some building elements may seem irrelevant or unnecessary, all building elements play a key role in the operation and function of the overall structure and its performance.

Replacement of any missing building element should be conducted as soon as possible to ensure that no damage or functional issues occur to associated building materials.

The appropriate tradesperson should be appointed as soon as possible to replace the missing building element.

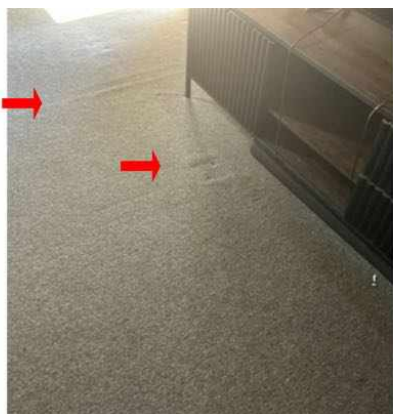
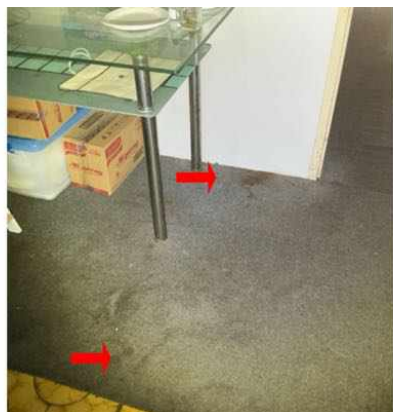
Finding 3.06

Building:	Main Building
Location:	All Internal Areas
Finding:	Building element - Damaged - Deteriorated carpet
Information:	Breakage occurs generally when the building materials have either aged and decayed, or as a result of damage (accidental or deliberate).

Repair and/or replacement of broken elements is advised to ensure that additional secondary defects do not arise as a consequence. Such works are necessary, as all building elements play a key role in the operation and function of the overall structure and its performance.

A relevant tradesperson should be appointed to repair or replace the affected building element prior to any subsequent damage being caused.

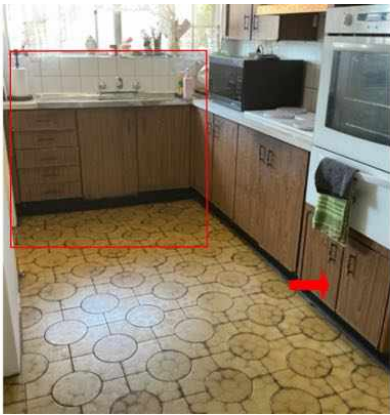
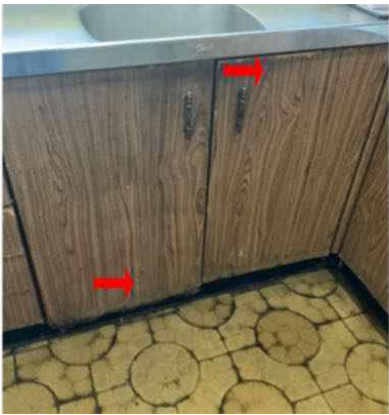
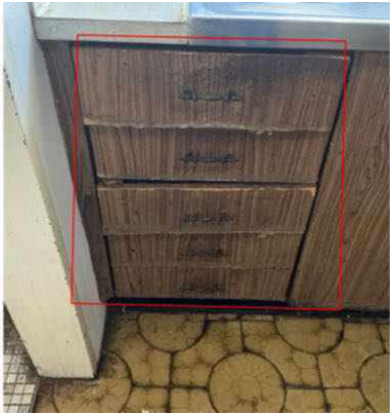
Finding 3.07

Building:	Main Building
Location:	All Internal Areas
Finding:	Building element - Damaged - Cabinetry deteriorated
Information:	Breakage occurs generally when the building materials have either aged and decayed, or as a result of damage (accidental or deliberate).

Repair and/or replacement of broken elements is advised to ensure that additional secondary defects do not arise as a consequence. Such works are necessary, as all building elements play a key role in the operation and function of the overall structure and its performance.

A relevant tradesperson should be appointed to repair or replace the affected building element prior to any subsequent damage being caused.

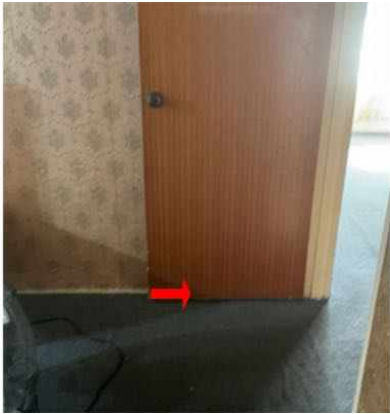
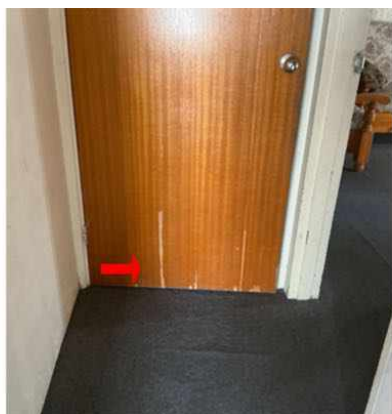
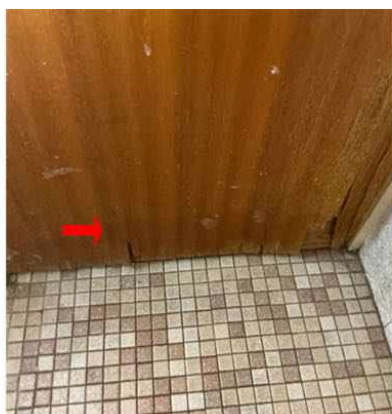
Finding 3.08

Building: Main Building
Location: All Internal Areas
Finding: Delamination of timbers to some areas
Information: Localised delamination and surface deterioration were observed to sections of laminated joinery panels. This condition commonly occurs where moisture exposure or wear causes separation of laminate finishes from the underlying substrate. The defect is generally cosmetic in nature but may worsen over time if moisture exposure continues. Repair or replacement of affected joinery components may be considered as part of routine maintenance.

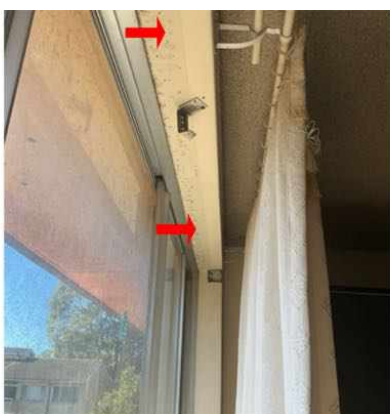
Building:	Main Building
Location:	Bedroom
Finding:	Building element - Rusted or corroded - Window sill rusted possible moisture
Information:	This building element shows evidence of rusting and corrosion, which is likely to have developed as a result of excessive exposure to moisture and or inadequate coatings.

As surface rust provides no protection to the underlying iron, the deteriorating condition is likely to worsen if not addressed in the short-term future.

Where possible, the use of galvanized (treated) metals or aluminium coated metals aid in rust prevention, as does regular general maintenance. Rust formation can be controlled with coatings, such as paint, that isolate the iron from the environment.

Rusting and corrosion should be managed by ideally removing or limiting the affected surface from exposure to moisture. A registered builder may be appointed to replace any building elements that have been severely affected by rust or water damage.

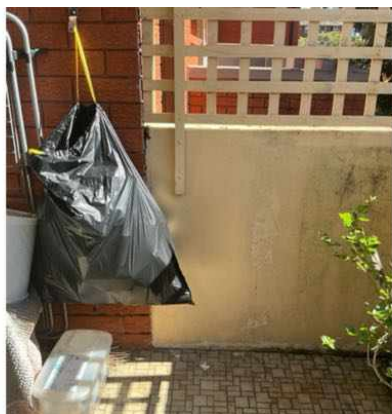
Finding 3.11

Building:	Main Building
Location:	Balcony
Finding:	Separation at Wall Junction – External Wall

Information: A vertical gap was observed at the junction between the brickwork and the adjacent rendered wall surface. The separation appears associated with differential movement between materials and is considered minor at the time of inspection. Sealing the joint with an appropriate flexible sealant is recommended to prevent moisture ingress. Further inspection by a licensed builder is recommended if gap widens or existing conditions worsen.

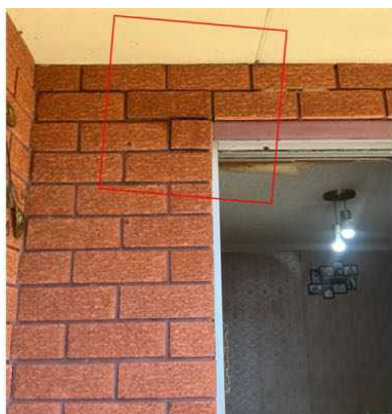
Finding 3.12

Building: Main Building
 Location: Balcony
 Finding: Building element - Damaged - Loose brick
 Information: Breakage occurs generally when the building materials have either aged and decayed, or as a result of damage (accidental or deliberate).

Repair and/or replacement of broken elements is advised to ensure that additional secondary defects do not arise as a consequence. Such works are necessary, as all building elements play a key role in the operation and function of the overall structure and its performance.

A relevant tradesperson should be appointed to repair or replace the affected building element prior to any subsequent damage being caused.

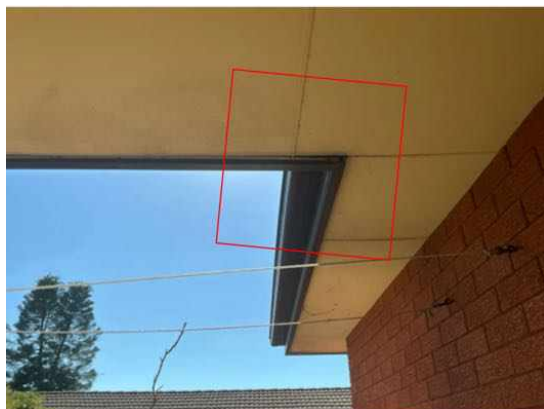
Finding 3.13

Building:	Main Building
Location:	Bedroom
Finding:	Eave Trim Separation
Information:	The external timber trim at the eaves corner displays a visible separation crack, likely due to minor building movement or timber shrinkage over time. While not structurally significant on its own, the gap may allow moisture ingress and should be sealed with a flexible exterior-grade sealant to prevent further deterioration.

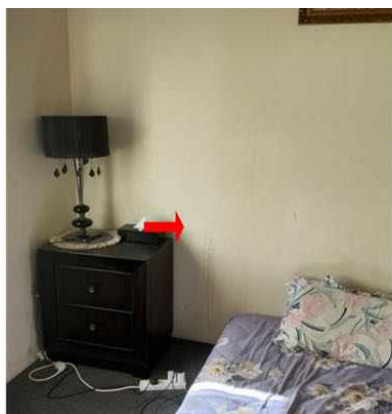
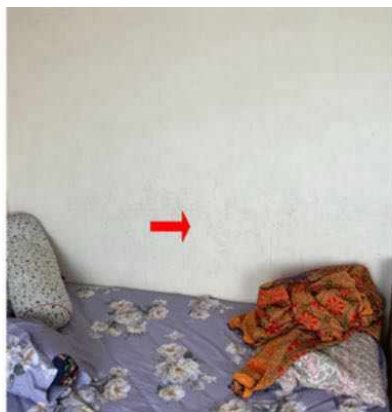
Finding 3.14

Building:	Main Building
Location:	All Internal Areas
Finding:	Paint finish and hairline cracking
Information:	The paint finish in this area was identified as being incomplete at the time of inspection including some hairline minor cracking.

Whilst incomplete or missing paint finish is generally an appearance defect, it can also lead to the development of secondary building defects over time. Incomplete areas of paint finish expose the area to moisture, potentially accelerating the deterioration of underlying building materials.

Incomplete paint finishes should be sanded back, filled, leveled and painted, as applicable. Where inadequate or missing paint protection has led to the deterioration of the associated building element, repair and/or replacement of this building element may be required.

A painting contractor should be appointed as soon as possible to perform necessary works to aid the appearance of the affected area and to ensure the area is protected against further deterioration. Alternatively, the homeowner following manufacturer instructions may perform these works.

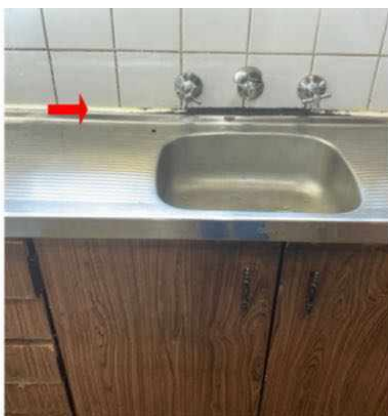
Finding 3.15

Building:	Main Building
Location:	All Internal Areas
Finding:	Sealant and grouting - Missing or degraded
Information:	It was noted on inspection that sealant or grout is degraded. There is also evidence of poor workmanship and excessive use of sealant. Silicone should never be used as a first line of defence against waterproofing. Further inspection by a licensed waterproofing contractor is highly recommended.

Different materials and floor areas move at different rates, generally causing cracking to grout or sealant at this point. A flexible sealant is required to allow for expected expansion and contraction, while keeping the joint water tight and protective of all associated building materials.

There appears to be excessive mould to the sealant and grout which will likely require scraping out and replacement.

Flexible and mould resistant materials should be applied to affected areas to prevent any subsequent water damage that is likely to occur. Regular maintenance and replacement of damage or missing or damaged sealant and grout is highly recommended to the wet areas, as this is a regular wear and tear defect. Sealant and grouting in areas that come into regular contact with water should be maintained for the long term care of your property.

A sealant specialist or tiling contractor should be appointed to complete these works as soon as possible

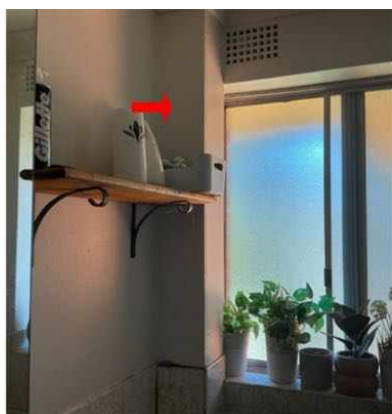
Building:	Main Building
Location:	All Internal Areas - Kitchen ,
Finding:	Asbestos - Suspected ACM Identified on Site
Information:	Reporting on Asbestos is outside the Scope of this Report. This suspected defect is highlighted as a caution only. We suspect that there is a higher risk of the identified building element containing asbestos.

As Asbestos Reporting is outside the scope of this report, we advise that you consider a separate Asbestos Inspection and Condition Audit, which can include the taking of samples for definitive confirmation of the presence of Asbestos.

In the interim, the client is advised to act with caution, especially when considering any damage to building materials general wear and tear renovations extensions demolition and general maintenance activities due to the suspected presence of Asbestos.
