Building and Timber Pest Inspection Report

Inspection Date: Wed, 11 Feb 2026

Property Address: 2 Tee Glade, Blacktown NSW 2148,
Australia

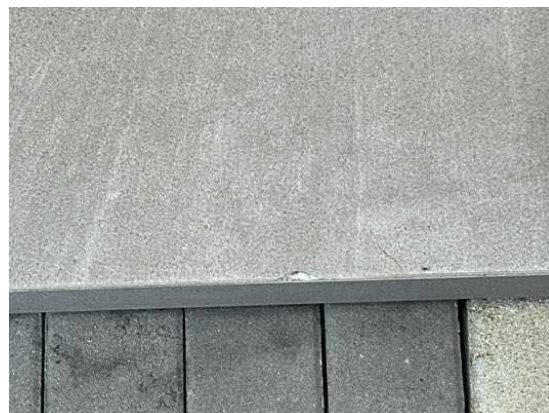
Building: Main Building
Location: Front porch
Finding: Floor Tile crack
Information: A floor tile has a visible crack on the surface.

The damaged tile presents a trip hazard, may lead to cuts if stepped on barefoot, and can allow moisture ingress into the substrate, which may cause further deterioration or loosening of adjacent tiles. It also affects the overall appearance of the floor.

Recommended Action / Who Can Fix It:

A licensed tiler should be engaged to remove the damaged tile and install a matching replacement. If spare tiles are unavailable, additional remedial work may be required to blend the repair with surrounding finishes.

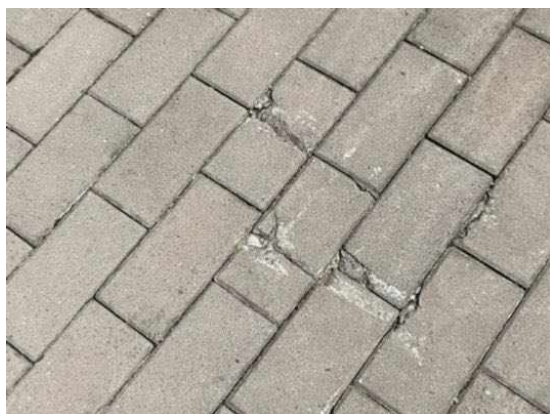
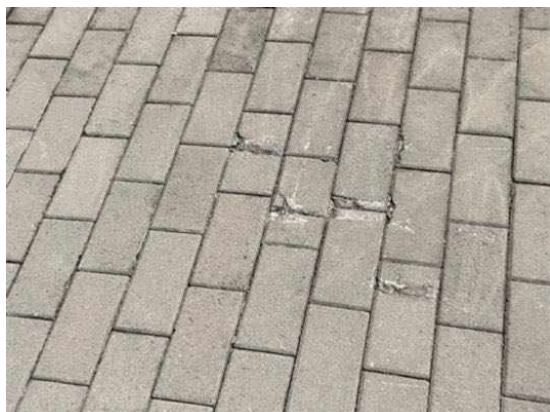
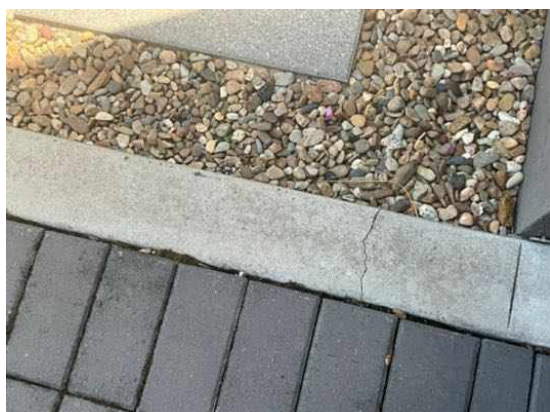
Finding 3.02

Building: Main Building
Location: Driveway
Finding: Bricks / Pavers uneven and displaced....
Information: Cracked, uneven, and displaced pavers were observed. Several pavers appear loose, misaligned, or deteriorated.

The uneven surface poses a significant trip hazard for pedestrians and may impact the usability of the driveway. Displacement and cracking can worsen over time due to vehicle traffic, poor subbase compaction, or water ingress. Wall cracking may lead to moisture entry or structural wear if left untreated.

Recommendation:

- A qualified paving contractor should be engaged to lift, relevel, and relay the affected pavers with proper bedding and compaction.
- A licensed builder or bricklayer should repair and seal the masonry wall crack around the pipe to prevent further water ingress and deterioration.
- Drainage should also be checked to ensure water is not contributing to the issue.

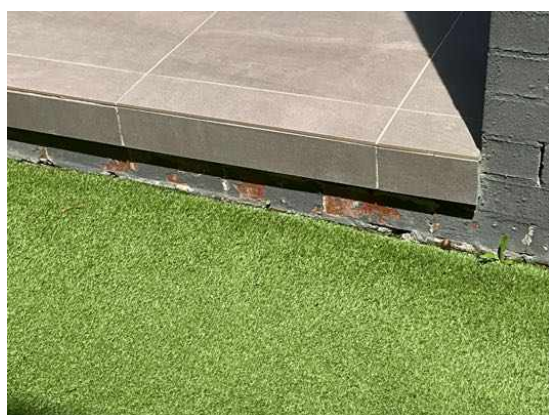
Finding 3.03

Information: Sections of the paint in this area was found to have deteriorated. Paint deteriorating is generally an indication of excessive moisture in the area that is currently hidden by the painted surface.

The presence of excessive moisture can have major implications on associated building elements if left unattended. While only seemingly minor at this stage, the damage cannot be determined due to the paint, obstructing any further inspection of the damage.

It is highly advised that the affected paint to be cleaned to allow a further, more invasive inspection by a licensed builder/painter. Failure to act on this defect may necessitate major works in the future.

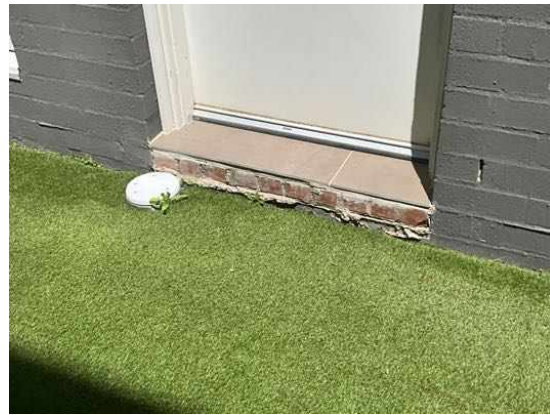
Finding 3.04

Building:	Main Building
Location:	Exterior walls - rear
Finding:	Poor workmanship
Information:	The structure exhibits signs of poor workmanship, evident in various aspects of construction and finishing.

Risk: Poor workmanship poses a range of risks, including compromised structural integrity, potential safety hazards, and a decreased lifespan of the structure. It may also lead to aesthetic and functional issues.

Resolution: A qualified contractor or construction professional should be consulted to assess and address the poor workmanship. They can implement corrective measures to ensure structural soundness, safety, and overall quality of the construction.

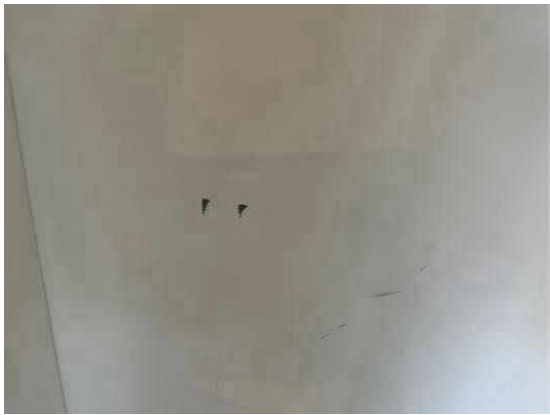
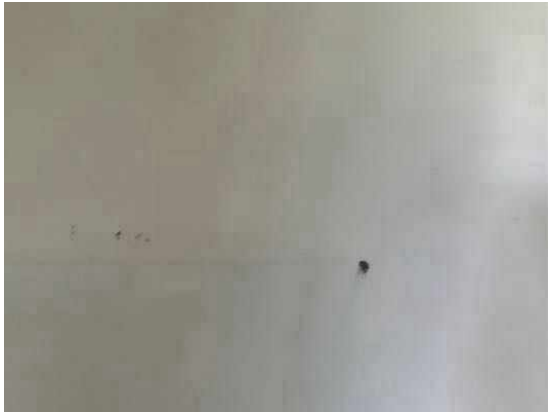
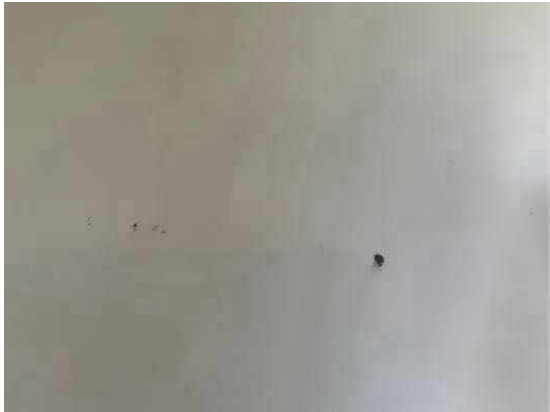
1. Aesthetic Degradation: Scratches mar the appearance of the painted surface, diminishing its visual appeal and potentially lowering property value.
2. Corrosion Vulnerability: Exposed areas of bare metal due to scratched paint are susceptible to corrosion, leading to structural damage and compromised durability.
3. Environmental Hazards: Scratched paint can release hazardous chemicals into the environment, posing risks to both human health and the ecosystem.

Who Can Fix It:

A qualified painter should address the issue promptly to repair the scratched paint. Depending on the severity of the scratches, repair options may include sanding, priming, and repainting the affected area to restore the integrity and appearance of the paint surface.

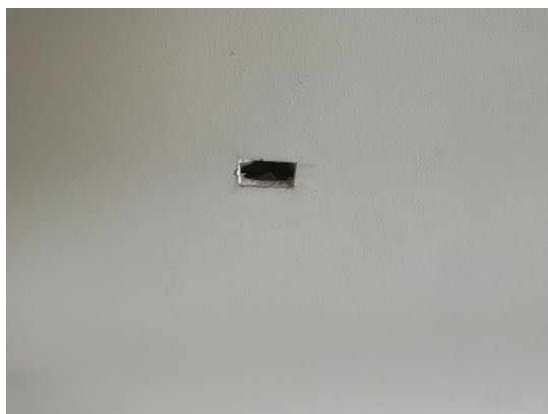
Finding 3.07

The hole in the drywall can allow drafts, pests, or moisture to enter the interior space, affecting insulation and potentially causing damage to the wall. It also detracts from the visual appeal of the room.

A professional drywall or plaster repair specialist can patch and repair the hole in the drywall, ensuring it is structurally sound and visually appealing once again.”

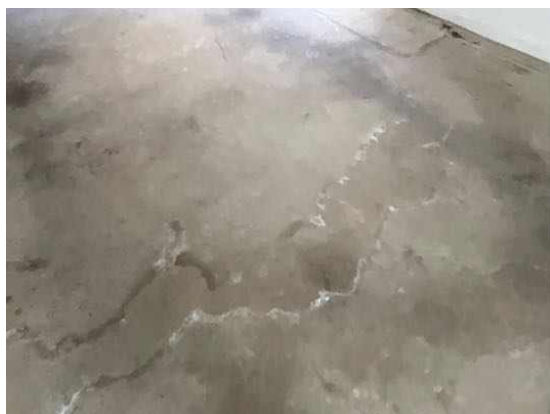
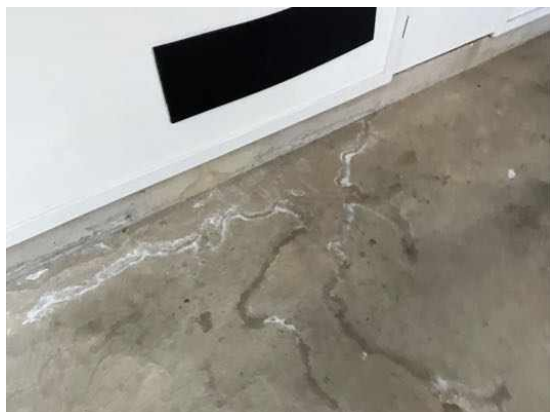
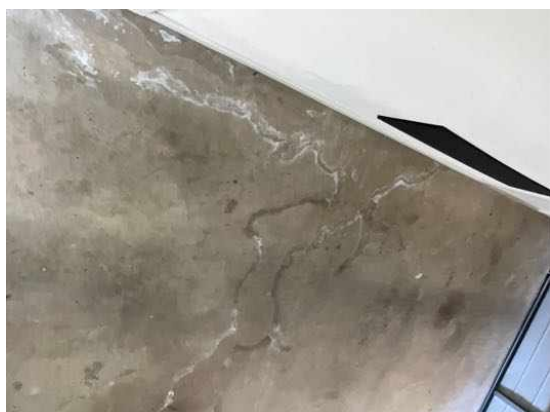
Finding 3.08

Finding: Water staining

Information: Water staining was evident in this area at the time of inspection. Water staining indicates that surfaces have been exposed to excessive moisture over time. The minerals and other elements in the water lead to staining, which may graduate to corrosion and deterioration if left unmanaged.

While mostly an appearance defect, water staining can be indicative of more serious defects, which may be currently concealed by other building elements.

Where water staining is active, a licensed plumber must be consulted to identify the cause of the staining and to provide advice on any reparation works that may be required. Replacement of any broken or damaged structures is advised.

Conversely, where water staining is old and inactive, affected building materials may be repaired or replaced at client discretion. A qualified carpenter or registered builder may be appointed to perform these works.

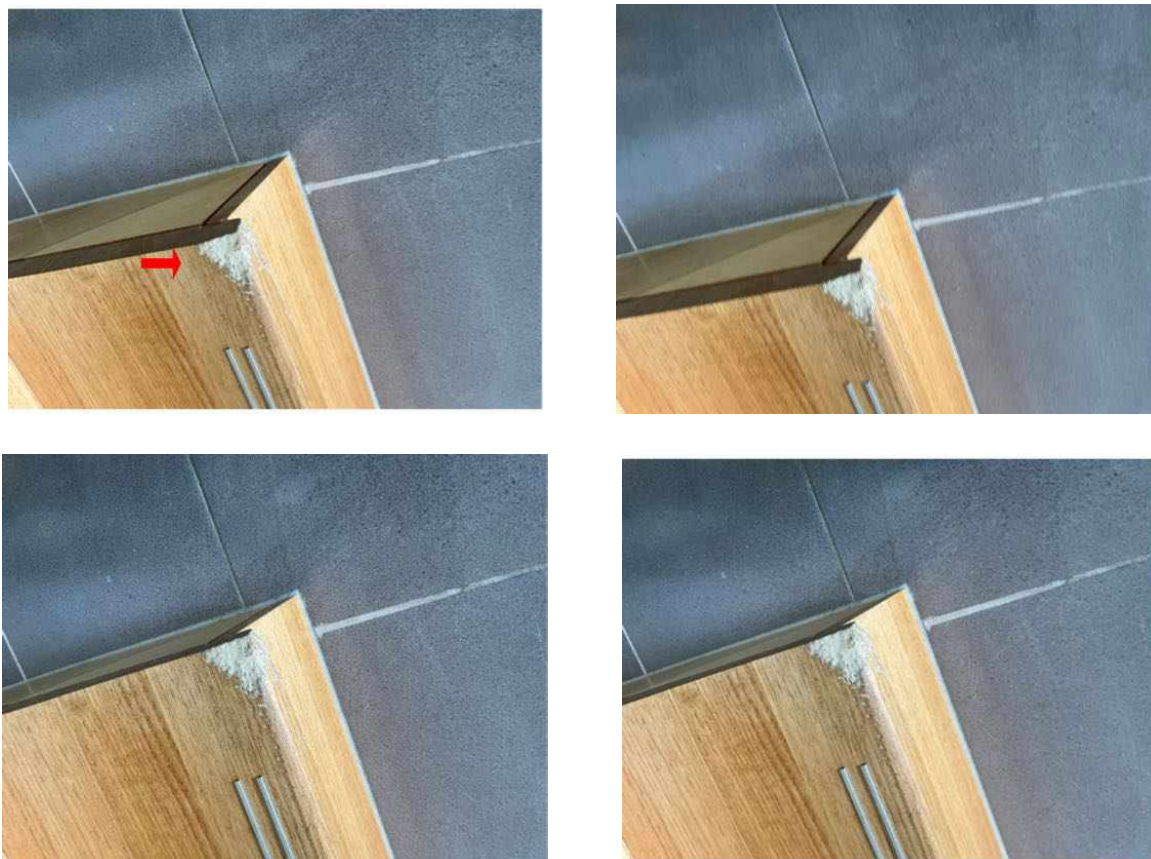
Finding 3.10

Building:	Main Building
Location:	Stairs - Internal
Finding:	Stair Tread Damaged
Information:	The stair tread shows signs of moisture damage and swelling to the laminated finish and underlying substrate. Deterioration of stair components may create a trip hazard and can worsen over time if the moisture source is not addressed.

It is recommended that the source of moisture be identified and rectified, and the damaged tread be repaired or replaced by a qualified carpenter or builder.

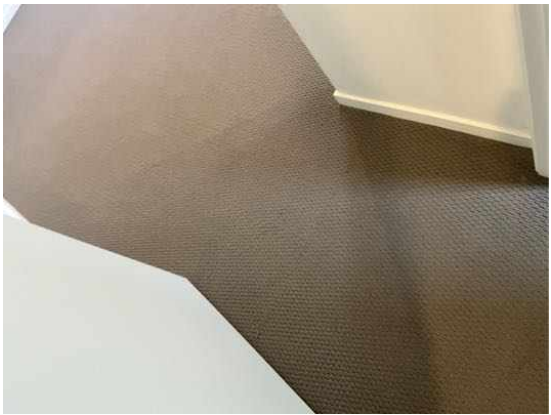
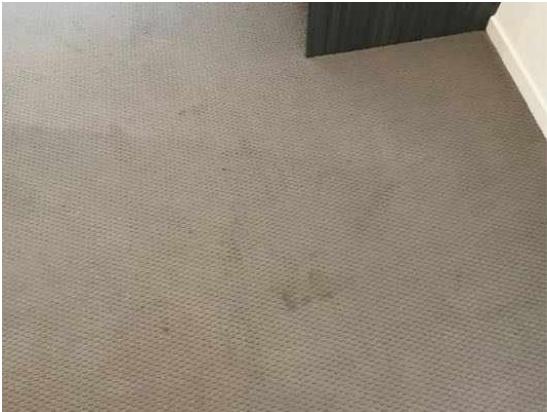
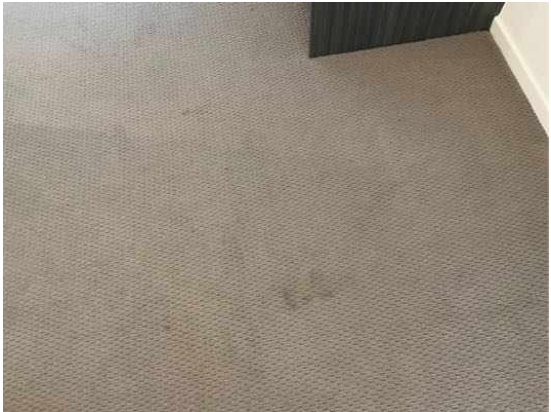
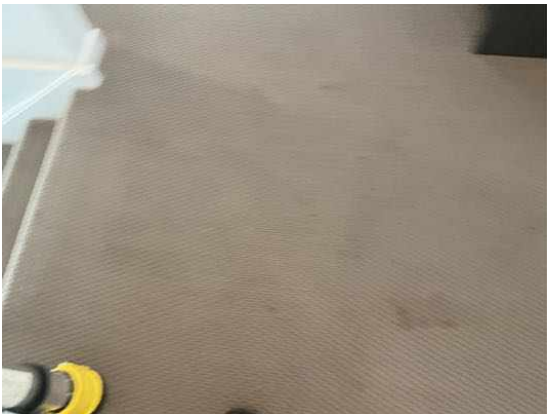
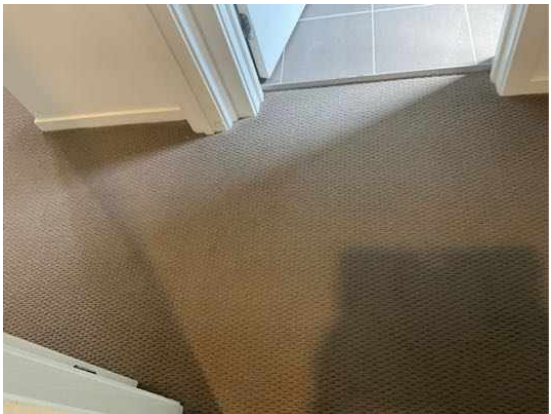
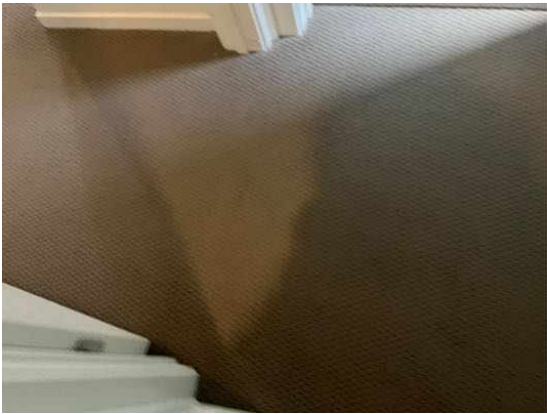
Finding 3.11

Building:	Main Building
Location:	All Areas
Finding:	carpet exhibits visible signs of aging
Information:	Carpets are exhibiting visible signs of aging, including fraying edges, faded colors, and flattened fibers, diminishing their aesthetic appeal and functional quality.

The risk associated with aging carpets includes diminished appearance, decreased comfort, potential tripping hazards due to frayed edges, and a negative impact on indoor air quality if fibers begin to degrade and release particles into the air.

Who can fix it:

Professional carpet cleaning and restoration services can address issues such as deep cleaning to rejuvenate colors, repairing frayed edges, and restoring fibers. Additionally, replacing the carpets entirely may be necessary in severe cases of aging or damage beyond repair.

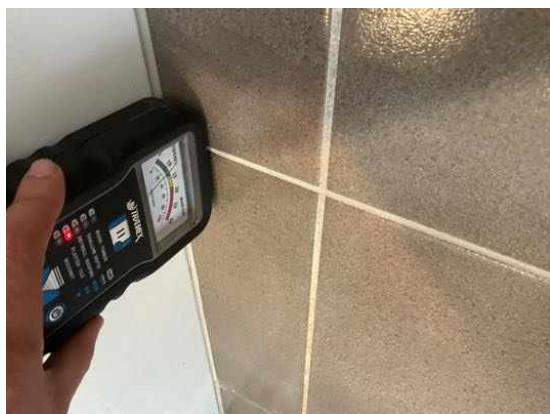
Finding 3.12

Building:	Main Building
Location:	Bathroom
Finding:	Shower - Damp
Information:	Damp is evident to the lower 300mm of wall to the shower alcove. This defect is quite common, and is suspected to have been caused by moisture permeating through the grouting in this area, which shows evidence of deterioration. Leaking pipes within the adjoining wall is also a possible cause.

Damp (or structural damp) refers to the presence of unwanted moisture in the structure of a building, either as the result of intrusion from outside, or condensation from within the structure. In the shower area, internal water leaks or other sources of excessive moisture are generally the cause of damp.

Unmanaged damp in the shower recess is likely to facilitate the formation and development of mould and fungi growth, decaying associated building materials and compromising their structural integrity. It is important to address damp conditions, as the World Health Organisation notes that excess moisture leads - on almost all indoor materials - to growth of microbes such as moulds, fungi and bacteria, which subsequently emit spores and other matter into the indoor air. Exposure to these contaminants is associated with a wide range of respiratory and other health-related problems.

Consultation with a qualified plumber or bathroom specialist is advised immediately to identify the cause of damp and to perform remedial works as required. Where excessive mould growth is present, further inspection by a specialist environmental health inspector should also be considered.

Always ensure that sealant and grout is in good condition to prevent any moisture issues occurring in the future.

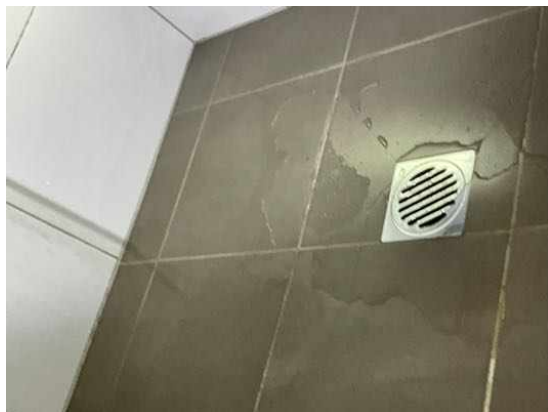
Finding 3.13

Building:	Main Building
Location:	Bathroom
Finding:	Shower base - Water pooling
Information:	Evidence of water pooling around the floor waste in the shower recess was noticed at the time of inspection. It is suspected that this excessive moisture is attributed to insufficient fall in the shower floor tiles.

This pooling is minor overall but is still considered unsatisfactory, as standard tiling practices would not permit this situation to occur. Pooling water around floor wastes can create a slip hazard in extreme cases and create conditions that are conducive to mould growth over time. Where left unmanaged, the degradation of sealant and grouting is also likely to occur, possibly necessitating further repair works.

Remedial works may involve some sections of tiling and flooring repair and replacement. A tiling contractor or bathroom specialist should be appointed to provide further advice on reparation options and to perform works as necessary.

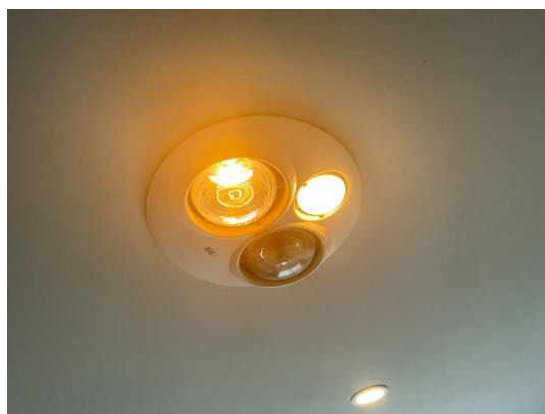
Finding 3.14

Building: Main Building
 Location: Ensuite
 Finding: Heating light in exhaust fan not working / operating
 Information: "The heating light in the exhaust fan is not operating, failing to provide the intended heating function."

Resolution:

A qualified electrician or HVAC technician can fix the issue by inspecting the heating element, wiring, and controls to identify and repair any faults or damages.

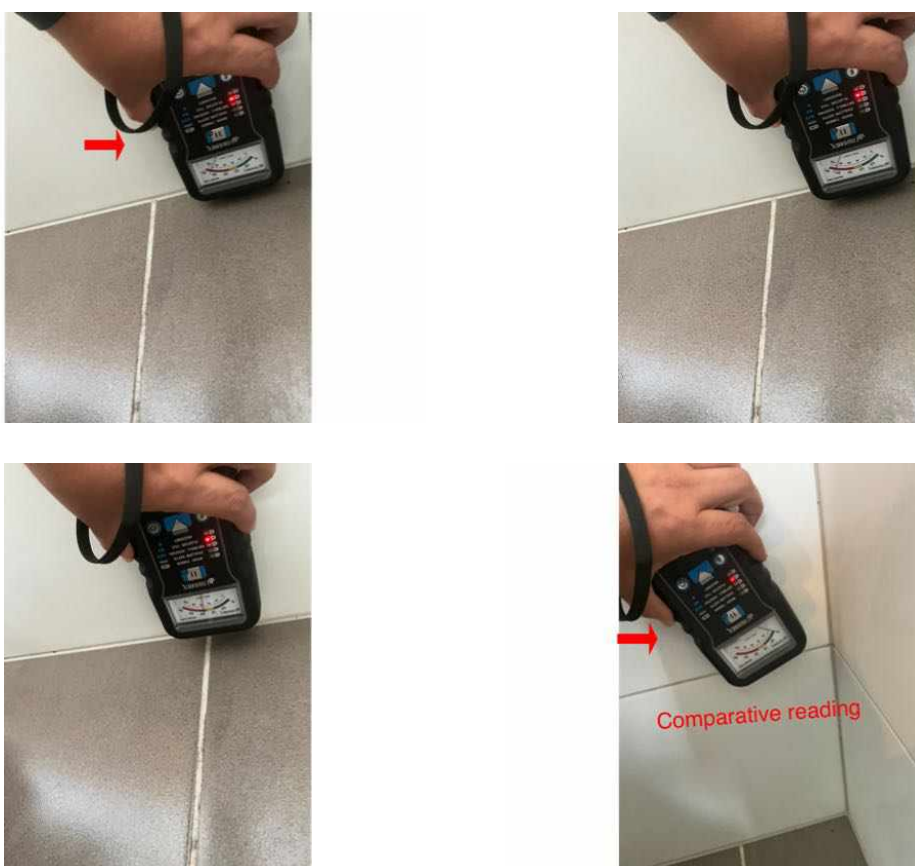
Building:	Main Building
Location:	Ensuite
Finding:	Shower - Damp
Information:	Damp is evident to the lower 300mm of wall to the shower alcove. This defect is quite common, and is suspected to have been caused by moisture permeating through the grouting in this area, which shows evidence of deterioration. Leaking pipes within the adjoining wall is also a possible cause.

Damp (or structural damp) refers to the presence of unwanted moisture in the structure of a building, either as the result of intrusion from outside, or condensation from within the structure. In the shower area, internal water leaks or other sources of excessive moisture are generally the cause of damp.

development of mould and fungi growth, decaying associated building materials and compromising their structural integrity. It is important to address damp conditions, as the World Health Organisation notes that excess moisture leads - on almost all indoor materials - to growth of microbes such as moulds, fungi and bacteria, which subsequently emit spores and other matter into the indoor air. Exposure to these contaminants is associated with a wide range of respiratory and other health-related problems.

Consultation with a qualified plumber or bathroom specialist is advised immediately to identify the cause of damp and to perform remedial works as required. Where excessive mould growth is present, further inspection by a specialist environmental health inspector should also be considered.

Always ensure that sealant and grout is in good condition to prevent any moisture issues occurring in the future.

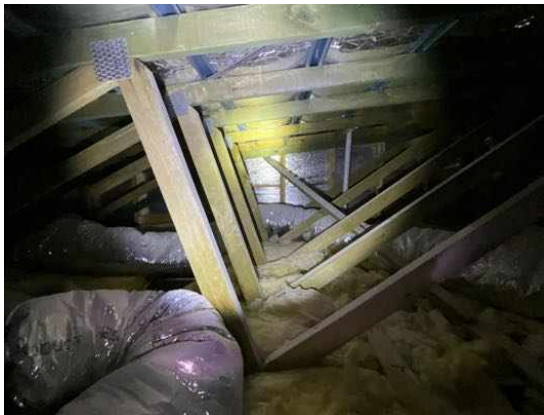
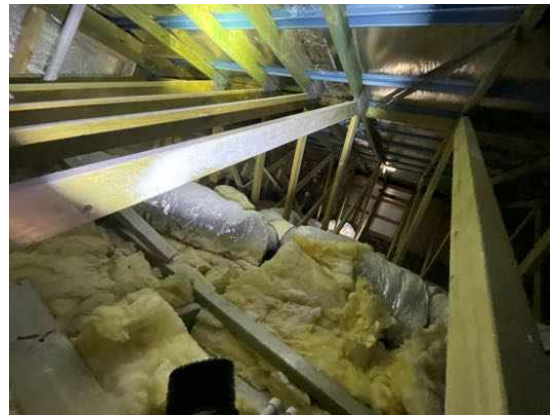
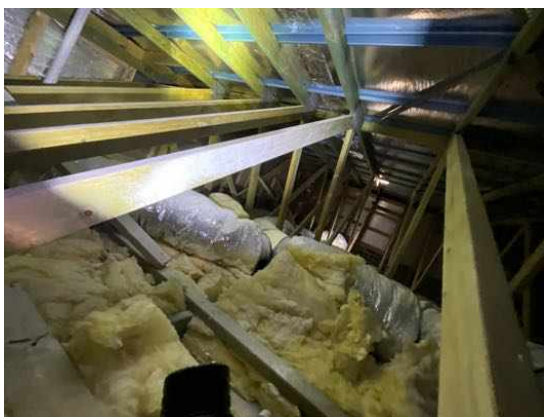
Finding 3.17

Building:	Main Building
Location:	Roof Void
Finding:	Insulation - Covering downlights
Information:	Sections of insulation in the roof void have been poorly installed or moved from their original position and are covering down light fittings. While the down lights have been

fitted with appropriate protective covers, the presence of this insulation creates a potential fire hazard.

Any insulation within the vicinity of down light fixtures should be moved and re-applied to more appropriate sections of the roof void, thus ensuring the area is fire-safe. An insulation contractor should be appointed as soon as possible to perform any necessary works as required.

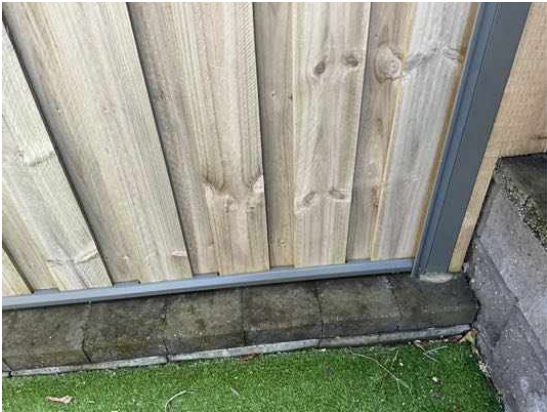
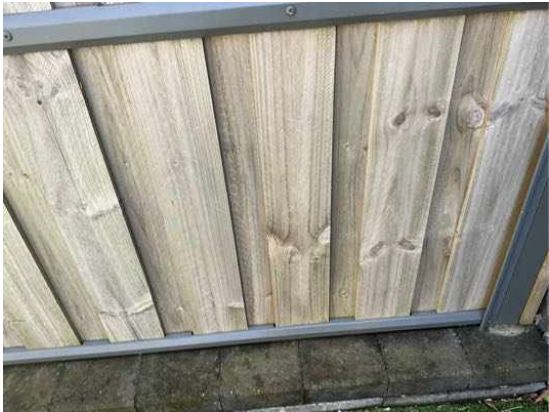
Finding 6.03

Building: Main Building
Location: All Areas
Finding: Timber on ground / conducive conditions to termite damage
Information: Timber on the ground is indeed conducive to termite damage. Termites are known to thrive in moist environments, and wood in contact with soil or moisture is more susceptible to infestation.

To prevent this, it's important to keep timber elevated and away from direct ground contact. Regular inspections and proper termite control measures are also essential to protect your wooden structures from termite damage.

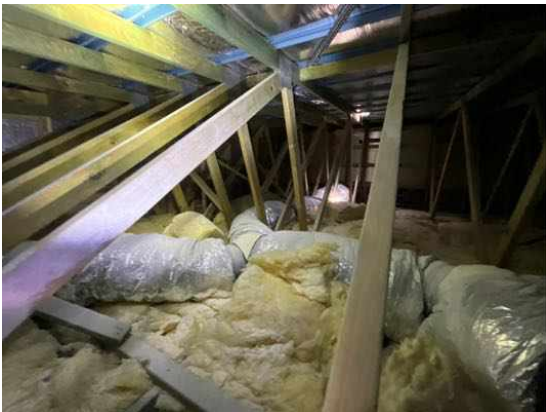
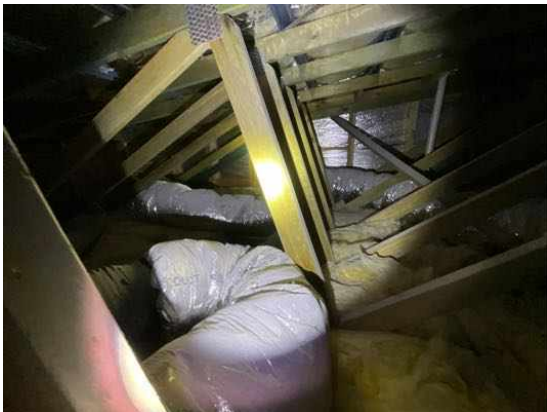
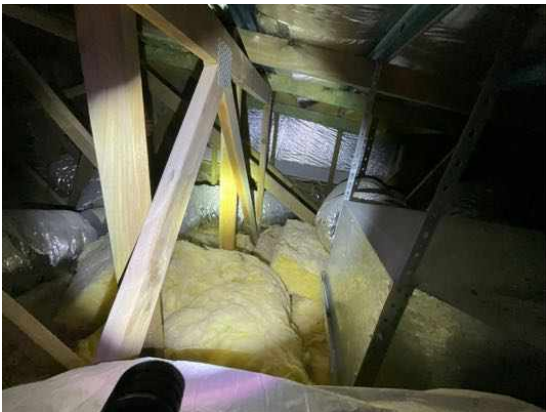
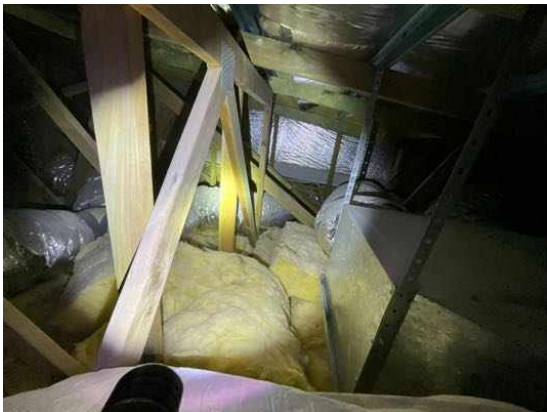
Noted Item

Building: Main Building
Location: All External Areas
Finding: Additional Photos - Obstructions and Limitations
Information: These photographs are an indication of the obstructions and limitations which impeded full inspection of the property at the time of inspection. These obstructions can hide an array of defects and should be removed to allow full inspection to be carried out. A re-inspection is recommended once the areas are made accessible.
