Building and Timber Pest Inspection Report

Inspection Date: Tue, 24 Feb 2026

Property Address: 2N Derby St, Walcher and 1E Fitzroy St,
Walcher

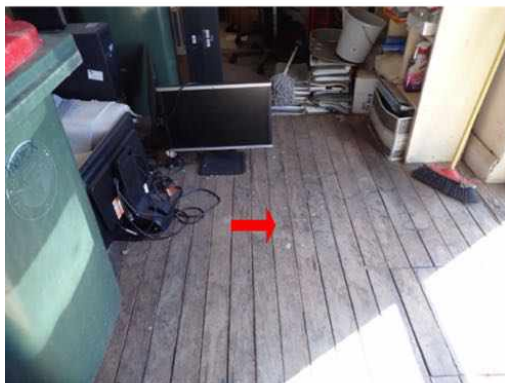
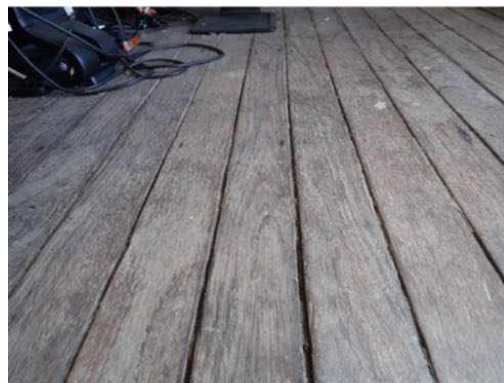
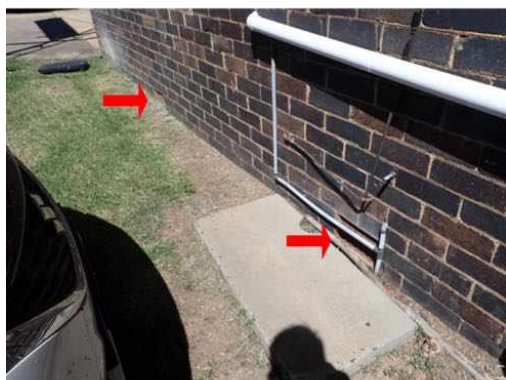
Finding 2.01

Finding: Weathered Timber Flooring – No Subfloor Access

Information: The visible timber flooring within the rear single-storey building appeared to be in weathered condition consistent with age. In simple terms, the timber floors look worn and aged. This is a common problem with buildings of this age. No access was available to inspect any subfloor areas at the time of inspection. The subfloor area is low to the ground with limited ventilation, which may contribute to accelerated timber deterioration over time. Due to the restricted access, the condition of subfloor framing and supports could not be confirmed. It is recommended that a qualified builder provide access to the subfloor for further assessment if concerns arise, and that a licensed timber pest controller be consulted to assess for any potential termite risk. Further investigation can be undertaken at the owner's discretion.

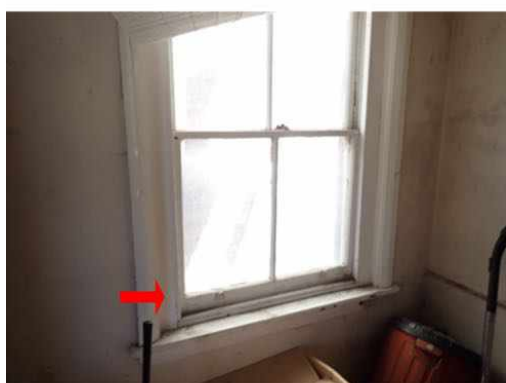
Finding 2.02

Building:	Main Building
Location:	Windows to rear single story building building
Finding:	Windows to Rear Single-Storey Building in Poor Condition
Information:	<p>The windows to the rear single-storey building were found to be in poor condition. Defects observed include surface rust to steel security screens, timber decay (wood rot) to window components, sections that were unable to be opened during normal operation, and deteriorated glass pane trims. In simple terms, the rear building windows are run down, with rust, rotting timber and parts that don't open properly. This condition is consistent with age and prolonged weather exposure and is a common issue with buildings of this age. If left unaddressed, deterioration may progress and affect functionality, weatherproofing and security. It is recommended that a qualified carpenter repair or replace the affected timber components, that a glazier replace deteriorated trims as required, and that a suitably qualified tradesperson treat or replace rusted security screens. Rectification can be undertaken at the owner's discretion depending on the desired standard of repair or replacement.</p>

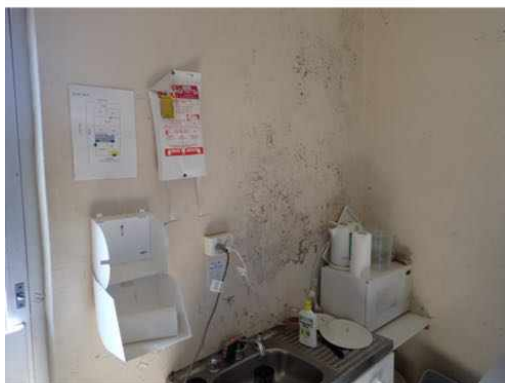
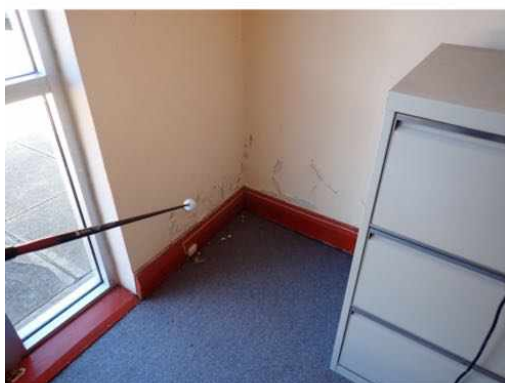
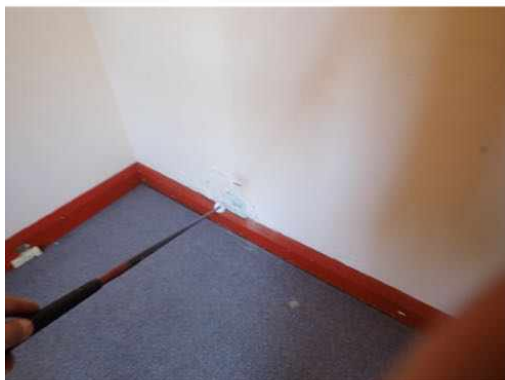
Finding 2.04

Building:	Main Building
Location:	Internal walls to rear single story building
Finding:	Internal Wall Paintwork in Poor Condition
Information:	The paintwork to internal walls was found to be in poor condition. Defects observed include general wear, scuffing, patching and areas of deterioration consistent with age and use. In simple terms, the inside wall paint is worn and run down. This is a common condition in buildings of this age and with normal occupancy. While primarily cosmetic, deteriorated paint may reduce protection to underlying surfaces over time. It is recommended that a qualified painter prepare and re-coat the affected areas as required. Repainting can be undertaken at the owner's discretion.

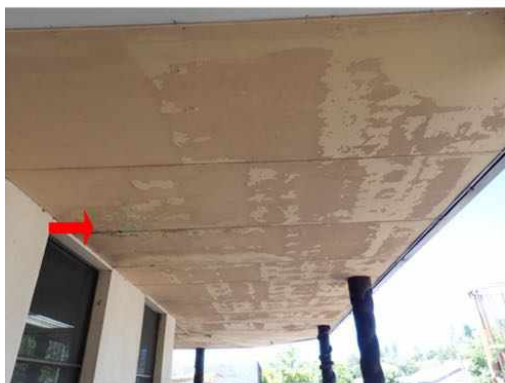
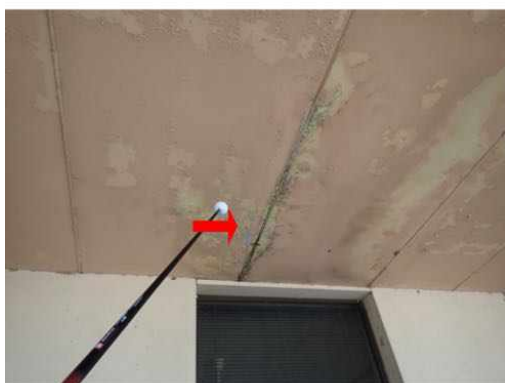
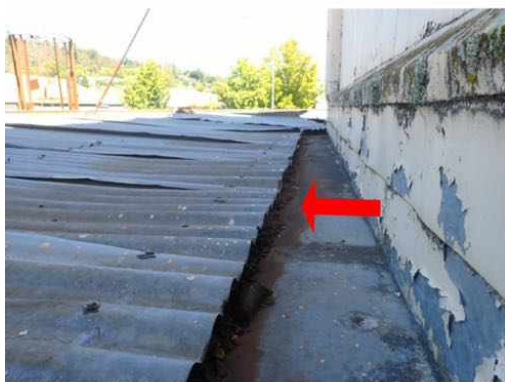
Finding 2.05

Building:	Main Building
Location:	Front awning
Finding:	External Awning in Poor Condition – Likely Leaking
Information:	<p>The external awning was found to be in poor condition. Defects observed include rusted and lifted roof sheeting, rusted box guttering and damaged/deteriorated eave sheets. The level of corrosion and displacement of the roof sheeting indicates that the awning is most likely leaking at the time of inspection. In simple terms, the awning is run down, with rusted and lifted metal that is likely allowing water to enter. This condition is commonly associated with age, prolonged weather exposure and lack of ongoing maintenance. If left unaddressed, deterioration is likely to continue and result in ongoing water ingress and further structural damage. It is recommended that a licensed roofing contractor or suitably qualified builder assess the awning, confirm the extent of leakage and carry out repairs or replacement of affected components as required. Rectification should be undertaken to prevent further deterioration and can be arranged at the owner's discretion.</p>

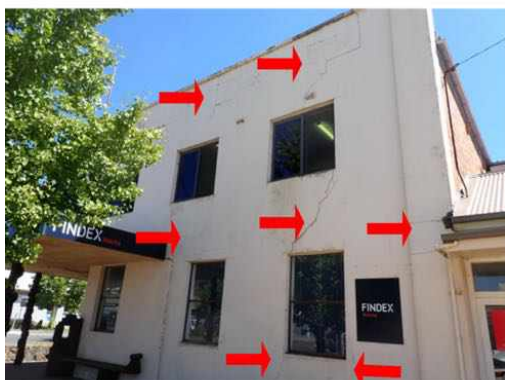
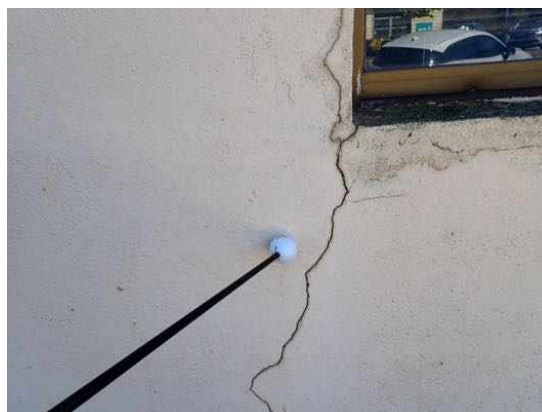
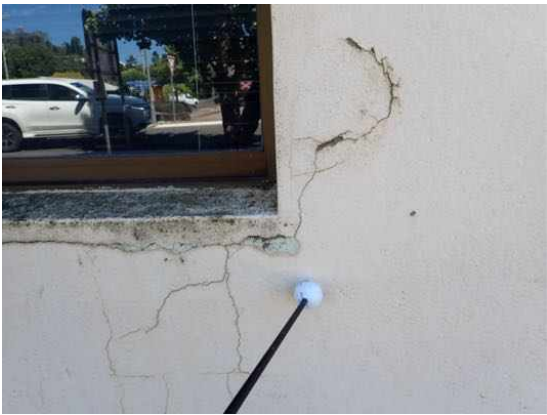
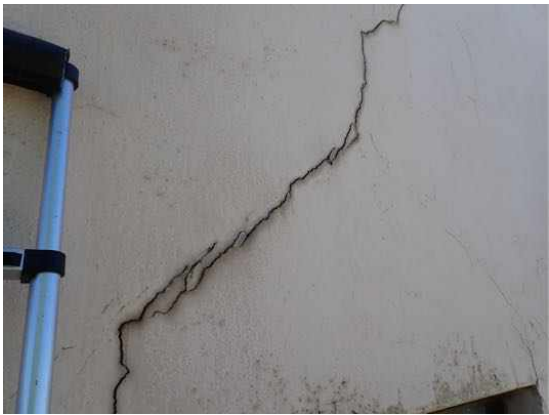
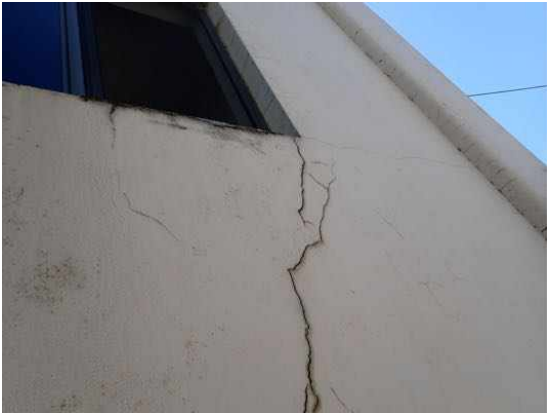
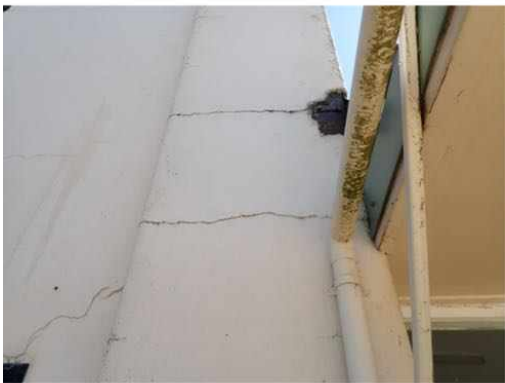
Finding 2.06

Building:	Main Building
Location:	External walls
Finding:	Major and Minor Cracks to Internal Brickwork and Render
Information:	Major and minor cracking was identified to sections of the external brickwork and rendered surfaces. The cracks vary in size and pattern, with some consistent with minor settlement and shrinkage, and others of greater width that may indicate movement within the structure. In simple terms, there are both small and larger cracks in the internal brick and rendered walls. Cracking of this nature is commonly associated with building movement, settlement, thermal expansion and age, and is a common issue in buildings of this age. Ongoing or progressive movement may lead to further cracking over time. It is recommended that a suitably qualified builder assess the cracks to determine whether they are cosmetic or structural in nature and carry out repairs as required. For significant or progressive cracking, consultation with a structural engineer is recommended to further assess structural implications and provide rectification advice. Monitoring of larger cracks for signs of movement is advised. Rectification can be undertaken at the owner's discretion depending on the severity and progression of cracking.

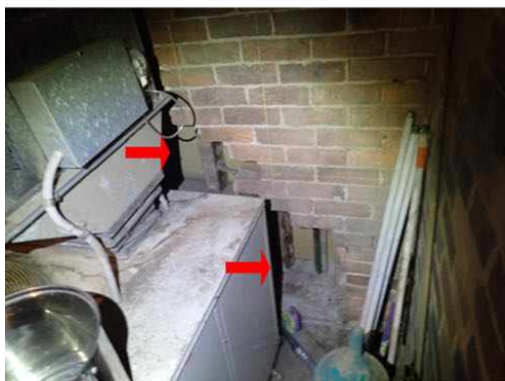
Finding 2.07

Building:	Main Building
Location:	Rear/side of single story building
Finding:	Brickwork Knocked Out Poorly to Accommodate Air Conditioning Unit
Information:	Brickwork has been poorly cut and removed to accommodate the installation of an air conditioning unit. The opening appears roughly formed and inadequately finished, which may affect the structural integrity, weatherproofing and overall appearance of the wall. In simple terms, bricks have been knocked out roughly to fit the air conditioner, and the work looks untidy. This type of alteration, if not properly supported or sealed, may allow moisture ingress or ongoing cracking around the opening. It is recommended that a qualified builder or bricklayer assess the

modification and carry out appropriate rectification works, including proper support, flashing and sealing as required. Rectification can be undertaken at the owner's discretion.

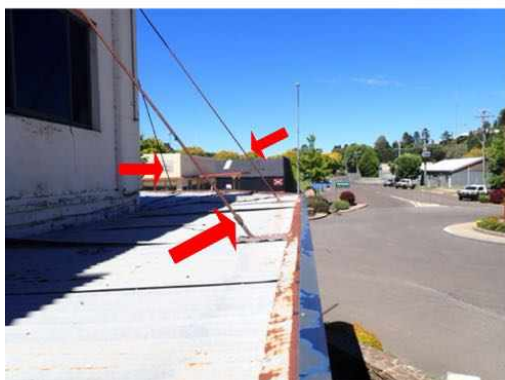
Finding 2.08

Building: Main Building
 Location: Front awning
 Finding: Corrosion to Front Awning Support – Engineering Consultation Recommended
 Information: Corrosion was identified to the front awning support structure. The rust observed is more than minor surface corrosion but no immediate failure was noted at the time of inspection. In simple terms, all the metal supports at the front awning are noticeably rusted. This condition is commonly associated with prolonged weather exposure and deterioration of protective coatings. If left unaddressed, corrosion may continue and potentially affect the long-term durability of the support. It is recommended that a qualified builder or metal fabricator assess the extent of deterioration and carry out repairs or treatment as required. Consultation with a structural engineer is recommended to confirm the structural adequacy of the support if concerns remain. Rectification can be undertaken at the owner's discretion to prevent further deterioration.

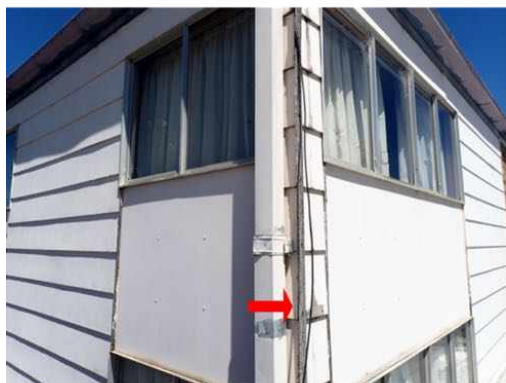
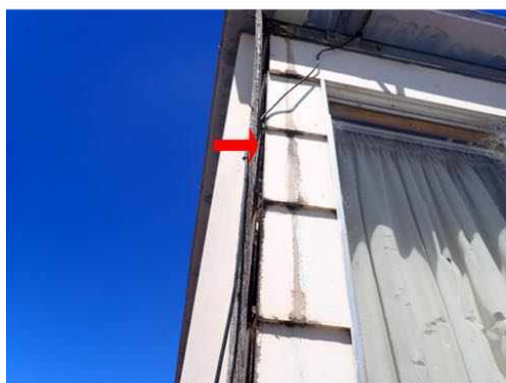
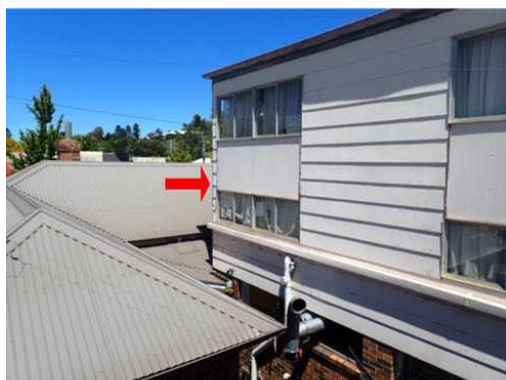
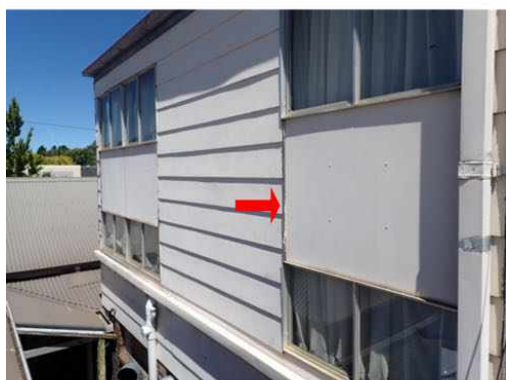
Finding 2.09

Building: Main Building
Location: Second story external cladding
Finding: Wood Rot to Timber Trims and Deterioration to Weatherboard Cladding
Information: Wood rot was identified to sections of the external timber trims, along with deterioration to areas of the weatherboard cladding. The timber shows signs of decay and breakdown consistent with age and weather exposure. In simple terms, parts of the external timber trims and cladding are rotting and wearing out. This is a common defect in buildings of this age due to ongoing exposure to the elements and maintenance requirements. If left unaddressed, deterioration may progress and allow moisture ingress into wall cavities. It is recommended that a qualified carpenter remove and replace affected timber components as required and that the external surfaces be properly prepared and re-coated to maintain protection. A licensed timber pest controller should also be consulted where decay is present to assess for any associated termite risk. Rectification can be undertaken at the owner's discretion to prevent further deterioration.

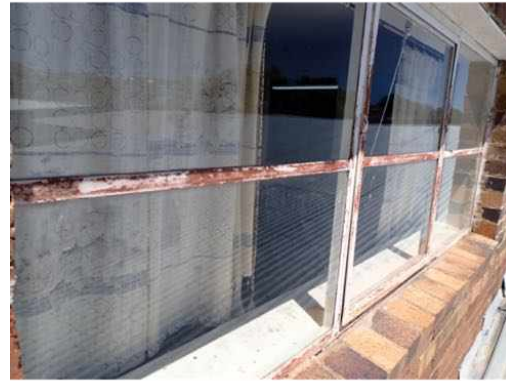
Finding 2.10

Building:	Main Building
Location:	Second story windows
Finding:	Second-Storey External Windows in Deteriorated Condition
Information:	<p>The second-storey external windows were found to be in deteriorated condition. Defects observed include age-related wear, breakdown of protective coatings and general deterioration of window components. In simple terms, the upstairs outside windows are run down and showing their age. This is a common condition in buildings of this age due to prolonged weather exposure and maintenance requirements. Access limitations typical of second-storey windows may restrict detailed inspection of all elements. If left unaddressed, deterioration may progress and affect operation, weatherproofing and durability. It is recommended that a qualified carpenter or window specialist assess the affected windows and carry out repairs, re-coating or replacement as required. Rectification can be undertaken at the owner's discretion to prevent further deterioration.</p>

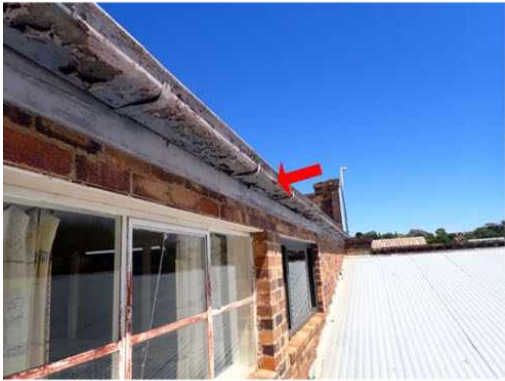
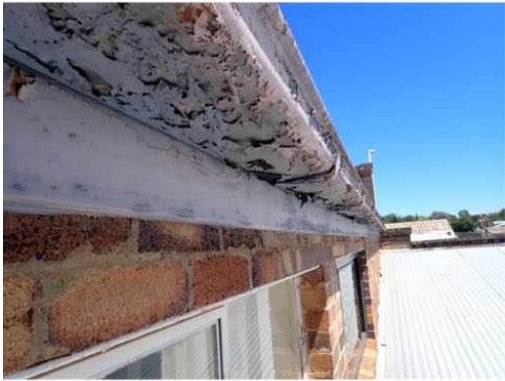
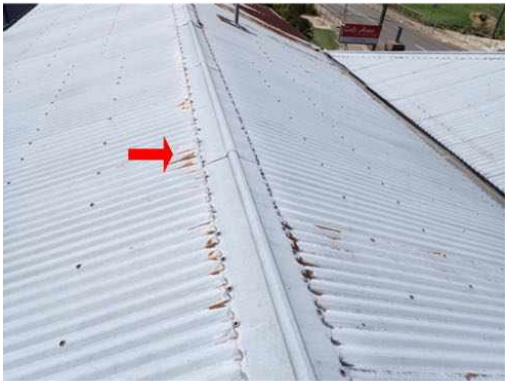
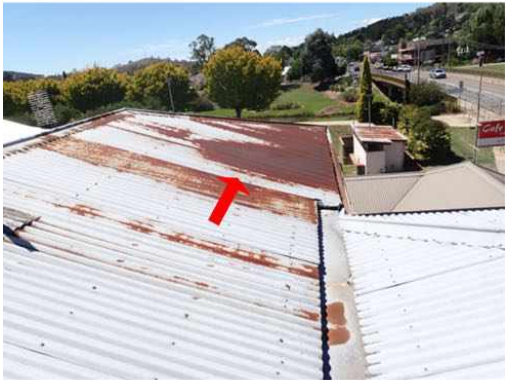
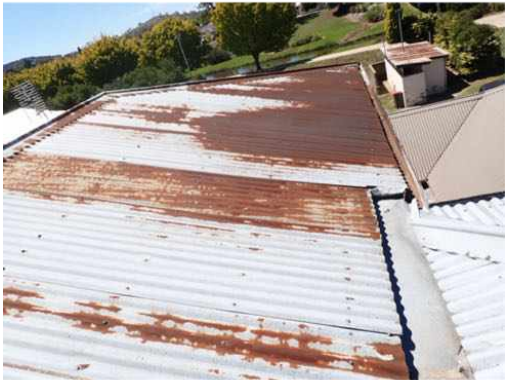
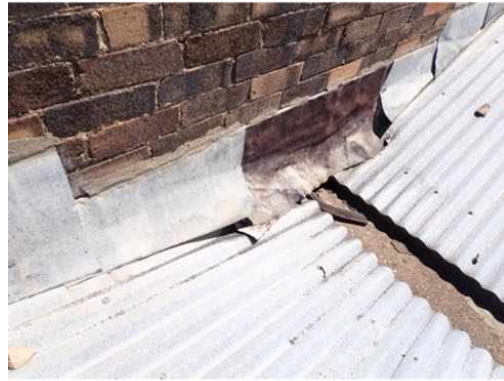
Finding 2.11

Building:	Main Building
Location:	Second story roof
Finding:	Second-Storey Roof Cladding and Plumbing in Poor, Rust-Affected Condition
Information:	The second-storey roof cladding and associated plumbing components were found to be in poor, rust-affected condition. Defects observed include corrosion, age-related deterioration and general wear consistent with prolonged weather exposure. In simple terms, the upstairs roof sheeting and plumbing are significantly rusted and run down. This is a common condition in buildings of this age. If left unaddressed, continued corrosion may lead to water ingress, ineffective stormwater discharge and further structural damage. It is recommended that a licensed roofing contractor and/or licensed plumber assess the affected areas and carry out repairs or replacement as required. Rectification can be undertaken at the owner's discretion to prevent further deterioration.

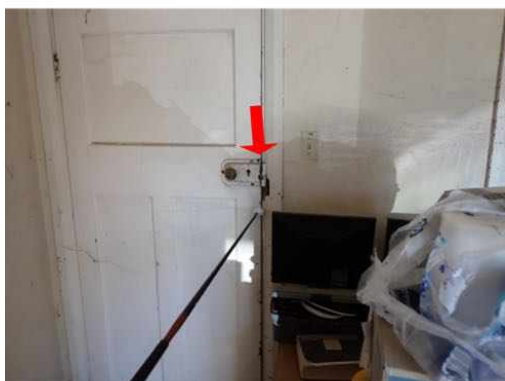
Finding 3.02

Building:	Main Building
Location:	Kitchen area rear single story building
Finding:	Door Hardware to Kitchen Area in Poor Condition
Information:	The door hardware to the kitchen area, although operational at the time of inspection, was found to be in poor condition. Components show signs of wear, age-related deterioration and possible loosening. In simple terms, the door handles and fittings work but are worn and run down. This condition is commonly associated with age and regular use. If left unaddressed, hardware may fail or become difficult to operate. It is recommended that a qualified handyman or carpenter repair or replace the affected hardware as required. Rectification can be undertaken at the owner's discretion.

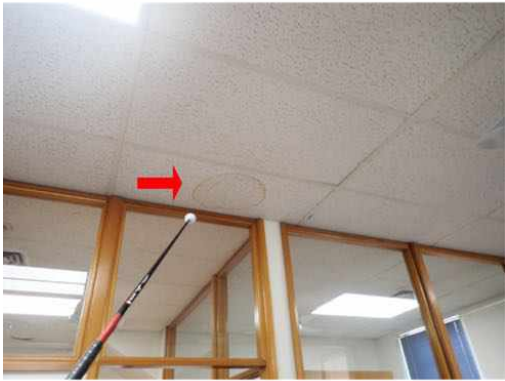
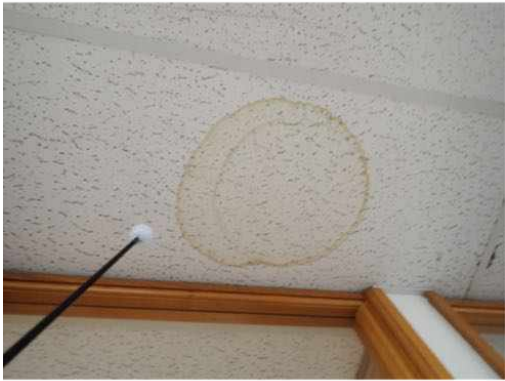
Finding 3.03

Building: Main Building
Location: Findex tenancy
Finding: Water-Stained Ceiling Tiles to Findex Tenancy
Information: Several water-stained ceiling tiles were identified within the Findex tenancy at the time of inspection. The staining indicates past or possible moisture ingress; however, no active leaks were observed to the accessible areas during the inspection. In simple terms, some ceiling tiles show water marks from previous moisture. This condition is commonly associated with roof leaks, plumbing leaks or condensation events. It is recommended that a qualified contractor investigate the source of the staining to confirm whether the issue is historical or ongoing, and replace affected ceiling tiles as required. Further action can be undertaken at the owner or tenant's discretion depending on lease arrangements.

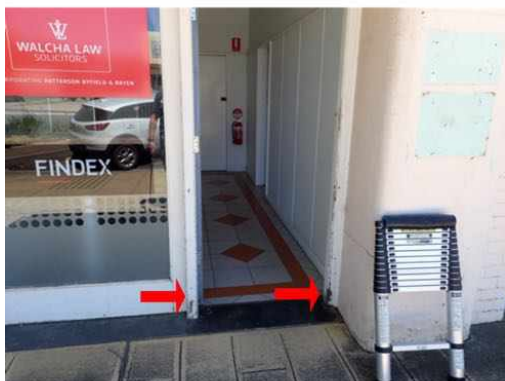
Finding 3.05

Building:	Main Building
Location:	External foyer entry
Finding:	Timber Door and Window Framing to External Foyer Entry Weathered Condition
Information:	The timber door and window framing to the external foyer entry were found to be in weathered condition. The timber shows signs of age-related wear and exposure to the elements. In simple terms, the timber around the entry door and windows is worn and weathered. This is a common condition due to ongoing sun and weather exposure. If left unmaintained, the timber may deteriorate further and become susceptible to decay. It is recommended that a qualified carpenter repair any damaged sections as required and that a qualified painter prepare and re-coat the timber to provide adequate protection. Maintenance can be undertaken at the owner's discretion to prevent further deterioration.

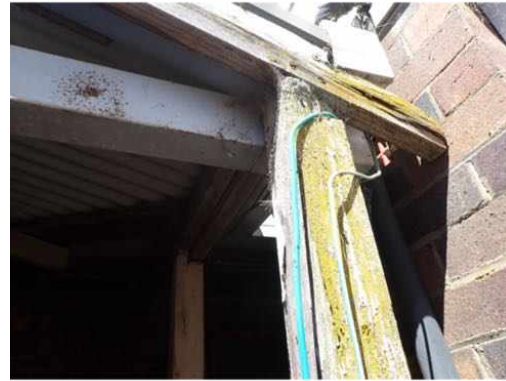
Finding 7.01

Building:	Main Building
Location:	Rear/side veranda.
Finding:	Wood Rot/Deterioration to Side/Rear Veranda Post and Surrounding Framing
Information:	Wood rot and deterioration were identified to the side/rear veranda post and the framing around the base of the post. The timber shows signs of decay consistent with prolonged moisture exposure and age-related wear. In simple terms, the timber post and surrounding frame at the veranda are rotting. This condition is commonly associated with weather exposure. If left unaddressed, deterioration may worsen and affect the structural stability of the veranda support. It is recommended that a qualified carpenter or builder remove and replace the affected timber components and ensure the area is adequately sealed and protected from moisture. A licensed timber pest controller should also be consulted to assess for any associated termite risk. Rectification should be undertaken to prevent further structural deterioration and can be arranged at the owner's discretion.

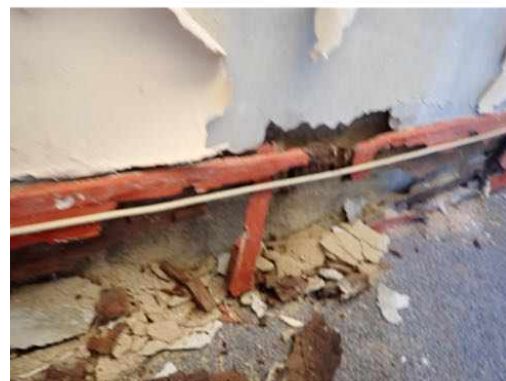
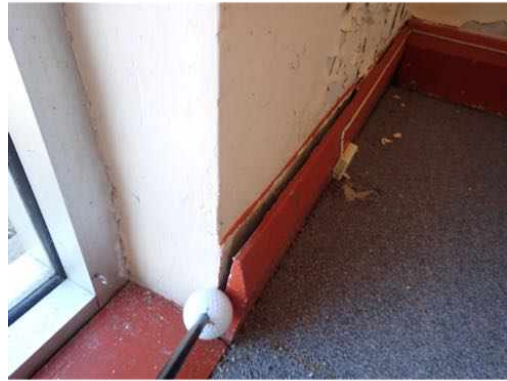
Finding 7.02

Building:	Main Building
Location:	Single story building
Finding:	Wood Rot and Damage to Skirting Board – Single-Storey Building (Room with Glass Door)
Information:	<p>Wood rot and associated damage were identified to the skirting board within the single-storey building, specifically in the room containing the glass door. The timber shows signs of decay consistent with moisture exposure and age-related deterioration. In simple terms, the skirting board in that room is rotting and damaged. This condition is commonly caused by moisture ingress, condensation or prolonged contact with damp surfaces. If left unaddressed, deterioration may progress and affect adjoining wall linings. It is recommended that a qualified carpenter remove and replace the affected skirting board and investigate the source of moisture if applicable. A licensed timber pest controller should also be consulted to assess for any associated termite risk. Rectification can be undertaken at the owner's discretion to prevent further deterioration.</p>

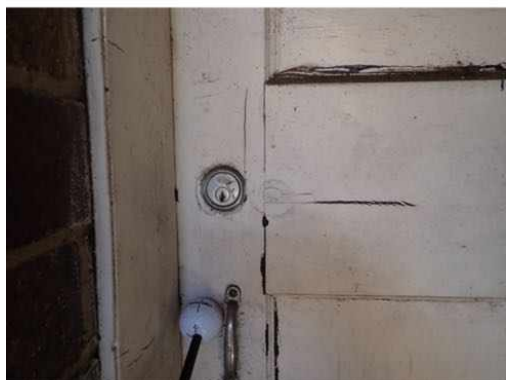
Noted Item

Building:	Main Building
Location:	Rear/side of single story building
Finding:	Side Timber Doors Locked at Time of Inspection – Fair Condition for Age
Information:	The side timber doors were locked at the time of inspection and internal faces/operation could not be fully assessed. Based on external visual observations only, the doors appear to be in fair condition consistent with their age. In simple terms, the side timber doors were locked so they couldn't be properly checked, but from what could be seen they look reasonable for their age. This is a common limitation where access is restricted. It is recommended that the doors be fully inspected once access is available to confirm condition and operation. Further assessment can be undertaken at the owner's discretion.
