# Building and Timber Pest Inspection Report

Inspection Date: Tue, 10 Feb 2026

Property Address: 549 Sanders Rd, Lavington NSW 2641,  
Australia

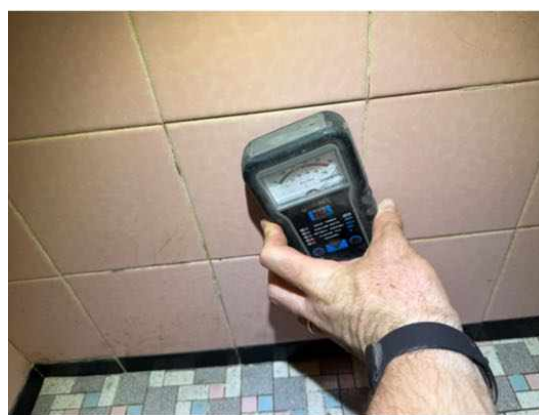
Building: Main Building  
 Location: Shower  
 Finding: Shower - Leaking / High Moisture  
 Information: It appears that high moisture is present at but not limited to, the base of the shower walls. It appears this has lead to fungal decay of the timbers in the subfloor beneath. Potential causes of leaking include but are not limited to loose or damaged plumbing fittings and fixtures, and/or deteriorated seals or waterproofing.

Areas of leaking and high moisture create an environment conducive to termite activity and should not be neglected. Recommend engaging a licensed plumber promptly, to provide remedial works, to ensure no further water damage occurs. A more invasive inspection may reveal secondary building defects.

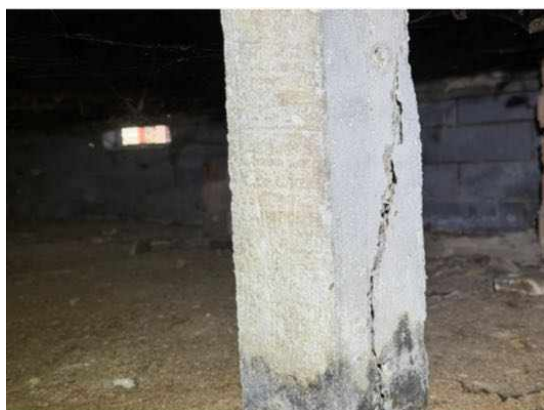
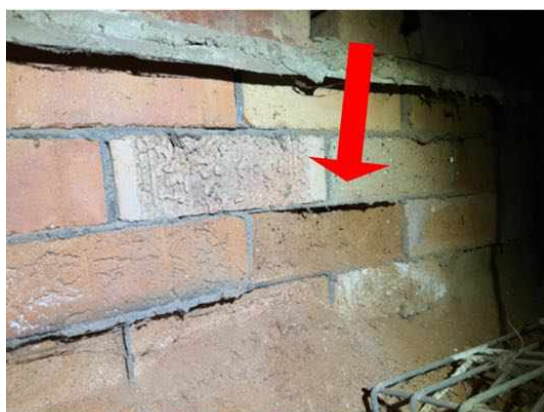
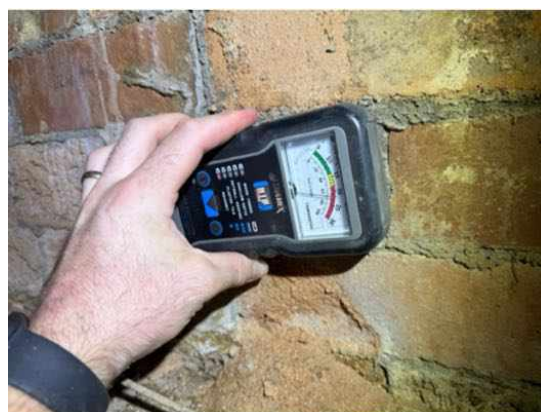
#### Finding 3.01

Building: Main Building  
 Location: Subfloor piers, & brickwork  
 Finding: Brickwork & Concrete Piers - Deterioration (Fretting) & Concrete Cancer  
 Information: Deterioration (fretting), was evident in some areas of the brickwork in the subfloor. Concrete cancer (rust of steel reinforcements inside a concrete structure) was also noted to some concrete piers & has caused cracking. Evidence of high moisture was

also noted in these areas.

If neglected, further deterioration is likely to occur overtime. Recommend consulting with a structural engineer, in the short term to provide further advice and specify any required remedial works.

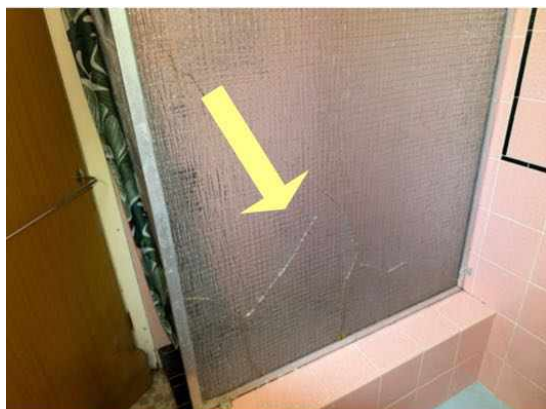
### Finding 3.02

Building:	Main Building
Location:	Bathroom
Finding:	Shower screen - Cracked
Information:	Cracking was evident to the shower screen at the time of inspection. The client should

engage a licensed glazier to replace the shower screen promptly. In the interim, anyone coming into close contact with the shower screen should do so with due caution.

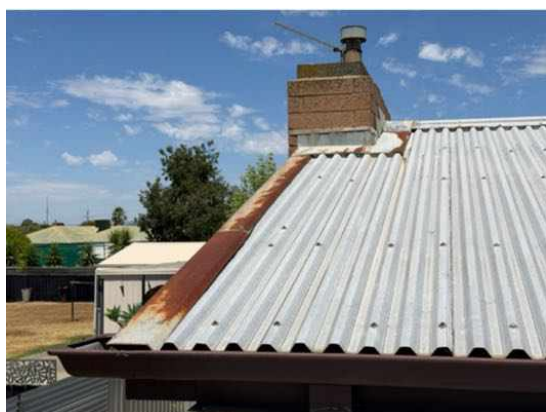
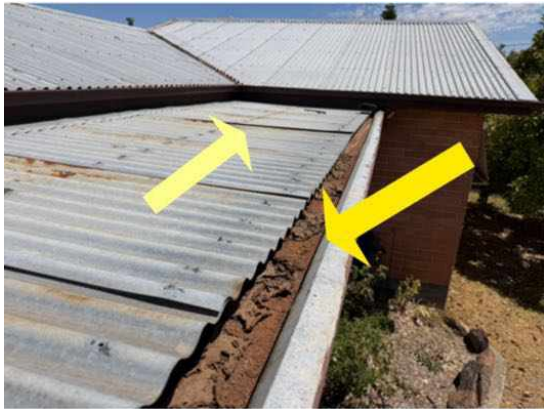
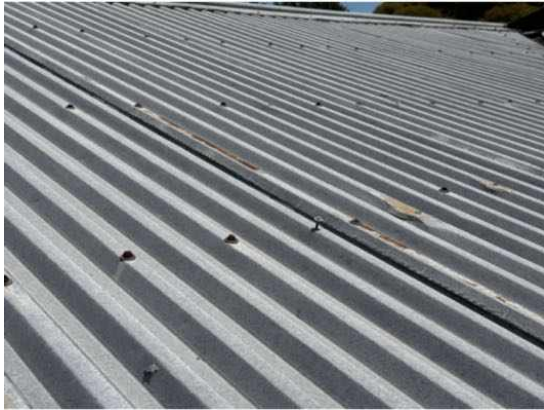
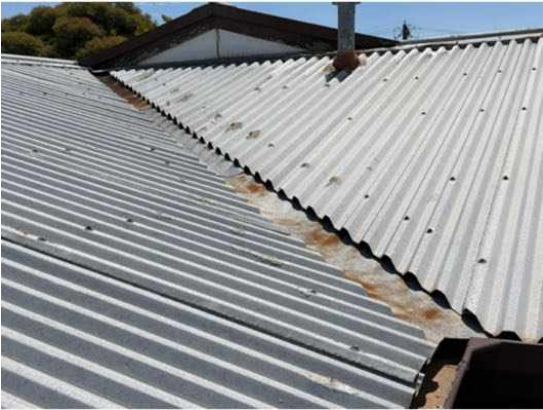
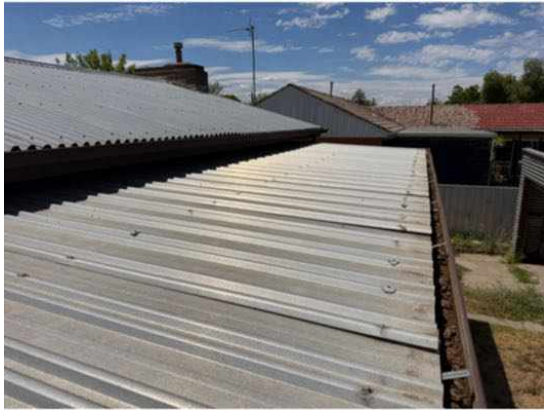
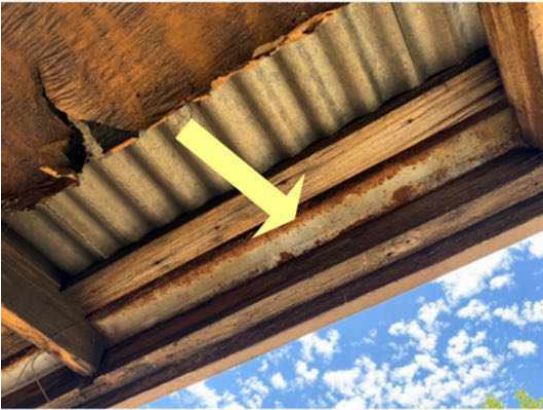
### Finding 3.03

Building:	Main Building
Location:	Roof Plumbing
Finding:	Roof plumbing & sheeting - Rusted & Loose / Disconnected
Information:	It appears that the roof plumbing including but not limited to the gutters, down-pipes and areas of the roof sheeting have areas of rust and corrosion. The shed gutter was found to be sagging and the down-pipe disconnected.

Rusted roof plumbing could eventually develop holes and leaks overtime that can affect other building elements if neglected. Recommend engaging a licensed roof plumber in the short term, to provide further advice & remedial works where necessary.

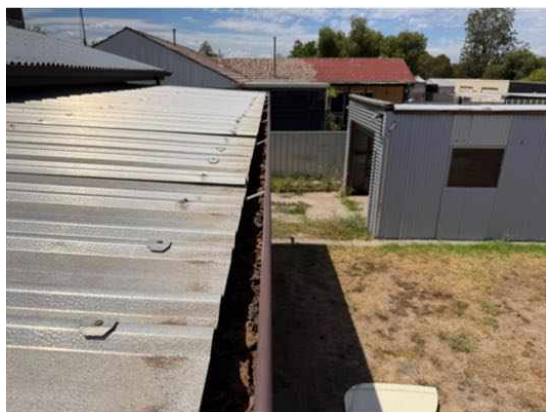
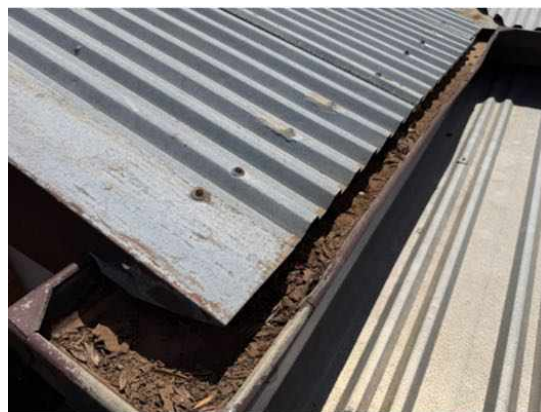
Finding 3.04

Building: Main Building  
 Location: Gutters  
 Finding: Debris in Gutters  
 Information: It appears that there is some debris in the gutters. Accumulation of debris can lead to blockages of the gutters & water overflows, if neglected.

Recommend engaging a general handyman to remove all debris from the gutters promptly to prevent overflows & blockages.

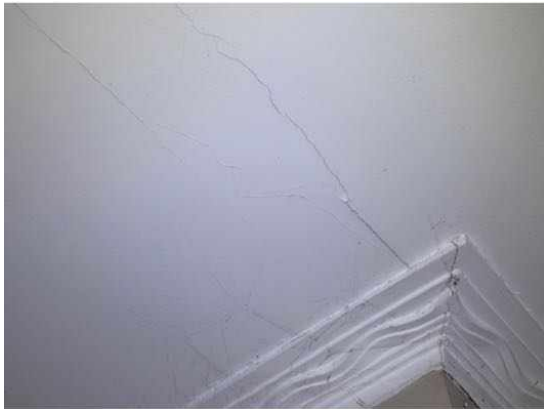
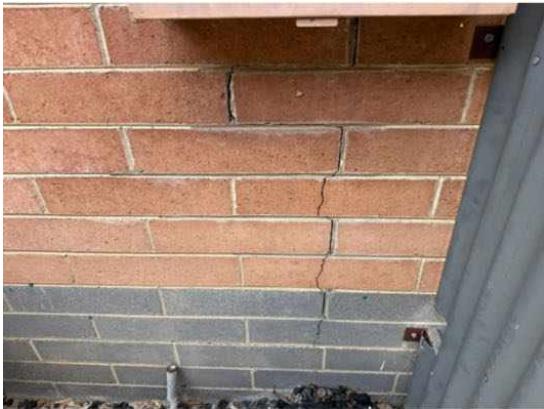
### Finding 3.05

Building: Main Building  
 Location: External Brickwork, Internal wall linings  
 Finding: Cracking - External & Internal  
 Information: Cracking was identified to some areas of the brickwork and internal wall / ceiling linings at the time of inspection. Cracking has a variety of possible causes, however, the most common is movement of adjacent footings and/or expansion / contraction of building materials.

Cracking is a relatively common defect, and is most likely to occur adjacent to windows, doors and other openings.

The client should monitor the cracking. Should the cracking lengthen, widen or become more numerous, the client should consult with a structural engineer promptly to provide further advice.

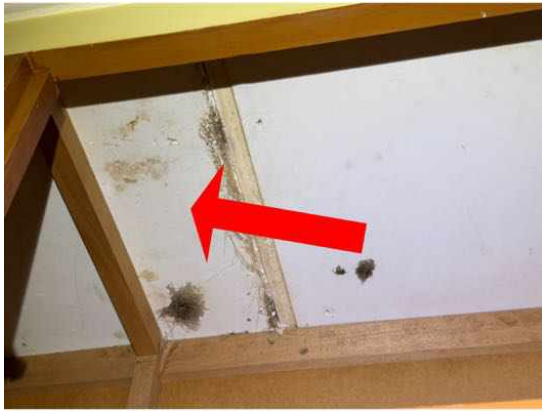
**Finding 3.06**

Building: Main Building  
Location: Cupboard Ceiling  
Finding: Water Staining Present  
Information: It appears that water staining was present at but not limited to, a cupboard ceiling. Potential causes of leaking include deteriorated roof cladding or damaged plumbing fittings and fixtures.

It is recommended that the client monitor the area and engage a licensed roof plumber promptly, should the leak persist or return.

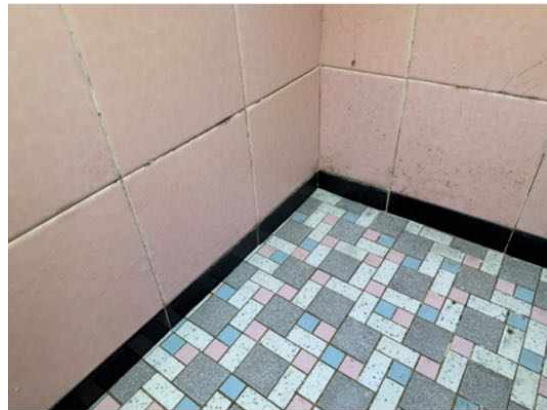
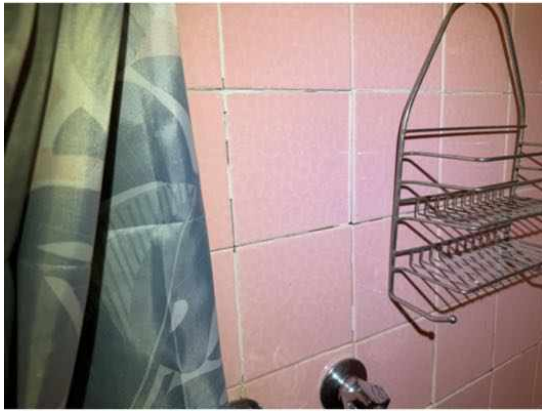
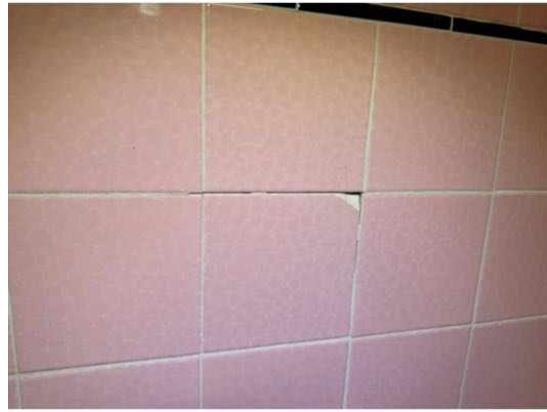
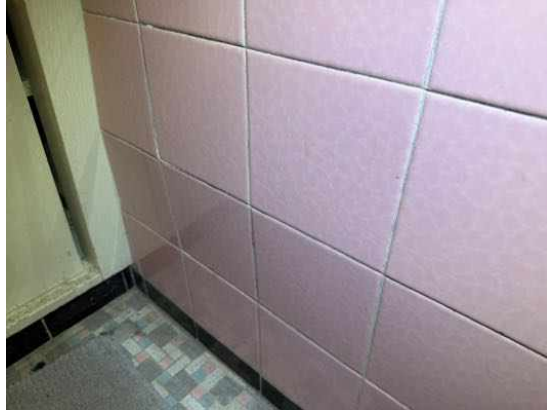
### Finding 3.07

Building: Main Building  
 Location: Bathroom  
 Finding: Sealant / grouting - deteriorated or missing & Cracked & Loose Tiles  
 Information: It appears that the sealant and grout has deteriorated in the bathroom. Areas of cracked and loose tiles were also noted, which can allow for moisture ingress behind the tiles, if neglected.

Sealant and grouting in areas that come into regular contact with water should be maintained for the long term care of your property.

Recommend engaging a licensed tiling contractor in the short term, to provide remedial works where necessary.

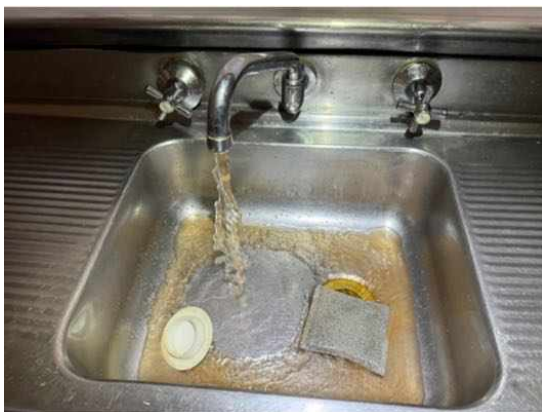
### Finding 3.08

Building:	Main Building
Location:	Kitchen & Bath Taps
Finding:	Taps - Rusty coloured water
Information:	The water emitting from the bath & kitchen sink taps appears to be rusty-coloured. This defect may be caused by erosion/deterioration of associated pipework.

While this is a relatively common defect in buildings of a similar age & condition, it is advised that the client engage a licensed plumber, to further inspect the pipework and provide any remedial works as required.

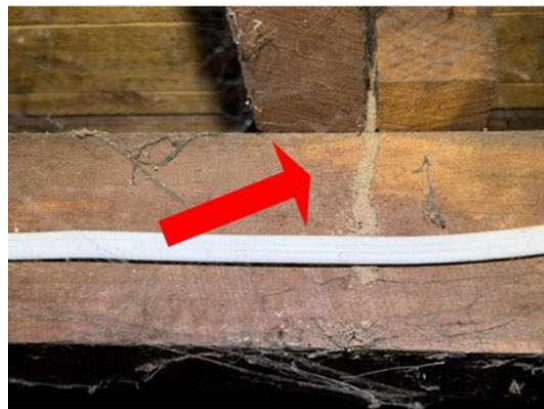
Building:	Main Building
Location:	Subfloor, Door frames, Kitchen & Bedroom Cupboards
Finding:	Evidence of termite workings & damage
Information:	Although no live termite activity was identified at the time of inspection, previous termite damage & workings were identified at, but not limited to, areas throughout the subfloor, rear trees, shed framing, beneath kitchen sink, bedroom cupboards and several door frames throughout the building.

The client should engage a licensed pest controller promptly, to provide further advice regarding installation of a termite treatment. A more invasive inspection, conducted by a licensed tradesperson, is also advised to identify the extent of the damage. 6 monthly ongoing termite inspections, conducted by a qualified termite inspector, are also recommended

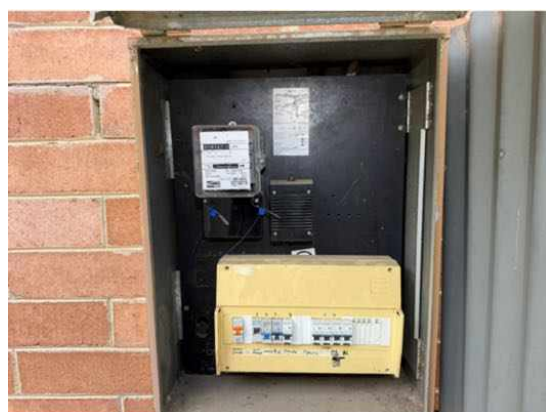
Building:	Main Building
Location:	Switchboard
Finding:	Termite Management System - no evidence of a chemical installation
Information:	The application of a termite barrier is strongly recommended, as it appears no termite management system has been installed, with no evidence or durable notice to suggest works taking place. Generally, a durable notice is placed in the meter box to indicate current termite barriers.

Such barriers are highly effective in preventing termite attack on the building and therefore should be installed.

Recommend seeking further advice from a licensed pest controller.

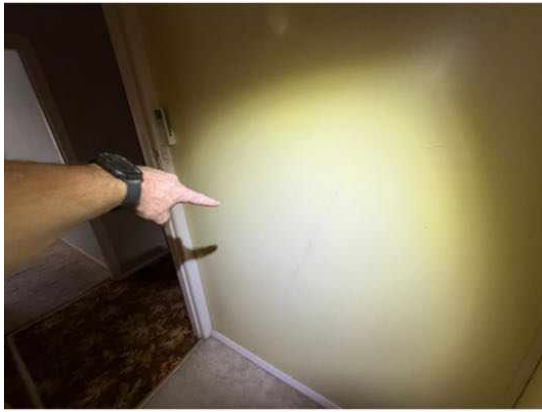
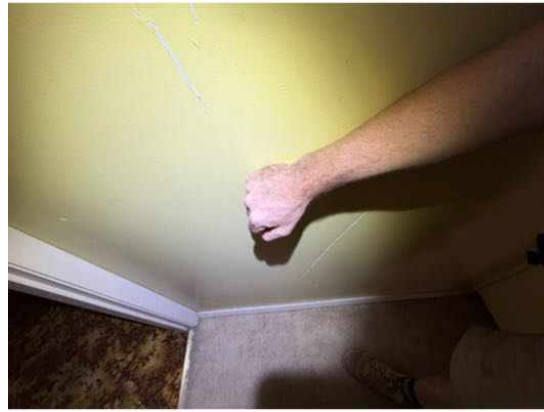
### Finding 6.02

Building:	Main Building
Location:	Bedroom, Lounge
Finding:	Audible Indications of Potential Termite Damage
Information:	It appears areas of audible droppings in the wall cavities were identified at, but not limited to the lounge room & bedroom walls. This may be an indicator of potential termite damage in the wall cavity. Therefore, a more invasive inspection conducted by a licensed tradesperson is recommended to confirm, and identify the extent of the damage.

Should termite damage be confirmed, a registered builder should then be engaged to replace any affected building materials.

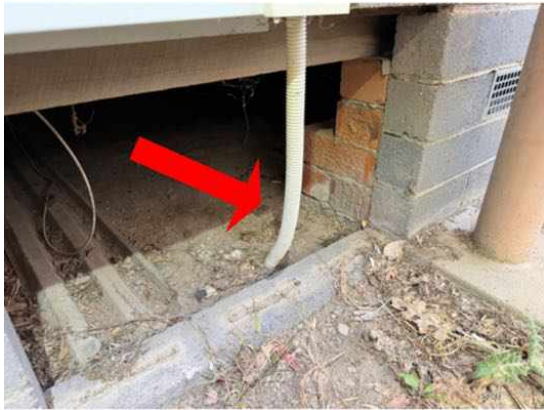
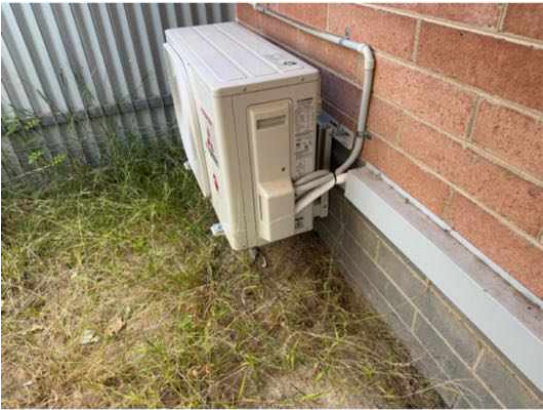
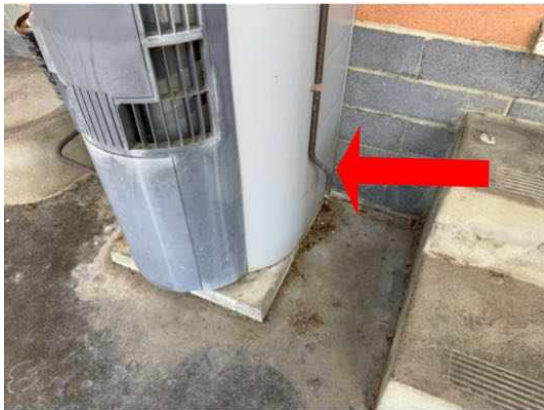
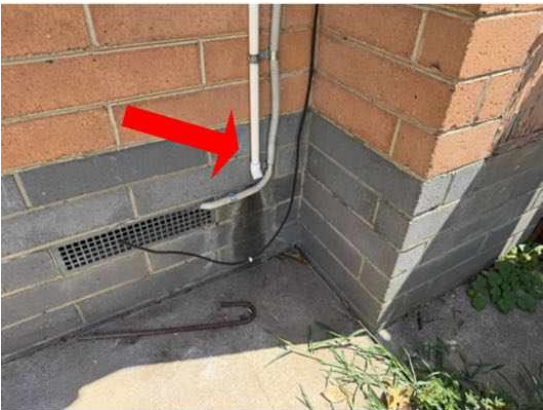
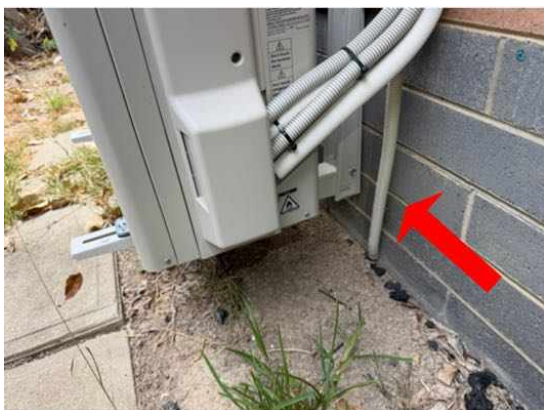
Where insufficient drainage of taps, hot water system & aircon overflows, and garden beds against the house are present, water pooling is likely to occur, and can create areas conducive to timber pests and potential damage to the subfloor structure overtime, if neglected.

Recommend consulting with a licensed plumber in the short term to further assess and provide remedial advice.

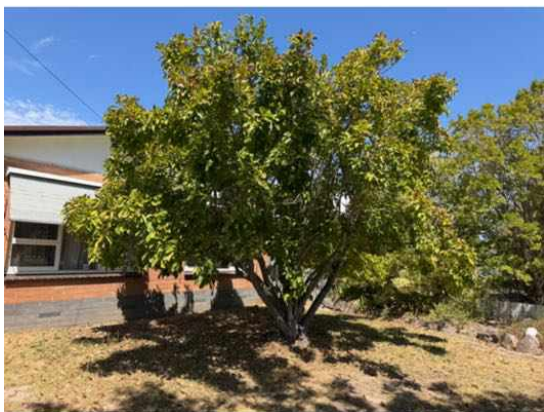
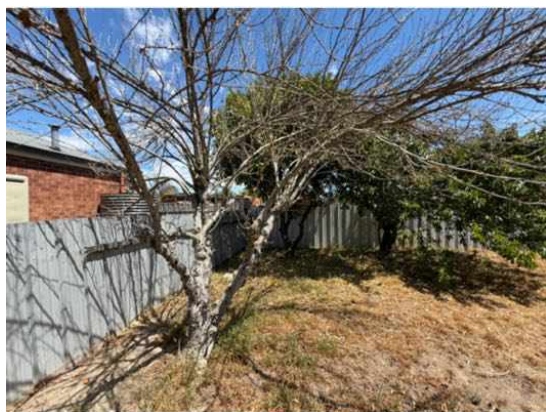
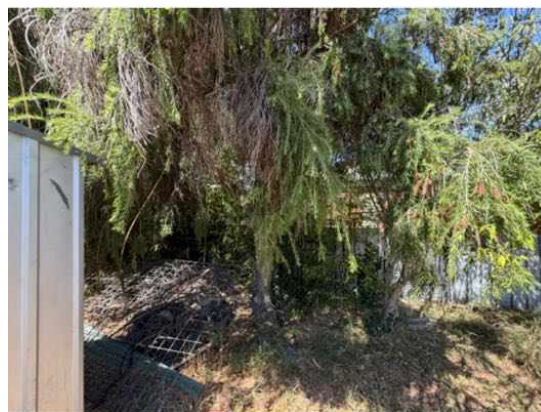
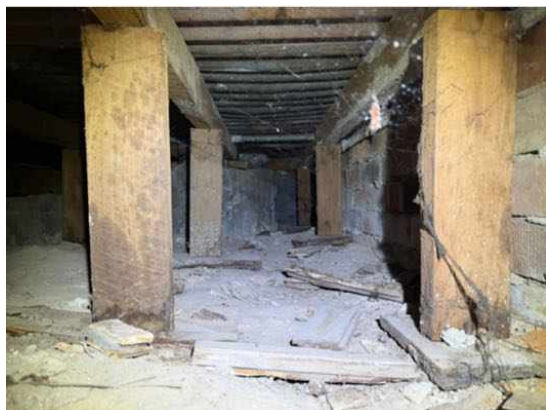
### Finding 6.05

Building:	Main Building
Location:	All External Areas
Finding:	Timber in direct ground contact & trees - conducive to termites
Information:	Where timber materials are in direct contact with the ground and consequently moisture, they become conducive to termite activity. The timber debris in the subfloor, landscaping timbers, shed framing, and trees surrounding the building create an environment conducive to termite infestation.

Where feasible, any timbers in direct contact with the ground should be removed and any trees in close proximity to the building should be removed or test drilled (inspected) at least annually to reduce the risk of termite infestation & detect any early signs of termite activity.

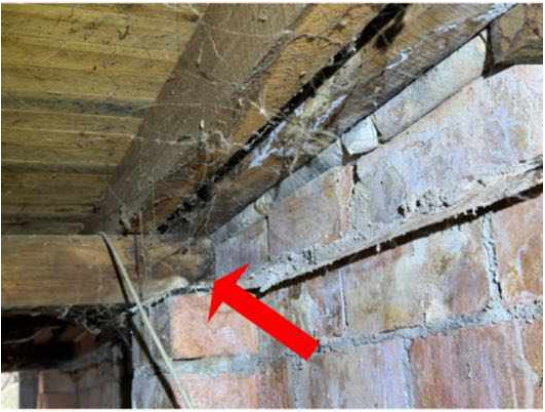
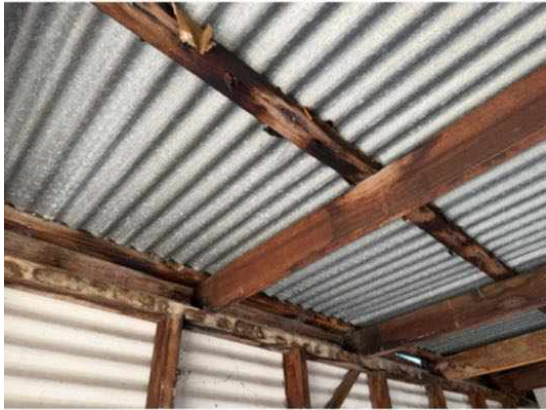
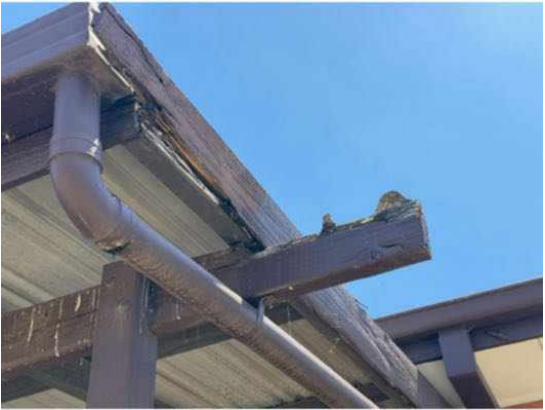
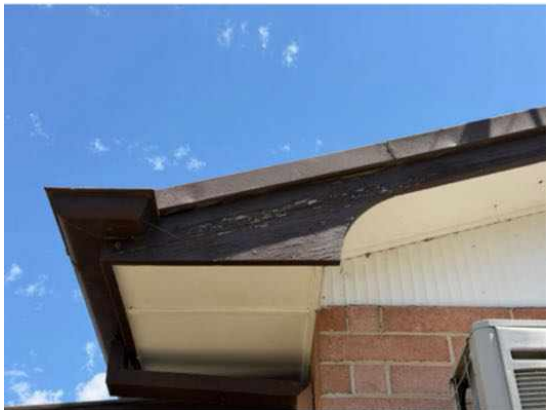
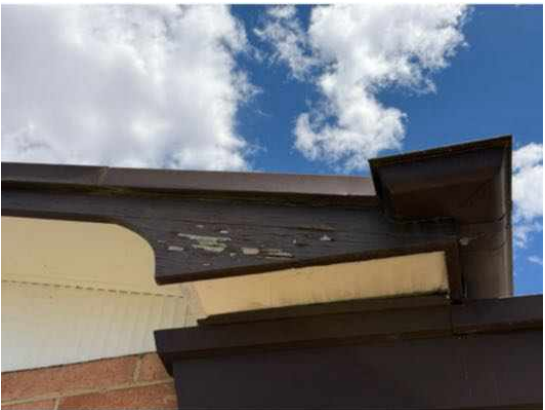
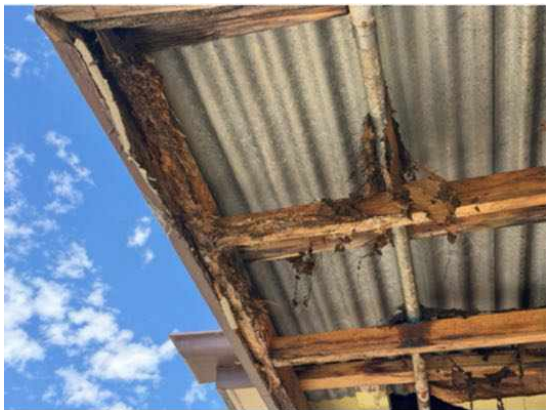
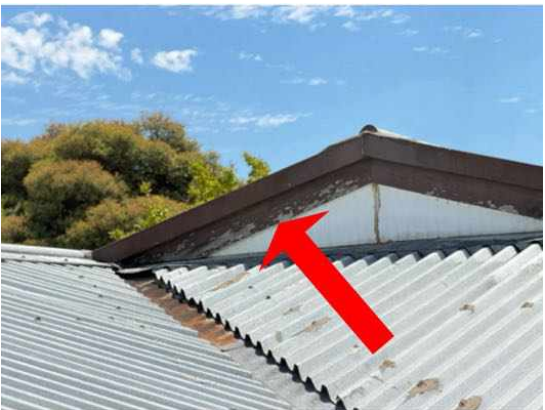
### Finding 7.01

Building:	Main Building
Location:	Subfloor beneath bathroom, Shed Framing, Fascia's, Verandah Framing
Finding:	Fungal decay & weathering
Information:	Areas of fungal decay (wood rot) were identified at but not limited to the subfloor timber's beneath the bathroom, fascias, verandah framing and shed framing.

For areas of fungal decay, the client can engage a licensed carpenter at their discretion to replace affected materials. For areas of general weathering, it is advised the client engage a licensed painter to apply protective sealant or coating to areas of weathered external timbers.

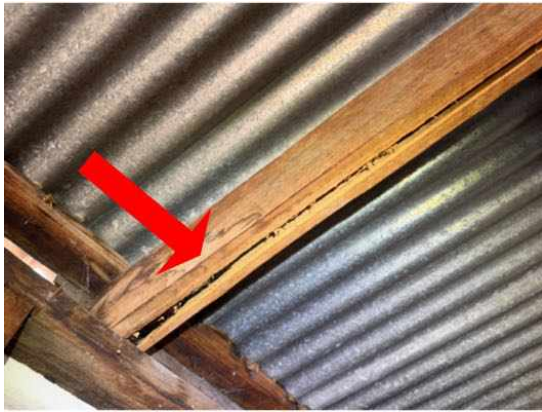
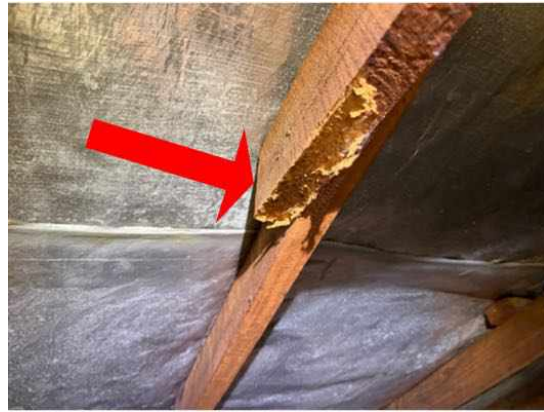
### Finding 8.01

Building:	Main Building
Location:	Shed & Roof Framing
Finding:	Evidence of wood borer damage identified (powder-post)
Information:	Evidence of previous Lyctus Borer (powder-post beetle) damage was identified at but not limited to a rafter in the roof void and areas of the shed framing. As no live wood borer activity was identified treatment is not required.

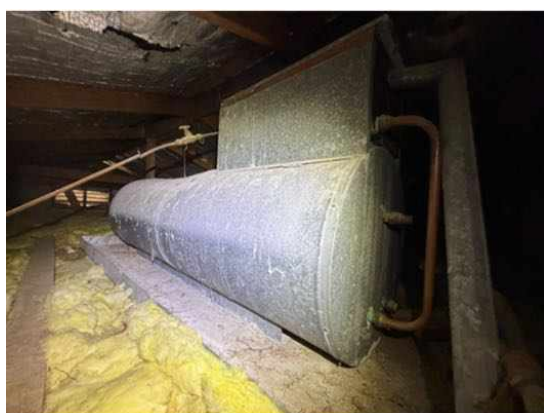
Despite this plumbing system being unused, it may contain residual water. If neglected, rust of the system overtime, may lead to residual water leaking.

Recommend that the client either monitor the condition of the system or get the system drained by a licensed plumber to prevent any potential future leaks.
