Building and Timber Pest Inspection Report

Inspection Date: Fri, 20 Feb 2026

Property Address: 3 St Albans Rd, Kingsgrove NSW 2208,
Australia

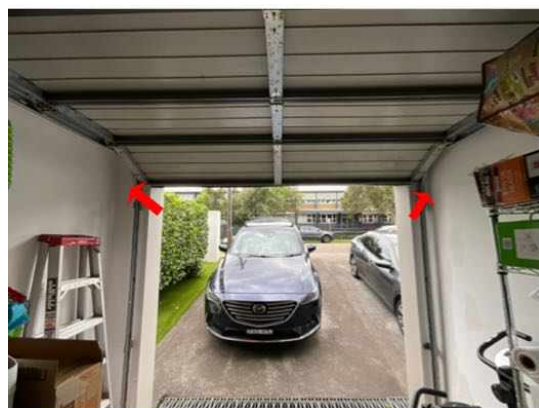
Finding 2.01

Building: Main Building
 Location: Garage
 Finding: Damp - Rain penetration
 Information: Rain penetration (also known as penetrating damp) is a common form of dampness that can occur through walls, roofs or openings (e.g. windows).

Common causes include faulty or missing flashing, lack of sealant, lateral damp and failed waterproofing membrane.

The cause of the water leak should be addressed to prevent further damage. It is recommended that the water leak be resolved prior to any repairs of the damaged area, which may require localised replacement of building materials and refinishing.

I recommend appointing a builder to see what necessary works are required.

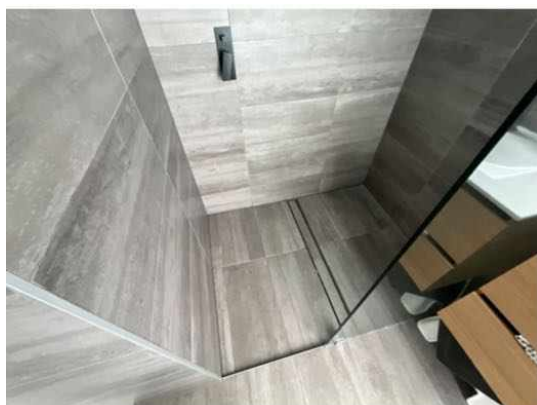
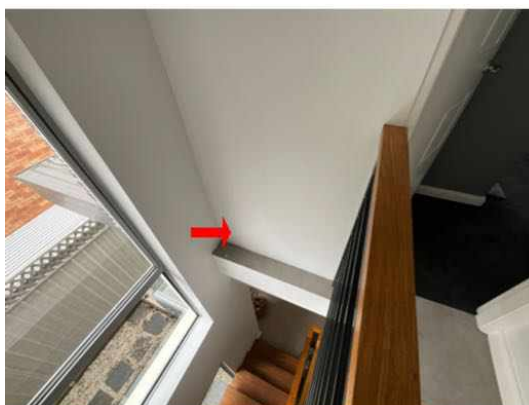
Finding 2.02

Building: Main Building
 Location: Ensuite
 Finding: Shower - Damp
 Information: Damp is evident to the lower 300mm of wall to the shower alcove. This defect is quite common, and is suspected to have been caused by moisture permeating through the grouting in this area, which shows evidence of deterioration.

Damp (or structural damp) refers to the presence of unwanted moisture in the structure of a building, either as the result of intrusion from outside, or condensation from within the structure. In the shower area, internal water leaks or other sources of excessive moisture are generally the cause of damp.

Consultation with a qualified plumber or bathroom specialist is advised to identify the cause of damp and to perform remedial works as required.

Always ensure that sealant and grout is in good condition to prevent any moisture issues occurring in the future.

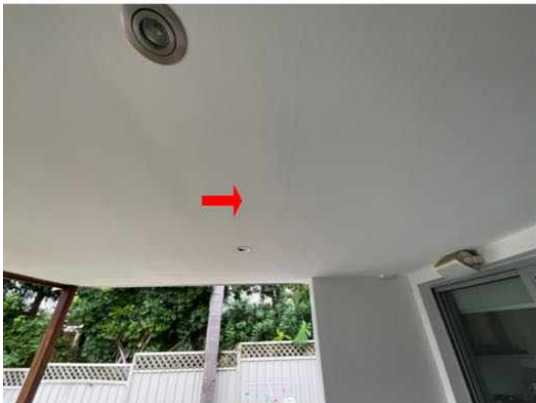
Finding 3.01

Building:	Main Building
Location:	External Areas
Finding:	Cracking - Damage Category 1 - Fine (up to 1mm)
Information:	Although fine cracks are quite noticeable, they are often only considered to be an appearance defect, and usually do not indicate any structural damage. Generally, the cause of a fine crack is indicative of a separation between building materials and finishes (e.g. paint, plaster, etc.) along joins.

Cracking of this nature can generally be repaired with minor sanding, filling and/or repainting. Such works should be performed by a qualified painter or a general handyman.

Monitoring of all cracking should be conducted frequently. Always contact a building inspector should cracks widen, lengthen, or become more numerous.

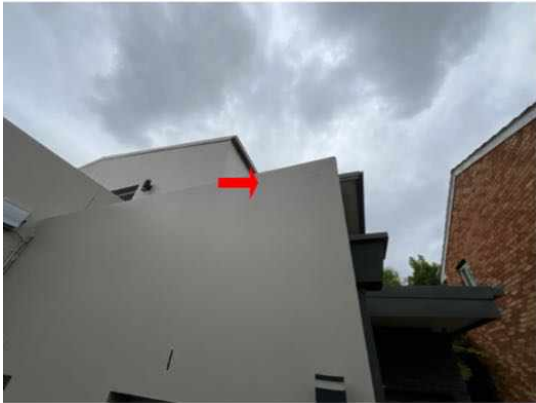
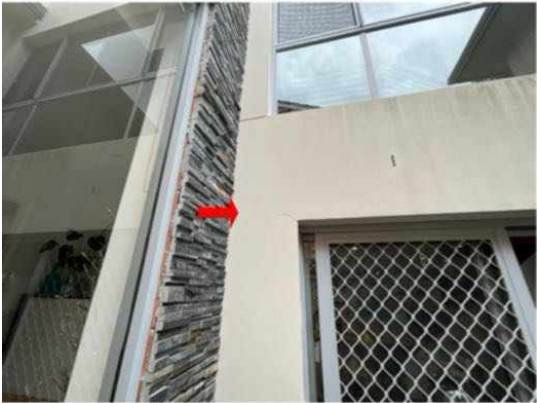
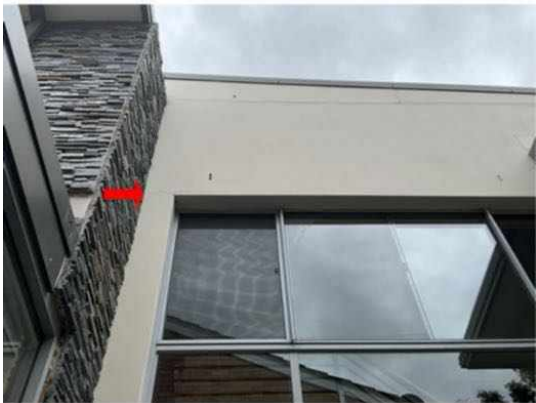
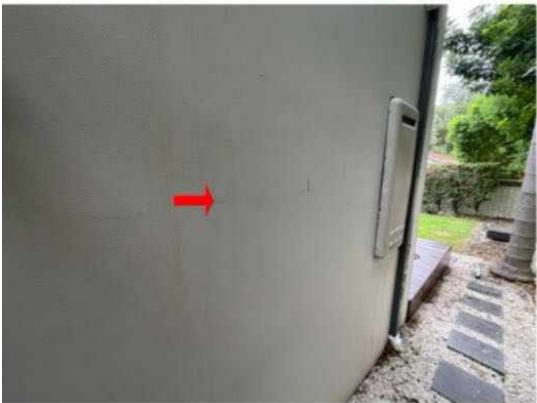
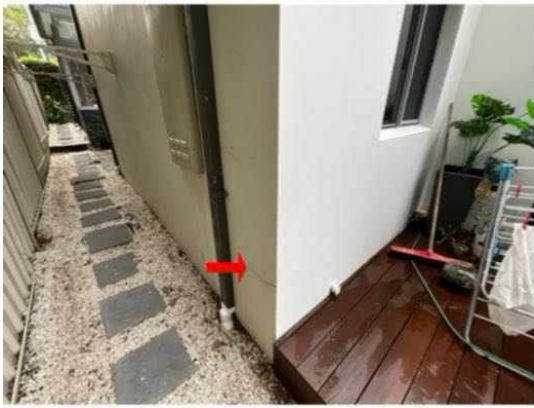
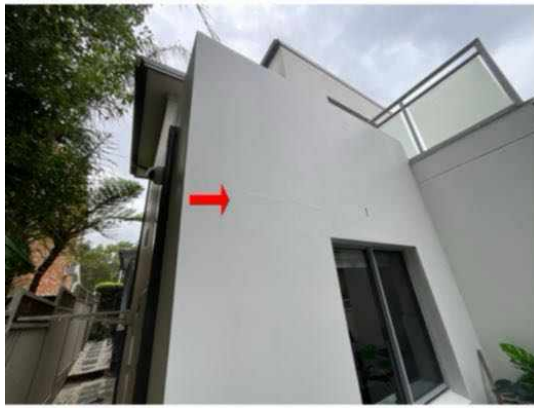
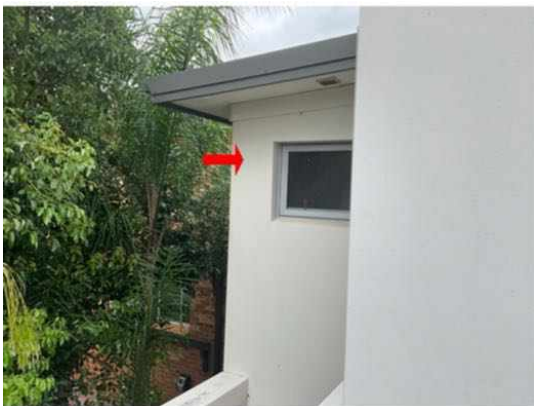
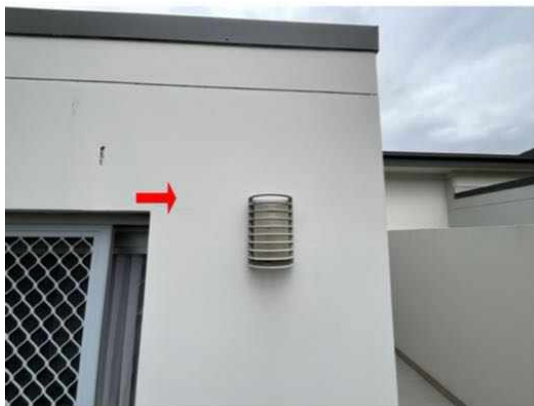
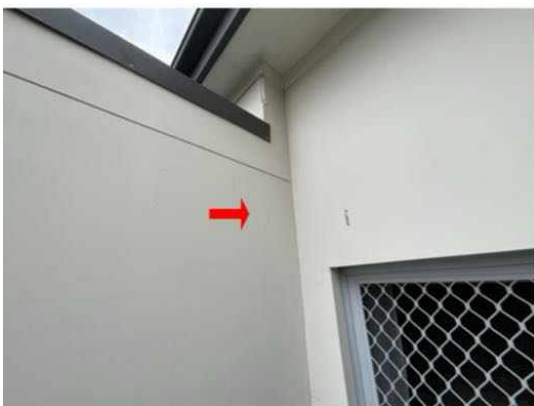
Finding 3.02

Building: Main Building
 Location: Exterior walls
 Finding: Cracking - Damage Category 2 - Noticeable (up to 5mm)
 Information: Noticeable cracks are a common occurrence as a result of many primary defects. Such causes may include age, general wear and tear, expected building movement, general expansion/contraction of building materials in different weather conditions, and/or minor failings in the installation or application of building materials.

I recommend monitoring and if further cracking is evident appoint a bricklayer to see what works are required.

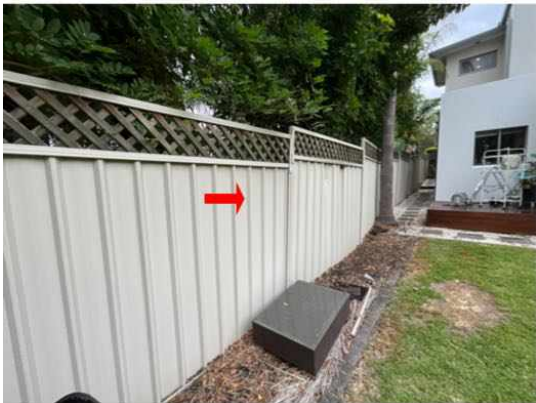
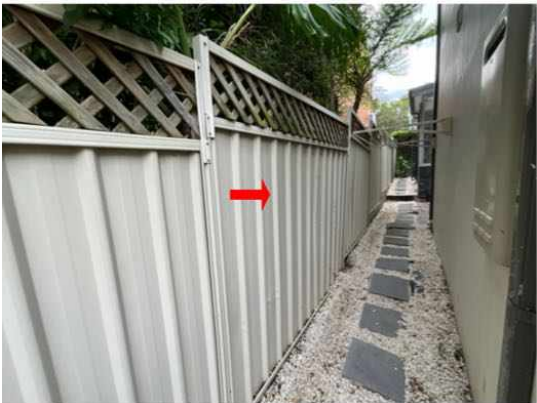
Finding 3.03

Building: Yard
Location: Fencing
Finding: Fencing - Leaning
Information: It was noted at the time of inspection that sections of the fencing in this area are leaning.

A licensed fencing contractor should be appointed to provide further advice and perform rectification works as necessary.

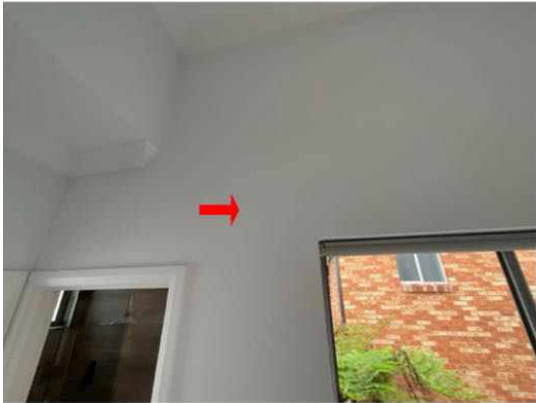
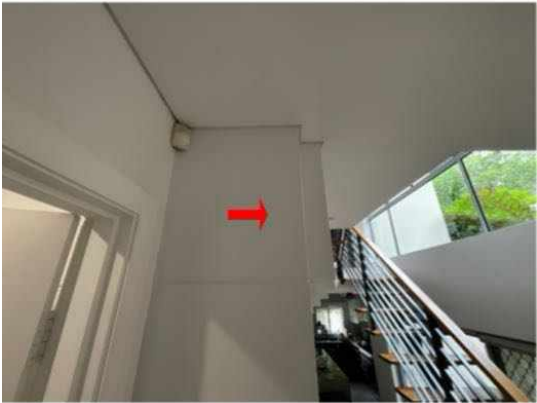
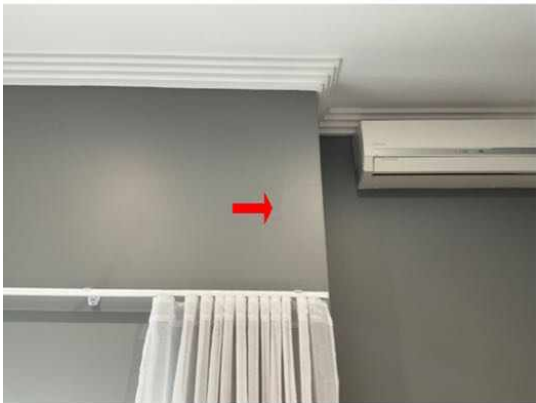
Finding 3.04

Building: Main Building
Location: Internal Areas
Finding: Cracking - Damage Category 2 - Noticeable (up to 5mm)
Information: Noticeable cracks are a common occurrence as a result of many primary defects. Such causes may include age, general wear and tear, expected building movement, general expansion/contraction of building materials in different weather conditions, and/or minor failings in the installation or application of building materials.

I recommend monitoring and if further cracking is evident appoint a bricklayer to see what works are required.

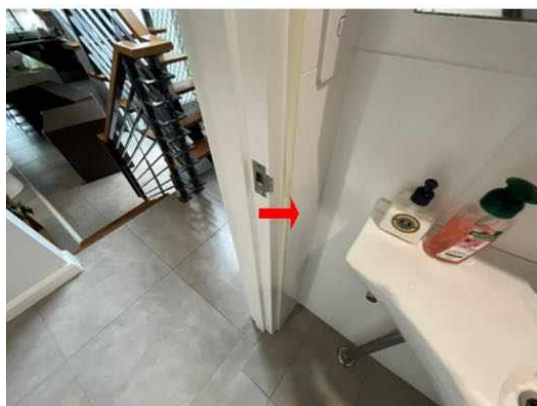
Finding 3.05

Building:	Main Building
Location:	Toilet (WC)
Finding:	Tile - Cracked or damaged
Information:	Cracking was evident to the tiling in this area at the time of inspection.

I recommend appointing a tiling contractor to see what necessary works are required to replace any damaged tiles.

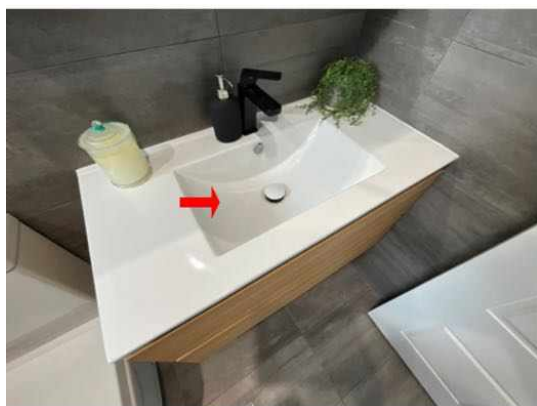
Finding 3.06

Building:	Main Building
Location:	Bathroom
Finding:	Basin - Cracked
Information:	Cracking was evident to the basin at the time of inspection, which is suspected to have been by minor impact damage. While the cracking appears to be minor, any further impact damage sustained by the basin may lead to additional cracking.

As the cracking provides potential ingress for water, secondary water damage may occur to associated cabinetry, walls or flooring, if the cracking is left unmanaged.

Consultation with a plumber regarding basin repair or replacement is required. Remedial works may be required to protect against any further damage.

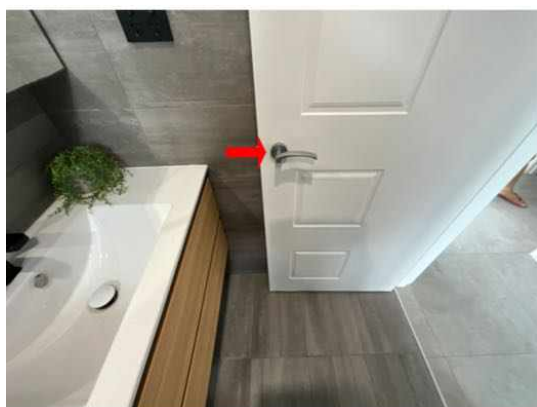
Finding 3.07

Building:	Main Building
Location:	Bathroom
Finding:	Fitting or fixture - Loose (Door Handle)
Information:	The fitting in this area is loose and requires adjustment to tighten.

If left unmanaged, the fitting may further deteriorate, causing potential for the development of other minor secondary defects.

A relevant tradesperson should be appointed to perform these rectification works at discretion of the client.

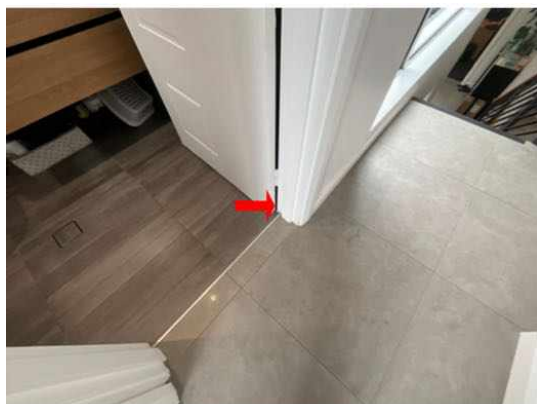
Finding 3.08

Building:	Main Building
Location:	Bathroom
Finding:	Rusting to Bathroom Door Frame
Information:	Rust was observed to the bathroom door frame.

The corrosion may be due to ongoing moisture exposure, potentially related to waterproofing issues within the bathroom, or may be the result of inadequate surface preparation prior to painting. Continued moisture exposure could lead to further deterioration.

Monitor the area for any signs of active moisture or worsening corrosion. If deterioration progresses or dampness becomes evident, further investigation into the bathroom waterproofing should be undertaken.

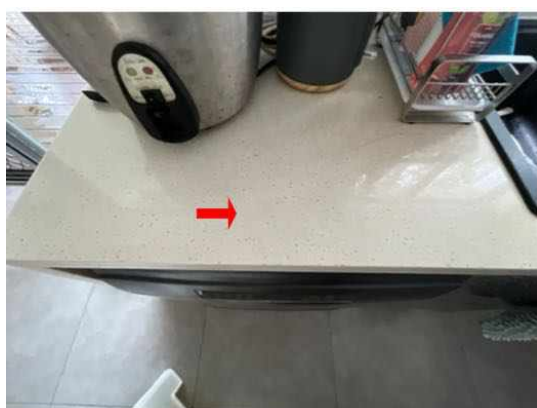
Finding 3.09

Building:	Main Building
Location:	Kitchen
Finding:	Crack to Kitchen Bench
Information:	A crack was observed on the kitchen bench surface.

The crack may worsen over time and could allow moisture ingress, potentially leading to further deterioration of the benchtop material.

A stone or cabinetry specialist should assess the crack and carry out repairs as required. Replacement may be necessary if the damage is significant.

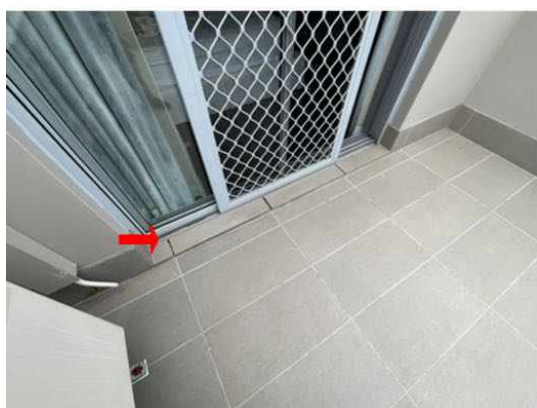
Finding 3.10

Building:	Main Building
Location:	Balcony
Finding:	Aluminium Door Frame Drainage Holes Installed Below External Linings

Information: The aluminium door frame drainage holes were observed to be positioned below the external wall linings. This installation detail prevents proper drainage of water from the frame and may allow moisture to become trapped behind the wall cladding.

Incorrect placement of drainage holes can lead to water ingress, damage to internal finishes, and deterioration of wall framing or cladding materials over time. The configuration also does not comply with standard installation practices for weep or drainage hole positioning.

A licensed builder or window installer should be engaged to assess the installation and modify the frame or surrounding linings to ensure the drainage holes discharge externally and clear of wall finishes. Works should be completed in accordance with manufacturer specifications and relevant building standards.

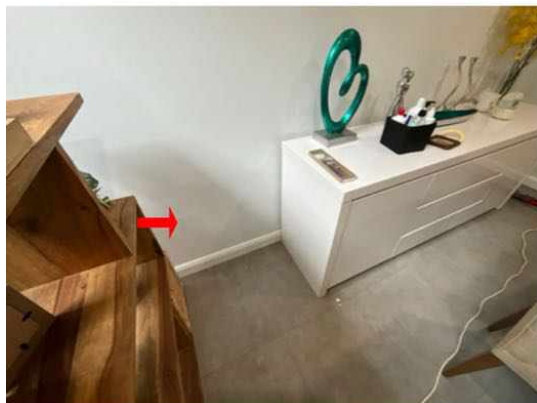
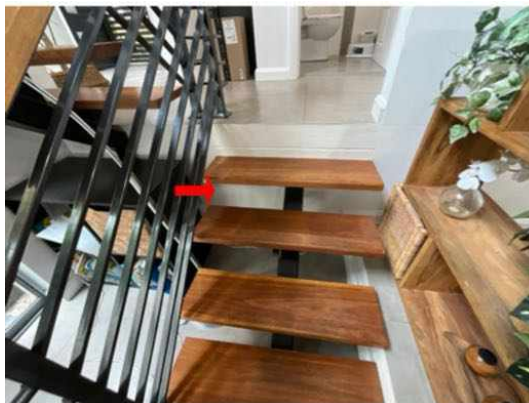
Finding 3.11

Location: Lounge Room

Finding: Interior walls - Lateral damp

Information: Lateral penetrating damp refers to the sideways movement of moisture. The implications of unmanaged damp range from mould fungi growth, wood rot and decaying building materials, to finishes including lifting, bubbling, peeling and staining of paint, plaster and wallpaper.

Structural waterproofing barriers or tanking barriers are often used to protect internal surfaces against the affects of lateral penetrating dampness. These types of work are generally undertaken where the source of the penetrating damp cannot be prevented.

Consultation with a damp proofing contractor is advised to address the cause of the damp and to perform remedial works as necessary.

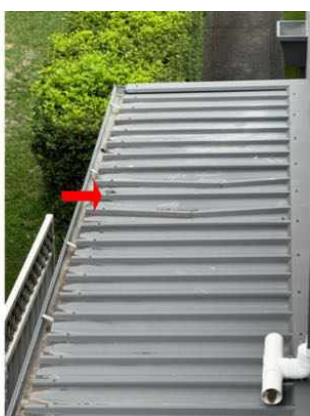
Finding 3.12

Location: Roof Exterior

Finding: Roof sheets - Deteriorated

Information: Upon inspection of the exterior roofing, it was found that the roof sheets show signs of deterioration, with some sheets having come loose from their original fixing. The roofing has sustained an array of issues due to the age of the materials and a lack of general maintenance over time, including loose sheeting, lifting and sagging of sheets, and deterioration of associated building elements.

Loose, deteriorated and damaged roof sheets are susceptible to water penetration, exposing the surrounding associated area to internal roof leaks and water damage.

Re-fixing of all loose roof sheets should be conducted to ensure that no further damage occurs. Depending on the extent of the damage, replacement of sections of roof sheets or associated materials may be required. Engagement of a roofing restoration contractor is highly advised to perform remedial works as necessary.

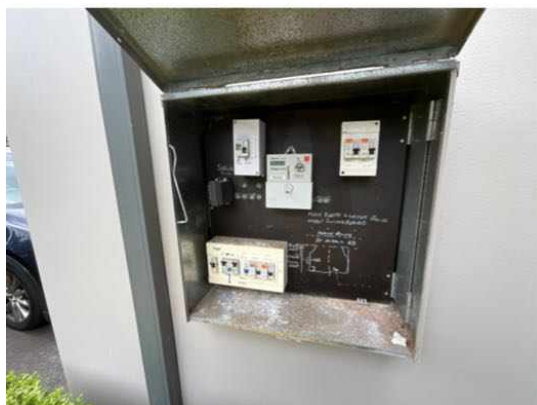
Finding 6.01

Building:	Main Building
Location:	All Areas
Finding:	Termite Management System - no evidence of a chemical installation
Information:	The application of a post-construction chemical termite barrier is highly recommended for all properties, particularly if live termite activity has been found on the site previously. Such barriers are highly effective in preventing termite attack on any timber building elements throughout the property.

A durable notice should be placed in the switchboard unit to indicate current termite barriers. At the time of inspection, it appeared as though no termite management system has been installed, with no evidence to suggest preventative works taking place.

The client may consider gaining further advice from a pest controller as to the costs and procedures involved with this application. It is recommended that obtaining such advice be a short-term priority.
