Building and Timber Pest Inspection Report

Inspection Date: Mon, 2 Mar 2026

Property Address: 33 Edward St, Corowa NSW 2646, Australia

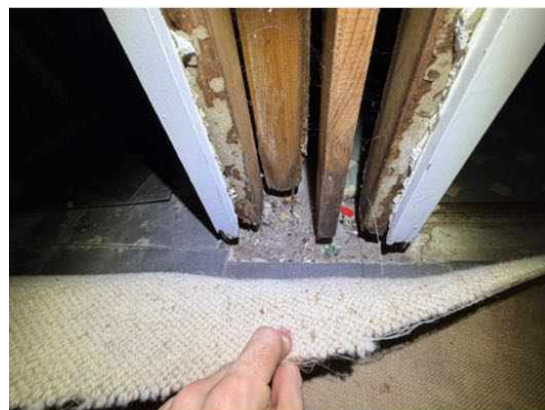
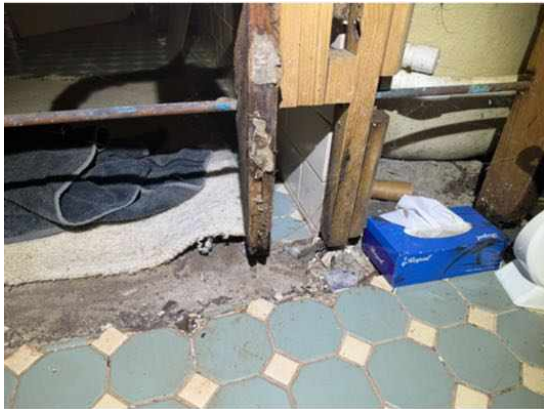
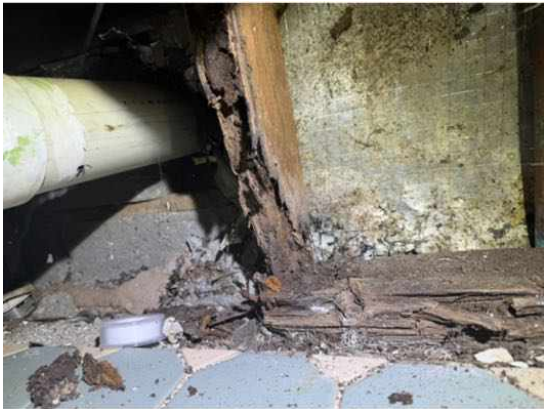
Finding 2.01

Building: Main Building
Location: Bathroom, Bedroom & Toilet Framing
Finding: Decayed & Unsupported Framing
Information: It was found that the framing at, but not limited to the bathroom, toilet and bedroom wall framing have been affected by fungal decay (wood rot) and areas of the framing are unsupported. This has likely been caused by a previous shower leak.

A registered builder is required promptly, to replace any affected structural materials, to avoid the development of secondary building defects.

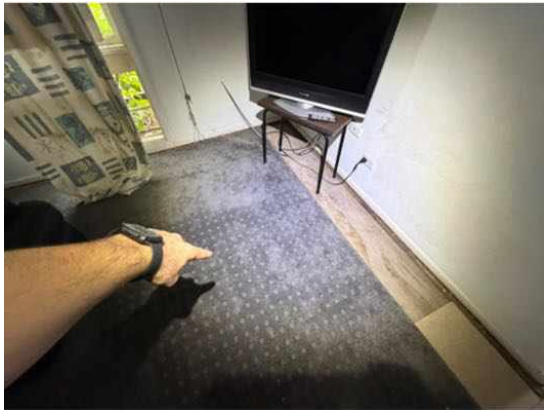
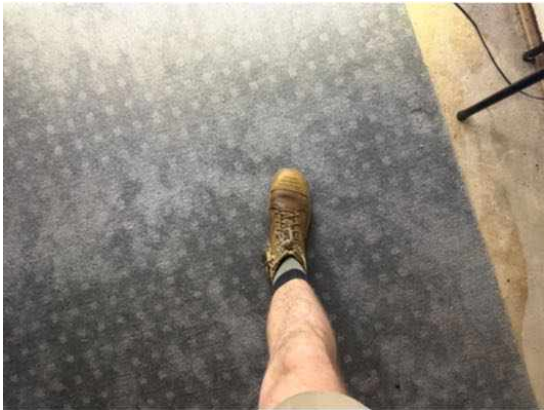
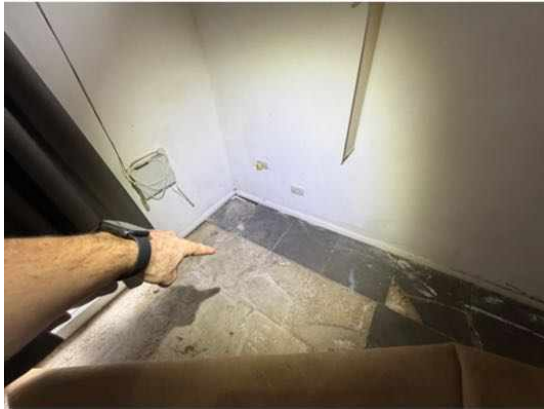
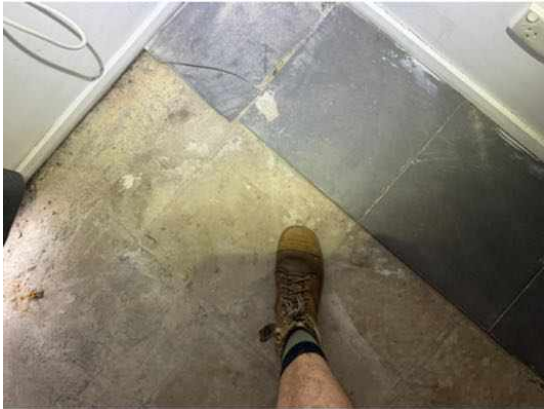
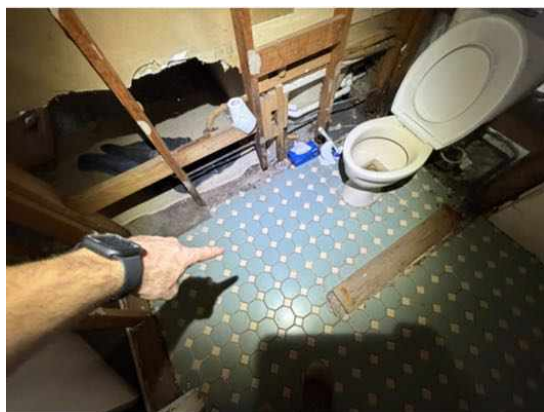
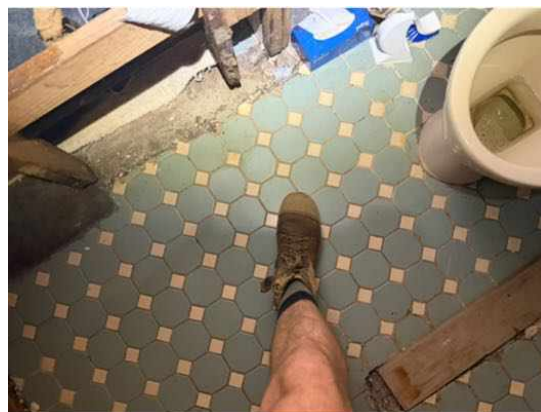
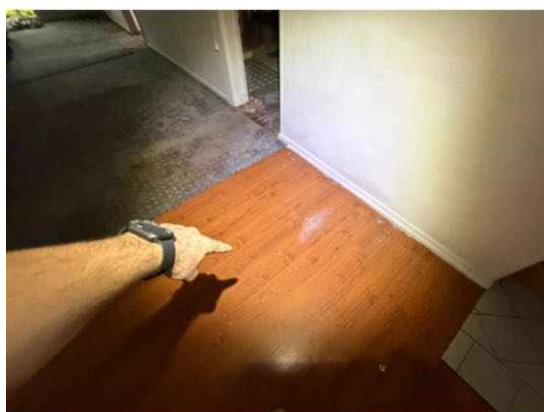
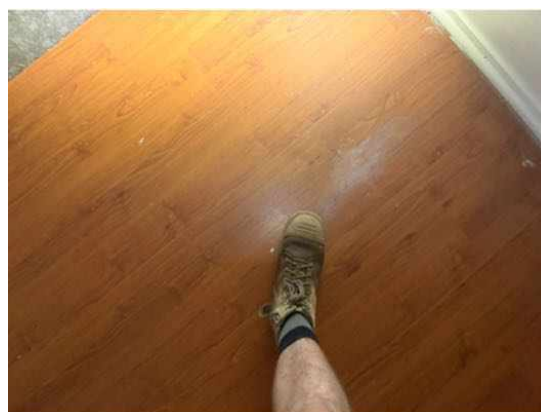
Finding 3.01

Building: Main Building
Location: All Internal Areas
Finding: Flooring - Uneven
Information: It appears that several areas of the flooring throughout the building appear to be uneven, indicating potential movement of the concrete slab and foundations of the building. It is advised that the client consult with a structural engineer at their earliest convenience, to provide further advice & remedial works where necessary.

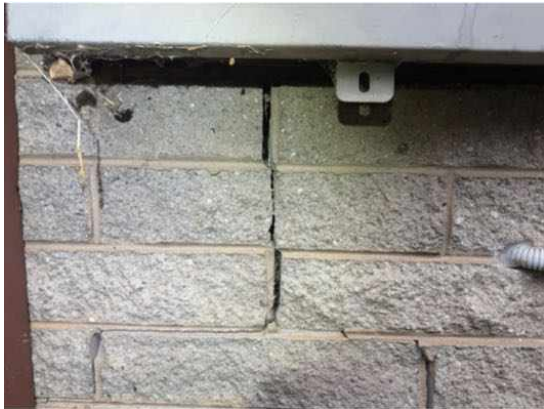
Finding 3.02

Building:	Main Building
Location:	All External Areas
Finding:	Brickwork & Plaster - Cracking, Movement
Information:	Cracking was identified to areas of the brickwork & plaster at the time of inspection. Gaps between the window frames and brickwork was also identified, indicating movement. Cracking has a variety of possible causes. However, the most common is movement of adjacent footings.

It is advised that the client consult with a structural engineer in the short term, to provide further advice regarding areas of cracking and movement. In the interim, these areas should be monitored to identify any further movement.

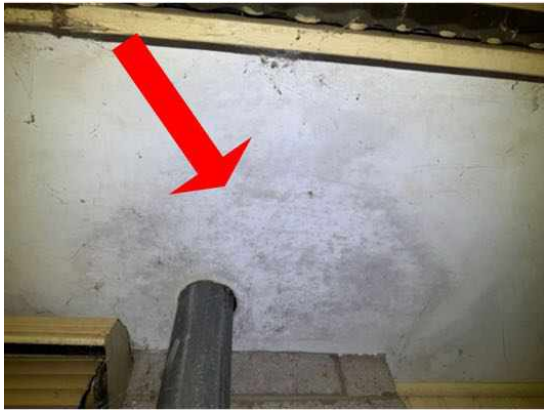
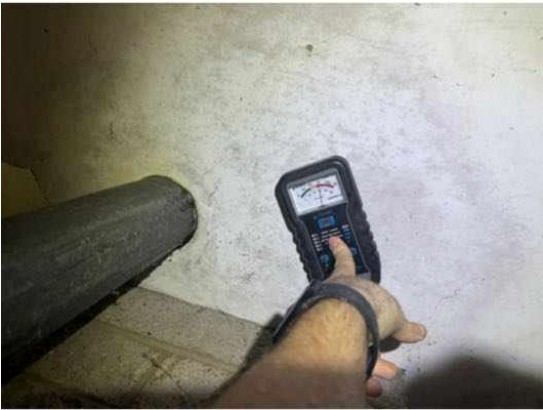
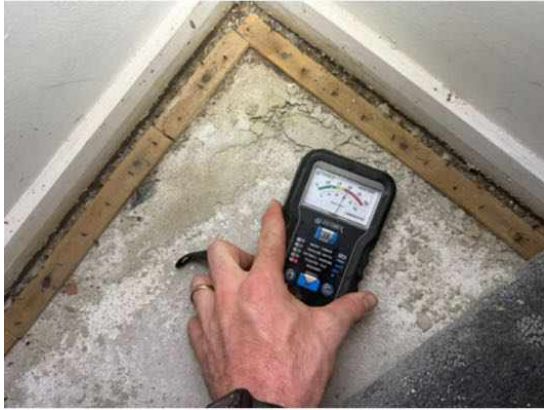
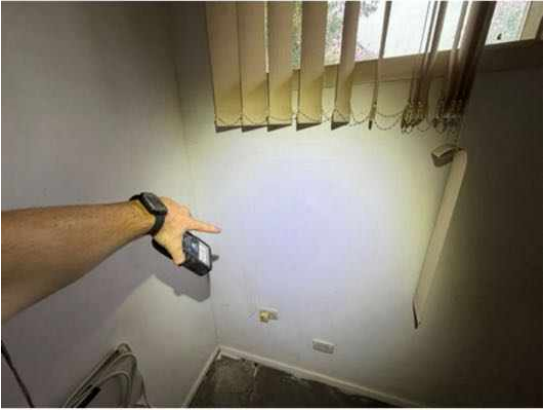
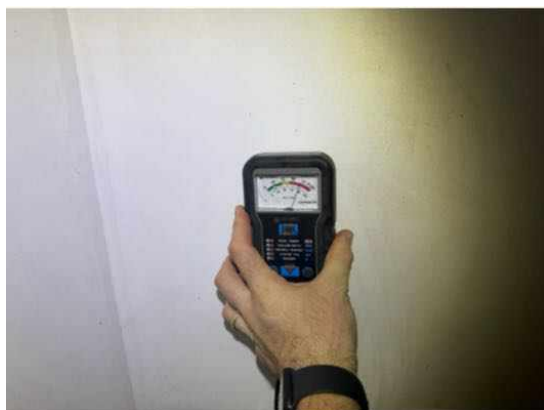
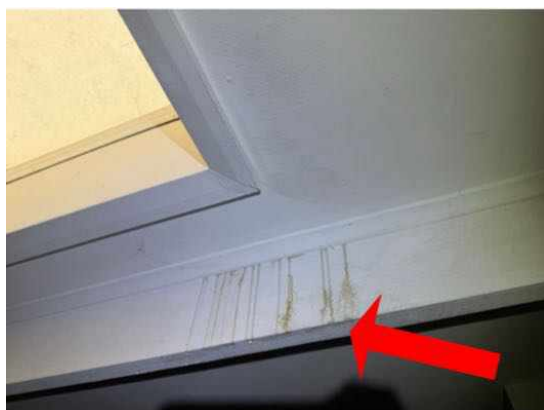
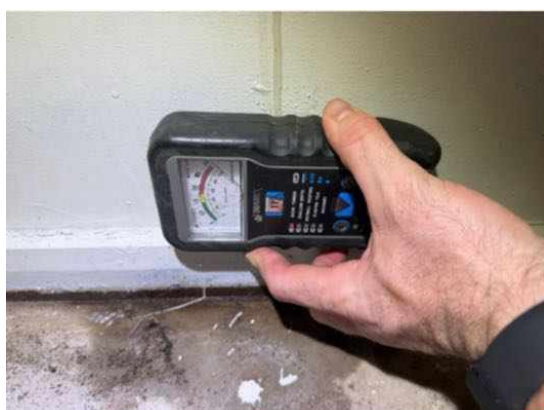
Finding 3.03

Building: Main Building
Location: Bedrooms, Lounge Room, Extension Wall, Rear Eave
Finding: Walls & Floor - Leaking & High Moisture
Information: High moisture and areas of leaking were identified at, but not limited to bedroom walls, lounge room & bedroom slab, extension wall, and rear eaves. Potential causes of leaking include damaged plumbing fittings and fixtures, or deterioration of the roof plumbing.

This creates an environment conducive to termite activity, and water damage to surrounding materials.

Recommend engaging a licensed roof plumber and/or roofing contractor promptly to provide remedial works.

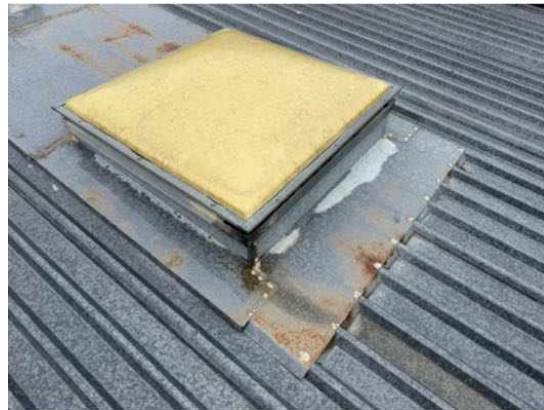
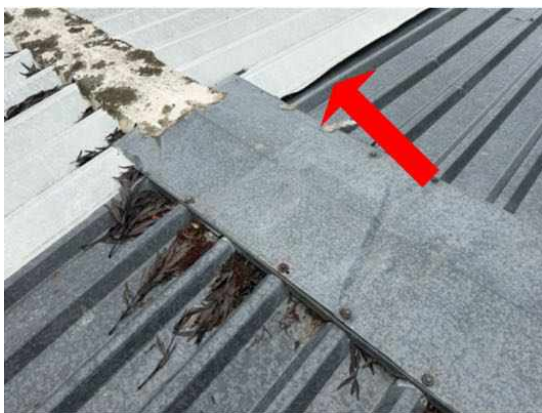
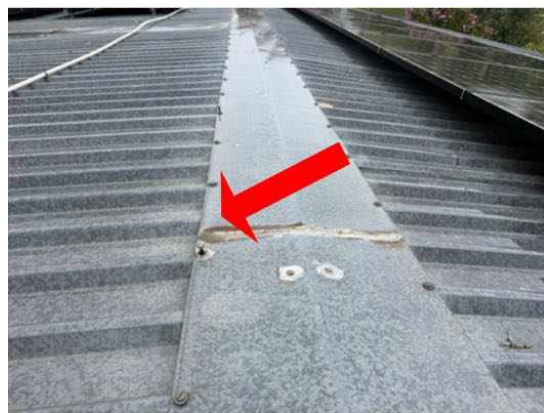
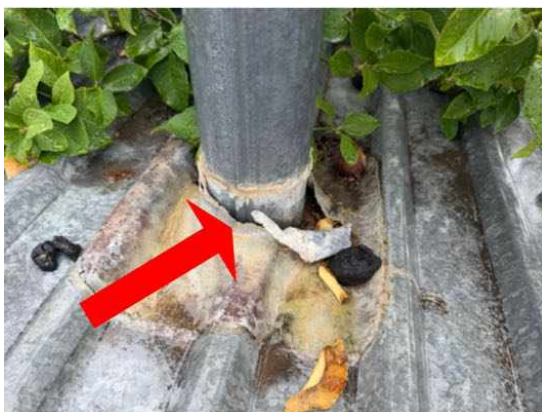
Finding 3.04

Building:	Main Building
Location:	Roof Exterior
Finding:	Roof Exterior & Flashings - Weathered, Rust & Loose
Information:	The roof exterior was found to be in a weathered condition at the time of inspection evidenced by loose screws, weathered/deteriorated flashings, and areas of rust. While weathering of the roof exterior is consistent with the age of the property, remedial works are required.

Where left unmanaged, deteriorating and damaged roof sheeting and plumbing is likely to lead to secondary defects, including water leaks.

A licensed roofing contractor should be engaged promptly, to provide further advice and remedial work's where necessary.

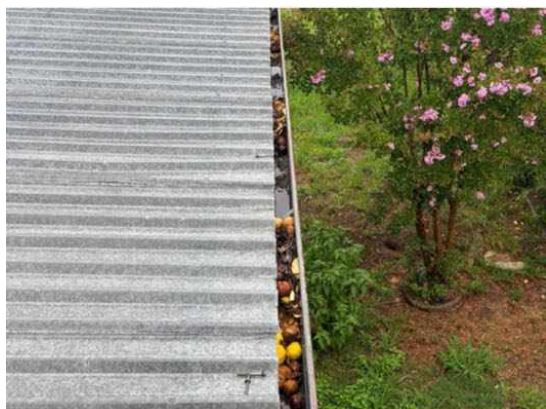
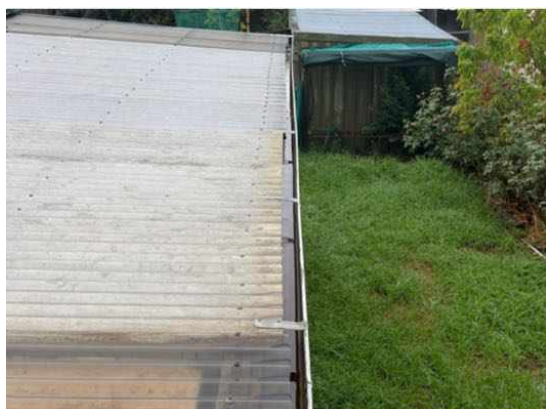
Finding 3.05

Building:	Main Building
Location:	Guttering
Finding:	Roof Plumbing - Insufficient & Debris/Water pooling
Information:	Water pooling and debris were noted in sections of the guttering at the time of inspection, likely due to sagging or blockages. It appears there is also insufficient roof plumbing installed. Water pooling can lead to deterioration of the roof plumbing over time, if neglected.

A licensed roof plumber should be engaged in the short term, to provide further advice & remedial works to ensure adequate roof drainage is achieved. All debris should be cleared promptly to ensure proper drainage and prevent overflows.

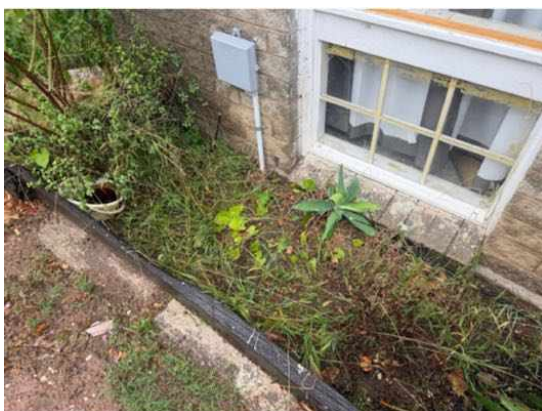
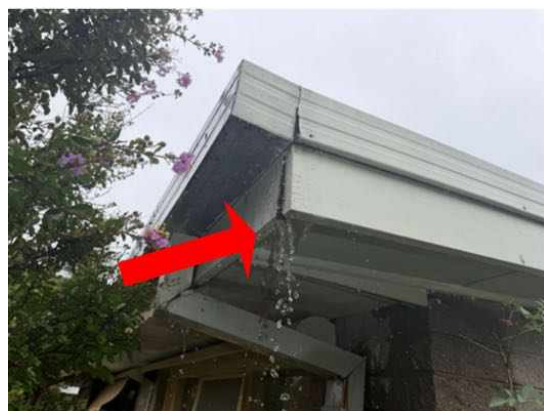
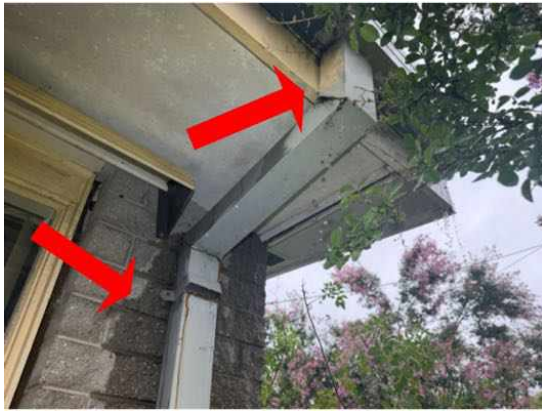
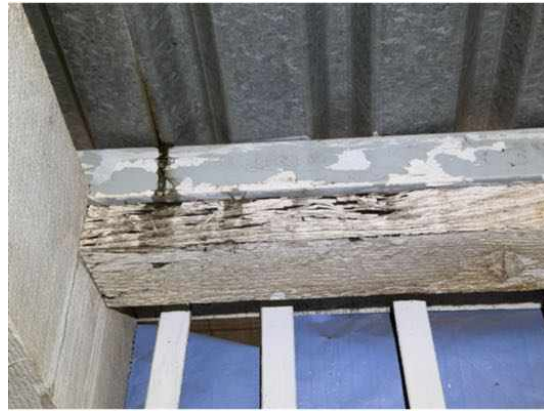
Finding 6.02

Building:	Main Building
Location:	All external areas, Roof Plumbing
Finding:	Water pooling against property & Leaking Roof Plumbing
Information:	Potential areas of water pooling around the perimeter of the property were identified. Leaking gutters, tanks and down-pipes were also noted.

Where insufficient drainage of taps, hot water system & aircon overflows, and garden beds against the house are present, water pooling is likely to occur, and can create areas conducive to timber pests & water damage to surrounding materials.

Recommend consulting with a licensed plumber and/or landscaping contractor promptly, to provide further advice & remedial works.

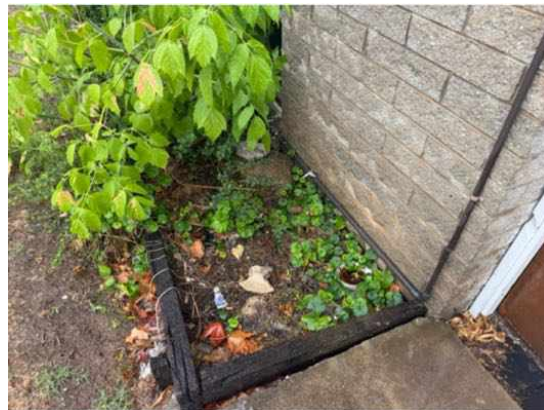
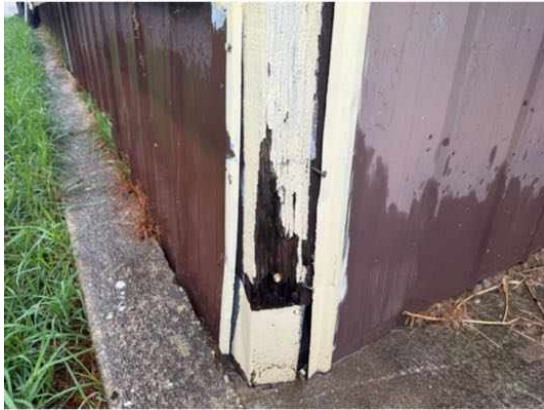
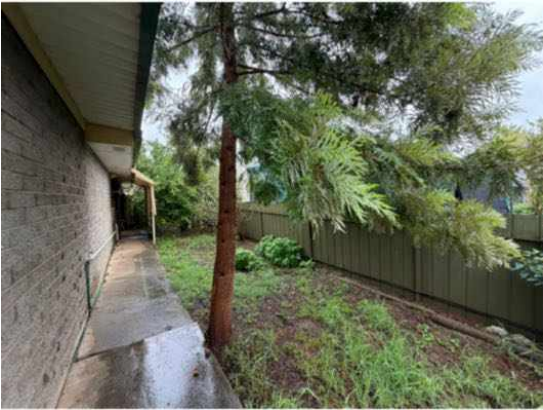
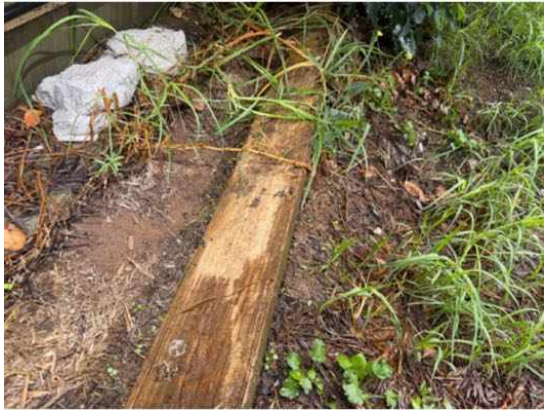
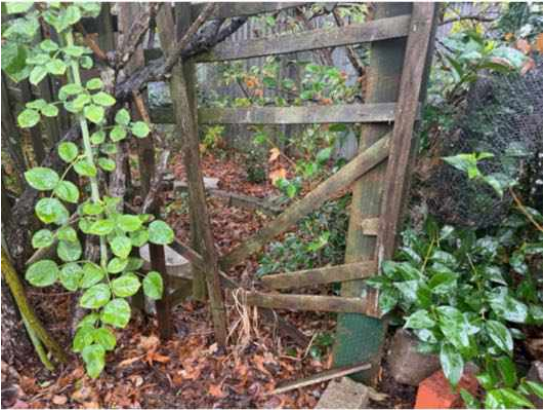
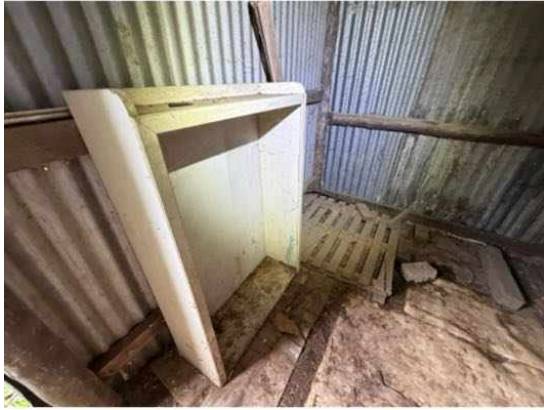
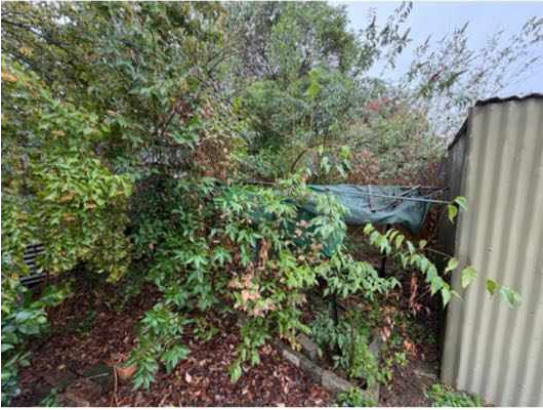
Finding 6.03

Building:	Main Building
Location:	All External Areas
Finding:	Timber in direct ground contact & trees - conducive to termites
Information:	Where timber materials are in direct contact with the ground and consequently moisture, they become conducive to termite activity. The tree stumps, landscaping timbers, and trees surrounding the building create an environment conducive to termite infestation.

Where feasible, any timbers in direct contact with the ground should be removed and any trees in close proximity to the building should be removed or test drilled (inspected) at least annually to reduce the risk of termite infestation & detect any early signs of termite activity.

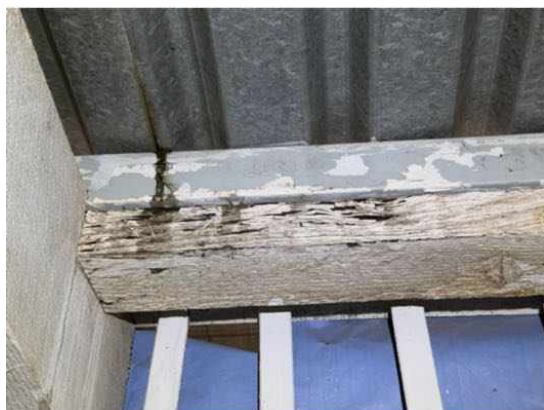
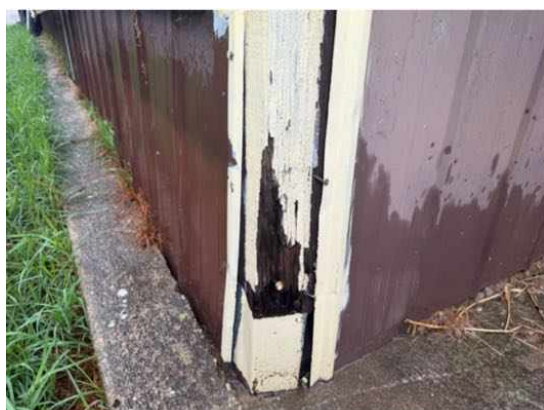
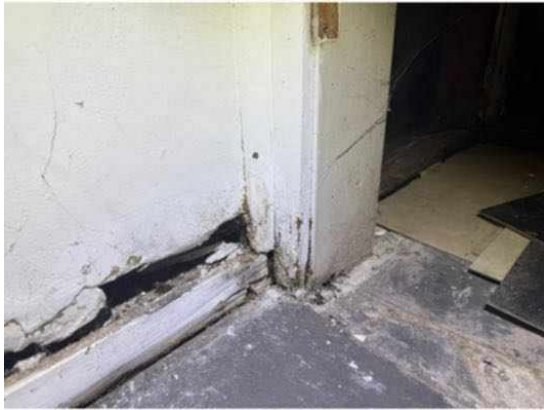
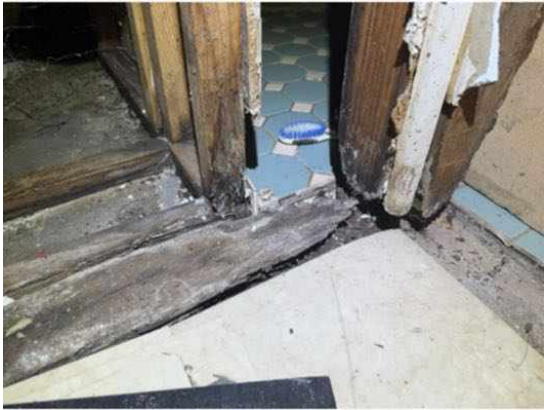
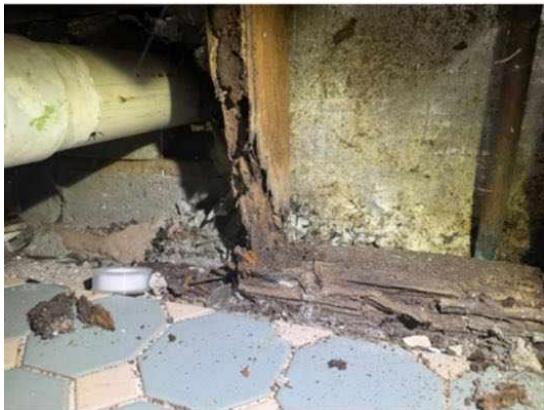
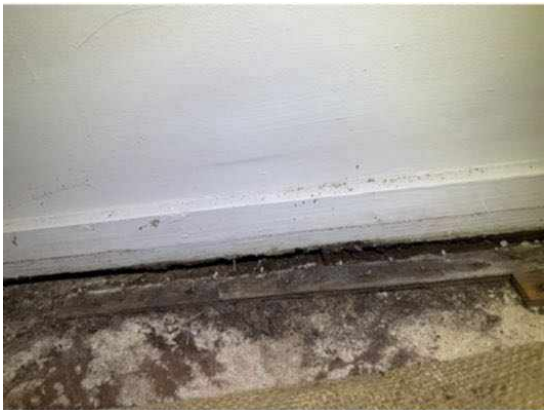
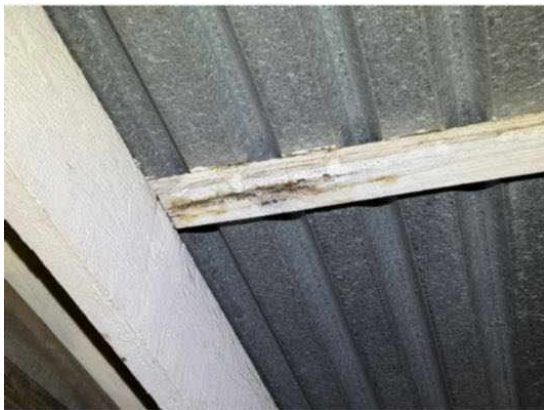
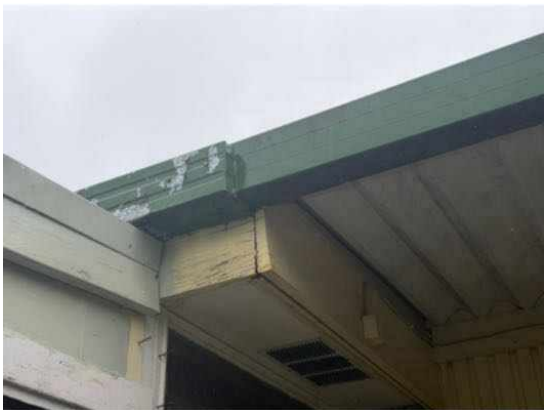
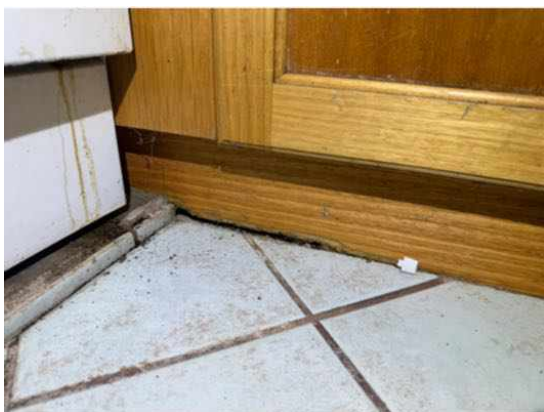
Finding 7.01

Building:	Main Building
Location:	Fascias, Carport Framing, Bathroom & Wall Framing, Skirting, Kitchen Kick board
Finding:	Fungal decay & weathering
Information:	Areas of fungal decay (wood rot) & weathering were identified at but not limited to the fascias, carport framing, bathroom & wall framing, skirting and kitchen kick board.

For areas where structural timbers are affected by wood rot (bathroom, bedroom and toilet framing) a registered builder should be engaged promptly to replace affected materials where necessary.

For areas where fungal decay is superficial, the client can engage a licensed carpenter at their discretion to replace affected materials.

For areas of general weathering, it is advised the client engage a licensed painter to apply protective sealant or coating to areas of weathered external timbers.

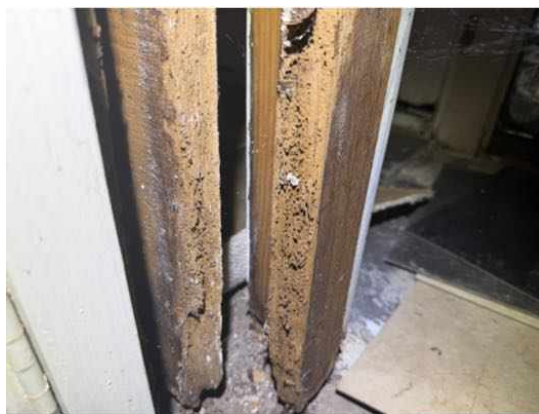
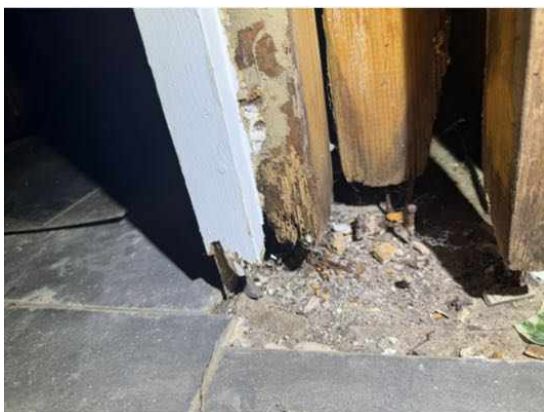
Finding 8.01

Building: Main Building
Location: Bathroom & Toilet Framing
Finding: Evidence of wood borer damage identified
Information: Evidence of previous Lyctus Borer (powder-post beetle) damage was identified at but not limited to, the bathroom & toilet framing.

As no live wood borer activity was identified treatment is not required.

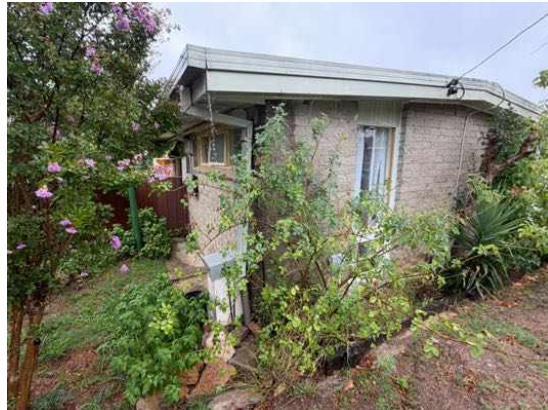
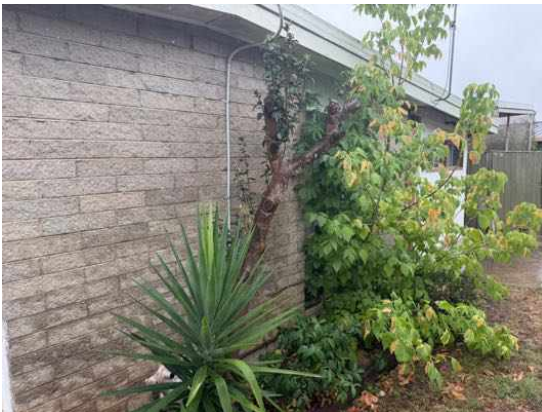
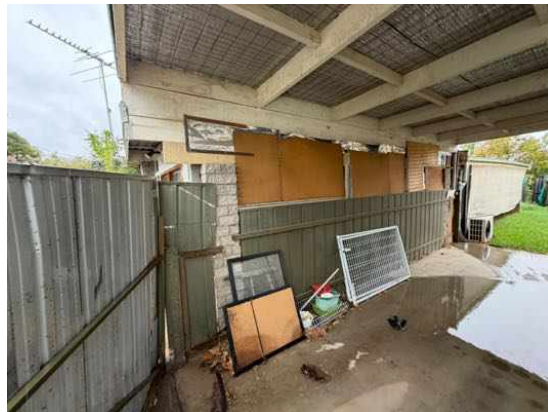
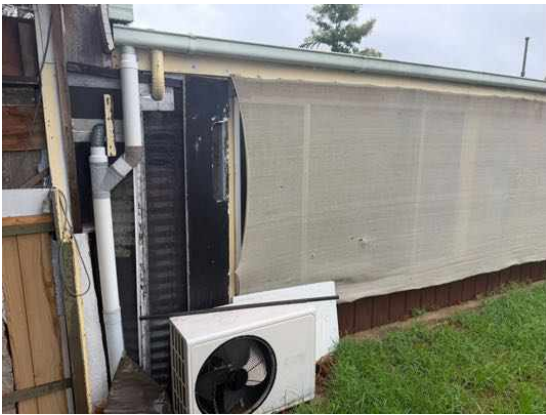
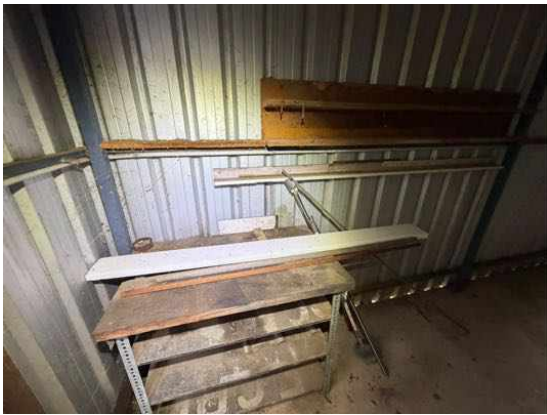
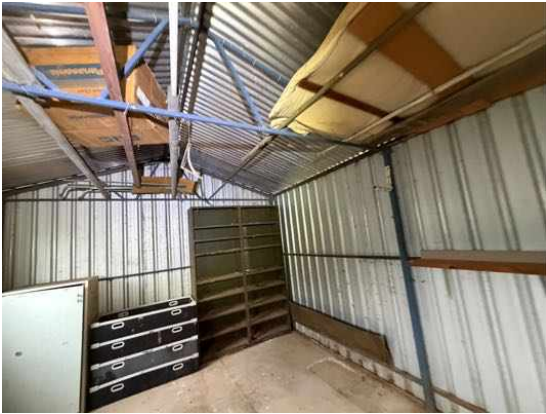
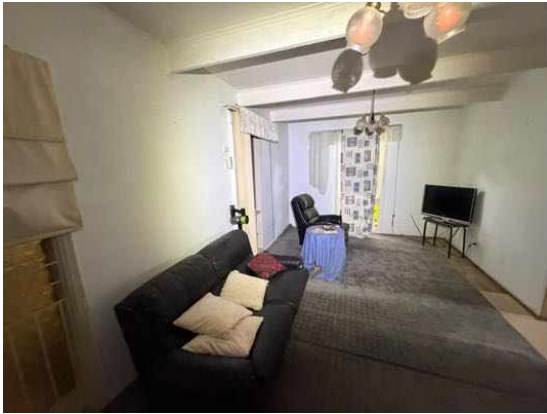
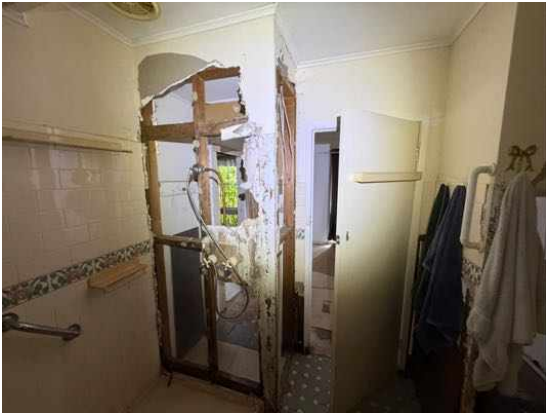
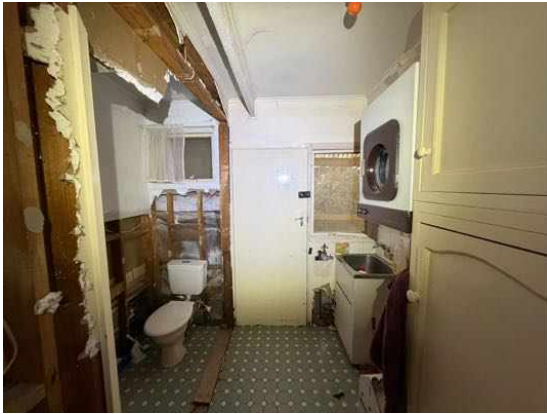
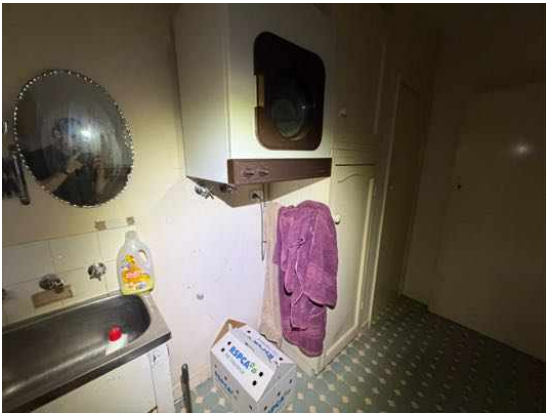
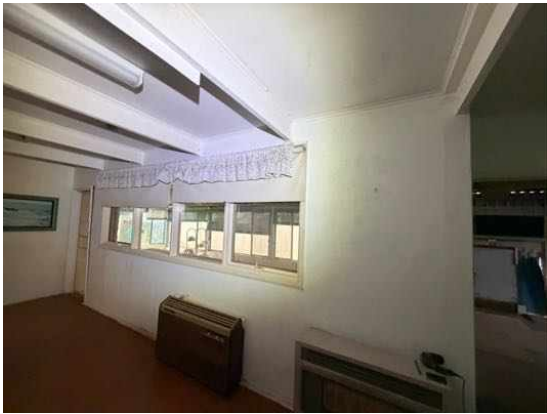
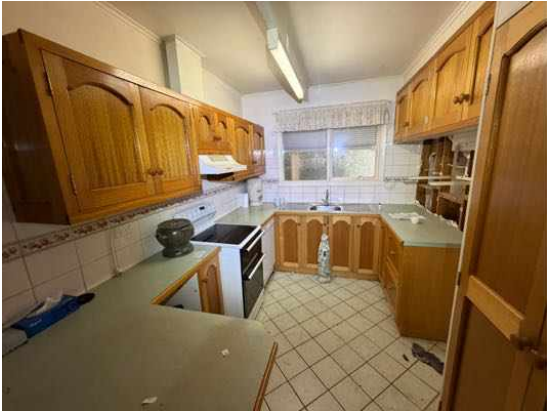
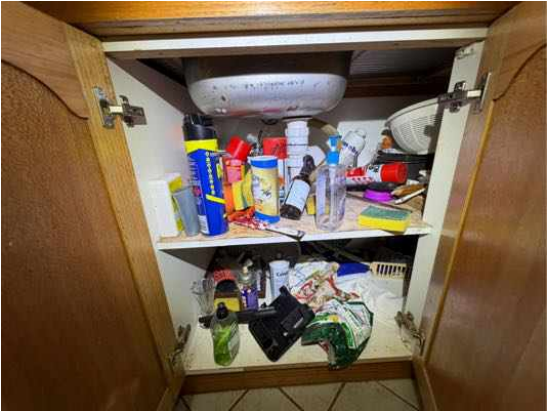
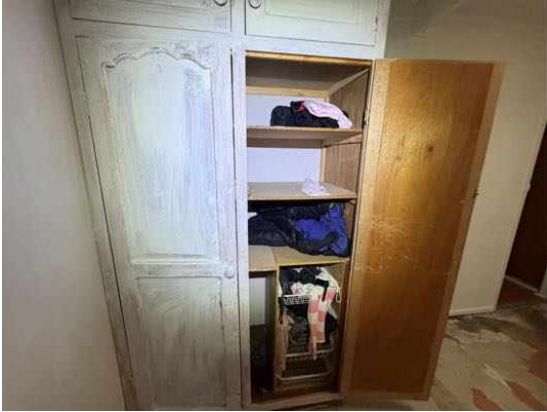
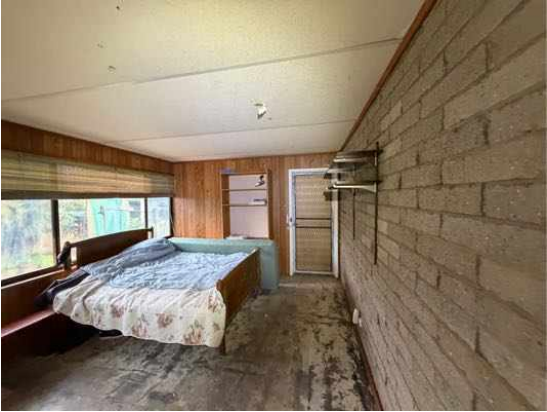
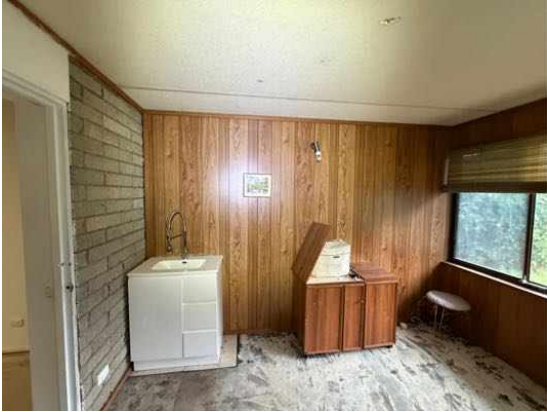
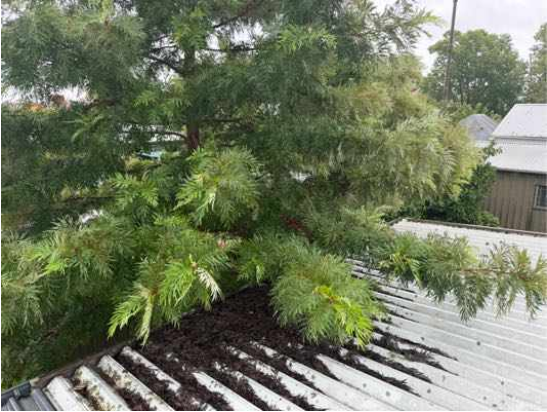
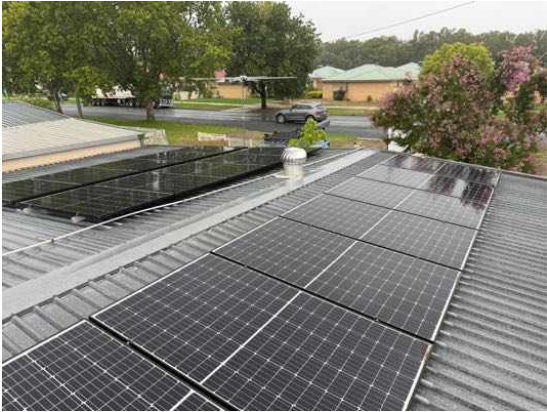
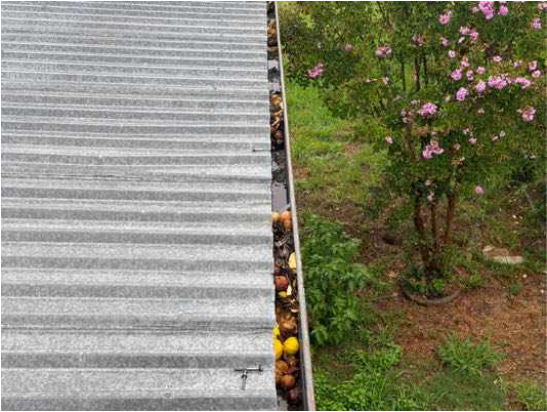
Building: Main Building
Location: All Areas
Finding: Additional Photos - Obstructions and Limitations
Information: These photographs are an indication of the obstructions and limitations which impeded full inspection of the property at the time of inspection. These obstructions can hide an array of defects and should be removed to allow full inspection to be carried out. A re-inspection is recommended once the areas are made accessible.

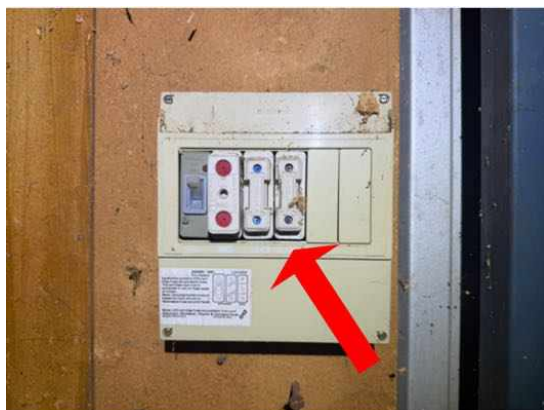
Building: Main Building
 Location: Shed Switchboard
 Finding: Electrical switchboard - Old ceramic fuses
 Information: It was noted that the shed's electrical switchboard has old ceramic fuses in place. It is noted for the clients consideration that a switchboard upgrade may be required. Recommend consulting with a licensed electrician to provide further advice.

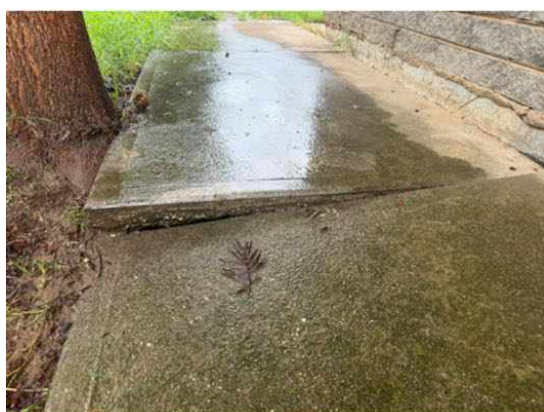
Building: Main Building
 Location: Pavement
 Finding: Cracking & Movement - Pavement
 Information: It was noted there has been cracking & movement in areas of the pavement, likely caused by the nearby tree root system. A licensed concreter can be engaged at clients discretion, to provide remedial works.

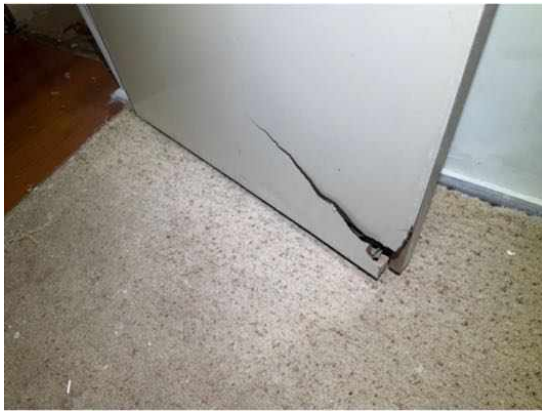
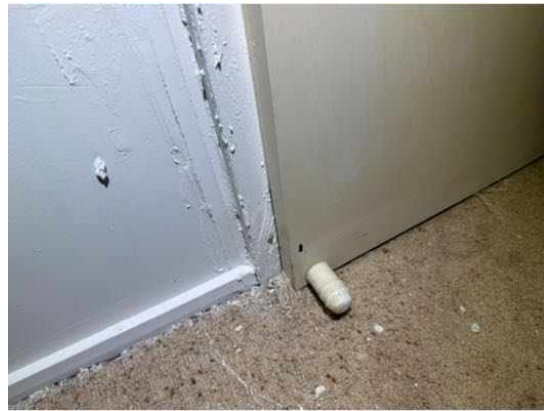
Building: Main Building
 Location: Bedroom Doors
 Finding: Door - Binding & Damaged
 Information: It was noted at the time of inspection that some doors were binding against the door

jamb and damage was noted to areas of the rear bedroom door.

A qualified carpenter or general handyman can be engaged to perform rectification works at clients discretion.
