Building Inspection Report

Inspection Date: Fri, 16 Jan 2026

Property Address: 505/11-13 Clifton St, Blacktown NSW 2148,
Australia

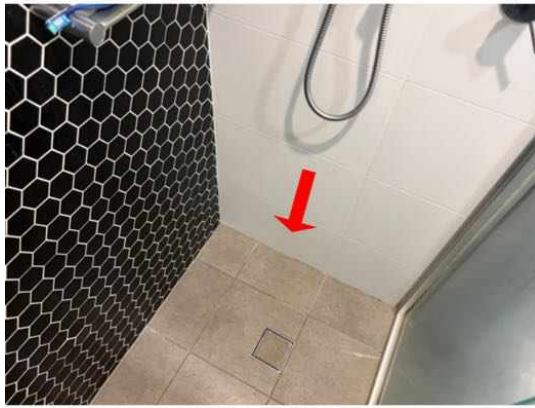
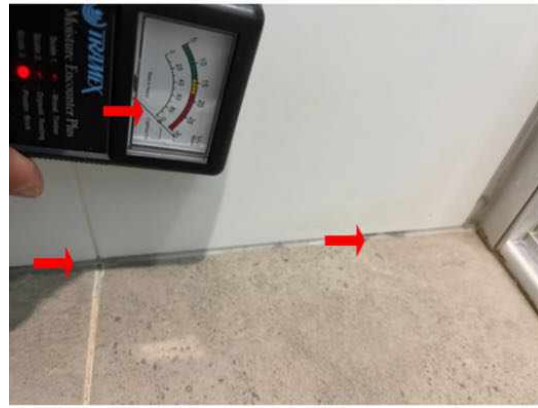
Defects 3.01

Building:	Main Building
Location:	Bathroom
Finding:	Shower damp - Sealant and grout
Information:	Damp is evident to the lower 400mm of wall to the shower alcove. This defect is quite common, and is suspected to have been caused by moisture permeating or leaching through the grouting and sealant in this area, which shows evidence of deterioration. Leaking pipes within the wall is also a possible cause however this seems unlikely in this instance as there is no moisture build up around the taps or transferring to the other side of the wall. There appears to be no sealant around the tap spindles which may be a small contributing factor.

Damp (or structural damp) refers to the presence of unwanted moisture in the structure of a building, either as the result of intrusion from outside, or condensation from within the structure. In the shower area, internal water leaks, degraded materials or other sources of excessive moisture are generally the cause of damp.

Unmanaged damp in the shower recess is likely to facilitate the formation and development of mould and fungi growth, decaying associated building materials and compromising their structural integrity of associated elements. It is important to address damp conditions, as the World Health Organisation notes that excess moisture leads - on almost all indoor materials - to growth of microbes such as moulds, fungi and bacteria, which subsequently emit spores and other matter into the indoor air. Exposure to these contaminants is associated with a wide range of respiratory and other health-related problems. Damp conditions also create a conducive environment for termite infestation.

Consultation with a bathroom sealant specialist is advised immediately to identify the cause of damp and to perform remedial works as required.

Always ensure that sealant and grout is in good condition to prevent any moisture issues occurring in the future.

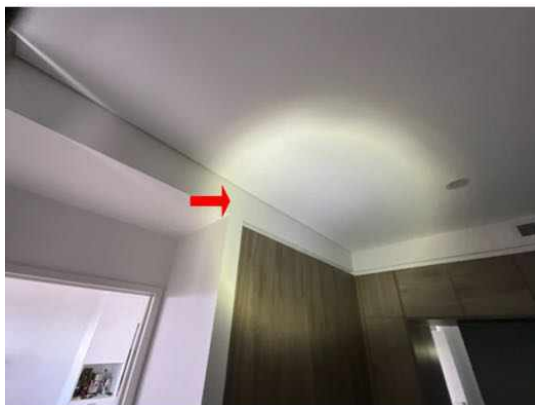
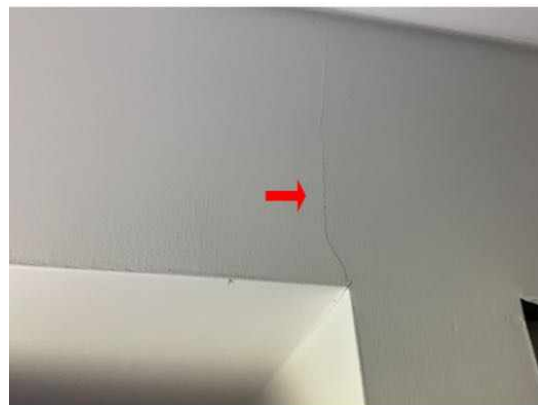
Defects 3.02

Building:	Main Building
Location:	Bedroom
Finding:	Cracking - Damage Category 0 - Hairline (less than 1mm)
Information:	Hairline cracks are very minor in nature and generally are only ever an appearance defect. While such cracking may be noticeable in some cases, it is quite common and does not indicate any structural damage.

Cracking of this nature can generally be repaired with minor sanding, filling and/or repainting. Such works should be performed by a qualified painter or a general handyman.

Monitoring of all cracking should be conducted frequently. Always contact a building inspector should cracks widen, lengthen, or become more numerous.

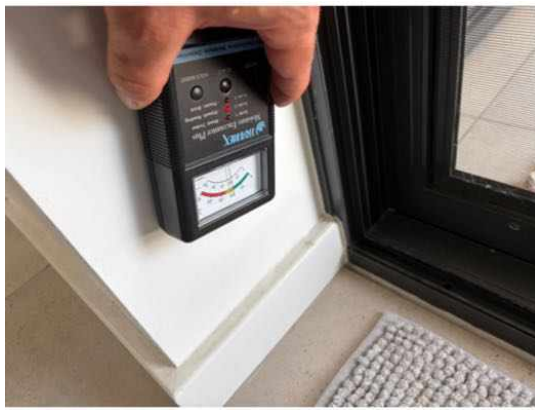
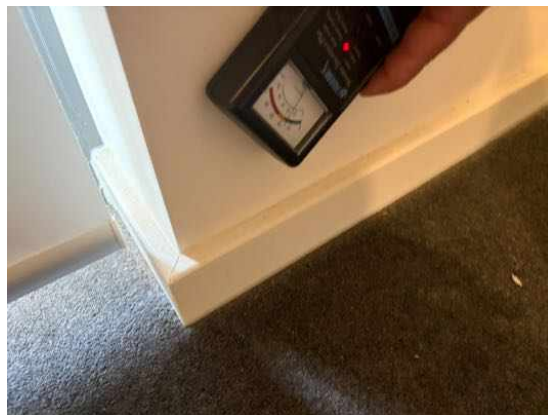
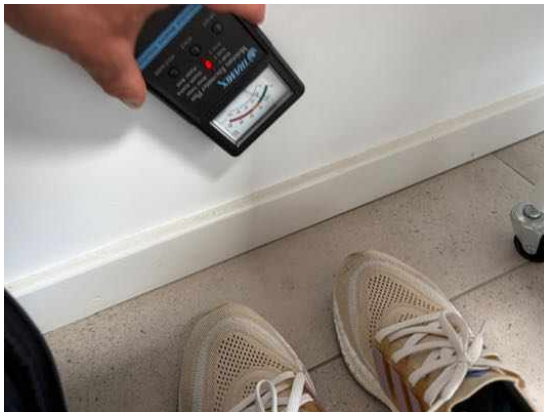
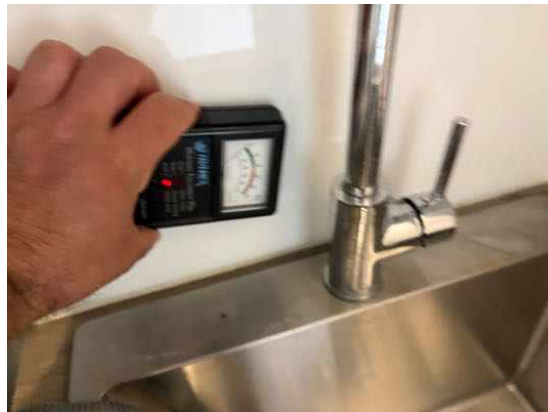
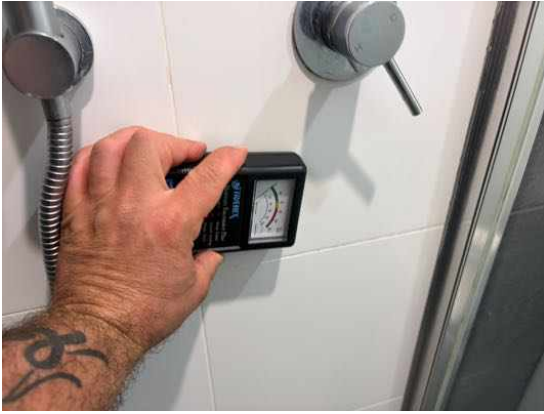
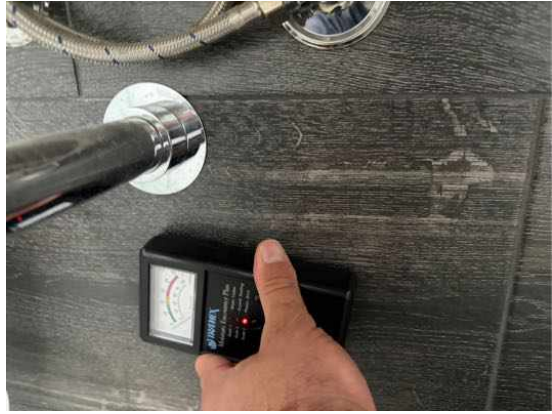
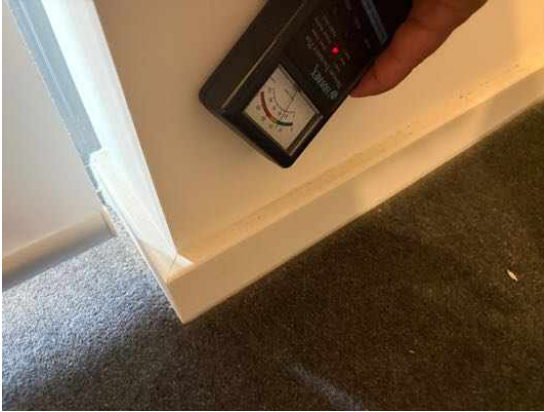
Building: Main Building
Location: All Areas
Finding: Moisture metre
Information: During the inspection the property was checked for moisture using a moisture metre.

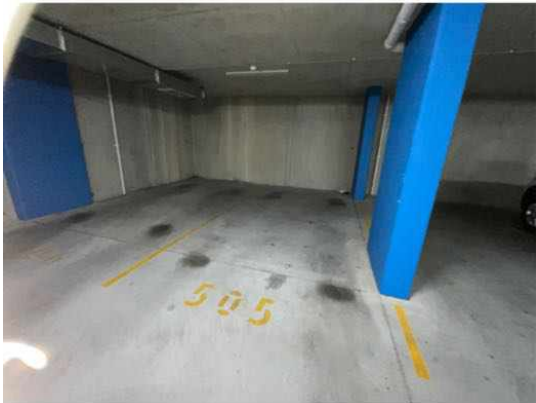
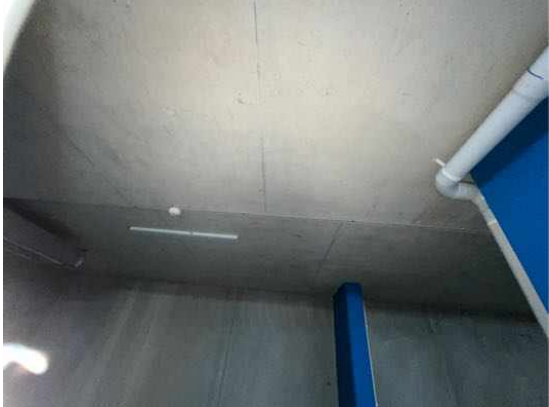
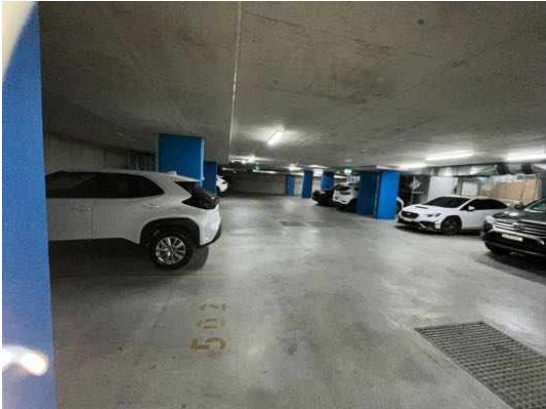
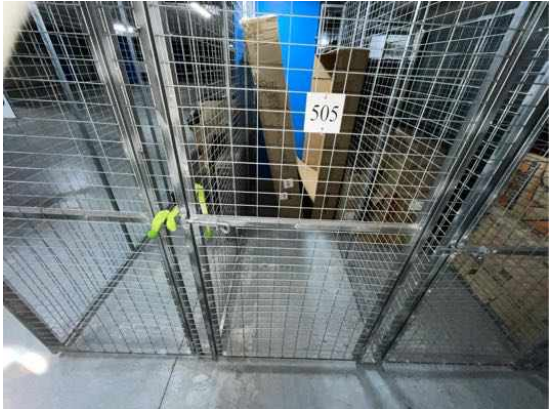
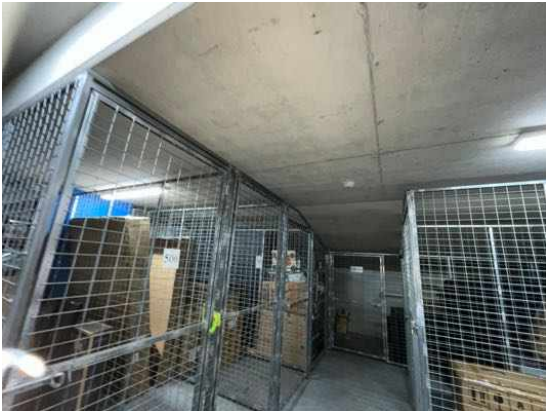
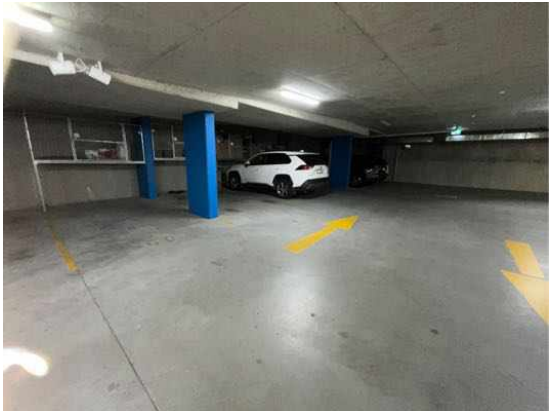
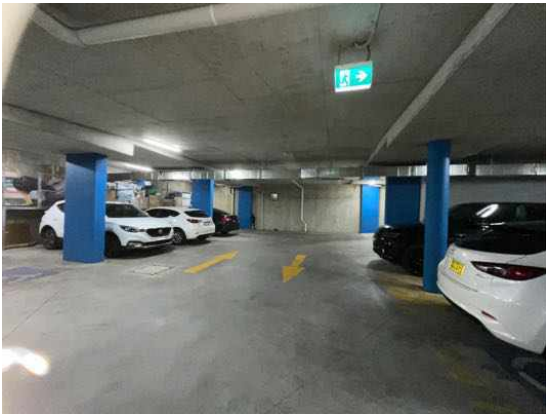
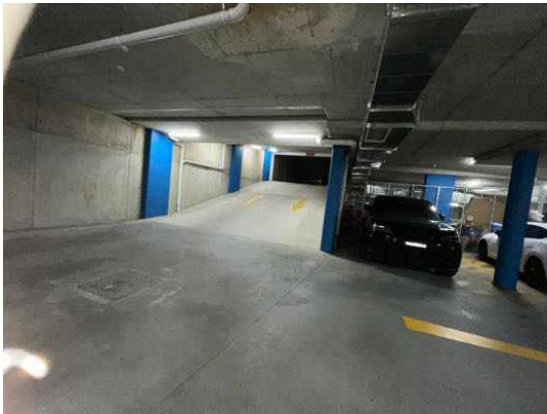
Building: Main Building
Location: Garage
Finding: Additional Photos- Garage
Information: Additional photos are provided for your general reference. Arrows may have been included to highlight areas of importance. Please discuss these photos with your building consultant for clarification.

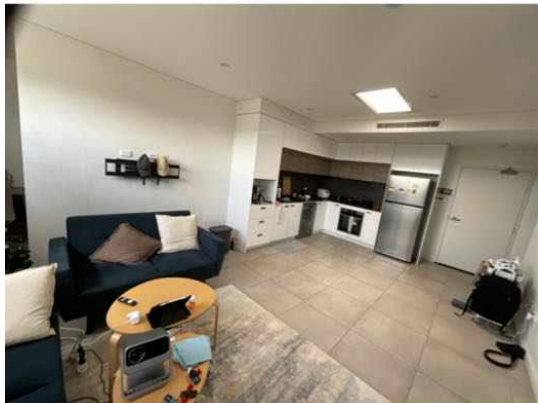
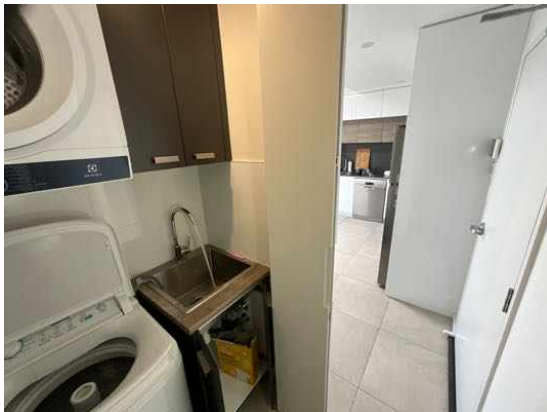
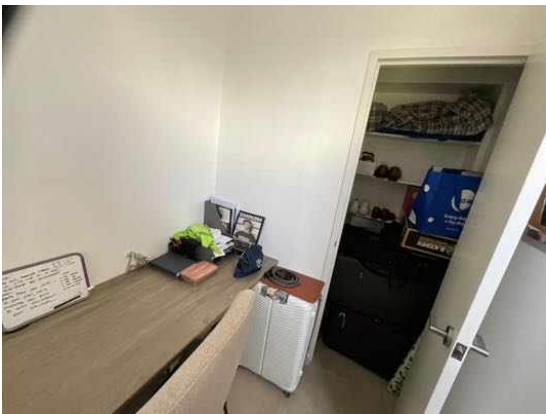
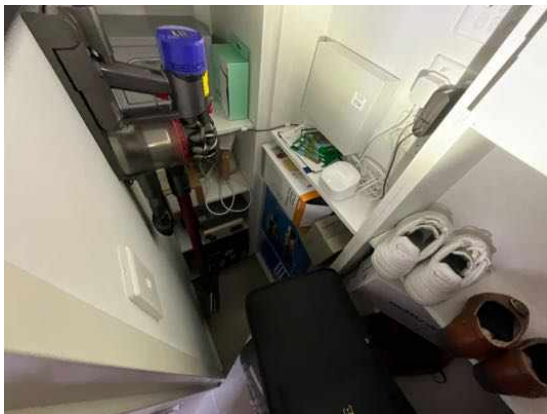
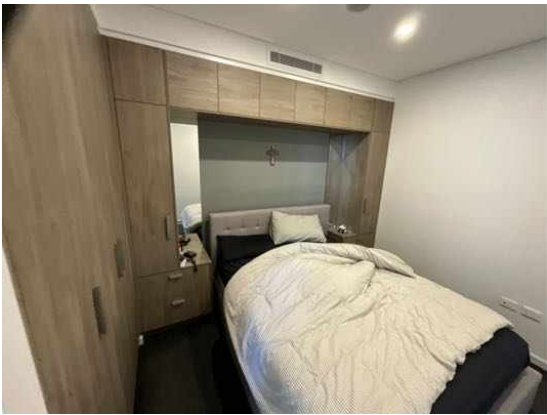
Building: Main Building
Location: All Areas
Finding: Additional Photos - Obstructions and Limitations
Information:

These photographs are an indication of the obstructions and limitations which impeded full inspection of the property at the time of inspection. These obstructions can hide an array of defects and should be removed to allow full inspection to be carried out. A re-inspection is recommended once the areas are made accessible.
