Building and Timber Pest Inspection Report

Inspection Date: Mon, 9 Feb 2026

Property Address: 8/23-27 Docker St, Elwood VIC 3184,
Australia

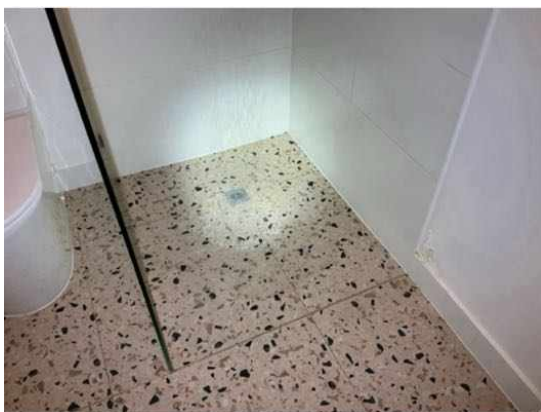
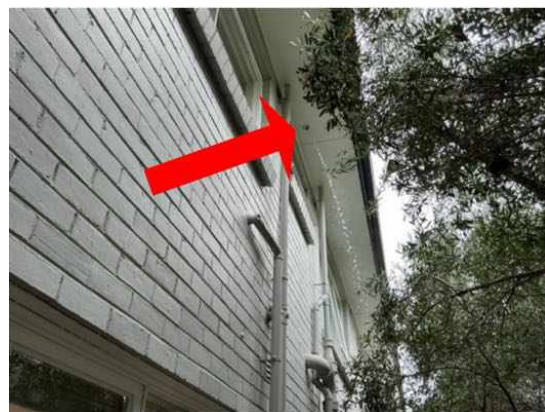
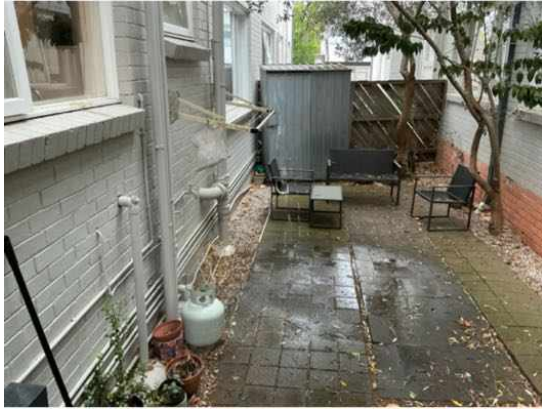
Information: At the time of inspection, the shower was operated for several minutes. During operation water was observed discharging externally from a pipe terminating at the upper story eaves, with the discharge falling directly onto the ground below.

Shower waste water must be connected to the sanitary drainage system or an approved grey water system.

It is recommended that a licensed plumber be engaged as a matter of urgency to further investigate and rectify the non-compliant plumbing connection. The shower waste should be directly connected to the sanitary sewer system in accordance with current building standards and local authority requirements.

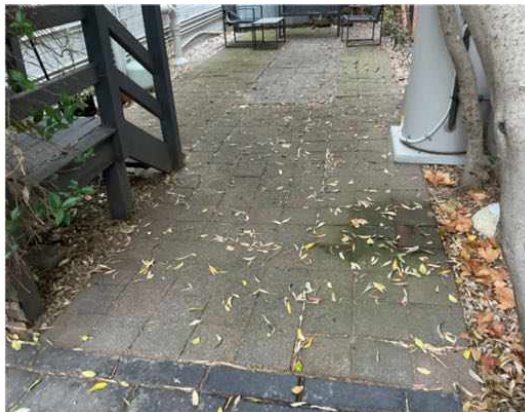
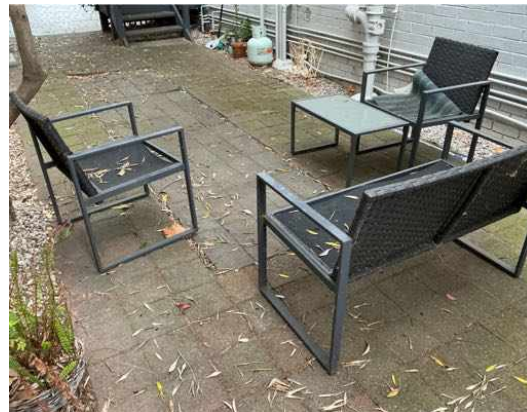
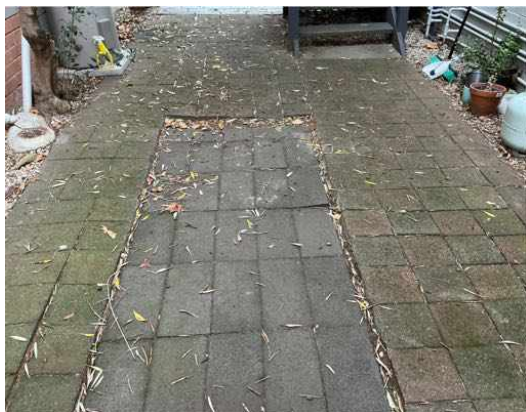
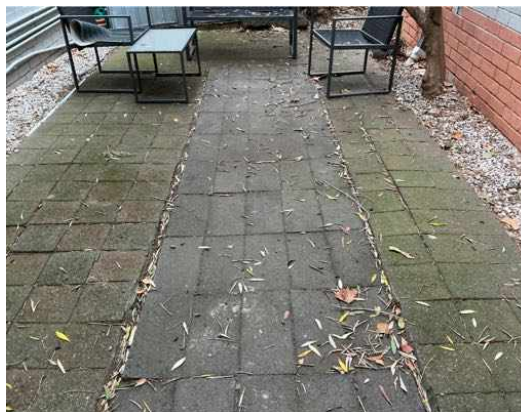
Finding 3.01

Information: Sections of the external paved area are uneven, creating a potential trip hazard. It appears as though the area has been subject to rough installation, or that paving sections have lifted due to movements in the foundation of the property.

Where paving creates a trip hazard, personal injury may ensue if due caution is not taken by all persons within this area.

Re-paving of the area is required as soon as possible to remedy this situation. Further consultation with a specialist paver is advised.

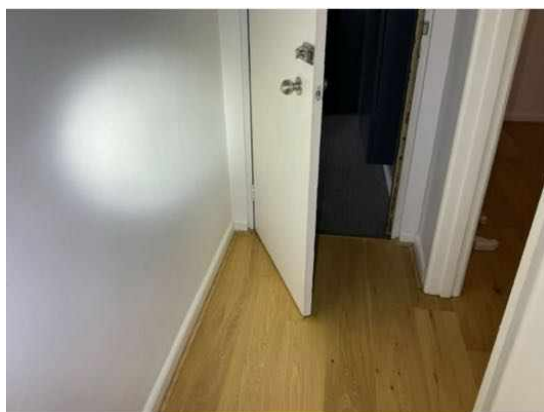
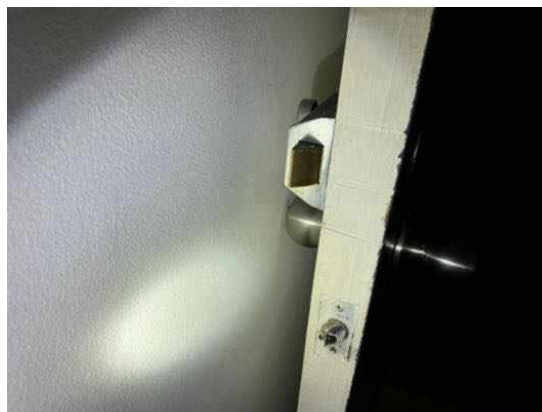
Finding 3.02

Building: Main Building
 Location: Entry
 Finding: Door stop missing
 Information: The door stop to the entrance is missing and is unable to stop the door furniture from damaging the wall. Although some building elements may seem irrelevant or unnecessary, all building elements play a key role in the operation and function of the overall structure and its performance.

Re-installation or replacement of the door stop is advised as soon as possible to prevent any subsequent damage to the door or associated structures. A general handyman may be appointed to perform these works at client discretion.

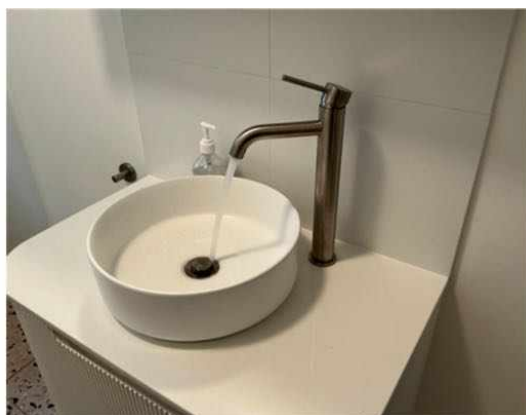
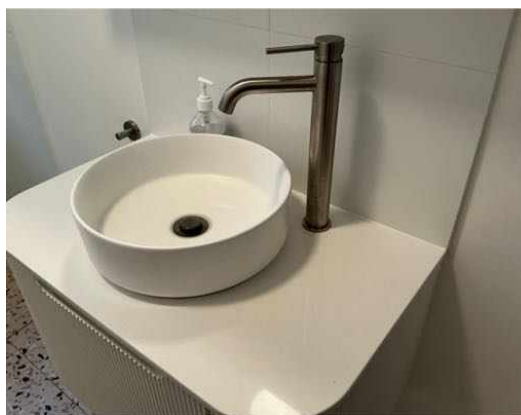
Finding 3.03

Building: Main Building
 Location: Bathroom
 Finding: Tap - Water hammer bathroom
 Information: The tap to the bathroom basin shows evidence of water hammer being present. Water hammer, a pressure surge resulting when a fluid is forced to suddenly change direction, is a common defect in plumbing fittings, particularly those that are aged and not frequently maintained. Water hammer is generally caused by factors that create

Although water hammer is generally considered to be a minor defect, subsequent damage such as erosion of tap hardware and/or water damage to associated building elements is likely to occur if left unmanaged.

A licensed plumber should be appointed as soon as possible to replace any affected tap hardware and perform any remedial works as necessary. Please be advised that the appointment of a cabinet maker or qualified carpenter may be necessary if water damage to associated building elements has occurred.

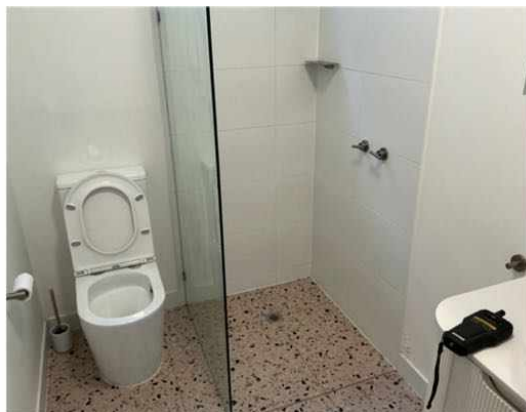
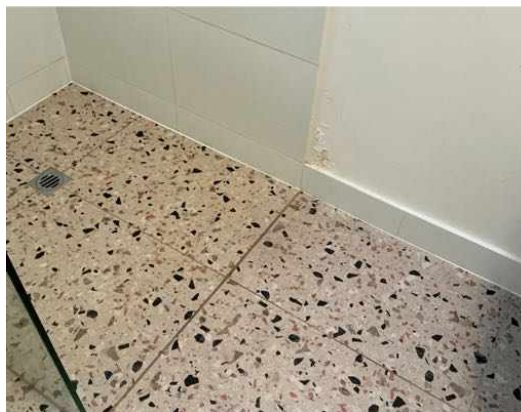
Finding 3.04

Building:	Main Building
Location:	Bathroom
Finding:	No Shower screen
Information:	No shower screen fitted to the bathroom.

Water from the shower where left unattended, is likely to lead to water damage to adjoining flooring and walls. Such damage can lead to water damage and necessitate extensive remedial works being required. Active water leaks may also create an environment that is susceptible to the formation and development of mould.

Appointment of a shower screen installer is required to install a shower screen to the shower area. Such works should be performed as soon as possible to ensure that no further damage occurs.

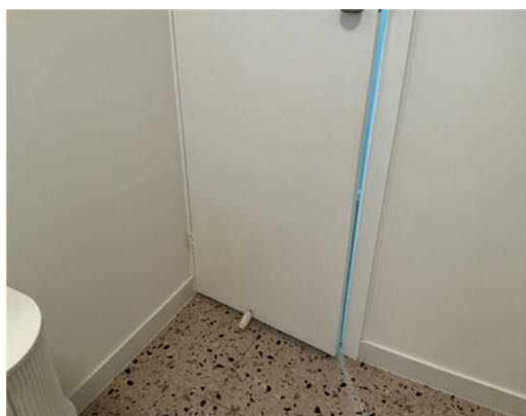
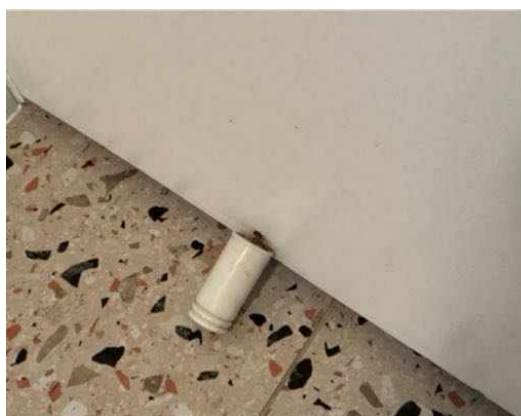
Finding 3.05

Building:	Main Building
Location:	Bathroom
Finding:	Door stop - inadequate
Information:	The bathroom door stop is inadequate to stop the door handle from damaging the wall. Although some building elements may seem irrelevant or unnecessary, all building elements play a key role in the operation and function of the overall structure and its performance.

Re-installation or replacement of the door stop is advised as soon as possible to prevent any subsequent damage to the door or associated structures. A general handyman may be appointed to perform these works at client discretion.

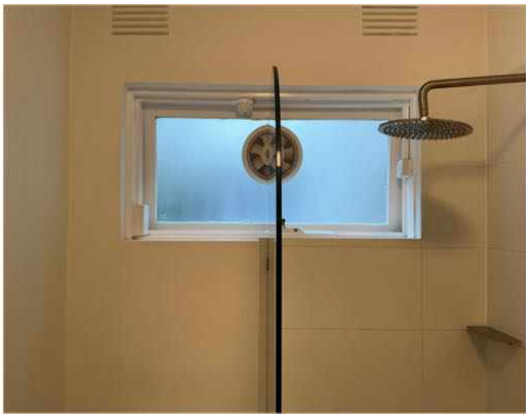
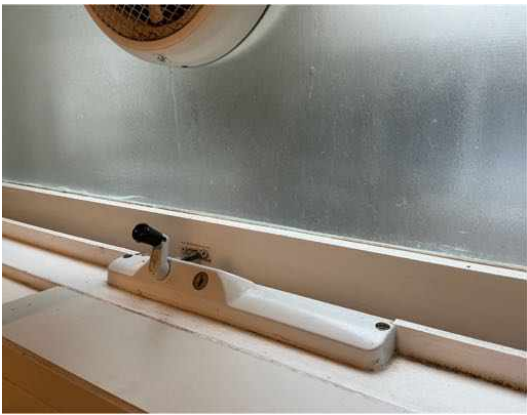
Finding 3.06

Building:	Main Building
Location:	Bathroom
Finding:	Window requires maintenance
Information:	The bathroom window requires some maintenance to make it operate more smoothly. This can happen overtime with deterioration or lack of maintenance. Recommend engaging a carpenter to repair/maintain windows and doors at the owners discretion.

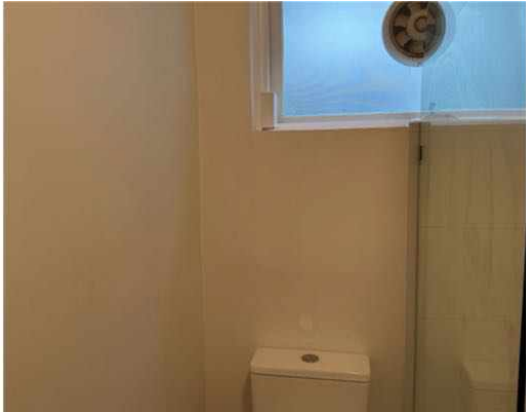
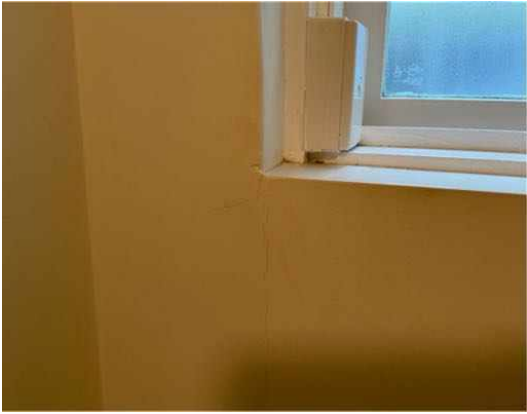
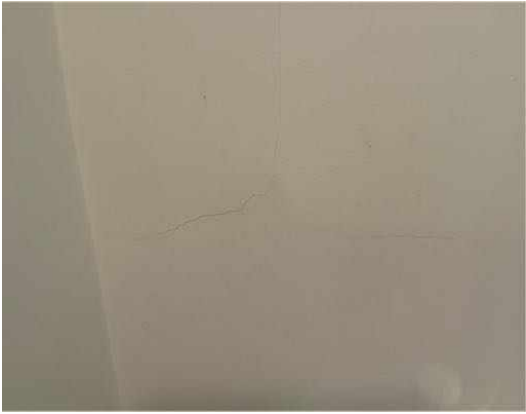
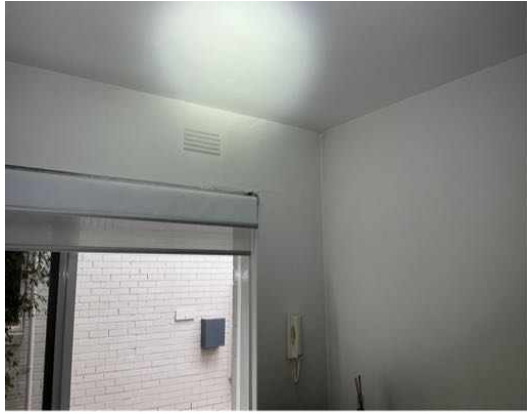
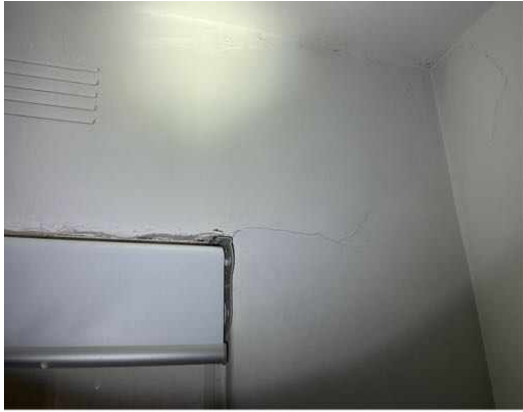
Finding 3.07

Building: Main Building
Location: Bathroom and living room
Finding: Cracks to plaster
Information: Cracks to parts of the bathroom and living room plaster. This can happen with general building movement, deterioration overtime or lack of maintenance. Recommend engaging a painter to repair to make more aesthetic at the owners discretion.

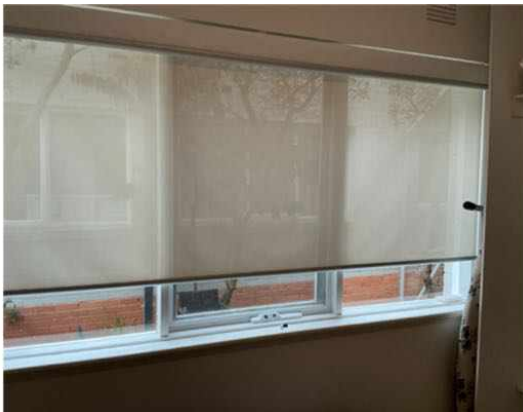
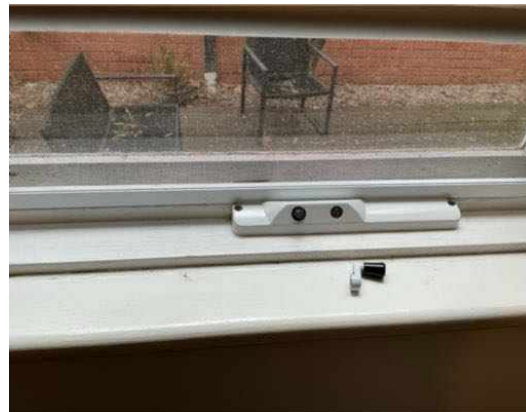
Finding 3.08

Building:	Main Building
Location:	Bedroom
Finding:	Window requires maintenance
Information:	The bedroom window requires some maintenance to make it operate more smoothly. This can happen overtime with deterioration or lack of maintenance. Recommend engaging a carpenter to repair/maintain windows and doors at the owners discretion.

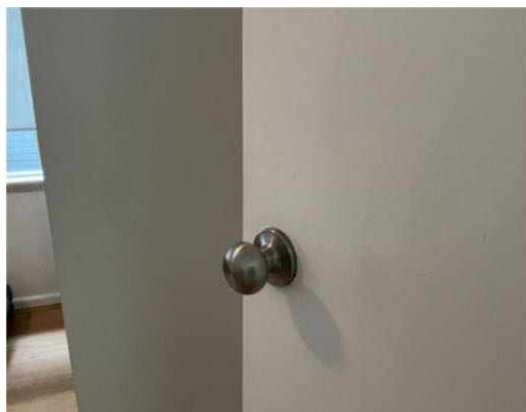
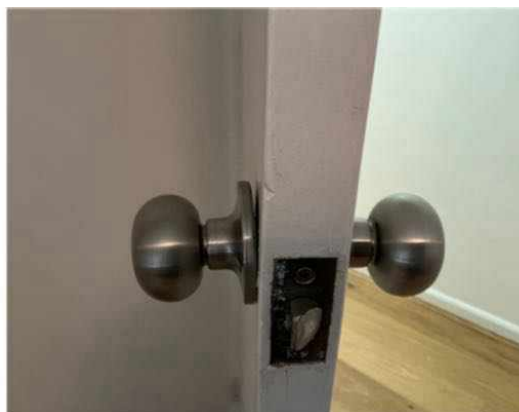
Finding 3.09

Building:	Main Building
Location:	Bedroom
Finding:	Loose handle bedroom
Information:	The door handle to the bedroom was found to be loose at the time of inspection. Looseness occurs generally when the building materials have aged and decayed, but may be indicative of impact damage (accidental or deliberate).

Repair of the loose door handle is advised to improve the operational state of the associated door.

A qualified carpenter or general handyman should be appointed to repair/replace the door handle at the client's discretion.

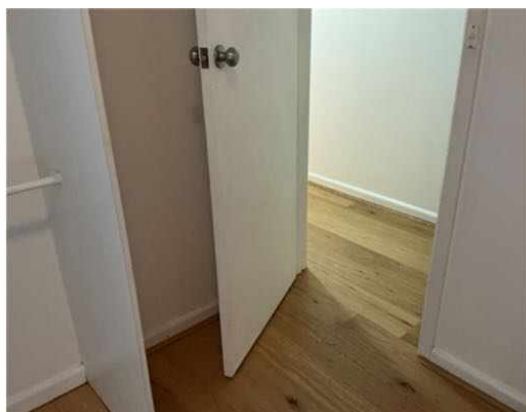
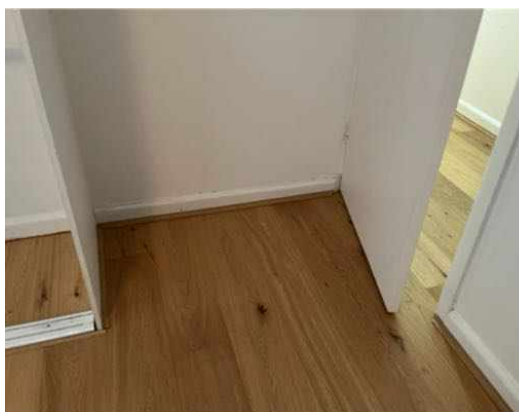
Finding 3.10

Finding: Door stop missing

Information: The door stop to the bedroom is missing and is unable to stop the door from damaging the hinges. Although some building elements may seem irrelevant or unnecessary, all building elements play a key role in the operation and function of the overall structure and its performance.

Re-installation or replacement of the door stop is advised as soon as possible to prevent any subsequent damage to the door or associated structures. A general handyman may be appointed to perform these works at client discretion.

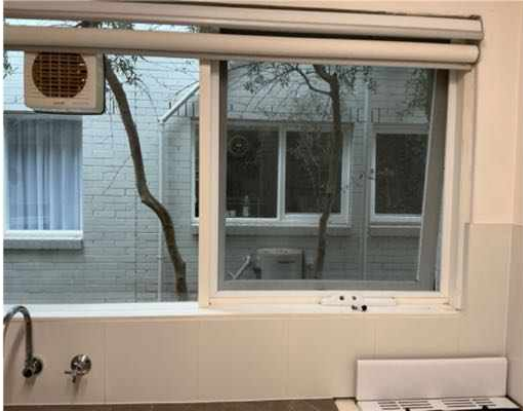
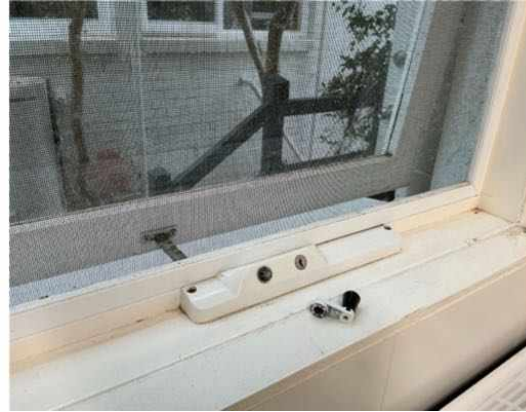
Finding 3.11

Finding: Window requires maintenance

Information: The kitchen window requires some maintenance to make it operate more smoothly. This can happen overtime with deterioration or lack of maintenance. Recommend engaging a carpenter to repair/maintain windows and doors at the owners discretion.

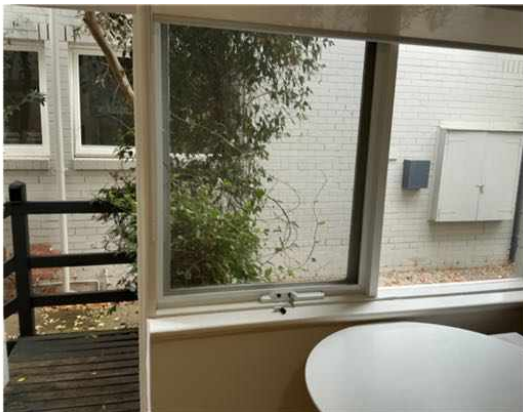
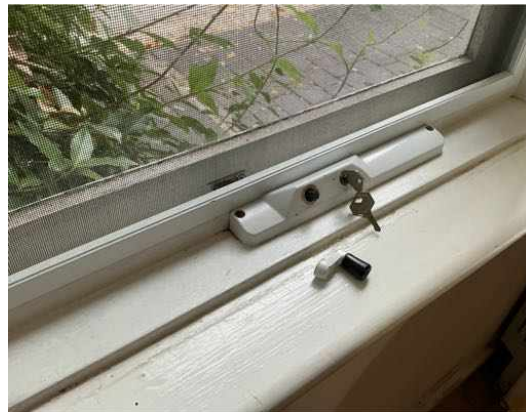
Finding 3.12

Building:	Main Building
Location:	Living Room
Finding:	Window requires maintenance
Information:	The living room window requires some maintenance to make it operate more smoothly. This can happen overtime with deterioration or lack of maintenance. Recommend engaging a carpenter to repair/maintain windows and doors at the owners discretion.

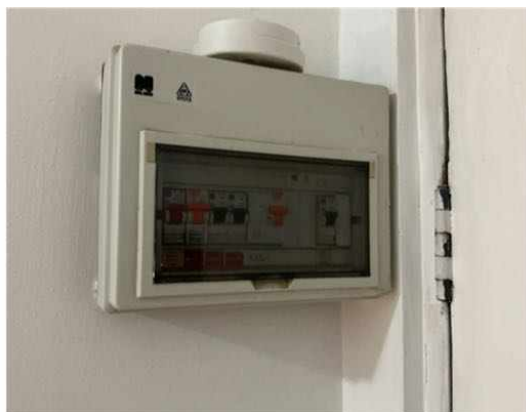
Building:	Main Building
Location:	All External Areas
Finding:	No Termite Management System - no evidence of a chemical installation
Information:	The application of a post-construction chemical termite barrier is highly recommended for all properties, particularly if live termite activity has been found on the site previously. Such barriers are highly effective in preventing termite attack on any timber building elements throughout the property.

A durable notice should be placed in the switchboard unit to indicate current termite barriers. At the time of inspection, it appeared as though no termite management system has been installed, with no evidence to suggest preventative works taking place.

The client may consider gaining further advice from a pest controller as to the costs and procedures involved with this application. It is recommended that obtaining such advice be a short-term priority.

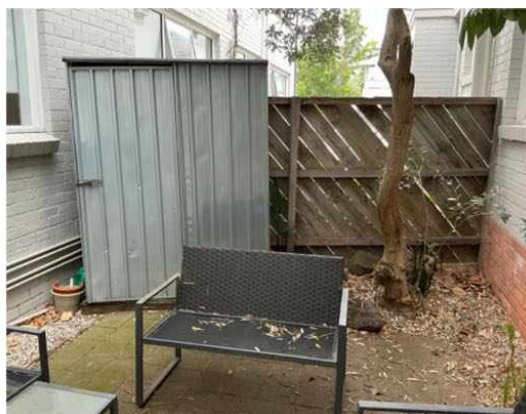
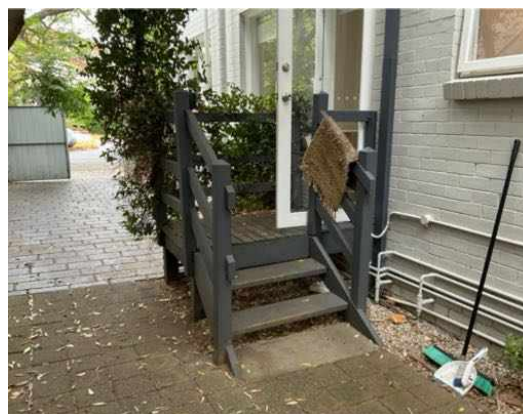
Finding 6.02

Building:	Main Building
Location:	Yard
Finding:	In ground contact
Information:	Any timbers in direct ground contact provide opportunity for concealed termite entry and are likely to be subject to premature rot and decay as the soil retains moisture or damp conditions against the timbers.

Remove untreated timber that is in direct contact with external grounds. Consider replacement with more durable materials i.e. treated timber or non timber elements. Frequent pest inspections are advised to readily identify any termite activity in these areas.

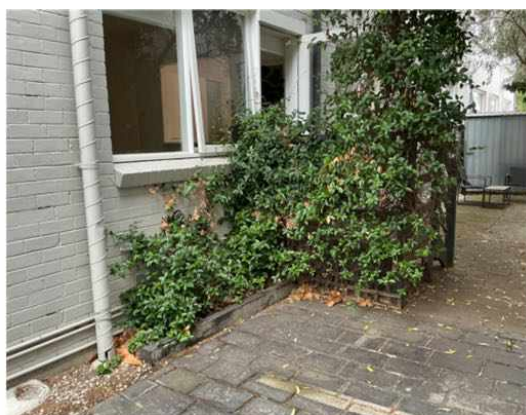
Finding 6.03

Building:	Main Building
Location:	Yard
Finding:	Garden Beds Conditions Conducive to Termites
Information:	Garden beds were found to be evident in close proximity to the building. Garden beds immediately adjacent to the perimeter of the building block the visual inspection of these areas, providing a concealed termite entry point.

These garden beds can include untreated timber, and with a combination of moisture from watering hosing can make conditions conducive to termite activity and termite ingress.

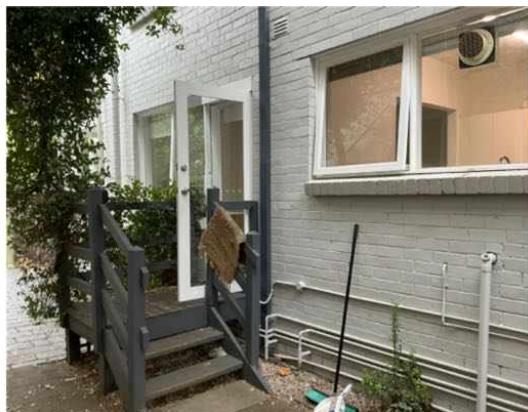
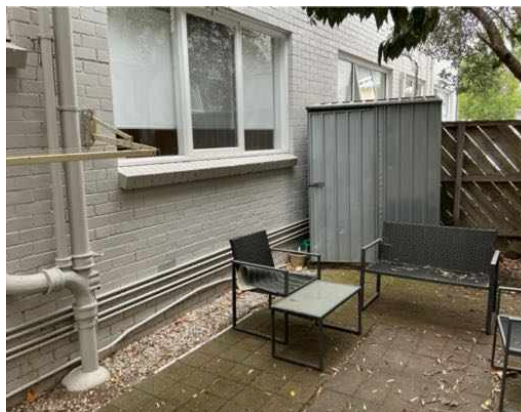
Finding 6.04

Building:	Main Building
Location:	Yard
Finding:	Bridging attachments to buildings
Information:	Bridging occurs when items against a building provide a concealed entry point for termites into the building or by passing around a termite management system.

buildings such as hot water services, downpipes, verandahs, decks, steps, fences, service conduits and the like provide the opportunity for concealed entry.

Building attachments of this nature need to be frequently inspected for termite activity by a qualified inspector.

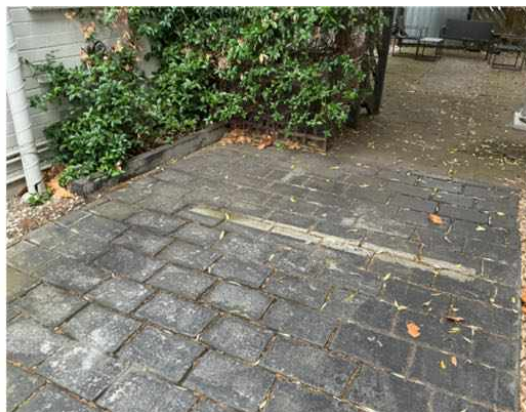
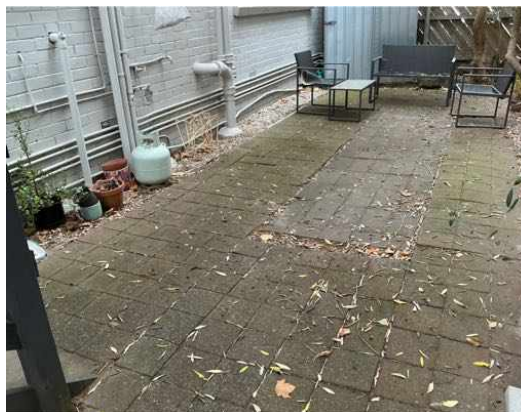
Finding 6.05

Building: Main Building
 Location: Yard
 Finding: Site drainage - poor/inadequate
 Information: The site drainage to the yard was found to be inadequate at the time of inspection, creating potential for subsequent water damage to associated building elements. Excessive moisture will attract termites.

It is important that water does not lie against the base of walls; surrounding paths and ground levels should be sloped to drain water away from walls. Downpipes should not discharge stormwater onto lower walls or plinths. Stormwater should be carried away by large, regularly cleaned drains. Ground levels may need to be lowered to expose a buried DPC.

Where site drainage is inadequate, installation of an Agricultural (Aggie) Drain may be required. A qualified plumber should be appointed to further inspect the property and perform any remedial works as necessary. Water damage and secondary defects are likely to occur if left unmanaged.

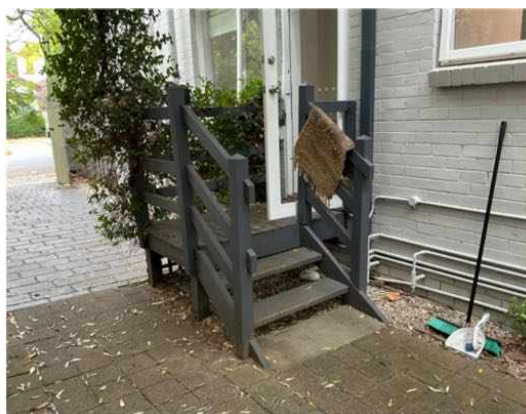
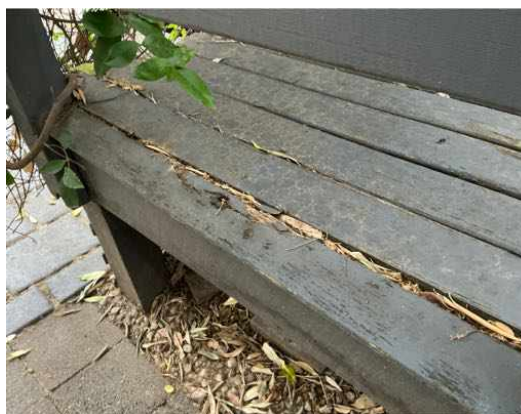
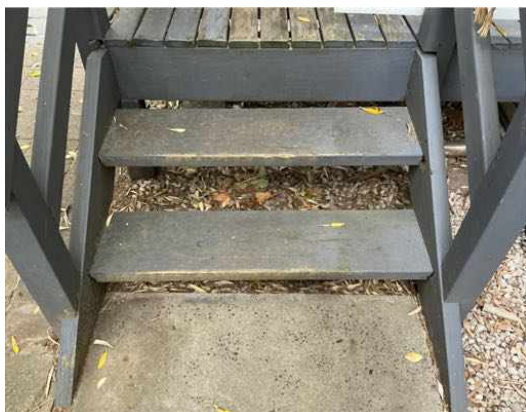
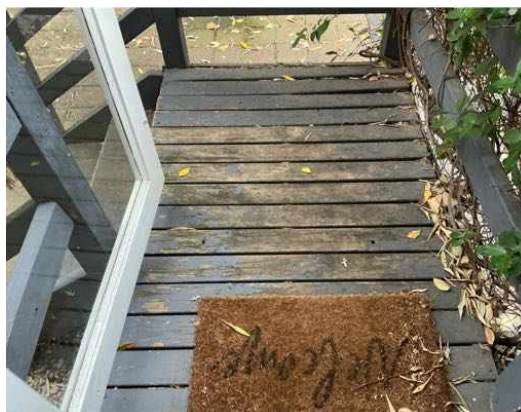
Finding 7.01

Finding: Wood rot rear steps

Information: The rear steps shows evidence of wood rot. Wood rot, also known as Fungal Decay, occurs when timbers and other cellulose building materials are exposed to damp conditions on an ongoing basis. This could be the result of exposure to weathering over a prolonged period of time, or the attraction of excessive moisture from other abutting building materials.

Wood rot is often associated with general damp problems and is evidenced by mould and mildew occurring on surfaces. If left unmanaged, damp conditions can lead to further health problems and the decay of timbers will continue.

Early intervention and regular maintenance, particularly of exterior timbers, will prolong the useful life of these building elements. Prior to any works being performed, the cause of the moisture that has created the visible wood rot should be identified and addressed in a suitable manner. Replacement of affected timbers may then be a necessary step in protecting surrounding building elements from such deterioration.

A qualified plumber may be appointed to assess the cause of excessive moisture and to provide advice on any remedial works as required. A qualified carpenter or registered builder may also be required to replace affected building materials.

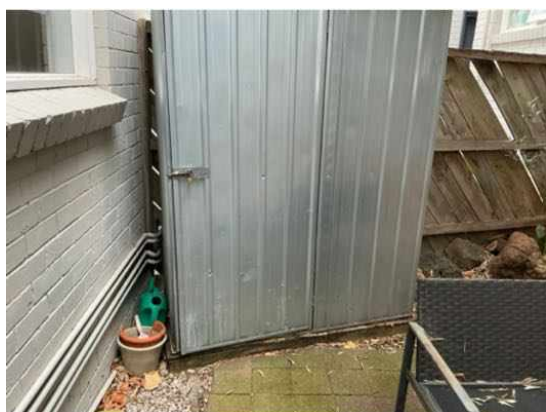
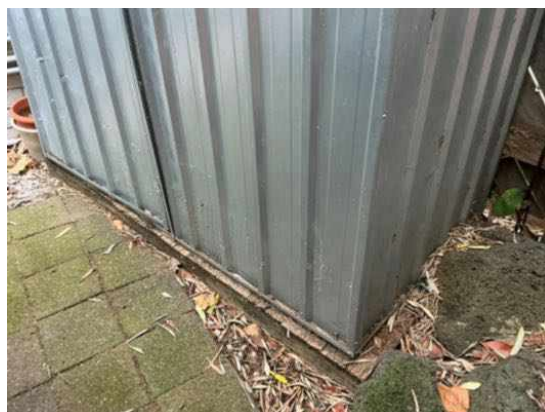
Finding 7.02

Building:	Main Building
Location:	Yard
Finding:	Wood rot shed base
Information:	The shed base shows evidence of wood rot. Wood rot, also known as Fungal Decay, occurs when timbers and other cellulose building materials are exposed to damp conditions on an ongoing basis. This could be the result of exposure to weathering over a prolonged period of time, or the attraction of excessive moisture from other abutting building materials. Contributing factors also include poor air ventilation in the area.

Wood rot is often associated with general damp problems and is evidenced by a 'musty' smell or mould and mildew occurring on surfaces. If left unmanaged, damp conditions can lead to further health problems and the decay of timbers will continue.

Early intervention and regular maintenance, particularly of exterior timbers, will prolong the useful life of these building elements. Prior to any works being performed, the cause of the moisture that has created the visible wood rot should be identified and addressed in a suitable manner. Replacement of affected timbers may then be a necessary step in protecting surrounding building elements from such deterioration.

A qualified plumber may be appointed to assess the cause of excessive moisture and to provide advice on any remedial works as required. A qualified carpenter or

registered builder may also be required to replace affected building materials.

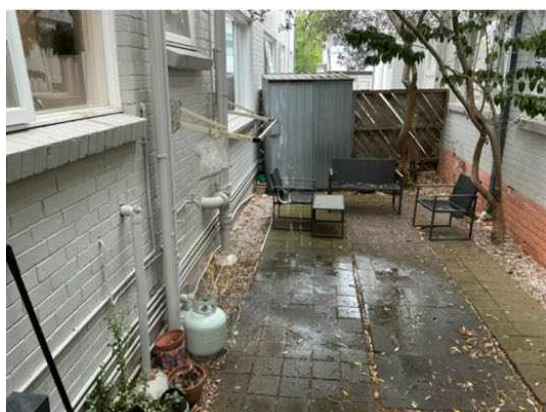
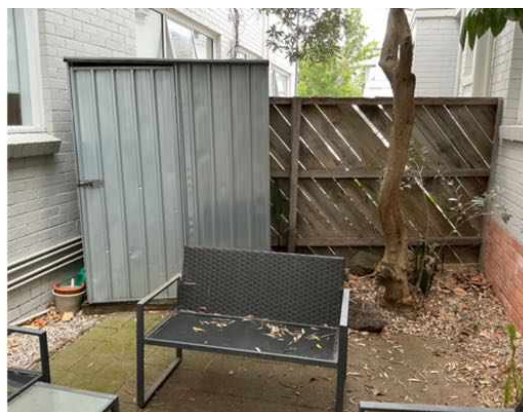
Finding 7.03

Finding: Fencing - wood rot-fungal decay

Information: It was noted at the time of inspection that sections of the fencing to the property have deteriorated and have fungal decay/wood rot present. Typically fencing deteriorates due to age and or wear, rot and or rust which is generally expected for a structure of this age, due to prolonged exposure to weather conditions. Sometimes inadequate installation or maintenance can be to blame.

If left unattended, it is likely that further damage will occur. It is suspected that repair of several elements of the fencing may be required however replacement may be a consideration of the client also.

A licensed fencing contractor should be appointed to provide further advice and perform rectification works as necessary.

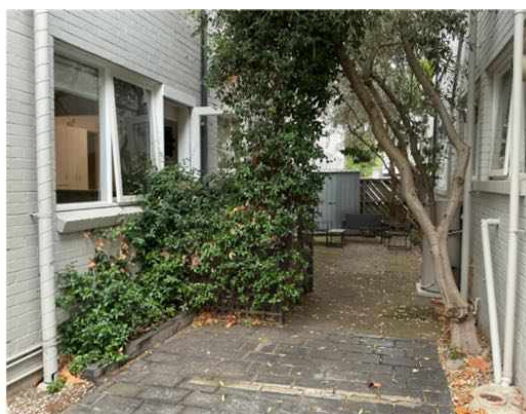
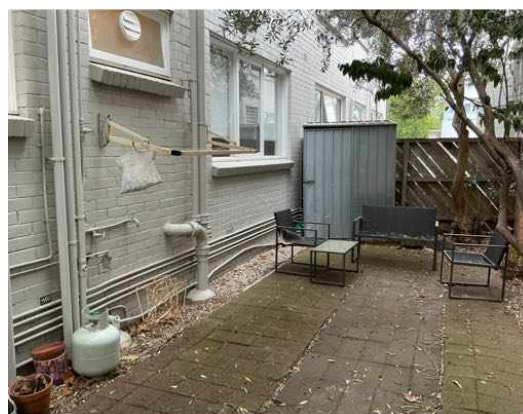
Building: Main Building
 Location: All External Areas
 Finding: Obstructions and Limitations -exterior
 Information: These photographs are an indication of the obstructions and limitations which impeded full inspection of the exterior at the time of inspection. These obstructions can hide an array of defects and should be removed to allow full inspection to be carried out. A re-inspection is recommended once the areas are made accessible.

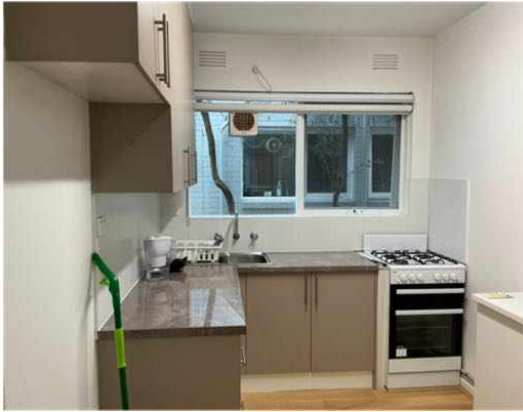
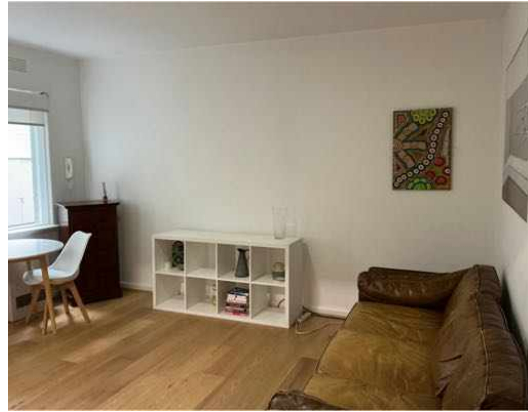
Building: Main Building
 Location: All Internal Areas
 Finding: Obstructions and Limitations -internal area
 Information: These photographs are an indication of the obstructions and limitations which impeded full inspection of the internal area at the time of inspection. These obstructions can hide an array of defects and should be removed to allow full inspection to be carried out. A re-inspection is recommended once the areas are made accessible.

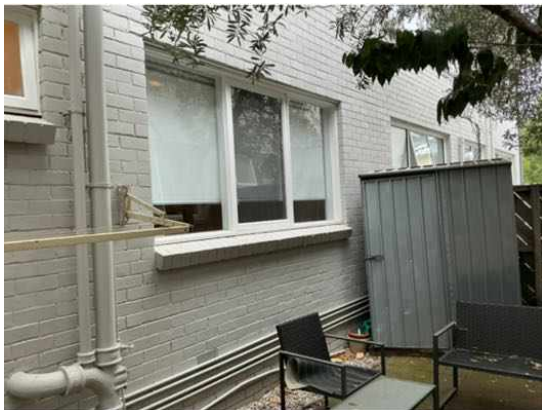
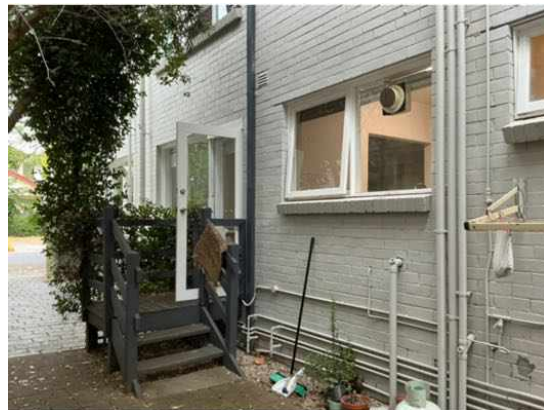
Building:	Main Building
Location:	Subfloor
Finding:	Obstructions and Limitations -no access subfloor
Information:	The subfloor space was inaccessible at the time of inspection due to no access hole which impeded the inspection of the subfloor of the main building. This obstructions can hide an array of defects and it is highly recommended that an access hatch be constructed to allow full inspection to be carried out. A re inspection is recommended once the area is made accessible.
