Building and Timber Pest Inspection Report

Inspection Date: Thu, 2 Apr 2026

Property Address: 26 Dorchester Cres, Carrum Downs VIC
3201, Australia

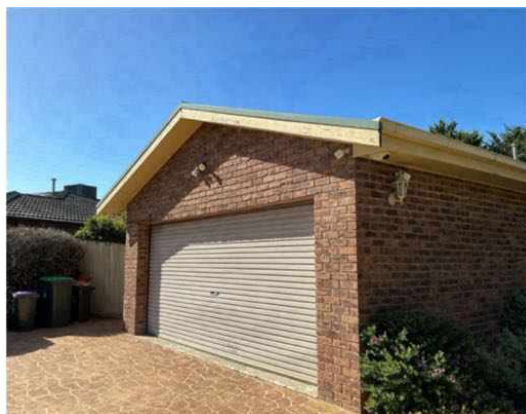
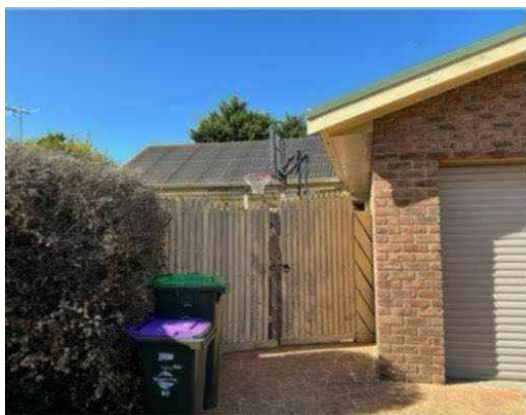
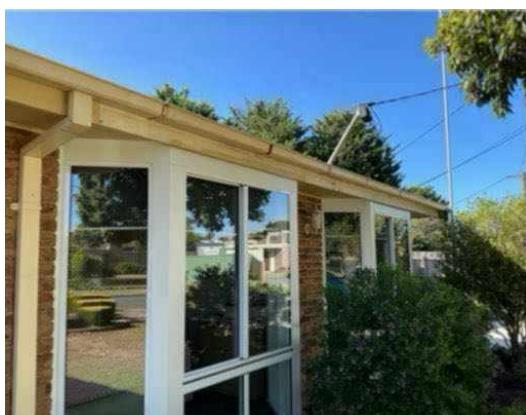
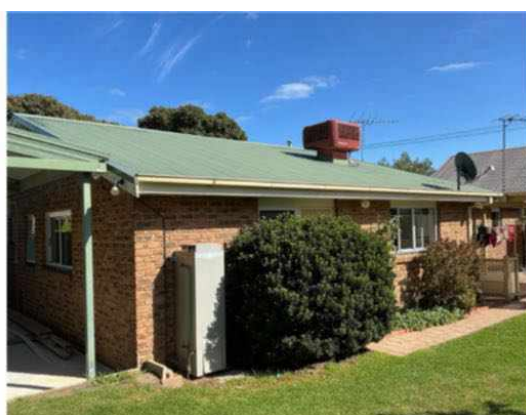
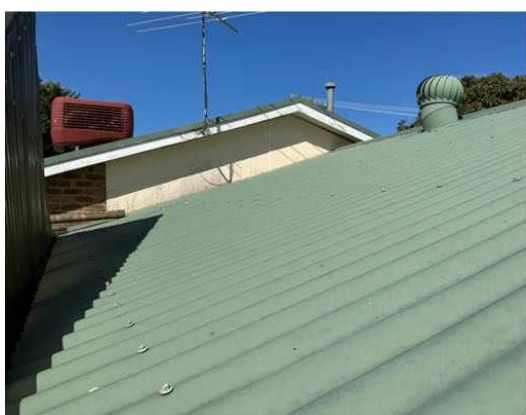
Building:	Main Building
Location:	Various parts of the building
Finding:	External painting deteriorated
Information:	Much of the external paintwork has been neglected and requires attention to prepare and re-paint.

Whilst incomplete or missing paint finish is generally an appearance defect, it can also lead to the development of secondary building defects over time. Incomplete areas of paint finish expose the area to moisture, potentially accelerating the deterioration of underlying building materials.

Degraded paint finishes should be sanded back, filled, leveled and painted, as applicable. Where inadequate or missing paint protection has led to the deterioration of the associated building element, repair and/or replacement of this building element may be required.

A painting contractor should be appointed as soon as possible to perform necessary works to aid the appearance of the affected area and to ensure the area is protected against further deterioration. Alternatively, the homeowner following manufacturer instructions may perform these works.

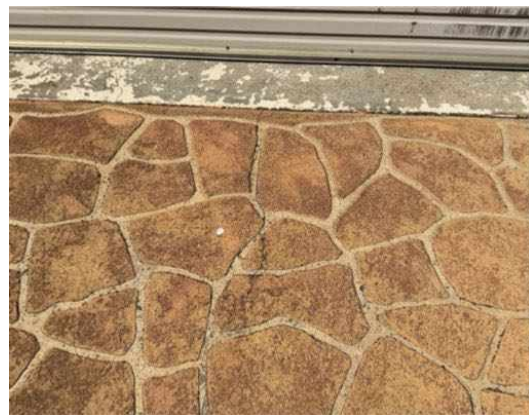
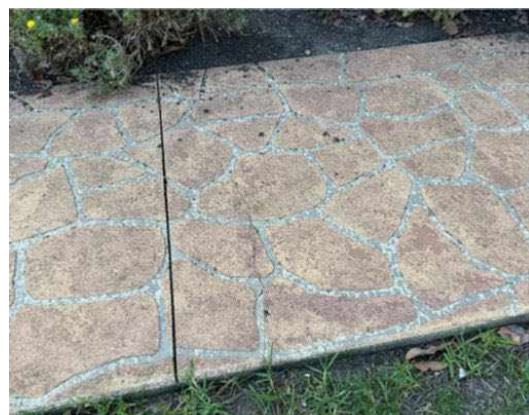
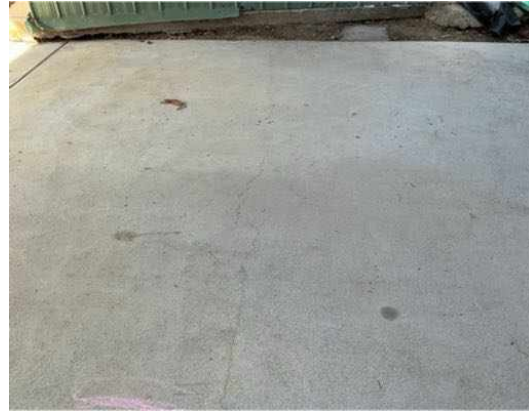
Finding 3.02

Building: Main Building
Location: Driveway and pathway
Finding: Driveway/pathway Cracking
Information: Cracks were identified in the driveway and pathways concrete paving. Although cracks are quite noticeable, they are often only considered to be an appearance defect, and usually do not indicate any structural damage.

Generally the cause of the cracks in existing concrete paving such as driveways and pathways is indicative of the expansion and contraction of the concrete. Such causes are generally due to environmental factors, such as moisture levels, weather conditions, root systems of nearby trees or the soil types on which they are laid.

Cracks may also be due to poor original installation of the concrete. Factors such as poor compaction of the sub surface and/or inadequate reinforcing of the slab may create cracking and other secondary defects.

Monitoring of all cracking should be conducted frequently. Always contact a building inspector should cracks widen, lengthen, or become more numerous.

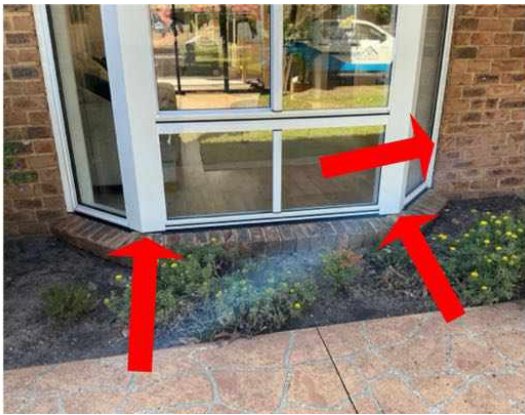
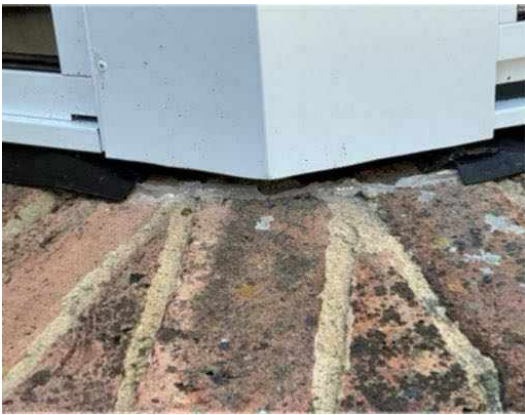
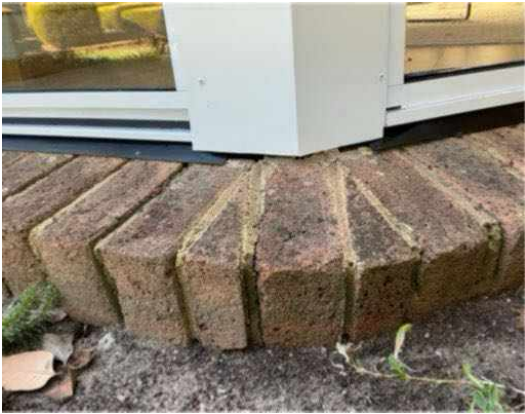
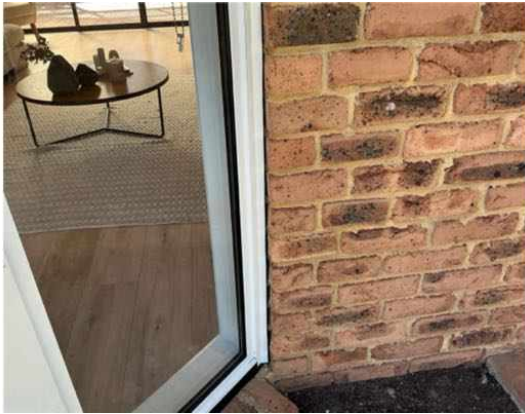
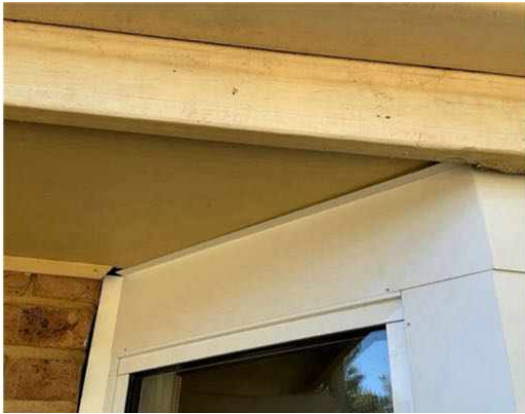
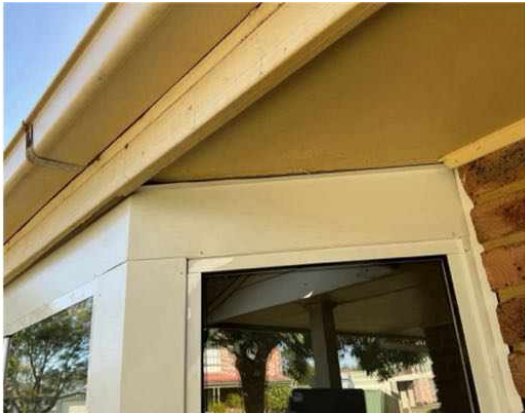
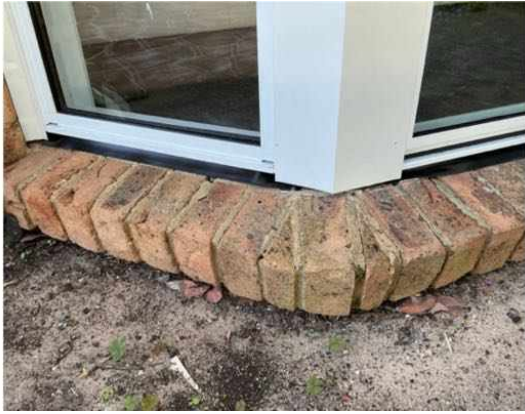
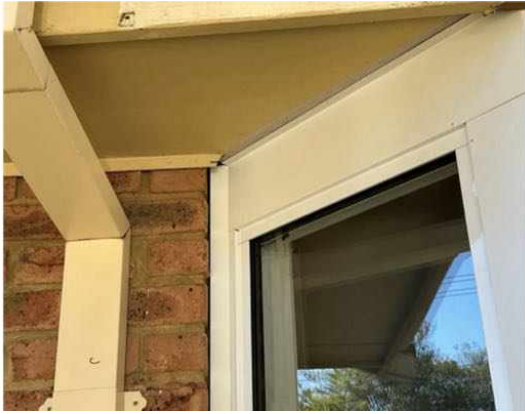
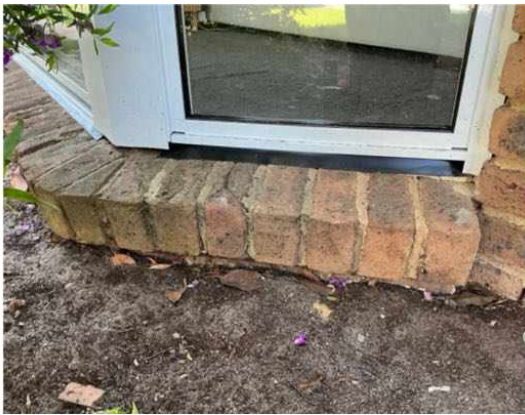
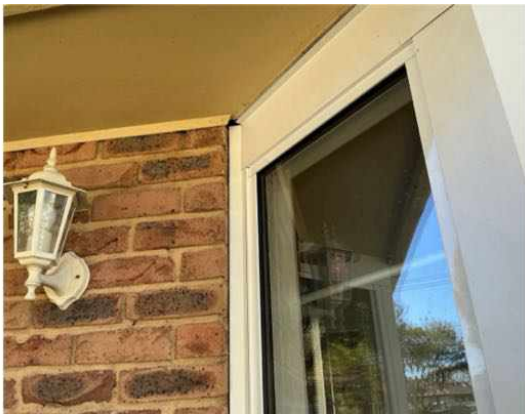
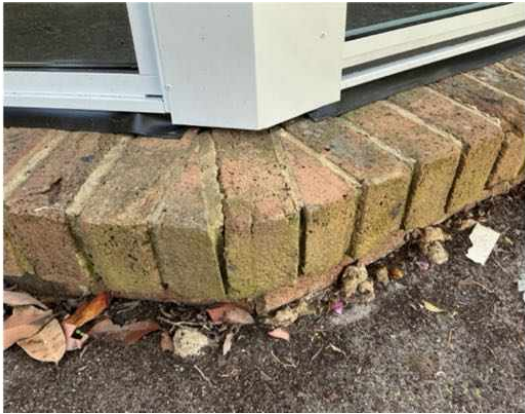
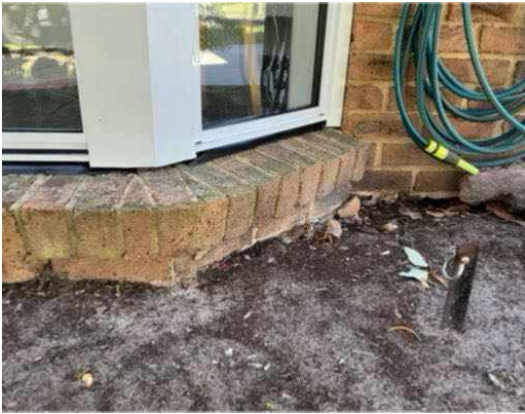
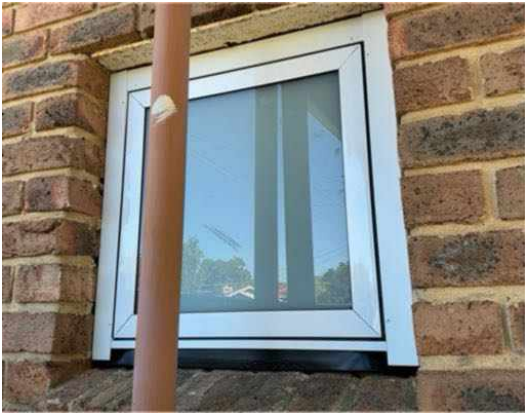
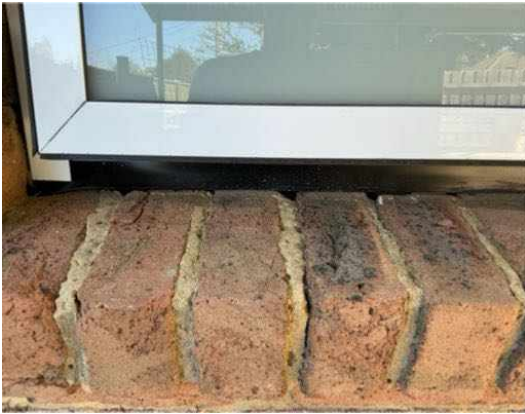
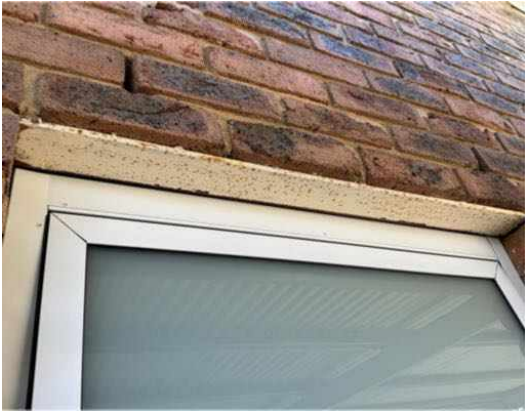
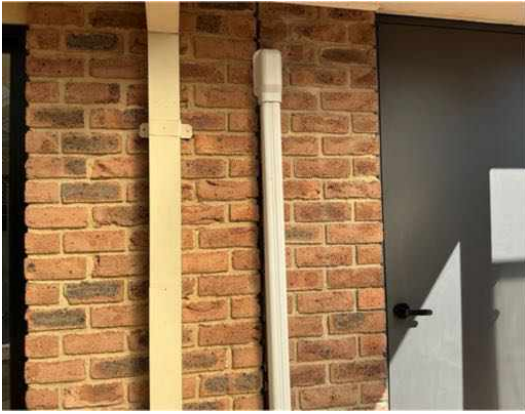
Building: Main Building
Location: Exterior walls
Finding: A few gaps to the exterior walls/windows
Information: A few gaps were noticed to some of the exterior walls/windows to the building. These gaps can let in water, drafts, and pests. Overtime moisture ingress may cause damage to internal walls, mould growth, or structural issues. Gaps also reduce the energy efficiency of the property. Recommend engaging a caulker to seal gaps with an exterior grade flexible sealant that is UV and weather resistant to reduce the risk of pest/water penetration to the building as soon as possible.

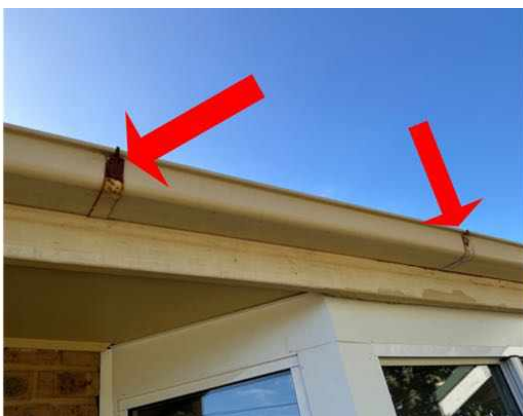
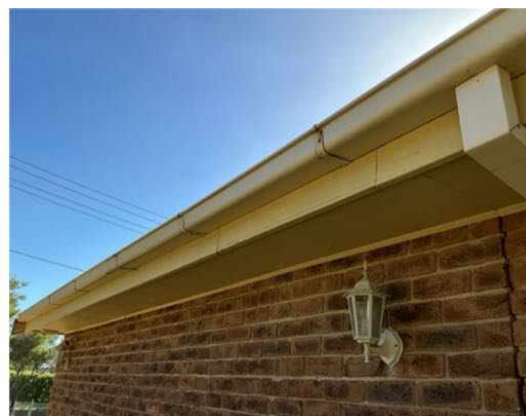
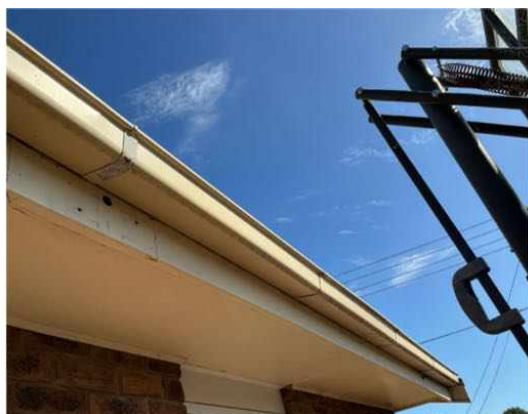
Finding 3.06

Building:	Main Building
Location:	Roof Exterior
Finding:	Gutters clips Rusted or corroded
Information:	The gutter clips to the roof shows evidence of rusting and corrosion, which is likely to have developed as a result of excessive exposure to moisture and or inadequate coatings.

As surface rust provides no protection to the underlying iron, the deteriorating condition is likely to worsen if not addressed in the short-term future.

Where possible, the use of galvanized (treated) metals or aluminium coated metals aid in rust prevention, as does regular general maintenance. Rust formation can be controlled with coatings, such as paint, that isolate the iron from the environment.

Rusting and corrosion should be managed by ideally removing or limiting the affected surface from exposure to moisture.

A licensed plumber may be appointed to replace any building elements that have been severely affected by rust or water damage.

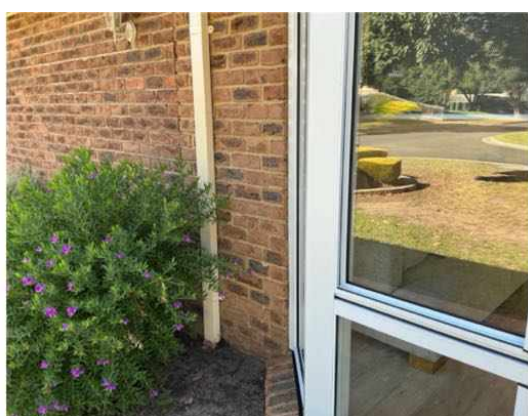
Finding 3.07

Building:	Main Building
Location:	Exterior walls - front
Finding:	Downpipe - Rusted or corroded
Information:	The front down pipe shows evidence of rusting and corrosion, which is likely to have developed as a result of excessive exposure to moisture and or inadequate coatings.

As surface rust provides no protection to the underlying iron, the deteriorating condition is likely to worsen if not addressed in the short-term future.

Where possible, the use of galvanized (treated) metals or aluminium coated metals aid in rust prevention, as does regular general maintenance. Rust formation can be controlled with coatings, such as paint, that isolate the iron from the environment.

Rusting and corrosion should be managed by ideally removing or limiting the affected surface from exposure to moisture. A registered builder may be appointed to replace any building elements that have been severely affected by rust or water damage.

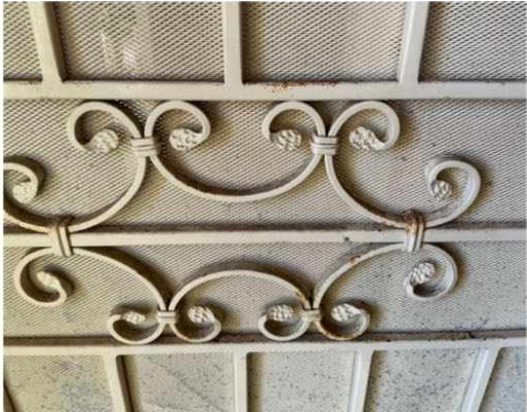
Finding 3.08

Building:	Main Building
Location:	Security doors
Finding:	Security door -Deteriorating/rust

Information: The front and rear security doors have deteriorated/rusted due to deterioration of the paint work overtime.Recommend engaging a carpenter/painter to repair or replace to reduce the risk of further damage at the owners discretion. Whilst incomplete or missing paint finish is generally an appearance defect, it can also lead to the development of secondary building defects over time. Incomplete areas of paint finish expose the area to moisture, potentially accelerating the deterioration of underlying building materials.

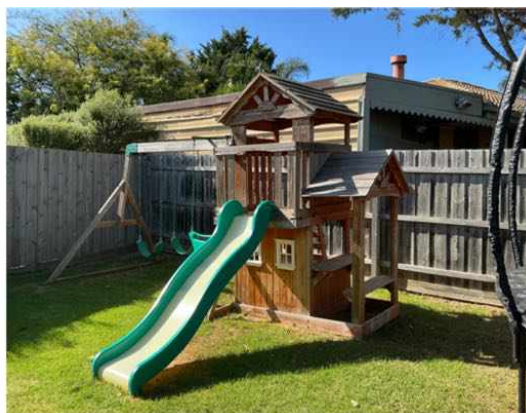
Finding 3.09

Building: Main Building
Location: Yard - Back

Finding: Cubby /play equipment leaning
 Information: The cubby/play equipment is leaning due to movement or poor installation. Recommend engaging a carpenter or handyman to level up to reduce the risk of further deterioration at the owners discretion.

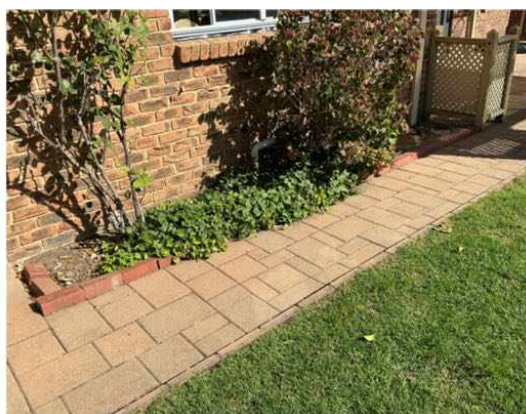
Finding 3.10

Building: Main Building
 Location: Yard - Back
 Finding: Deteriorating/loose garden edging
 Information: The garden edging in the rear yard has deteriorated and is coming loose due to poor installation. Recommend engaging a landscaper to repair/replace to reduce the risk of further deterioration as soon as possible.

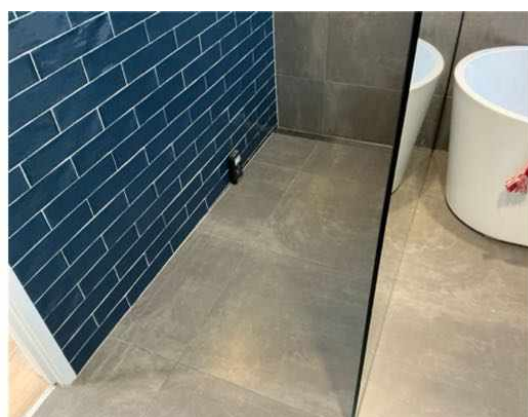
Finding 3.11

Building: Main Building
 Location: Bathroom
 Finding: Bathroom Sealant and grouting - Missing or damaged
 Information: It was noted on inspection that sealant or grout is degraded to the tiled shower alcove and or other areas of the bathroom.

Different materials and floor areas move at different rates, generally causing cracking

Flexible and mould resistant materials should be applied to affected areas to prevent any subsequent water damage that is likely to occur. Regular maintenance and replacement of damage or missing or damaged sealant and grout is highly recommended to the wet areas, as this is a regular wear and tear defect. Sealant and grouting in areas that come into regular contact with water should be maintained for the long term care of your property.

A sealant specialist or tiling contractor should be appointed to complete these works as soon as possible

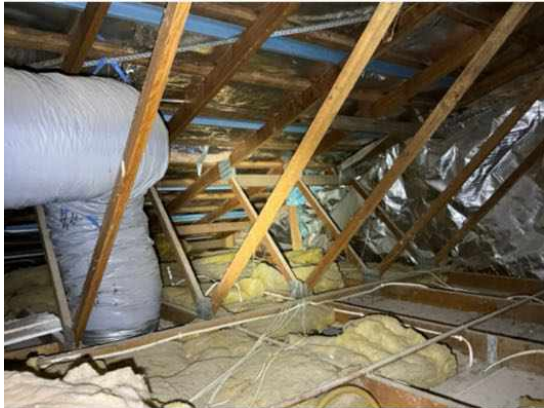
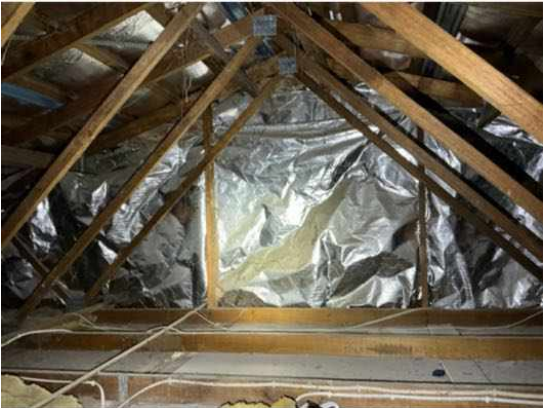
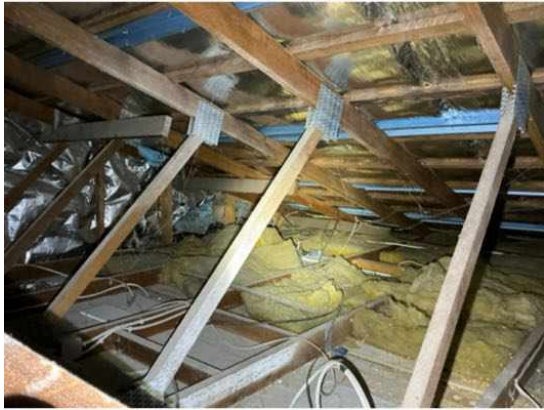
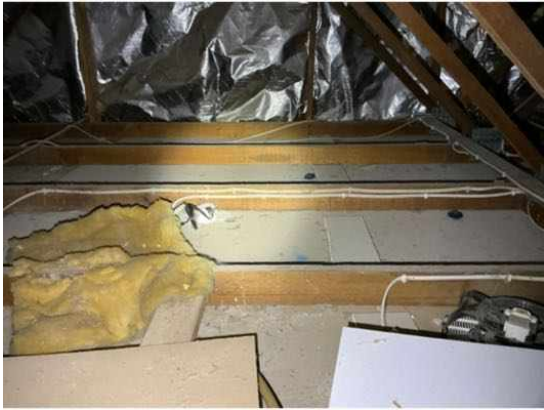
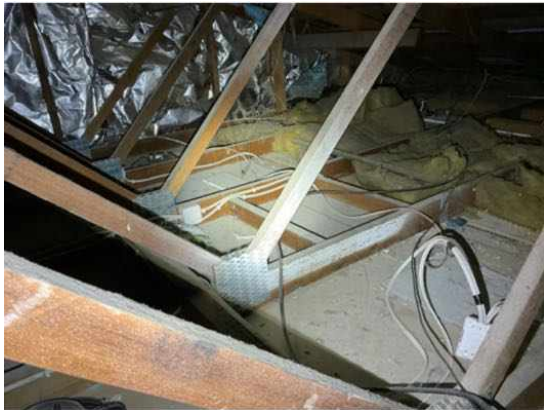
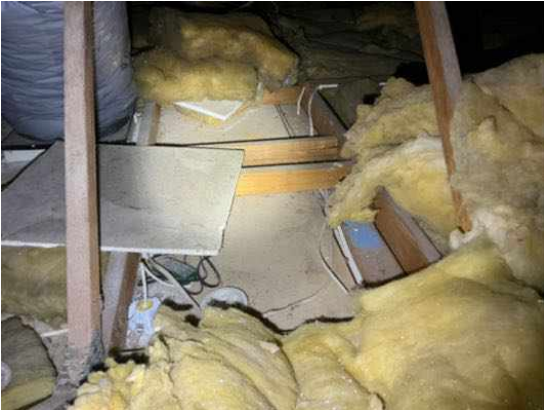
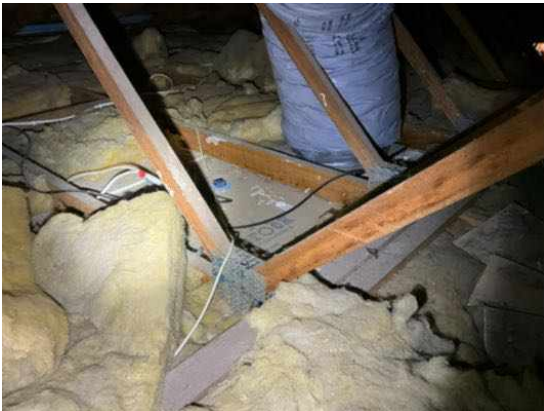
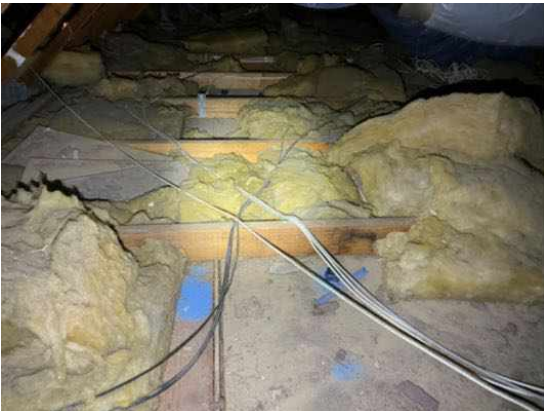
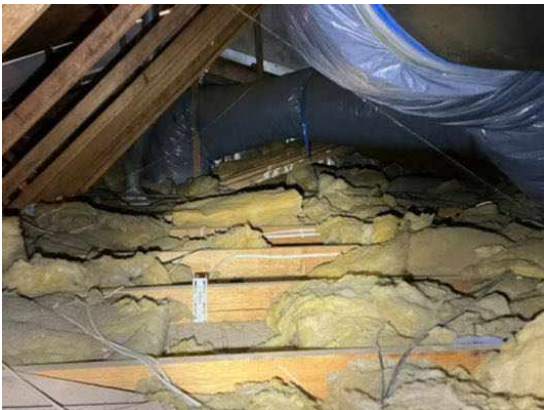
Finding 3.13

Building: Main Building
Location: Roof Void
Finding: Insulation missing
Information: On inspection of the roof cavity it was noticed that there is some insulation missing. Recommend installing insulation to improve energy costs at the owners discretion.

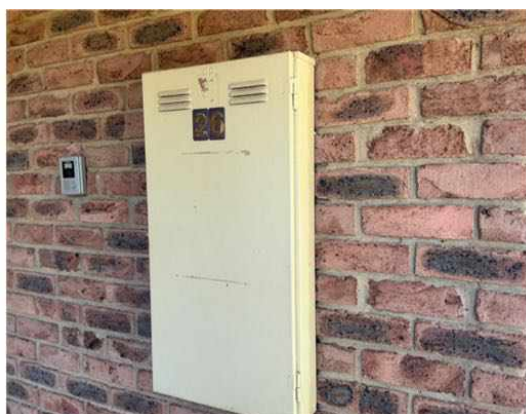
Building:	Main Building
Location:	All External Areas
Finding:	No Termite Management System - no evidence of a chemical installation
Information:	The application of a post-construction chemical termite barrier is highly recommended for all properties, particularly if live termite activity has been found on the site previously. Such barriers are highly effective in preventing termite attack on any timber building elements throughout the property.

A durable notice should be placed in the switchboard unit to indicate current termite barriers. At the time of inspection, it appeared as though no termite management system has been installed, with no evidence to suggest preventative works taking place.

The client may consider gaining further advice from a pest controller as to the costs and procedures involved with this application. It is recommended that obtaining such advice be a short-term priority.

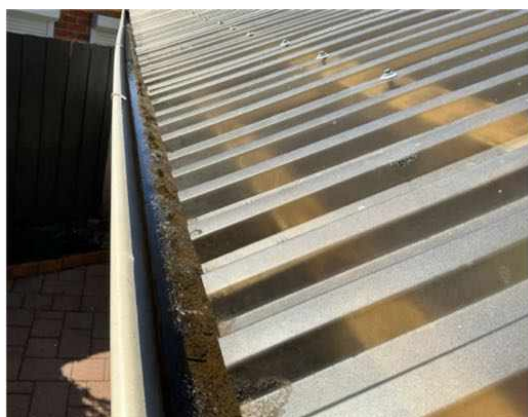
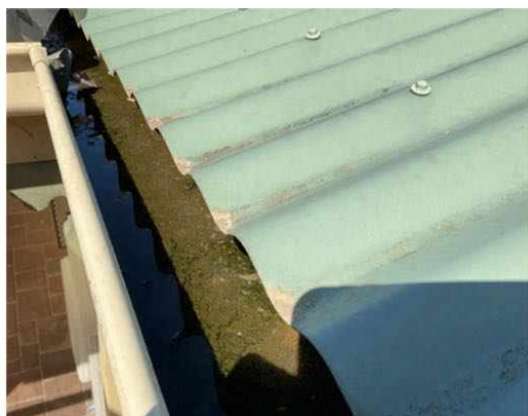
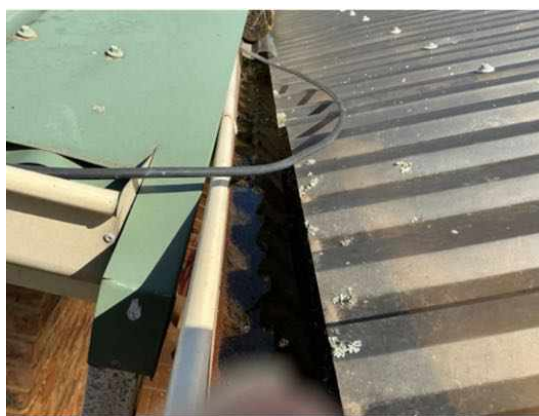
Finding 6.02

Building:	Main Building
Location:	Roof Exterior
Finding:	Gutters - Water pooling
Information:	Water was found to be pooling in sections of the rear roof and patio roof guttering. This creates excessive moisture which can attract termites. This is generally a

secondary defect caused by blocked or partially blocked gutters or if the gutters do not have enough fall to the down pipes. Such blockages and subsequent water pooling are likely to lead to rust and water damage to associated structures if left unattended.

Any areas of guttering that shows evidence of water pooling should be checked for partial or full blockages and any secondary damage that may have occurred as a result. Depending on the extent of the damage, building elements may require repair and/or replacement to ensure adequate roof drainage and function of exterior plumbing system.

A roofing plumber should be appointed as soon as possible to rectify this issue. It is highly advised that all gutters be maintained on a frequent basis to ensure the condition of roof plumbing.

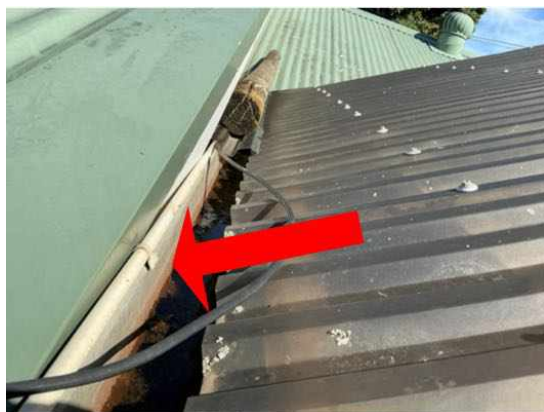
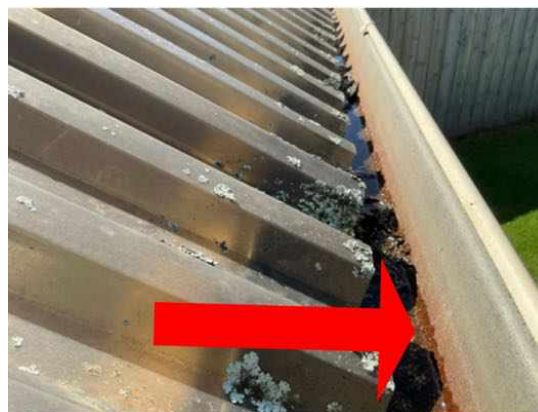
Finding 6.03

Building:	Main Building
Location:	Roof Exterior
Finding:	Gutters - Rusted or corroded
Information:	The gutters to the patio roof shows evidence of rusting and corrosion, which is likely to have developed as a result of excessive exposure to moisture and or inadequate coatings. This will cause excessive moisture and could attract termites.

As surface rust provides no protection to the underlying iron, the deteriorating condition is likely to worsen if not addressed in the short-term future.

Where possible, the use of galvanized (treated) metals or aluminium coated metals aid in rust prevention, as does regular general maintenance. Rust formation can be controlled with coatings, such as paint, that isolate the iron from the environment.

Rusting and corrosion should be managed by ideally removing or limiting the affected surface from exposure to moisture. A registered builder may be appointed to replace any building elements that have been severely affected by rust or water damage.

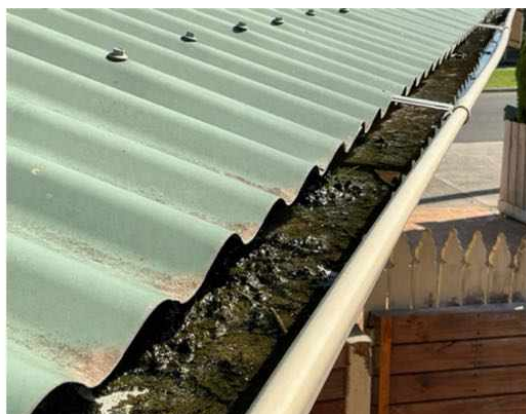
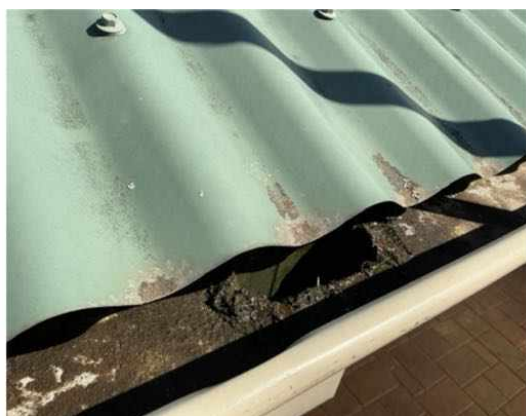
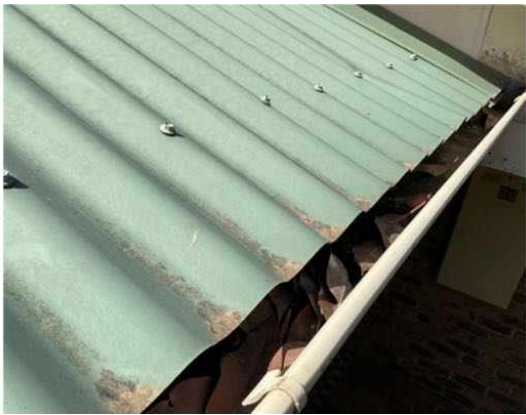
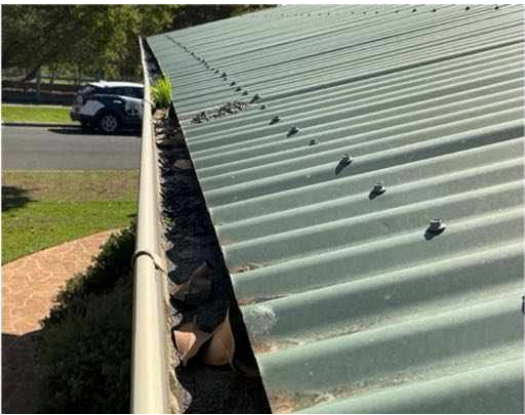
Blocked gutters are likely to lead to high levels of moisture in the affected areas. Such moisture will not only cause rust and decay of the associated building materials, but can also provide conditions that are conducive to termite and timber pest activity. Blockages in gutters should therefore be removed immediately to ensure dry conditions are maintained.

Consult a Licensed Plumber for further specific advice on remedial works that may be required. In the interim, it is highly advised that blocked gutters be removed by the homeowner or a general handyperson as a matter of urgency.

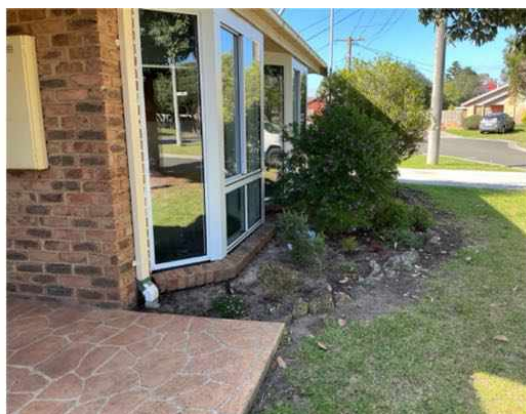
Building:	Main Building
Location:	Yards
Finding:	Site drainage - poor/inadequate
Information:	The site drainage to parts of the yards was found to be inadequate at the time of inspection. Where drainage doesn't drain adequately, the area at the base perimeter can become excessively damp, potentially creating an environment that is susceptible to rust and corrosion of surrounding building elements as well as attracting termites and other pests.

Where site drainage is inadequate, installation of an Agricultural (Aggie) Drain may be required. A qualified plumber should be appointed to further inspect the property and perform any remedial works as necessary. Water damage and secondary defects are likely to occur if left unmanaged.

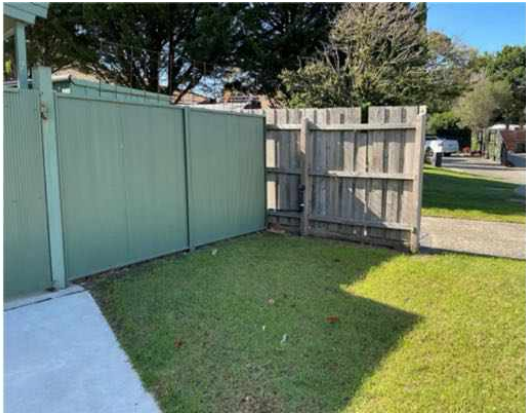
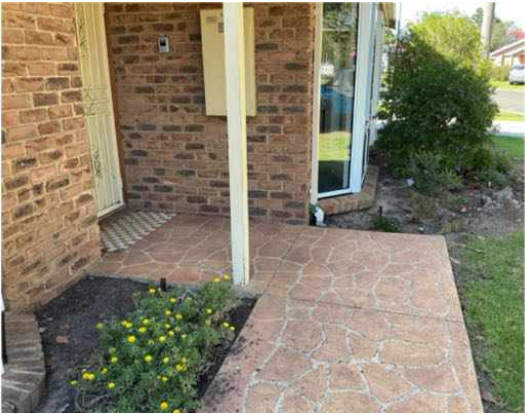
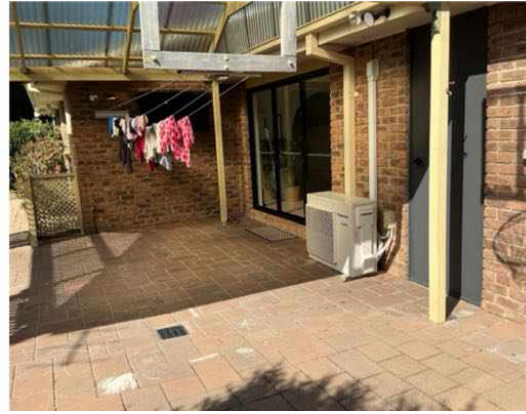
Building: Main Building
Location: Various parts of the building
Finding: In ground contact
Information: Any timbers in direct ground contact provide opportunity for concealed termite entry and are likely to be subject to premature rot and decay as the soil retains moisture or damp conditions against the timbers.

Remove untreated timber that is in direct contact with external grounds. Consider replacement with more durable materials i.e. treated timber or non timber elements. Frequent pest inspections are advised to readily identify any termite activity in these areas.

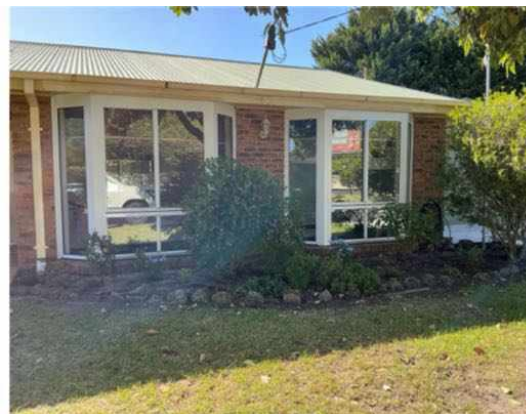
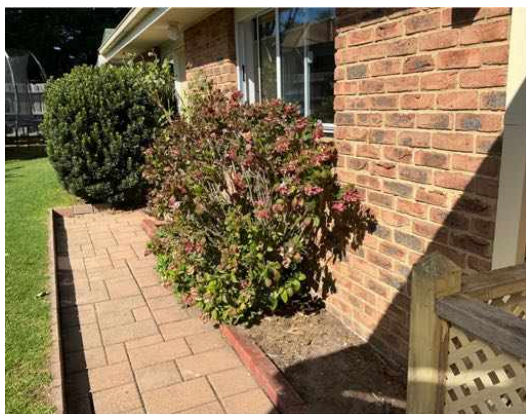
Finding 6.12

Finding: Garden Beds Conditions Conducive to Termites

Information: Garden beds were found to be evident in close proximity to the building. Garden beds immediately adjacent to the perimeter of the building block the visual inspection of these areas, providing a concealed termite entry point.

These garden beds can include untreated timber, and with a combination of moisture from watering hosing can make conditions conducive to termite activity and termite ingress.

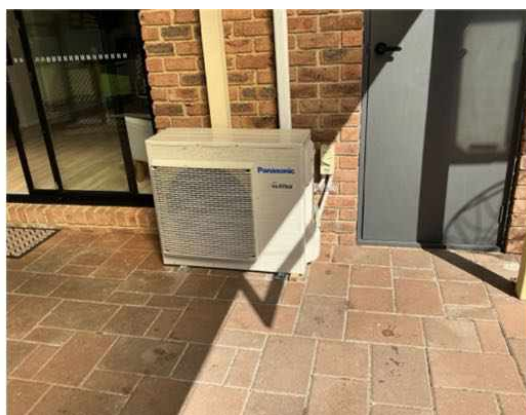
Finding 6.13

Building:	Main Building
Location:	Yard - Back
Finding:	Air conditioning unit overflow -Not plumbed for drainage
Information:	The overflow to the air conditioning unit is not plumbed or connected to suitable drainage, which has resulted in the surrounding area becoming excessively damp. These damp conditions can lead to secondary defects such as rot, rust or corrosion of associated building elements, the formation of fungal decay, or even the creation of potential slip hazards. When coupled with poor site drainage, pooling of water may also attract termite activity to this area. It is highly recommended that a qualified plumber be appointed to install adequate drainage to the overflow. These works will ensure that the area remains dry and free of any secondary defects.

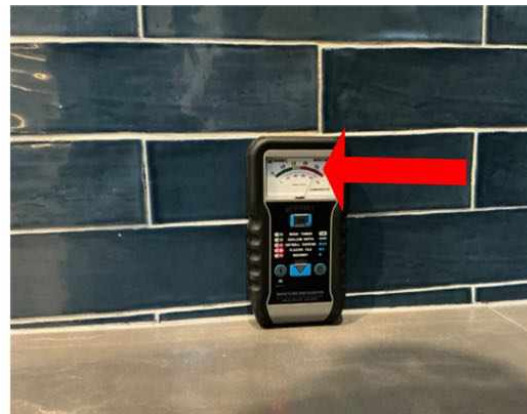
Finding 6.14

Building:	Main Building
Location:	Bathroom
Finding:	Shower - Damp
Information:	Damp is evident to parts of the bathroom shower alcove found using using a moisture meter. This defect is quite common, and is suspected to have been caused by moisture permeating through the grouting in this area, which shows evidence of

Always ensure that sealant and grout is in good condition to prevent any moisture issues occurring in the future.

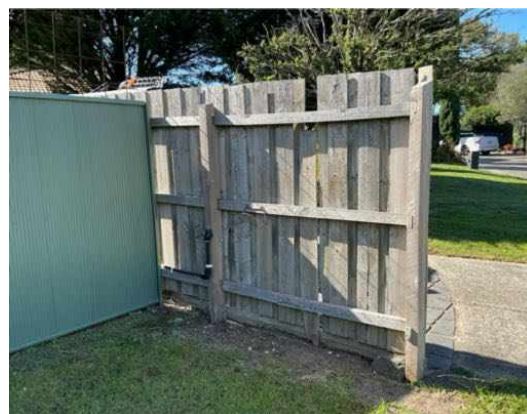
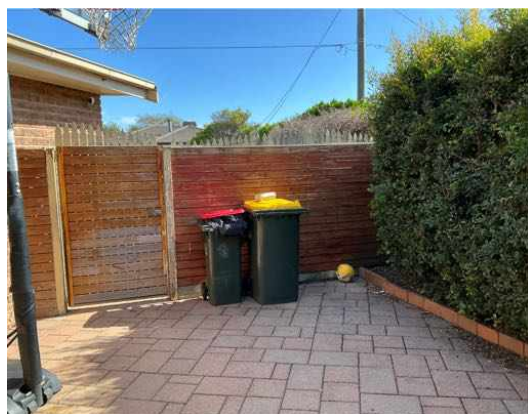
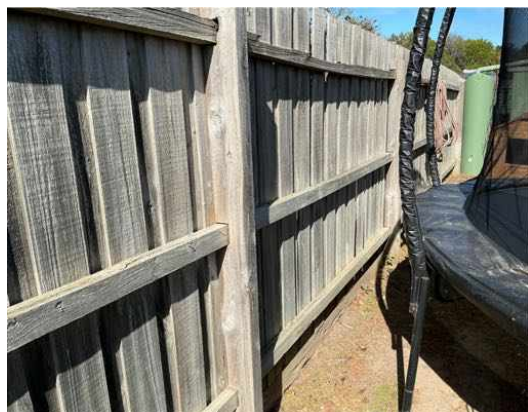
Finding: Fencing - wood rot-fungal decay

A licensed fencing contractor should be appointed to provide further advice and perform rectification works as necessary.

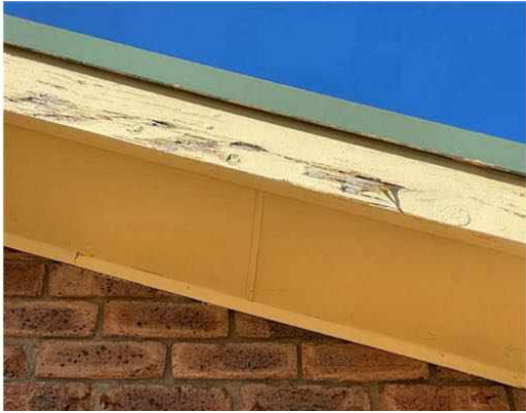
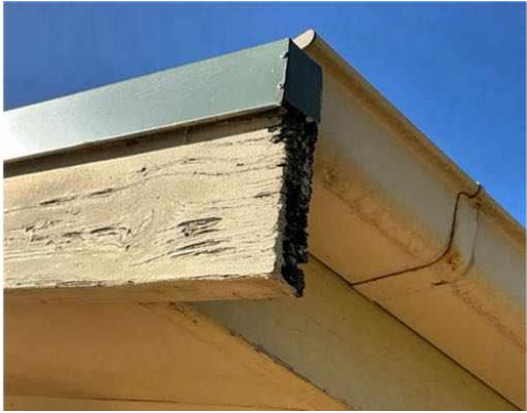
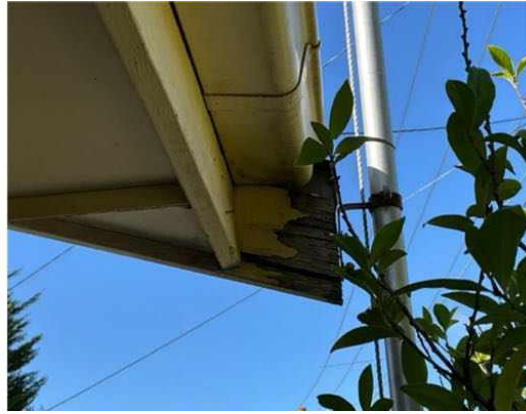
Finding 7.02

Building:	Main Building
Location:	Exterior walls
Finding:	Fascias - Wood rot
Information:	Wood rot was found to be affecting fascias/barges to various parts of the building evidenced by the presence of mould on the surface in some areas. Wood rot, also known as Fungal Decay, occurs when timbers and other cellulose building materials are exposed to damp conditions on an ongoing basis.

to provide advice on any remedial works as required. A qualified carpenter or registered builder may also be required to replace affected building materials.
