Building and Timber Pest Inspection Report VR

Inspection Date: Thu, 2 Apr 2026

Property Address: 15 Abelia Ave, Yamba NSW 2464, Australia

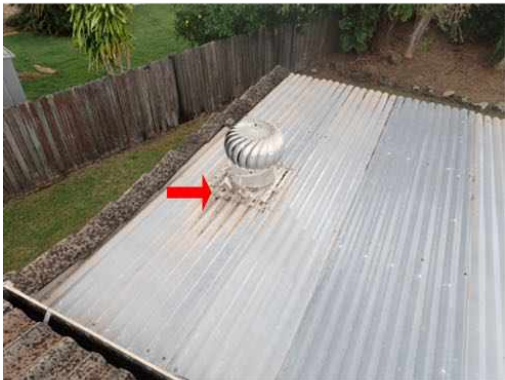
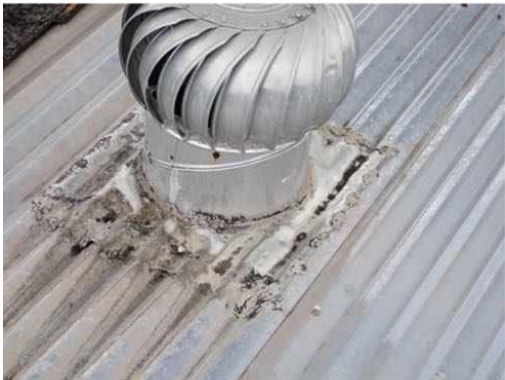
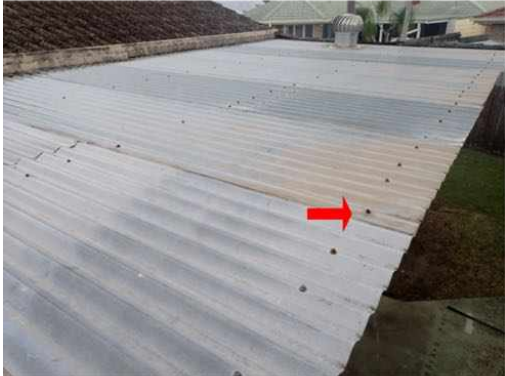
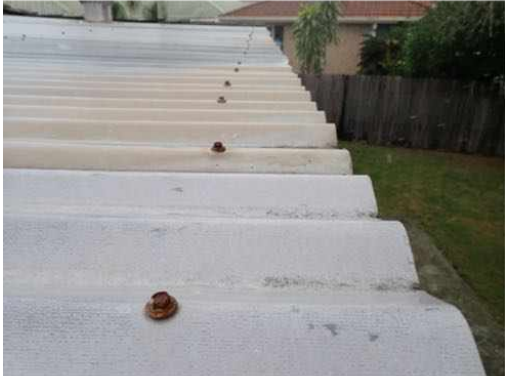
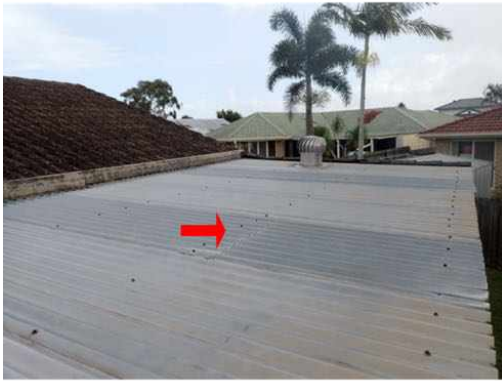
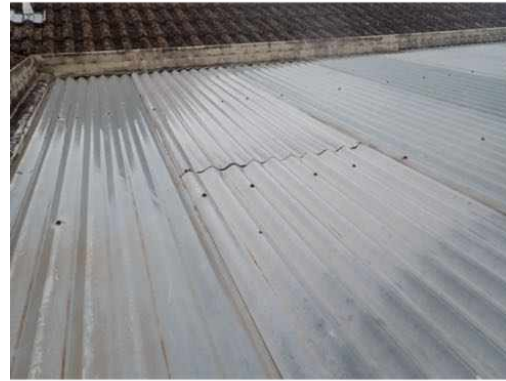
Finding 2.01

Building: Main Building
Location: Roof
Finding: Defects To Colorbond Roof Over Outdoor Entertaining Area
Information: Defects were identified to the Colorbond roof over the outdoor entertaining area, including rusted screws, poorly lapped sheets, a poorly installed whirlybird, and general age-related deterioration. These issues are typically associated with weather exposure, ageing materials, and poor installation practices. If left unaddressed, they may lead to water ingress, corrosion, and reduced roof performance. It is recommended that a licensed roofer inspect and carry out necessary repairs or replacement of defective components to prevent further deterioration and potential water damage to the structure.

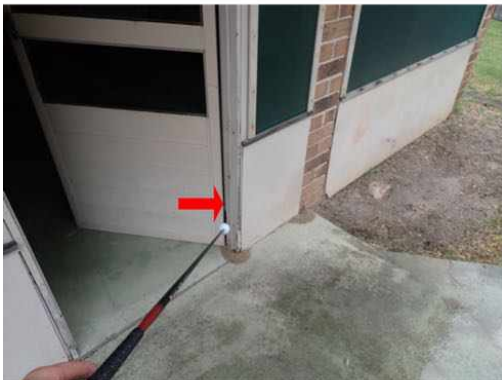
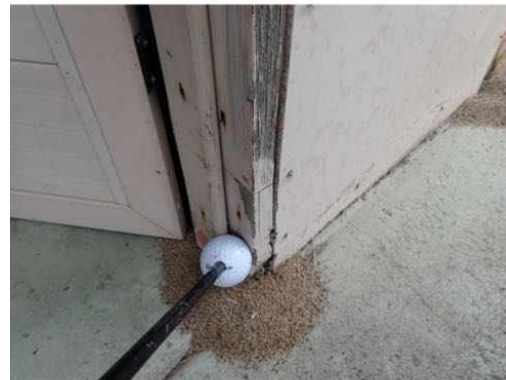
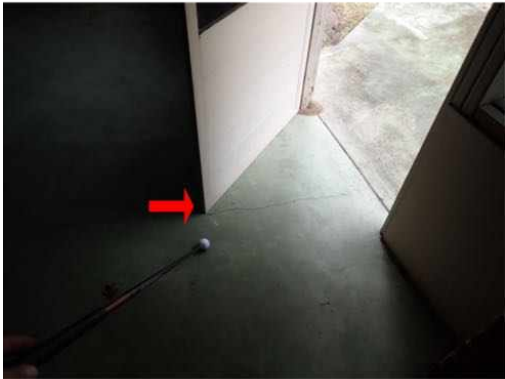
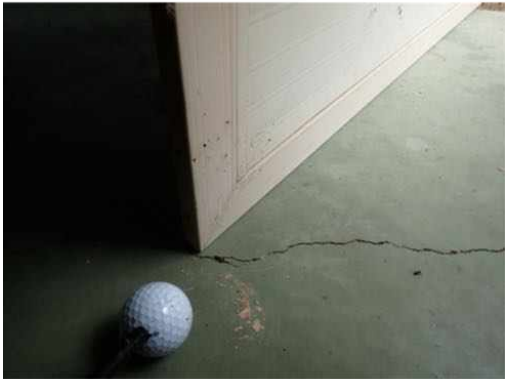
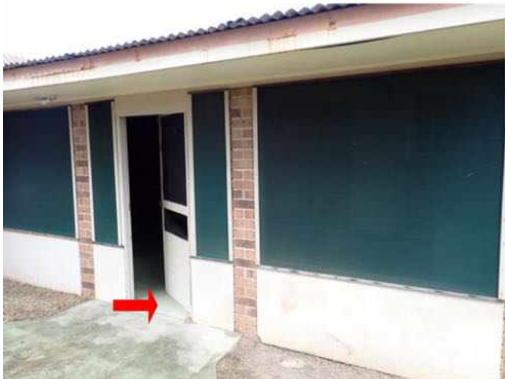
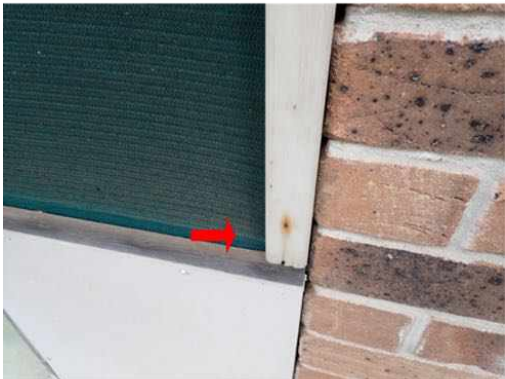
Finding 2.02

Building:	Main Building
Location:	Out door entertaining room
Finding:	Poorly Constructed And Deteriorated Infill Walls And Door To Outdoor Entertaining Room
Information:	The infill walls and door to the outdoor entertaining room were found to be poorly constructed and in a deteriorated condition. This is likely due to substandard workmanship, weather exposure, and age-related wear. Defects of this nature may compromise overall durability if left unaddressed. It is recommended that a licensed builder or carpenter assess the construction, carry out necessary repairs or replacement, and ensure the structure is built to an acceptable standard. Repairs are recommend to prevent further deterioration.

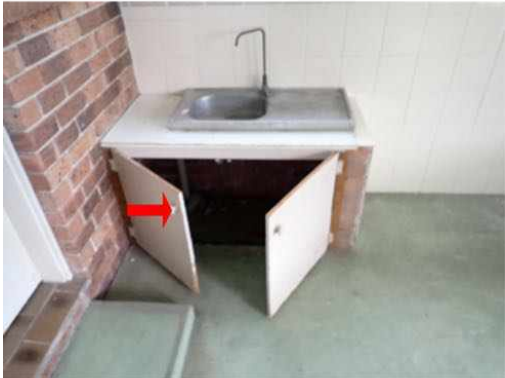
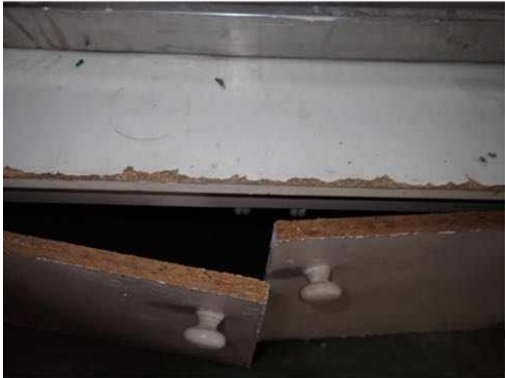
Finding 2.03

Building: Main Building
Location: Out door entertaining room
Finding: Outdoor Entertaining Room Sink Unit In Poor Condition
Information: The sink unit in the outdoor entertaining room was observed to be in poor condition. This may be due to age-related deterioration, weather exposure, or general wear and tear. Components may continue to deteriorate over time, potentially affecting functionality and leading to further damage if left unaddressed. It is recommended that a licensed plumber or suitably experienced handyman assess the unit and carry out repairs or replacement as required. Repairs can be carried out at the owner's discretion.

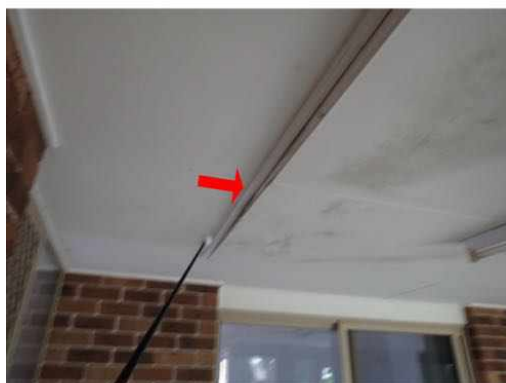
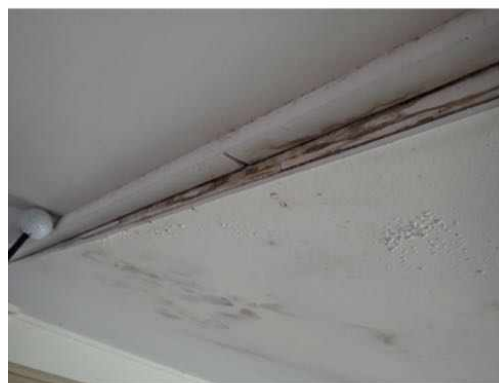
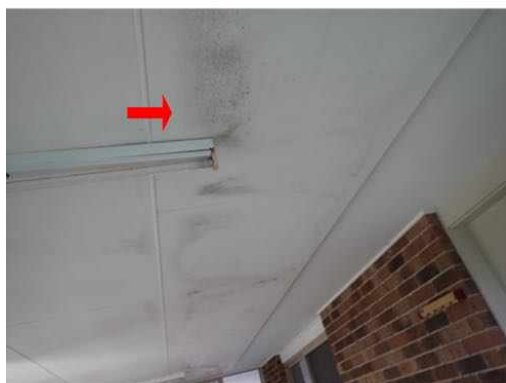
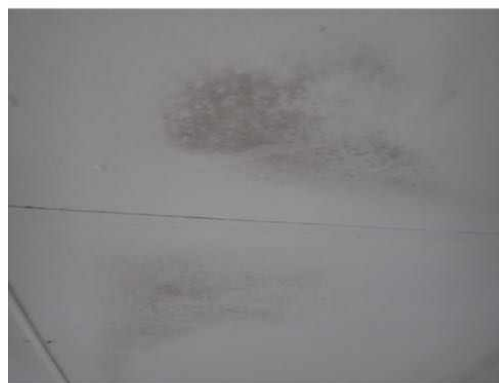
Finding 2.04

Building:	Main Building
Location:	Out door entertaining room
Finding:	Water Staining To Outdoor Entertaining Room Ceiling
Information:	Water staining was identified to the ceiling of the outdoor entertaining room, possibly resulting from minor leaks from the Colorbond roof above. This is typically associated with roofing defects, inadequate sealing, or age-related deterioration. If left unaddressed, continued moisture ingress may lead to further damage to ceiling materials and surrounding structures. It is recommended that a licensed roofer inspect the roof and rectify any defects, and that a suitably experienced handyman or painter repair the affected ceiling once the source of moisture has been addressed. Timely repairs are recommended to prevent further deterioration and potential damage.

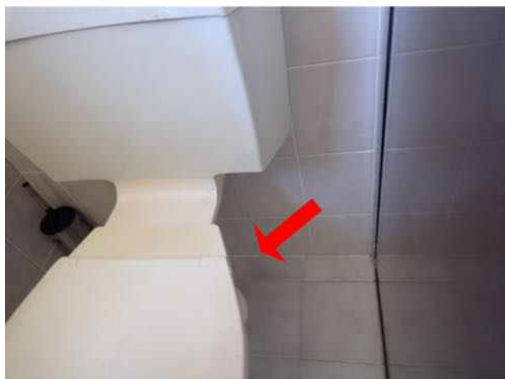
Finding 3.01

Building:	Main Building
Location:	Toilet (WC)
Finding:	Minor Leak to Toilet Cistern During Flushing

Information: A minor leak was identified to the toilet cistern during flushing. The leak is likely associated with worn internal components such as the inlet valve, outlet seal, or flush mechanism. Continued leakage may lead to unnecessary water wastage and potential deterioration to surrounding building materials over time. It is recommended that a licensed plumber inspect, repair, or replace the defective components as required. Repairs should be undertaken at the owner’s discretion.

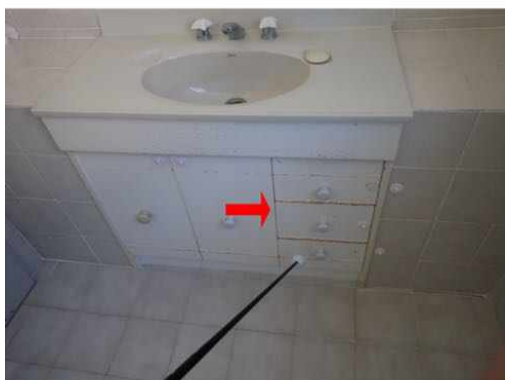
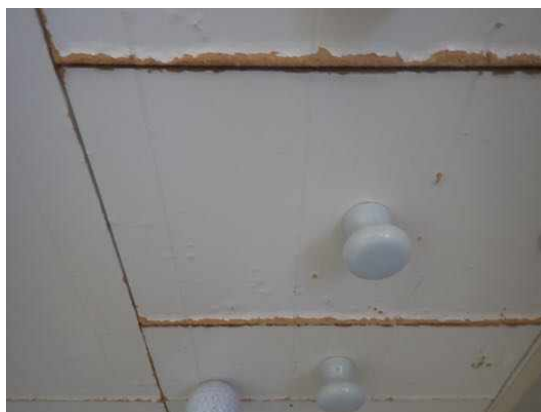
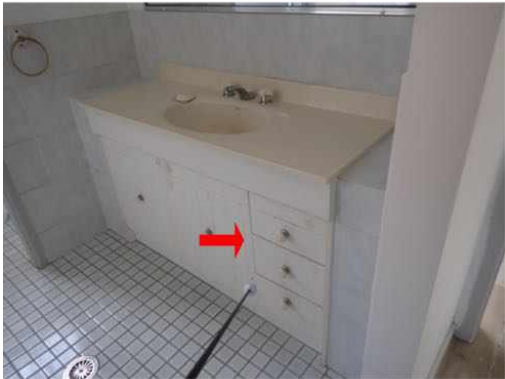
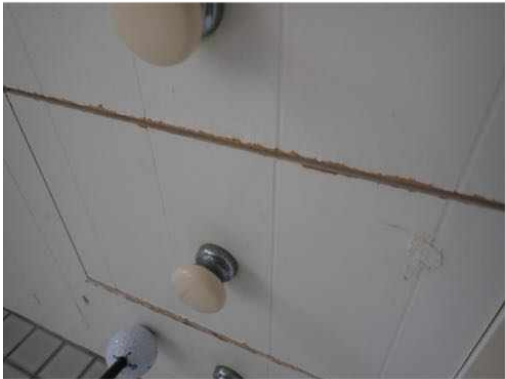
Finding 3.02

Building: Main Building
 Location: Bathroom and ensuite
 Finding: Swelling to Bathroom and Ensuite Vanity Doors and Drawer Fronts
 Information: Swelling was identified to the edges of the bathroom and ensuite vanity doors and drawer fronts. This condition is consistent with moisture ingress and age-related deterioration of the materials, likely due to prolonged exposure to humidity and water. This is a common defect in property’s of this age. Continued exposure may result in further deterioration of the cabinetry. A cabinet maker or suitably experienced handyman should be engaged to repair or replace the affected components as required. Repairs should be undertaken at the owner’s discretion.

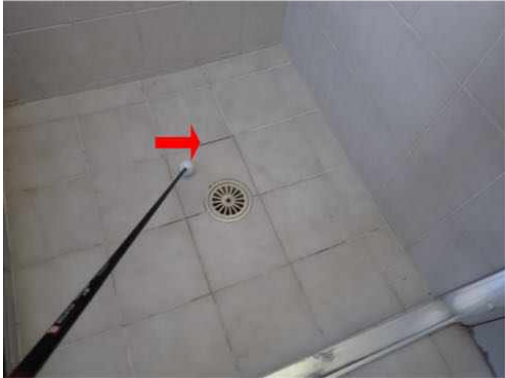
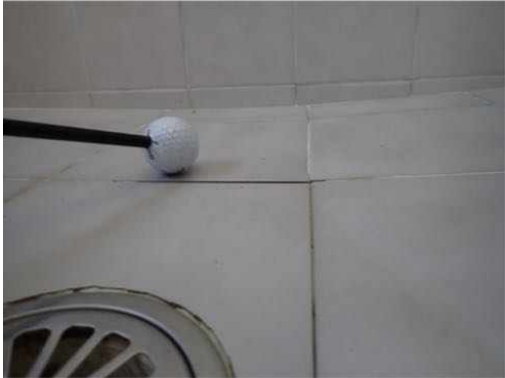
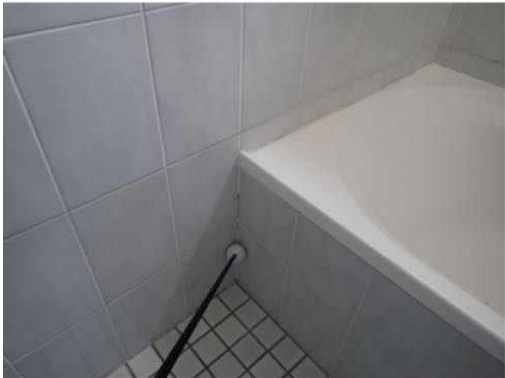
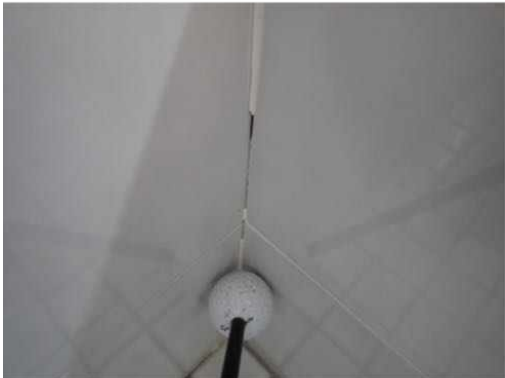
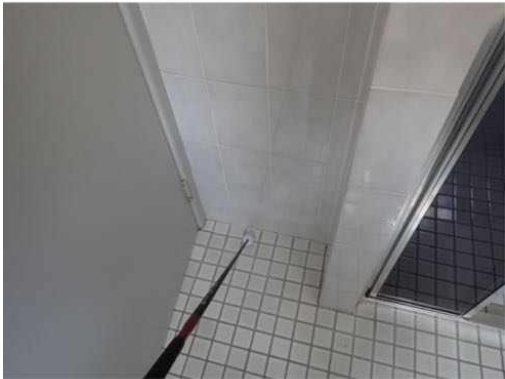
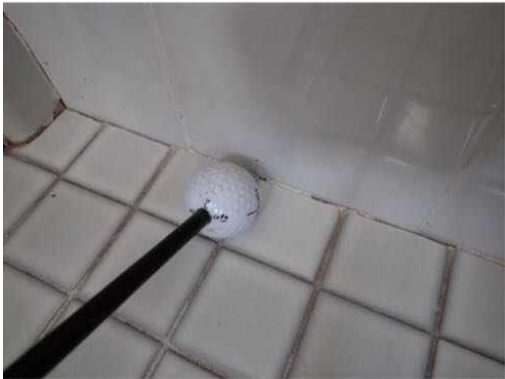
Finding 3.03

Building: Main Building
Location: Bathroom and ensuite
Finding: Deteriorated Grout and Silicone to Bathroom and Ensuite Tiled Surfaces
Information: Deterioration of grout and silicone was identified to the bathroom and ensuite tiled surfaces. This condition is consistent with age-related wear and ongoing exposure to moisture, and is a common defect in wet areas. Deteriorated seals may allow water ingress behind tiles, potentially leading to damage of underlying building materials over time. A licensed tiler should be engaged to re-grout and re-seal the affected areas as required. Repairs should be undertaken at the owner’s discretion.

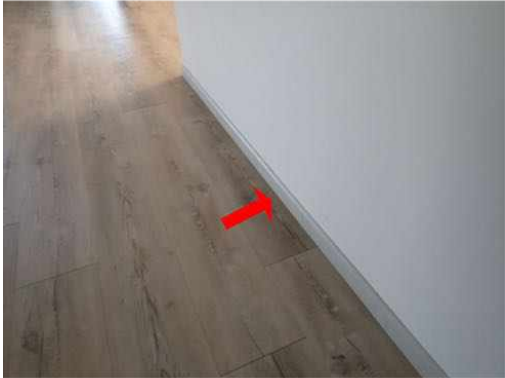
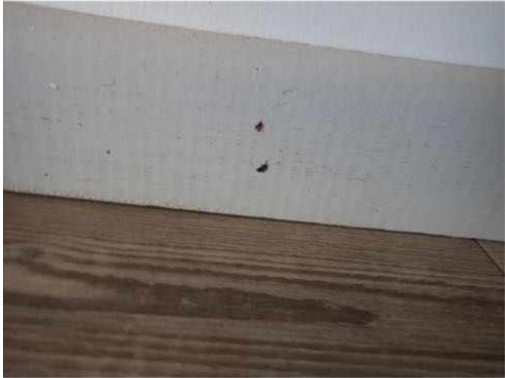
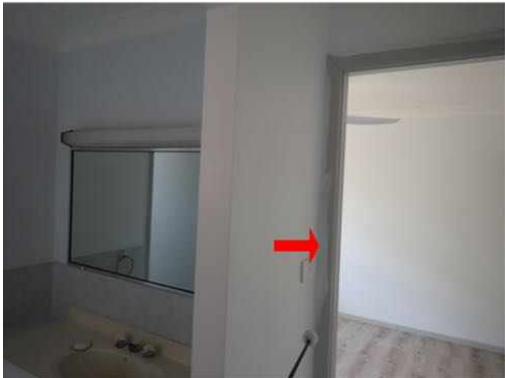
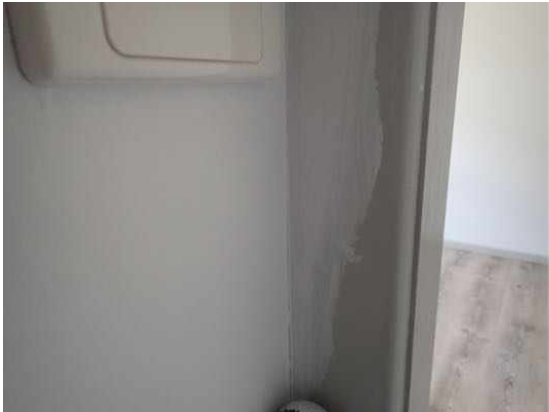
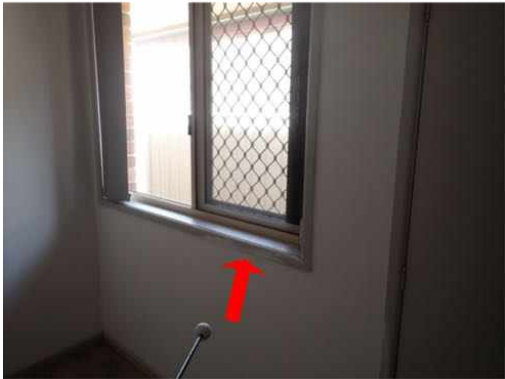
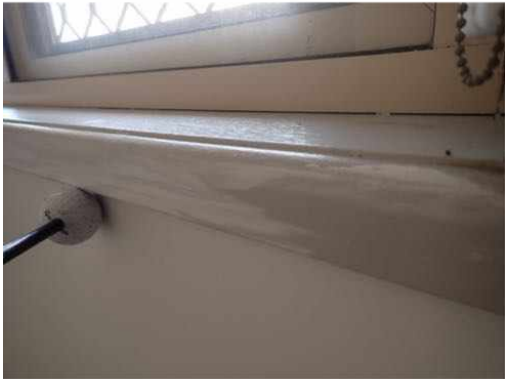
Finding 3.04

Building: Main Building
Location: All Areas
Finding: Unpainted Timber Trims And Exposed Nail Holes
Information: Timber trims have been installed with visible nail holes and sections left unpainted. This is typically due to incomplete finishing works or poor workmanship during installation. Unsealed timber can absorb moisture over time, leading to deterioration, swelling, or potential timber decay. It is recommended that a painter or suitably experienced handyman fill all nail holes, sand, and apply appropriate primer and paint to seal and protect the timber. Repairs can be carried out at the owner’s discretion.

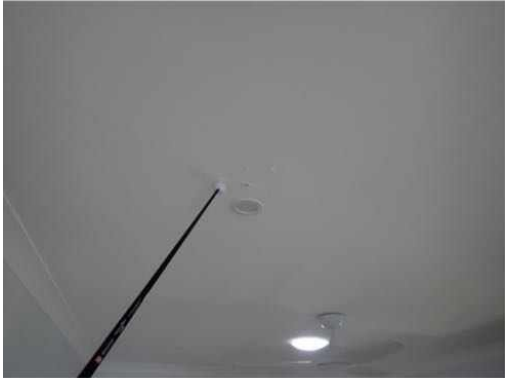
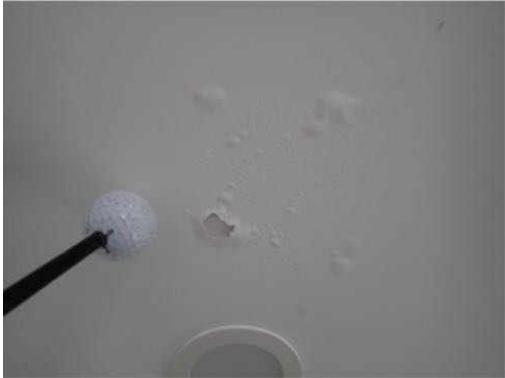
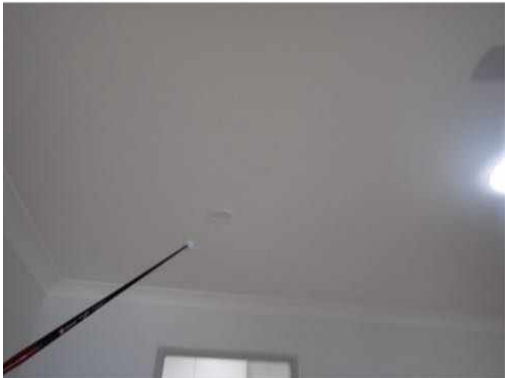
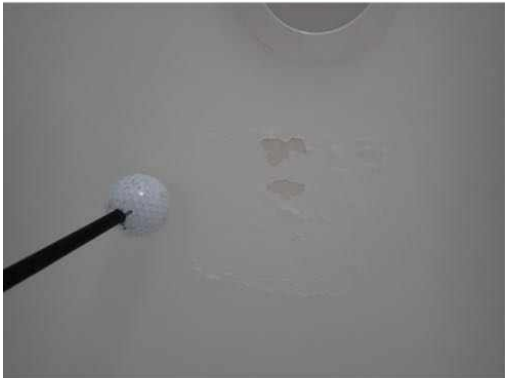
Finding 3.05

Building: Main Building
Location: Living room
Finding: Flaking Paint To Living Room Ceiling
Information: Paint is flaking in sections of the living room ceiling. This is typically associated with age-related deterioration, moisture exposure, or inadequate surface preparation during previous painting works. Continued deterioration may result in further paint loss and potential exposure of underlying surfaces. It is recommended that a painter or suitably experienced handyman prepare the affected areas, address any underlying cause if present, and repaint as required. Repairs can be carried out at the owner’s discretion.

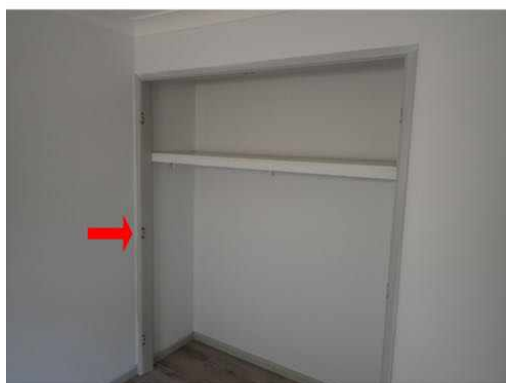
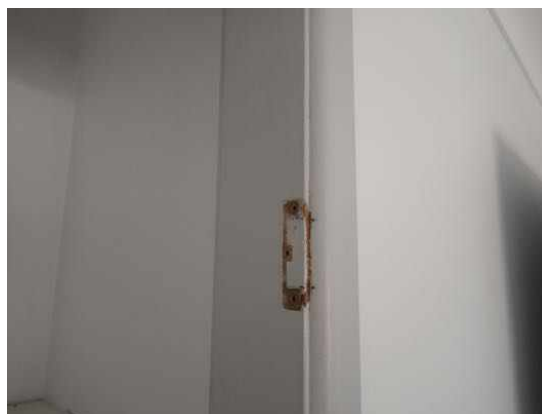
Finding 3.06

Building:	Main Building
Location:	Bedroom
Finding:	Missing Robe Doors To Bedroom
Information:	Robe doors are missing within the bedroom. This may be due to removal, damage, or incomplete installation. The absence of doors reduces functionality and allows dust accumulation within the robe space. It is recommended that a carpenter or suitably experienced handyman install replacement doors to restore functionality. Repairs can be carried out at the owner's discretion.

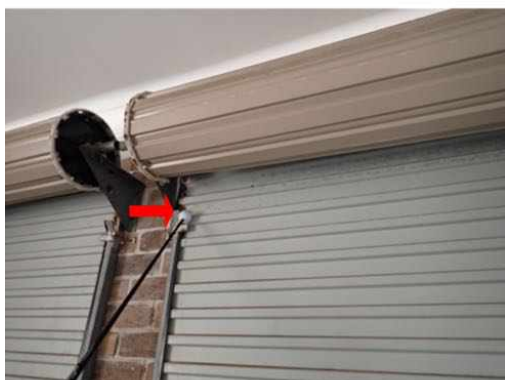
Finding 3.07

Building:	Main Building
Location:	Garage
Finding:	Surface Rust To Garage Roller Door Edges
Information:	Surface rust has been identified to the edges of the garage roller doors. This is typically associated with age-related deterioration, exposure to moisture, or breakdown of protective coatings and is a common defect with garage roller doors of this age. If left untreated, rust may progress and lead to further corrosion and deterioration of the metal components. It is recommended that a painter, metal fabricator, or suitably experienced handyman treat the affected areas, remove corrosion, and apply appropriate protective coatings. Repairs can be carried out at the owner's discretion.

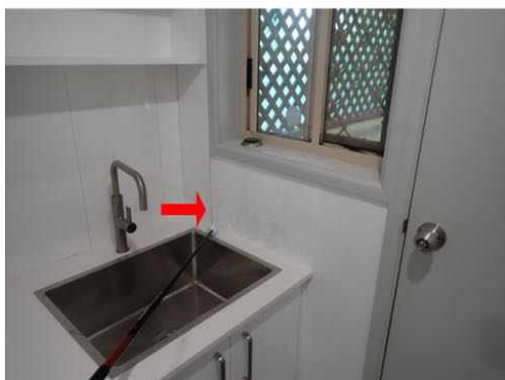
Finding 3.08

Building:	Main Building
Location:	Laundry
Finding:	Missing Tiles To Laundry Splashback
Information:	Tiles are missing to the laundry splashback area. This may be due to previous removal, damage, or incomplete installation works. The absence of tiles can expose underlying wall materials to moisture ingress, potentially leading to deterioration over time. It is recommended that a tiler or suitably experienced handyman replace the missing tiles and ensure appropriate sealing to prevent moisture penetration. Repairs can be carried out at the owner's discretion.

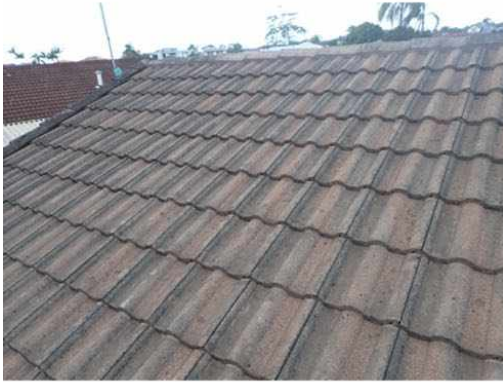
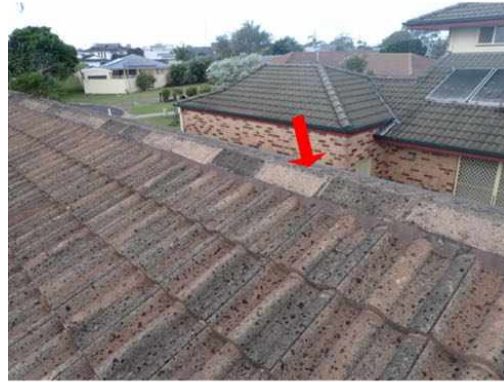
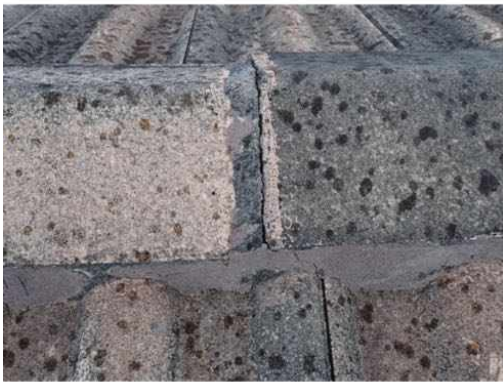
Finding 3.09

Building:	Main Building
Location:	Roof
Finding:	Roof Tiles In Fair Condition With Age Related Fading And Minor Mortar Cracking
Information:	Roof tiles were observed to be in fair condition overall, however age-related fading and minor cracking to the mortar have been identified. This is typical wear and tear for roofing materials of this age. Over time, cracked mortar may allow water ingress or tile movement if deterioration progresses. It is recommended that a licensed roofer inspect, repair, and re-point mortar as required to maintain the integrity of the roof. Repairs can be carried out as deemed necessary.

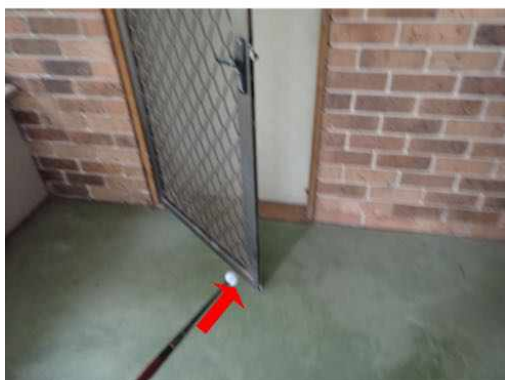
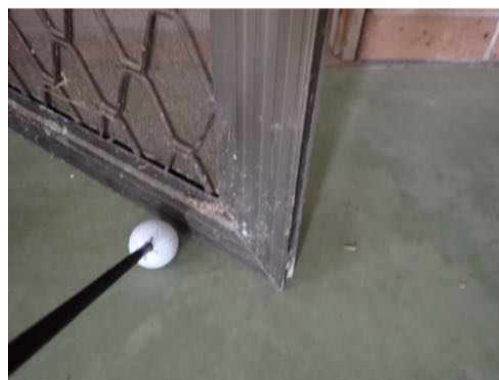
Finding 3.10

Building:	Main Building
Location:	Out door entertaining room
Finding:	Garage Screen Door Catching On Concrete Floor
Information:	The garage screen door was observed to be catching on the concrete floor. This is typically due to misalignment, settlement, wear to hinges or tracks, or minor movement in the structure. Continued use may cause further damage to the door or floor surface. It is recommended that a carpenter or suitably experienced handyman adjust, repair, or realign the door to ensure smooth operation. Repairs can be carried out at the owner's discretion.

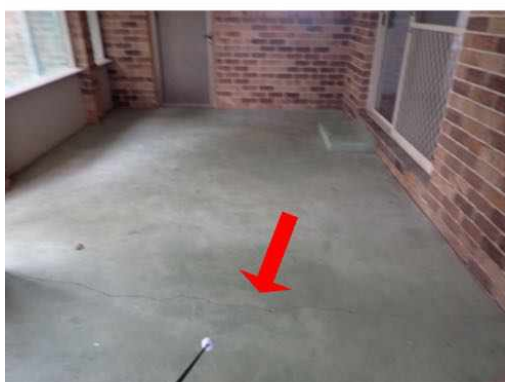
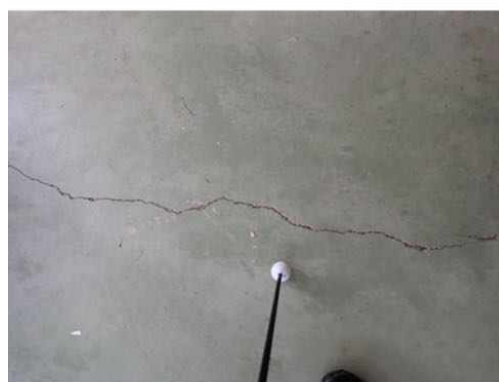
Finding 3.11

Building:	Main Building
Location:	Out door entertaining room
Finding:	Crack To Outdoor Entertaining Room Concrete Floor
Information:	A crack has been identified in the concrete floor of the outdoor entertaining room. This is typically associated with minor movement, shrinkage, or age-related deterioration of the concrete. If the crack worsens over time, it may allow moisture ingress or further deterioration. It is recommended that a concreter or suitably experienced handyman assess and repair the crack as required. Repairs can be carried out at the owner's discretion.

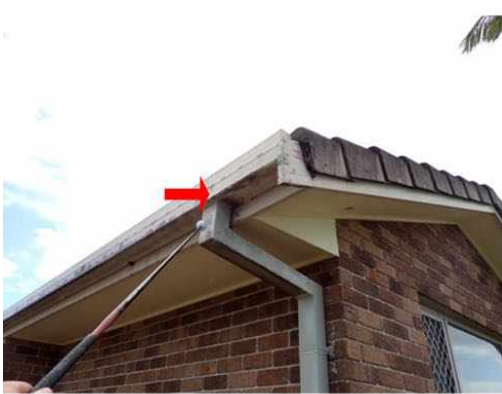
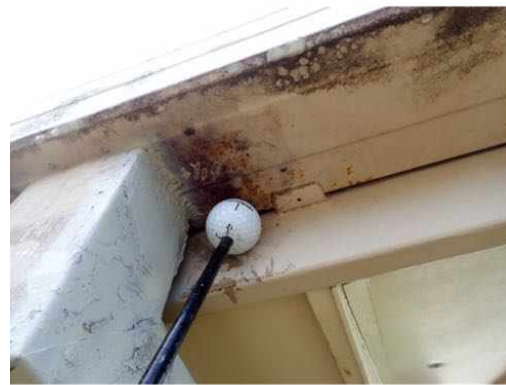
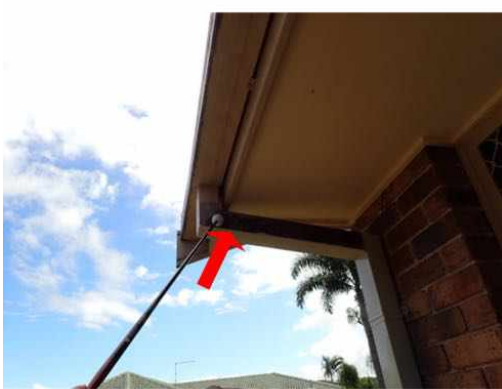
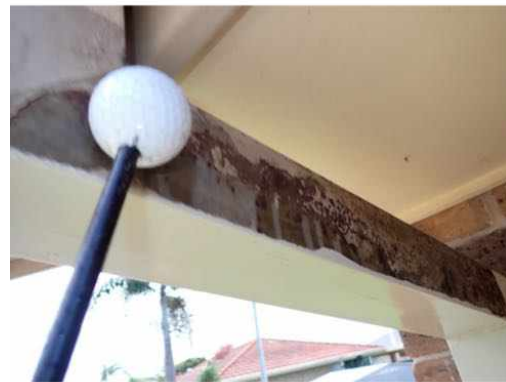
Finding 3.12

Building:	Main Building
Location:	Down pipes
Finding:	Surface Rust To Downpipe And Adjacent Gutter
Information:	Surface rust has been identified to the downpipe and surrounding gutter area. This is typically associated with age-related deterioration, prolonged moisture exposure, or breakdown of protective coatings. If left untreated, corrosion may progress and lead to leaks or failure of the affected components. It is recommended that a licensed plumber or suitably experienced handyman clean, treat, and apply protective coatings, or replace sections as required. Repairs can be carried out at the owner's

discretion.

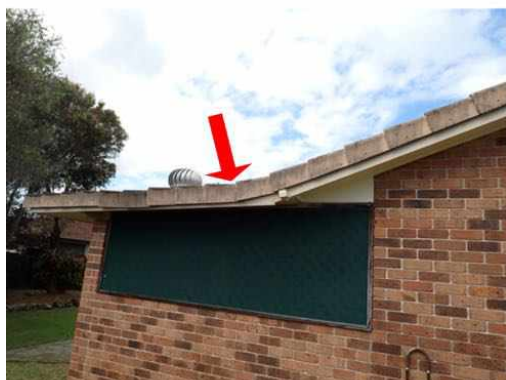
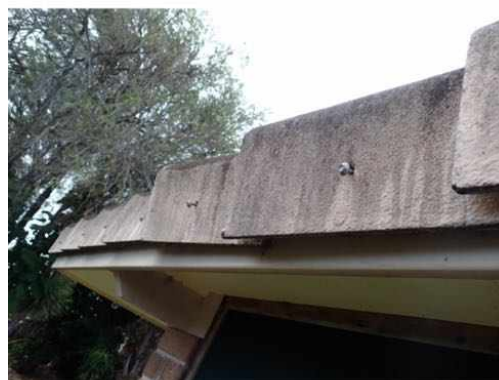
Finding 3.13

Building:	Main Building
Location:	Rear fascia
Finding:	Poorly Repaired Roof Tile End Capping To Rear Of Building
Information:	The roof tile end capping at the rear of the building has been poorly repaired. This is likely due to substandard workmanship. Defective capping may allow water ingress and lead to further deterioration if left unaddressed. It is recommended that a licensed roofer re-bed and re-point the end capping to ensure a durable and watertight finish. Timely repairs are recommended to prevent further deterioration and potential damage.

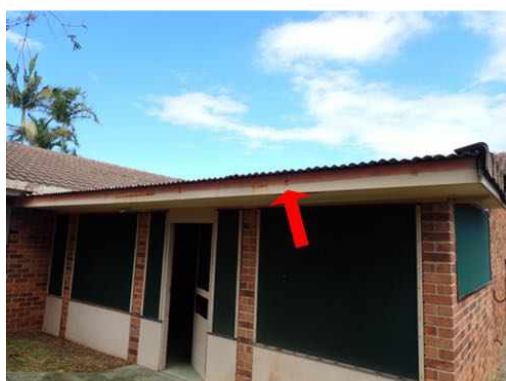
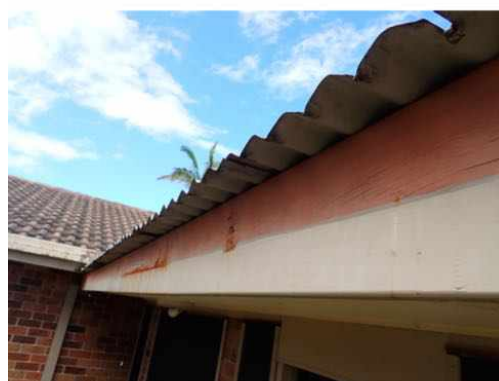
Finding 3.14

Building:	Main Building
Location:	Out door entertaining room
Finding:	Missing Gutter To Outdoor Entertaining Room Roof
Information:	A gutter is missing to the outdoor entertaining room roof. This may be due to removal, damage, or incomplete installation. The absence of a gutter can result in uncontrolled water discharge, potentially leading to water ingress, erosion, or damage to adjacent building elements. It is recommended that a licensed plumber or suitably experienced handyman install an appropriate gutter system to manage roof water effectively.

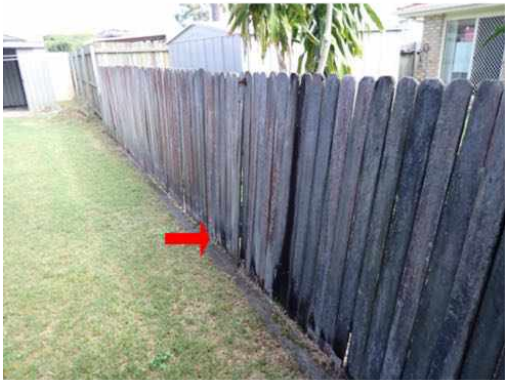
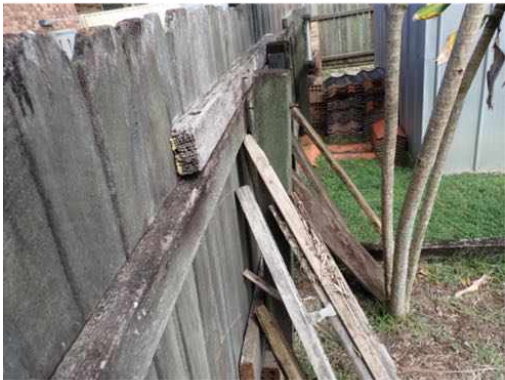
Finding 3.15

Building:	Yard
Location:	Rear timber fence
Finding:	Rear Timber Fence In Average Condition
Information:	The rear timber fence was observed to be in average condition. This is typical for fencing of this age and may include general wear, weathering, and minor deterioration. Ongoing exposure to the elements may result in further deterioration over time. It is recommended that a carpenter or suitably experienced handyman carry out general maintenance and repairs as required to prolong the service life of the fence. Repairs can be carried out at the owner's discretion.

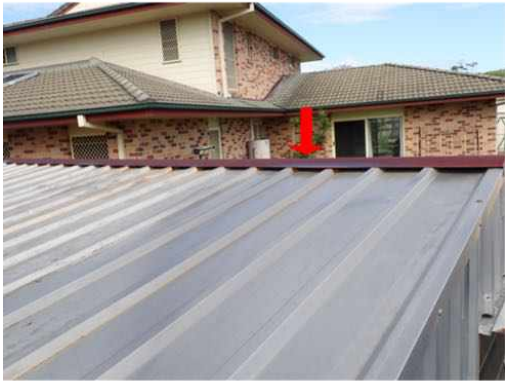
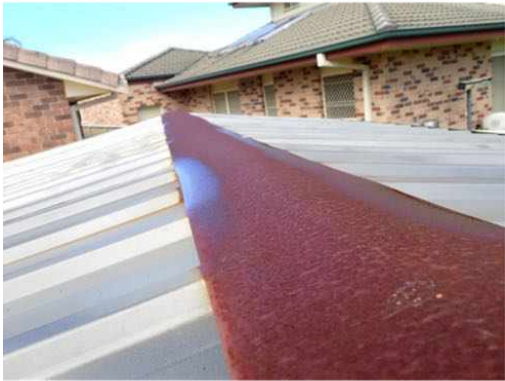
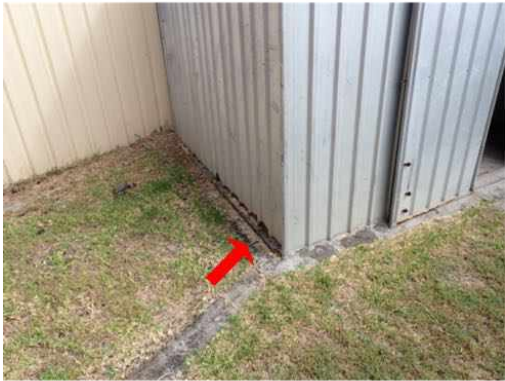
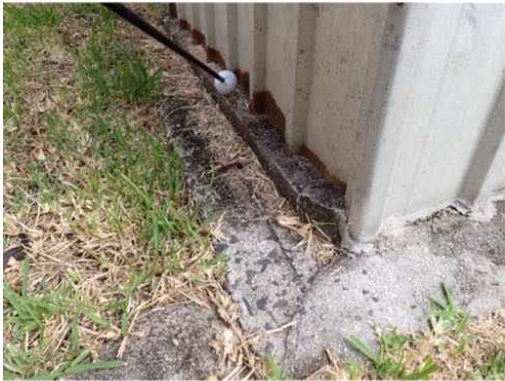
Finding 3.16

Finding: Surface Rust To Tin Garden Shed

Information: Surface rust has been identified to the tin garden shed at several locations. This is typically associated with age-related deterioration, weather exposure, and breakdown of protective coatings. If left untreated, corrosion may progress and lead to further deterioration of the metal panels. It is recommended that a painter, metal fabricator, or suitably experienced handyman treat the affected areas, remove corrosion, and apply appropriate protective coatings. Repairs can be carried out at the owner's discretion.

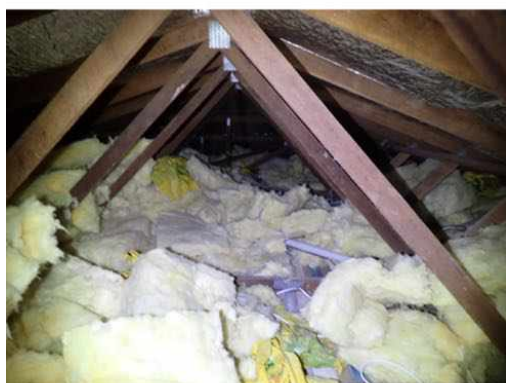
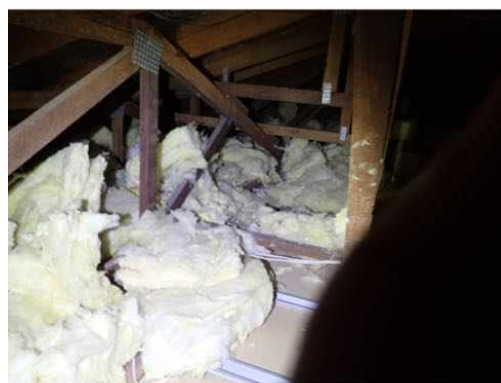
Finding 3.17

Building:	Main Building
Location:	Ceiling space
Finding:	Ceiling Insulation Displaced Within Roof Space
Information:	Insulation within the ceiling space has been moved and is no longer evenly distributed. This may be due to previous works, maintenance activity, or pest movement within the roof space. Displaced insulation can reduce thermal efficiency and may lead to inconsistent temperature control within the building. It is recommended that a suitably experienced handyman or insulation contractor reposition and reinstate the insulation to ensure even coverage. Repairs can be carried out at the owner's discretion.

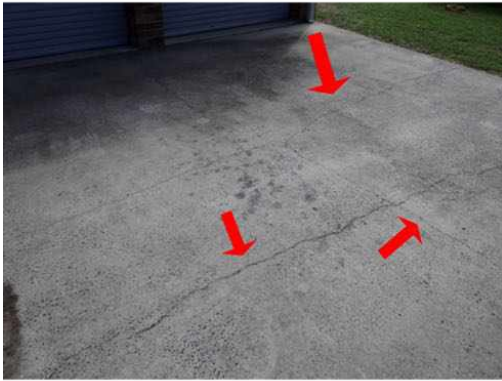
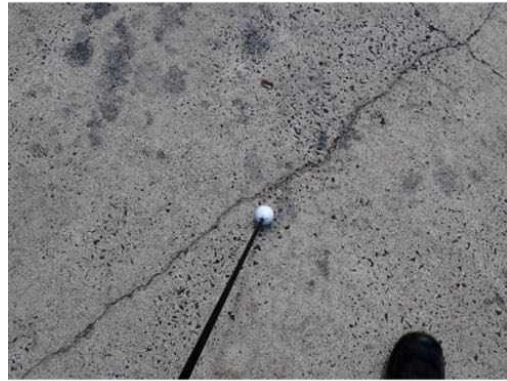
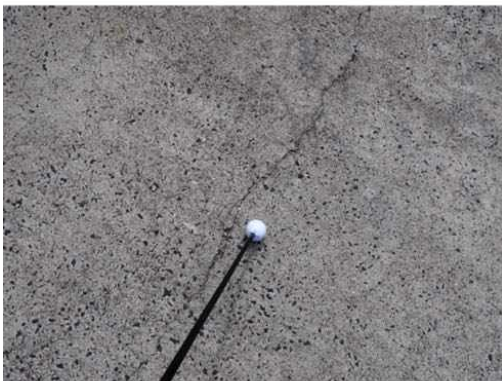
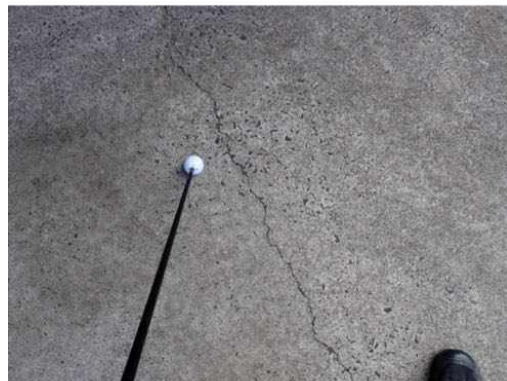
Finding 3.18

Building:	Yard
Location:	Driveway
Finding:	Minor Cracking To Concrete Driveway
Information:	Minor cracks have been identified to the concrete driveway. This is typically associated with normal shrinkage, minor ground movement, or age-related deterioration and is considered a common defect. If the cracks worsen over time, they may allow moisture ingress and further deterioration. It is recommended that a concreter or suitably experienced handyman monitor and repair the cracks as required. Repairs can be carried out at the owner's discretion.
