Building and Timber Pest Inspection Report

Inspection Date: Thu, 22 Jan 2026

Property Address: 1064 S Arm Rd, South Arm NSW 2460, Australia

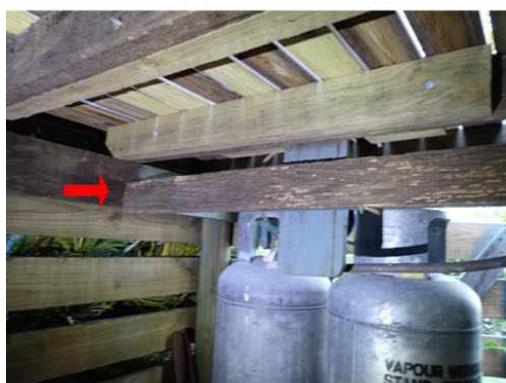
Finding 1.01

Building:	Main Building
Location:	Subfloor
Finding:	External – Gas Regulator Timber Mount Age Related Damage
Information:	Age related damage was identified to the timber that the gas regulator is fixed to. Maintenance or replacement of the affected timber is recommended to ensure adequate support to the installation. Repairs can be carried out by a suitably qualified carpenter, with a licensed gas plumber engaged if the regulator requires adjustment or removal.

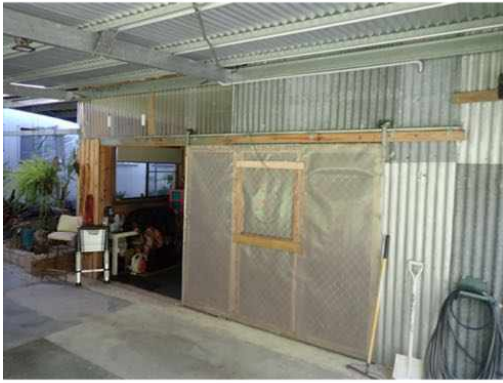
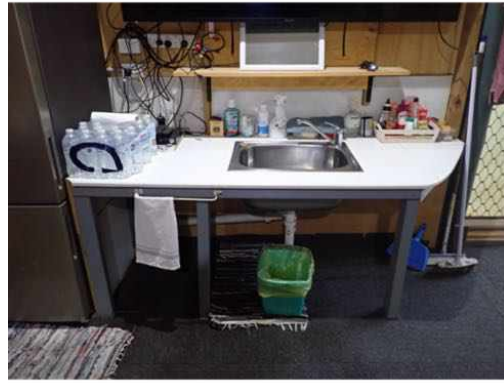
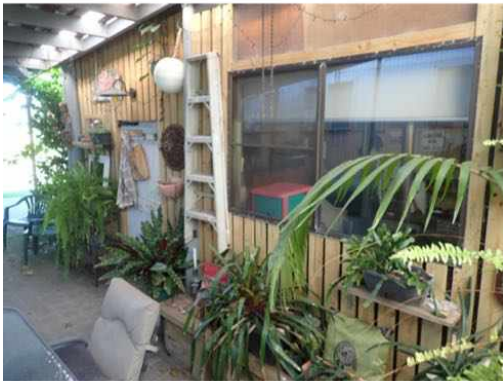
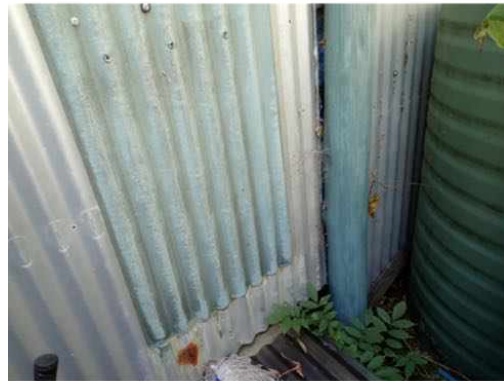
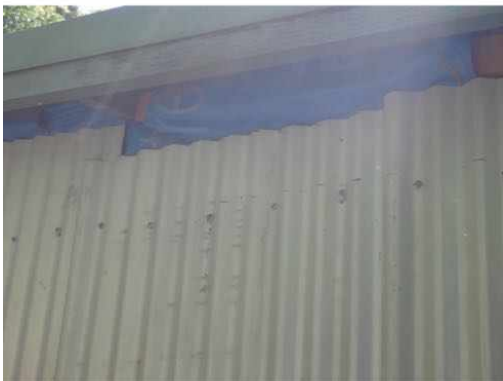
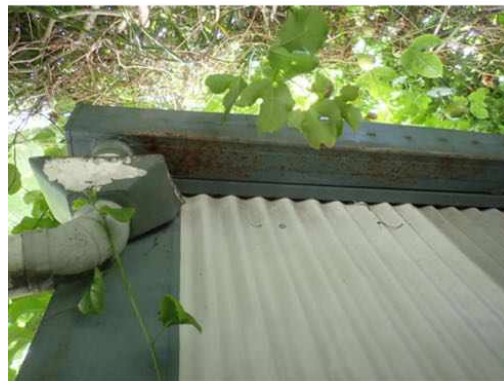
Finding 2.01

Building:	Shed
Location:	All areas
Finding:	Outbuilding – Converted Shed / Habitable Room
Information:	The shed that has been converted to a room appears to be of basic handyman-style construction. The external cladding was in poor condition, the kitchen installation was makeshift in nature, and rust was identified to the gutters. Notwithstanding the standard of construction, the space appears functional for use as a habitable room. Improvements and maintenance may be required depending on intended use. Repairs and upgrades can be carried out by a suitably qualified builder, carpenter, or handyman.

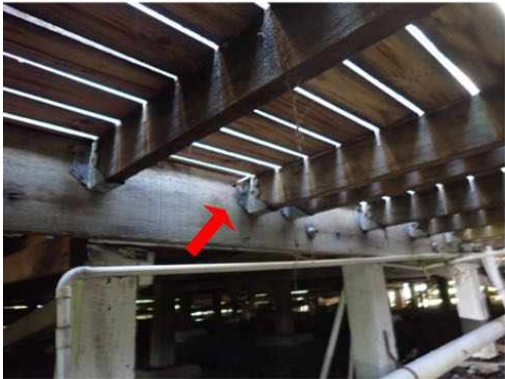
Finding 2.02

Building:	Main Building
Location:	Subfloor
Finding:	External – Deck Framing Joist Hangers
Information:	Rusted joist hangers were identified to the deck framing. This is a common age-related condition and maintenance or replacement of affected fixings is recommended to maintain structural support. Repairs can be carried out by a suitably qualified carpenter or builder.

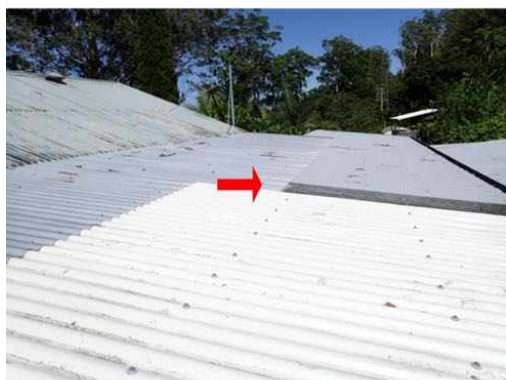
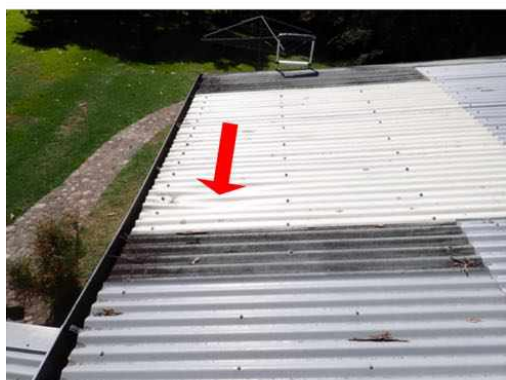
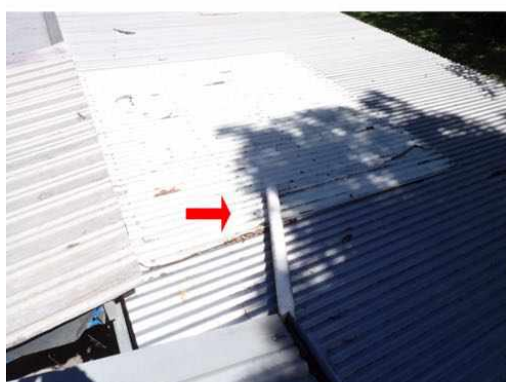
Finding 2.03

Building: Main Building
Location: Roof Exterior
Finding: Roof – Cladding Poor Condition.
Information:

The roof cladding was found to be in poor condition, with defects including flaking paint, surface rust, impact-related damage, rusted fixings, and evidence of sheet patchwork add ons. This condition is consistent with age-related deterioration and ongoing maintenance or further works may be required to maintain weatherproofing. Further assessment and repairs can be carried out by a suitably qualified roofing contractor or builder.

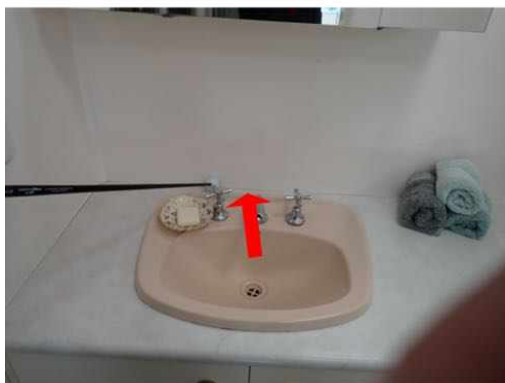
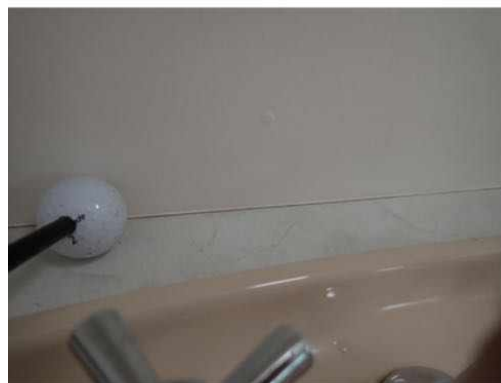
Finding 3.01

Building:	Main Building
Location:	Bathroom
Finding:	Bathroom – Vanity Benchtop Silicone
Information:	Deteriorated silicone sealant identified to the bathroom vanity benchtop at the wall/splashback junction. This is a common age-related condition and routine maintenance is recommended to maintain an effective seal and prevent minor moisture ingress over time.

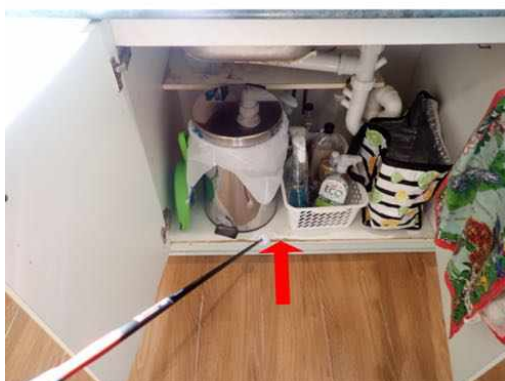
Finding 3.02

Finding: Kitchen – General Good Condition

Information: The kitchen was found to be in generally good condition for its age. Minor defects consistent with normal age-related wear and tear were noted. Ongoing routine maintenance is recommended as required. Repairs, if desired, can be carried out by a suitably qualified handyman or cabinet maker.

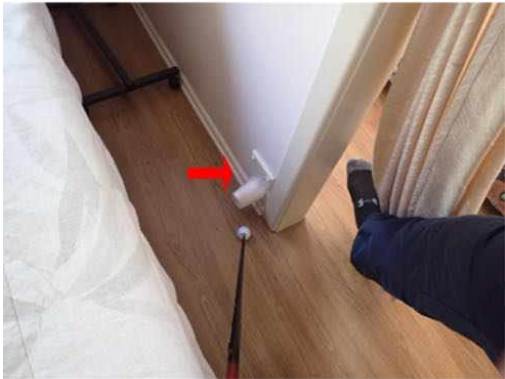
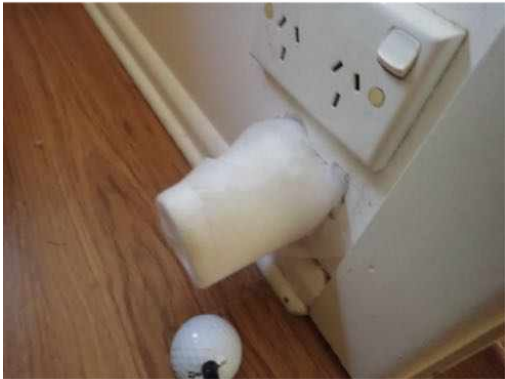
Finding 3.03

Finding: Bedroom – Hole in Wall

Information: A hole in the bedroom wall was observed to have been filled with a rolled material rather than being properly repaired. While not considered significant. Rectification, can be carried out by a suitably qualified plasterer or handyman.

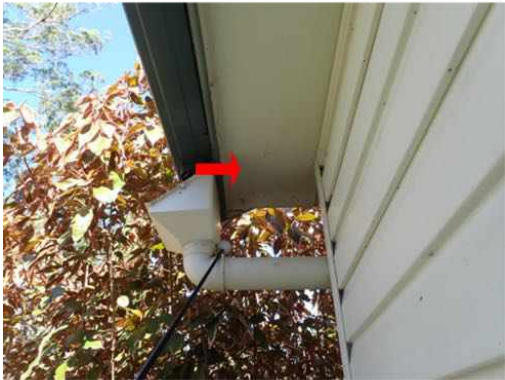
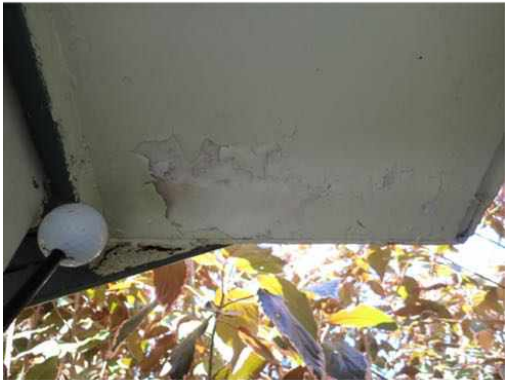
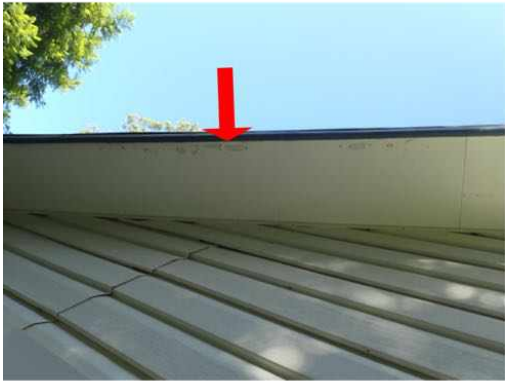
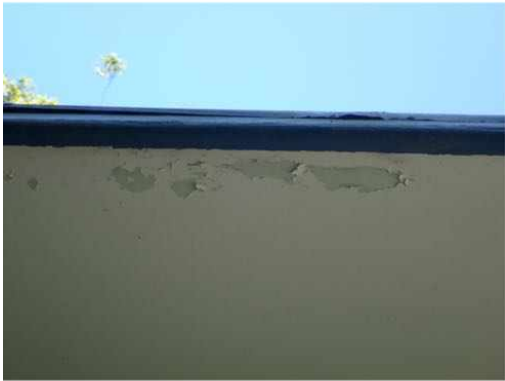
Finding 3.05

Building: Main Building
Location: Eaves
Finding: Roof Exterior – Eave Sheets and Paint Finish
Information: Deteriorated paint was identified to eave sheets at several locations. This is a common age-related condition and primarily cosmetic in nature, however ongoing maintenance is recommended to help protect the underlying materials. Repainting can be carried out by a suitably qualified painter.

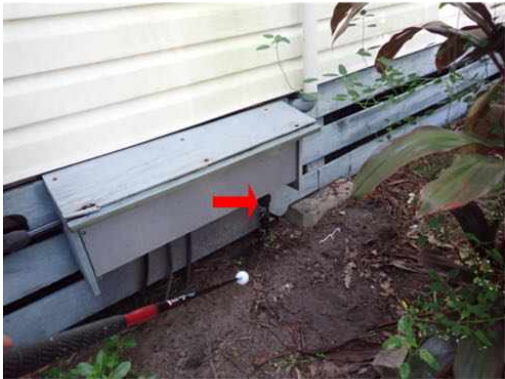
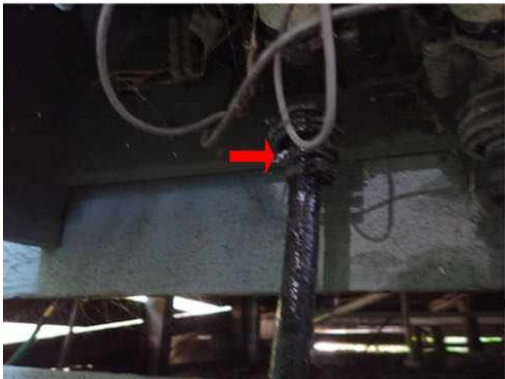
Finding 3.06

Building: Main Building
Location: Left hand side of building
Finding: Plumbing – Leaks
Information: Minor leaks in the plumbing were identified at this location. Maintenance and repairs are recommended to prevent ongoing moisture-related issues. Repairs can be carried out by a suitably qualified plumber

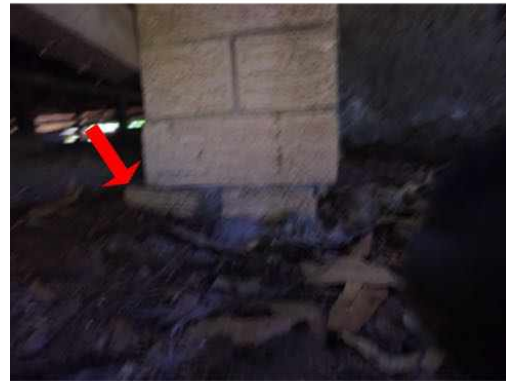
Finding 3.08

Building:	Main Building
Location:	Subfloor
Finding:	Subfloor – Brick Pier Alignment
Information:	A damaged brick pier was identified to be out of alignment at the base. While this appears localised, maintenance and rectification are recommended to ensure continued support and stability. Repairs can be carried out by a suitably qualified bricklayer or builder.

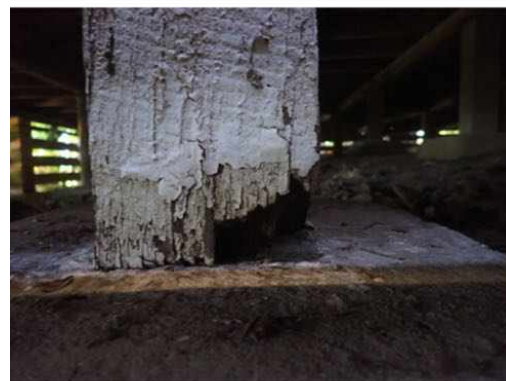
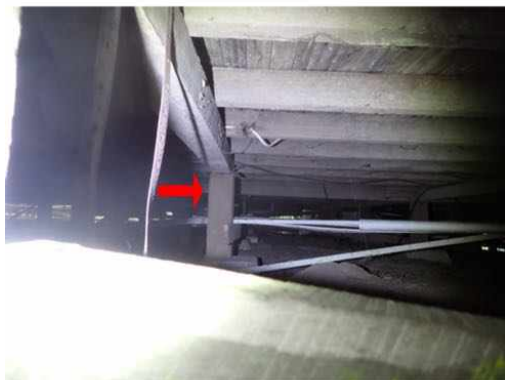
Finding 3.09

Building:	Main Building
Location:	Subfloor
Finding:	Subfloor – Timber Stumps
Information:	Although the majority of the timber stumps were found to be in good condition, several stumps were identified to be out of plumb and/or exhibit minor wood rot. This is a common defect with a building of this age and appears localised in nature. Repairs can be carried out as deemed necessary by a suitably qualified builder or carpenter.

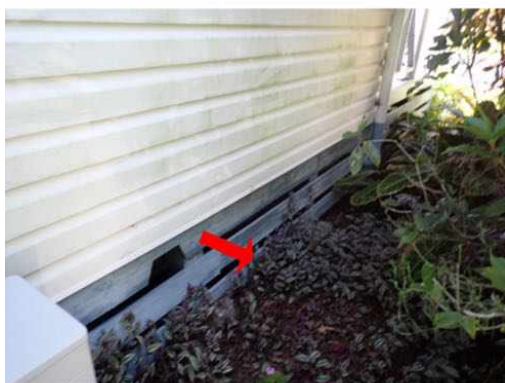
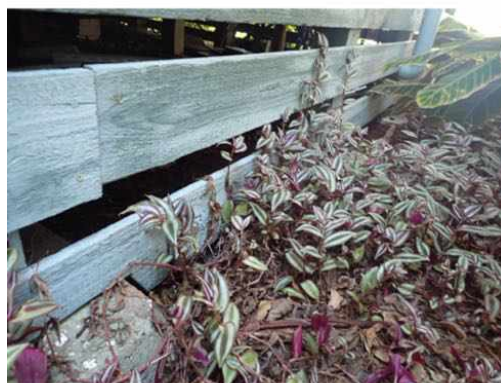
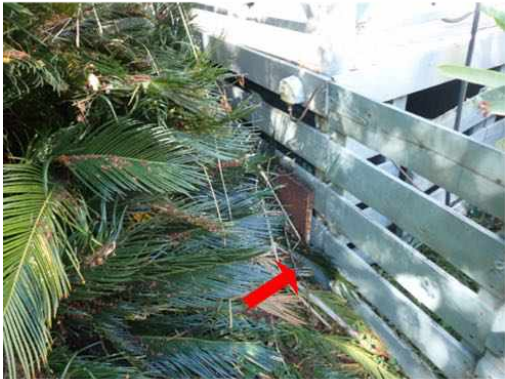
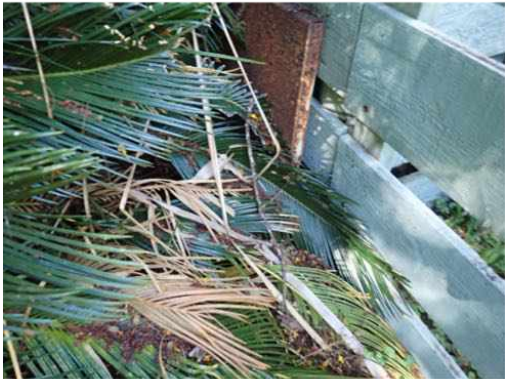
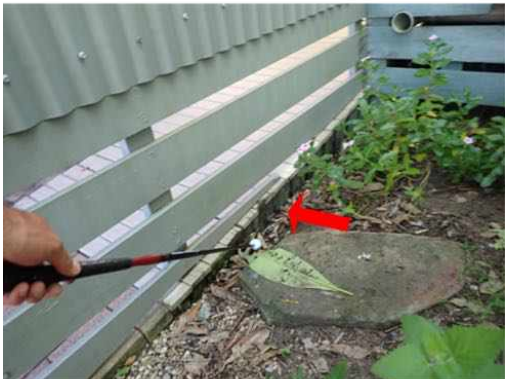
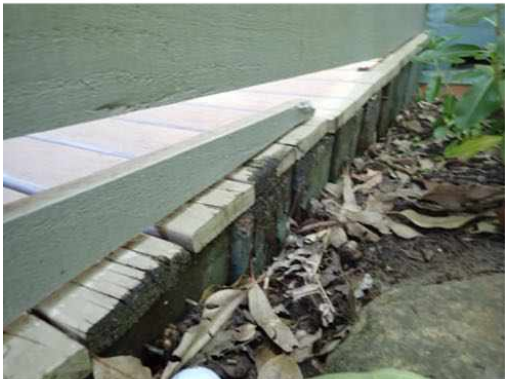
Finding 6.01

Building: Main Building
 Location: Decking and perimeter of building
 Finding: Subfloor / Exterior – Timber in Contact with Ground
 Information: Timber was identified in direct contact with the ground around the building and decking at multiple locations. This is a common condition that is considered conducive to termite activity and timber deterioration. Improving clearances and ongoing maintenance is recommended. Works can be carried out by a suitably qualified carpenter, with advice from a licensed timber pest technician if required.

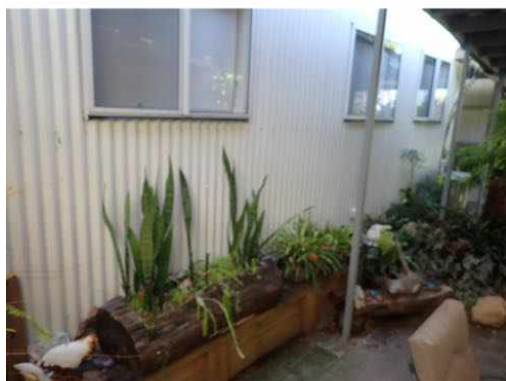
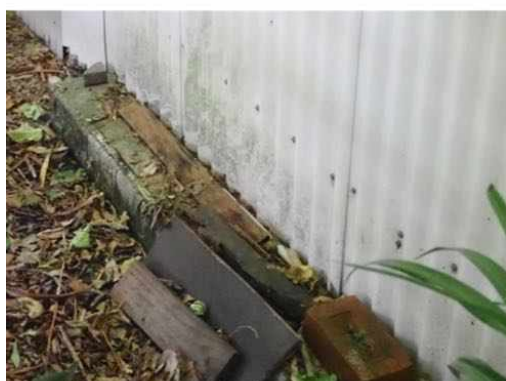
Finding 6.03

Building:	Shed
Location:	Perimeter of shed/granny flat
Finding:	Subfloor / Exterior – Conditions Conducive to Timber Pest Activity
Information:	Conditions conducive to timber pest attack were identified around the lower perimeter of the building. This is a common condition and improving ground clearances and ongoing maintenance is recommended to reduce risk. Works can be carried out by a suitably qualified carpenter, with advice from a licensed timber pest technician if required.

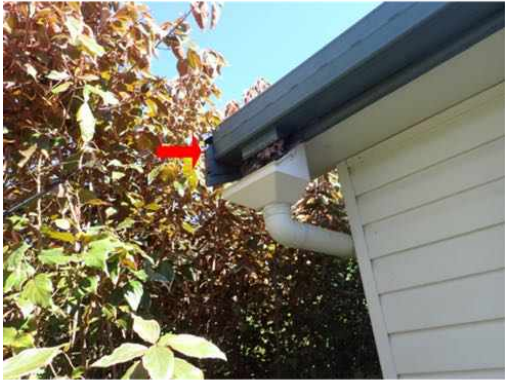
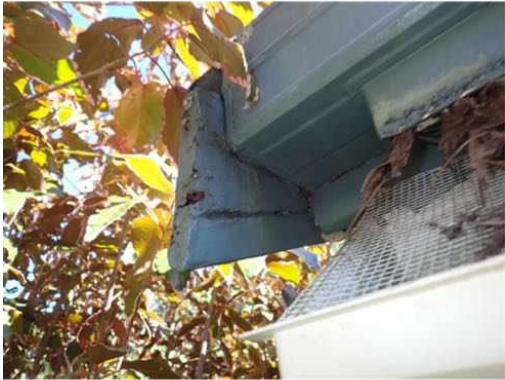
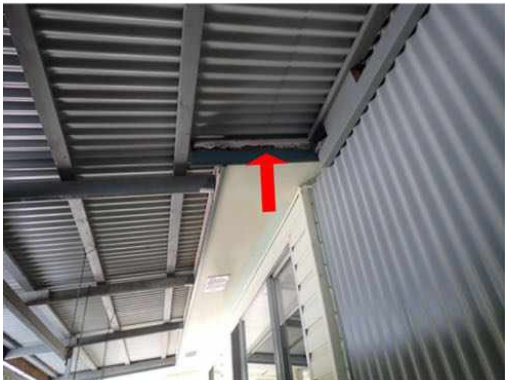
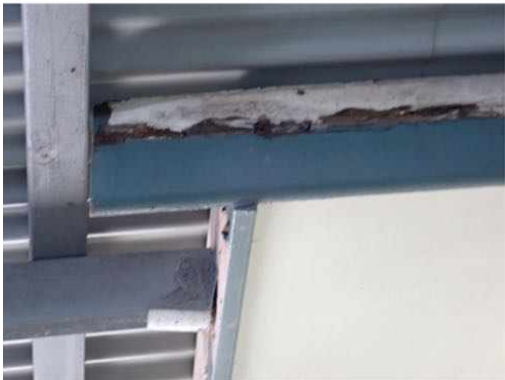
Finding 7.01

Building:	Main Building
Location:	Fascia boards
Finding:	Roof Exterior – Fascia Boards
Information:	Wood rot was identified to the ends of fascia boards at several locations. This is a common age-related condition typically associated with prolonged weather exposure. Repairs or replacement of affected sections as part of routine maintenance is recommended to prevent further deterioration. Works can be carried out by a suitably qualified carpenter.

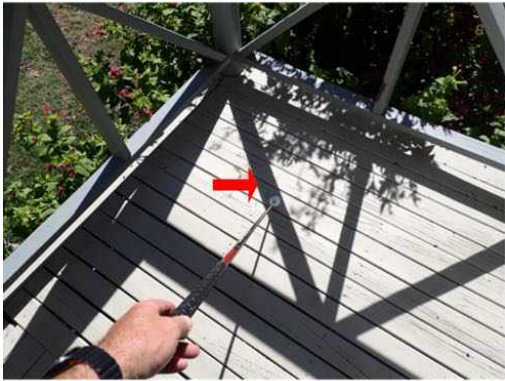
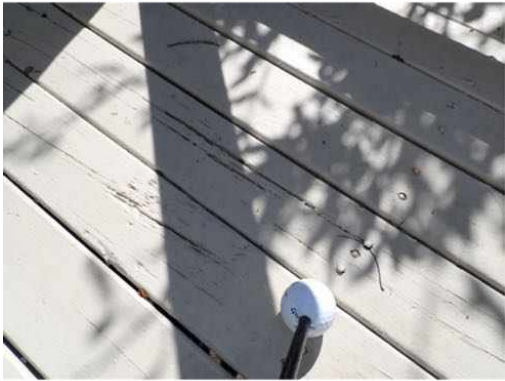
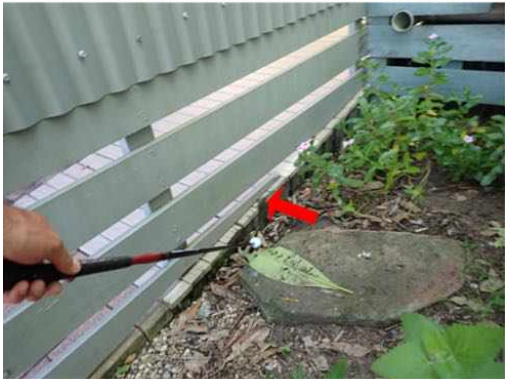
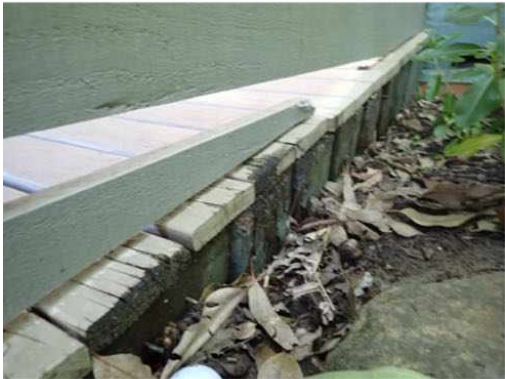
Finding 7.02

Building: Main Building
Location: Decked areas
Finding: External – Timber Decking Boards
Information: Minor wood rot was identified to decking boards at several locations. This is a common age-related condition and appears minor at the time of inspection. Ongoing maintenance and localised repairs or replacement of affected boards is recommended as required. Works can be carried out by a suitably qualified carpenter or handyman.
