Building and Timber Pest Inspection Report

Inspection Date: Mon, 16 Mar 2026

Property Address: 14 Cut Glade, Blacktown NSW 2148,
Australia

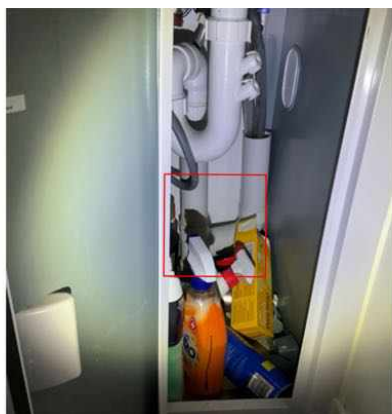
Building: Main Building
Location: All Internal Areas - Laundry
Finding: Painted surface - Bubbling
Information: Sections of paint in this area was found to have bubbled and deteriorated. Paint bubbling is generally an indication of excessive moisture in the area, that is currently hidden by the painted surface.

The presence of excessive moisture can have major implications on associated building elements if left unattended. While only seemingly minor at this stage, the damage cannot be determined due to the paint obstructing any further inspection of the damage.

It is highly advised that the affected paint be cleaned to allow a further, more invasive inspection by a licensed plumber. Failure to act on this defect may necessitate major works in the future.

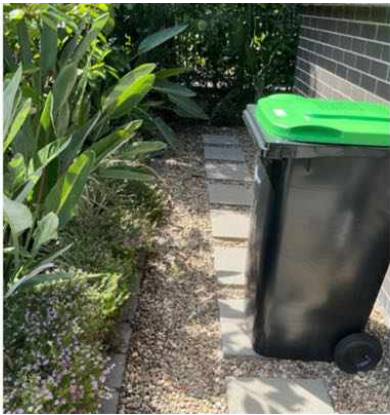
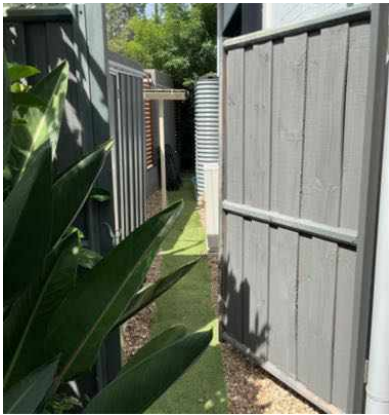
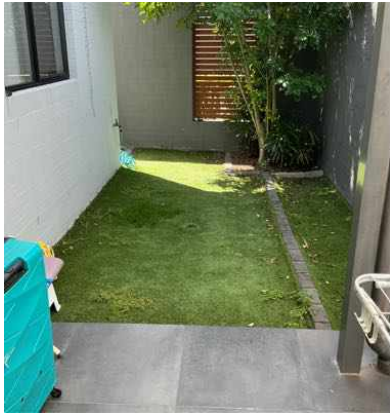
Finding 3.03

Building: Main Building
Location: All External Areas
Finding: Surface Drainage - Gravel
Information: The setback is finished with loose aggregate. While gravel can assist with surface dispersion of water, it is not a controlled drainage system. The adequacy of falls and stormwater connection could not be confirmed at the time of inspection. Monitoring during rainfall is recommended to ensure no ponding or water discharge occurs toward the slab edge. Further inspection by a licensed plumber is recommended to check adequate grading around the building.

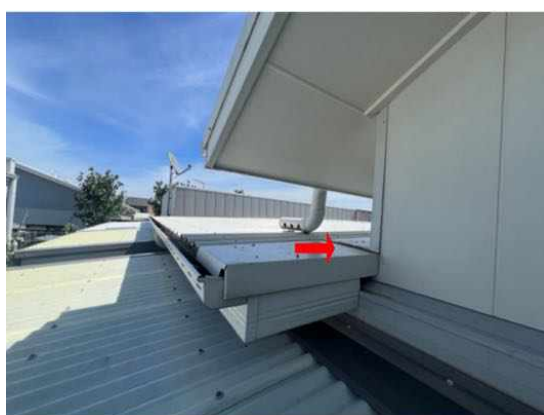
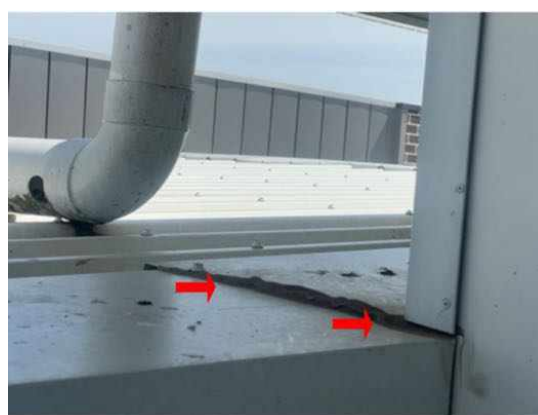
Finding 3.04

Building:	Main Building
Location:	Roof Exterior
Finding:	Flashing defective -poor installation
Information:	The metal flashing at the wall junction appears inadequately installed, with visible gaps and lifting and reliance on surface sealant rather than a properly chased and continuous detail. The junction does not appear fully weather-tight, increasing the risk of moisture ingress into the wall cavity or roof structure over time. Defective flashing installation can lead to concealed deterioration if not addressed. Recommend assessment and rectification by a qualified roofing contractor to ensure compliant and effective weatherproofing.

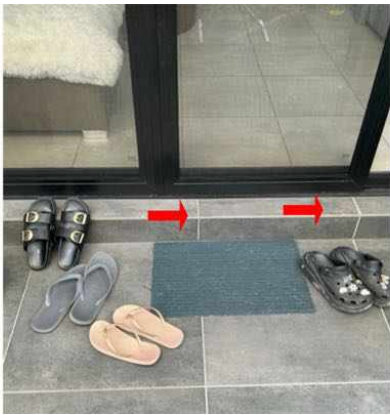
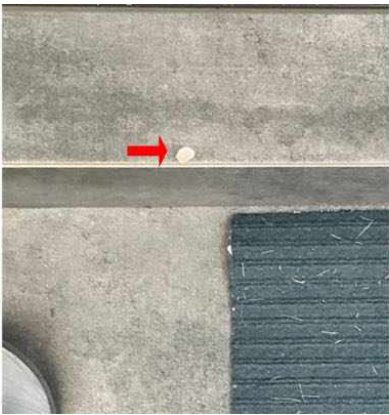
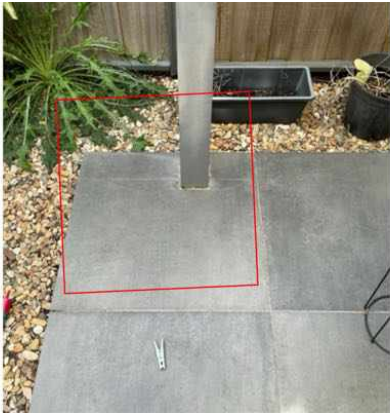
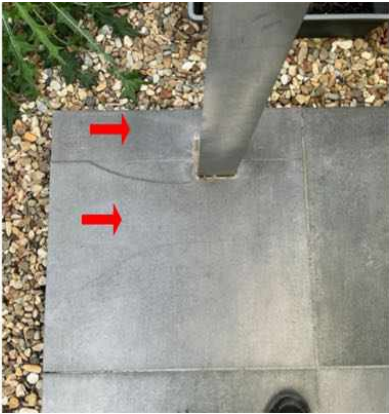
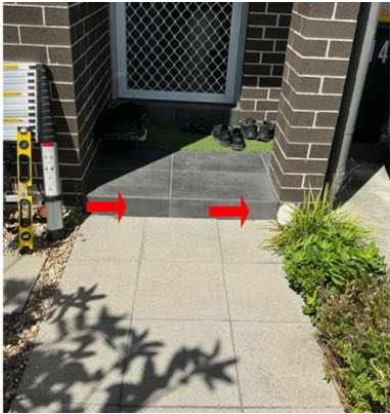
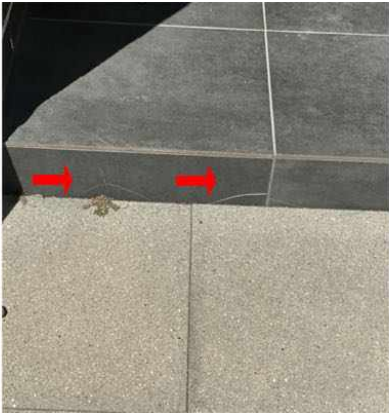
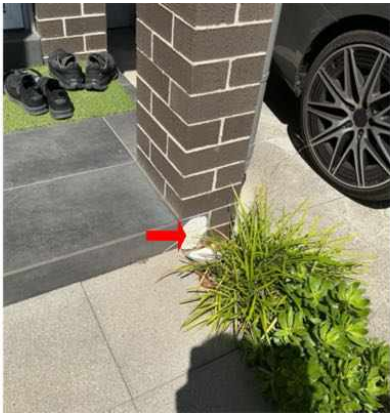
Finding 3.05

Building:	Main Building
Location:	All External Areas- Rear
Finding:	Tiles - Cracked or damaged to some areas
Information:	Cracking was evident to the tiling in this area at the time of inspection. While the cracking appears to be minor, this area is frequently exposed to water, allowing potential for water penetration into adjoining sections of walls or flooring.

If left unmanaged, water penetration to these areas may lead to subsequent water damage, which is likely necessitate repair work to affected building elements.

A tiling contractor should be appointed to ensure that no further water damage occurs. The re-application of silicone and grouting throughout remaining tile work is also advised, to further protect the area against water penetration.

Where water penetration has led to water damage, appointment of a relevant tradesperson may be required to repair damaged building elements.

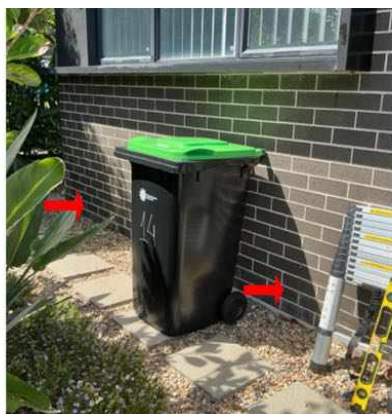
Finding 3.06

Building:	Main Building
Location:	All External Areas
Finding:	Brickwork - Efflorescence
Information:	Efflorescence appears to be affecting the brickwork, concrete or tiles in this area. Efflorescence typically occurs when excess salts within the concrete or cement mortar is leached to the surface due to water transfer.

It is typically seen as white salt deposits on the surfaces of concrete pavement or mortar between bricks or tiles. While detracting from the overall appearance of the affected area, efflorescence is not likely to develop into secondary damage if left unmanaged.

Generally, soluble salt deposits can be removed by dry brushing with a stiff-bristled brush. Repeated dry brushing is an ideal treatment for eliminating this forming of efflorescence. A cleaning contractor or general handyperson may be appointed to perform these works at the discretion of the client.

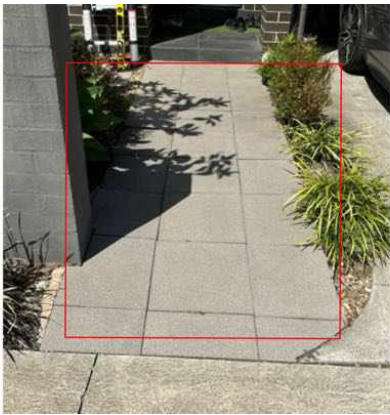
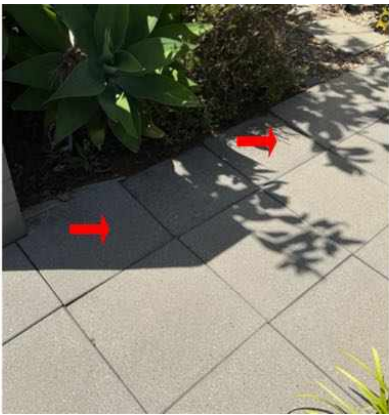
Finding 3.07

Building:	Main Building
Location:	All External Areas
Finding:	Paving - Uneven
Information:	Sections of the external paved area are uneven, creating a potential trip hazard. It appears as though the area has been subject to rough installation, or that paving sections have lifted due to movements in the foundation of the property.

Where paving creates a trip hazard, personal injury may ensue if due caution is not taken by all persons within this area.

Re-paving of the area is required as soon as possible to remedy this situation. Further consultation with a specialist concreter is advised.

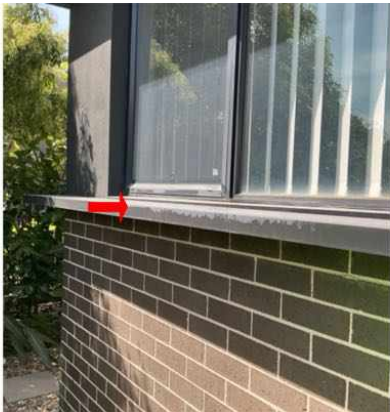
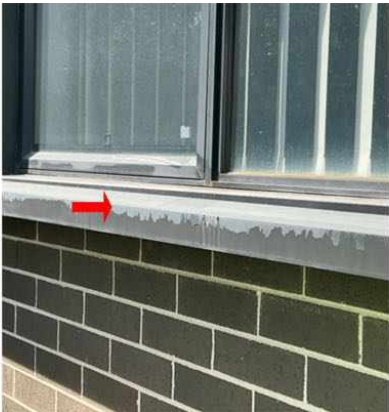
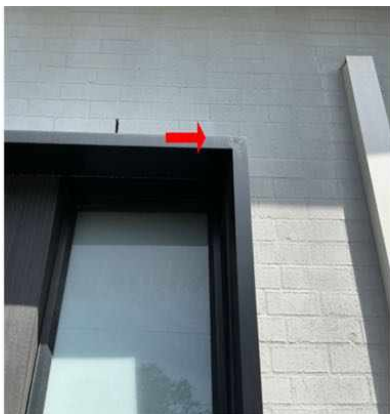
Finding 3.08

Building: Main Building
Location: All External Areas
Finding: External painting deteriorated
Information: Whilst incomplete or missing paint finish is generally an appearance defect, it can also lead to the development of secondary building defects over time. Incomplete areas of paint finish expose the area to moisture, potentially accelerating the deterioration of underlying building materials.

Degraded paint finishes should be sanded back, filled, leveled and painted, as applicable. Where inadequate or missing paint protection has led to the deterioration of the associated building element, repair and/or replacement of this building element may be required.

A painting contractor should be appointed as soon as possible to perform necessary works to aid the appearance of the affected area and to ensure the area is protected against further deterioration. Alternatively, the homeowner following manufacturer instructions may perform these works.

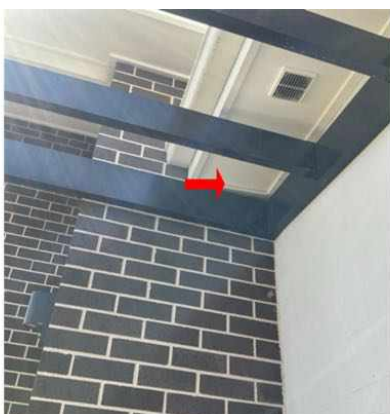
Finding 3.09

Building:	Main Building
Location:	All External Areas
Finding:	Eave Trim Separation
Information:	The external timber trim at the eaves corner displays a visible separation crack, likely due to minor building movement or timber shrinkage over time. While not structurally significant on its own, the gap may allow moisture ingress and should be sealed with a flexible exterior-grade sealant to prevent further deterioration.

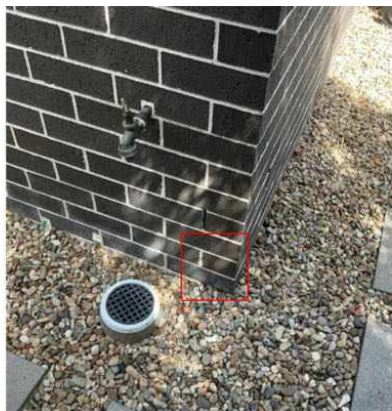
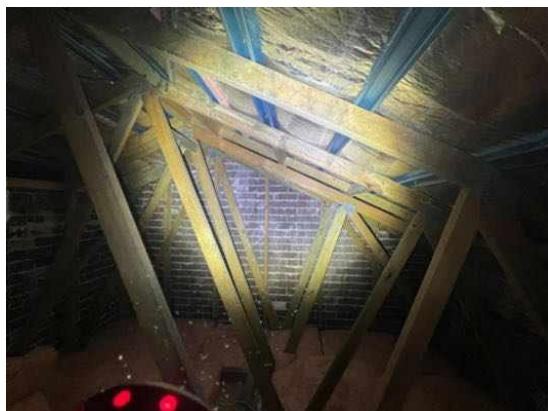
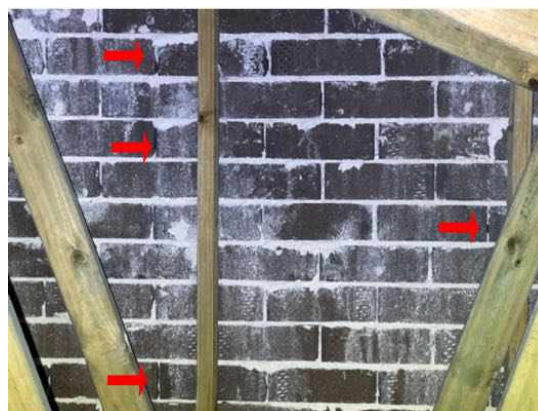
Finding 3.10

Building:	Main Building
Location:	All External Areas and roof void
Finding:	Brickwork - Deteriorated mortar to some areas
Information:	Mortar, or 'bedding', is the material which fills joints and intersections between bricks in masonry walls and structures. Sections of mortar in this brickwork were identified as having deteriorated, which is generally expected for a property of this age and condition.

Mortar may deteriorate as a result of age of building materials, minor movement of bricks, or frequent exposure to weathering. Mortar should be replaced to ensure that bricks remain in their intended location and to prevent gaps, which would allow water

or moisture ingress and secondary damage as a result.

Mortar deterioration can be addressed by a bricklayer where areas of deterioration are localised and easily accessible. Alternatively, appointment of a registered builder is advised, to repoint large areas of decaying mortar. Where secondary structural defects have become evident, consultation with a structural engineer may be required.

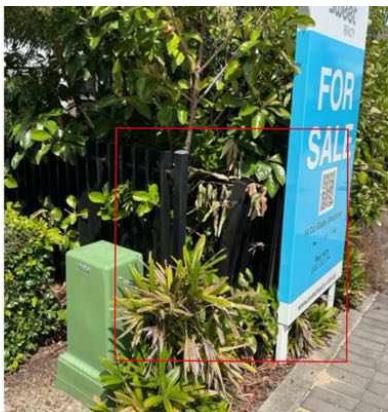
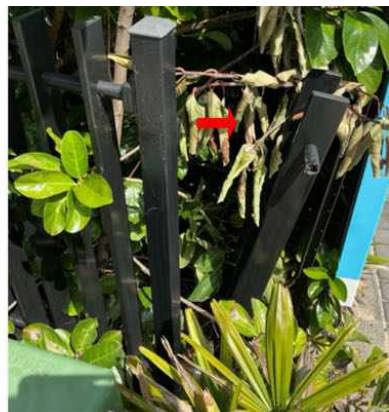
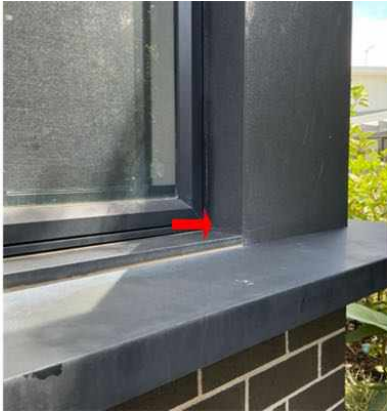
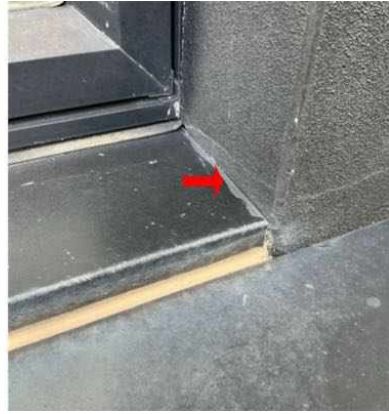
Building:	Main Building
Location:	All External Areas
Finding:	Building element - Damaged - External fence damaged , sealant missing window side
Information:	Breakage occurs generally when the building materials have either aged and decayed, or as a result of damage (accidental or deliberate).

Repair and/or replacement of broken elements is advised to ensure that additional secondary defects do not arise as a consequence. Such works are necessary, as all building elements play a key role in the operation and function of the overall structure and its performance.

A relevant tradesperson should be appointed to repair or replace the affected building element prior to any subsequent damage being caused.

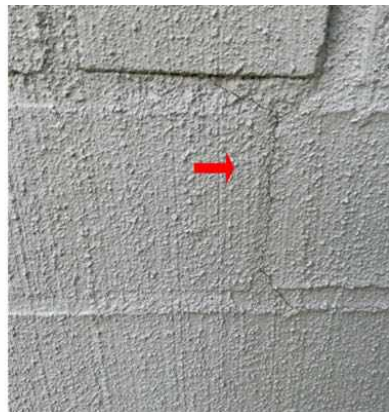
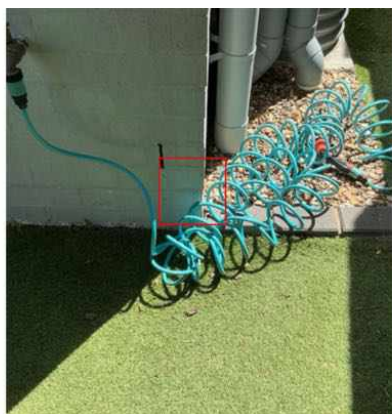
Finding 3.13

Finding: Brickwork - Cracking [Fine] to some areas

Information: Although fine cracks are quite noticeable, they are often only considered to be an appearance defect and usually do not indicate any structural damage. Generally, the cause of a fine crack is indicative of a separation between brickwork and mortar throughout the structure, but single bricks may also show cracks of this nature.

Cracking of this nature can generally be repaired with minor filling and should be conducted by a qualified bricklayer.

Always contact a building inspector should cracks widen lengthen or become more numerous.

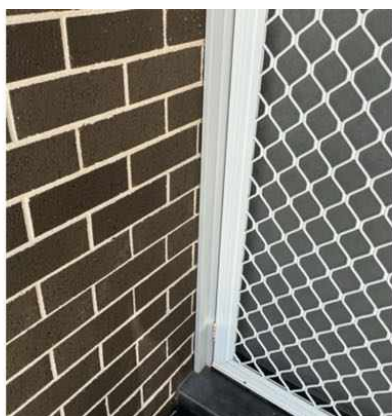
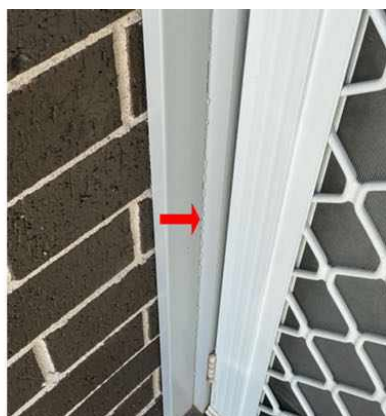
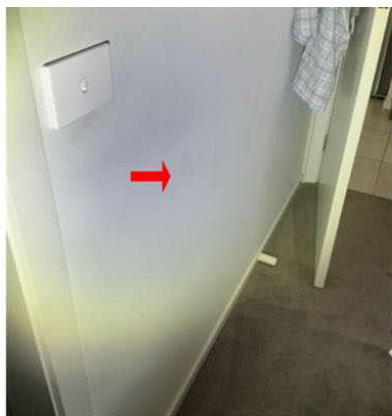
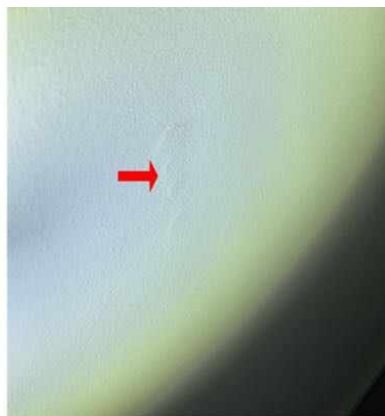
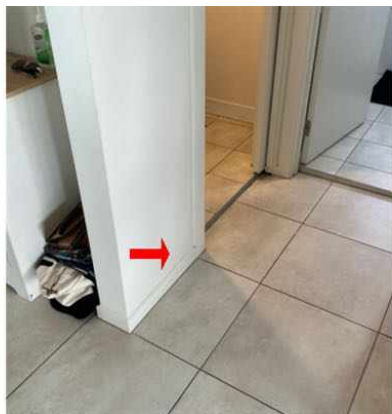
Finding 3.14

Building:	Main Building
Location:	All Internal Areas
Finding:	Paint Finish & Hairline Cracking - To some areas
Information:	The paint finish in this area was identified as being incomplete or substandard at the time of inspection including some hairline minor cracking/separation. Monitoring is recommended where cracking and separation is evident.

Whilst incomplete or missing paint finish is generally an appearance defect, it can also lead to the development of secondary building defects over time. Incomplete areas of paint finish expose the area to moisture, potentially accelerating the deterioration of underlying building materials.

Incomplete paint finishes should be sanded back, filled, leveled and painted, as applicable. Where inadequate or missing paint protection has led to the deterioration of the associated building element, repair and/or replacement of this building element may be required.

A painting contractor should be appointed as soon as possible to perform necessary works to aid the appearance of the affected area and to ensure the area is protected against further deterioration. Alternatively, the homeowner following manufacturer instructions may perform these works.

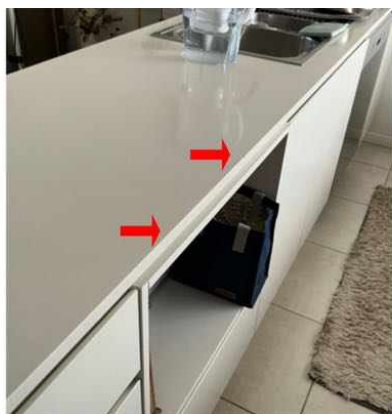
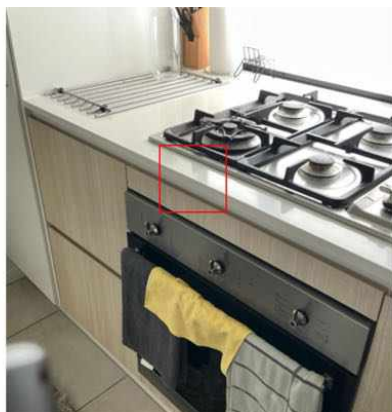
Finding 3.15

Building:	Main Building
Location:	All Internal Areas
Finding:	Building element - Damaged - Bench top cracked
Information:	Breakage occurs generally when the building materials have either aged and decayed, or as a result of damage (accidental or deliberate).

Repair and/or replacement of broken elements is advised to ensure that additional secondary defects do not arise as a consequence. Such works are necessary, as all building elements play a key role in the operation and function of the overall structure and its performance.

A relevant tradesperson should be appointed to repair or replace the affected building element prior to any subsequent damage being caused.

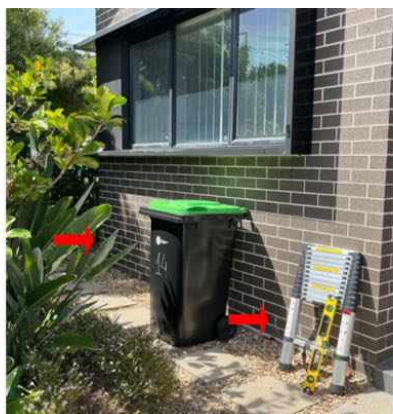
Building:	Main Building
Location:	All External Areas
Finding:	Termite Management System - no evidence of a chemical installation
Information:	The application of a post-construction chemical termite barrier is highly recommended for all properties, particularly if live termite activity has been found on the site previously. Such barriers are highly effective in preventing termite attack on any timber building elements throughout the property.

If the slab edge is not properly exposed there is a high risk of termite attack. Sometimes, in order to determine the type of slab, a suitably qualified person such as an architect or builder may be required to consult the construction plans.

Where the slab edge cannot be properly inspected, it is highly recommended that termite or timber pest inspections be carried out every 6-12 months to aid protection of the property against infestation.

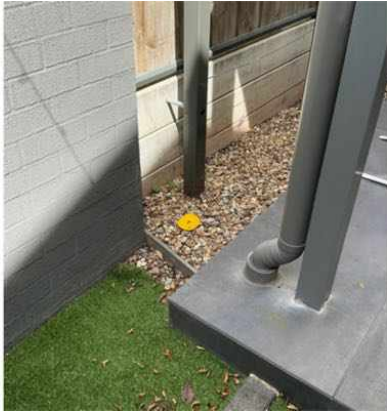
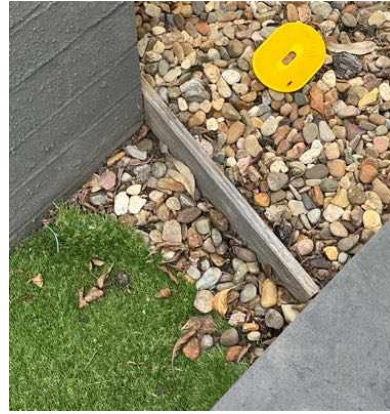
Finding 6.04

Building:	Main Building
Location:	All External Areas
Finding:	In ground contact - Timber
Information:	Any timbers in direct ground contact provide opportunity for concealed termite entry and are likely to be subject to premature rot and decay as the soil retains moisture or damp conditions against the timbers.

Remove untreated timber that is in direct contact with external grounds. Consider replacement with more durable materials i.e. treated timber or non timber elements. Frequent pest inspections are advised to readily identify any termite activity in these areas.

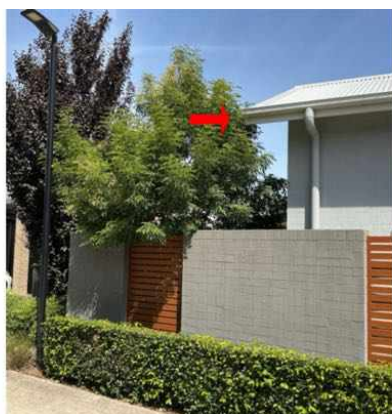
Building: Main Building
Location: All External Areas
Finding: Bridging - Vegetation
Information: Where vegetation obstructs inspection of building elements, also known as bridging as it provides a bridging point for the access of termites, full inspection can not be achieved. Consequently moisture or dampness may be present and the areas becomes conducive to termite activity. Plants against or very close to buildings provide cover, shade and can provide an environment that is attractive to termite infestation.

The removal and replanting of species that do not provide "cover" or cutting back of existing vegetation will assist greatly in preventing Bridging from occurring.

The removal of any such materials that may be conducive to termite activity should be carried out as soon as possible and arrange re inspection to minimize the risk of termite attack.
