# Building and Timber Pest Inspection Report

Inspection Date: Thu, 22 Jan 2026

Property Address: 8 Fern St, Pymble NSW 2073, Australia

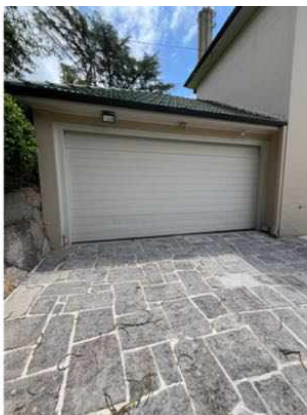
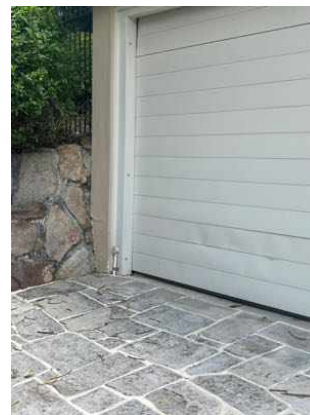
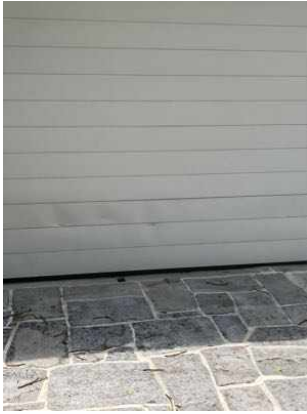
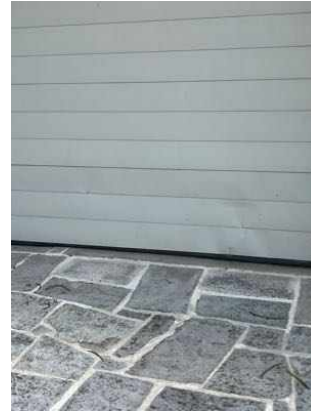
#### Finding 3.01

Building: Main Building  
Location: Garage  
Finding: Garage door - Superficial markings  
Information: The garage roller door has a number of marks and dents likely to have resulted from impact damage be it accidental or deliberate impact at sometime.

Garage roller doors can fail when the building materials have aged but may be indicative of impact damage (accidental or deliberate). While superficial markings detract from the aesthetics of the building element, the functionality has not been hindered in any way.

Repair and/or replacement of the two garage doors would improve the condition of the garage but certainly not an urgent item

A qualified roller door installer or supplier should be engaged to check out the operation and overall condition of the doors to determine if repair is an option otherwise replacement may need to be considered.

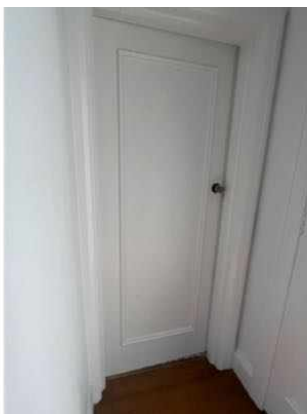
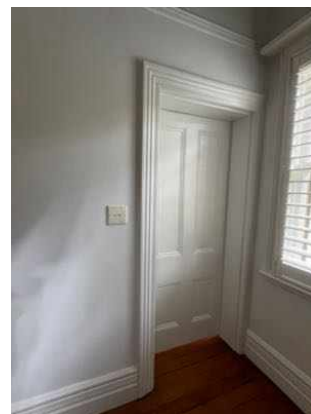
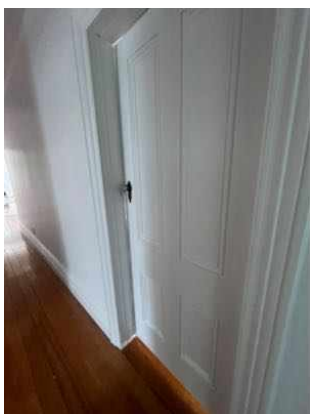
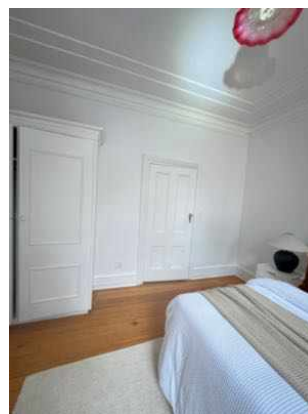
### Finding 3.02

Finding: Doors Binding or Jamming

Information: It appears that there is a problem with this door as it is binding or jamming during normal operation. This defect not only affects the functionality of the door but also poses a risk for other building elements such as damage to the floor covering.

There could be various reasons behind the binding of the door, ranging from minor issues like poor installation or damaged hinges to major structural problems such as damage to the subfloor.

For minor issues, it is recommended to hire a qualified carpenter or handyman to carry out the necessary repairs as per the client's discretion.

In some cases, the binding of the door may be caused by termite activities. In such instances, it is recommended to monitor the situation closely or conduct an invasive inspection to identify the root cause of the problem.

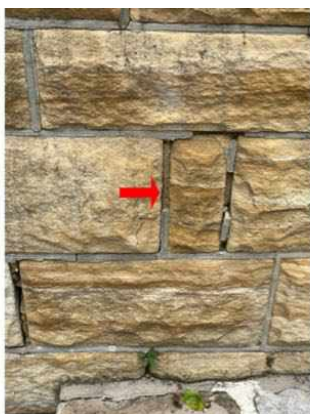
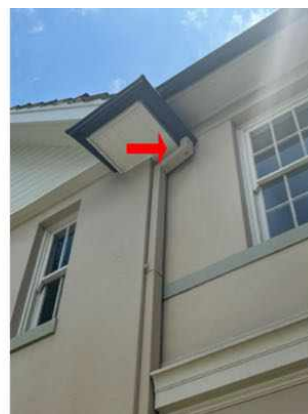
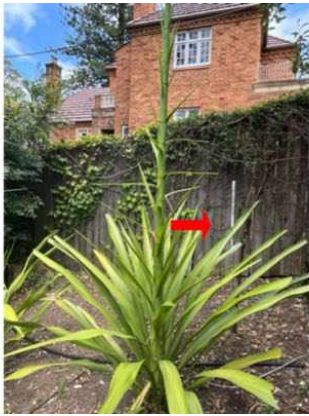
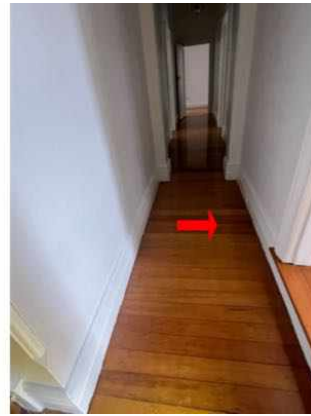
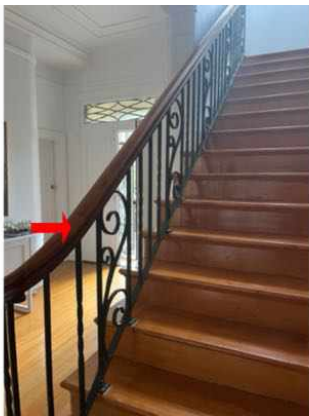
### Finding 3.03

Building:	Main Building
Location:	All Areas
Finding:	Deterioration caused by Fair and Wear and Tear
Information:	Certain forms of deterioration commonly associated with fair wear and tear may not be individually itemised within this report. During the inspection, general age-related conditions were observed throughout the property, including areas of deteriorated mortar between stonework, minor rust visible on sections of the downpipe, and weathered or deteriorated fencing consistent with prolonged external exposure. Internally, the timber flooring exhibited localised squeaking and isolated loose or deflecting boards, which is typical in older dwellings and does not, in itself, indicate structural failure. The staircase handrail was also noted to have minor looseness at its fixing points, reflecting natural movement and ageing of materials. These conditions are characteristic of buildings of this era and generally fall within acceptable tolerances unless contributing to a safety concern or major defect.

In accordance with the pre-inspection agreement, such minor and cosmetic issues are typically excluded from detailed reporting unless they constitute a significant structural concern or hazard. Therefore, the absence of specific reference to every instance of deterioration should not be interpreted as confirmation of their absence, but rather as recognition that they fall within the expected scope of fair wear and tear and normal ageing for a property of this type.

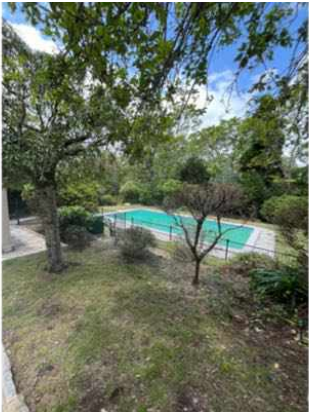
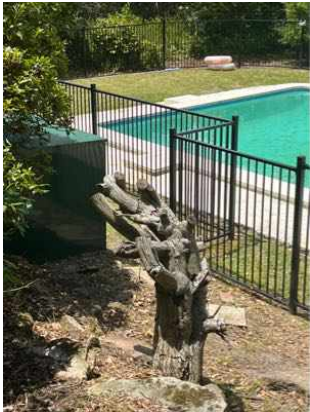
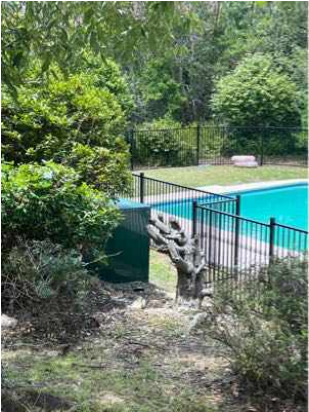
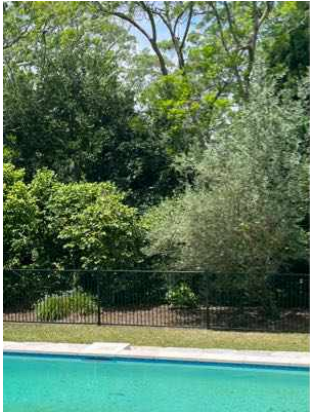
Building: Main Building  
 Location: Pool Area  
 Finding: Pool Fence  
 Information: It is important to check on the compliance status of the pool fence. As the pool fence is required for renewal in every three years checking on the date of the expiry and the issuing body is important.

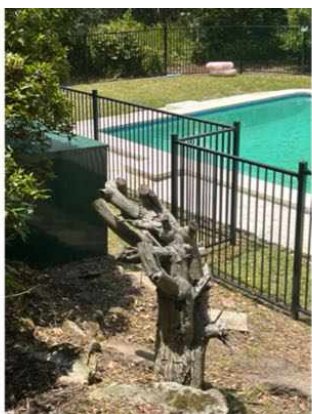
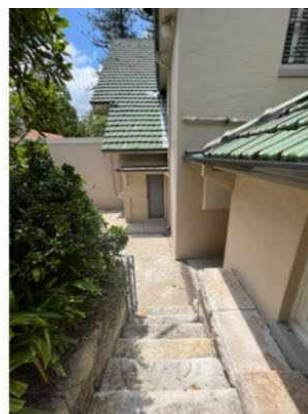
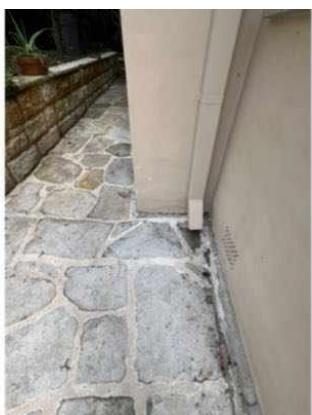
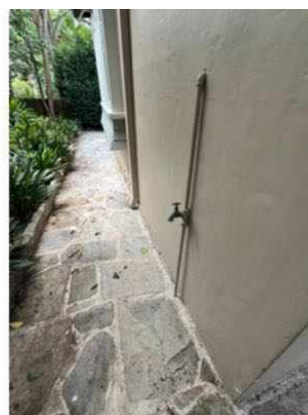
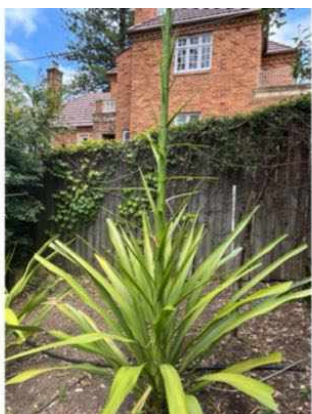
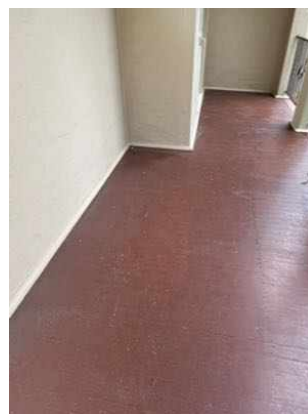
Building: Main Building  
 Location: All Areas  
 Finding: Conditions Conducive to Termite  
 Information: During the inspection, several conditions commonly found in residential properties were noted that may, over time, contribute to an environment conducive to termite activity if left unaddressed. These are typical in many homes and do not indicate active termite presence but highlight areas where general maintenance or preventative

\* General Moisture-Related Items (e.g., HWS and Air Conditioner Overflow): Minor overflow drainage from hot water systems and air conditioning units was noted. These are common features in residential dwellings and can be easily managed by ensuring proper discharge to appropriate drainage points.

\* Taps and External Drains: Occasional unconnected or unprotected taps were noted. Ensuring that external taps are adequately drained is a simple maintenance task that helps manage moisture near the building perimeter.

\* Vegetation and Garden Features: The presence of tree stumps or garden beds near the structure is typical in many residential landscapes. While they may attract termites if left unmanaged, they can be easily maintained or relocated to reduce potential risk.

General Recommendation: □ The conditions identified are typical of residential dwellings and can be readily managed through routine maintenance. No evidence of active termite activity was found at the time of inspection. To ensure continued protection of the property, it is recommended to maintain good site drainage, remove timber debris, and consider installing a termite management system as a precautionary measure. Regular inspections in accordance with Australian Standards are also advisable.

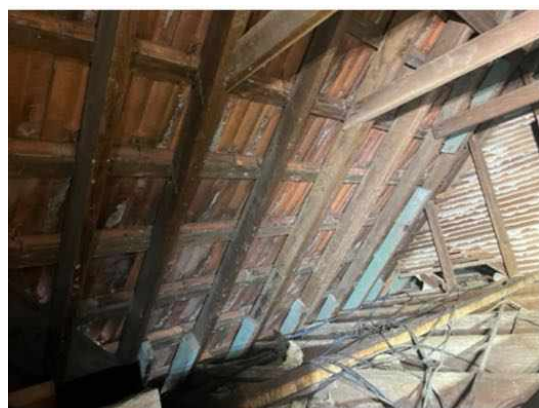
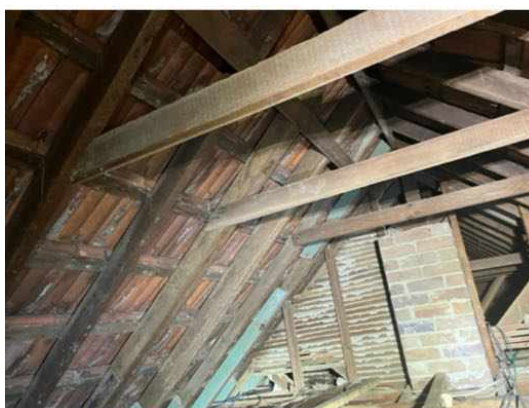
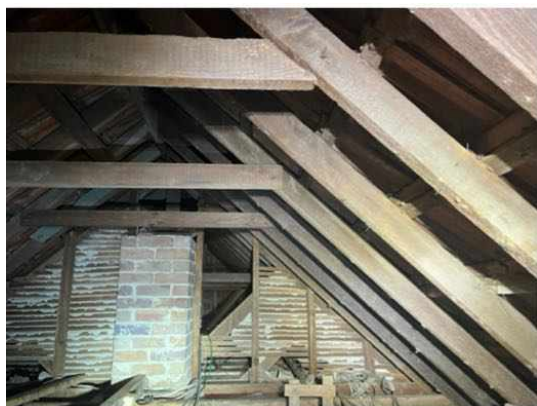
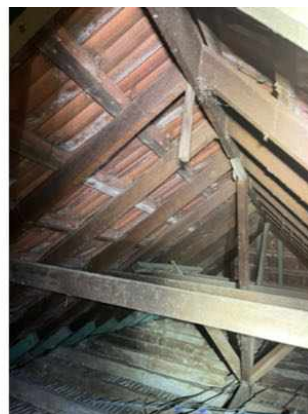
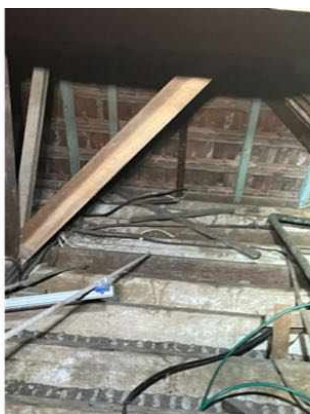
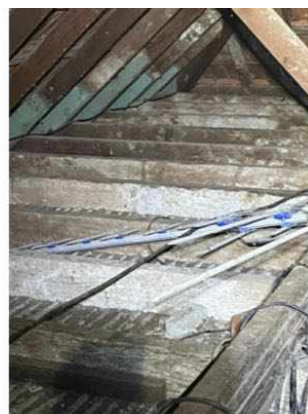
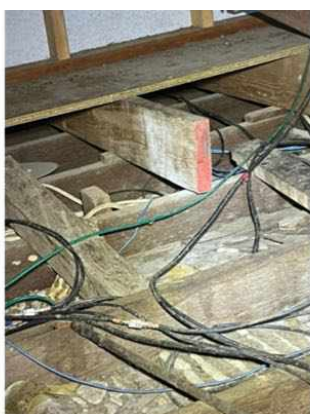
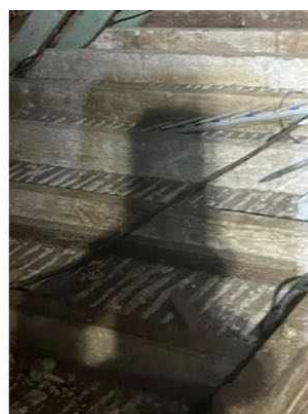
Building:	Main Building
Location:	Roof Void
Finding:	Condition of Building Elements in the Roof Void
Information:	Following the inspection of the roof void, the original timber framing, rafters and ceiling joists were generally found to be in serviceable condition for a building of this age, with no evidence of significant structural distortion, failure or active timber pest activity observed at the time of attendance. The timbers display typical age-related wear, including minor surface weathering, historic dust accumulation and isolated areas of cosmetic deterioration, all of which are consistent with long-term use and do not detract from their current performance.

The tiled roof battens appear original and remain adequately aligned, with no notable signs of sagging or distress. Some redundant cabling, old fixings and accumulated debris were present on the ceiling lining, which is expected in older roof spaces and does not represent a structural concern. The chimney structure and associated bracing also presented as stable, with no cracking indicative of movement.

Overall, the roof void presents well considering the age of the dwelling, and no major defects or safety issues were identified during the inspection, with only routine housekeeping and optional upgrades recommended if desired.

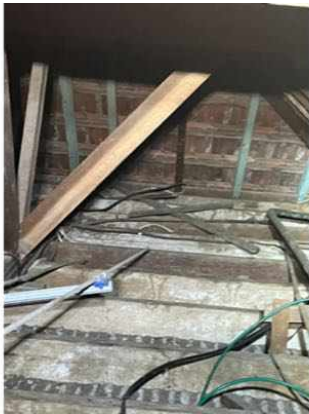
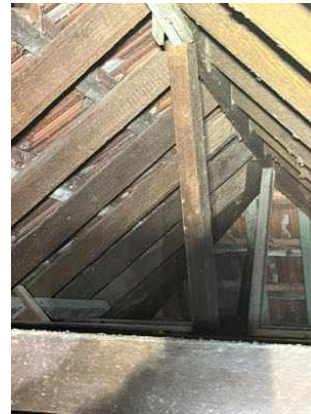
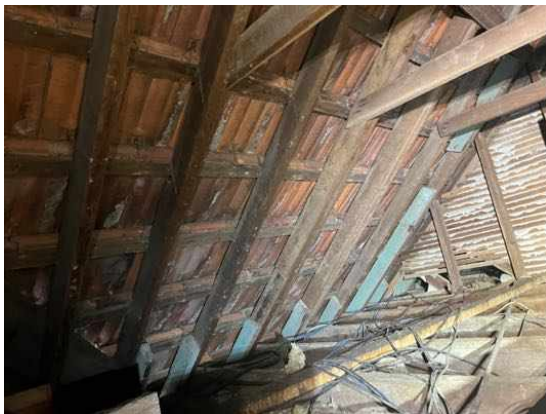
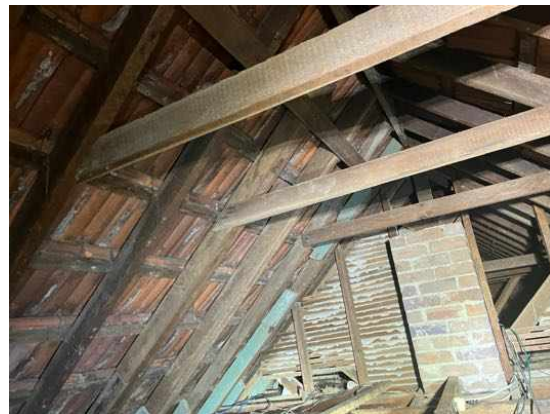
Building:	Main Building
Location:	Roof Void
Finding:	New Timber Beams
Information:	During the inspection, several new timber beams were discovered in the subfloor and roof voids. It is unclear why these beams were installed, but it is important to determine whether they were added to address structural issues or to address a termite infestation. It is crucial to confirm the reason for their installation and the repair method used to ensure compliance with current regulations.

If the beams were added due to a termite infestation, it is important to verify that the

property now has a preventive termite management system in place. It is also necessary to investigate whether there is any structural inadequacy in the hidden timber beams, especially those within the walls.

Further investigation is recommended to determine the cause and method of repair for the new timber beams to ensure the safety and structural integrity of the property.

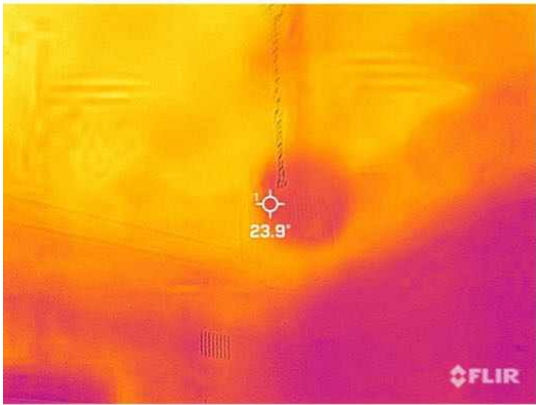
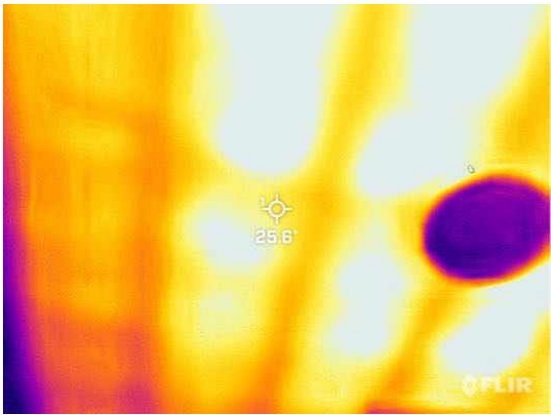
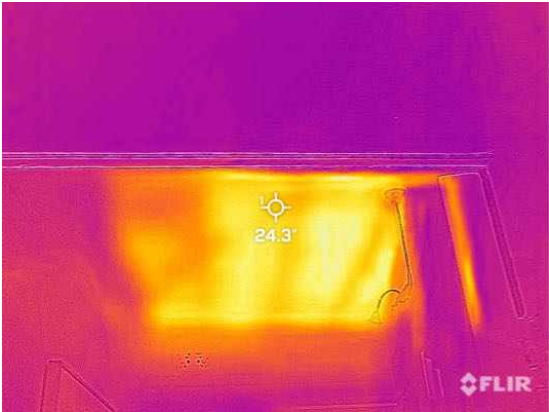
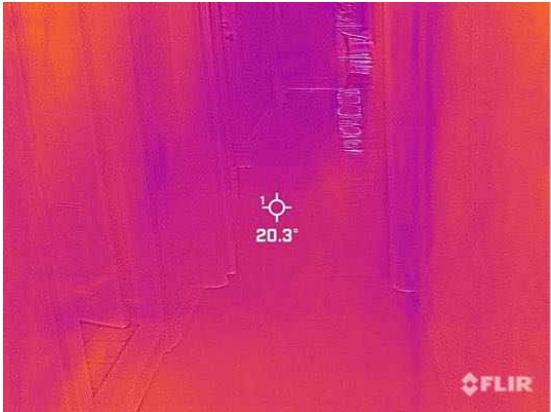
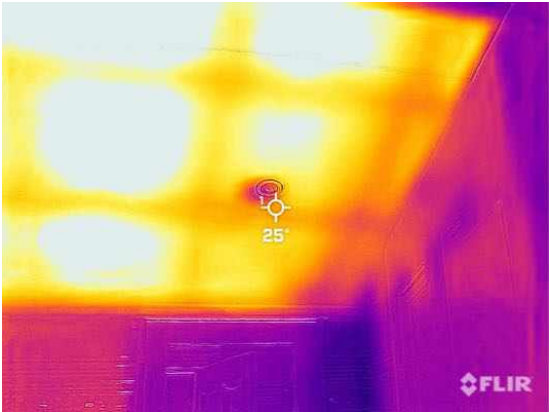
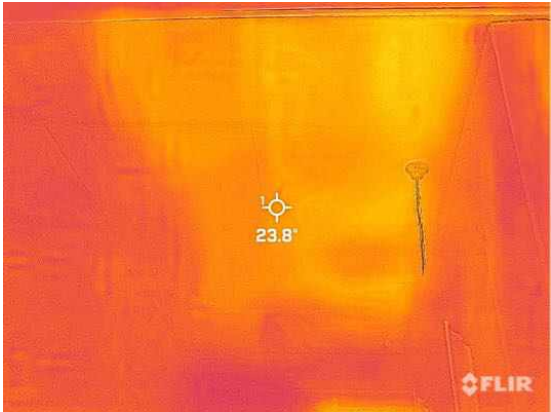
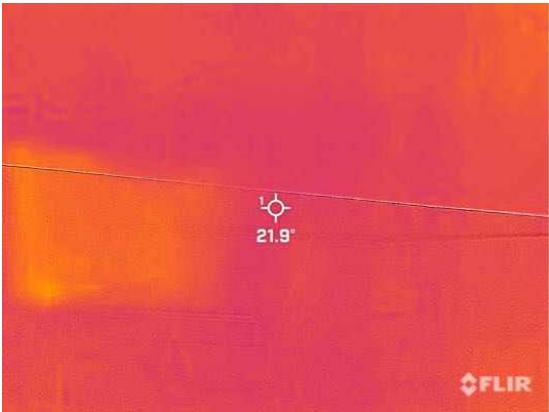
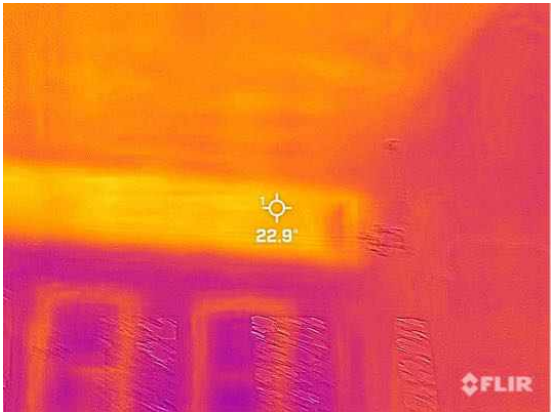
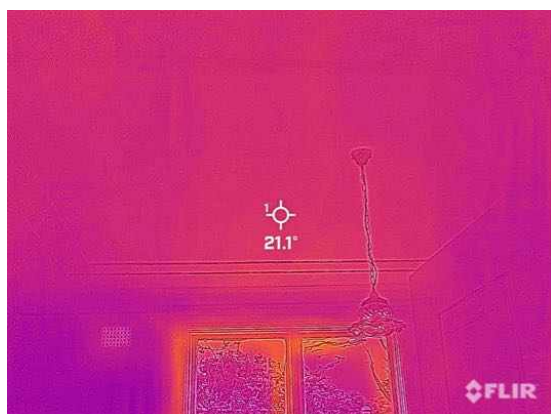
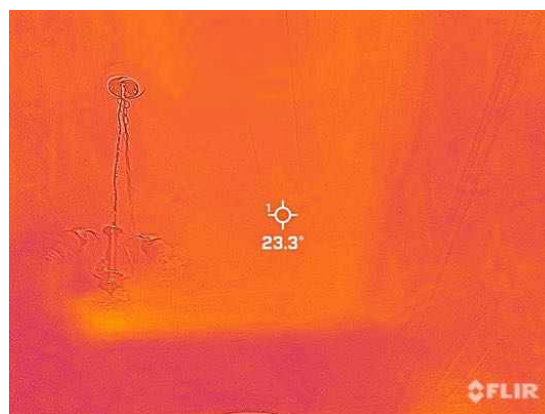
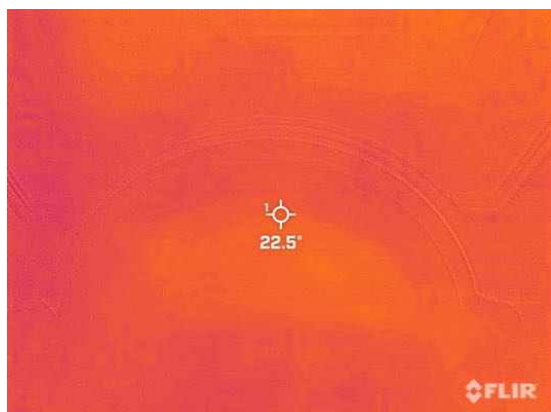
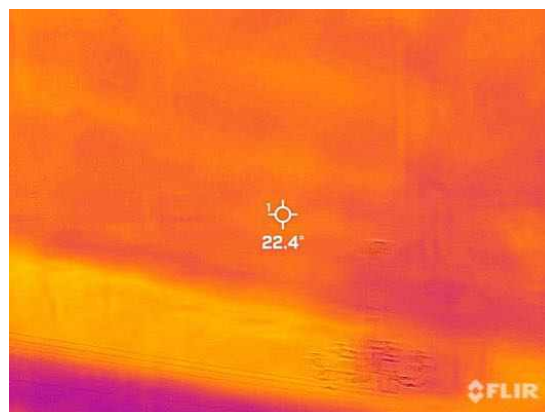
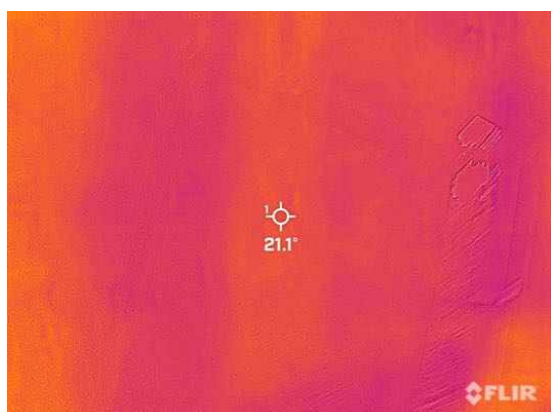
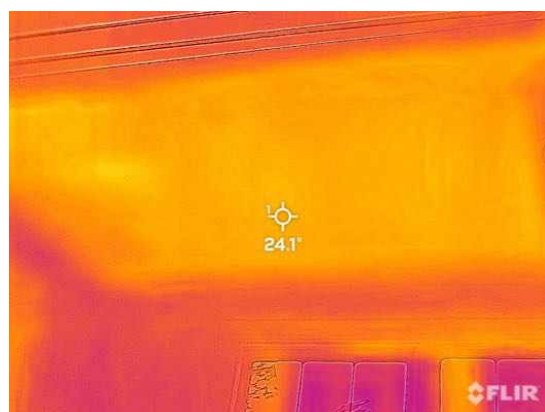
Building:	Main Building
Location:	All Areas
Finding:	Additional Photos
Information:	Thermal imaging camera was used to detect any active water leaks or/ and termite activities in the property. No water leaks or termite activities were found from inspection by thermal imaging camera.

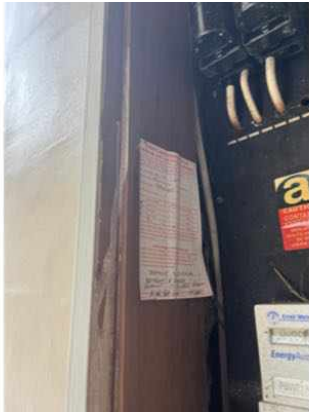
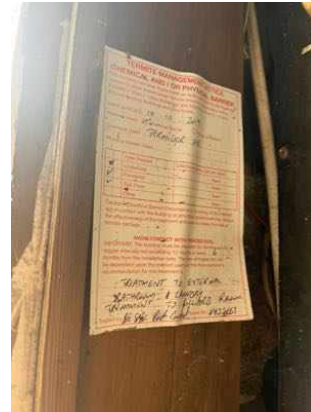
Building:	Main Building
Location:	Meter Box
Finding:	Evidence of a previous termite management system was identified
Information:	There are a number of factors which indicate the presence of a previously installed or applied termite barrier. The most common are a durable notice (to the inside of your meter box) observable physical barriers installed to building perimeter and in ground

reticulation systems.

Where a Termite Management System has been identified you should refer to the type of barrier date of installation warranty conditions and any documentation provided by a builder or past owner. Consult the company who installed the barrier to confirm whether the system is still under warranty.

Most chemical termite management systems expire and require replenishment and all physical systems are primarily designed to prevent concealed entry.
