Building and Timber Pest Inspection Report

Inspection Date: Fri, 6 Feb 2026

Property Address: 72 Cottesloe Dr, Robina QLD 4226,
Australia

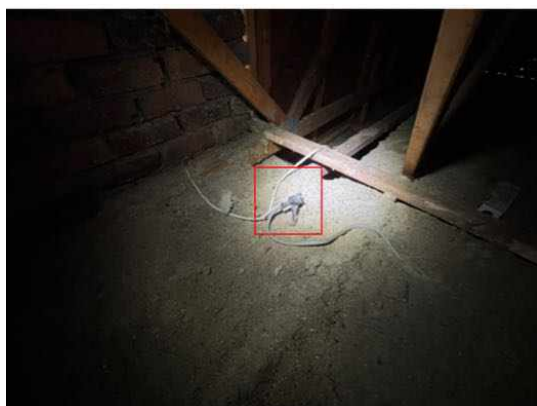
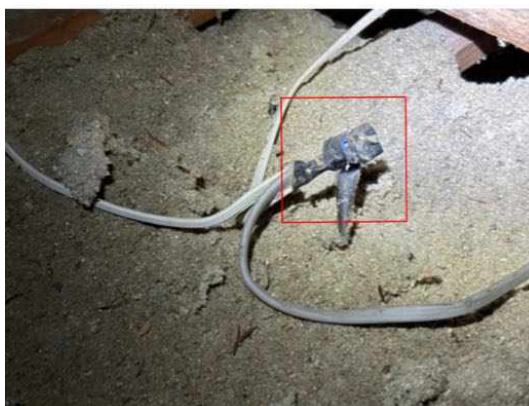
Building: Main Building
Location: Roof Void
Finding: Electrical junction box - Missing
Information: At the time of the inspection, it was noted that an electrical cable in the roof void has not been terminated in a junction box. It could not be determined if the wire is live at the time of the inspection, and as such should be treated as if it is live. This is in the area above the entry.

Junction boxes provide a second insulation barrier to adequately seal off and protect the wires, increasing the safety of the immediate environment and ensuring that the wiring is not damaged.

The absence of junction boxes poses as an electrical safety hazard, providing risk of electrocution. It appears as though wiring in this area has been completed to a substandard level of workmanship, evidenced by the lack of adequate wiring protection.

Appointment of a licensed electrician is highly advised to provide additional information on the risks of unprotected wiring and to install junction boxes and any other elements as required. Such works should be carried out as a matter of urgency; until this time, any persons within this area should exercise a high level of caution.

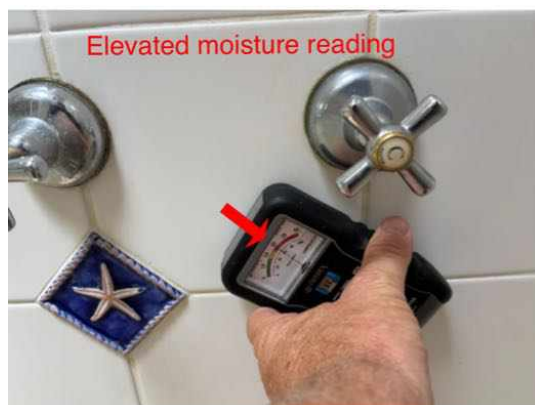
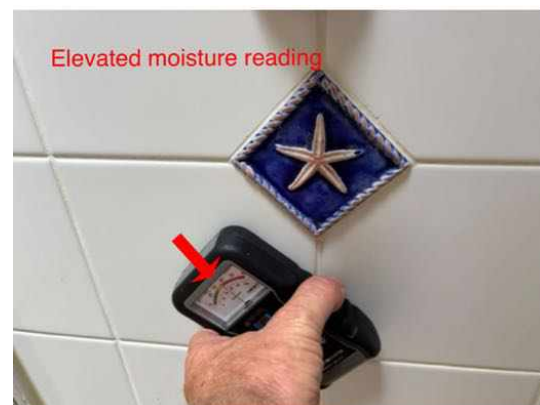
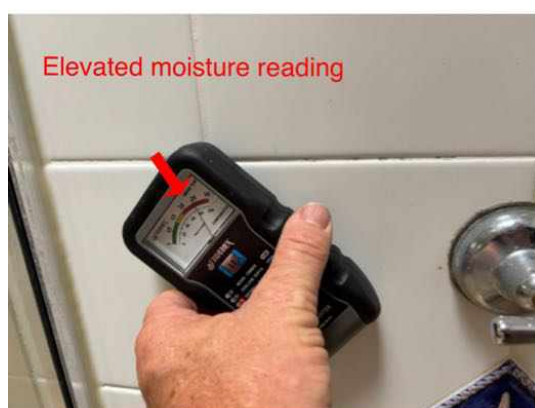
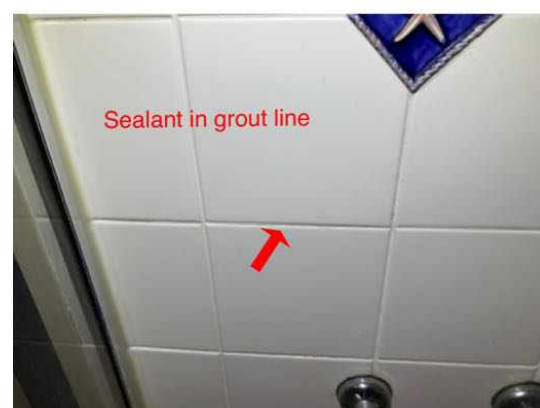
Finding 2.01

Finding: Family bathroom - evidence of moisture damage

Information: At the time of the inspection, it was noted that there was evidence of moisture damage around the shower area of the family bathroom. Elevated moisture readings were recorded on the tiled shower wall and the wall on the bedroom side of the shower. The grout in the shower was not in a good condition and sealant has been applied to at least one grout line.

Moisture damage was found to the bottom of the timber door frames to the bathroom and to the hallway. Excessive moisture readings were recorded at the base of the timber door frame for the door into the bathroom. This appears to have had previous repairs carried out to it.

The moisture readings indicate that there may be an issue with the shower water-proofing which is allowing moisture to enter the wall cavity. An invasive inspection may be required to determine if the water-proofing has failed and if any damage has occurred in the wall cavity.

Moisture in wall cavities creates a conducive environment for termite activity and can cause undetected damage to the associated building materials.

A bathroom specialist should be engaged to assess the shower area and provide a solution to rectify this issue. This should be done as a matter of urgency.

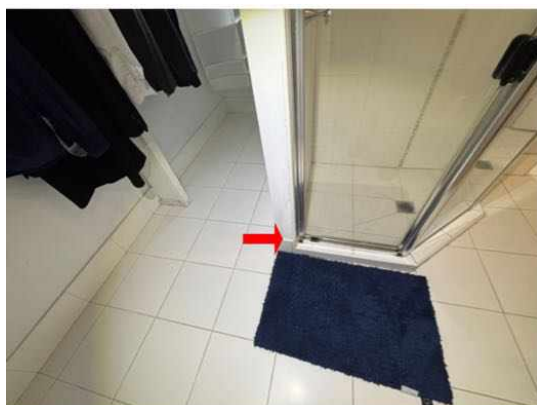
Building:	Main Building
Location:	Ensuite
Finding:	Ensuite - moisture damage
Information:	At the time of the inspection, it was noted that there was evidence of moisture damage to the wall next to the shower in the ensuite. Moisture readings were inconclusive due to the metal corner beads under the plaster which give false excessive moisture readings. It appears that the shower screen may be leaking.

A bathroom specialist should be engaged to assess the shower area in the ensuite and provide a solution for this issue. This should be done as a short term priority.

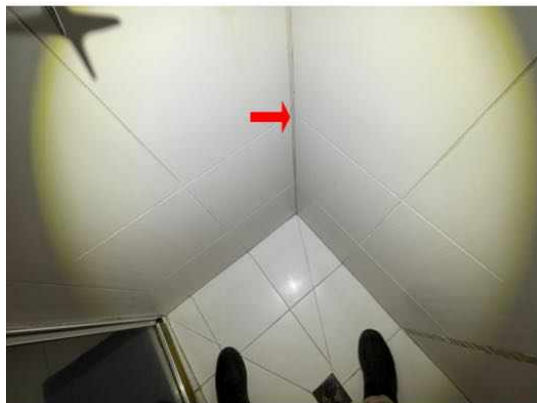
Finding 3.02

Building:	Main Building
Location:	Ensuite
Finding:	Ensuite - sealant deteriorating
Information:	At the time of the inspection it was noticed that the sealant in shower of the ensuite was deteriorating.

Sealant is used in tiled areas to prevent moisture from entering the wall cavity and causing damage to the building elements. A moist environment in the wall cavity may also be a conducive condition for termite activity.

If it is not addressed, damage to building elements will occur and would require invasive works to rectify any damage.

A building maintenance professional or sealant applicator should be appointed to replace all sealant as a matter of urgency.

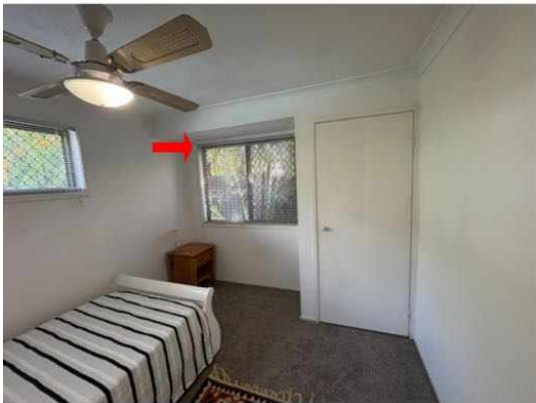
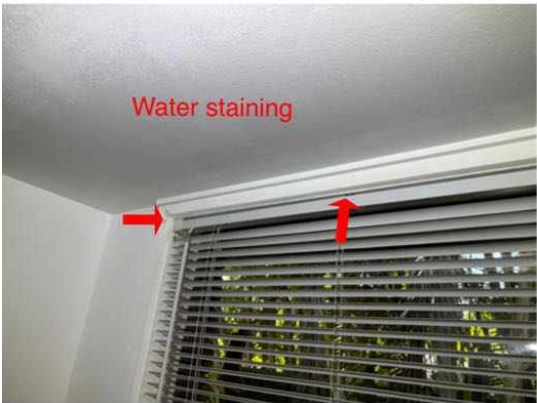
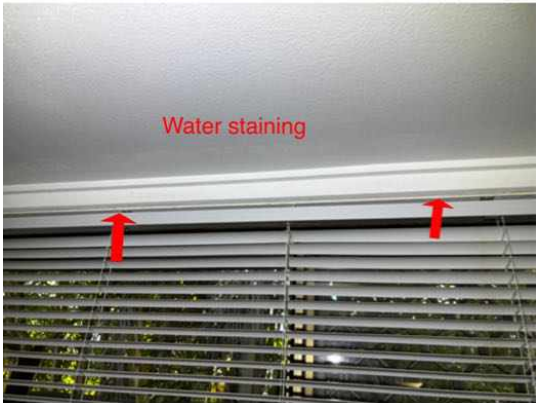
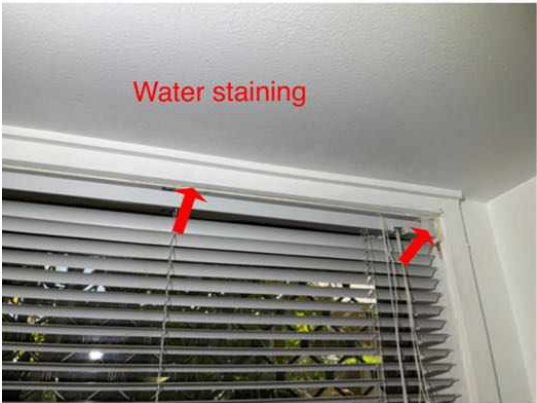
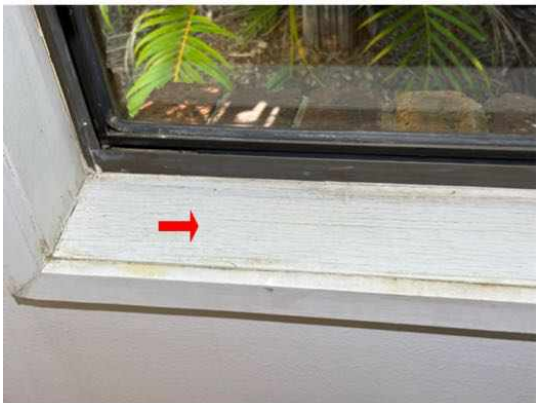
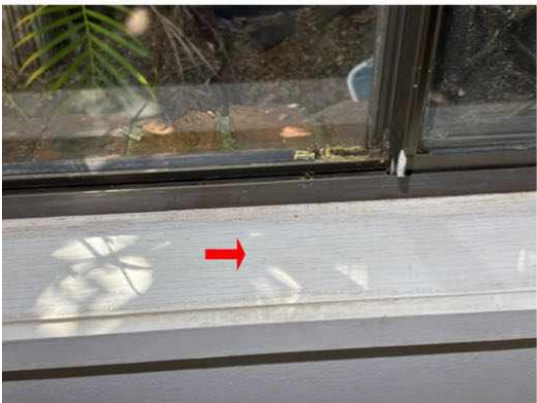
Finding 3.03

Building:	Main Building
Location:	Bedroom 4
Finding:	Window frame - Water stained
Information:	At the time of the inspection, it was noted that there was evidence of water staining to the top of the window frame in bedroom 4(back right corner). Moisture damage was found on the window sill of this window. Elevated moisture readings were recorded on the timber window frame.

Water staining indicates that surfaces have been exposed to excessive moisture over time. The minerals and other elements in the water lead to staining, which may graduate to corrosion and deterioration if left unmanaged.

While mostly an appearance defect, water staining can be indicative of more serious defects, which may be currently concealed by interior ceilings.

Where water staining is active, a licensed plumber must be consulted to identify the cause of the staining and to provide advice on any reparation works that may be required. Replacement of any damaged structures is advised.

Conversely, where water staining is old and inactive, affected building materials may be repaired or replaced at client discretion.

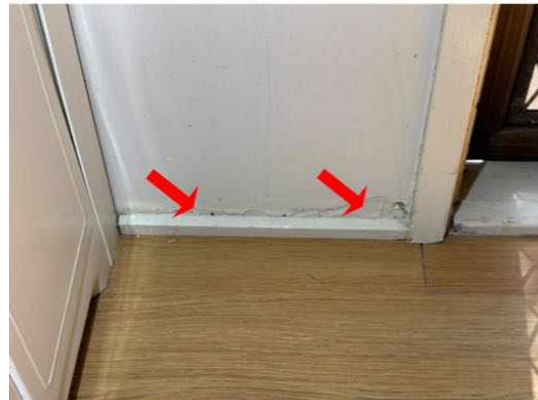
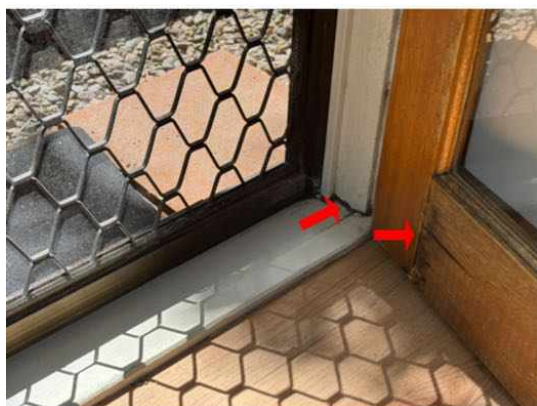
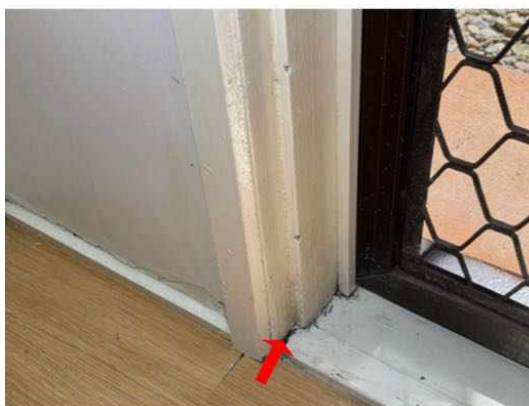
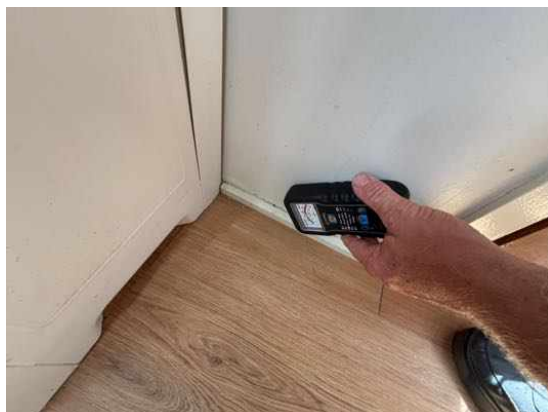
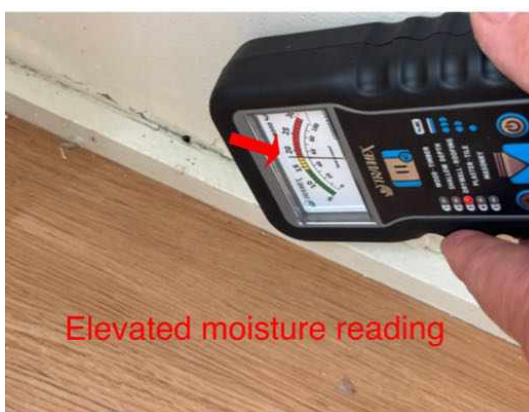
Finding 3.04

Finding: Laundry - evidence of moisture damage

Information: At the time of the inspection, it was noted that there was evidence of moisture damage to a lower section of the exterior wall in the laundry. This may be due to the external laundry door having no weather seals to it. Elevated moisture readings were recorded in this area.

Again, this part of the dwelling has little to no eaves on the exterior and as such, blocked gutters could overflow back into the building. The gutters were clear when inspected.

A building maintenance professional could be engaged to install weather seals to the external laundry door and repair the moisture damage. This can be done at the clients discretion.

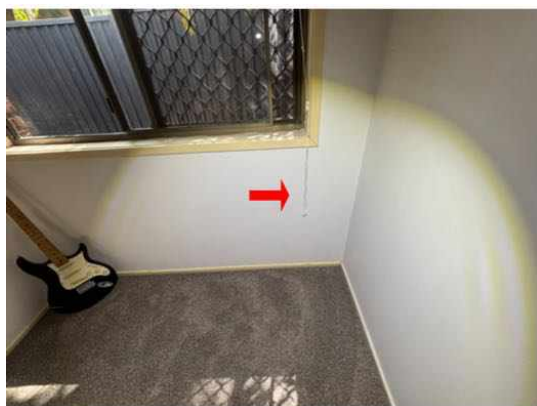
Finding 3.05

Finding: Bedroom 3 - water stain

Information: At the time of the inspection, it was noted that there was a water stain to the wall under the window in bedroom 3. Elevated moisture readings were recorded on the window sill but only in front of the opening side of the window. It is suspected that moisture has entered the room through the open window. Again, this part of the dwelling has little to no eaves and as a result the window is not protected from weather.

A building maintenance professional or painting contractor could be engaged to carry out the necessary repairs to this area. This can be done at the clients discretion.

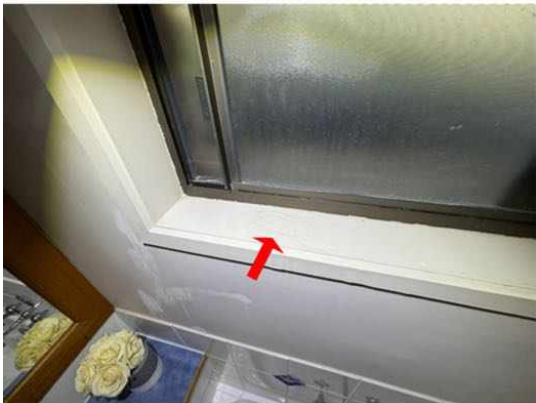
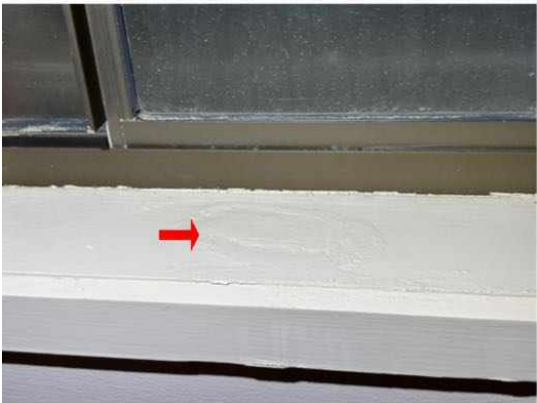
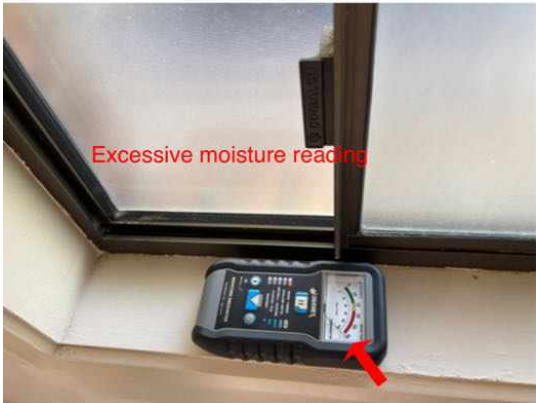
Finding 3.06

Building:	Main Building
Location:	Family bathroom
Finding:	Family bathroom - window sill damage
Information:	At the time of the inspection, it was noted that a section of the window sill in the family bathroom has been poorly repaired. Excessive moisture readings were recorded on the repair. The possible source of this moisture reading could not be determined.

The client should monitor the area for any change in appearance which may suggest a leak.

A building maintenance professional or painting contractor could be engaged to redo this repair. This can be done at the clients discretion.

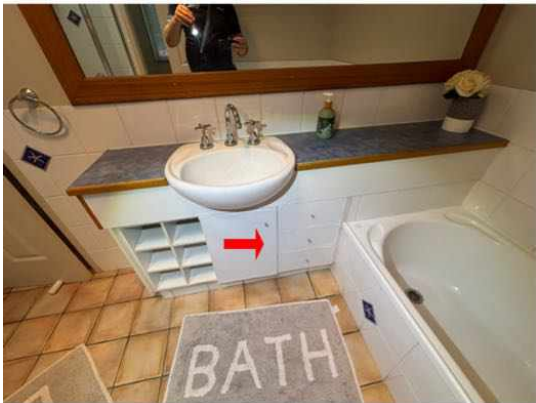
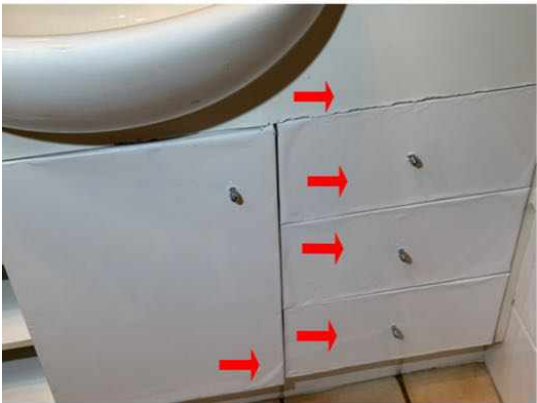
Finding 3.07

Building: Main Building
Location: Family bathroom
Finding: Family bathroom - vanity has moisture damage
Information: At the time of the inspection, it was noted that the vanity in the family bathroom had evidence of moisture damage to it. This has been covered with a film to improve the appearance. Due to the age of the materials, this is not unusual where exposure to moisture is expected.

A bathroom specialist could be engaged to replace the vanity. This can be done at the clients discretion.

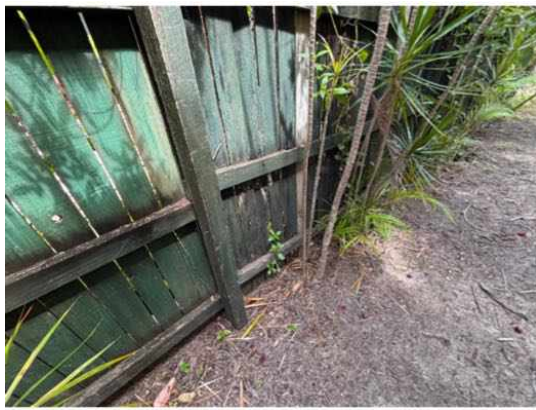
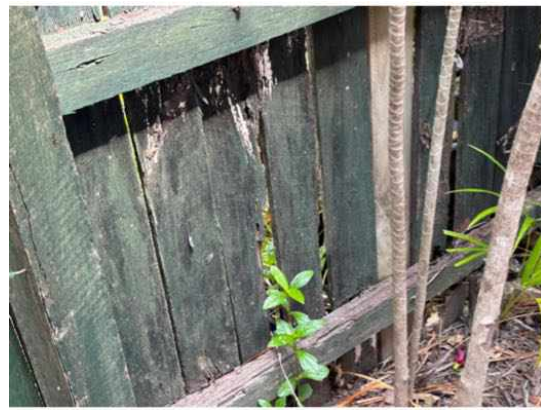
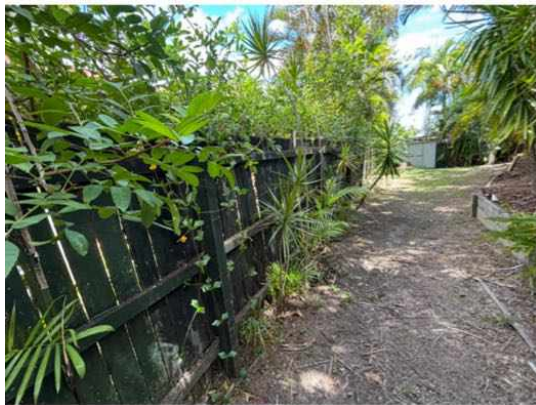
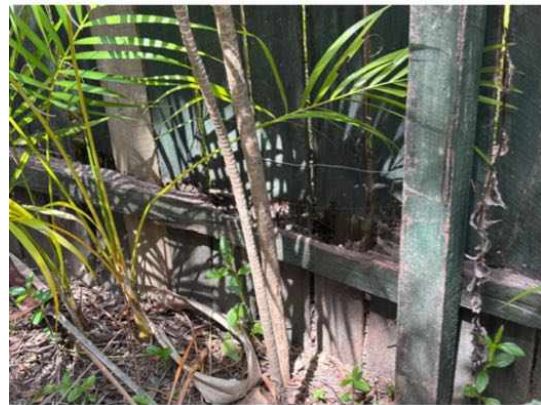
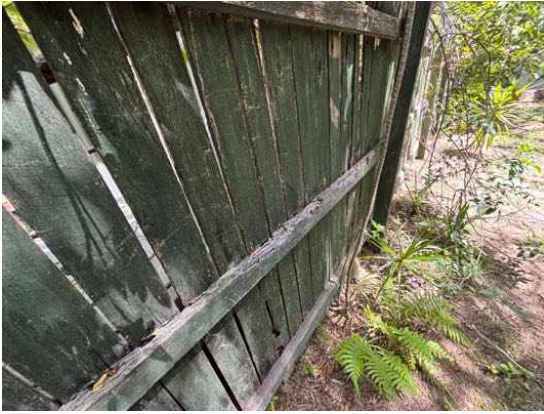
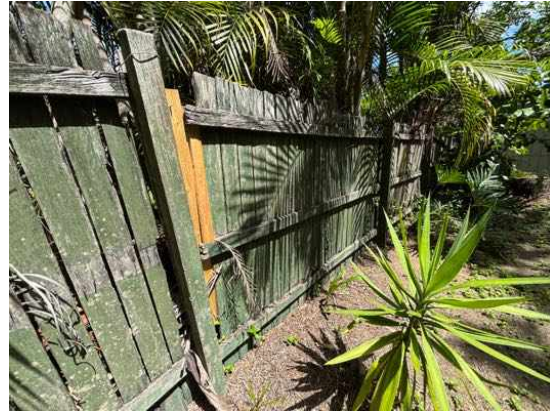
Finding 3.08

Building: Main Building
Location: Boundary fence
Finding: Boundary fence- deteriorating
Information: At the time of the inspection, it was noted that the left hand side timber boundary fence was deteriorating. This will be due to the age of the materials and general weathering. The fence is currently upright however there is movement to some sections when pressure is applied to them.

A fencing contractor should be engaged to assess the fences and provide a solution to rectify this issue. This can be done at the clients discretion.

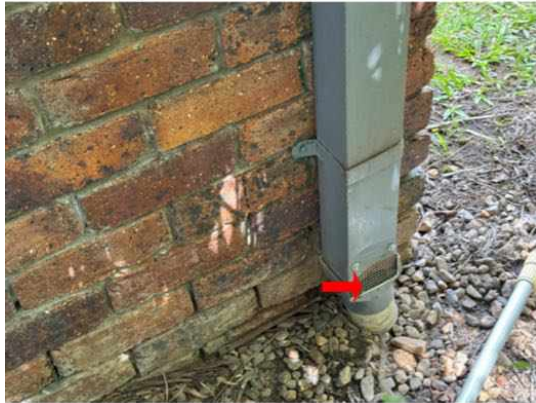
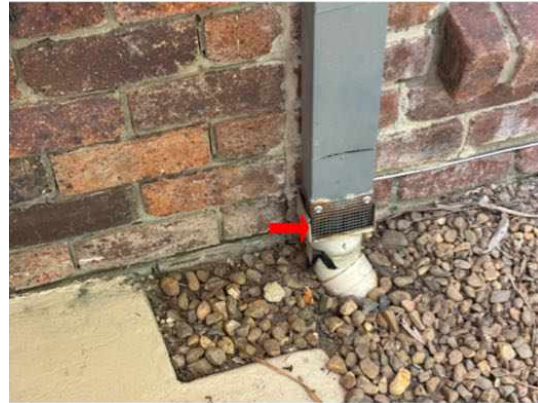
Finding 3.09

Building: Main Building
 Location: All External Areas
 Finding: Down pipes - modified
 Information: At the time of the inspection, it was noted that the base of two of the down pipes for the gutter system has been modified. A section has been cut out and covered with mesh. The reason for this modification could not be determined.

This may allow moisture to escape near the foundations of the dwelling which will create a conducive environment for termite activity and may cause damage to the associated building materials.

A licensed plumber should be engaged to repair the affected down pipe bases. This can be done at the clients discretion.

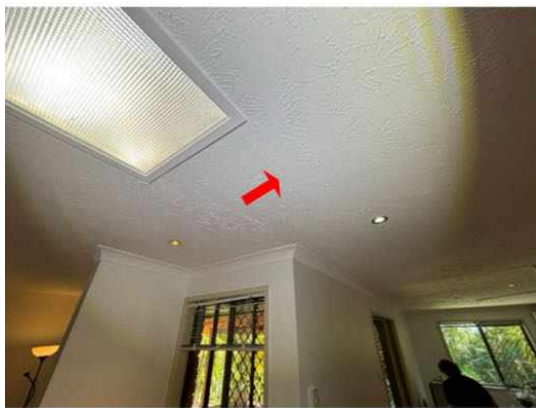
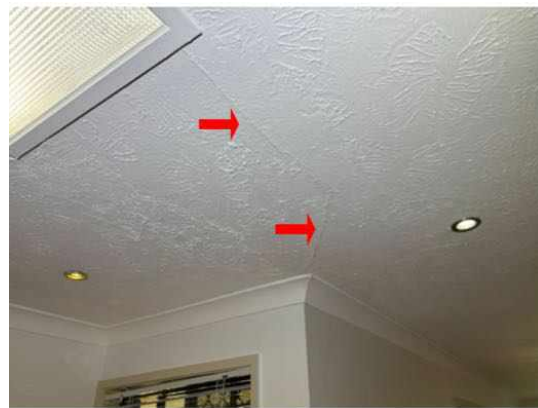
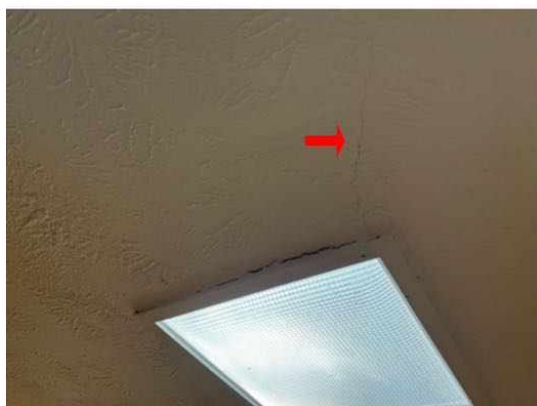
Finding 3.10

Finding: Kitchen - ceiling lining cracking

Information: At the time of the inspection, it was noted that there was minor cracking to the ceiling lining around the skylight in the kitchen area. This appears to be general wear and tear and movement of the associated building materials. Normal moisture readings were recorded around the skylights.

The functionality of the ceiling lining is not affected at present. A plasterer could be engaged to repair the cracks. This can be done at the clients discretion.

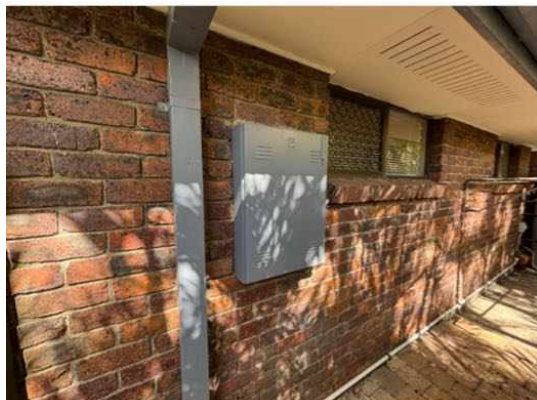
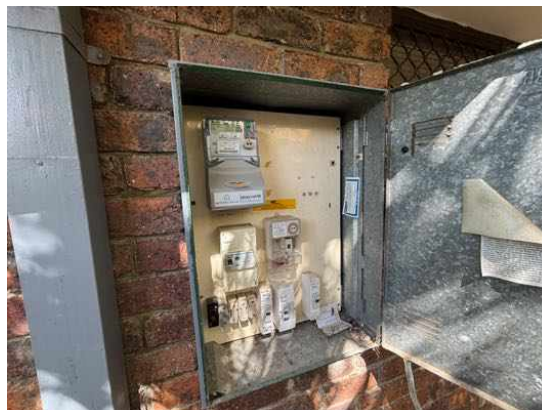
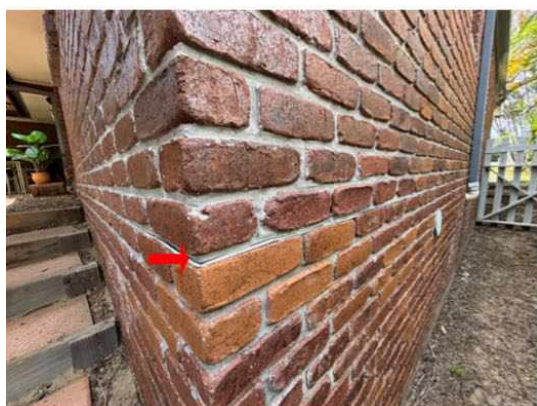
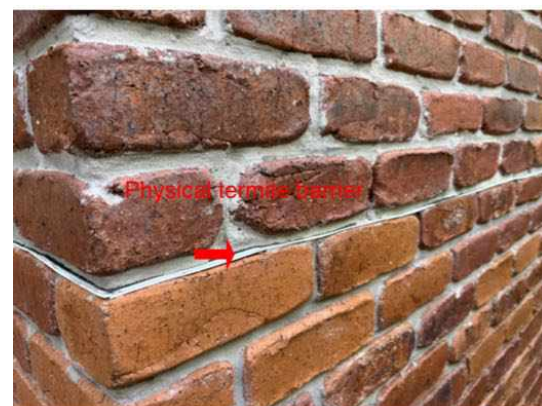
Building:	Main Building
Location:	All External Areas
Finding:	Termite Management System - no evidence of a chemical installation
Information:	At the time of the inspection, no evidence of a chemical termite management system was found. There is no durable notice in the meter box. Visual evidence of a physical termite barrier was found to the left hand side extension which appears to have been built in 2020. The original dwelling on the right hand side has no termite treatment system.

The application of a post-construction chemical termite barrier is highly recommended for all properties, particularly if live termite activity has been found on the site previously. Such barriers are highly effective in preventing termite attack on any timber building elements throughout the property.

A termite treatment system and annual termite inspections are important parts of an ongoing termite management plan.

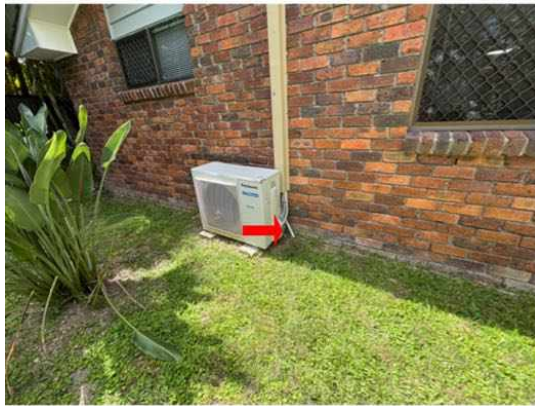
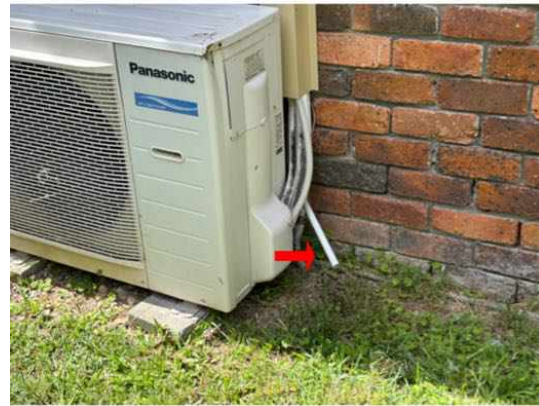
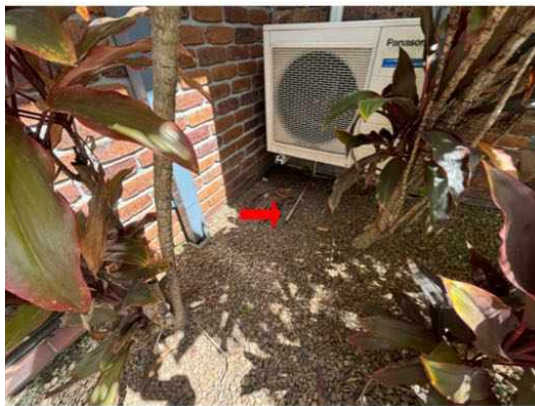
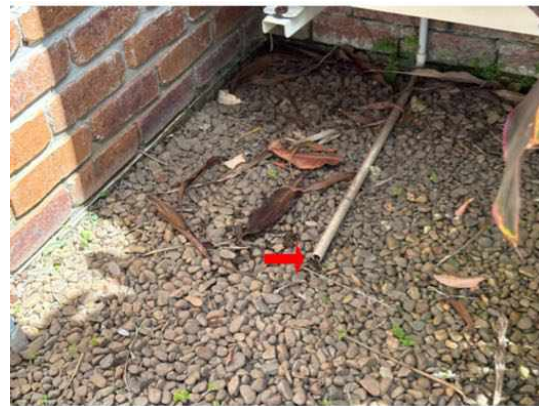
Finding 6.02

Building:	Main Building
Location:	All External Areas
Finding:	Air conditioner - Disconnected overflows
Information:	At the time of the inspection, it was noted that the air conditioner drain overflows to all the units were not connected to the storm water drainage and as a result are draining next to the foundations of the dwelling.

Air conditioning overflows that are not connected to the storm water drainage and are draining near the foundation can create excessive moisture in the surrounding area.

Such leaking creates an environment which is conducive to an array of defects, including water damage to associated building elements and the attraction of termite or timber pest infestation.

It is highly recommended that a licensed plumber be appointed to connect the A/C overflow in order to prevent such an environment from being created. These minor

works should be carried out as soon as possible.

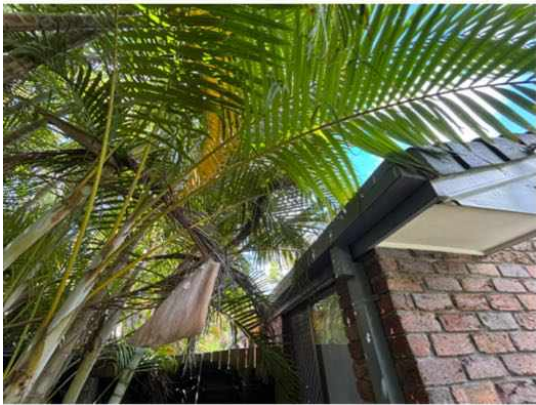
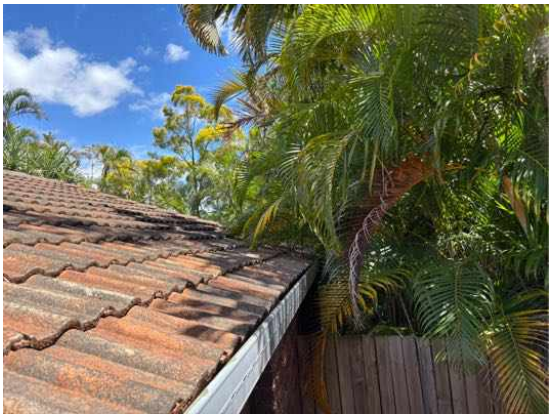
Finding 6.03

Building:	Main Building
Location:	All External Areas
Finding:	Vegetation touching the building
Information:	At the time of the inspection, it was noted that there was vegetation touching the building in several locations. This creates a potential access point for termites to enter the building undetected. This is a conducive condition for termite activity.

The client is to ensure that the vegetation is trimmed back to prevent undetected termite entry to the building and to provide a clear inspection area between the vegetation and the dwelling. This should be done as a matter of urgency.

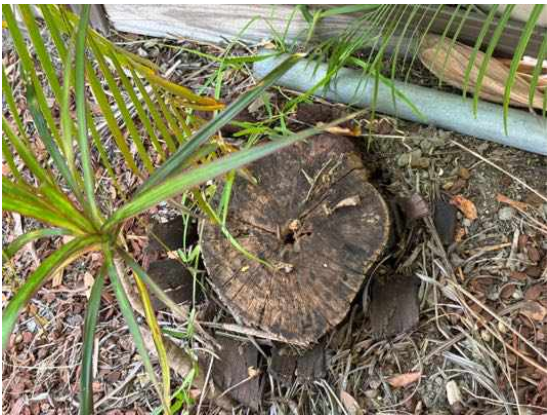
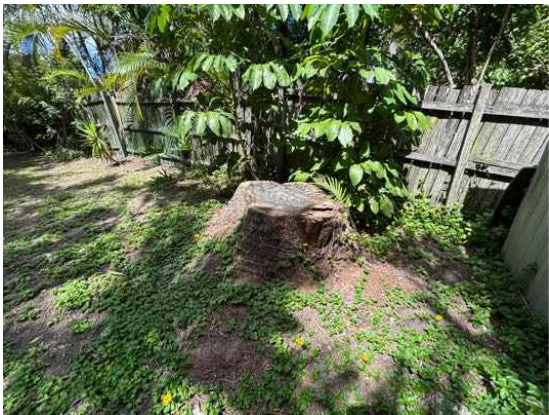
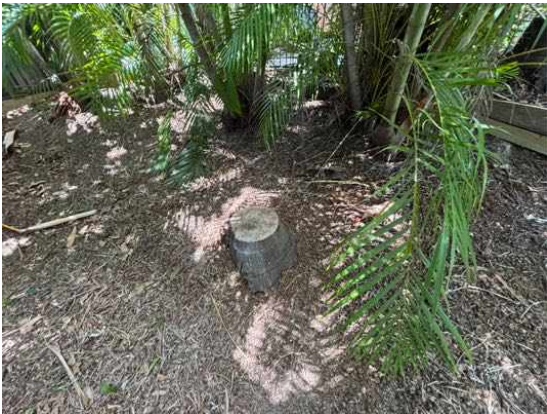
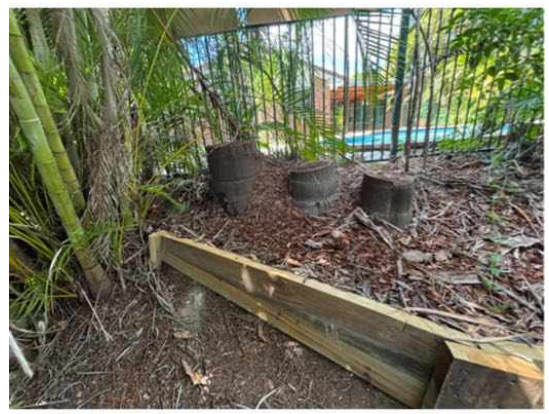
Finding 6.04

Building: Main Building
Location: All External Areas
Finding: External areas - tree stumps
Information: At the time of the inspection, it was noted that there were several tree stumps throughout the yard. Over time they will decay and become a conducive environment from termite activity.

The client should have the stumps and any leaf or garden litter removed. This should be done as a short term priority.
