# Building and Timber Pest Inspection Report

Inspection Date: Mon, 19 Jan 2026

Property Address: 504/16 Flack Ave, Hillsdale NSW 2036,  
Australia

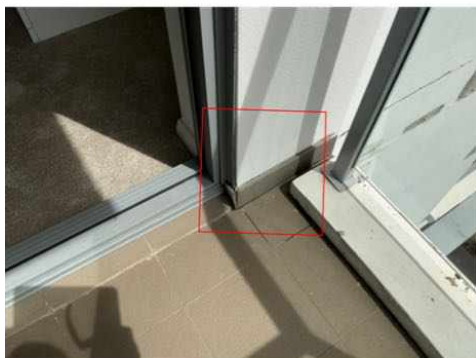
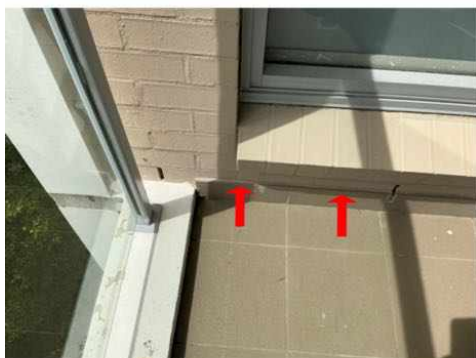
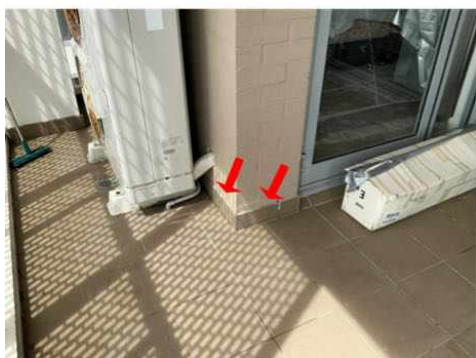
Building: Main Building  
Location: Both balconies  
Finding: Tiles - Drummy  
Information: Drummy tiled areas were identified at the time of inspection. The term 'drummy' refers to tiles that have become detached from their fixing, despite otherwise being in relatively good condition. Such defects are generally caused by physical or moisture damage to the area. Drummy tiled areas may also be a direct result of poor workmanship during the construction process.

Tiled areas may swell and shrink with changes in air humidity if the area has sustained moisture damage. Any exposure to moisture is capable of causing tiled areas to become drummy and/or cracked over a prolonged period of time. Drummy tiled areas generally require removal and replacement of affected tiles, with adequate sealant and grouting.

Specialist trades are available for these types of services. A registered builder may be required to undertake works if damage is extensive or if secondary building defects have resulted. Otherwise, it is advised that a tiling contractor be appointed to perform works as necessary. Immediate action is recommended to ensure that no further damage is sustained in the affected area.

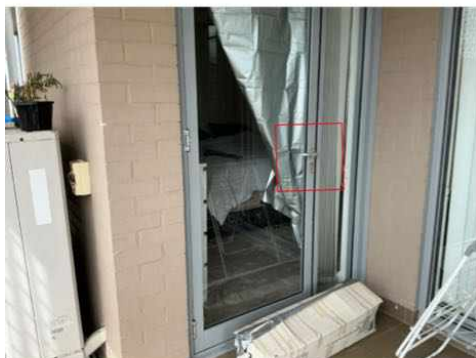
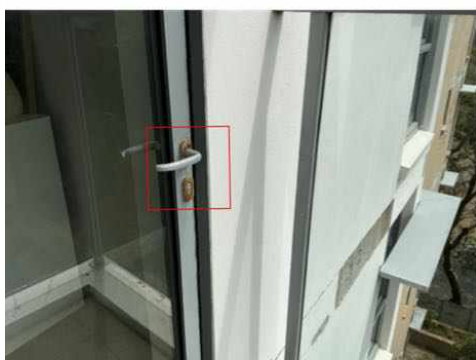
### Finding 3.02

Building:	Main Building
Location:	Balconies
Finding:	Building element - Rusted or corroded. Door handles/ key entries
Information:	This building element shows evidence of rusting and corrosion, which is likely to have developed as a result of excessive exposure to moisture and or inadequate coatings.

As surface rust provides no protection to the underlying iron, the deteriorating condition is likely to worsen if not addressed in the short-term future.

Where possible, the use of galvanized (treated) metals or aluminium coated metals aid in rust prevention, as does regular general maintenance. Rust formation can be controlled with coatings, such as paint, that isolate the iron from the environment.

Rusting and corrosion should be managed by ideally removing or limiting the affected surface from exposure to moisture. A registered builder may be appointed to replace any building elements that have been severely affected by rust or water damage.

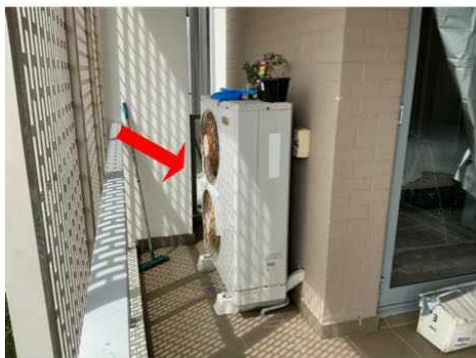
### Finding 3.03

Building:	Main Building
Location:	Balcony
Finding:	Building element - Rusted or corroded- Air Conditioner
Information:	This building element shows evidence of rusting and corrosion, which is likely to have developed as a result of excessive exposure to moisture and or inadequate coatings.

As surface rust provides no protection to the underlying iron, the deteriorating condition is likely to worsen if not addressed in the short-term future.

Where possible, the use of galvanized (treated) metals or aluminium coated metals aid in rust prevention, as does regular general maintenance. Rust formation can be controlled with coatings, such as paint, that isolate the iron from the environment.

Rusting and corrosion should be managed by ideally removing or limiting the affected surface from exposure to moisture. A registered builder may be appointed to replace any building elements that have been severely affected by rust or water damage.

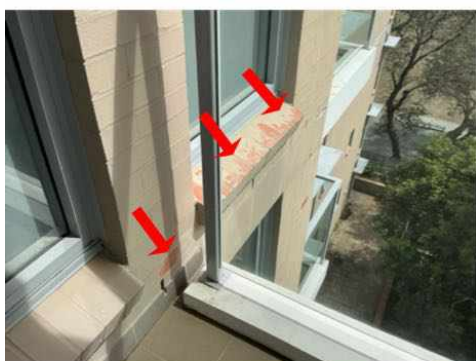
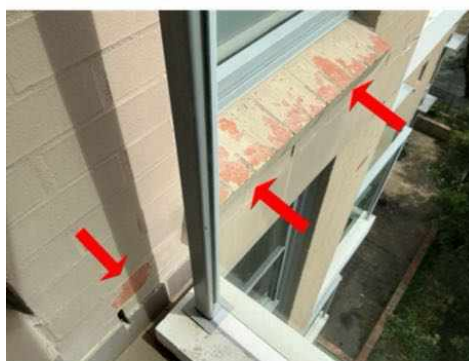
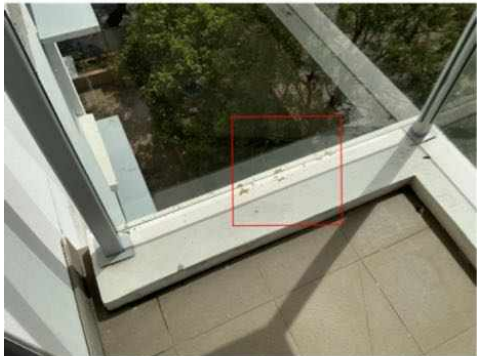
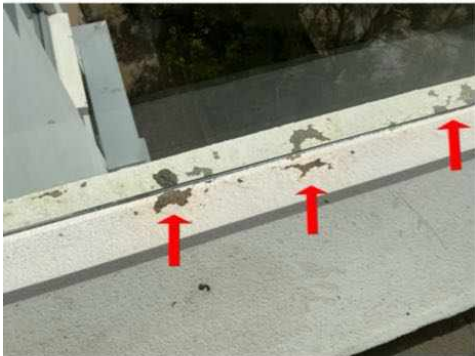
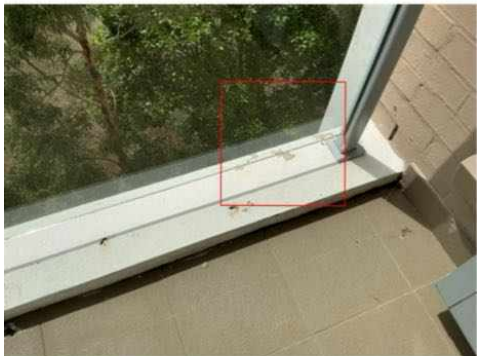
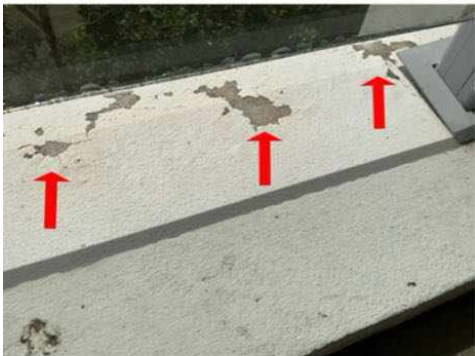
### Finding 3.04

Building:	Main Building
Location:	Balconies
Finding:	External painting deteriorated- balconies
Information:	Much of the external paintwork including but not limited to balconies and other external fitments have been neglected and require attention to prepare and re-paint.

Whilst incomplete or missing paint finish is generally an appearance defect, it can also lead to the development of secondary building defects over time. Incomplete areas of paint finish expose the area to moisture, potentially accelerating the deterioration of underlying building materials.

Degraded paint finishes should be sanded back, filled, leveled and painted, as applicable. Where inadequate or missing paint protection has led to the deterioration of the associated building element, repair and/or replacement of this building element may be required.

A painting contractor should be appointed as soon as possible to perform necessary works to aid the appearance of the affected area and to ensure the area is protected against further deterioration. Alternatively, the homeowner following manufacturer instructions may perform these works.

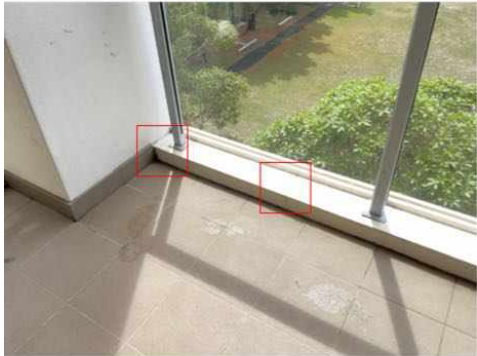
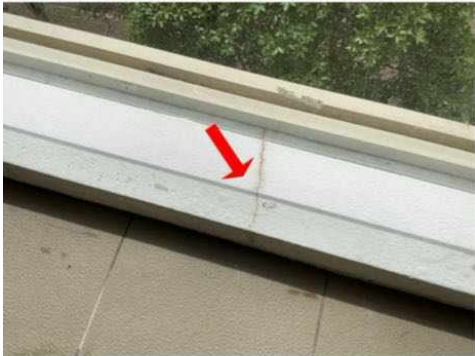
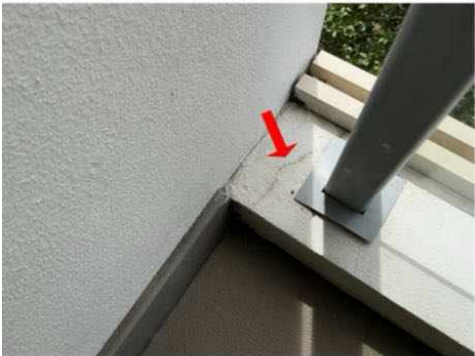
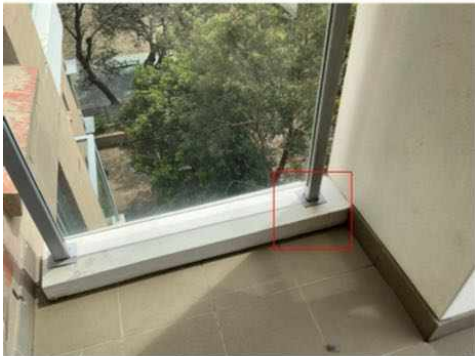
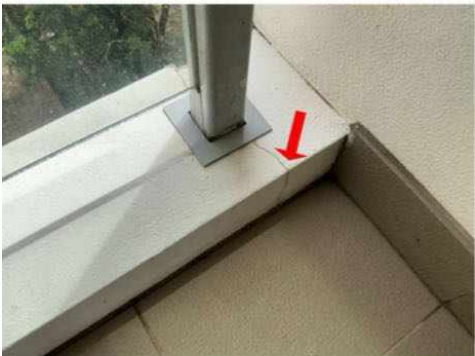
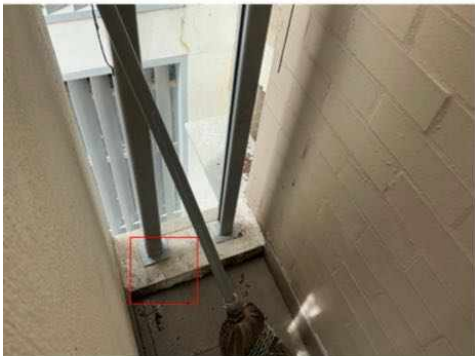
**Finding 3.05**

Building: Main Building  
Location: Balconies  
Finding: Cracks to external render - Category 1  
Information: It has been observed that cracking to internal rendered surfaces has occurred. The degree of damage falls within Category 1, described as fine cracks that do not need repair and which are less than 1.0mm in width limit.

Damage of this category is not considered a defect for rectification. Always contact your building inspector should cracks widen, lengthen, or become more numerous.

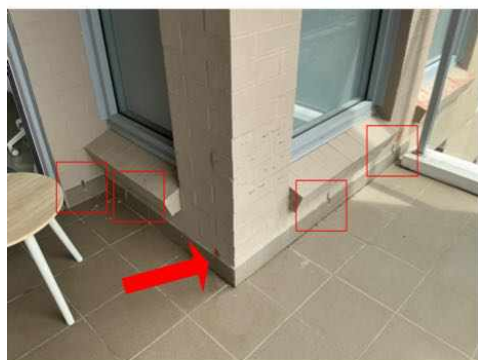
Finding 3.06

Building: Main Building  
 Location: Balcony  
 Finding: Weep hole blocked- main balcony  
 Information: The weep holes to the brickwork are blocked. Weep holes are designed to allow water to escape the cavity from leaks or seepages in brickwork before the water enters in or damages the wall cavity and in particular to windows and doorways. Weep holes should be kept clean and free of debris or blockages

Depending on the nature of the blockage the homeowner may be able to undertake remedial works. Where weepholes are extensively blocked the registered builder on site should perform such works.

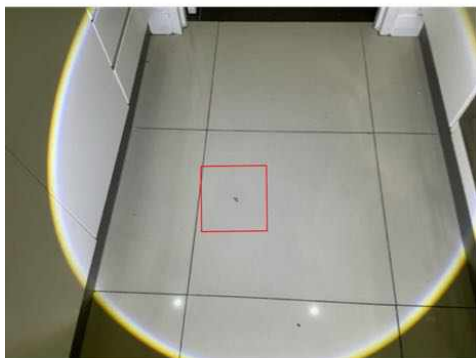
### Finding 3.07

Building: Main Building  
 Location: Kitchen floor  
 Finding: Surface - Chipped  
 Information: The surface of this building element appears to have chipped as a result of general wear and tear. While being an appearance defect, such damage is expected of a property of this age and condition.

Chipped surfaces rarely impede on the structure or functionality of the affected building element and generally only create a blemish on its appearance. Chipped surfaces may be left in situ at client discretion, as no repairs or replacement are necessarily required. However, the client may wish to seek quotations for the cost of refurbishment or replacement of the identified building element.

A qualified Tiler or Builder should be appointed to repair chipped surfaces and replace building elements where major damage has occurred.

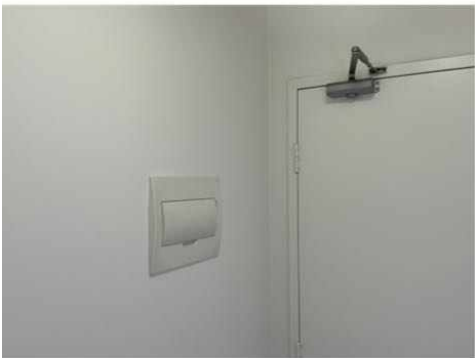
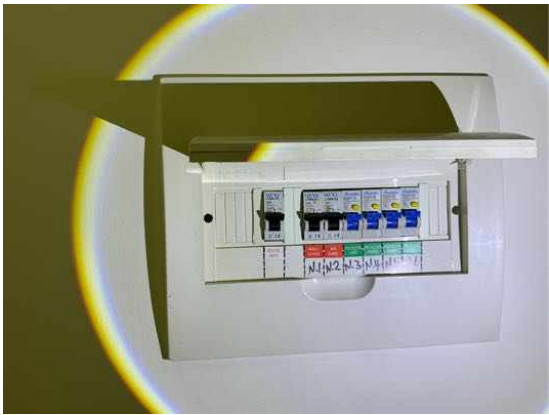
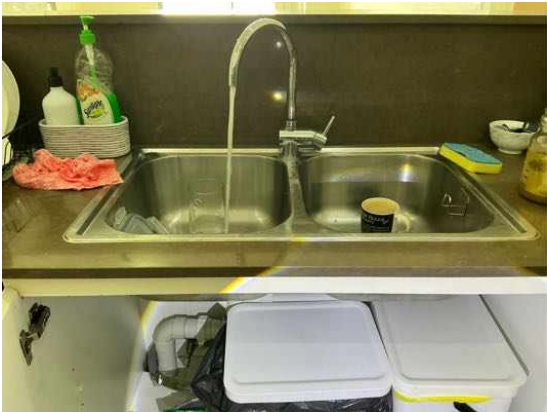
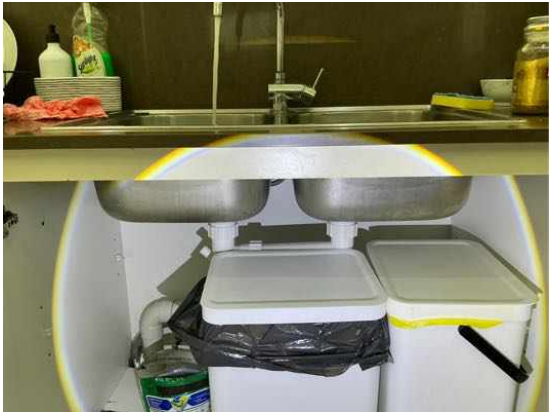
Building:	Main Building
Location:	All Areas
Finding:	Termite Management System - no evidence of a chemical installation
Information:	The application of a post-construction chemical termite barrier is highly recommended for all properties, particularly if live termite activity has been found on the site previously. Such barriers are highly effective in preventing termite attack on any timber building elements throughout the property.

A durable notice should be placed in the switchboard unit to indicate current termite barriers. At the time of inspection, it appeared as though no termite management system has been installed, with no evidence to suggest preventative works taking place.

The client may consider gaining further advice from a pest controller as to the costs and procedures involved with this application. It is recommended that obtaining such advice be a short-term priority.

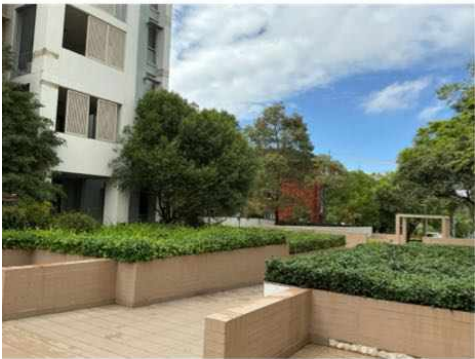
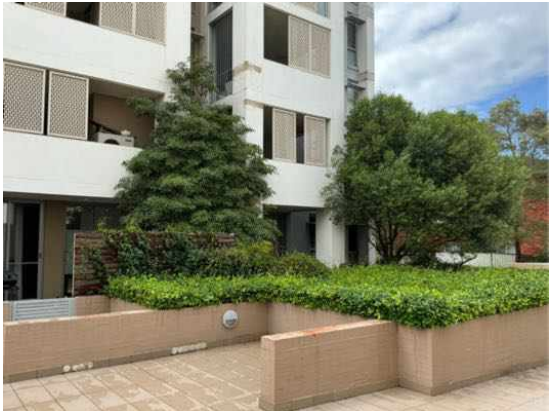
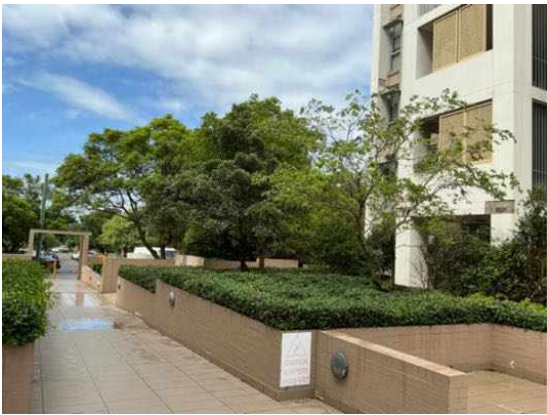
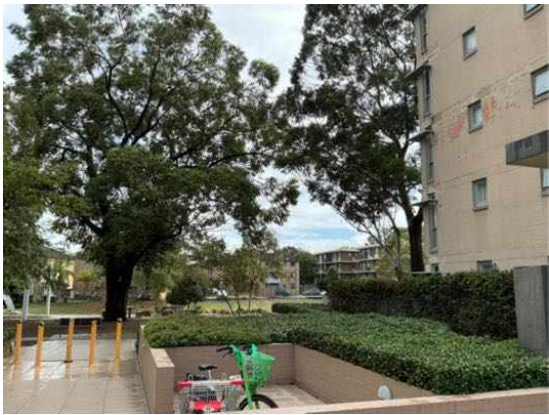
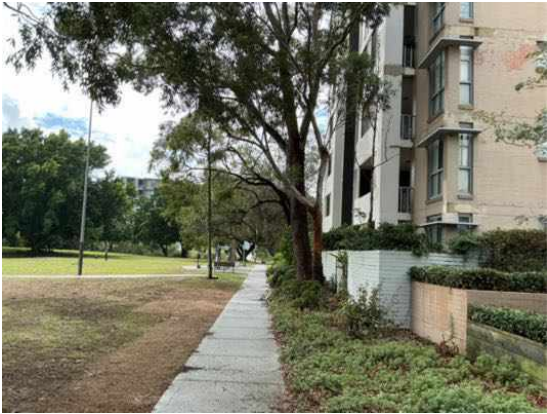
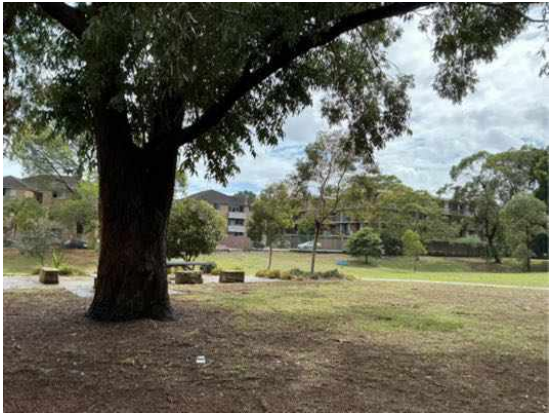
**Finding 6.02**

Building: Main Building  
 Location: All Areas  
 Finding: Trees to be inspected within the property.  
 Information: Trees can be conducive to termite activity and nesting. Trees over 100mm on the property, should be drilled and tested for termite activity.

Regular inspections every 6-12 months- or advised by the termite management system installer.

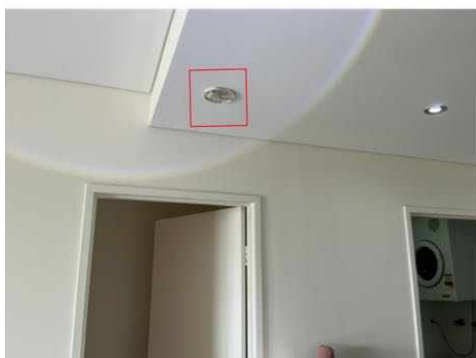
Please note that this defect is highlighted as a caution only. We suspect, based on our experience in the building industry, that the absence of smoke detectors, or their poor condition, should be addressed as a matter of urgency to improve occupant safety.

Always ensure sufficient working and suitable smoke detectors are installed prior to occupying any building. Additionally, it is advised that all smoke detectors be tested by the homeowner on a monthly basis.
