Building Inspection Report

Inspection Date: Wed, 1 Apr 2026

Property Address: 54 Ohallorans Rd, Lara VIC 3212, Australia

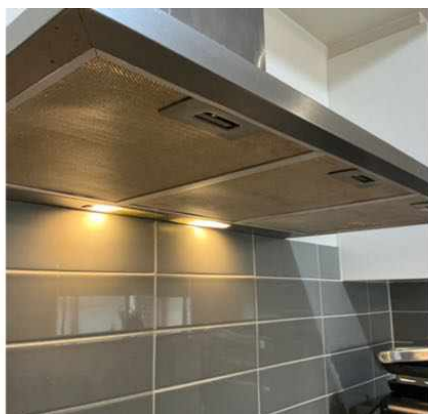
Defects 1.01

Contemporary requirements for mechanical kitchen ventilation systems specify that ducted rangehoods must discharge directly to the external atmosphere. Venting into the roof void introduces airborne grease particles, cooking odours, and moisture-laden air into an enclosed space, which may result in long-term deterioration of insulation materials, framing components, and roof elements.

- Accumulation of grease and moisture within the roof void
- Potential mould or condensation-related damage to insulation and framing
- Non-compliance with current NCC requirements for mechanical exhaust systems
- Possible reduction in indoor air quality and ventilation performance

While this installation may have been permissible under older standards, it is not compliant with current construction and health expectations. Rectification is advised to prevent further impact to the roof space and to meet modern regulatory requirements.

- A licensed plumber or mechanical ventilation specialist should be engaged to modify the ductwork and install a compliant termination to the external atmosphere
- The roof cavity should be inspected for signs of moisture damage or grease build-up resulting from prolonged internal discharge
- Any insulation affected by grease or moisture contamination should be replaced

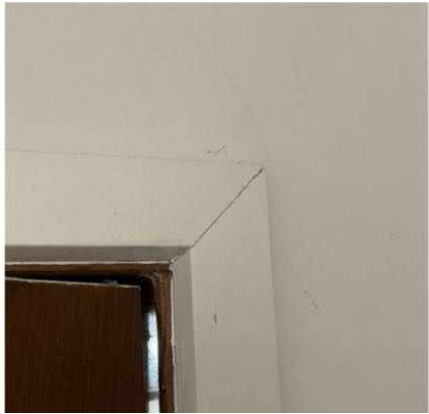
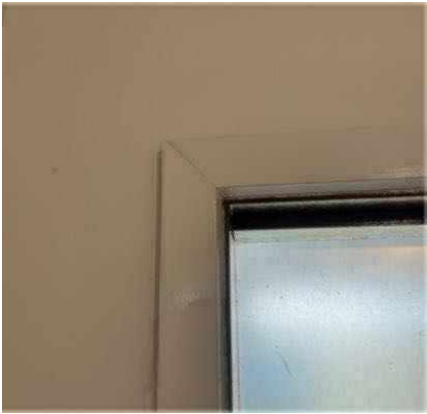
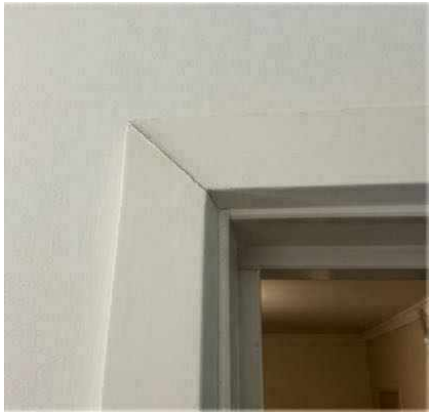
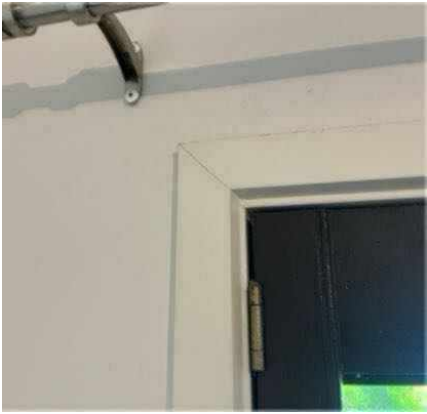
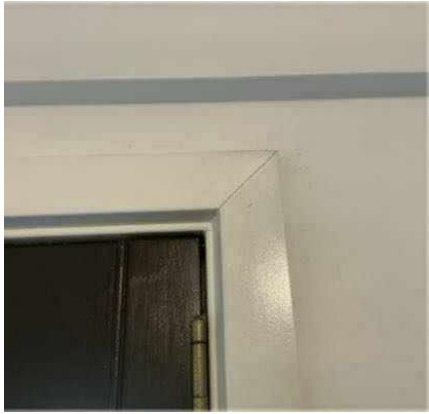
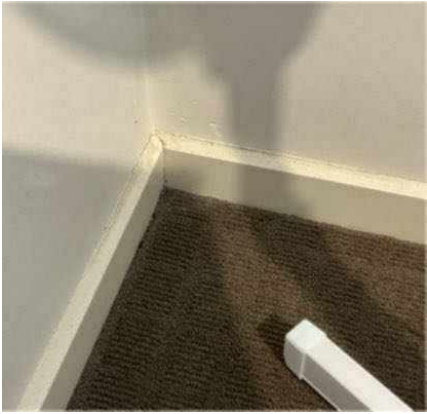
Defects 3.01

Building:	Main Building
Location:	All Internal Areas
Finding:	Cracking to Painted Architraves and Skirting Boards
Information:	Cracks were observed opening up in various sections of the painted architraves and skirting boards. These cracks may be associated with minor building movement, timber shrinkage, or inadequate surface preparation prior to painting.

- Aesthetic presentation is compromised by visible cracking.
- Potential ongoing movement may lead to further deterioration or require repeated maintenance.
- May indicate underlying workmanship or preparation issues.

This condition is not uncommon following recent painting, particularly in timber joinery, and is typically considered a maintenance item unless associated with significant structural movement.

- Engage a qualified painter or builder to assess the extent of cracking and undertake necessary repairs, which may include filling, sanding, and repainting affected areas.
- Monitor for any signs of worsening or recurring movement over time.

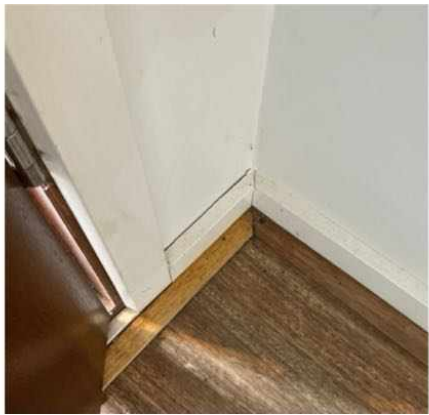
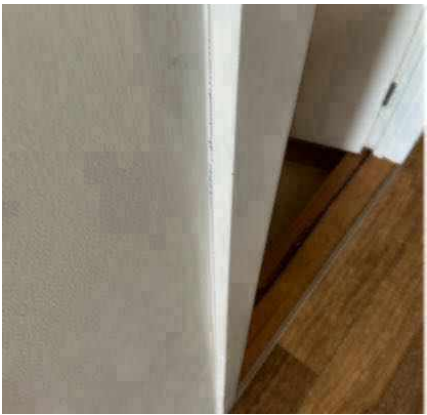
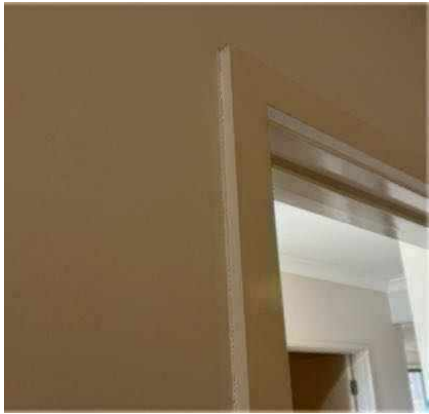
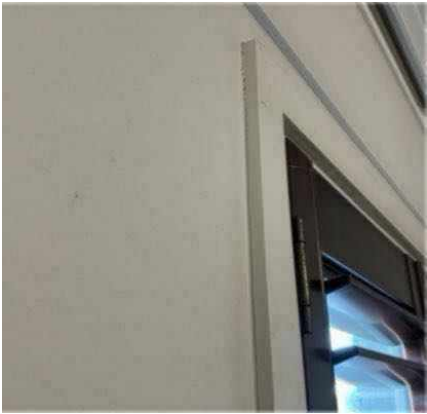
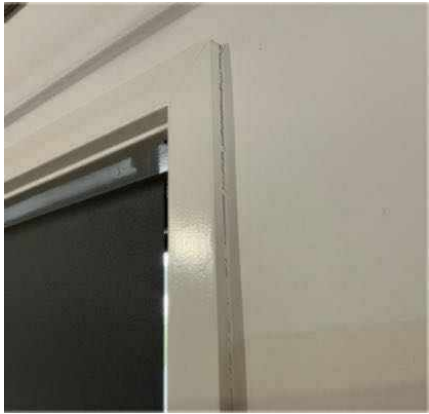
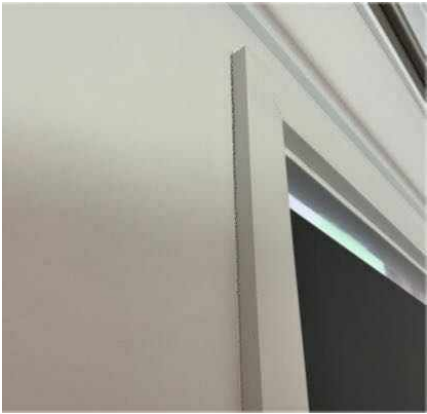
Defects 3.02

Building:	Main Building
Location:	All Internal Areas
Finding:	Cracking Between Architrave and Wall Junction
Information:	During the inspection, cracking and separation were observed between the architrave and the adjoining wall surface. This condition is commonly caused by normal building movement, minor frame shrinkage, or seasonal expansion and contraction of materials. In some cases, movement may also be influenced by additional loads from attached fittings such as blinds or curtain brackets.

- Cracking detracts from the appearance of internal finishes.
- Minor separation may continue with seasonal changes or building movement.
- Unsealed gaps can collect dust or allow minor moisture staining over time.

The condition appears cosmetic and is typical of normal building movement. It can be readily repaired through routine maintenance and repainting.

- Inspect the affected areas and refix or reinforce the architrave where movement is evident.
- Recaulk or fill the junction using a flexible sealant suitable for painted surfaces, then sand and repaint.
- Ensure that any attached fittings are adequately supported to reduce future stress on trim components.

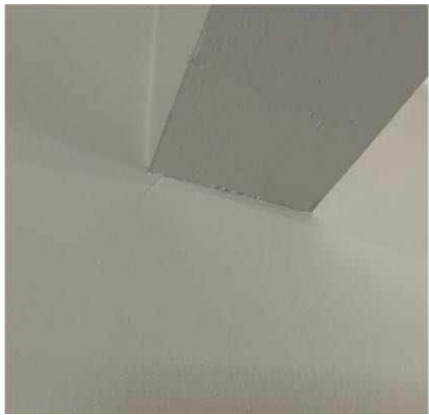
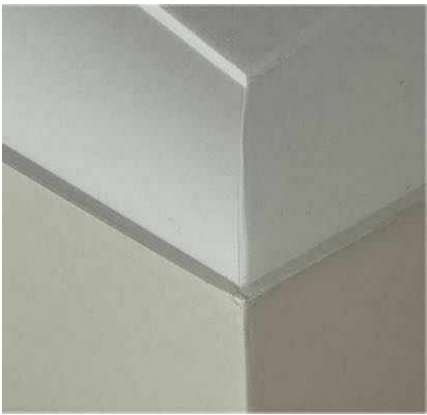
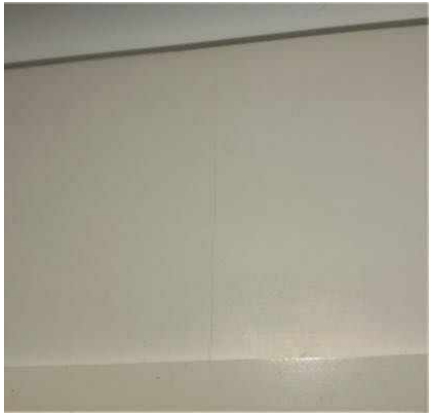
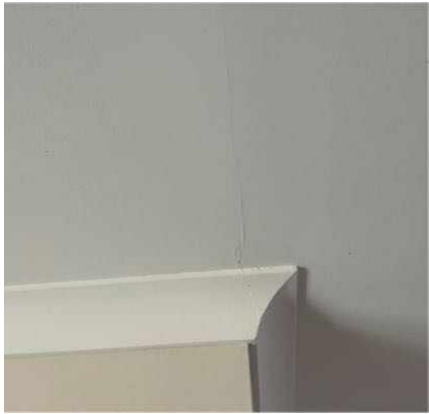
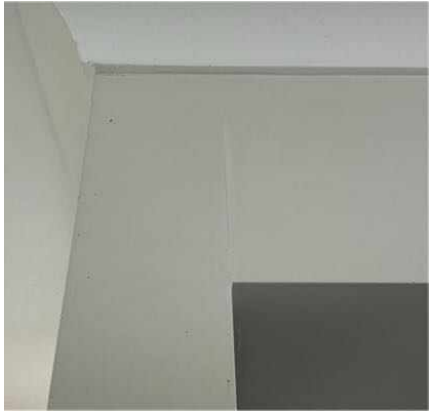
Defects 3.03

Building:	Main Building
Location:	All Internal Areas
Finding:	Cracking to Internal Wall Linings
Information:	Cracking was observed to internal wall linings during the inspection. These types of cracks are generally considered common and are typically the result of natural building movement, age-related wear, thermal expansion and contraction, or minor installation-related issues in plasterboard or supporting framing members.

The cracking noted is typical of minor building movement and does not currently present as structural. Regular monitoring and cosmetic repair will assist in preserving the internal presentation and allow early intervention if future issues arise.

- Engage a qualified plasterer to repair cracks and consider installing expansion joints if necessary to accommodate ongoing building movement.
- Arrange for repainting by a qualified painter following any plaster repairs.
- Monitor cracks over time for signs of progression (e.g. widening, lengthening, or new cracks forming).
- If deterioration continues or operational issues with doors/windows arise, seek further assessment from a building inspector or structural engineer.

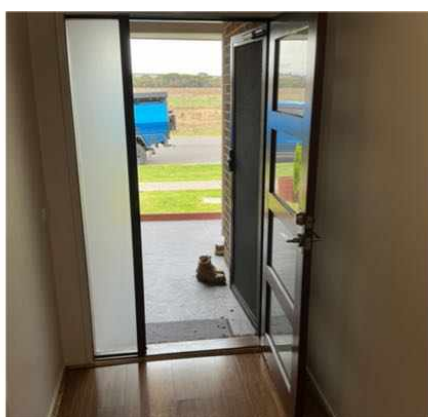
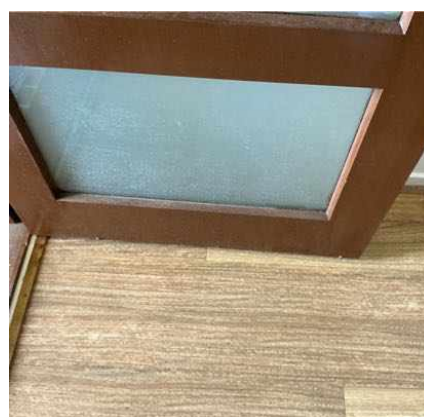
Defects 3.06

Building:	Main Building
Location:	Entry
Finding:	Missing Bottom Door Seal(s) – External
Information:	During the inspection, one or more external doors were found to be missing bottom door seals. These seals—commonly used in conjunction with perimeter weather seals—are essential for preventing the intrusion of wind, rain, pests, and dust, as well as reducing energy loss from internal conditioned spaces.

Addressing the absence of bottom door seals will improve the weatherproofing and energy efficiency of the dwelling while contributing to a more secure and comfortable living environment.

- After settlement, engage a qualified handyman or carpenter to install suitable bottom door seals to all affected external doors.
- Select weather-rated seals appropriate for the exposure and use of each door.
- Inspect existing perimeter seals to ensure they are in good condition and functioning as intended.
- Regularly inspect and maintain seals to preserve performance over time.

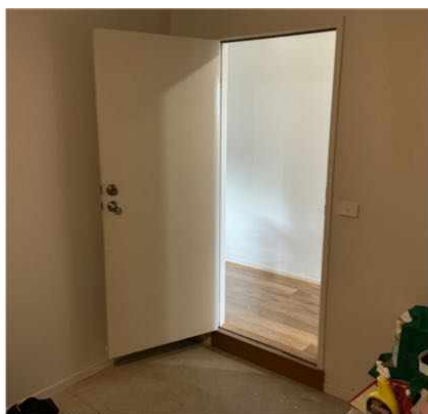
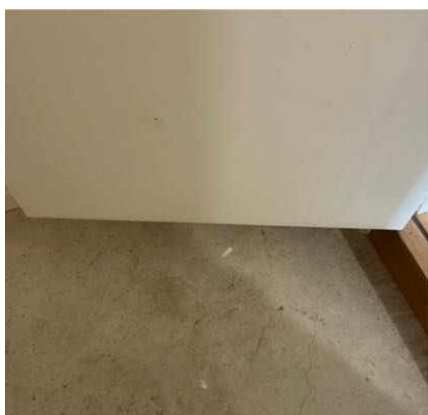
Defects 3.07

Building:	Main Building
Location:	Garage Access
Finding:	Deteriorated and Missing External Door Seals
Information:	During inspection, several external door seals were found to be deteriorated and no longer providing effective sealing, while other openings were observed with seals completely missing. The deterioration appears consistent with age, ongoing wear, and weather exposure. Missing seals leave visible gaps between the door leaf and frame threshold.

The absence or failure of seals compromises the door's intended function of restricting air, moisture, and pest ingress.

- Allows wind, dust, and moisture to enter the dwelling
- Reduces thermal efficiency and may increase heating/cooling costs
- Creates potential pathways for insects or vermin through unsealed gaps
- May contribute to drafts, discomfort, or internal condensation under certain weather conditions

Restoring effective sealing to external doors will improve comfort, reduce energy loss, and minimise moisture or pest ingress risks.

- Install new seals to openings where seals are missing
- Replace deteriorated seals with suitable weather-resistant products
- Check frames for alignment during seal installation to ensure proper contact
- Implement periodic maintenance inspections of external openings to sustain weather-tightness

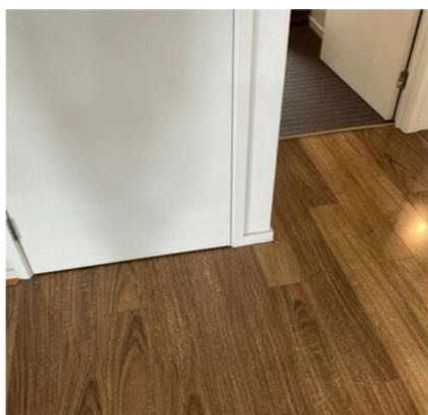
Defects 3.08

Building: Main Building
 Location: Kitchen
 Finding: Missing Floating Floor Trims
 Information: At the time of inspection, floating floor trims were observed to be missing in one or more areas at floor junctions. This has resulted in exposed flooring edges and an incomplete finish. The absence of trims does not meet acceptable standards of workmanship and leaves the flooring installation vulnerable to movement and edge damage during normal use.

- Exposed flooring edges are prone to damage and deterioration.
- Increased likelihood of floor movement or separation at junctions.
- Potential trip hazard where level transitions are not properly finished.
- Overall finish and durability of the flooring installation is reduced.

The current condition reflects an incomplete flooring installation. Rectification is recommended to provide a complete, durable, and serviceable finish.

- Engage a qualified flooring contractor to supply and install all missing trims.
- Ensure trims are securely fixed and neatly finished at all floor junctions.
- Confirm all exposed flooring edges are adequately protected.

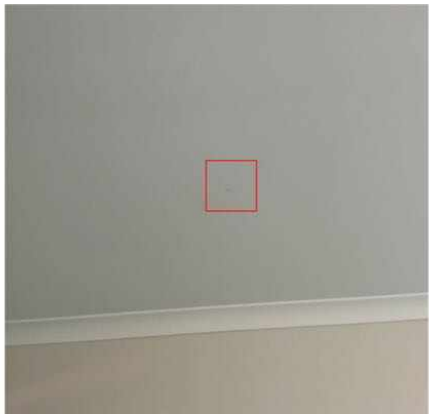
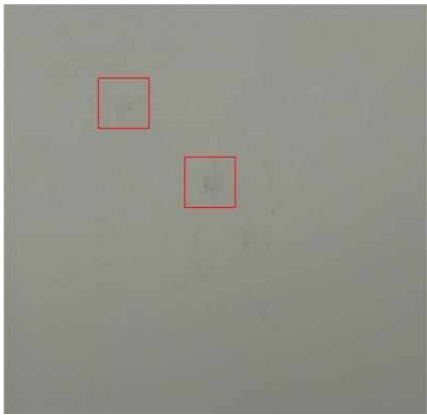
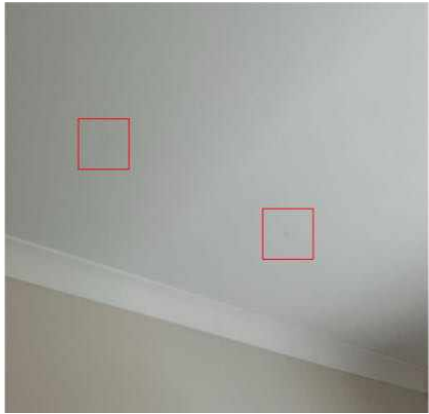
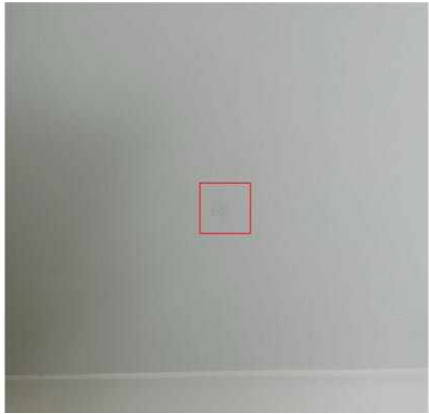
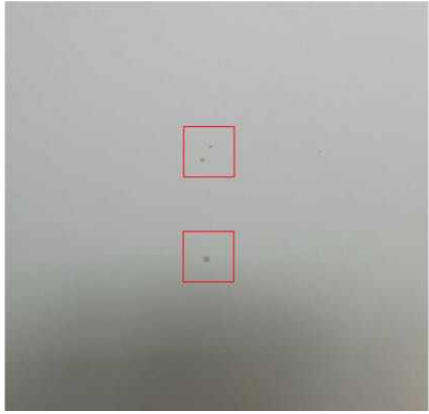
Defects 3.09

Building: Main Building
 Location: Living Room
 Finding: Historic Water Damage to Ceiling Linings
 Information: During the inspection, areas of the ceiling linings displayed visible staining, patchiness,

and surface irregularities consistent with historic moisture exposure. The affected areas appear dry at the time of inspection, and no active dripping or moisture ingress was observed. However, the exact source and extent of the previous moisture event could not be confirmed. The condition suggests prior water penetration or prolonged humidity exposure, which has affected the ceiling lining finishes.

In summary, the ceiling linings show evidence of historic water damage. While no active moisture was observed at the time of inspection, the underlying cause has not been confirmed, and further investigation and ongoing monitoring are recommended to ensure no continuing or future moisture issues are present.

- Monitor the affected ceiling areas during rainfall and high-humidity conditions for any signs of active moisture.
- Engage a licensed builder or plumber to investigate possible sources of historic water ingress, including roof coverings, flashings, gutters, or plumbing services.
- If no active moisture is present, engage a qualified tradesperson to repair, prepare, and repaint the affected ceiling linings.
- If further moisture activity is detected, undertake immediate investigation and rectification to prevent further damage.

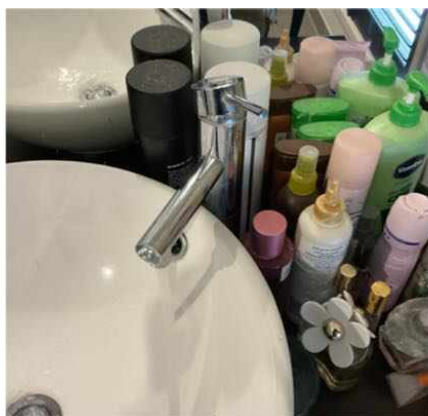
Defects 3.10

Building:	Main Building
Location:	Ensuite
Finding:	Loose Basin Mixer Tap
Information:	At the time of inspection, the basin mixer tap was found to be loose at its base where it connects to the countertop. The fitting does not sit firmly in place, indicating that the securing components beneath the benchtop may not have been adequately tightened or installed. Fixtures should be securely fixed to prevent movement during normal use.

The mixer tap is not adequately secured and should be rectified to ensure it is stable and performs as intended.

- Engage a licensed plumber to secure the mixer tap correctly.
- Ensure the base is properly sealed to maintain water resistance.
- Check for any associated leaks or movement in connected pipework.

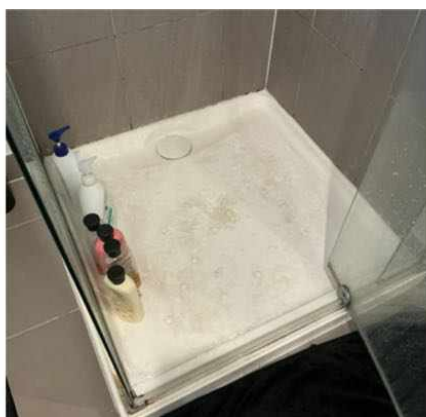
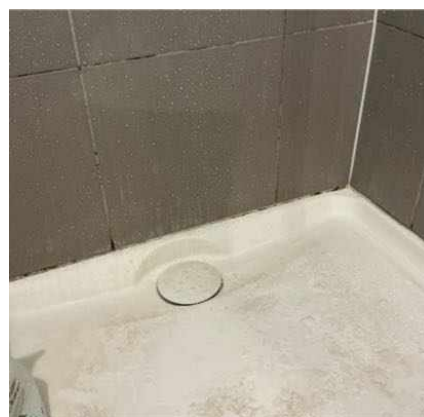
Defects 3.12

In summary, the mould growth appears superficial at this stage, but cleaning and improved ventilation are recommended to maintain hygiene and prevent recurrence.

- Clean the affected silicone using a suitable mould-removal product designed for wet areas.
- Improve ventilation within the bathroom where possible to assist with drying after use.
- If mould staining persists, consider replacing the silicone with a mould-resistant sanitary-grade product in accordance with AS 3740:2021 Waterproofing of domestic wet areas.

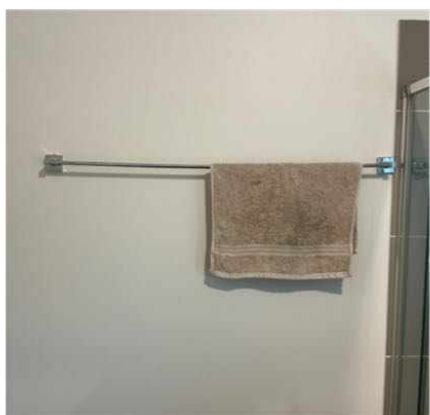
Defects 3.13

In summary, the towel rail is loose and requires repair or replacement to prevent further cosmetic or structural damage and to restore full functionality.

- Engage a qualified handyperson or contractor to re-secure the towel rail using appropriate fixings suited to the wall type.
- If fixings are stripped or damaged, reposition or replace the towel rail as required.
- Ensure appropriate wall plugs, anchors, or brackets are used to provide long-term stability.
- Periodically check the towel rail and surrounding wall for signs of movement, cracking, or deterioration and address issues promptly.

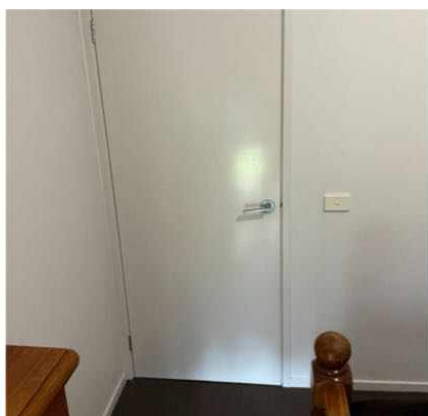
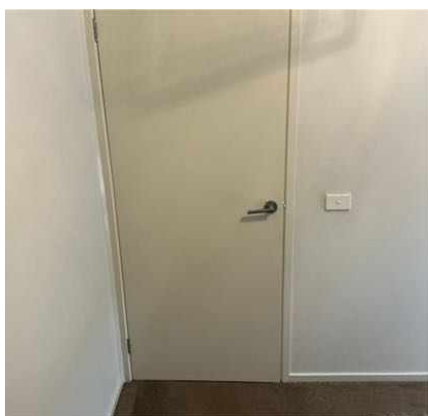
Defects 3.14

Building:	Main Building
Location:	Bedroom 4
Finding:	Internal Doors Binding – Striker Plate
Information:	During the inspection, one or more internal doors were noted to bind against their striker plates during the inspection, preventing smooth operation. This condition is commonly caused by minor frame movement, striker plate misalignment, or changes in humidity affecting the door's fit within the frame.

This condition is considered maintenance-related and can typically be resolved through minor repairs. Prompt action will restore functionality and prevent further wear to door components.

- Engage a qualified carpenter or handyman to:
- Realign or reposition striker plates as needed
- Tighten or replace worn hinge hardware
- Plane or sand door edges where minor swelling or warping is present
- Monitor humidity in high-moisture areas to prevent ongoing movement
- Repaint or seal affected door edges to minimise moisture ingress

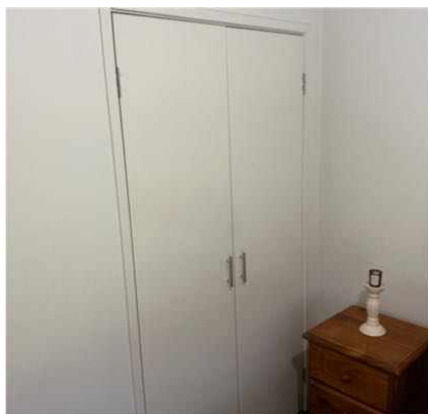
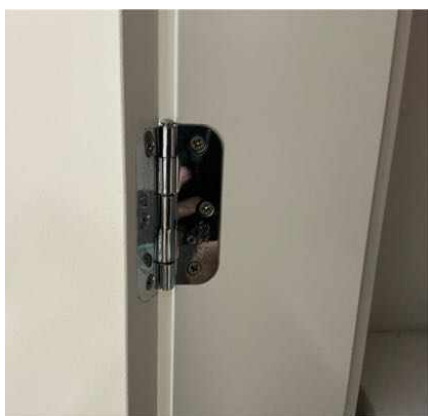
Defects 3.15

Building:	Main Building
Location:	Bedroom 4
Finding:	Internal Binding Robe Doors
Information:	During the inspection, it was found that one or more internal robe doors throughout the property were observed to be binding against each other during opening and closing. This issue affects the functionality of the doors and may lead to progressive

Correcting this issue will restore proper functionality and prevent long-term deterioration of cupboard door systems.

- Engage a qualified carpenter or handyman to assess all affected robe doors.
- Adjust hinges, realign doors, or plane down contact points as needed to ensure smooth operation.
- Inspect hardware for wear or looseness and replace if necessary.
- Continue to monitor door performance and perform routine maintenance such as hinge tightening and lubrication.

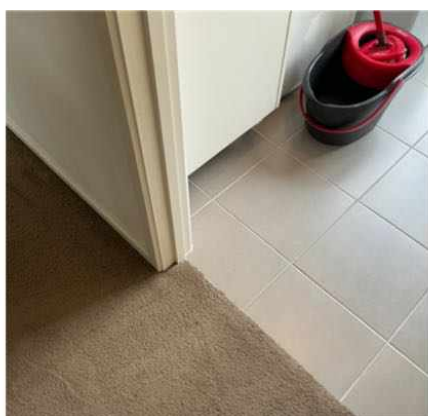
Defects 3.16

Building: Main Building
 Location: Laundry
 Finding: Cracked Floor Tiles - Non Structural
 Information: Cracks were observed in the floor tiles across multiple areas of the home. These appear to be the result of minor settlement in the floor structure or natural expansion and contraction of materials over time. The cracking is localised and does not appear to indicate any structural concern at this stage.

Cracked tiles are a relatively common occurrence and typically considered a maintenance or cosmetic issue unless accompanied by other signs of structural movement.

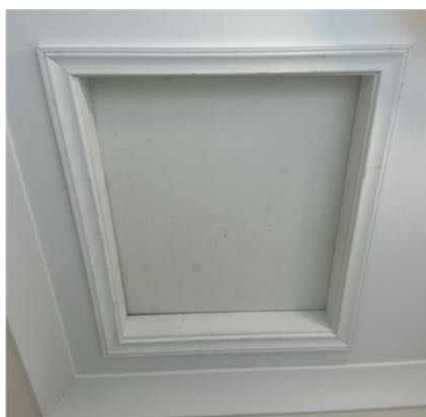
Defects 3.17

The current condition reflects inadequate installation of ceiling insulation in one or more areas. Rectification is recommended to restore thermal performance and ensure a consistent and effective insulation layer.

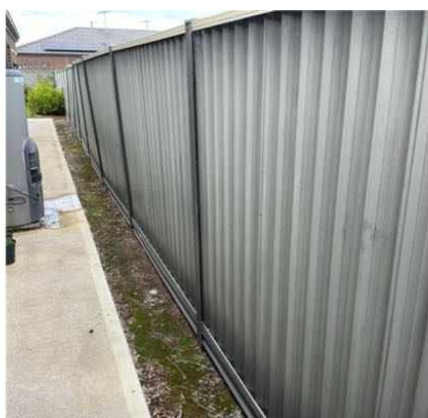
Defects 3.18

The fence shows signs of movement and deterioration and requires rectification to restore alignment, function, and overall presentation.

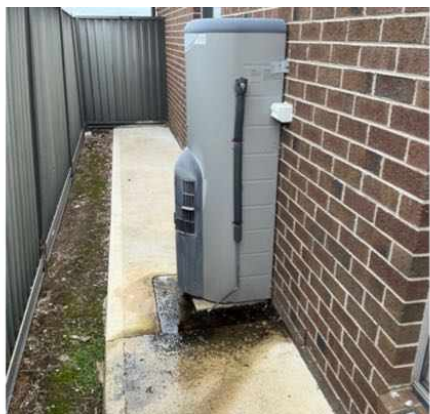
Defects 3.21

Building: Main Building
Location: Right-hand Side
Finding: Hot Water System – Continuous Discharge from Relief Valve
Information: At the time of inspection, the hot water system was observed to be discharging water continuously from the pressure/temperature relief valve. This has resulted in ongoing water pooling at the base of the unit and surrounding concrete area. The discharge pipe appears to terminate directly onto the ground without appropriate drainage, contributing to surface saturation and staining.

The hot water system is not operating as intended and requires further investigation and rectification to prevent ongoing water discharge and associated issues.
