Building and Timber Pest Inspection Report

Inspection Date: Wed, 25 Mar 2026

Property Address: 31 Pedder St, Marsden QLD 4132, Australia

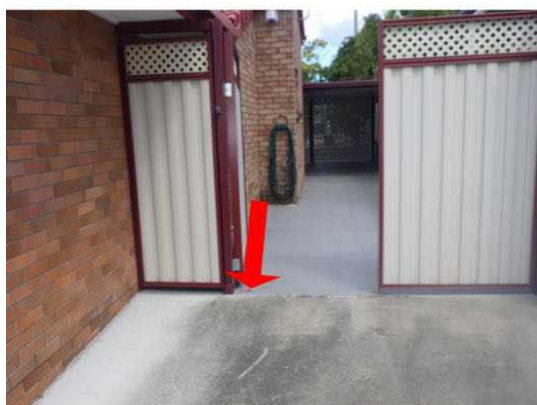
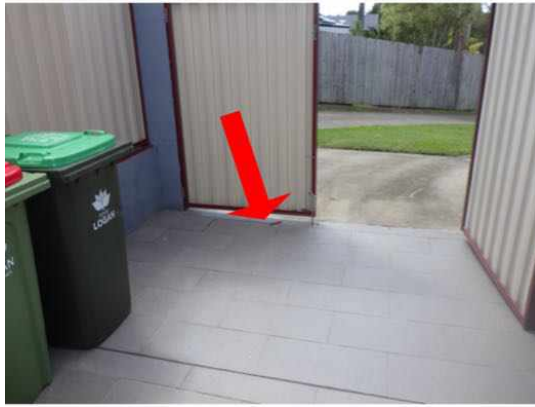
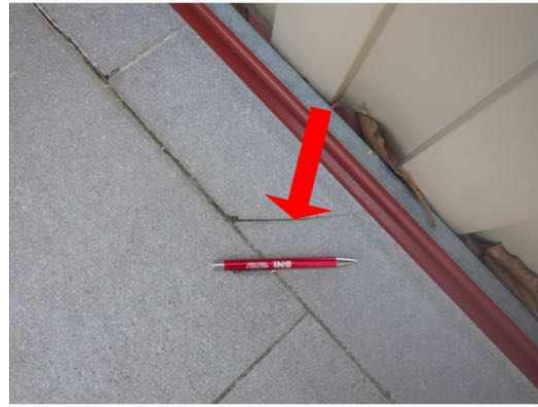
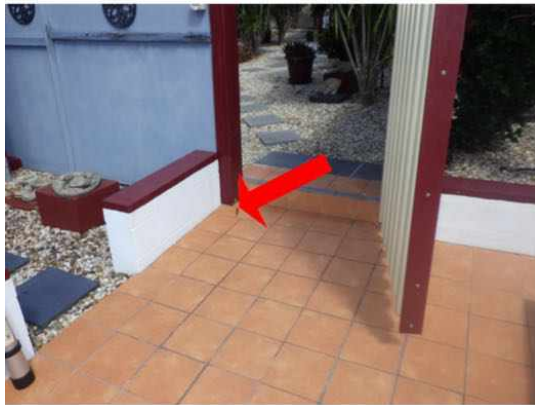
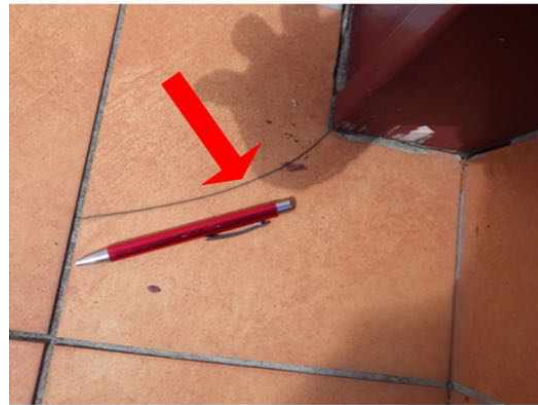
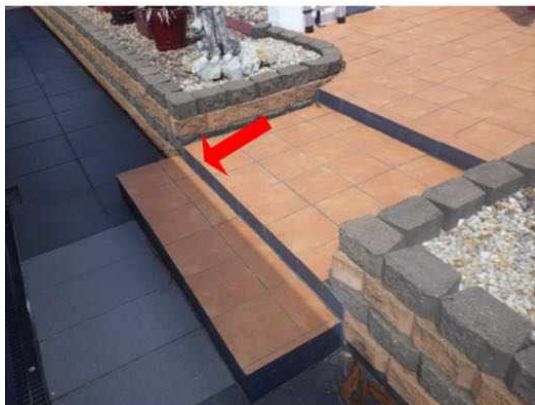
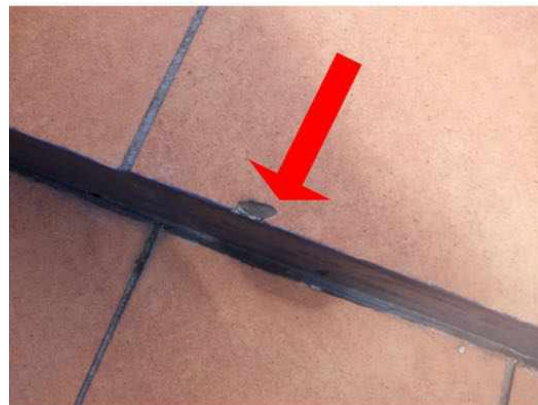
Building: Main Building
Location: External Areas > Ground Level
Finding: Tile - Cracked
Information: Cracked tiles to external paved areas were identified at the time of inspection. Such defects are generally caused by impact. Cracked or broken tiled areas may also be a direct result of poor workmanship during the construction process.

A tiling contractor could be appointed to perform repair works at the clients discretion.

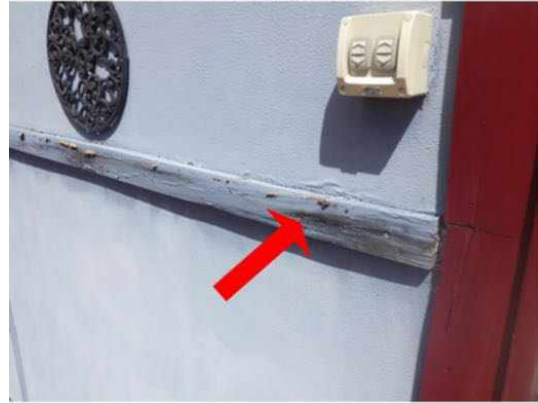
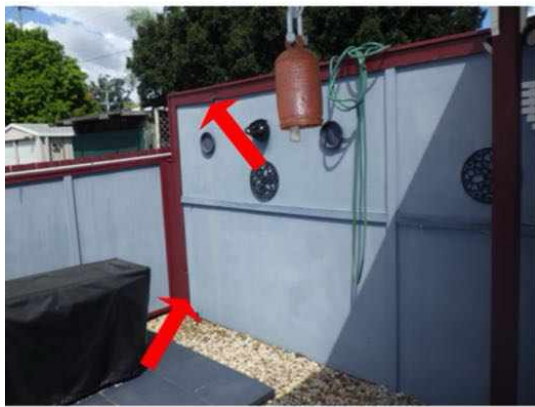
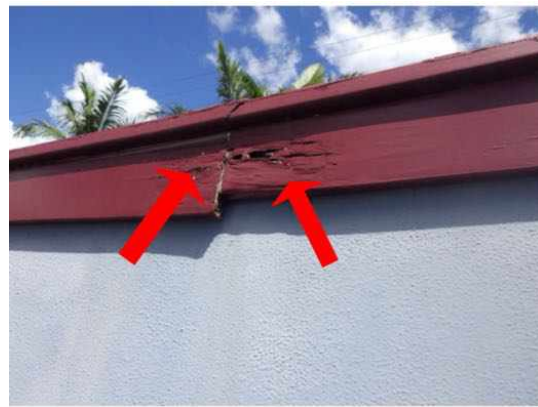
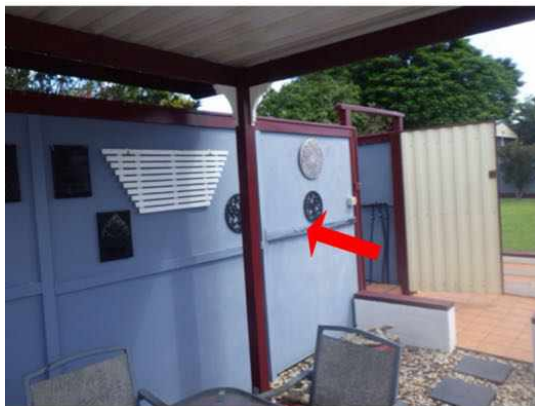
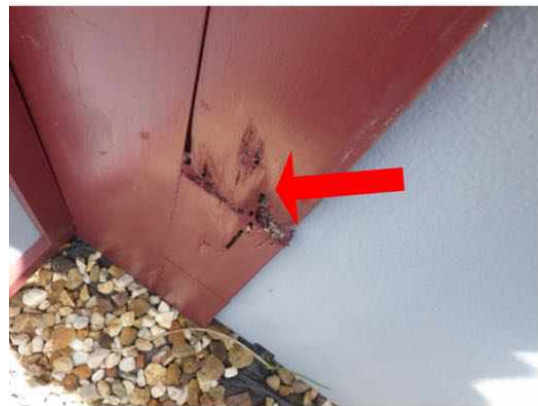
Finding 3.02

Building:	Main Building
Location:	External Areas > Existing
Finding:	Wood rot
Information:	The timber facing boards to the external fence/screens at the rear of the property show evidence of wood rot (as per example photos). Wood rot, also known as Fungal Decay, occurs when timbers and other cellulose building materials are exposed to damp conditions on an ongoing basis. This could be the result of exposure to weathering over a prolonged period of time, or the attraction of excessive moisture from other abutting building materials.

A qualified carpenter or general handyman may be required to replace the affected building materials.

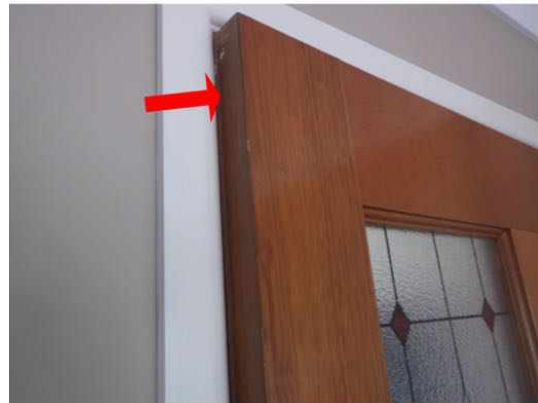
Finding 3.03

Building: Main Building
 Location: Study > Front
 Finding: Door - Binding/Jamming
 Information: Binding of the study door on the door frame was evident during standard operation.

A door that binds to the associated door frame or sill may have several causes, such as poor installation of the door or deteriorated hinges.

A qualified carpenter or general handyperson could be appointed to perform minor rectification works at client discretion.

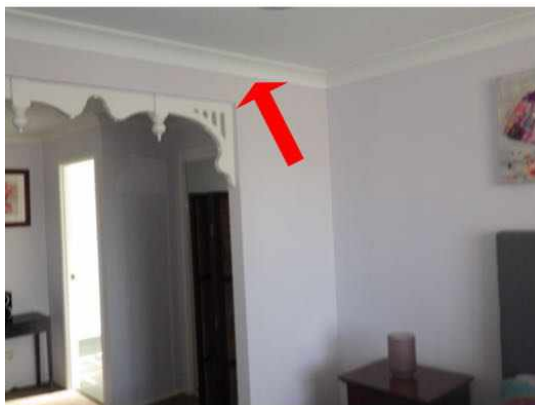
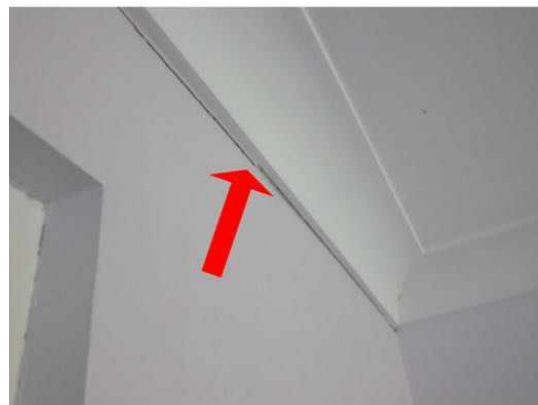
Finding 3.04

Information: It was noted that the ceiling cornice in the main bedroom is showing signs of minor separation from the wall linings and cracking.

This is a common defect caused through normal movement of homes.

A licensed painter or general handyman could be engaged to undertake minor repair work.

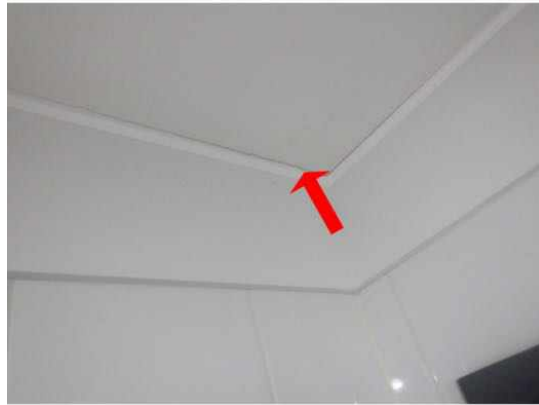
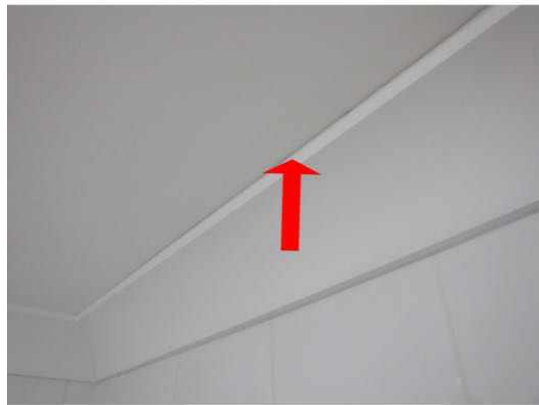
Finding 3.07

Building: Main Building
Location: Bathroom > Existing
Finding: Cornice Movement
Information: It was noted that the ceiling cornice in the bathroom is showing signs of minor separation from the ceiling linings and cracking.

This is a common defect caused through normal movement of homes.

A licensed painter or general handyman could be engaged to undertake minor repair work.

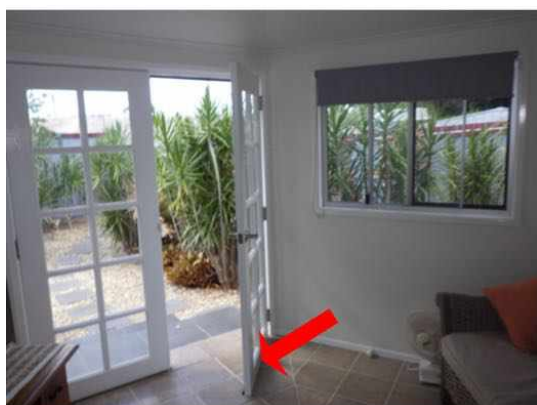
Finding 3.08

Building: Out Building
 Location: Cabana > Front
 Finding: Door Rubbing
 Information: It was noted that the bottom edge of the left side Cabana door is rubbing on the floor tiles making the door stiff to open and close at the time of inspection.

This is noted as a minor defect that you need to be aware of.

A licensed carpenter or general handyman could be engaged to ease the door at the clients discretion.

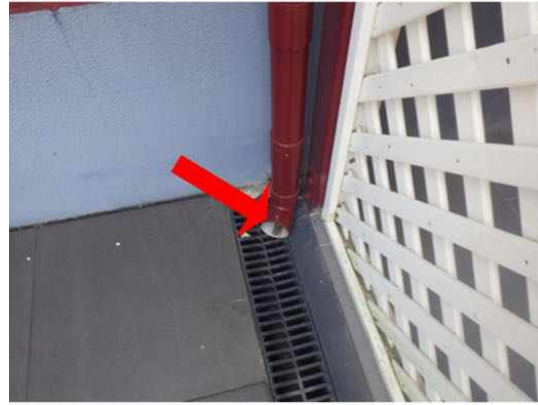
Where roof plumbing doesn't drain as required, the area at the base perimeter can become excessively damp, potentially creating an environment that is susceptible to flooding and rust or corrosion of surrounding building elements, as well as attracting termites and other pests.

It is recommended that a licensed plumber be appointed to further inspect and to extend the down pipe to the properties stormwater line as necessary.

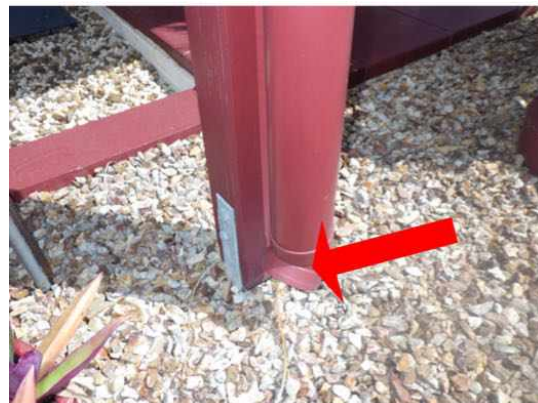
Finding 6.06

Building:	Out Building
Location:	Pergola > Front Left
Finding:	Stormwater downpipe
Information:	The down pipe to the pergola roof area at the rear of the property is not connected to the stormwater drainage on the site. This disconnection negatively impacts the functional capacity of the downpipe and the surrounding ground area.

Where roof plumbing doesn't drain as required, the area at the base perimeter can become excessively damp, potentially creating an environment that is susceptible to flooding and rust or corrosion of surrounding building elements, as well as attracting termites and other pests.

It is recommended that a licensed plumber be appointed to further inspect and to extend the down pipe to the properties stormwater line as necessary.

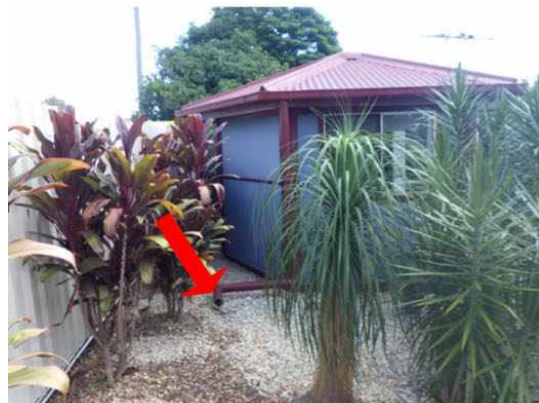
Finding 6.07

Building:	Out Building
Location:	Cabana > Rear Left
Finding:	Stormwater downpipe
Information:	The down pipe to the Cabana roof area at the rear of the property is not connected to

Where roof plumbing doesn't drain as required, the area at the base perimeter can become excessively damp, potentially creating an environment that is susceptible to flooding and rust or corrosion of surrounding building elements, as well as attracting termites and other pests.

It is recommended that a licensed plumber be appointed to further inspect and to extend the down pipes to the properties stormwater line as necessary.

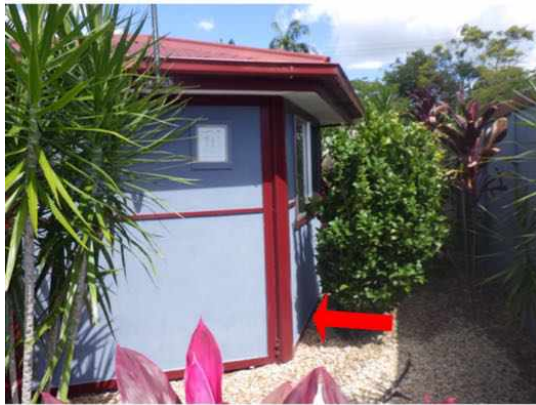
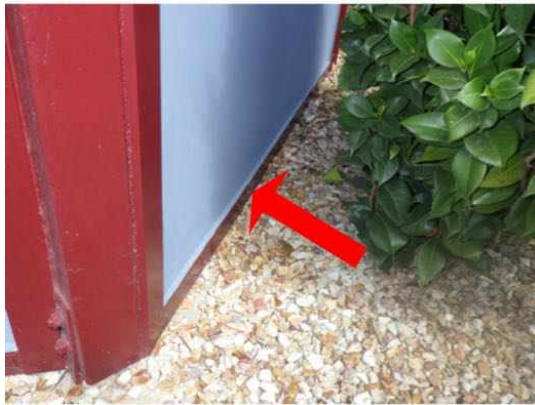
Finding 6.08

Building:	Out Building
Location:	Cabana > Ground Level
Finding:	In ground contact
Information:	At the time of inspection it was observed the Cabana area exterior wall cladding and timber trims are in direct contact it's the finished ground surface.

Any building materials or timbers in direct ground contact provide opportunity for concealed termite entry and are likely to be subject to premature rot and decay as the ground retains moisture or damp conditions against the timbers.

Ideally these types of construction materials or timber members would be clear of the ground area by a minimum of 50mm to provide a clear inspection zone.

Frequent pest inspections are advised to readily identify any termite activity in these areas.
