Building and Timber Pest Inspection Report

Inspection Date: Wed, 25 Feb 2026

Property Address: 2 Wilgah St, St Kilda East VIC 3183,
Australia

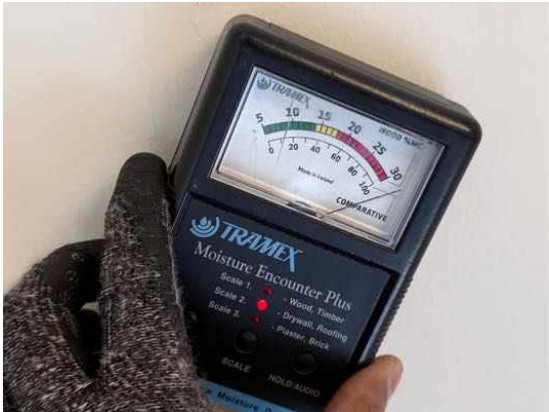
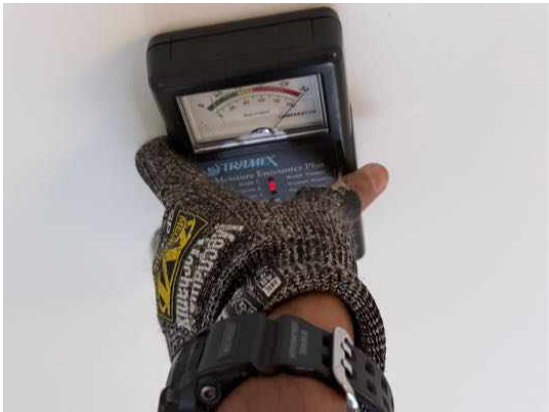
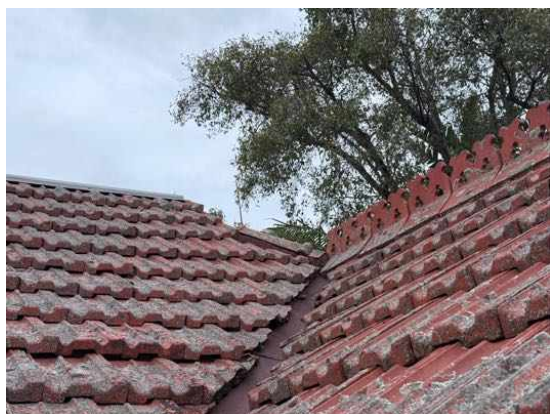
Building:	Main Building
Location:	Bedroom 2 & Roof exterior.
Finding:	Water ingress & Associated Roofing issues.
Information:	<p>Water staining and damage were identified to the ceiling/wall area within Bedroom 2. This was confirmed visually (physical staining), instrument tested (elevated moisture readings recorded via moisture meter), and supported by thermal imaging, which showed abnormal temperature patterns consistent with retained moisture within the lining/cavity. Although the exact entry point could not be verified because no direct roof-void access was available above this area at the time of inspection, the findings are consistent with active or intermittent water ingress and should be treated as a major defect due to the risk of ongoing deterioration (plaster breakdown, mould growth, timber decay/rot to concealed framing, and progressive internal damage).</p>

The most likely contributing factors were observed at the roof level. While the roof covering itself did not present as catastrophic, it displayed multiple defects that materially increase the likelihood of leaks, including rusted valley flashings (with evidence of prior patch repairs), deteriorated/cracked mortar to ridge/hip bedding and pointing, and blocked/contaminated gutters with debris that can cause overflow and backflow beneath tiles during rainfall. Collectively, these conditions reduce the roof's weatherproofing reliability and provide plausible leak pathways consistent with the internal moisture findings. Urgent investigation and rectification by a qualified roofing contractor is recommended, including leak tracing (ideally during/after rainfall), clearance of gutters, and targeted repairs/replacement to valley flashings and defective mortar areas, followed by reinstatement/repair of affected internal linings once the moisture source is confirmed resolved.

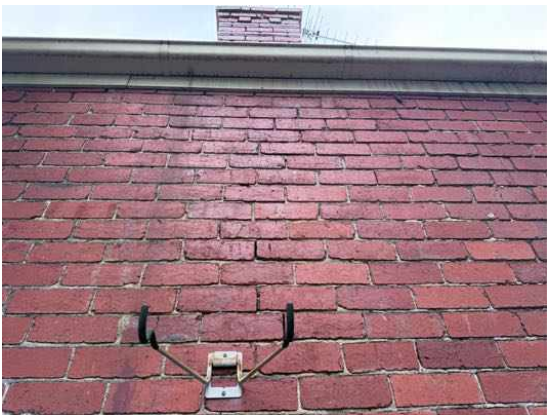
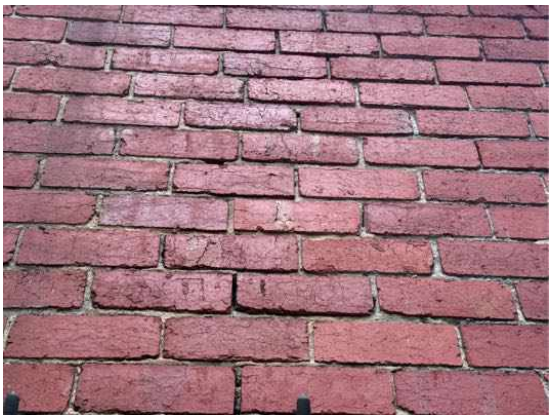
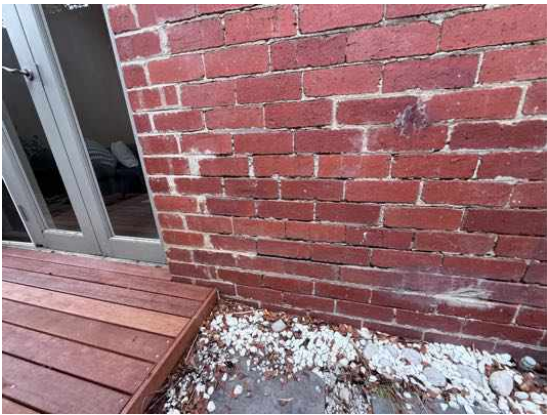
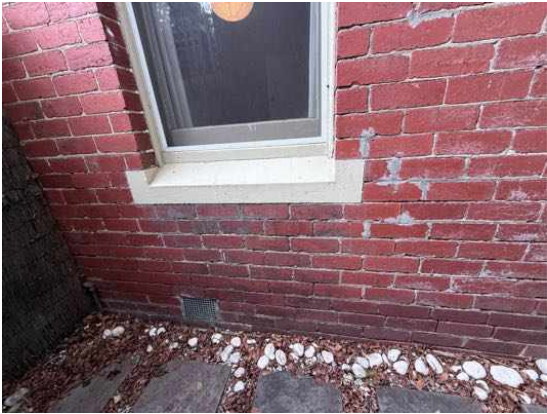
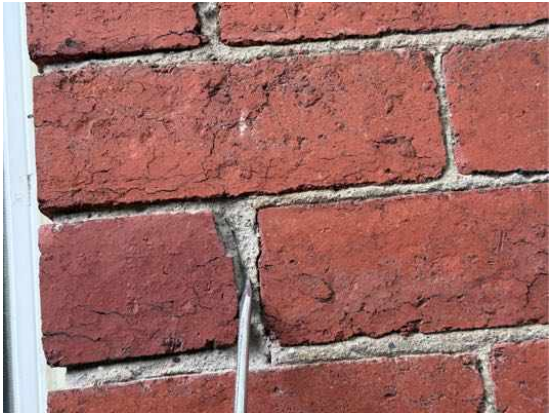
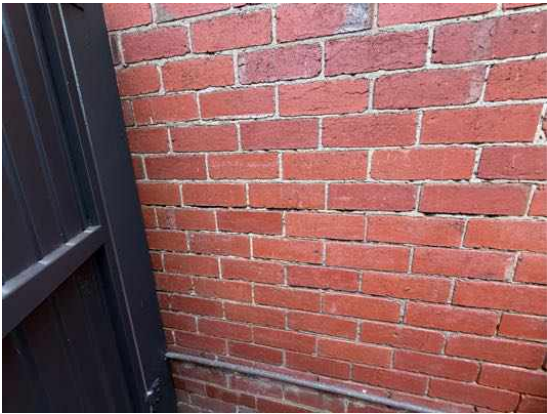
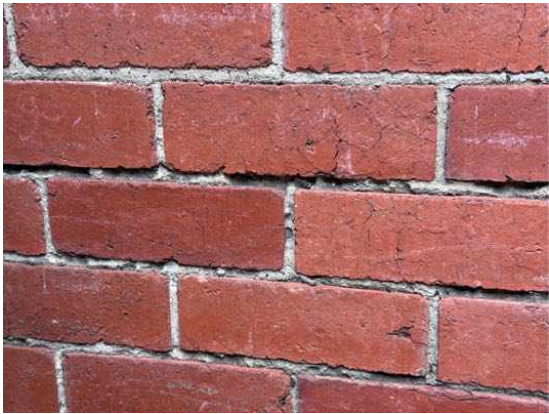
Finding 3.01

Building:	Main Building
Location:	Exterior walls - right side
Finding:	Mortar Deterioration (Moderately Significant)
Information:	The external brickwork mortar joints display age-related deterioration, with multiple sections observed to be loose, powdery, eroded and locally recessed beyond typical weathering tolerances. This condition is consistent with long-term exposure and natural binder breakdown; however, the inconsistent joint hardness and variable finish

may also indicate substandard mortar mix ratios or workmanship in certain areas. Localised patch repairs are evident but appear limited in extent and do not comprehensively address the broader deterioration. Progressive mortar loss can increase moisture penetration, reduce lateral bond between bricks, and accelerate brick arris fretting over time.

Consultation with a qualified bricklayer is recommended to assess the extent of joint degradation and determine whether staged or full elevation repointing is required in the medium term to restore overall integrity and durability of the masonry.

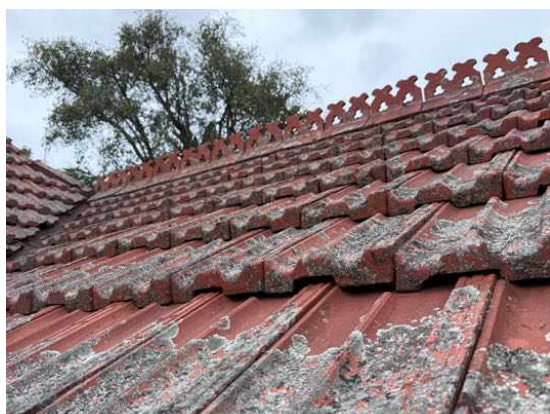
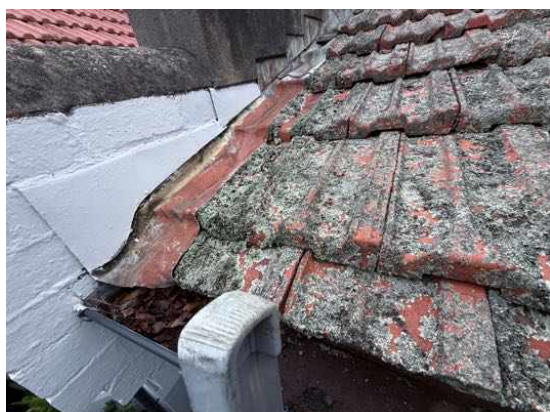
Building:	Main Building
Location:	Roof Exterior
Finding:	Roof Tiles Covered with Moss and Lichen Growth
Information:	The roof tiles are observed to be covered with moss and lichen. This biological growth can retain moisture against the tile surface, potentially accelerating tile degradation, loosening of fixings, and increasing the risk of water ingress over time.

At clients discretion roof tiles can be cleaned using a low-pressure wash or a suitable biocide treatment to remove the moss and lichen without damaging the tiles. Following cleaning, a roof inspection should be carried out to assess for any cracked, dislodged, or deteriorated tiles, with necessary repairs or replacements undertaken. Preventive maintenance such as improving roof ventilation and trimming overhanging branches can also help reduce regrowth.

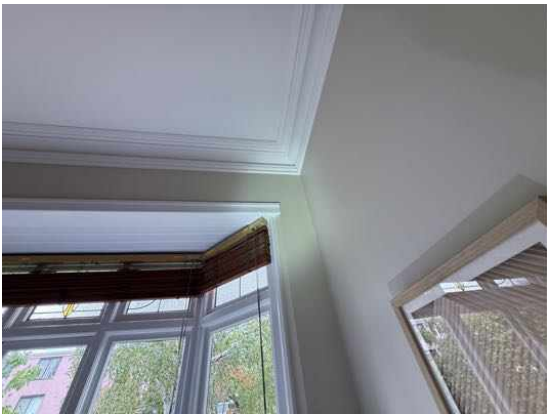
Building:	Main Building
Location:	Some Internal Areas
Finding:	Cracking - Damage Category 1 - Fine (up to 1mm)
Information:	Although fine cracks are quite noticeable, they are often only considered to be an appearance defect, and usually do not indicate any structural damage. Generally, the cause of a fine crack is indicative of a separation between building materials and finishes (e.g. paint, plaster, etc.) along joins.

Cracking of this nature can generally be repaired with minor sanding, filling and/or repainting. Such works should be performed by a qualified painter or a general handyman.

Monitoring of all cracking should be conducted frequently. Always contact a building inspector should cracks widen, lengthen, or become more numerous.

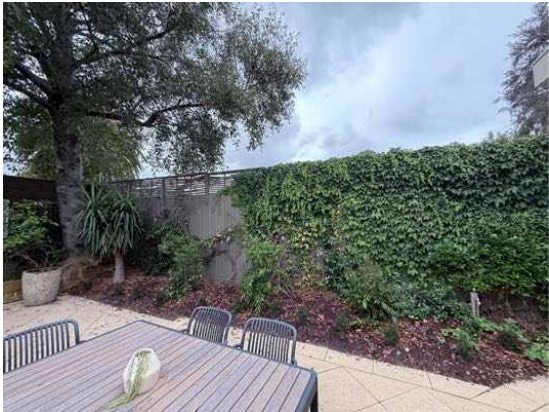
Finding 6.02

Building: Main Building
Location: All External Areas
Finding: Garden Bed/ Mulch - Conditions Conducive to Termites
Information: Mulch were found around the property. These areas can include untreated timber, and with a combination of moisture from watering hosing can make conditions conducive to termite activity and termite ingress.

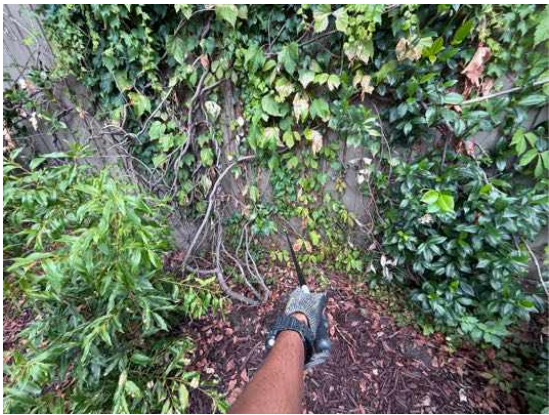
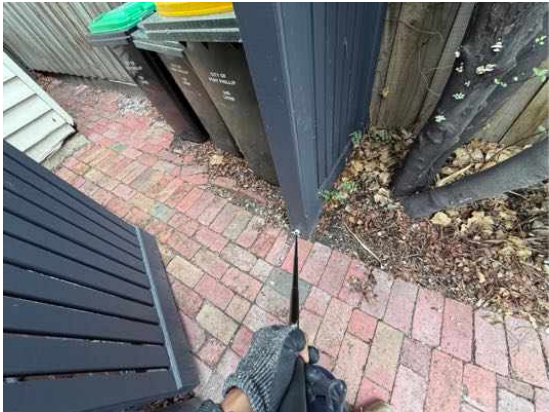
Finding 6.03

Building:	Main Building
Location:	All External Areas
Finding:	In ground contact
Information:	Any timbers in direct ground contact provide opportunity for concealed termite entry and are likely to be subject to premature rot and decay as the soil retains moisture or damp conditions against the timbers.

Remove untreated timber that is in direct contact with external grounds. Consider replacement with more durable materials i.e. treated timber or non timber elements. Frequent pest inspections are advised to readily identify any termite activity in these areas.

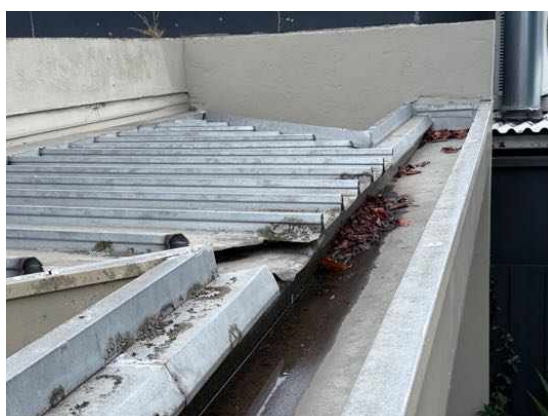
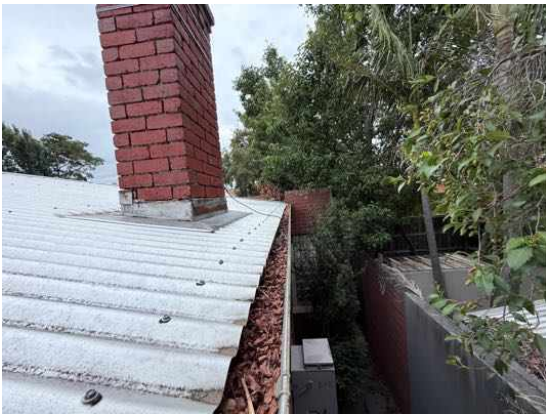
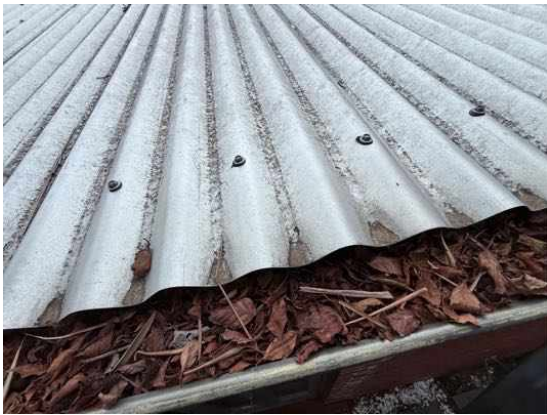
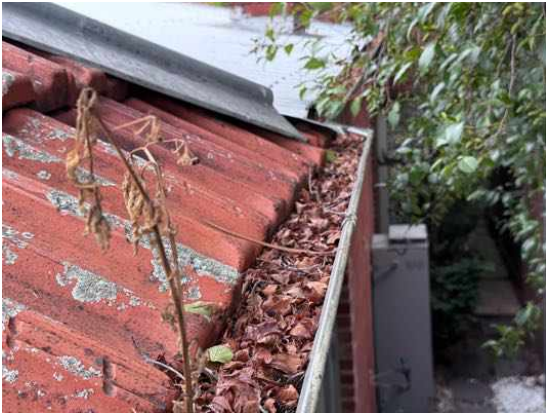
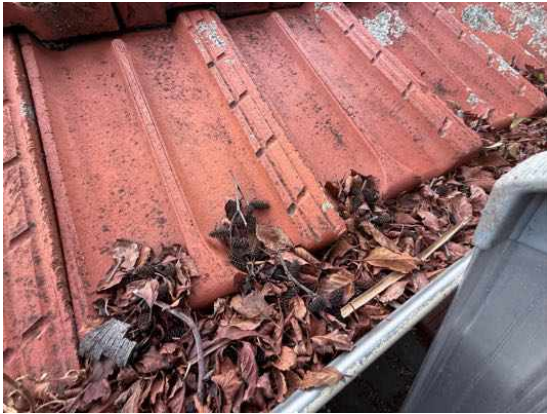
Blocked gutters are likely to lead to high levels of moisture in the affected areas. Such moisture will not only cause rust and decay of the associated building materials, but can also provide conditions that are conducive to termite and timber pest activity. Blockages in gutters should therefore be removed immediately to ensure dry conditions are maintained.

Consult a Licensed Plumber for further specific advice on remedial works that may be required. In the interim, it is highly advised that blocked gutters be removed by the homeowner or a general handyperson as a matter of urgency.

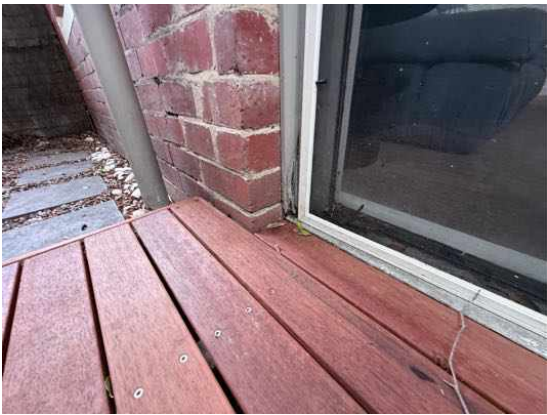
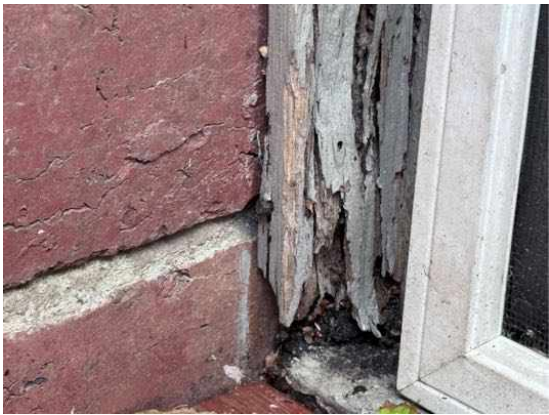
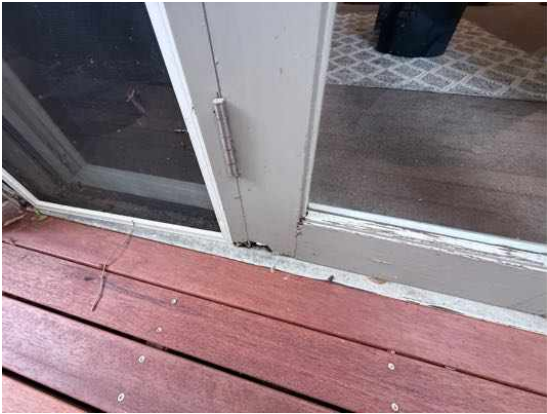
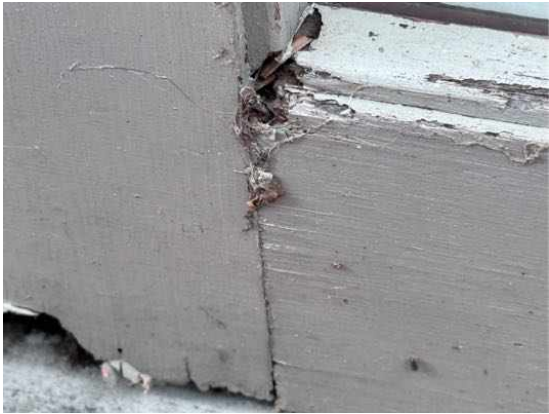
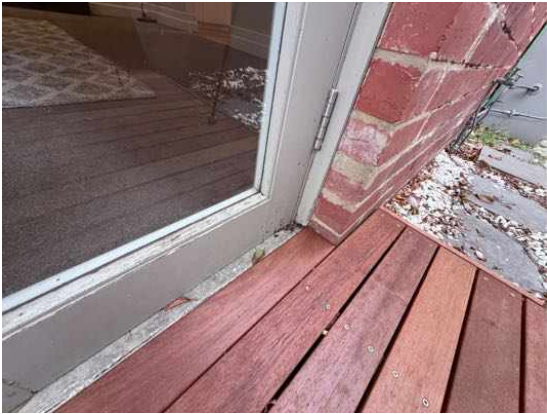
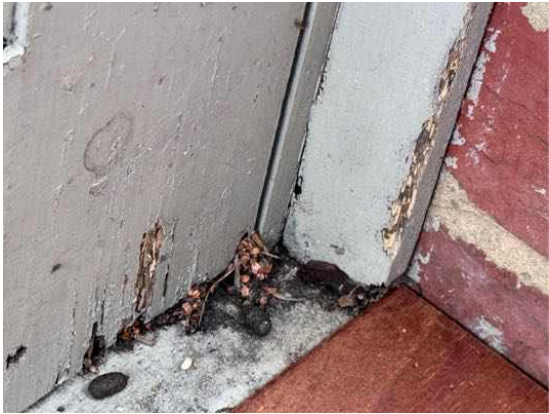
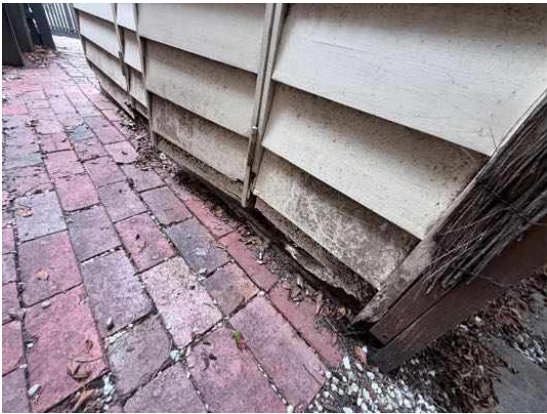
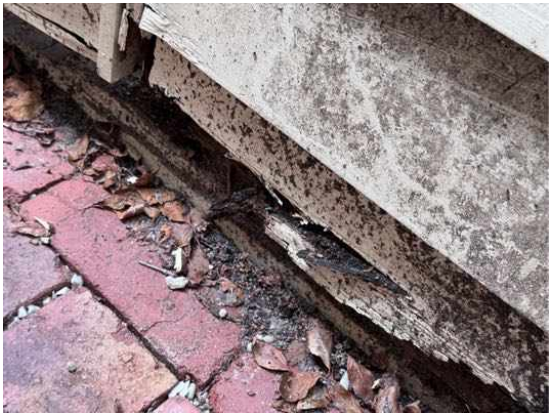
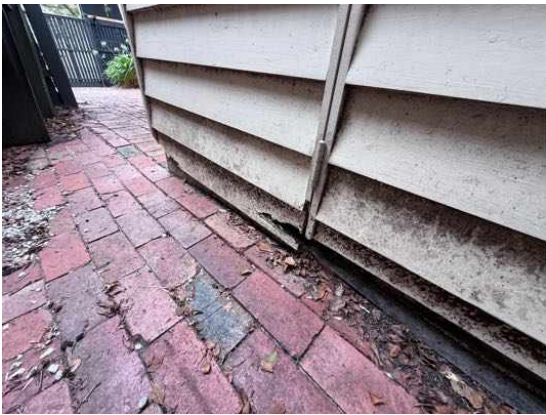
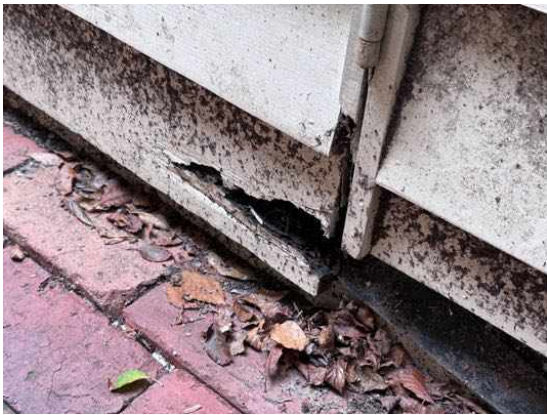
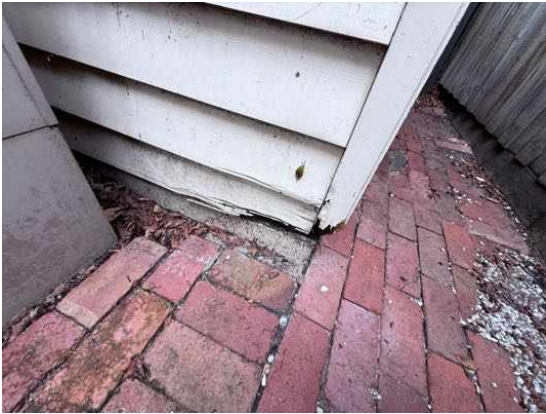
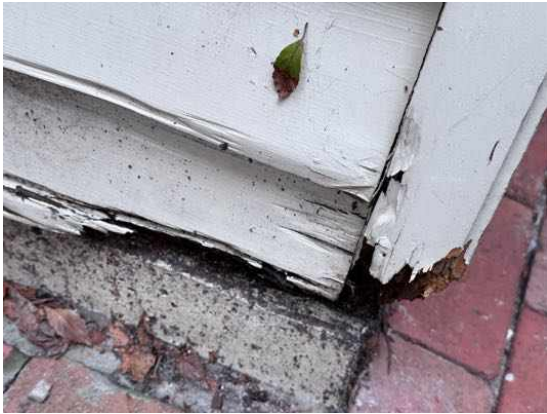
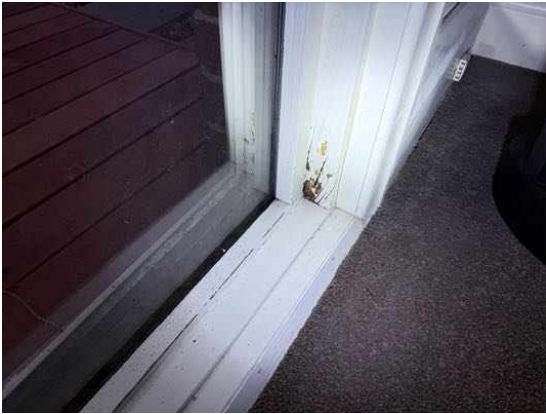
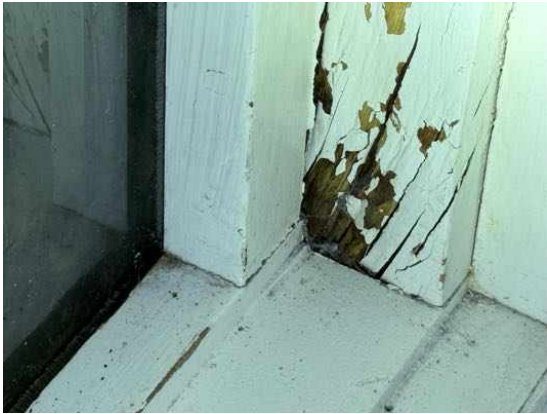
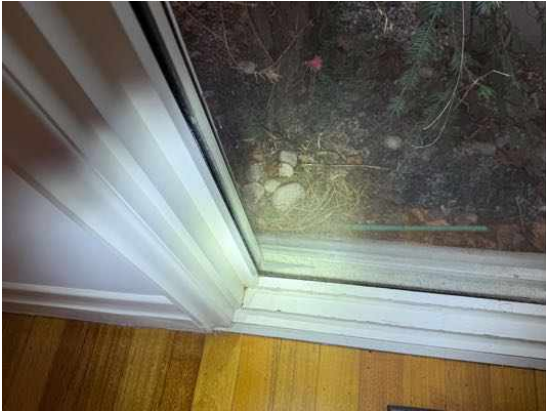
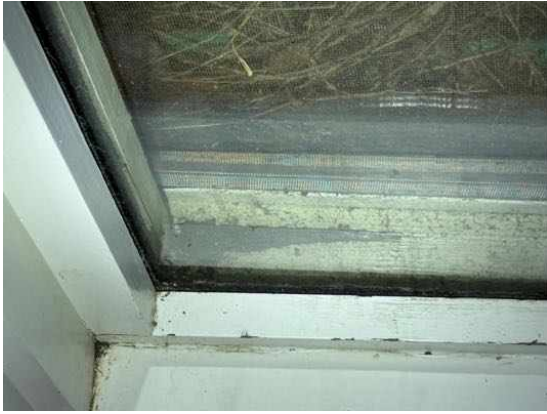
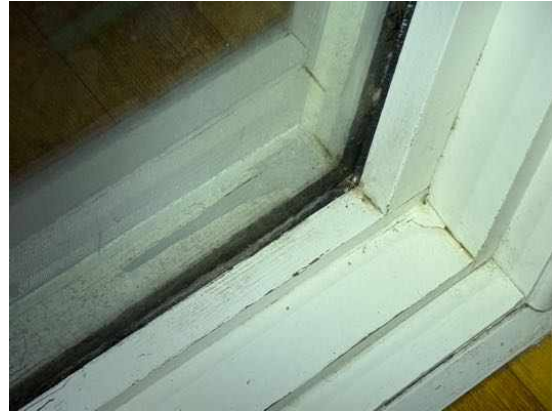
Building:	Main Building
Location:	Exterior walls - right side
Finding:	Wood rot
Information:	These building elements shows evidence of wood rot. Wood rot, also known as Fungal Decay, occurs when timbers and other cellulose building materials are exposed to damp conditions on an ongoing basis. This could be the result of exposure to weathering over a prolonged period of time, or the attraction of excessive moisture from other abutting building materials. Contributing factors also include poor air ventilation in the area.

Wood rot is often associated with general damp problems and is evidenced by a 'musty' smell or mould and mildew occurring on surfaces. If left unmanaged, damp conditions can lead to further health problems and the decay of timbers will continue. This also creates a huge conducive condition for termites.

Early intervention and regular maintenance, particularly of exterior timbers, will prolong the useful life of these building elements. Prior to any works being performed, the cause of the moisture that has created the visible wood rot should be identified and addressed in a suitable manner. Replacement of affected timbers may then be a necessary step in protecting surrounding building elements from such deterioration.

A qualified plumber may be appointed to assess the cause of excessive moisture and to provide advice on any remedial works as required. A qualified carpenter or registered builder may also be required to replace affected building materials.

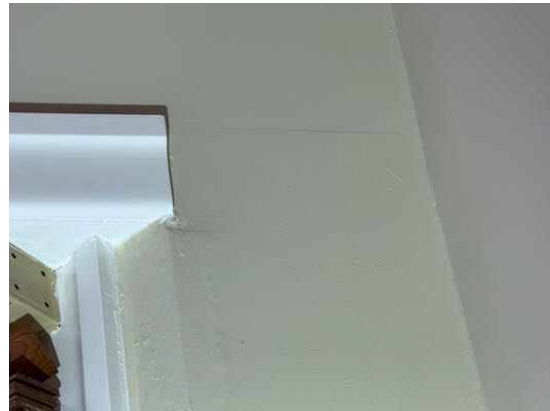
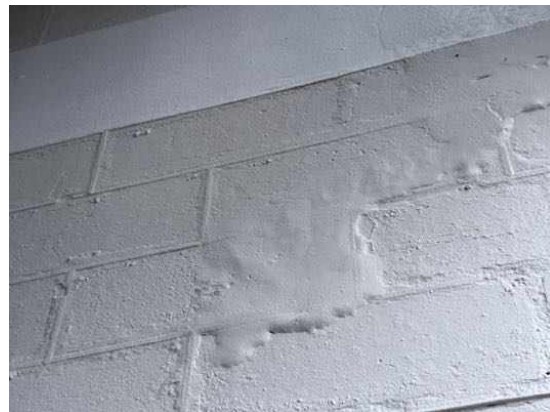
Building: Main Building
 Location: All Areas
 Finding: Evidence of recent renovations.
 Information: Whenever a property is refurbished, majority of the defects if present could get obscured beneath the revamped work. The same can be said for this property as well. Some fine cracks are filled over, walls have been painted etc. It is difficult to pinpoint on any particular defects present below such layers.

Once the property is occupied, all areas should be monitored for a period of 12-24 months to lookout for any arising defects. If staining or cracking is noticed extensively in that period, always consult your building inspector.
