Building and Timber Pest Inspection Report

Inspection Date: Wed, 1 Apr 2026

Property Address: 13 Kean Ave, Sanctuary Point NSW 2540, Australia

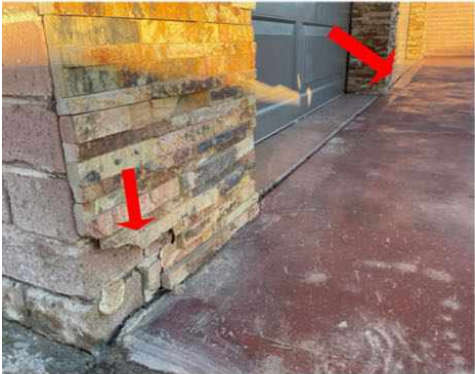
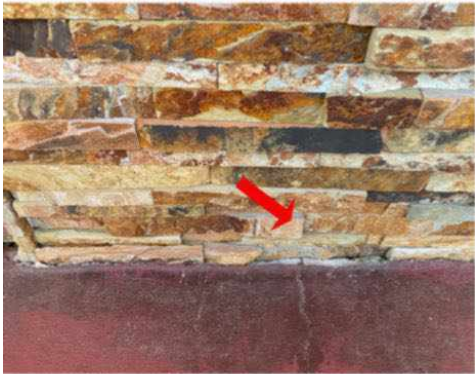
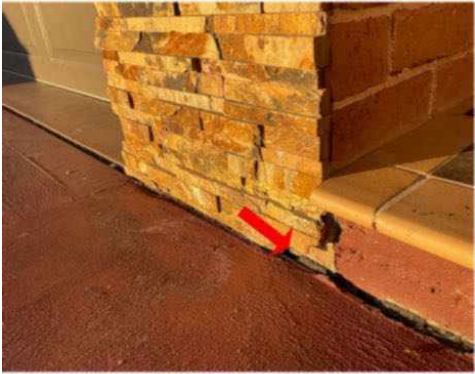
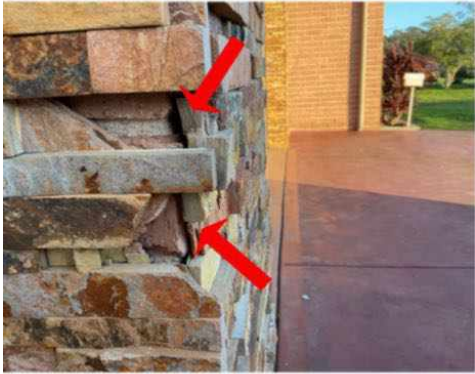
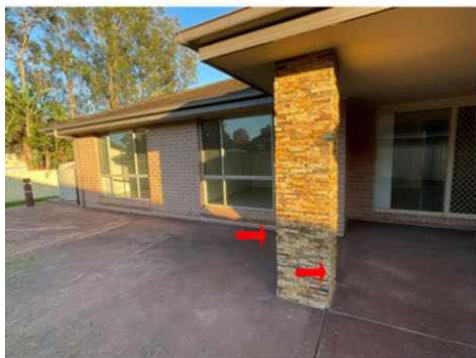
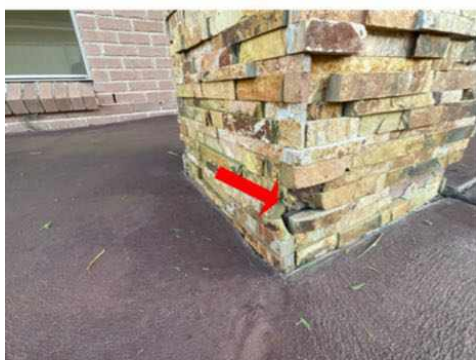
Finding 3.01

Building: Building 1
Location: Exterior front walls and rear pillar
Finding: Cladding damaged
Information: Evidence of damage was identified to the left side rear and front cladding that has minor damage. This cladding is only decorative and weatherproof cladding and sarking should be installed underneath. A carpenter would be the trade responsible for rectification of this wall areas.

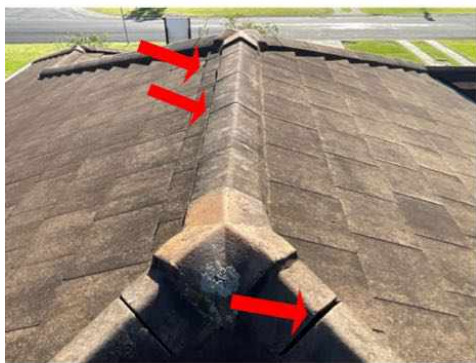
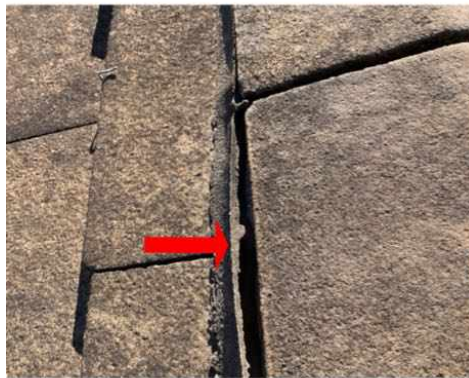
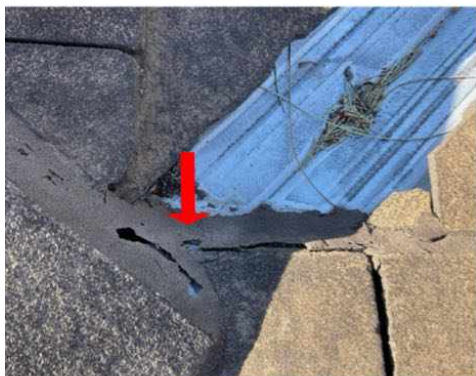
Finding 3.02

Building:	Building 1
Location:	Roof Exterior
Finding:	Roof tiles - Weathered
Information:	<p>Upon inspection of the exterior roofing, the majority of roof areas were considered to be in a fair to good condition. While weathering of the tiles is consistent with the age of the property, maintenance works are required. Isolated areas of mortar show minor cracking present. Re-pointing and re-sealing the may be considered as an interim solution by the client to help preserve and extend the life span of the tiles. This design of tile has gaps evident between the tiles. This has waterproof sarking installed under these areas. On this roof, some of these gaps are large and uneven, ie up to 14mm.</p>

Where left unmanaged, deteriorating roof areas like mortar are likely to lead to a number of secondary defects, including minor water leaks and weather exposure to internal roofing structures.

Note - no leaks or staining was found at the time of the inspection however no recent rain had fallen.

Consultation with a roofing contractor is highly advised to gain advice on cost of remedial works that may be required in the short to medium term. This should include checking all tile gaps, damage mortar and any areas of potential roof leaks. Remedial works are likely to increase the longevity of the exterior roofing structure.

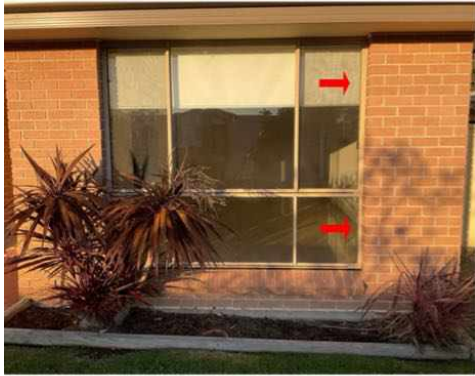
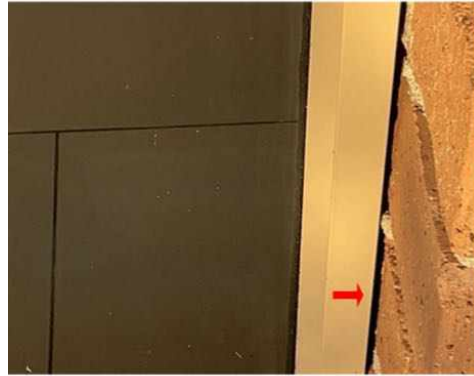
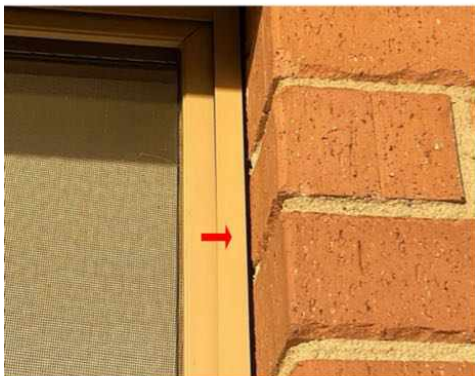
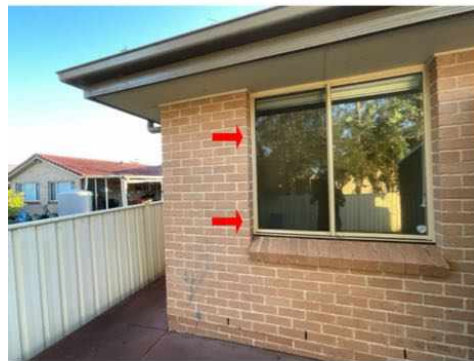
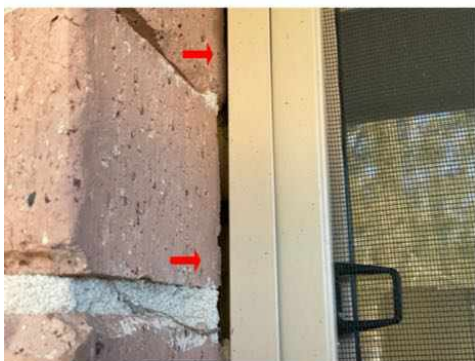
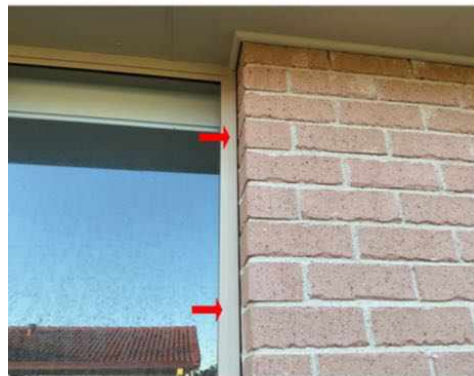
Finding 3.03

Building:	Building 1
Location:	Some exterior windows
Finding:	Sealant (external) - missing
Information:	It was noted on inspection that areas of external sealant was missing to these pictured window areas.

Flexible sealants should be applied to these affected areas to prevent any subsequent water damage that is likely to occur.

A sealant specialist or skilled handy person should be appointed to complete these works as soon as possible

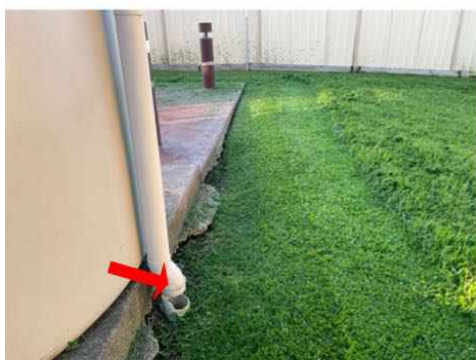
Finding 3.04

Building: Building 1
 Location: Walls at rear
 Finding: Site drainage - Inadequate
 Information: The site drainage in these areas was found to be inadequate at the time of inspection, creating potential for subsequent water damage to associated building elements.

The air conditioner and hot water system overflows run against the house walls and water tank overflow and black irrigation pipe show minor damage.

disgorge stormwater onto lower walls or plinths. Stormwater should be carried away by large, regularly cleaned drains. Ground levels may need to be lowered to expose a buried DPC.

Where site drainage is inadequate, installation of an Agricultural (Aggie) Drain may be required. A qualified plumber should be appointed to further inspect the property and perform any remedial works as necessary. Secondary defects are likely to occur if left unmanaged.

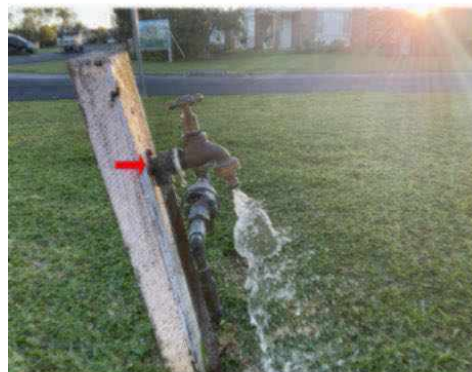
Finding 3.05

Building:	Building 1
Location:	Pictured external areas
Finding:	Building elements - Loose or Damaged
Information:	Evidence of minor missing or damaged areas was identified at the time of the inspection. These include - <ol style="list-style-type: none"> 1. The front yard two right side taps are impact damaged and bent but functioning normally. 2. The front door handle inside mechanism and ensuite handle is loose requiring adjustment. 3. A 3-4 mm split 920mm long at the top of the south garage door beam was found.

4. The kitchen tap leaked into the sink, the ensuite hot tap and vanity spout are loose, the laundry tap covers are missing, all requiring repair in the near future by a licensed plumber.

5. A few popped ceiling nails were found from very minor ceiling movement in the entry and front bedroom. No sagging or water damage was evident. A bottle was found taped to a roof trusses above the kitchen indicating there may be a very small leak. This bottle was empty. As no rain has fallen for days and no ceiling staining was evident, it appears there is no current leak. This area was only accessible from over 1 metres away for inspection. Numerous moisture readings were undertaken in ten nearby kitchen walls with no moisture found.

6. The roof aerial has minor damage and broken parts requiring an aerial technician for repair.

It is recommended to monitor this split annually and if it widens, to consult a structural engineer.

A carpenter would be the trade responsible for rectification of these areas when convenient.

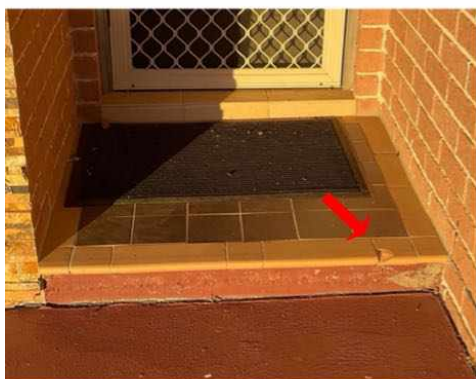
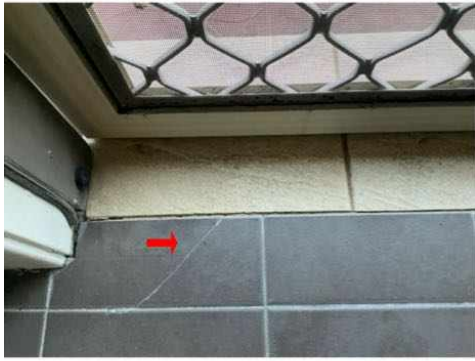
Finding: Tiles cracked

Information: A few cracked tiles were evident in these pictured areas at the time of inspection. It is suspected that this cracking has occurred as a result of minor settlement or impact damage. Cracked tiles throughout the household detract from the overall appearance of the affected areas. In wet areas of kitchens and bathrooms, it can lead to water damage of adjoining walls and floors.

Replacement of cracked tiles is recommended as soon as possible. A tiling contractor may be appointed to perform these works. Where cracks become more numerous, contact a licensed building inspector for further investigation.

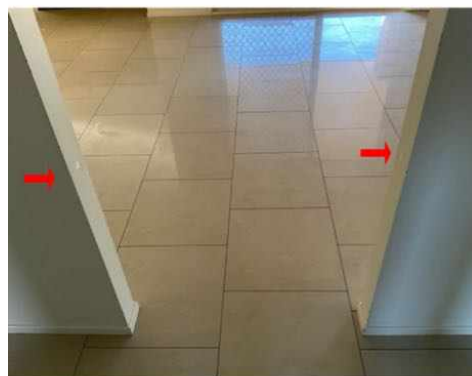
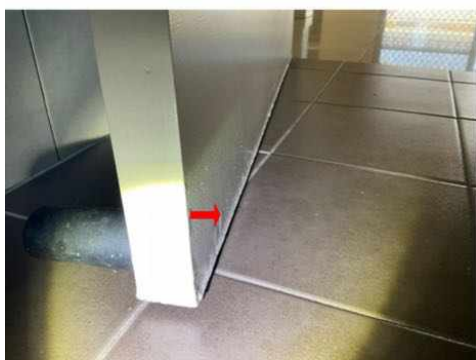
Finding 3.07

Building: Building 1
 Location: Pictured areas
 Finding: Paint missing or damaged
 Information: The paint finish in some areas of the house was found to be missing or damaged. Damaged painting is generally classified as an appearance defect. However, the appearance may also be indicative of poor surface preparation and substandard workmanship. Damaged paint finishes in areas exposed to moisture,

e.g. external areas or wet areas, could lead to deterioration of underlying building materials. Damaged paint finishes should be sanded back, filled, leveled and repainted, as applicable.

A painting contractor should be appointed as soon as possible to perform necessary works to aid the appearance of the affected area and to ensure that the area is protected against further deterioration. Alternatively, the homeowner following manufacturer instructions may be able to provide this service.

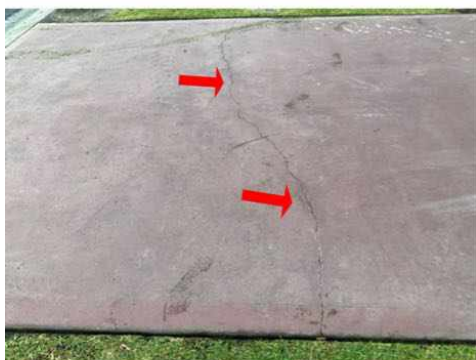
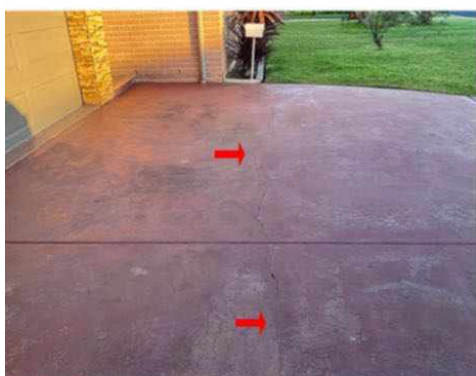
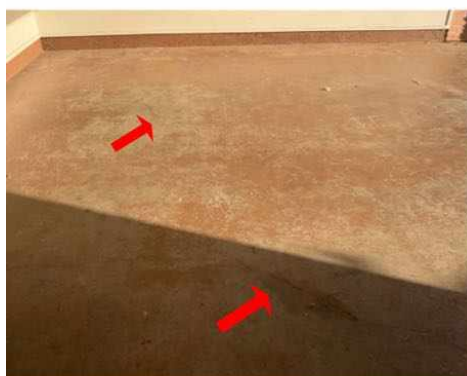
Finding 3.08

Building:	Building 1
Location:	Driveway & garage
Finding:	Crack in concrete slabs - Category 1
Information:	Small cracks coded as Category 1 was identified in these pictured slabs. These are common. A Category 1 crack is described as a fine but noticeable crack, with the slab at an otherwise reasonable level. To be considered Category 1, the approximate width of the crack is less than 1.0mm, or a less than 10mm change in offset when a 3m straight edge is placed over the defect.

Category 1 cracks should be monitored for a period of 12 months. At the end of the monitoring period, identified cracks that are rated greater than Category 2 are considered defects, and require rectification.

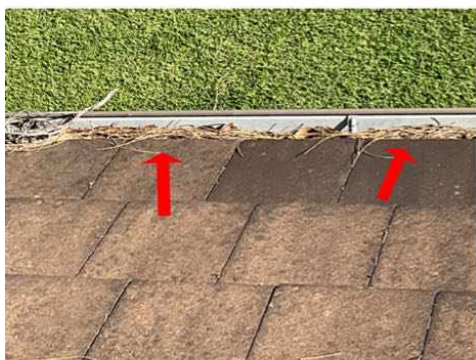
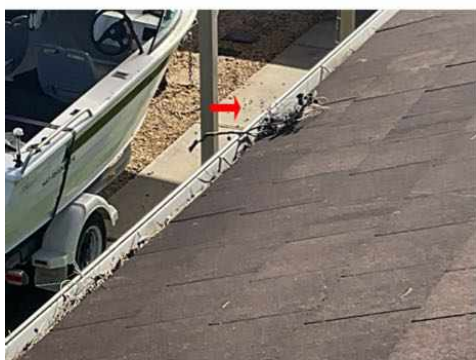
Finding 3.09

Building:	Building 1
Location:	Roof exterior
Finding:	Gutters - Full and blocked
Information:	The guttering on around the roof was found to be blocked at the time of the inspection. Roof plumbing structures, such as guttering and downpipes, should be free of all debris to prevent blockages. Blockages of the guttering and downpipes will lead to pooling and accumulated water overflows, which is likely to subsequently flood eaves and exterior walls.

Blocked gutters are likely to lead to high levels of moisture in the affected areas. Such moisture will not only cause rust and decay of the associated building materials, but can also provide conditions that are conducive to termite and timber pest activity. Blockages in gutters should therefore be removed immediately to ensure dry conditions are maintained.

It is highly advised that gutters be cleaned by the homeowner or a general handyperson as a matter of urgency.

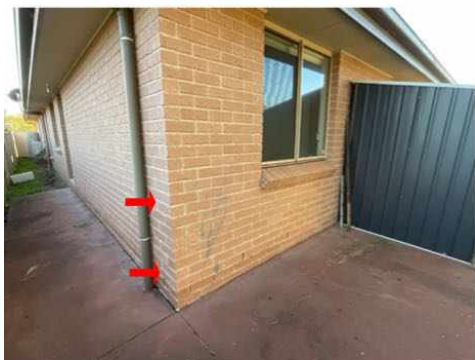
Building:	Building 1
Location:	Exterior wall
Finding:	Step cracking to brickwork (minor)
Information:	Step cracking (hairline under 0.5mm) was identified to the brickwork in this area at the time of inspection. Step cracking, which is similar to other forms of cracking, has a variety of possible causes. However, the most common is the subsidence of adjacent footings.

Step cracking is a relatively common defect, and is most likely to occur adjacent to windows, doors and other openings. Mortar failure in the gaps between affected bricks indicates the stresses and tensions affecting the wall.

Where step cracking is extensive or severe, the client is advised to consult a structural engineer. This minor step cracking can be used as a warning sign to address factors causing stress to the wall, which can include the effect of surrounding trees, water leaks, soil erosion, or even the presence of reactive soils in the surrounding area.

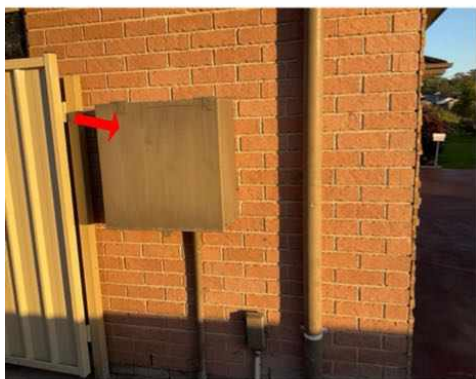
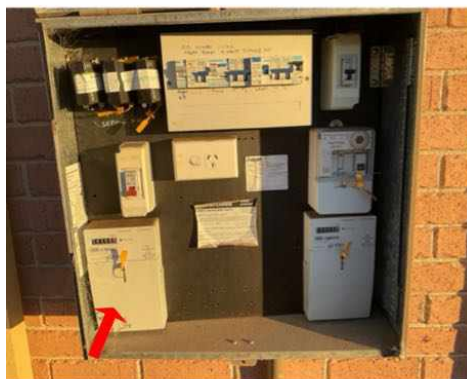
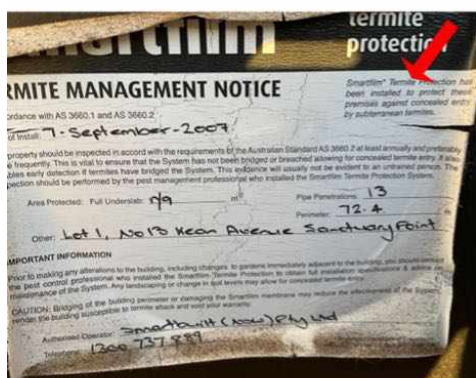
Building:	Building 1
Location:	Meter Box
Finding:	Termite Management System - no evidence of a chemical installation
Information:	The application of a post-construction chemical termite barrier is highly recommended for all properties. Such barriers are highly effective in preventing termite attack on any timber building elements throughout the property.

A durable notice should be placed in the switchboard unit to indicate current termite barriers. At the time of inspection, the durable notice was evident and it appeared as though no chemical termite management system has been installed, with no evidence to suggest preventative works taking place since the property was built.

The client may consider gaining further advice from a pest controller as to the costs and procedures involved with a 'chemical' application. It is recommended that obtaining such advice be a short-term priority.

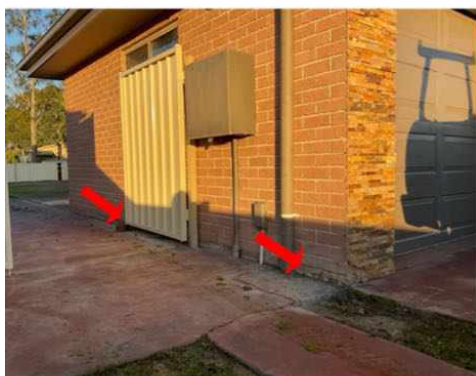
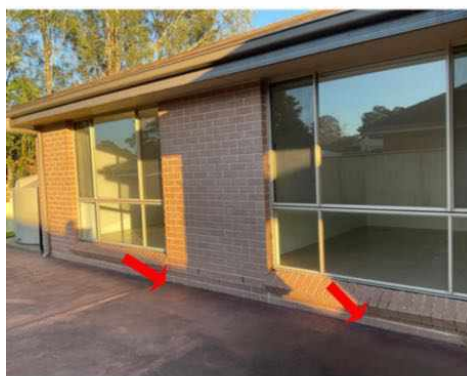
Finding 6.02

Building:	Building 1
Location:	Exterior walls
Finding:	Slab Edge - Exposure
Information:	An inspection zone of at least 75mm in relation to the exposed slab edge, between the bottom brick and the perimeter pavement, is required. This inspection zone should be maintained in order to force termites into the open where they can be detected more readily during regular inspections. The slab edge should not be concealed by anything that may prevent inspection of the area, including render, landscaping, soil, turf, paving, concrete cladding or other structures.

If the slab edge is not properly exposed there is a high risk of termite attack. Sometimes, in order to determine the type of slab, a suitably qualified person such as an architect or builder may be required to consult the construction plans.

Where the slab edge cannot be properly inspected, it is highly recommended that termite or timber pest inspections be carried out every 6-12 months to aid protection of the property against infestation.

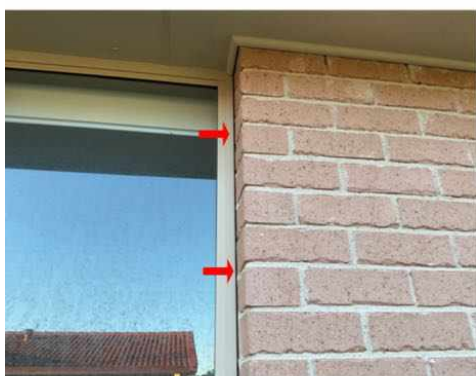
Finding 6.03

Building:	Building 1
Location:	Some window areas
Finding:	Sealant (external) - missing and attractive to termites
Information:	It was noted on inspection that areas of external sealant was missing to small areas of the external walls. A flexible sealant or flashing is required to protect the associated building materials from rainwater ingress. Any moisture ingress into the property is very attractive to termites. Flexible sealants or flashing should be applied to these affected areas to prevent termite activity.

A sealant specialist or skilled handy person should be appointed to complete these works as soon as possible.

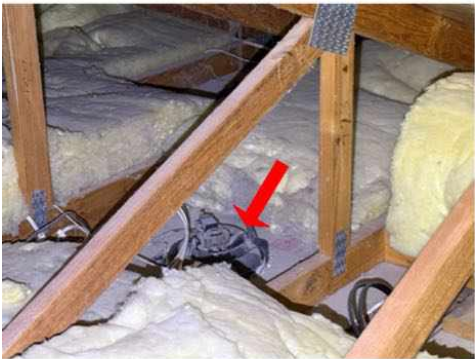
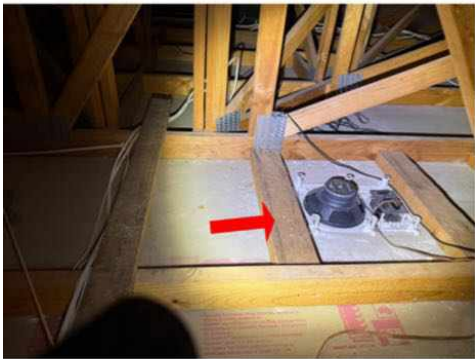
Building: Building 1
Location: Roof Void
Finding: Exhaust fans not ducted outside
Information: On inspection of the roof void, it was observed that the exhaust fans to the bathroom and ensuite are not connected directly to the outside of the building, only into the roof void. Although no mould was evident in the roof void, ducting these fans is recommended for the health of the roof void and the house in general.
