Building and Timber Pest Inspection Report

Inspection Date: Thu, 5 Feb 2026

Property Address: 8 Burton Ave, Chester Hill NSW 2162,
Australia

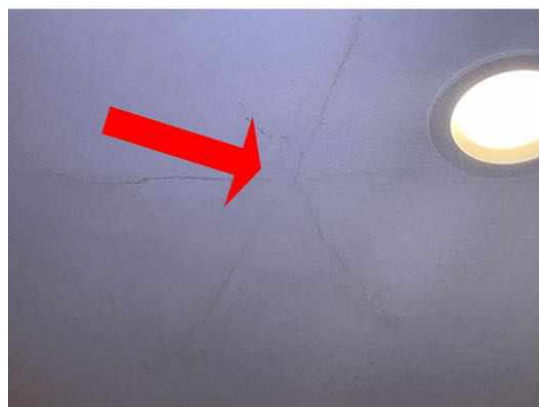
Building: Main Building
 Location: Bedroom
 Finding: Ceiling - Water damaged
 Information: Water damage to the ceiling lining is generally an indication of excessive moisture being present in the roof void, usually via a leak to the roof covering.

Where water damage is evident to the ceiling, the primary requirement is to identify and rectify the source of the leak. A roofing plumber should be appointed as soon as possible to identify the leak and perform rectification works as necessary, ensuring the water damage is restricted. Invasive inspection is highly recommended.

Once the leak is repaired, consultation with relevant tradespeople, including plasterers and painters, is advised. Rectification works may include replacement of ceiling lining or minor repainting, depending on the extent of the damage.

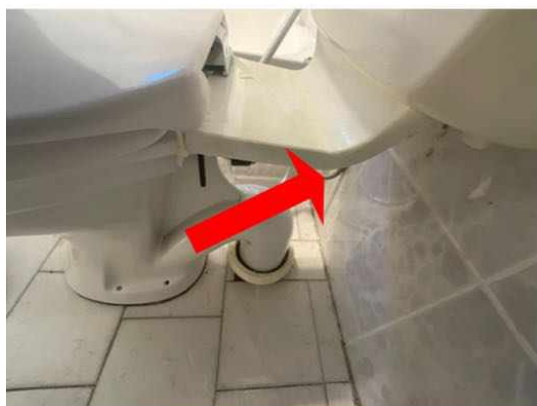
Building:	Main Building
Location:	Bathroom
Finding:	Water leak - Active
Information:	Generally, water leaks occur when a particular area of the property is not weather or water tight. As the surrounding area was found to be damp at the time of inspection, the leak is considered ongoing and hence requires urgent action.

Regardless of the location, even minor leaks that are left unmanaged can lead to serious damage of associated building elements and result in the need for replacement of building materials. Mould and other hazards such as electrical hazards may also arise if the leak is left to develop.

It is highly advised that the cause of the leak be identified and resolved immediately by a licensed plumber to prevent any further damage. Depending on the extent of the damage previously sustained, repair and/or replacement of any affected building materials may be required.

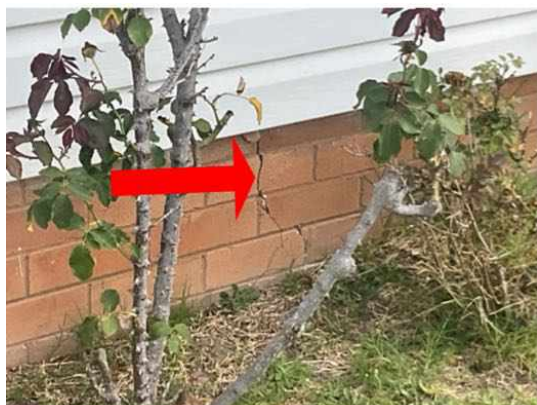
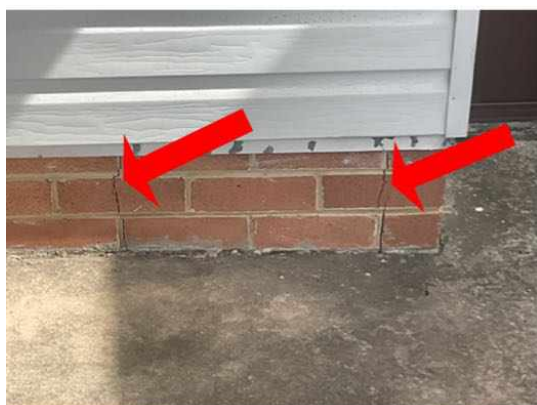
Finding 3.01

Building:	Main Building
Location:	Exterior walls
Finding:	Brickwork - Cracking [Fine]
Information:	Although fine cracks are quite noticeable, they are often only considered to be an appearance defect and usually do not indicate any structural damage. Generally, the cause of a fine crack is indicative of a separation between brickwork and mortar throughout the structure, but single bricks may also show cracks of this nature.

Cracking of this nature can generally be repaired with minor filling and should be conducted by a qualified bricklayer.

Always contact a building inspector should cracks widen lengthen or become more

numerous.

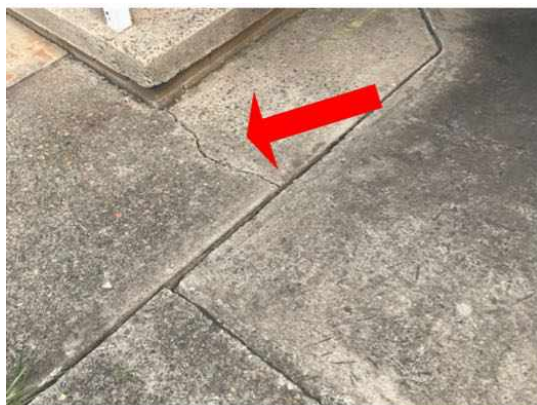
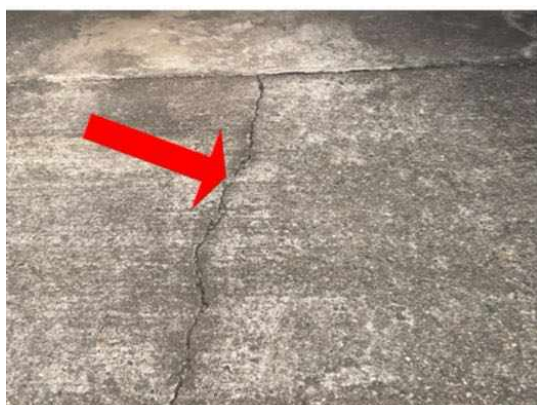
Finding 3.02

Building:	Main Building
Location:	All Internal Areas
Finding:	Cracking - External Concrete Paving Damage Category 1 - Fine (less than 2mm)
Information:	Fine cracks were identified in external concrete paving. Although fine cracks are quite noticeable, they are often only considered to be an appearance defect, and usually do not indicate any structural damage. To be considered a Category 1 or fine crack, the crack is found to be less than 2mm in width.

Generally the cause of a hairline crack in existing concrete paving such as driveways and pathways is indicative of the expansion and contraction of the concrete. Such causes are generally due to environmental factors, such as moisture levels, weather conditions, root systems of nearby trees or the soil types on which they are laid.

Fine cracks may also be due to poor original installation of the concrete. Factors such as poor compaction of the sub surface and/or inadequate reinforcing of the slab may create cracking and other secondary defects.

Monitoring of all cracking should be conducted frequently. Always contact a building inspector should cracks widen, lengthen, or become more numerous.

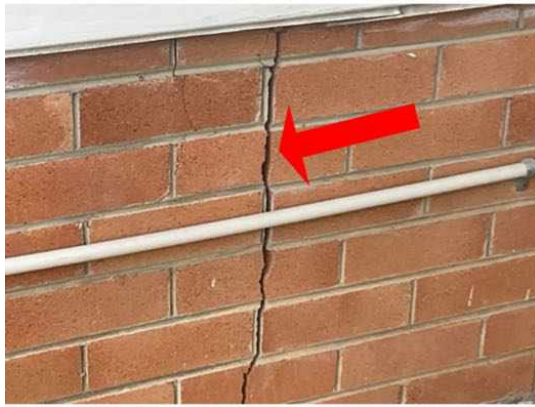
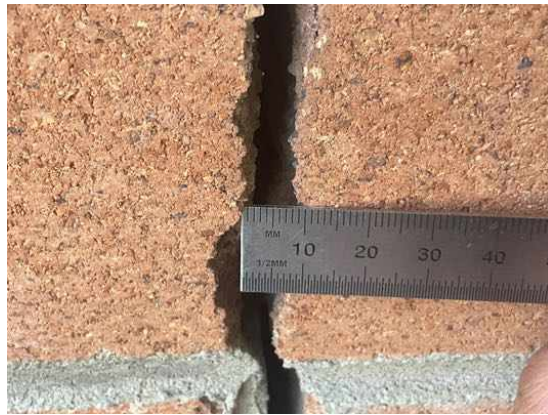
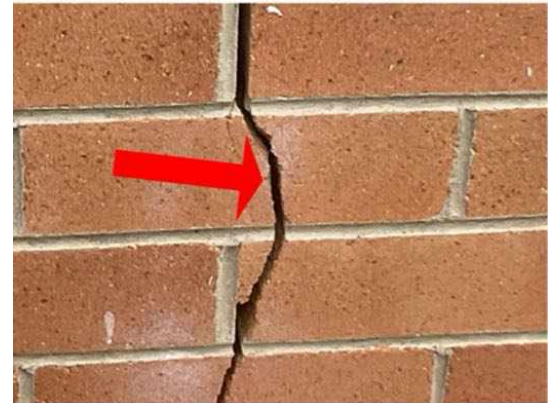
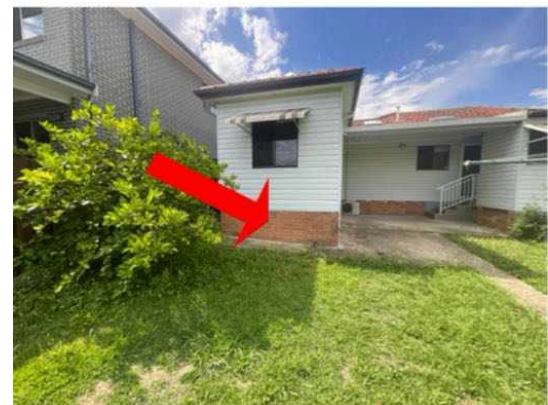
Finding 3.03

Building:	Main Building
Location:	All External Areas
Finding:	Brickwork - Cracking noticeable
Information:	There were several cracks and or crack repairs evident to external brickwork.

Noticeable cracks are a common occurrence in external brickwork and are a likely result of age expected building movement, general expansion, and/or contraction of building materials in different weather conditions. Noticeable cracks in brickwork may develop if left unattended, with potential for necessitating major remedial works or replacement of the brickwork.

It is highly advised that a qualified bricklayer be appointed to provide necessary works to cracked brickwork to prevent any further damage. Such works should be conducted as soon as possible.

Always monitor these cracks and contact a building inspector should cracks widen, lengthen, or become more numerous.

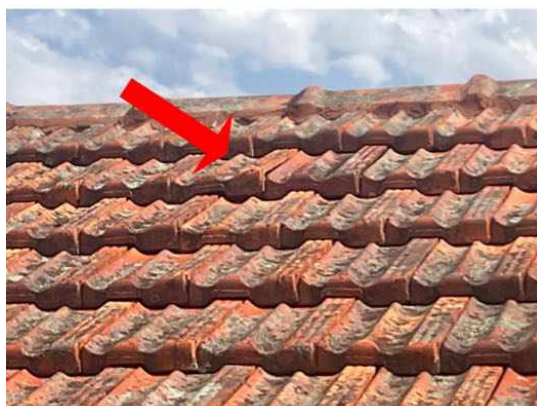
Building:	Main Building
Location:	Roof Exterior
Finding:	Roof tiles - Slippage
Information:	Upon inspection of the exterior roof covering, it was noted that numerous tiles have slipped from their original fixing. Tiles may slip over time due to a number of minor causes, including breakage of tiles, failings in the adjoining battens, or fixings that may have failed.

Roof tiles that have moved from their original position are very likely to allow water penetration into the roof void, exposing roofing structures to excessive moisture. This creates an environment that is conducive to water damage and accelerated deterioration of all associated building elements.

Replacement of loose or missing roofing tiles is recommended immediately to prevent the development of any secondary defects. A roofing restoration specialist should be appointed to complete such works as necessary.

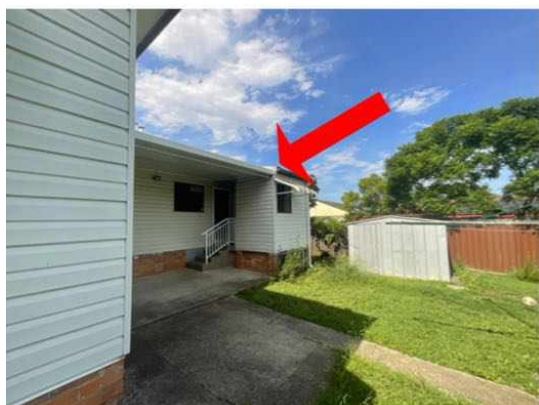
Finding 3.07

Building:	Main Building
Location:	Roof Exterior
Finding:	Asbestos - Suspected ACM Identified on Site
Information:	Reporting on Asbestos is outside the Scope of this Report. This suspected defect is highlighted as a caution only. We suspect, based on our experience in the building industry, that there is a higher risk of the identified building element containing asbestos.

As Asbestos Reporting is outside the scope of this report, we advise that you consider a separate Asbestos Inspection and Condition Audit, which can include the taking of samples for definitive confirmation of the presence of Asbestos.

In the interim, the client is advised to act with caution, especially when considering any damage to building materials general wear and tear renovations extensions demolition and general maintenance activities due to the suspected presence of Asbestos.

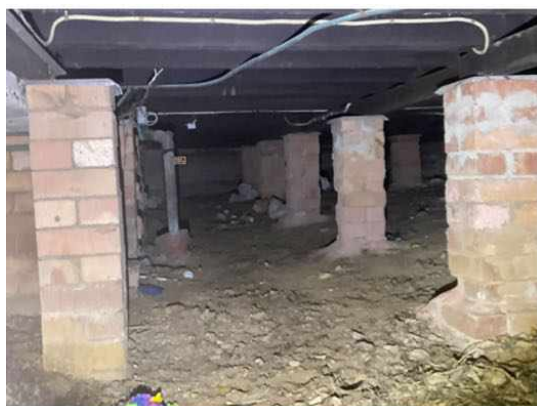
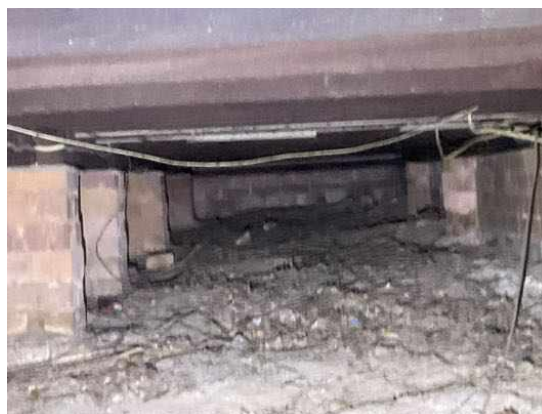
Finding 3.08

Building:	Main Building
Location:	Subfloor
Finding:	Subfloor - Lack of ventilation
Information:	It was noted at the time of inspection that the subfloor area lacks adequate ventilation. Ventilation can be restricted by a variety of minor defects, including obstructions in the subfloor space, a lack of vents or a low clearance.

A well ventilated subfloor aids in maintaining dry conditions, preventing secondary damage such as wood rot and pest activity, as well as preventing the development of mould and mildew (which can lead to respiratory safety hazards for occupants).

The initial step in improving ventilation is to ensure that the subfloor area is free of any debris or stored items. Where ventilation is still inadequate, it is advised to ensure that all vents are clear of blockages, and additional vents may be installed.

The client may also consider mechanical ventilation (powered fans) to improve subfloor airflow. Remedial works should be conducted as a matter of urgency to protect against the development of potentially harmful subfloor conditions.

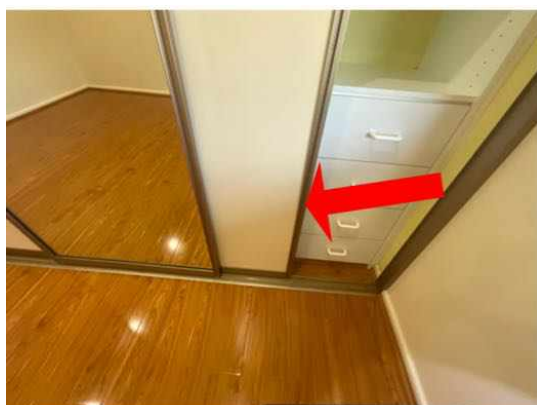
Finding 3.09

Building:	Main Building
Location:	Built In Robe
Finding:	Sliding Door - Stiff to slide
Information:	The door in this area was jammed and difficult to slide along the associated tracks at the time of the inspection. Restricted function of the affected door may pose as a potential safety hazard if required for emergency egress from the building.

Generally, factors such as general age of the building element and a lack of maintenance are the usual causes for this type of defect.

Replacement of door hardware or tracks may be required, as well as minor repairs and cleaning. A registered builder or general handy person will be required to repair the affected doors.

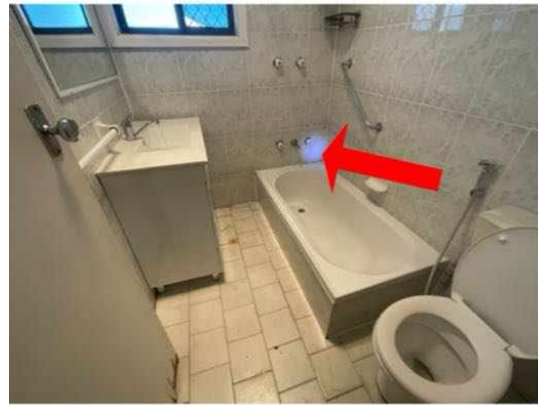
Building:	Main Building
Location:	Bathroom
Finding:	Sealant and grouting - Missing or damaged
Information:	It was noted on inspection that sealant or grout is degraded to the tiled shower alcove and or other areas of the bathroom.

Different materials and floor areas move at different rates, generally causing cracking to grout or sealant at this point. A flexible sealant is required to allow for expected expansion and contraction, while keeping the joint water tight and protective of all associated building materials.

There appears to be excessive mould to the sealant and grout which will likely require scraping out and replacement.

Flexible and mould resistant materials should be applied to affected areas to prevent any subsequent water damage that is likely to occur. Regular maintenance and replacement of damage or missing or damaged sealant and grout is highly recommended to the wet areas, as this is a regular wear and tear defect. Sealant and grouting in areas that come into regular contact with water should be maintained for the long term care of your property.

A sealant specialist or tiling contractor should be appointed to complete these works as soon as possible

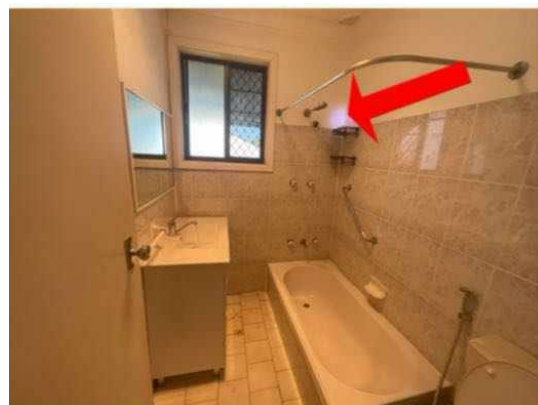
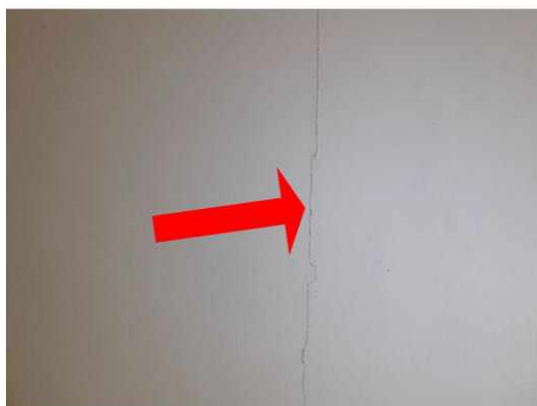
Finding 3.13

Building:	Main Building
Location:	All Internal Areas
Finding:	Cracking - Damage Category 1 - Fine (up to 1mm)
Information:	Although fine cracks are quite noticeable, they are often only considered to be an appearance defect, and usually do not indicate any structural damage. Generally, the cause of a fine crack is indicative of a separation between building materials and finishes (e.g. paint, plaster, etc.) along joins.

Cracking of this nature can generally be repaired with minor sanding, filling and/or repainting. Such works should be performed by a qualified painter or a general handyman.

Monitoring of all cracking should be conducted frequently. Always contact a building inspector should cracks widen, lengthen, or become more numerous.

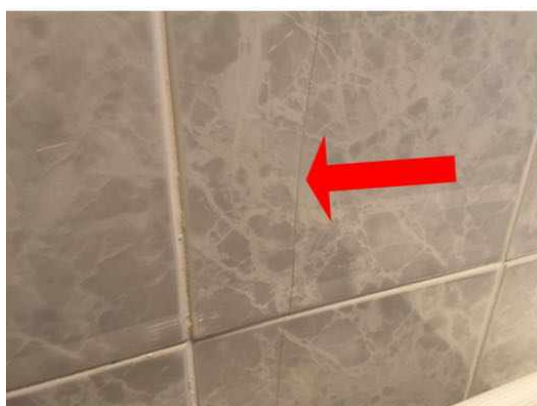
Finding 3.14

Building:	Main Building
Location:	All Areas
Finding:	Tiles - Cracked or damaged
Information:	Cracking was evident to the tiling in this area at the time of inspection. While the cracking appears to be minor, this area is frequently exposed to water, allowing potential for water penetration into adjoining sections of walls or flooring.

If left unmanaged, water penetration to these areas may lead to subsequent water damage, which is likely necessitate repair work to affected building elements.

A tiling contractor should be appointed to ensure that no further water damage occurs. The re-application of silicone and grouting throughout remaining tile work is also advised, to further protect the area against water penetration.

Where water penetration has led to water damage, appointment of a relevant tradesperson may be required to repair damaged building elements.

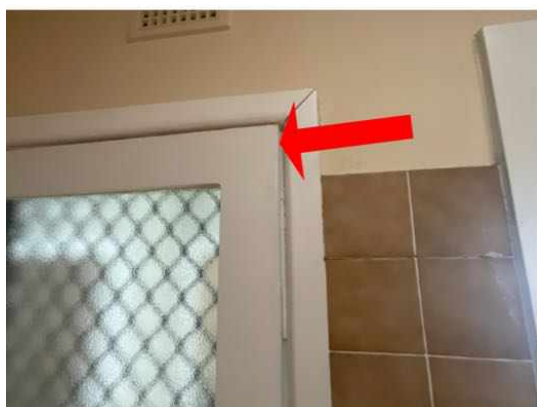
Finding 3.15

Building:	Main Building
Location:	Kitchen
Finding:	Door - Binding/jamming

Information: Binding and/or jamming of this door is evident during standard operation. This defect inhibits the functionality of the affected door as well as creating potential for secondary defects to associated building elements, such as damage to the floor covering.

A door that binds to flooring or to the associated door frame may have several causes, ranging from minor defects, such as poor installation of the door or deteriorated hinges, through to major structural issues, such as damage to subfloor structures.

Where door binding/jamming appears to indicate major structural issues, a registered builder specialising in re-stumping should be appointed to provide an estimate on the cost of rectification.

For minor causes, a qualified carpenter or general handyperson should be appointed to perform minor rectification works at client discretion.

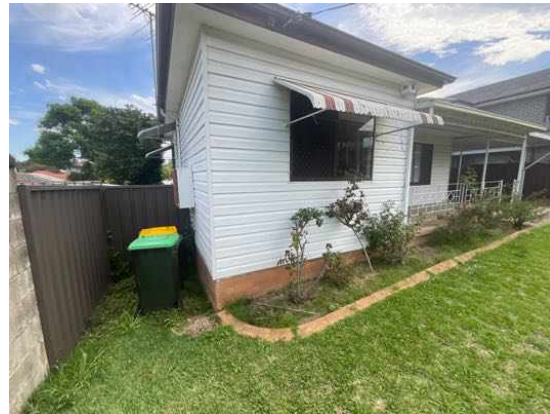
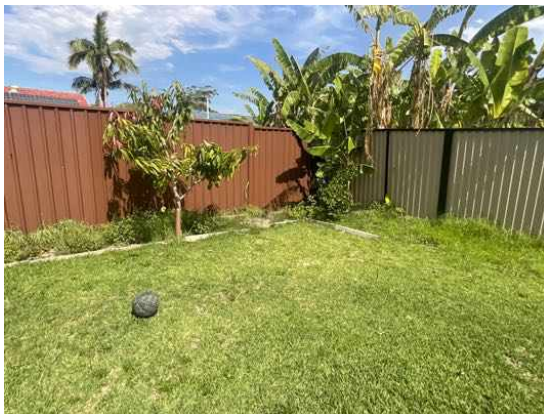
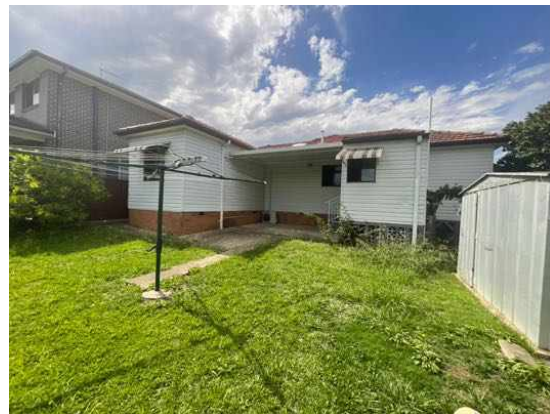
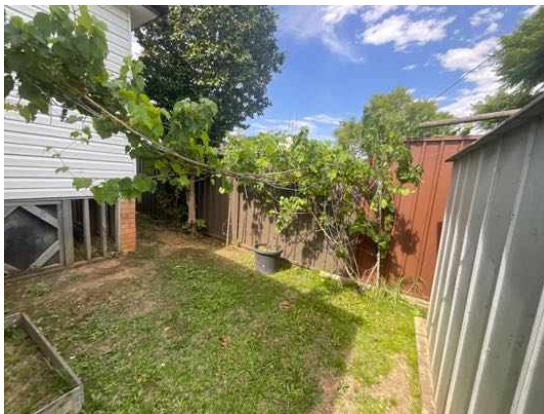
Building: Main Building
 Location: All Areas
 Finding: Garden Beds - Conditions Conducive to Termites
 Information: Garden beds were found to be evident in the garden area. These garden beds can include untreated timber, and with a combination of moisture from watering hosing

can make conditions conducive to termite activity and termite ingress.

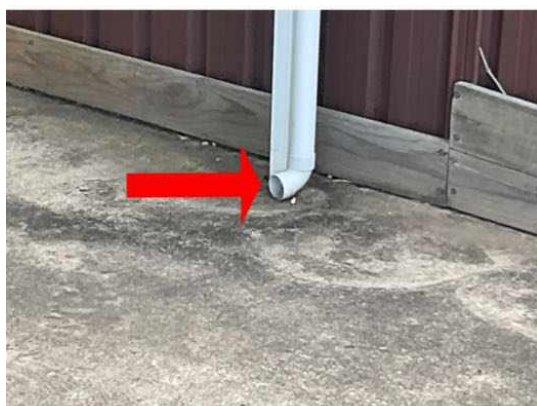
Finding: Overflow - Not plumbed for drainage

Information: The overflow is not plumbed or connected to suitable drainage, which has resulted in the surrounding area becoming excessively damp. These damp conditions can lead to secondary defects such as rot, rust or corrosion of associated building elements, the formation of fungal decay, or even the creation of potential slip hazards. When coupled with poor site drainage, pooling of water may also attract termite activity to this area. It is highly recommended that a qualified plumber be appointed to install adequate drainage to the overflow. These works will ensure that the area remains dry and free of any secondary defects.

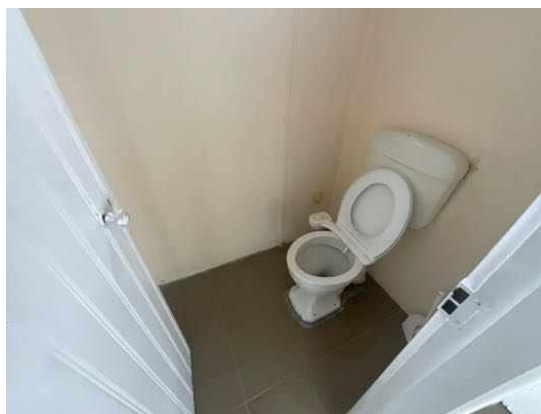
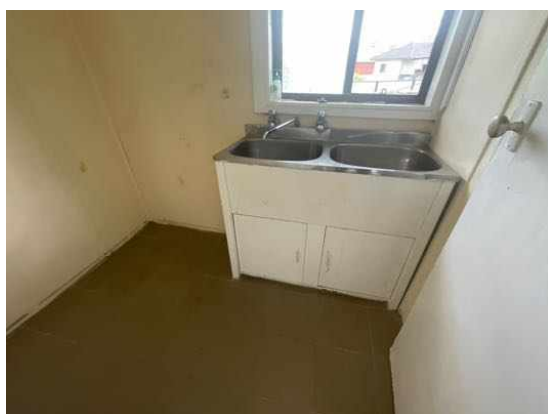
Building:	Main Building
Location:	All Areas
Finding:	Water Proofing Membranes - Information Only
Information:	Internal Water Proofing Membranes, are crucial in preventing water ingress into the property is important to know that the Membrane System used is to Australian Standards and has been installed correctly. Please refer to the original Building Documents or Maintenance Schedule for the relevant information including; - Membrane used and Manufacturers Specifications. - The Installer and Installation Certification. Especially with older property's where this information is unavailable, all wet areas should be monitored. Generally new waterproofing with a certificate may only have a guarantee of 8yrs. If any leaks, water staining, peeling or bubbling of the paint become evident to any adjacent walls or ceilings below a licensed builder or waterproofing specialist is recommended to investigate further.

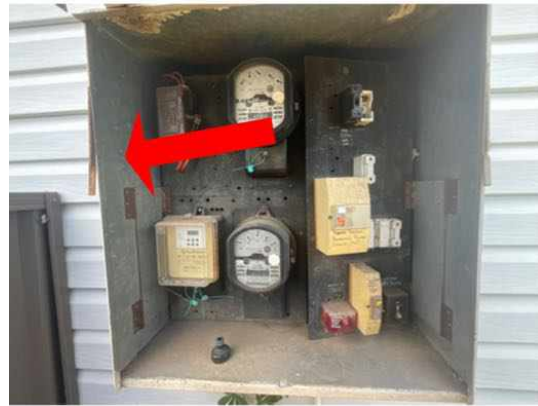
A durable notice should be placed in the switchboard unit to indicate current termite barriers. At the time of inspection, it appeared as though no termite management system has been installed, with no evidence to suggest preventative works taking place.

The client may consider gaining further advice from a pest controller as to the costs and procedures involved with this application. It is recommended that obtaining such advice be a short-term priority.
