## Building Inspection Report

Inspection Date: Thu, 22 Jan 2026

Property Address: 18 Mawarra Ave, Capel Sound VIC 3940,  
Australia

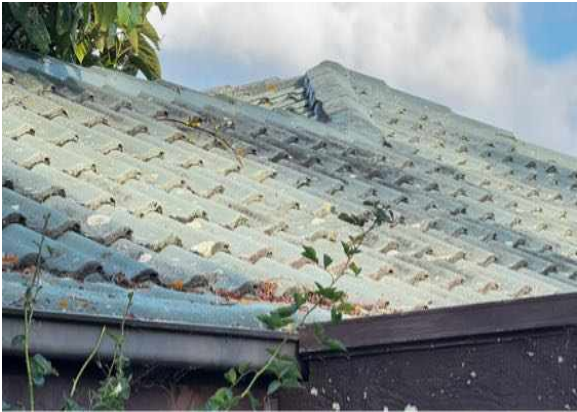
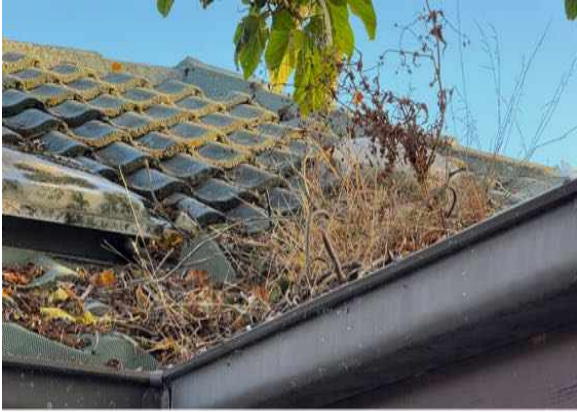
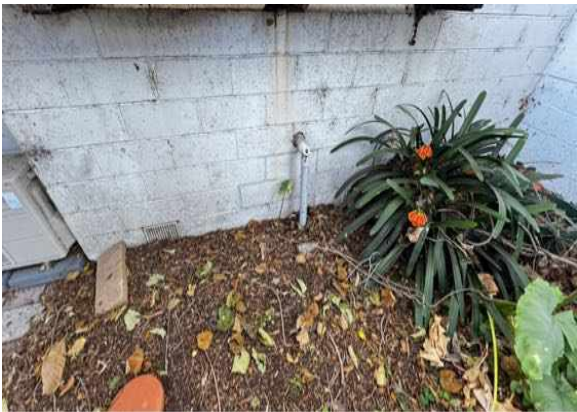
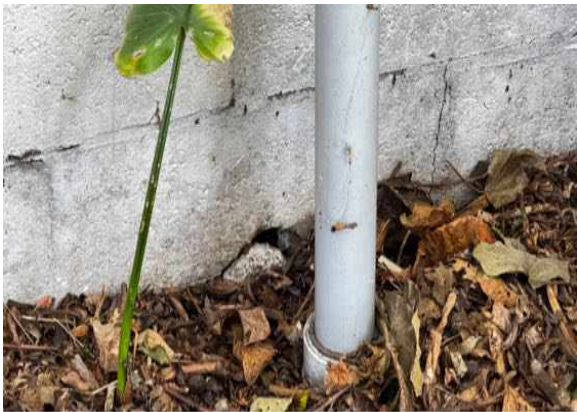
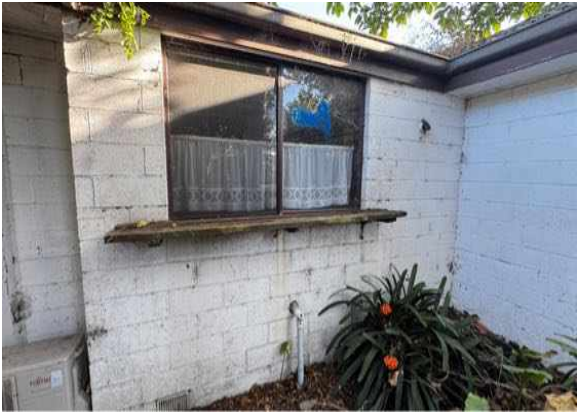
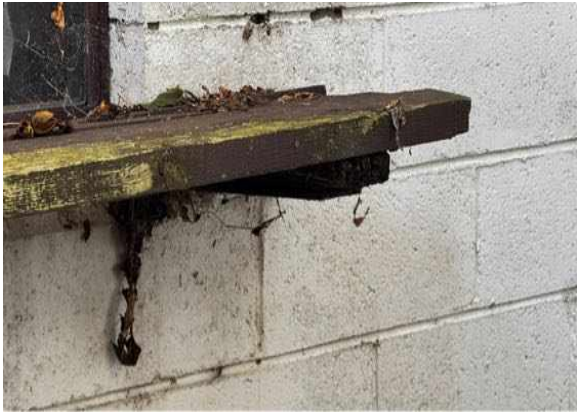
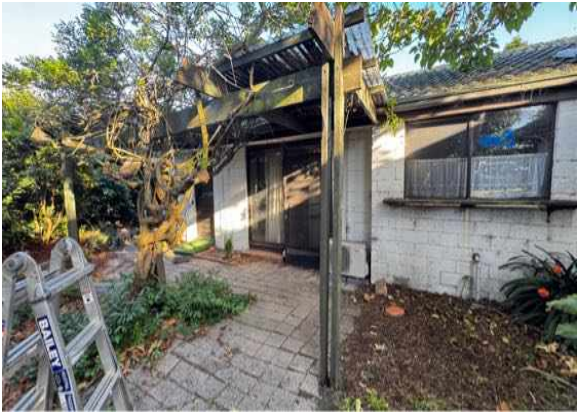
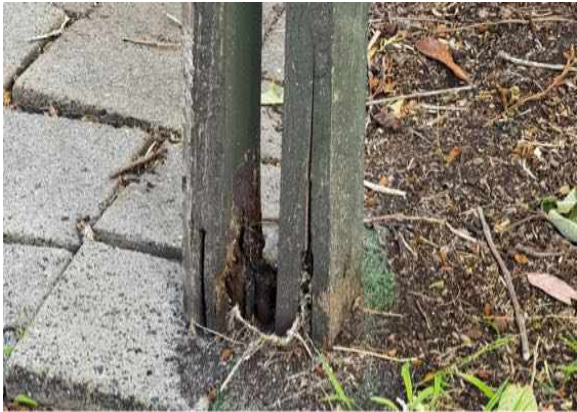
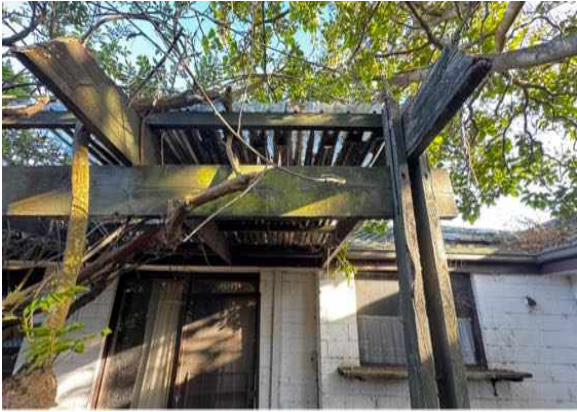
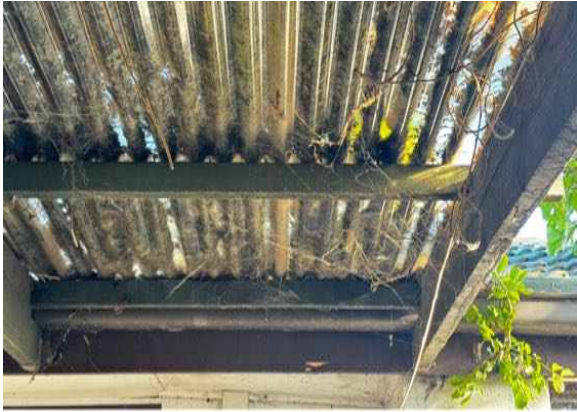
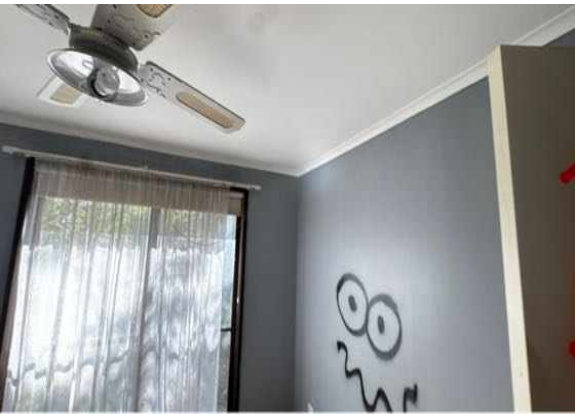
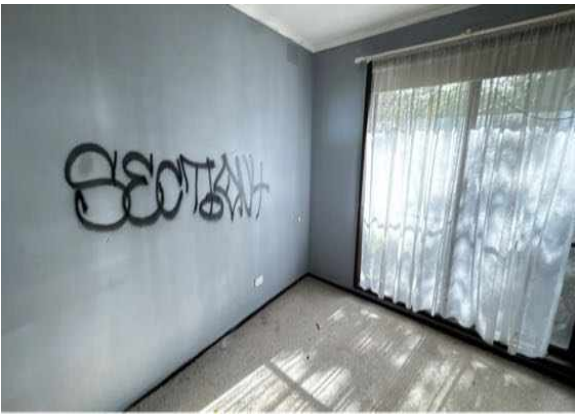
### Defects 2.01

Building:	Main Building
Location:	
Finding:	Building Elements - Damaged
Information:	The dwelling is in a severely deteriorated condition and requires a full and comprehensive renovation throughout. At the time of inspection, electrical cabling has been removed entirely, rendering the property non-functional from an electrical services perspective. The majority of hot and cold water plumbing has also been removed, leaving the dwelling without essential plumbing services. Multiple areas of internal flooring have been cut open, and plaster wall linings have been extensively vandalised and damaged.

In addition, a significant number of windows are in poor condition, with broken and smashed glass evident, and most windows will require full replacement. Due to the extent of damage and removal of critical building services, the property is not habitable in its current state and will require substantial rectification works prior to occupation.

\*\*\* It is recommended that the following suitably qualified trades and professionals be engaged immediately to conduct full invasive inspections on the property, provide expert advice for all required remedial works including but not limited to:

\*All inspections and remedial works should be coordinated, and the dwelling should not be occupied until essential services, structural integrity and safety hazards have been addressed, fully reinstated and certified.

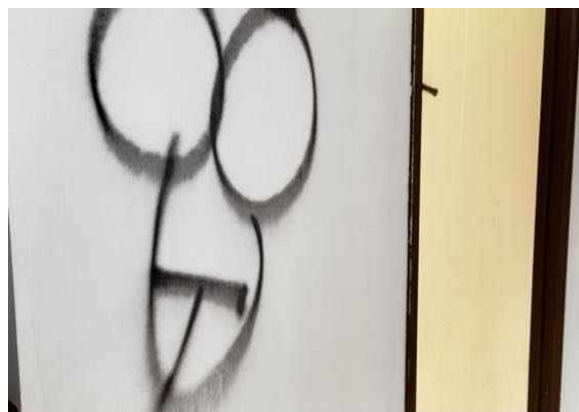
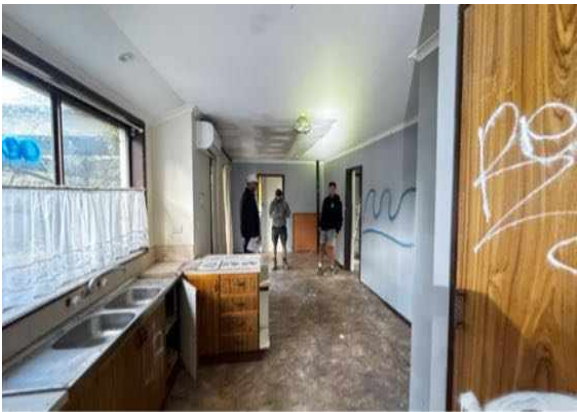
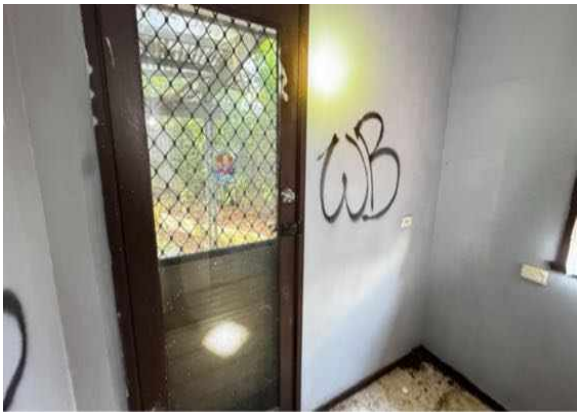
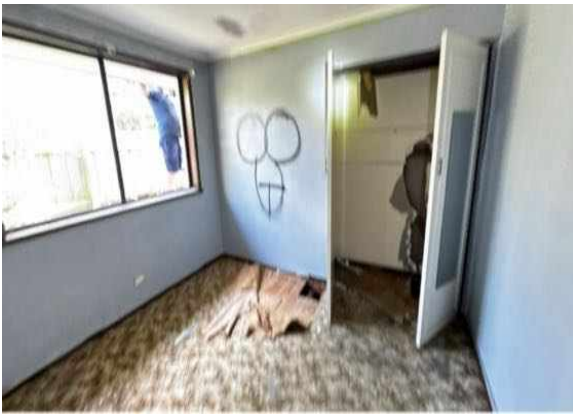
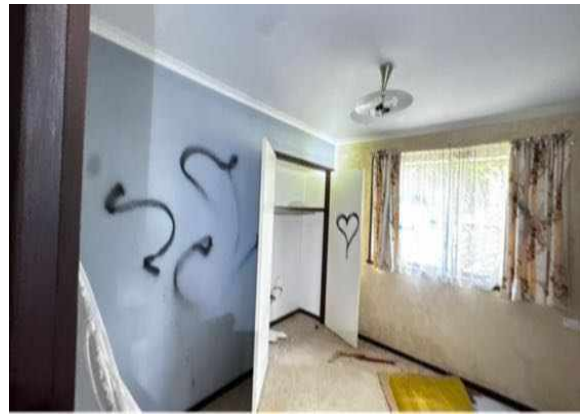
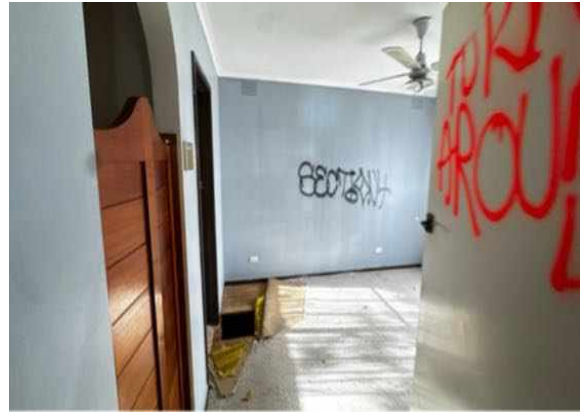
### Defects 3.03

Information: Discolouration and damage to painted wall finishes were observed in multiple areas of the dwelling at the time of inspection. The condition appears consistent with vandalism and significantly detracts from the internal presentation of the property.

The affected paint finishes may also conceal underlying damage to plaster surfaces and, if left unaddressed, may lead to further deterioration of wall linings.

It is recommended that a qualified painter or registered builder be engaged to assess the extent of the discolouration, identify any underlying substrate damage, and carry out appropriate surface preparation and repainting works once all other remedial repairs have been completed.

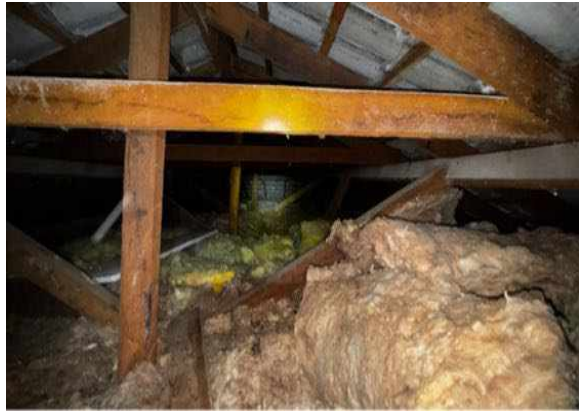
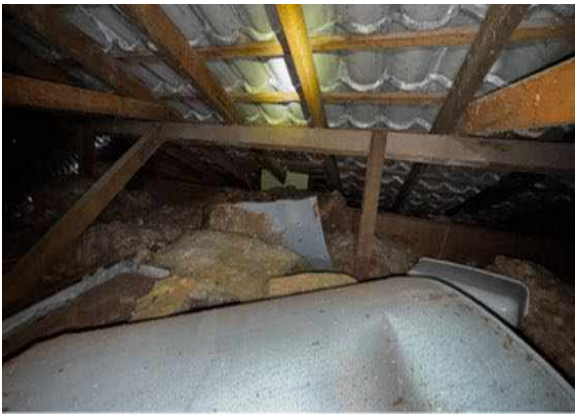
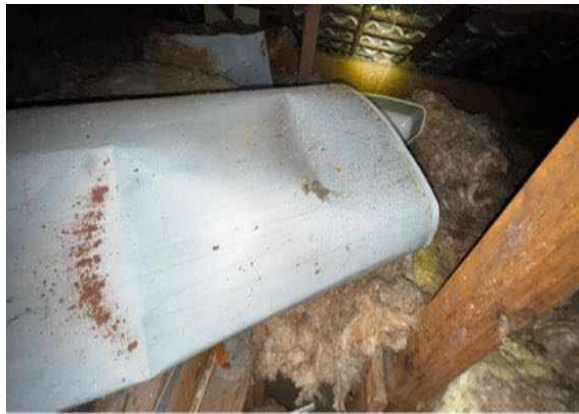
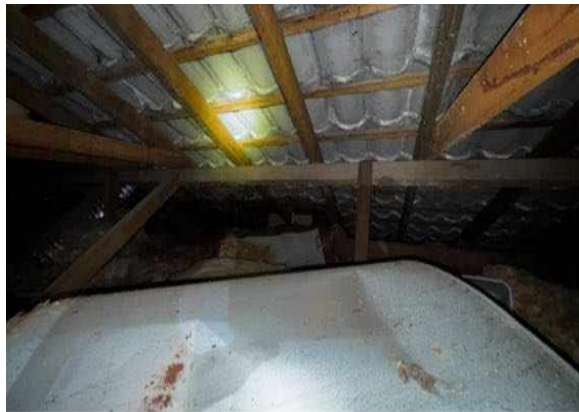
**Defects 3.09**

Building: Main Building  
 Location: Roof Void  
 Finding: Roof Void - Limited Access  
 Information: Limited access to the roof void was present due to facts including but not limited to, limited access, insulation, Air condition Unit & ducting, obstructions or placement of insulation and or sarking, for this reason complete access to the roof void was not possible.

Additional photos are supplied for your general reference.

A visual inspection was carried out from accessible areas only, recommend installing another access hatch in a more accessible area for a re-inspection.

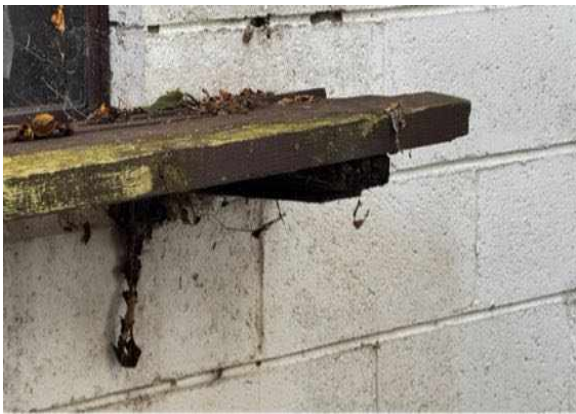
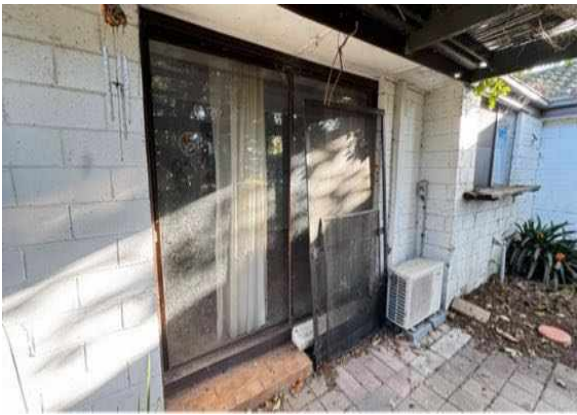
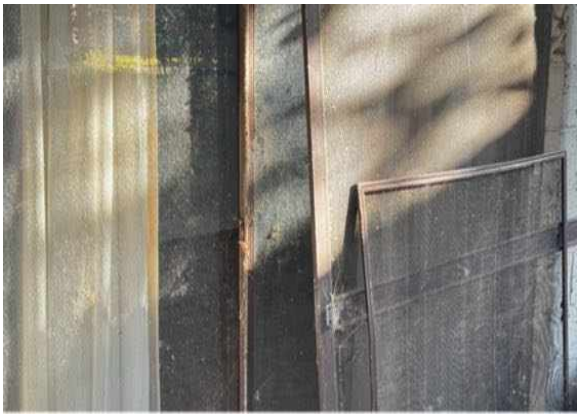
### Defects 3.11

Building:	Main Building
Location:	All External Areas
Finding:	External Timber - Timber Rot
Information:	Timber elements including wall claddings, timber rails & posts, landscaping timbers, and other external timber surfaces were inspected and show signs of rot, decay and fungal attack in these areas. Softening, discoloration, splitting, and moisture penetration indicate ongoing timber degradation.

This is likely caused by prolonged moisture exposure, inadequate protective coatings or maintenance, direct contact with soil or water, or poor detailing that traps water or limits ventilation.

If left unaddressed, the affected timber may lose structural integrity, leading to progressive decay, potential collapse of walls, decks, or landscaping features, mould growth, and reduced durability and appearance of the building exterior.

A registered builder or timber specialist should inspect the affected areas immediately to determine the extent of damage. Damaged timbers should be repaired or replaced, protective treatments applied, and drainage or detailing corrected to prevent recurrence. Ongoing monitoring and urgent remedial action are required to prevent further deterioration.

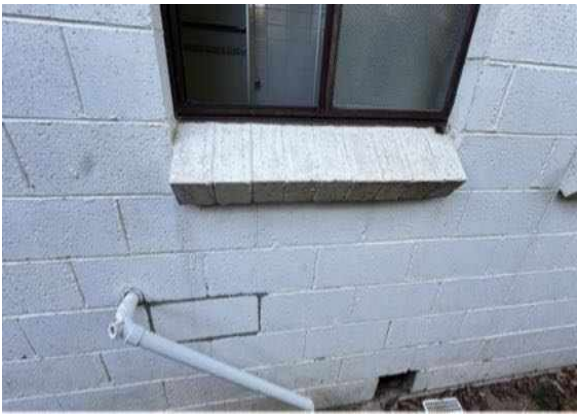
### Defects 3.12

Building:	Main Building
Location:	All External Areas >
Finding:	External Walls - Minor Cracking To Wall Claddings
Information:	Minor cracking was observed to the external walls in this area. The cracking appeared superficial and did not indicate significant structural movement; however, such cracking can allow moisture ingress if left unaddressed.

The cracking is likely due to building movement or minor settlement.

When practical, a registered builder should assess and repair the cracking, which may include sealing and repainting. The area should be monitored, and any increase in cracking or signs of movement should be further investigated immediately by a Structural Engineer.

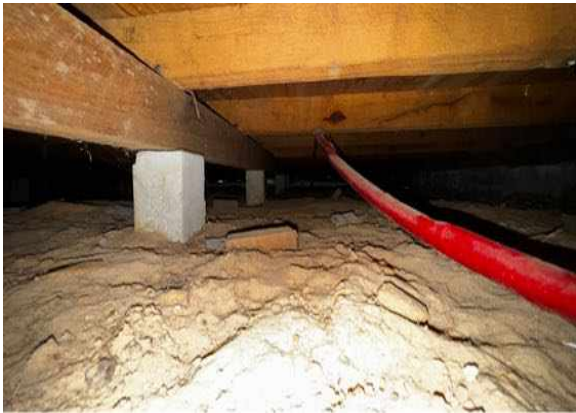
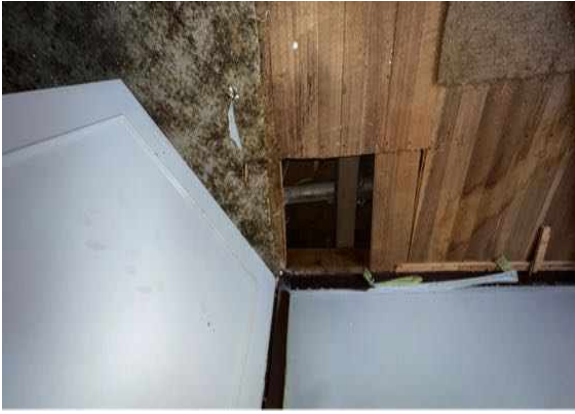
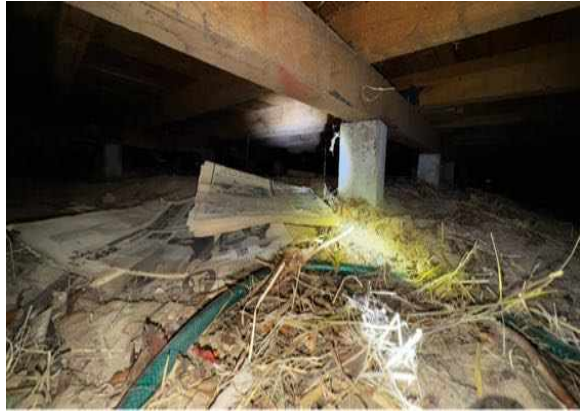
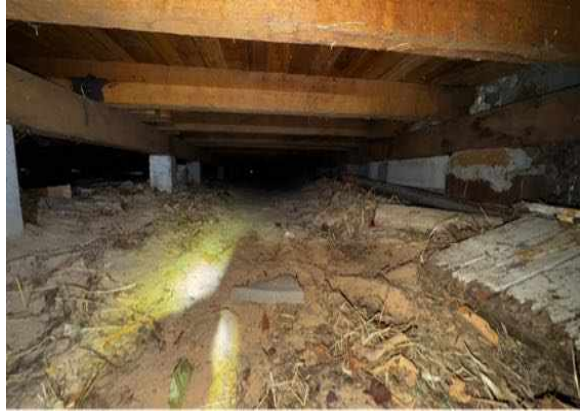
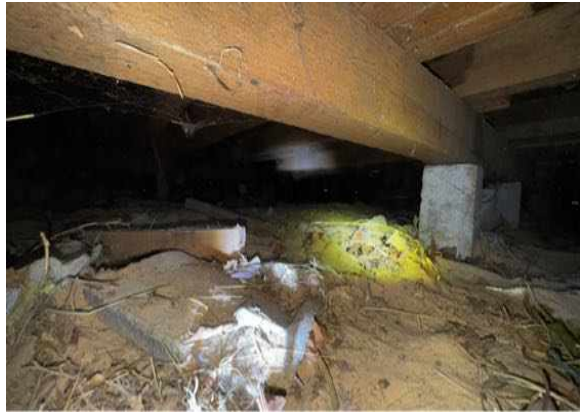
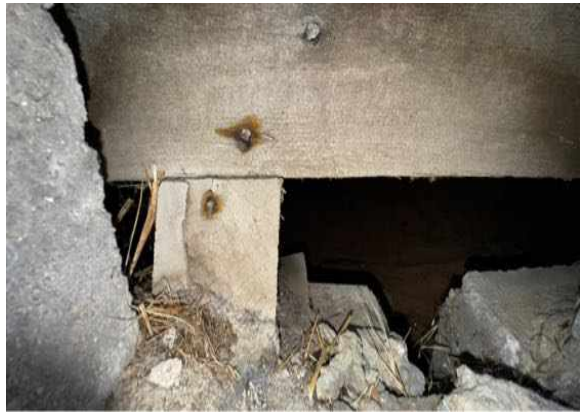
This has likely occurred due to inadequate access points. Poor access can impede inspections, maintenance, and timely identification of structural, pest, or service issues, increasing long-term repair costs and safety risks.

A registered builder is required to assess and improve subfloor access. This should be addressed as soon as possible to ensure safe entry, proper inspection, and maintenance of the subfloor.

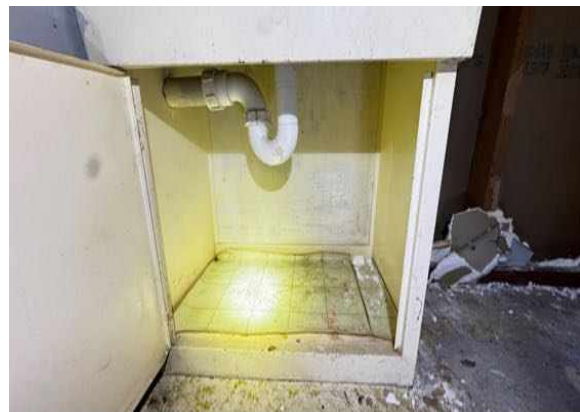
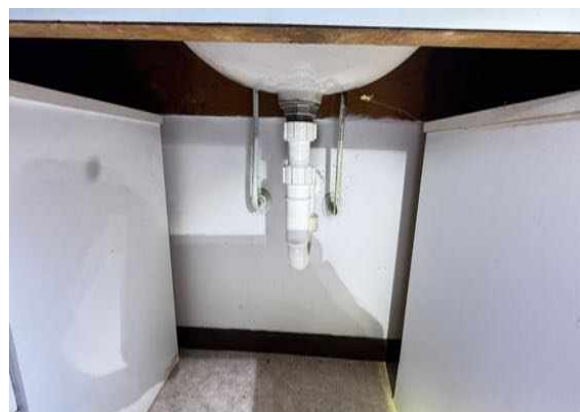
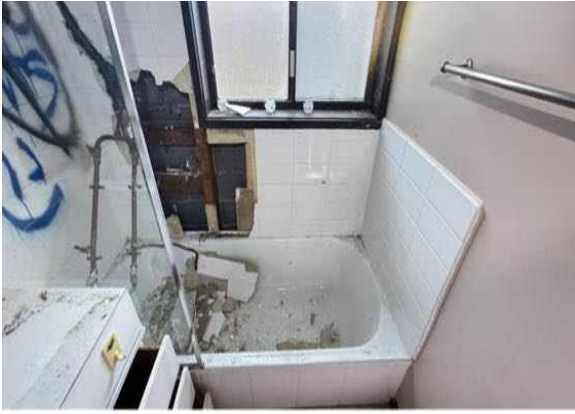
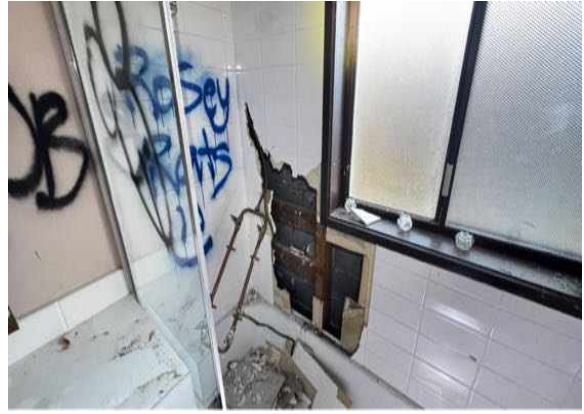
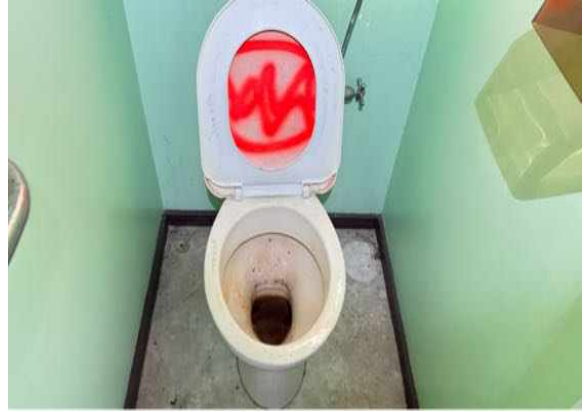
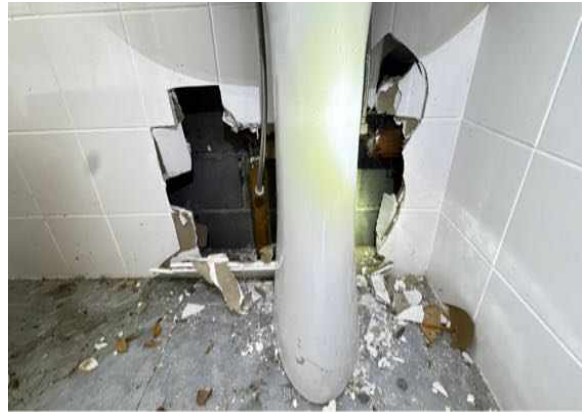
The condition is likely due to vandalism. Without reinstatement, the dwelling remains uninhabitable and non-compliant with basic service requirements.

It is recommended that a licensed plumber be engaged as a matter of urgency to inspect the plumbing system, determine the extent of removed or damaged services, and provide a scope of works and cost estimate for full reinstatement of water supply and drainage to all plumbing fixtures.
