Building Inspection Report

Inspection Date: Tue, 31 Mar 2026

Property Address: 30/37 Bradley Street Glenmore Park NSW
2745

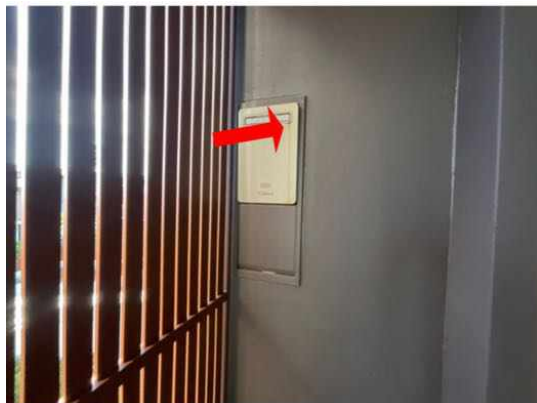
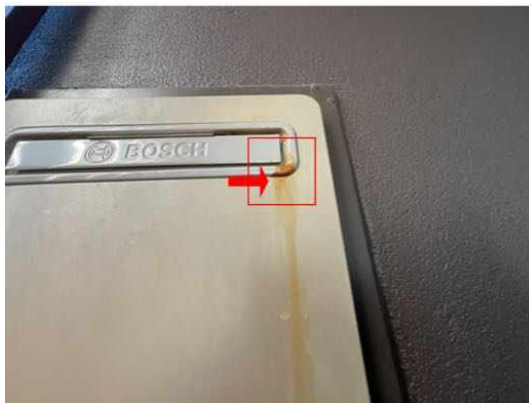
Defects 3.01

Building: Main Building
Location: Balcony
Finding: Minor Defect – External Hot Water Unit – Rust or Corrosion

At the time of inspection, minor rusting and surface deterioration were identified to the external casing and components of the gas instantaneous hot water system. The observed corrosion appeared superficial in nature and limited in extent, with no obvious signs of active leakage or immediate functional failure noted during the inspection.

While the corrosion is presently minor, it indicates exposure to environmental conditions and the early stages of material degradation. If left unaddressed, ongoing corrosion may lead to accelerated deterioration of external components, potential reduction in service life, and possible impact on system reliability over time.

It is recommended that the unit be monitored for any progression of corrosion. Preventative maintenance, such as cleaning and treatment of affected areas, may assist in limiting further deterioration. Should corrosion worsen or performance issues arise, assessment and servicing by a suitably qualified plumber or gas technician is advised.

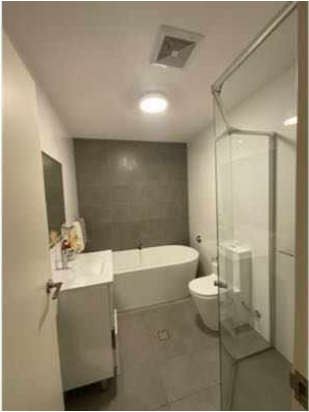
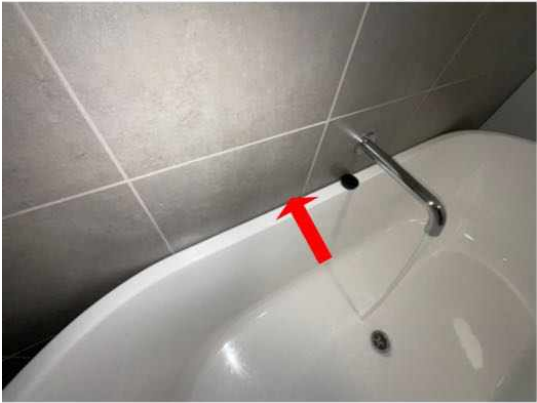
Defects 3.02

Building: Main Building
 Location: Bathroom
 Finding: Minor Defect – Bathroom Sealant (Bath/Wall Junction)
 Information:

At the time of inspection, sealant was noted to be missing to sections of the junction between the bathtub and adjacent wall. This junction is considered an area for water penetration due to regular exposure to moisture during normal use.

The absence of sealant may allow water to penetrate behind the bath. Over time, this can contribute to moisture ingress and the development of mould or mildew.

It is recommended that a flexible, mould-resistant sanitary-grade sealant be applied to all affected junctions to reinstate a watertight barrier. Ongoing maintenance of sealant to wet areas is essential, as this is a common wear-and-tear item subject to deterioration over time. Regular inspection and timely replacement of cracked, deteriorated, or missing sealant is advised to support the long-term durability of the bathroom.

A suitably qualified tradesperson or sealant specialist should be engaged to carry out the necessary works.

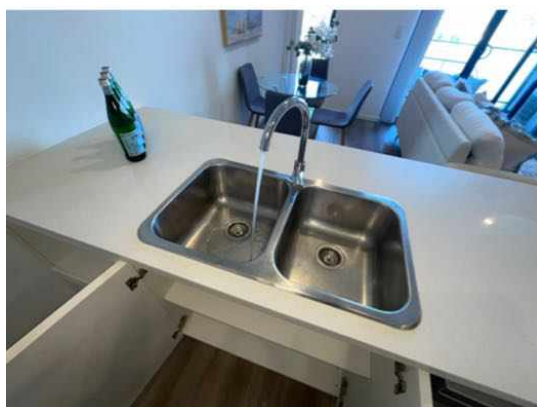
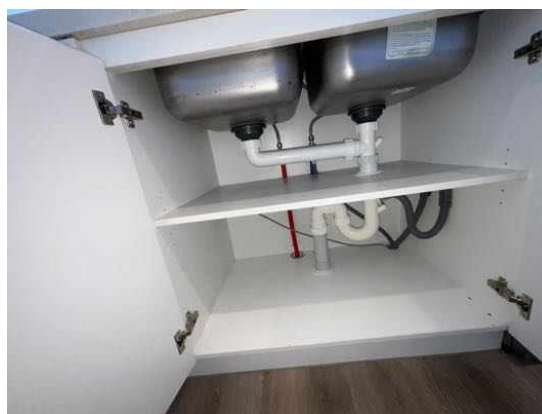
Building: Main Building
 Location: Kitchen
 Finding: Kitchen Sink – Overall Condition & Recommendations.
 Information: Observations:

- The kitchen sink tap(s) were water tested at the time of inspection, with no evidence of leaks or blockages observed in the visible plumbing or drainage.
- No significant water damage was observed to the cabinetry/unit.

- Further monitoring and testing are recommended once the tap(s) are in constant use, to identify any drainage issues or signs of slow leaks not evident during the limited inspection.

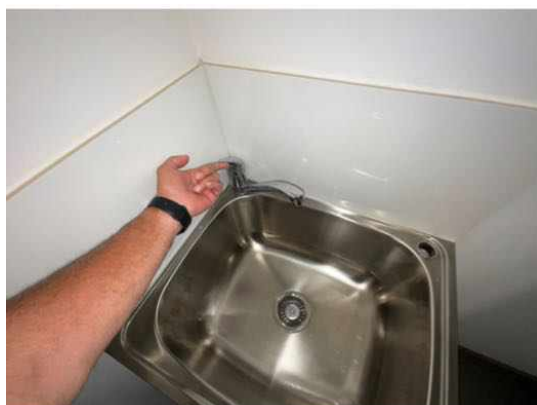
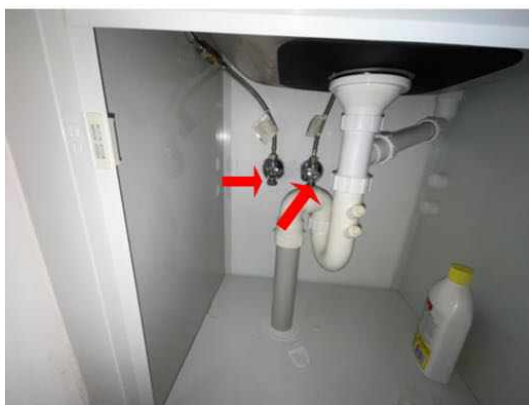
Building: Main Building
 Location: Laundry
 Finding: Tap/s - Not Operational (2 way tap connection).
 Information: Tap Not Operational – Laundry

The laundry tap(s) did not operate at the time of inspection. The tap assembly includes a two-way connection or stop valve, which appears to require the washing machine to

be installed in order to enable proper water flow to the taps.

- Unable to confirm serviceability of tap(s) or related plumbing at the time of inspection.
- Potential issues (e.g., blockage, faulty valve, or incorrect plumbing configuration) may be concealed until appliances are installed and the system is fully operational.

- Tap(s) should be checked for proper operation once the washing machine is connected.
- If issues persist, a licensed plumber should be engaged to assess and repair as required.

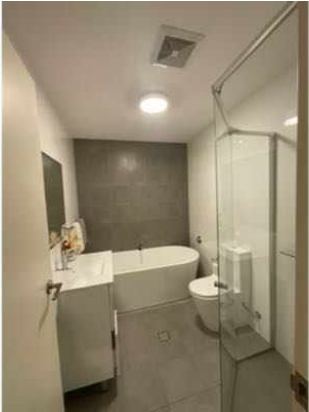
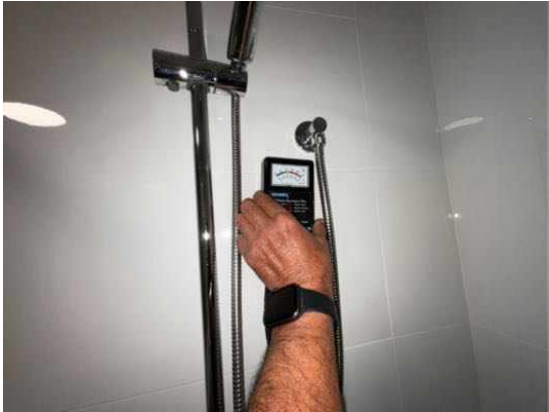
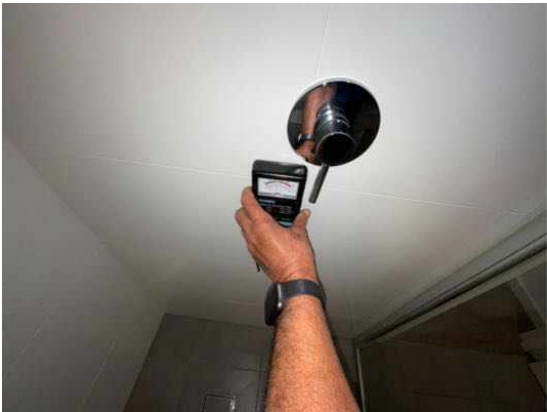
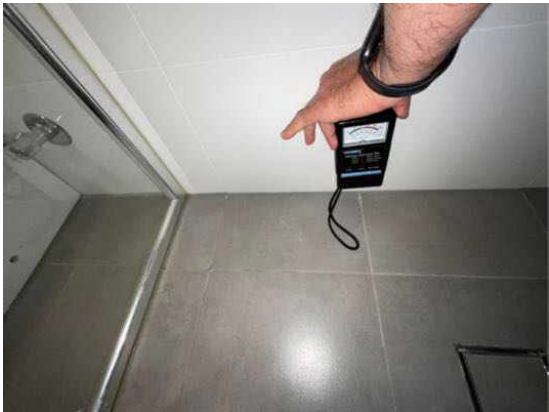
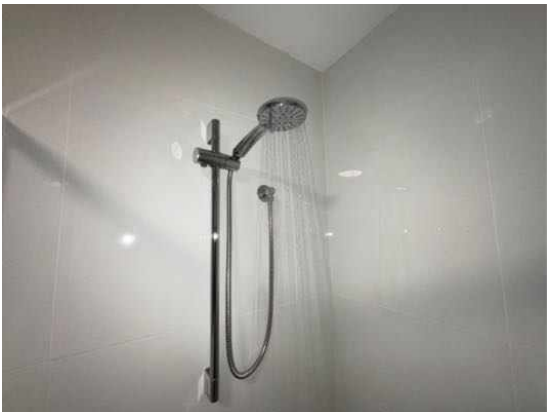
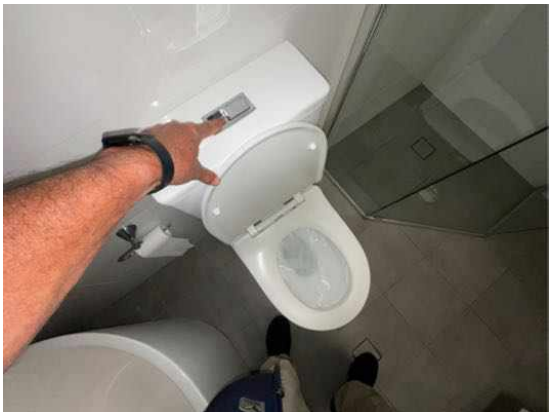
Building: Main Building
 Location: Bathroom
 Finding: Wet Areas - Bathroom(s) - Overall Condition & Recommendations.
 Information: Overall Condition & Recommendations

- Water appeared to flow freely towards the floor waste during testing of the shower taps. However, further monitoring is required after regular use to determine whether water pooling or retention occurs.

- No leaks were observed during flushing. The toilet operated normally, and the toilet pan appeared to be securely fixed to the floor.

- Basin(s) were water tested and inspected, with no leaks or blockages identified in the plumbing or drainage system at the time of inspection.
- Further monitoring is recommended after the basin(s) are placed under regular use to confirm ongoing performance and cleanliness.
- No visible water damage was observed to the vanity cabinetry at the time of inspection.

- Flood testing of the shower recess is recommended. This may reveal inadequacies in the waterproofing or shower screens, which could lead to water damage in surrounding areas.
- Floor waste was found to be clear and free of blockages at the time of inspection. Further monitoring is advised after consistent use to identify any drainage issues or buildup requiring cleaning.
- No elevated moisture readings were detected around the tap fittings or behind the shower walls (as viewed from adjacent rooms), suggesting no active plumbing leaks at the time of inspection.
- Sealing of grout and tiles is recommended to prevent moisture buildup and mould growth in damp areas such as showers.
- The condition of grout and sealant appeared to be good.
- The exhaust fan appeared to be operational, which supports moisture control in the bathroom.

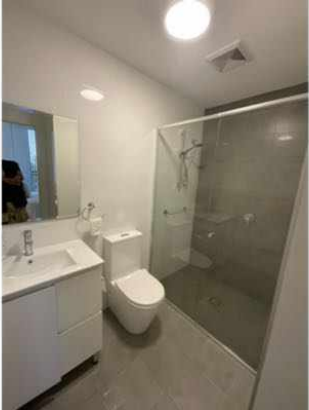
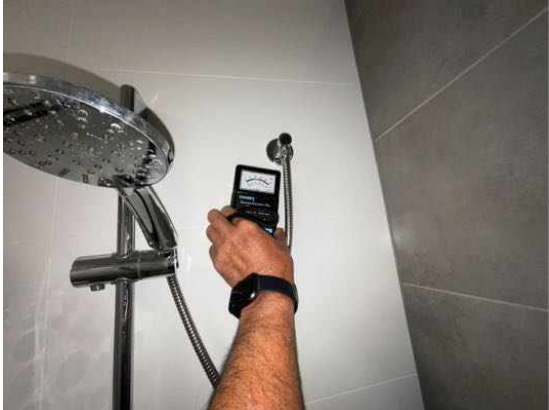
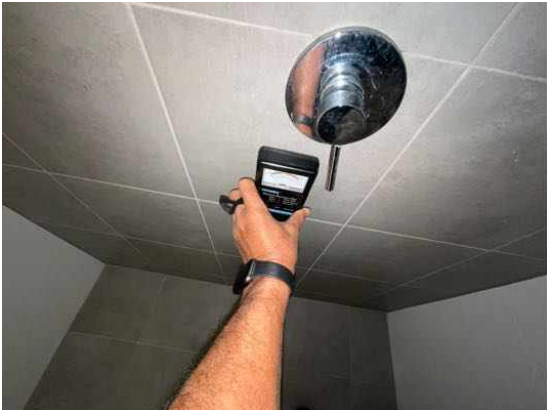
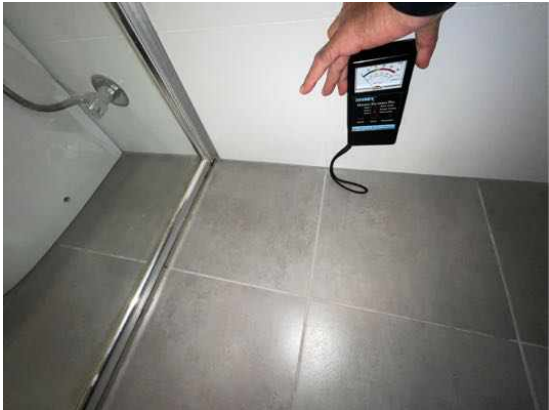
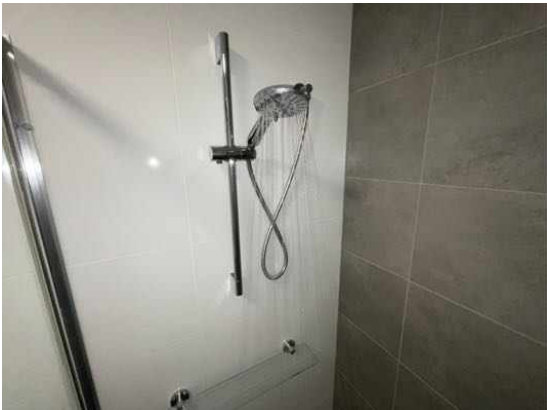
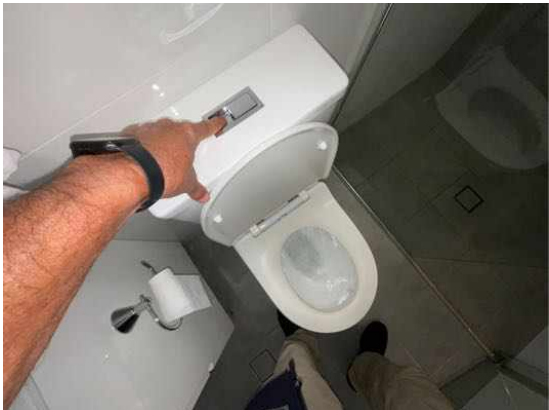
Building: Main Building
Location: Ensuite
Finding: Wet Areas - Bathroom(s) - Overall Condition & Recommendations.
Information: Overall Condition & Recommendations

- No leaks were observed during flushing. The toilet operated normally, and the toilet pan appeared to be securely fixed to the floor.

- Basin(s) were water tested and inspected, with no leaks or blockages identified in the plumbing or drainage system at the time of inspection.
- Further monitoring is recommended after the basin(s) are placed under regular use to confirm ongoing performance and cleanliness.
- No visible water damage was observed to the vanity cabinetry at the time of inspection.

- Flood testing of the shower recess is recommended. This may reveal inadequacies in the waterproofing or shower screens, which could lead to water damage in surrounding areas.
- Floor waste was found to be clear and free of blockages at the time of inspection. Further monitoring is advised after consistent use to identify any drainage issues or buildup requiring cleaning.
- No elevated moisture readings were detected around the tap fittings or behind the shower walls (as viewed from adjacent rooms), suggesting no active plumbing leaks at the time of inspection.
- Sealing of grout and tiles is recommended to prevent moisture buildup and mould growth in damp areas such as showers.
- The condition of grout and sealant appeared to be good.
- The exhaust fan appeared to be operational, which supports moisture control in the bathroom.

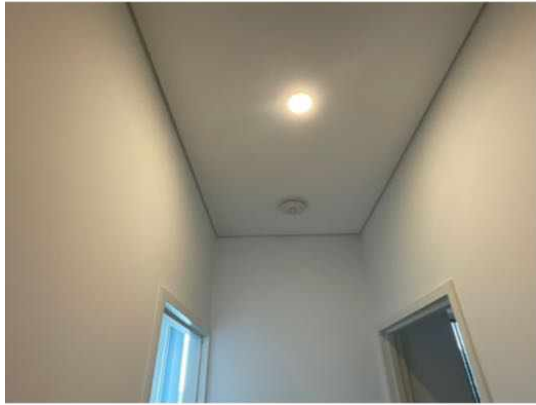
Building:	Main Building
Location:	All Areas
Finding:	Smoke Detectors / Alarms.
Information:	Reporting on the presence, type, location, or compliance of smoke detectors or alarms, including hard-wired smoke detection systems and their legislative requirements, is outside the scope of this inspection report.

To ensure compliance and safety, further inspection and/or advisory services from a qualified specialist are recommended. These services can confirm the sufficiency, type, location, and functionality of all smoke detection devices within the property.

- All smoke detectors be tested monthly by the homeowner.
- All systems comply with the requirements of AS 3786 and any applicable state-based legislation.
