Building Inspection Report

Inspection Date: Thu, 15 Jan 2026

Property Address: 2/30-32 Lydbrook Street, Westmead NSW
2145

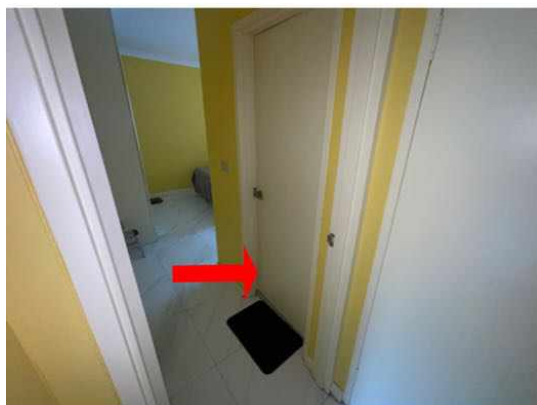
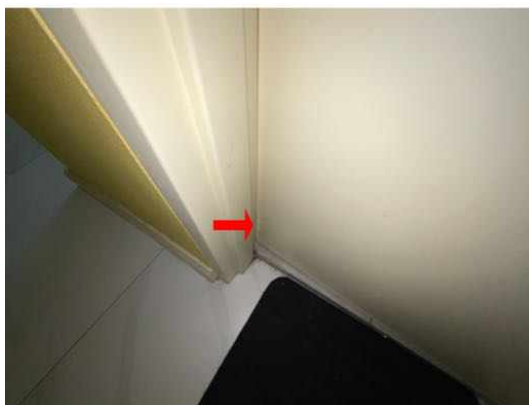
Defects 3.01

Building:	Main Building
Location:	Ensuite
Finding:	Door - Binding and/or Jamming.
Information:	Functional Defect Identified

Binding and/or jamming of this door was observed during standard operation and appeared to be rubbing or binding. This issue impairs the normal functionality of the door and may lead to secondary damage to adjacent building elements, such as scuffing or tearing of floor coverings, or stress to door hardware and framing.

- Poor door installation
- Worn, damaged, or misaligned hinges
- Swelling or warping of materials
- Differential movement in the building structure (e.g. due to settlement, subfloor deflection, or foundation issues)

- If the issue appears to be related to major structural movement, it is recommended that a registered builder with experience in re-stumping or subfloor repairs be engaged to assess the extent of the movement and provide a quotation for necessary remedial works.
- Where the issue is minor in nature, a qualified carpenter or general handyperson may be appointed to carry out corrective works at the client's discretion.

Prompt assessment and remediation are advised to prevent further deterioration or related damage.

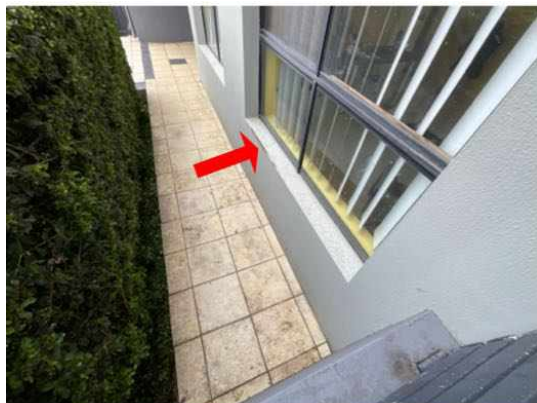
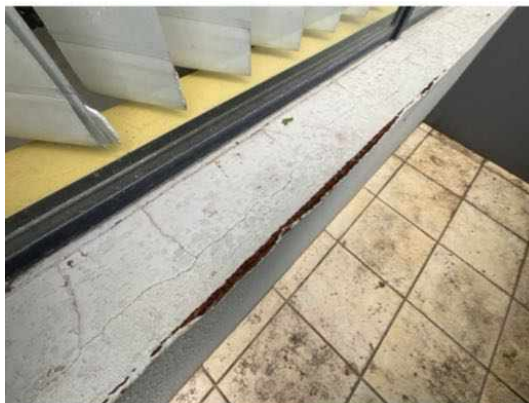
Defects 3.02

Building:	Main Building
Location:	Exterior walls - front
Finding:	Minor Defect – Front Rendered Wall (Window Sill Area)
Information:	Observation:

Damage was observed to the front rendered wall in the vicinity of the window sill. The metal external corner strips incorporated within the rendered finish have deteriorated and are no longer providing adequate edge protection. This deterioration has resulted in localised damage to the render and loss of integrity to the finished surface.

Deteriorated corner beads can allow moisture to penetrate behind the rendered surface, which may lead to further cracking, delamination, and progressive deterioration of the render system. If left unaddressed, this condition may contribute to ongoing cosmetic degradation and potential moisture-related issues to the underlying wall substrate.

It is recommended that the affected rendered area be repaired as soon as practicable. Repairs should include the removal and replacement of the deteriorated metal corner strips, followed by reinstatement of the render and appropriate finishing to match the existing façade. Works should be carried out by a suitably qualified tradesperson to prevent further deterioration.

As this defect relates to an external wall and façade element, it may fall under the responsibility of the strata body. Confirmation should be sought with the relevant strata

manager or owners corporation to determine responsibility and arrange rectification if applicable.

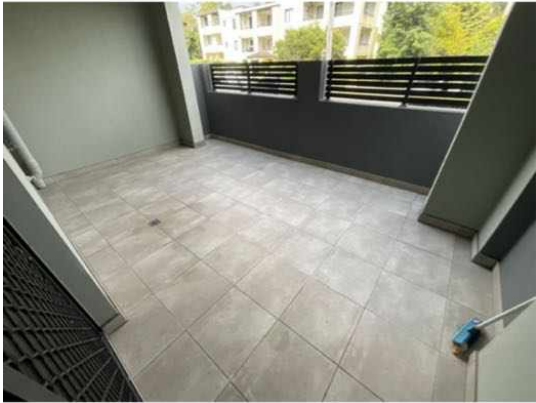
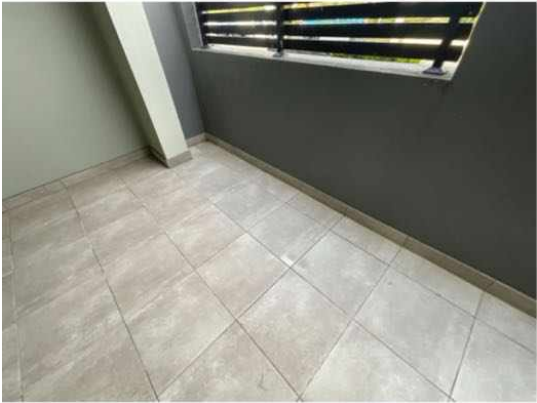
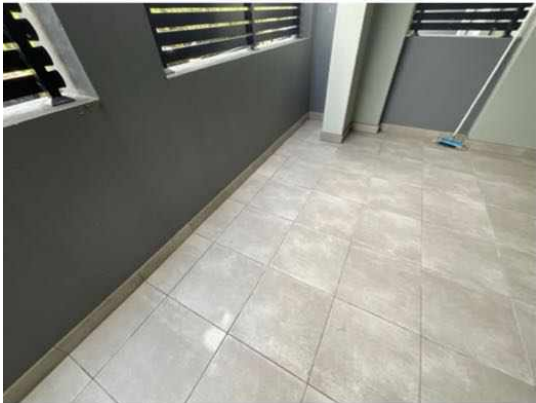
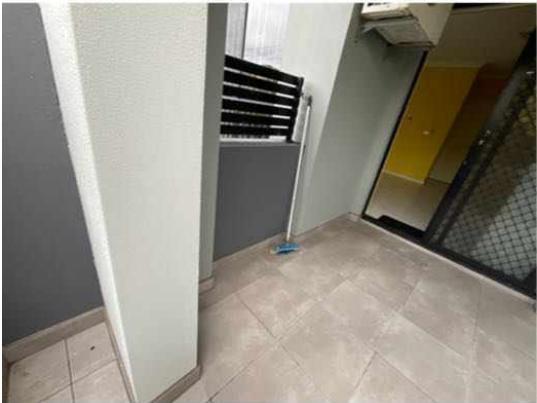
Defects 3.03

Building:	Main Building
Location:	Verandah
Finding:	Observation – Balcony Drainage & Lack of Overflow Provision
Information:	During the inspection, a floor waste outlet was observed on the balcony floor, indicating that a primary drainage point has been installed. However, no visible overflow provision was noted at the time of inspection. The balcony is fully enclosed, creating a vessel-like area where water may accumulate if the floor waste becomes blocked or overwhelmed during periods of heavy rain.

In multi-residential or strata-managed buildings, such conditions present a particular concern due to the proximity of the balcony to internal living areas and the potential for water to enter adjoining apartments. Should water levels exceed the balcony threshold or sub-sill, it may penetrate internal walls and floors, leading to damage of moisture-sensitive materials such as floor coverings, cabinetry, and plasterboard. This can also result in strata insurance claims or disputes regarding repair responsibilities between lot owners and the owners corporation.

- The matter should also be raised with the owners corporation to confirm maintenance responsibilities and ensure the drainage system meets current building and waterproofing standards.

Implementing proper drainage and overflow measures is critical to safeguarding the building structure, internal finishes, and minimising the risk of future strata-related water ingress issues.

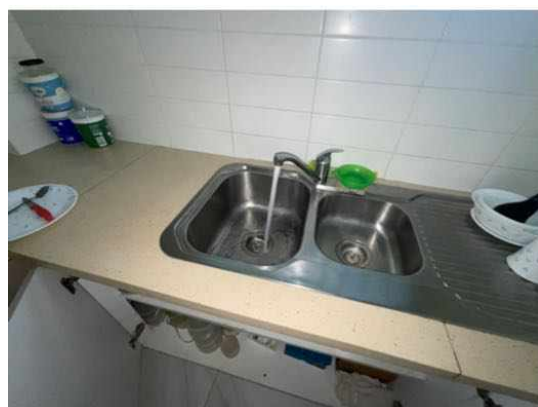
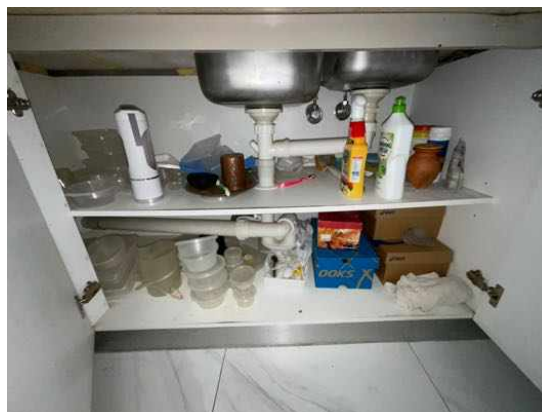
Noted Item

Building: Main Building
Location: Kitchen
Finding: Kitchen Sink – Overall Condition & Recommendations.
Information: Observations:

- The kitchen sink tap(s) were water tested at the time of inspection, with no evidence of leaks or blockages observed in the visible plumbing or drainage.
- No significant water damage was observed to the cabinetry/unit, however, minor water damage was noted, which may be indicative of past moisture exposure.
- Stored items under the sink obstructed access, limiting a full inspection of the plumbing and internal cabinetry.

- Further monitoring and testing are recommended once the tap(s) are in constant use, to identify any drainage issues or signs of slow leaks not evident during the limited inspection.
- For long-term property care, it is advised that sealant and grouting in water-exposed areas be regularly inspected and maintained. A sealant specialist or tiling contractor may be engaged to carry out these works where necessary.
- It is recommended that the stored items beneath the sink be removed to allow for a full re-inspection of the plumbing and cabinetry, ensuring no concealed defects are present.

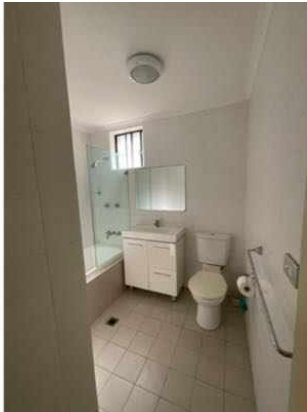
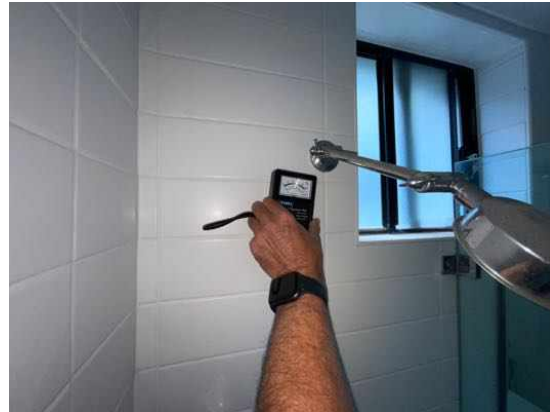
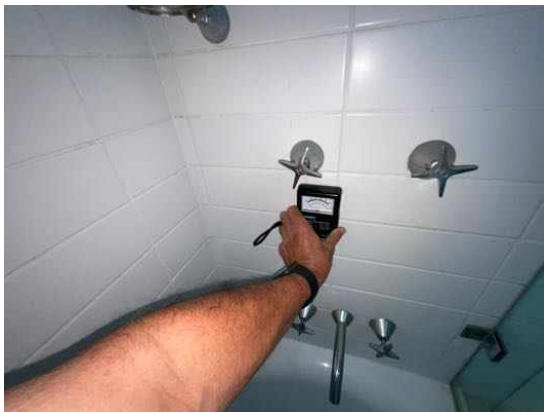
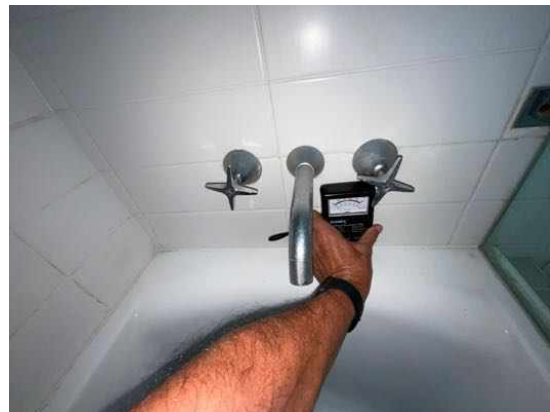
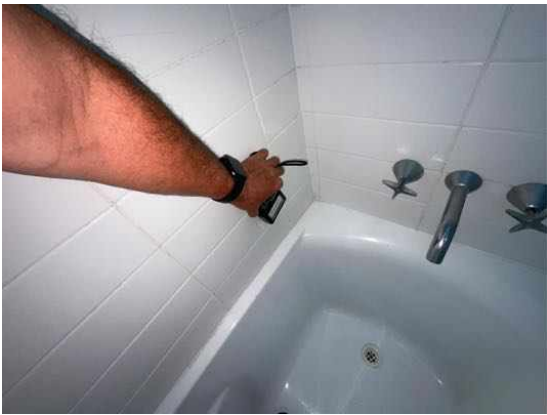
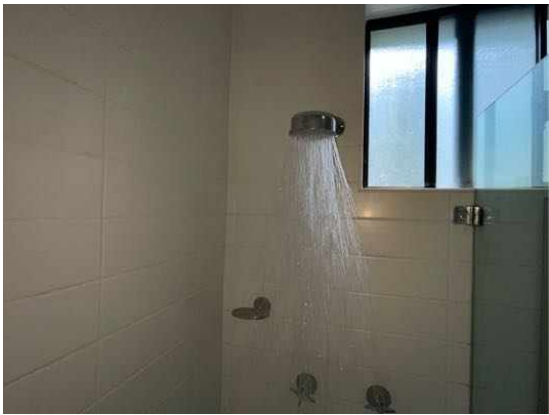
Noted Item

Building: Main Building
Location: Bathroom
Finding: Wet Areas - Bathroom(s) - Overall Condition & Recommendations.
Information: Overall Condition & Recommendations

- Water appeared to flow freely towards the floor waste during testing of the shower taps. However, further monitoring is required after regular use to determine whether water pooling or retention occurs.
- Floor waste was found to be clear and free of blockages at the time of inspection. Further monitoring is advised after consistent use to identify any drainage issues or buildup requiring cleaning.
- No elevated moisture readings were detected around the tap fittings or behind the shower walls (as viewed from adjacent rooms), suggesting no active plumbing leaks at the time of inspection.
- Sealing of grout and tiles is recommended to prevent moisture buildup and mould growth in damp areas such as showers.
- The condition of grout and sealant appeared to be serviceable.

- No leaks were observed during flushing. The toilet operated normally, and the toilet pan appeared to be securely fixed to the floor.

- Basin(s) were water tested and inspected, with no leaks or blockages identified in the plumbing or drainage system at the time of inspection.
- Further monitoring is recommended after the basin(s) are placed under regular use to confirm ongoing performance and cleanliness.
- Water damage was noted to the vanity unit, appearing minor.
- Stored items inside the vanity obstructed full visibility during the inspection. It is

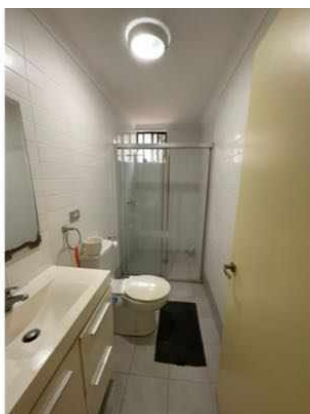
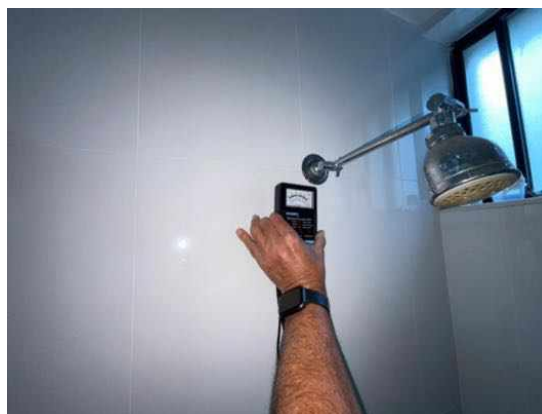
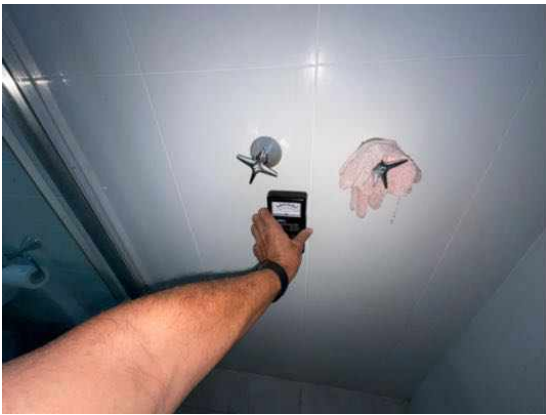
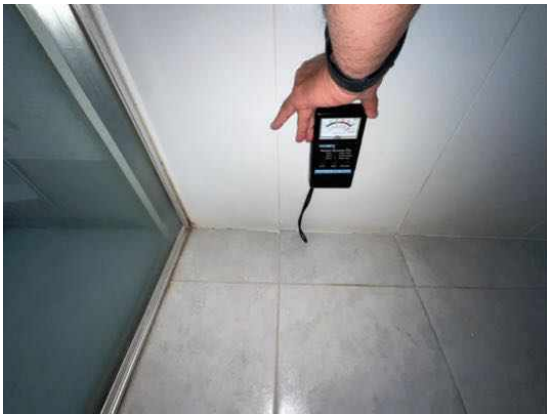
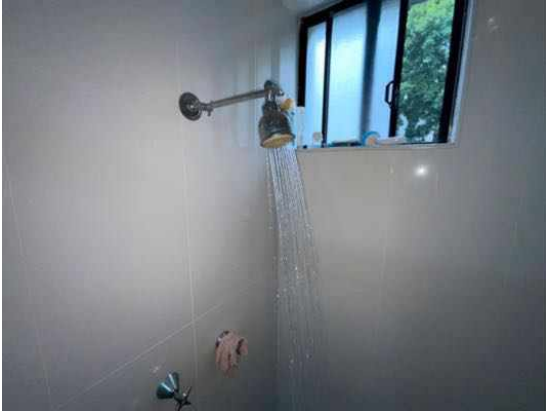
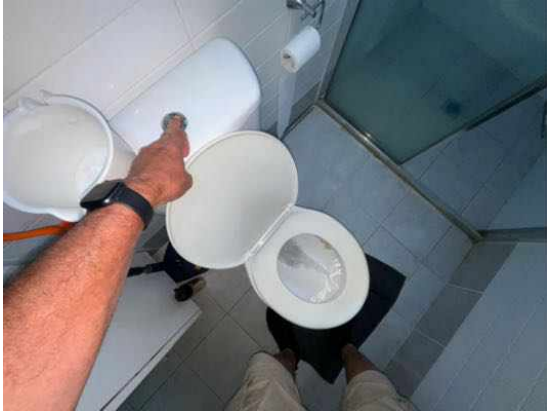
Noted Item

Building: Main Building
Location: Ensuite
Finding: Wet Areas - Bathroom(s) - Overall Condition & Recommendations.
Information: Overall Condition & Recommendations

- Floor waste was found to be clear and free of blockages at the time of inspection. Further monitoring is advised after consistent use to identify any drainage issues or buildup requiring cleaning.

- No elevated moisture readings were detected around the tap fittings or behind the shower walls (as viewed from adjacent rooms), suggesting no active plumbing leaks at the time of inspection.

- Elevated moisture readings were found in the lower shower walls, which is a common occurrence with certain tile types that naturally absorb more moisture. This should be monitored over time.

- Sealing of grout and tiles is recommended to prevent moisture buildup and mould growth in damp areas such as showers.
- The condition of grout appeared to be serviceable

- Flood testing of the shower recess is recommended. This may reveal inadequacies in the waterproofing or shower screens, which could lead to water damage in surrounding areas.

- Grout in wall and/or floor junctions may crack and deteriorate over time. It is recommended to remove any rigid grout from junctions and replace with flexible, mould-resistant sealant in accordance with best building practices.

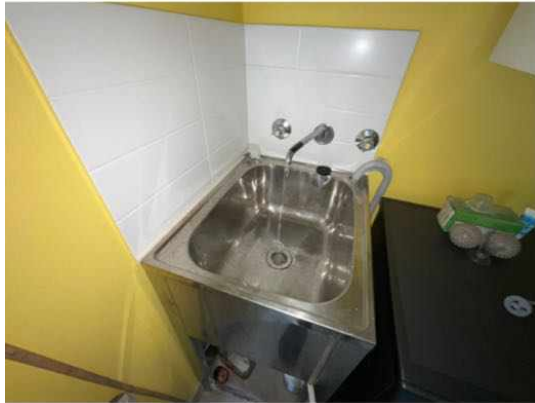
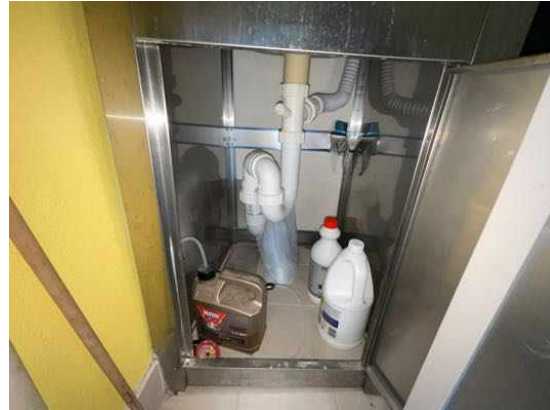
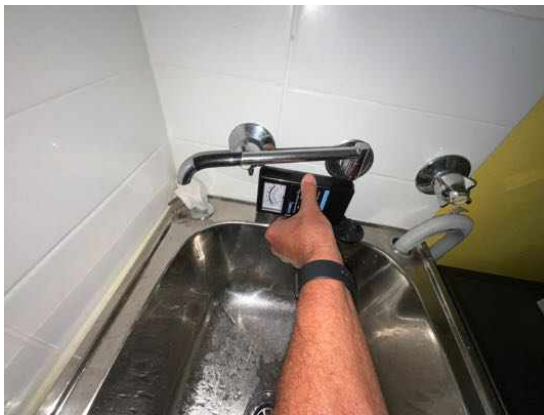
Noted Item

Building: Main Building
 Location: Laundry
 Finding: Laundry - Taps/Plumbing/Drainage.
 Information: Observation: Laundry Tub – Taps, Plumbing, and Cabinetry

- The taps to the laundry tub were water tested and inspected, with no evidence of plumbing or drainage leaks observed at the time of inspection.
- No elevated moisture readings were detected around the tap fittings
- No visible signs of water damage, rust, or corrosion were noted to the cabinetry or surrounding unit during the inspection.
- The exhaust fan appeared to be operational.

- Further monitoring or testing is recommended once the taps are placed into regular use, to ensure no leaks develop over time and that the drainage system continues to perform adequately.

- Sealant and grouting in wet areas should be maintained as part of the long-term care and upkeep of the property.
