Building Inspection Report

Inspection Date: Mon, 22 Dec 2025

Property Address: 1/30 Estramina Dr, Oakdowns TAS 7019,
Australia

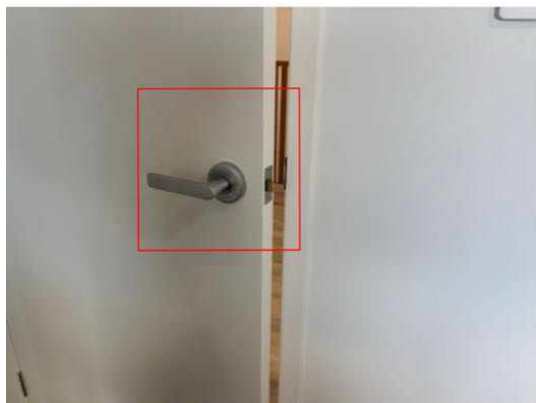
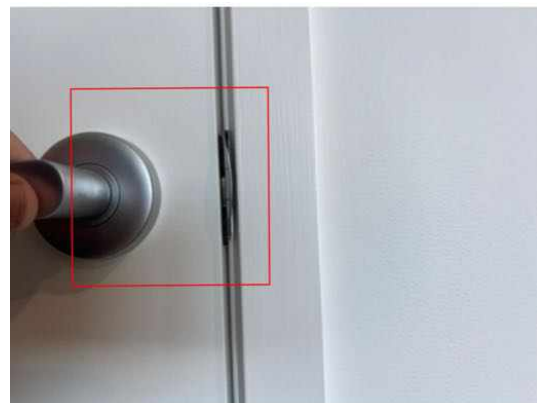
Defects 3.01

Building: Main Building
 Location: Front bedroom closest to driveway
 Finding: Door not latching
 Information: The door to the front bedroom closest to the driveway, wouldn't latch properly.

This defect inhibits the functionality of the affected door as well as creating potential for secondary defects to associated building elements, such as damage to the frame.

Recommend client engage a Handy Person to rectify at clients convenience.

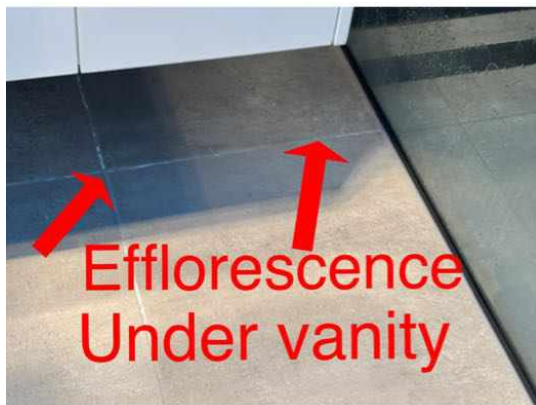
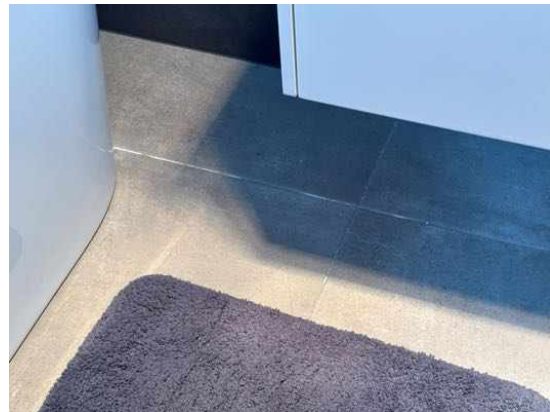
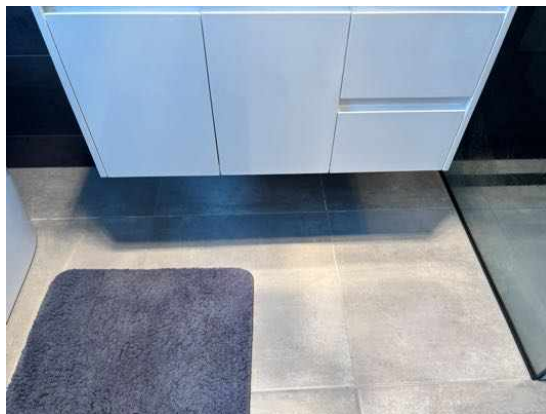
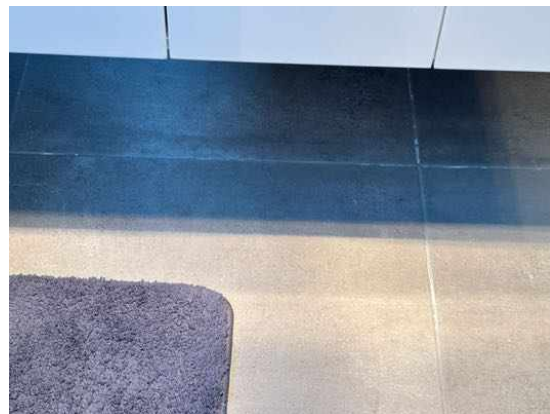
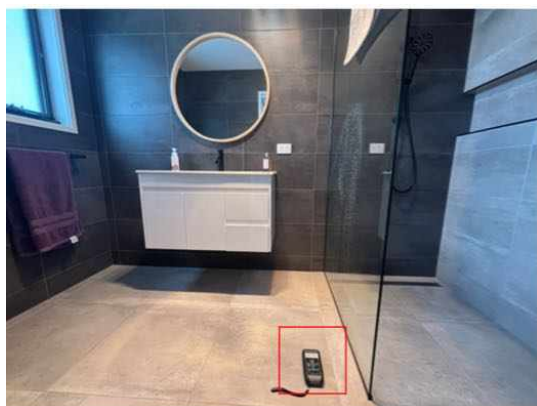
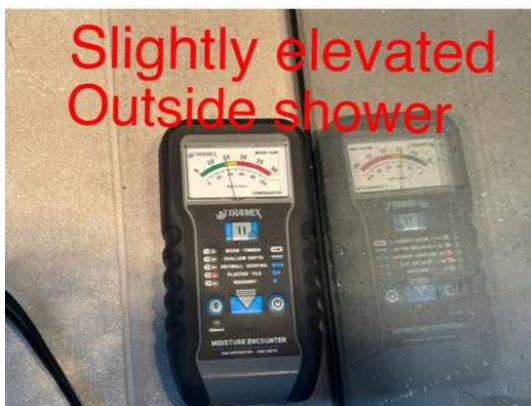
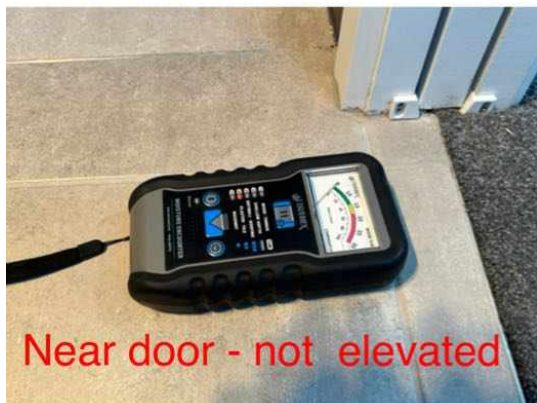
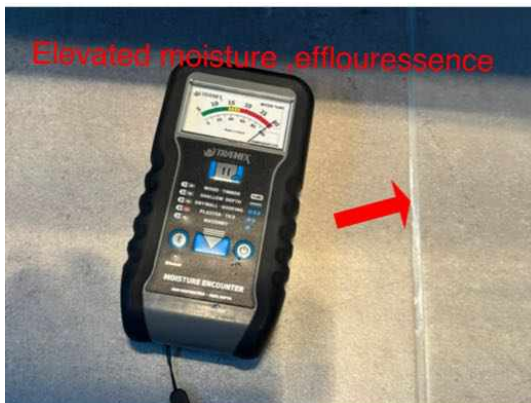
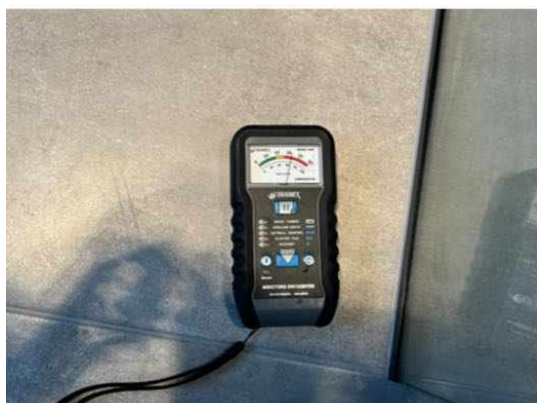
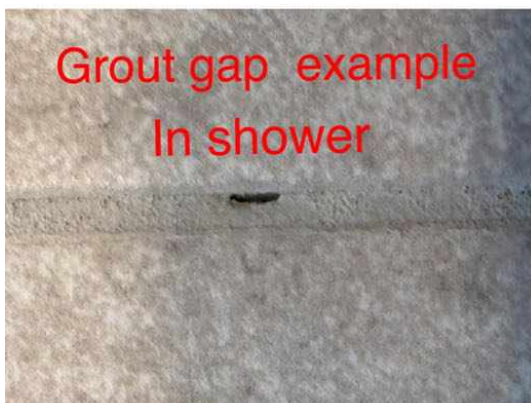
Defects 3.02

Building: Main Building
 Location: Bathroom
 Finding: Bathroom upstairs - elevated moisture readings & efflorescence
 Information: In the bathroom upstairs there were elevated moisture readings under the floor tiles, including outside the shower. There is also some efflorescence to the grout outside the shower. These are both indicators that some water is migrating under the floor tiles.

It was noted that there were small gaps in the grouting to the floor tiles.

If not rectified, water will continue to ingress and may lead to water damage and deterioration of the surrounding building elements if the water proofing membrane is not intact or absent. However our non invasive inspections is unable to determine the adequacy of the water proofing membrane but no damage was observed. Tiles, grout and sealants are used to protect building materials to ensure that they are water-tight and prevent water penetration to the associated structures.

Efflorescence typically occurs when excess salts within the concrete or cement mortar is leached to the surface due to water transfer. It is typically seen as white salt deposits on the surfaces of concrete pavement or mortar between bricks or tiles.

Recommend client engage a Tiler to re-grout as soon as possible.

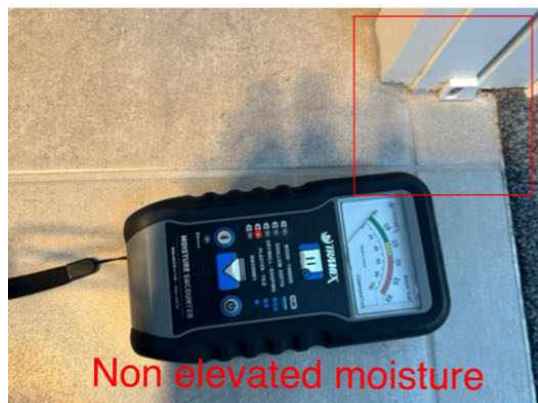
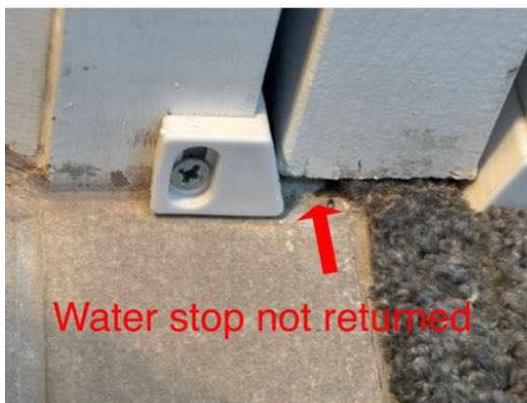
Defects 3.03

Building: Main Building
 Location: Bathroom
 Finding: Water stop - water proofing potential non compliance
 Information: The water stop has not been returned under the sliding door. The water stop is designed to prevent water from leaving the bathroom.

These items may be non compliant with current waterproofing standards according to National Construction Code 2022.

There were not elevated moisture readings near this area at the time of inspection, however there were in other parts of the bathroom.

Recommend that client engage a Tiler as soon as practicable, to inspect and rectify to prevent sub tile moisture from escaping the bathroom.

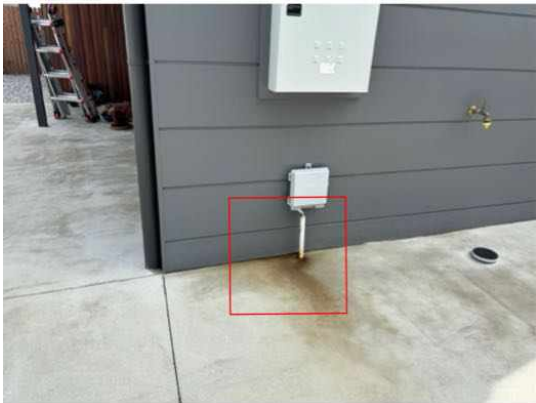
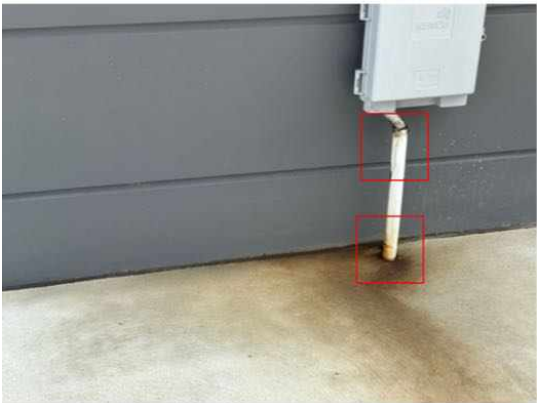
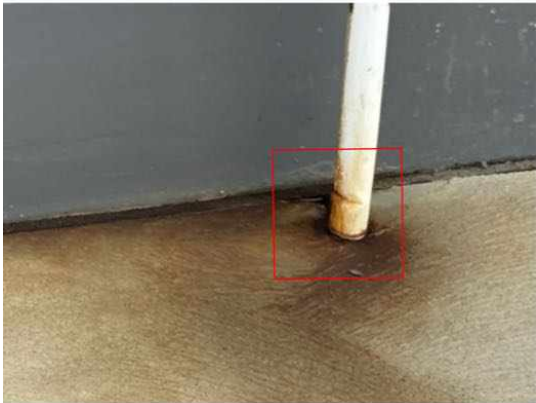
Defects 3.04

| Finding: | NBN - water |
| Information: | The NBN box is located on the side of the garage. Water appears to be channeling from the pit up the hill somewhere, down via the conduit attached to the box. There is water staining to the conduit and the concrete. This is creating a wet spot, the paint on the cladding is starting to bubble, which could cause eventual deterioration to the cladding. |

Recommend client engage a Communications Contractor to inspect, advise and rectify as soon as practicable.

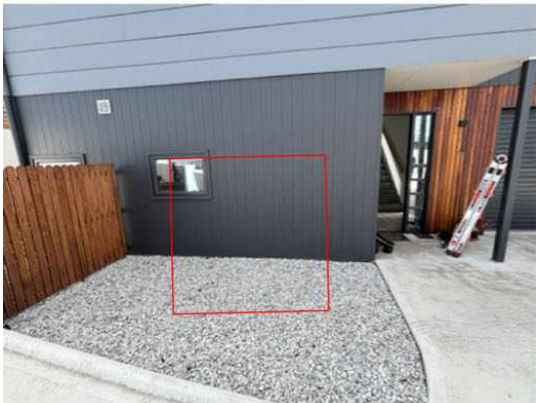
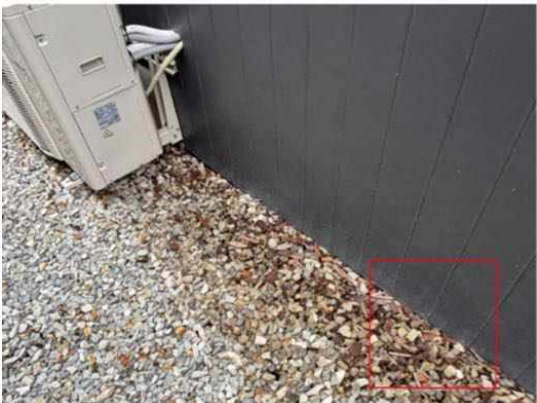
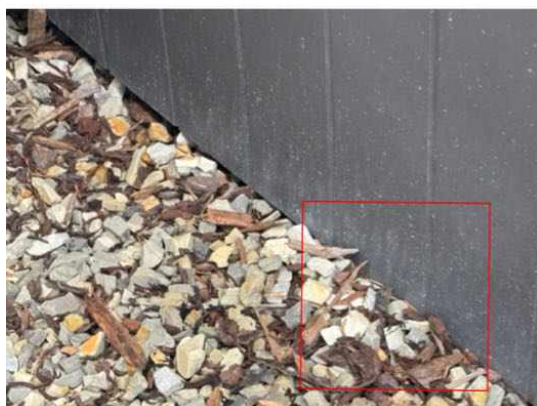
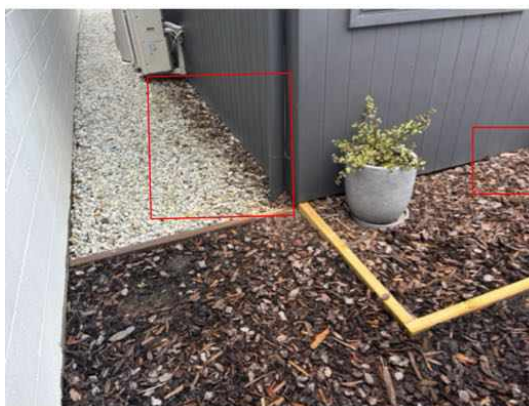
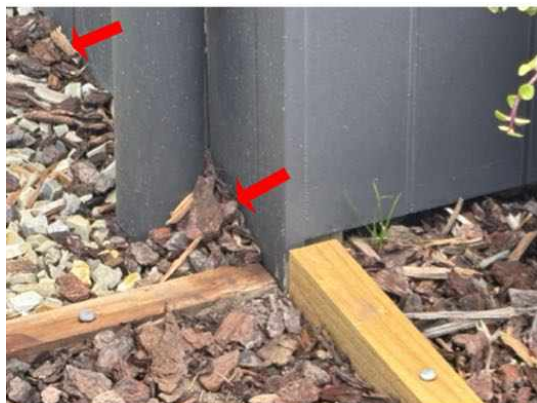
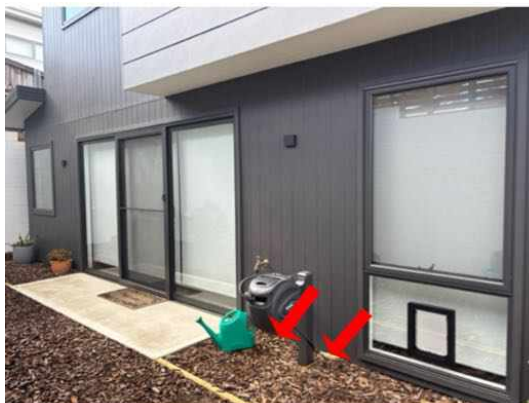
Defects 3.05

Building: Main Building
Location: Multiple locations
Finding: Cladding in ground contact
Information: In multiple locations on the exterior of the property, the light weight cladding is in direct contact with the ground and landscaping. This will accelerate the decay of these building materials.

Recommend client engage a Handy Person to remove landscaping materials that comes into contact with the cladding as soon as practicable.

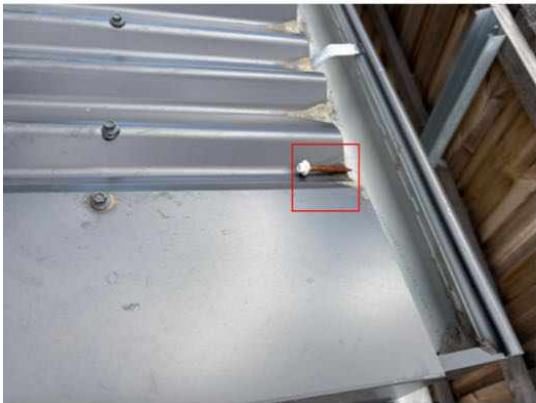
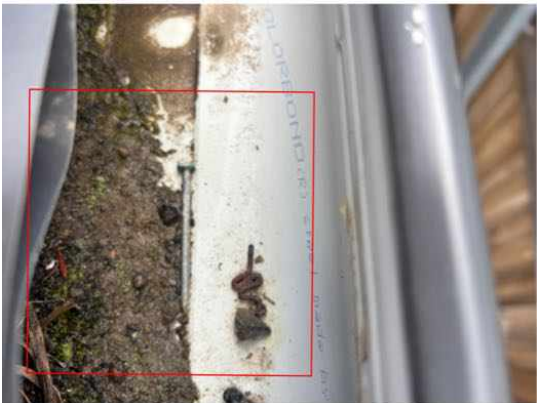
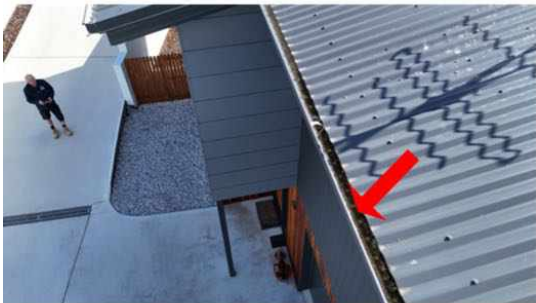
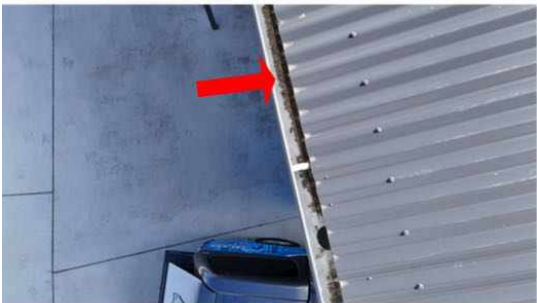
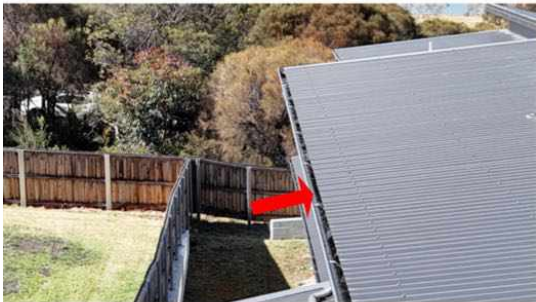
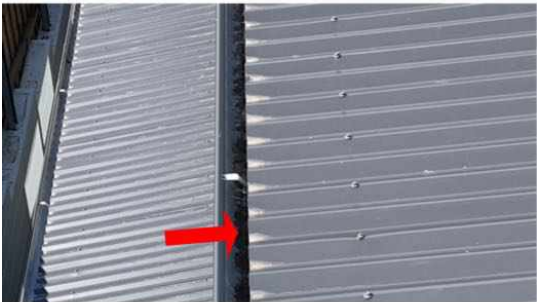
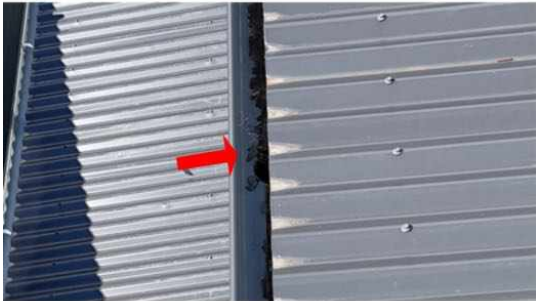
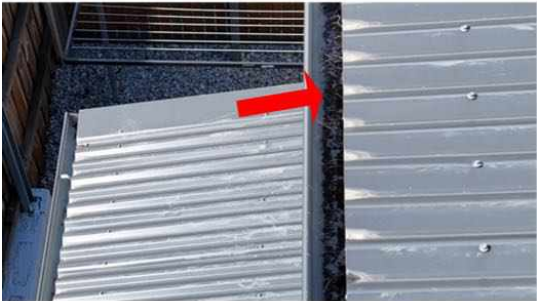
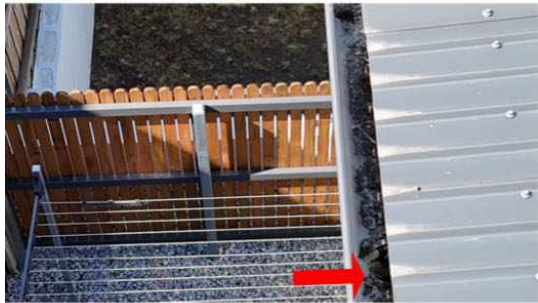
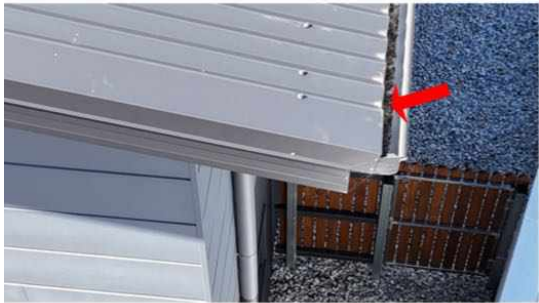
Defects 3.06

| Finding: | Gutters - debris & water pooling |
| Information: | There is some building debris and water pooling in the gutters, such as nails which can cause corrosion. |

Roof plumbing structures, such as guttering and downpipes, should be free of all debris to prevent blockages. Blockages of the guttering and downpipes will lead to pooling and accumulated water overflows, which is likely to subsequently flood eaves and exterior walls.

Blocked gutters are likely to lead to high levels of moisture in the affected areas. Such moisture can cause rust and decay of the associated building materials. Blockages in gutters should therefore be removed immediately to ensure dry conditions are maintained.

Recommend client engage a Handy Person to clean the gutters as soon as possible.

Recommend client ensure that all gutters be maintained on a frequent basis to ensure the condition of roof plumbing.

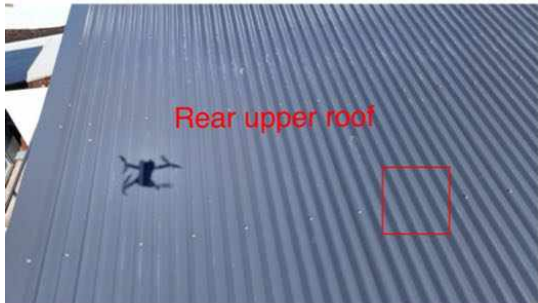
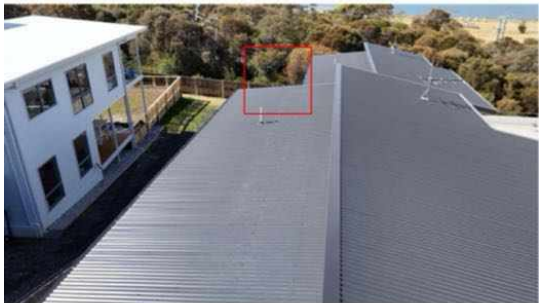
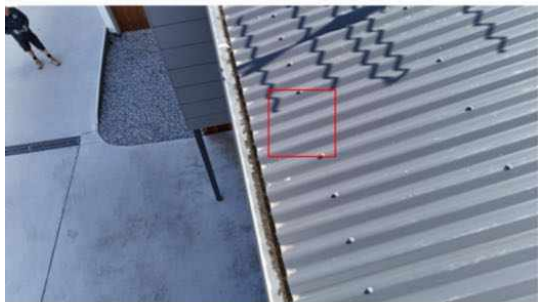
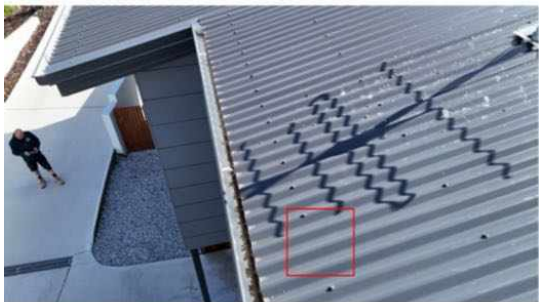
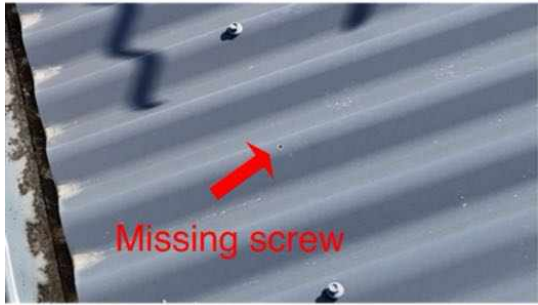
Defects 3.07

Finding: Roof screws missing

Information: In a couple of locations there are some roof screws missing.

Failure to rectify could allow water ingress.

Recommend client engage a Handy Person to rectify as soon as possible.

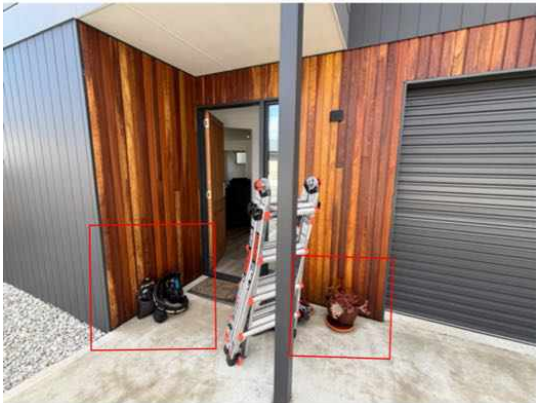
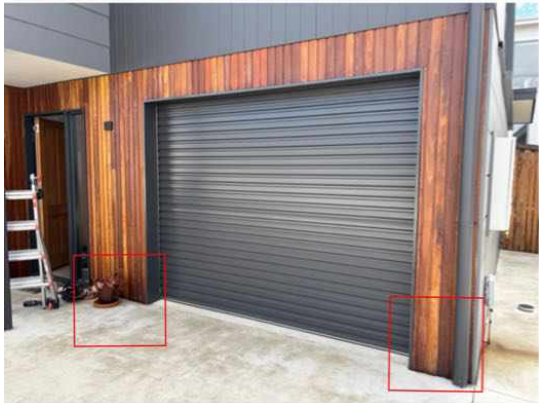
Building: Main Building
 Location: Multiple locations
 Finding: FYI timber cladding
 Information: In multiple locations on the exterior of the property, the timber cladding is in direct contact with the concrete. This will accelerate the decay of these building materials.
