Building and Timber Pest Inspection Report

Inspection Date: Fri, 6 Mar 2026

Property Address: 16 Ibex St, Earlwood NSW 2206, Australia

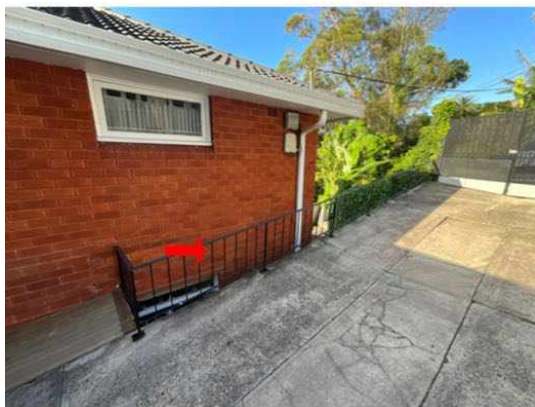
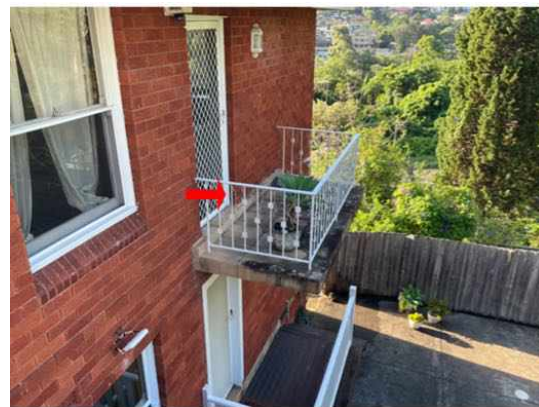
Finding 1.01

Building:	Main Building
Location:	External Areas
Finding:	Balustrade - Suspected Non-Compliance
Information:	The balustrade was measured and found to less than the present building regulation requirement of 1000mm high.

This defect creates a potential safety hazard and should be rectified as soon as possible to ensure the safety of the area and to meet present building standards and regulations.

A registered builder should be contacted to discuss possible rectification solutions.

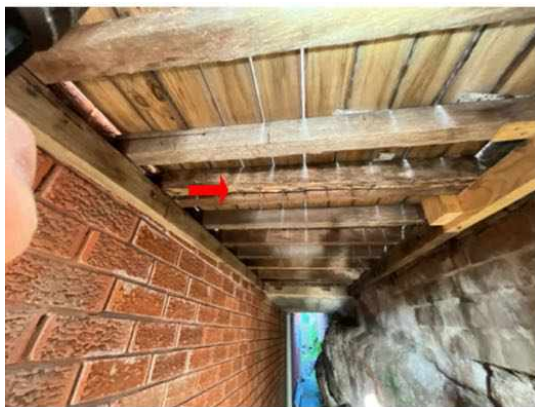
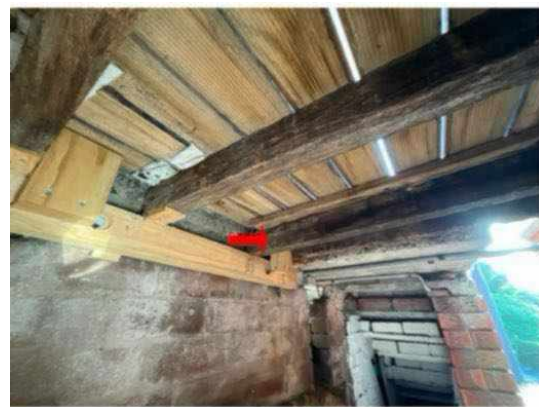
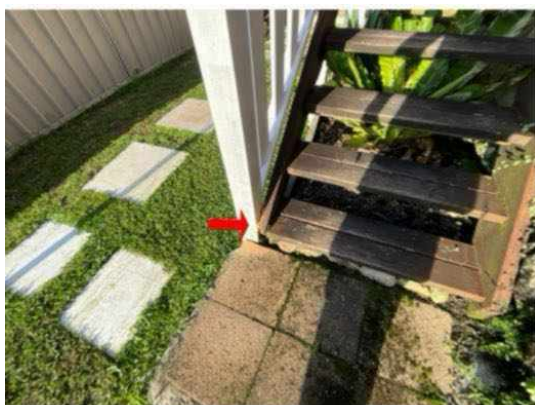
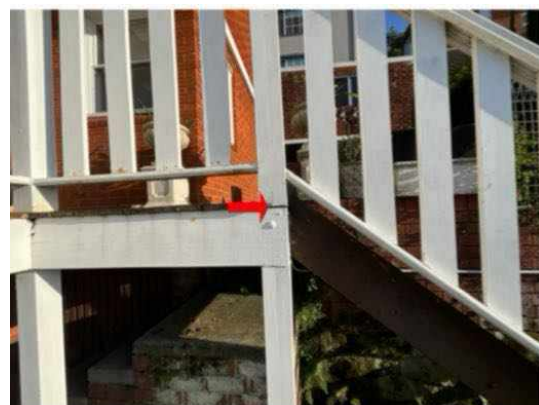
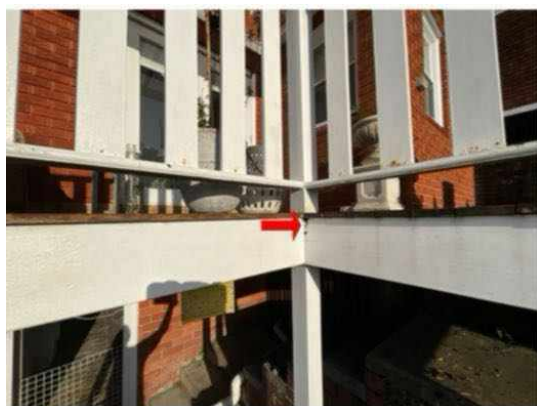
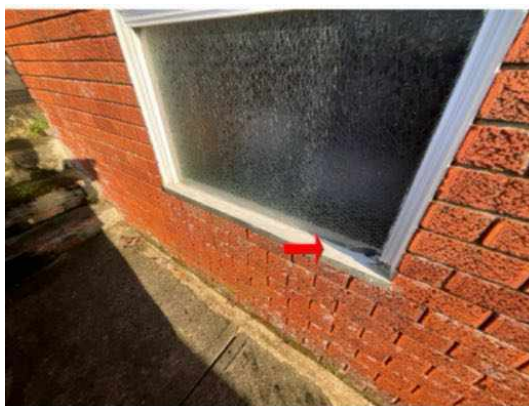
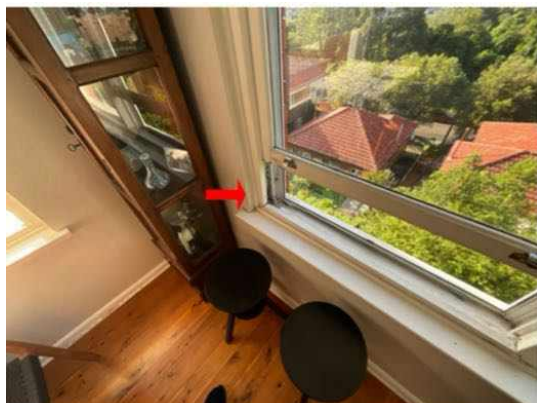
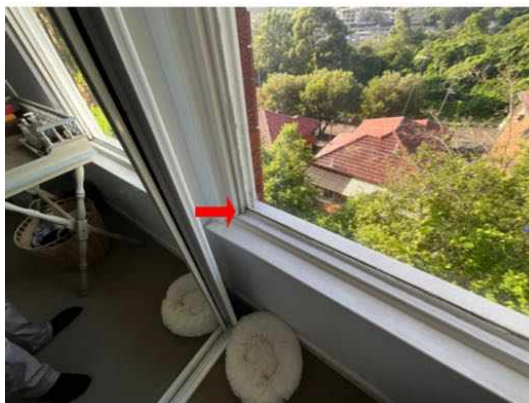
Finding 3.01

Building:	Main Building
Location:	External Areas
Finding:	Wood rot
Information:	This building element shows evidence of wood rot. Wood rot, also known as Fungal Decay, occurs when timbers and other cellulose building materials are exposed to damp conditions on an ongoing basis. This could be the result of exposure to weathering over a prolonged period of time, or the attraction of excessive moisture from other abutting building materials.

Early intervention and regular maintenance, particularly of exterior timbers, will prolong the useful life of these building elements. Prior to any works being performed, the cause of the moisture that has created the visible wood rot should be identified and addressed in a suitable manner. Replacement of affected timbers may then be a necessary step in protecting surrounding building elements from such deterioration.

A qualified carpenter or registered builder may also be required to replace affected building materials.

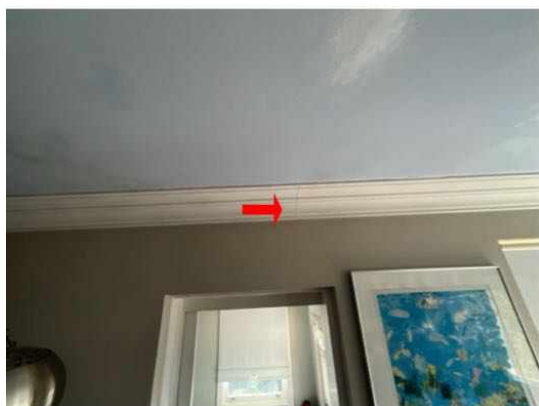
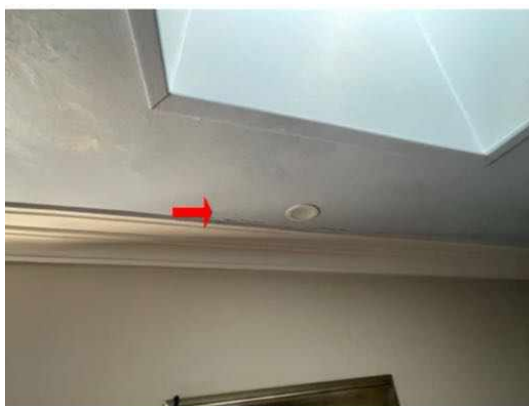
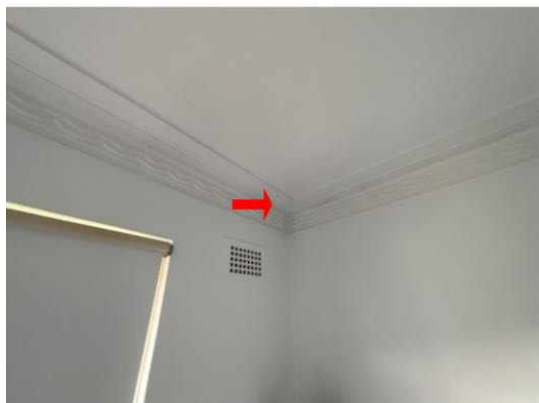
Finding 3.02

Building:	Building 1
Location:	Internal Areas
Finding:	Cracking - Damage Category 1 - Fine (up to 1mm)
Information:	Although fine cracks are quite noticeable, they are often only considered to be an appearance defect, and usually do not indicate any structural damage. Generally, the cause of a fine crack is indicative of a separation between building materials and finishes (e.g. paint, plaster, etc.) along joints.

Cracking of this nature can generally be repaired with minor sanding, filling and/or repainting. Such works should be performed by a qualified painter or a general handyman.

Monitoring of all cracking should be conducted frequently. Always contact a building inspector should cracks widen, lengthen, or become more numerous.

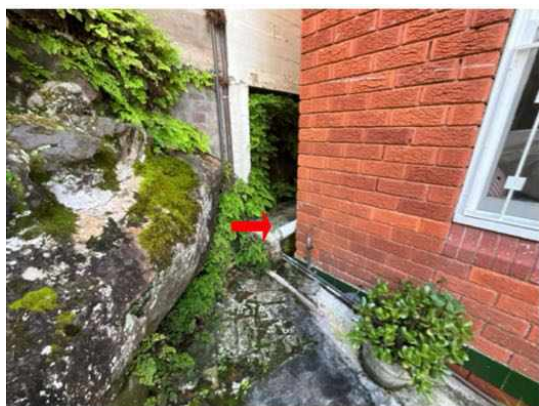
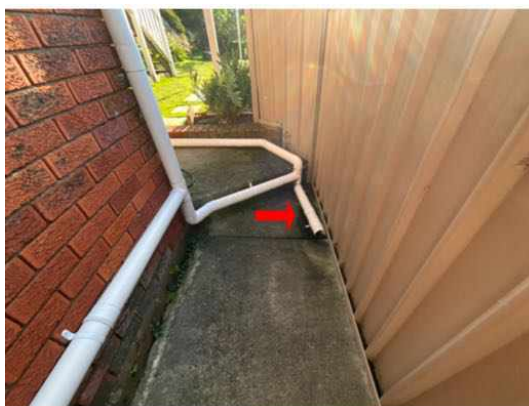
Finding 3.03

Building:	Main Building
Location:	Exterior walls
Finding:	Stormwater drain - Not connected
Information:	The roof plumbing is not adequately connected to stormwater drainage on the site. This disconnection negatively impacts the functional capacity of the roof plumbing.

Where roof plumbing doesn't drain adequately, the area at the base perimeter can become excessively damp, potentially creating an environment that is susceptible to rust and corrosion of surrounding building elements, as well as attracting termites and other pests.

It is highly recommended that a plumber be appointed to further inspect the area and to install adequate drainage equipment where necessary.

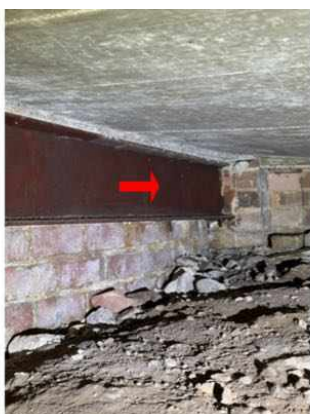
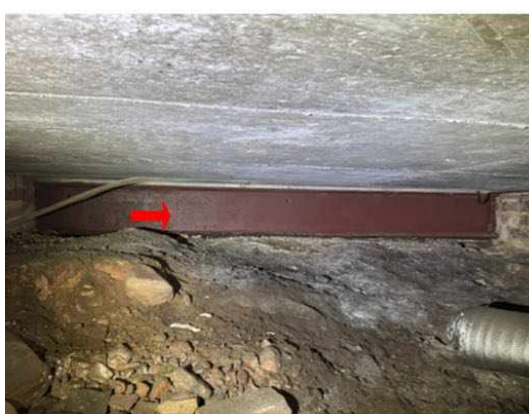
Finding 3.04

Building:	Main Building
Location:	Subfloor
Finding:	Building element - Rusted or corroded
Information:	This building element shows evidence of rusting and corrosion, which is likely to have developed as a result of excessive exposure to moisture and or inadequate coatings. As surface rust provides no protection to the underlying iron, the deteriorating condition is likely to worsen if not addressed in the short-term future. Where possible, the use of galvanized (treated) metals or aluminium coated metals aid in rust prevention, as does regular general maintenance. Rust formation can be controlled with coatings, such as paint, that isolate the iron from the environment. Rusting and corrosion should be managed by ideally removing or limiting the affected surface from exposure to moisture.

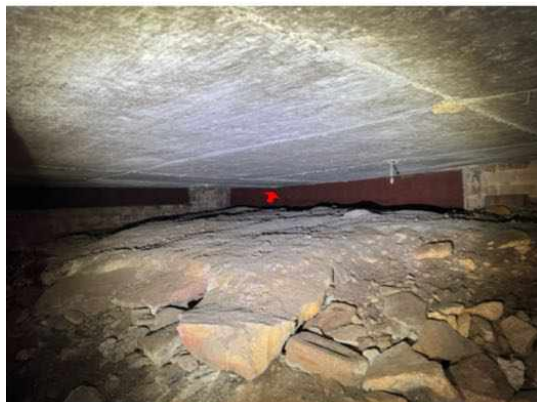
Finding 3.05

Building:	Main Building
Location:	Subfloor
Finding:	Bowing Evident in Concrete Slab
Information:	Bowing was observed in the concrete slab. The condition appears to be related to the formwork used during construction, with the concrete likely formed in this manner. The slab appears structurally stable at the time of inspection.

While the slab currently appears stable, uneven concrete surfaces may affect finishes or load distribution and should be monitored for any signs of further movement.

No immediate works are required; however, the area should be monitored for any signs of cracking or additional movement. A builder should be consulted if the condition worsens.

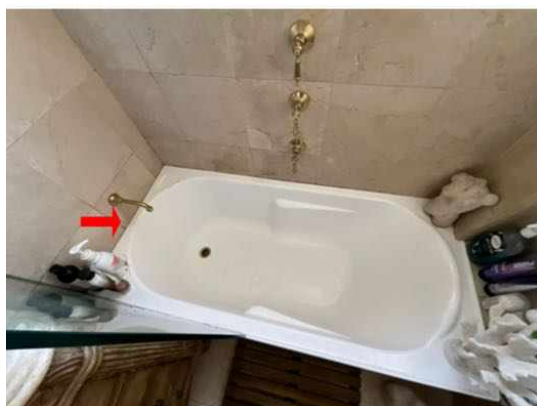
Finding 3.06

Building:	Building 2
Location:	Bathroom
Finding:	Sealant and grouting - Missing or damaged
Information:	It was noted on inspection that sealant or grout is degraded to the tiled areas.

Different materials and floor areas move at different rates, generally causing cracking to grout or sealant at this point. A flexible sealant is required to allow for expected expansion and contraction, while keeping the joint water tight and protective of all associated building materials.

Flexible and mould resistant materials should be applied to affected areas to prevent any subsequent water damage that is likely to occur. Regular maintenance and replacement of damage or missing or damaged sealant and grout is highly recommended to the wet areas, as this is a regular wear and tear defect. Sealant and grouting in areas that come into regular contact with water should be maintained for the long term care of your property.

A sealant specialist or tiling contractor should be appointed to complete these works.

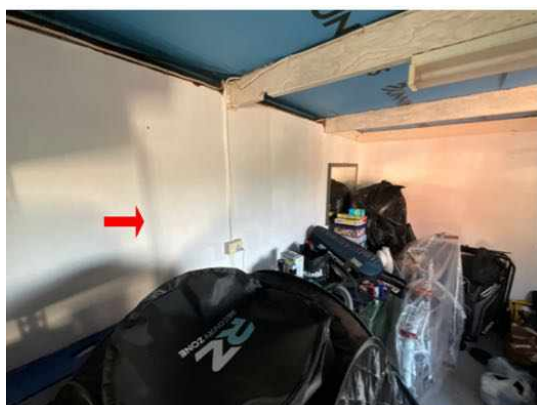
Finding 3.07

Building:	Garage
Location:	Garage
Finding:	Interior walls - Lateral damp
Information:	Lateral penetrating damp refers to the sideways movement of moisture. The implications of unmanaged damp range from mould fungi growth, wood rot and decaying building materials, to finishes including lifting, bubbling, peeling and staining of paint, plaster and wallpaper.

Structural waterproofing barriers or tanking barriers are often used to protect internal surfaces against the affects of lateral penetrating dampness. These types of work are generally undertaken where the source of the penetrating damp cannot be prevented.

Consultation with a damp proofing contractor is advised to address the cause of the damp and to perform remedial works as necessary.

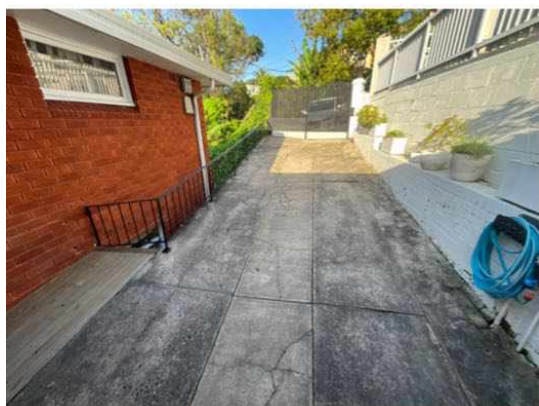
Finding 3.08

Building:	Yard
Location:	Pathway
Finding:	Cracking - External Concrete Paving Damage Category 1 - Fine (less than 2mm)
Information:	Fine cracks were identified in external concrete paving. Although fine cracks are quite

noticeable, they are often only considered to be an appearance defect, and usually do not indicate any structural damage. To be considered a Category 1 or fine crack, the crack is found to be less than 2mm in width.

Generally the cause of a hairline crack in existing concrete paving such as driveways and pathways is indicative of the expansion and contraction of the concrete. Such causes are generally due to environmental factors, such as moisture levels, weather conditions, root systems of nearby trees or the soil types on which they are laid.

Fine cracks may also be due to poor original installation of the concrete. Factors such as poor compaction of the sub surface and/or inadequate reinforcing of the slab may create cracking and other secondary defects.

Monitoring of all cracking should be conducted frequently. Always contact a building inspector should cracks widen, lengthen, or become more numerous.

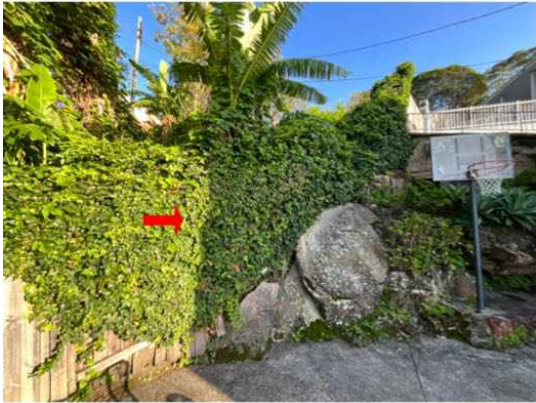
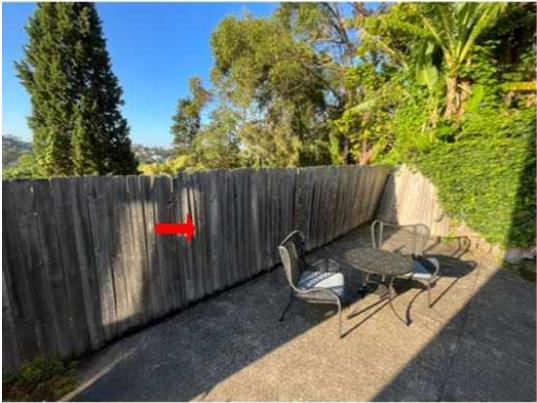
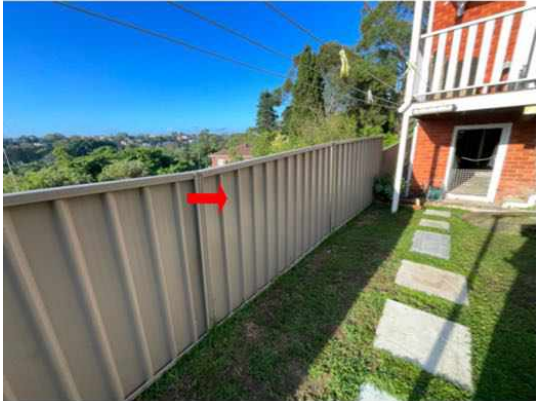
Finding 3.09

Building:	Yard
Location:	Fencing
Finding:	Fencing - Deteriorated
Information:	It was noted at the time of inspection that sections of the fencing throughout the property have deteriorated. Typically fencing deteriorates due to age and or wear, rot and or rust which is generally expected for a structure of this age, due to prolonged exposure to weather conditions. Sometimes inadequate installation or maintenance can be to blame.

If left unattended, it is likely that further damage will occur. It is suspected that repair of several elements of the fencing may be required however replacement may be a consideration of the client also.

A licensed fencing contractor should be appointed to provide further advice and perform rectification works as necessary.

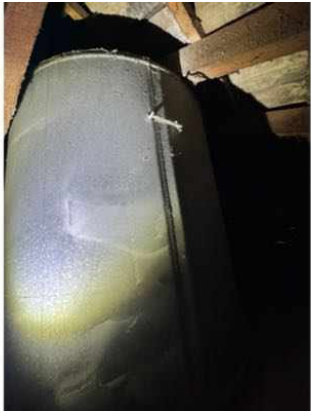
Finding 3.10

Building: Main Building
Location: Roof Void
Finding: Gravity-Fed HWS - Disconnected
Information: It was noted at the time of inspection that a disconnected gravity-fed hot water system (HWS) remains in this area.

I recommend appointing a plumber to see what necessary works are required to remove the unit from the area.

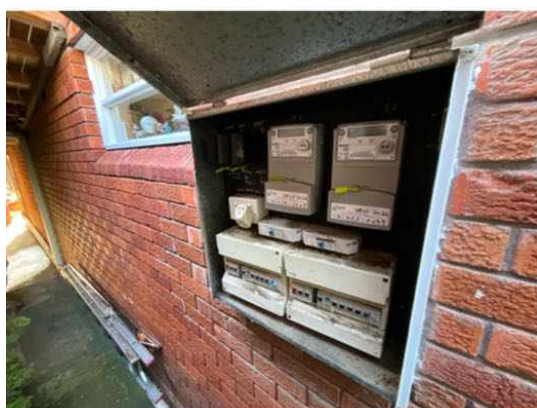
Finding 6.01

Building: Main Building
 Location: All Areas
 Finding: Termite Management System - no evidence of a chemical installation
 Information: The application of a post-construction chemical termite barrier is highly recommended for all properties, particularly if live termite activity has been found on the site previously. Such barriers are highly effective in preventing termite attack on any timber building elements throughout the property.

A durable notice should be placed in the switchboard unit to indicate current termite barriers. At the time of inspection, it appeared as though no termite management system has been installed, with no evidence to suggest preventative works taking place.

The client may consider gaining further advice from a pest controller as to the costs and procedures involved with this application. It is recommended that obtaining such advice be a short-term priority.

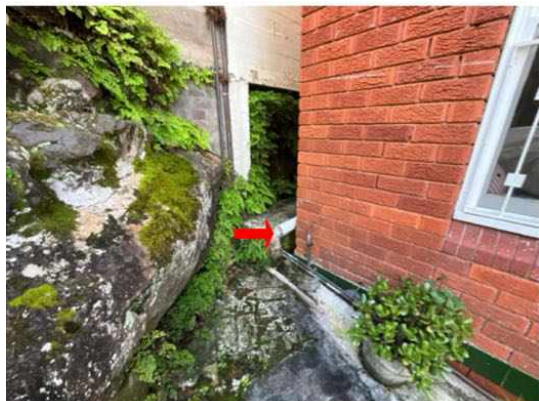
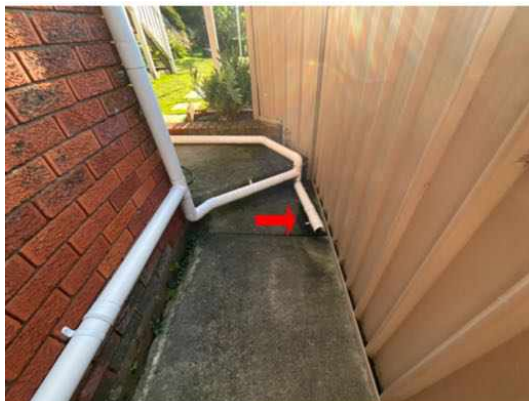
Finding 6.02

Building: Main Building
 Location: Exterior walls
 Finding: Excessive moisture - identified

Information: Excessive moisture can attract termites and produce conditions that promote fungal growth and wood decay.

Prior to any remedial works being performed a qualified plumber should be appointed to further inspect the property and to identify the cause of the excessive moisture.

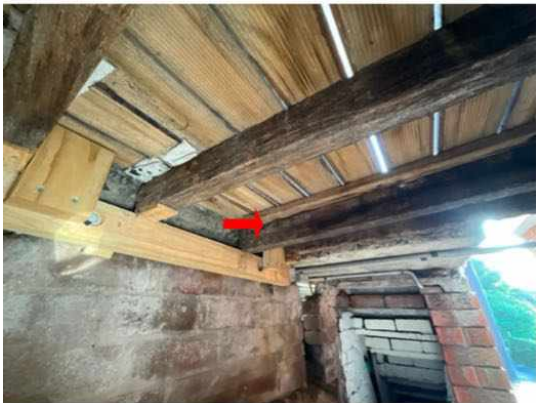
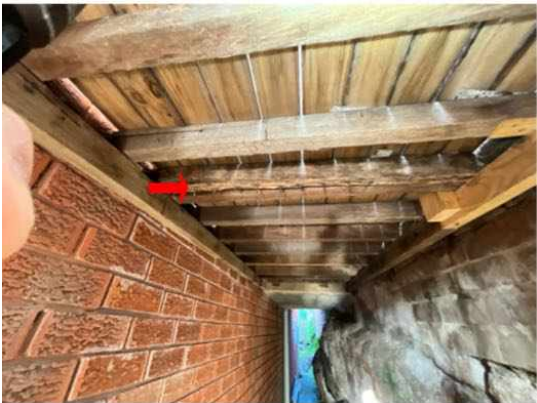
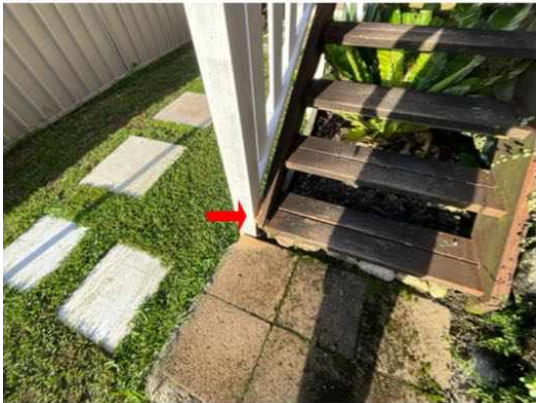
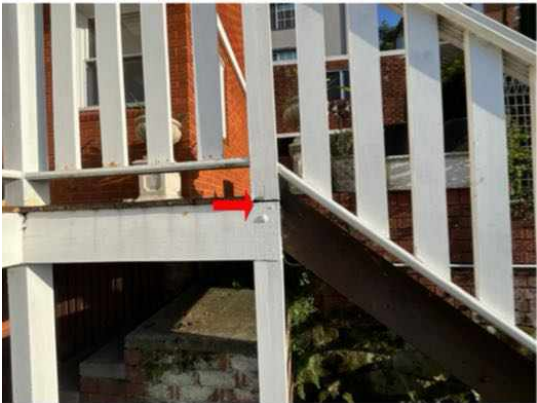
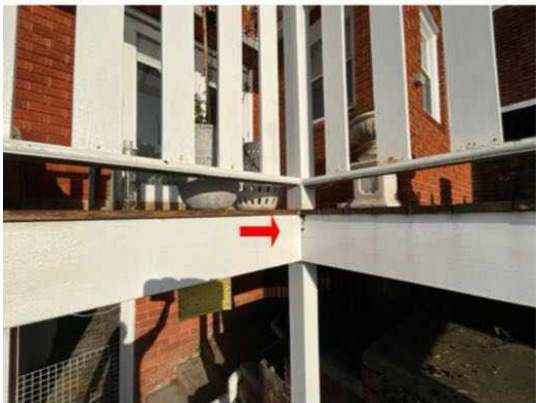
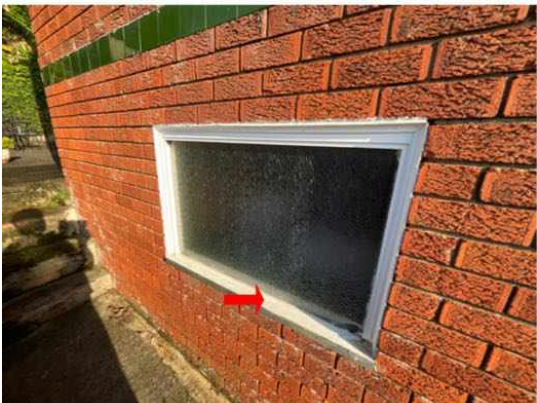
Finding 7.01

Building: Main Building
 Location: External Areas
 Finding: Fungal decay - present (localised)
 Information: Fungal decay also known as wood decay or wood rot generally refers to the deterioration of timber elements when in contact with excessive levels of moisture for a prolonged period of time.

The development of fungal decay is accelerated by temperatures in the range of 5degreeC to 40degreeC as well as the presence of oxygen. Generally fungal decay develops on timber elements that are in use in an external environment which are exposed to rain penetration.

In this case although the affected timber element is in a decaying state the extent of any visible damage appears to be localised to a specific area and is yet to spread to other parts of the building element or affect adjoining structures. The fungal decay is therefore likely to be of a relatively superficial nature with minimal impact on the structural integrity or tensile strength of the timber element.
