## Building and Timber Pest Inspection Report

Inspection Date: Wed, 21 Jan 2026

Property Address: 199 Grey St, Glen Innes NSW 2370,  
Australia

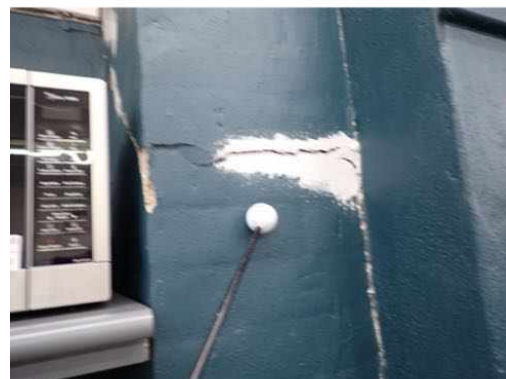
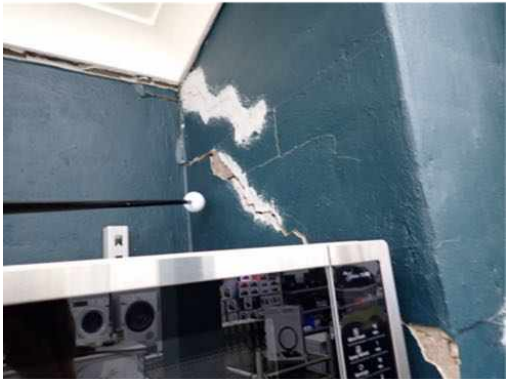
#### Finding 2.01

Building:	Main Building
Location:	Right hand side of show room approximately half way down
Finding:	Brickwork Wall – Structural Cracks
Information:	Brickwork Wall – Structural Cracks (Showroom Right-Hand Side)

Minor structural cracks were identified in the rendered brickwork wall approximately halfway down the showroom on the right-hand side at the time of inspection. These may be the result of building movement or age-related settlement. While not considered severe at this stage, further movement could lead to increased cracking over time. It is recommended that a suitably qualified builder or structural engineer assess and carry out repairs as deemed necessary to prevent further deterioration.

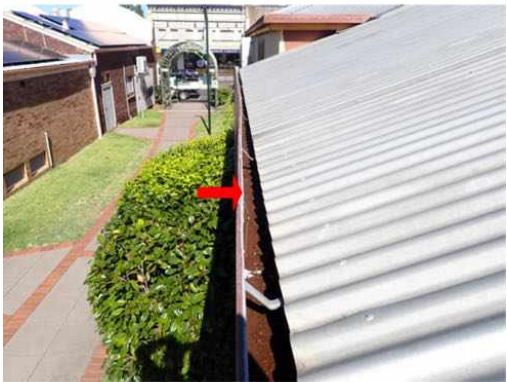
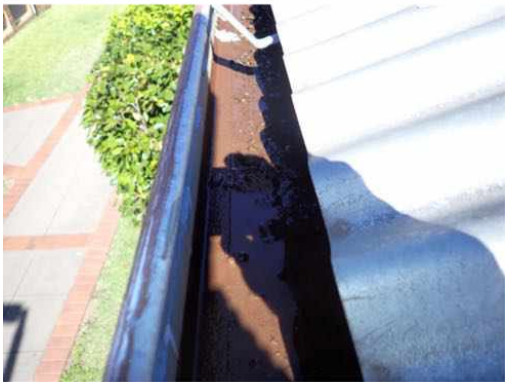
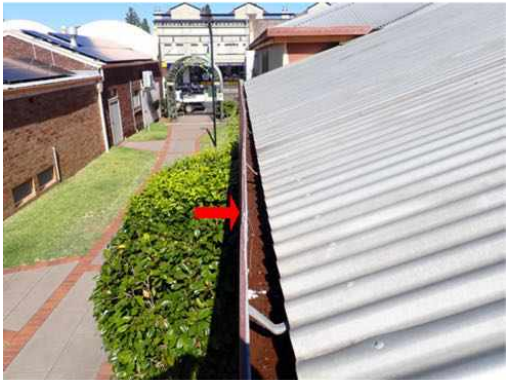
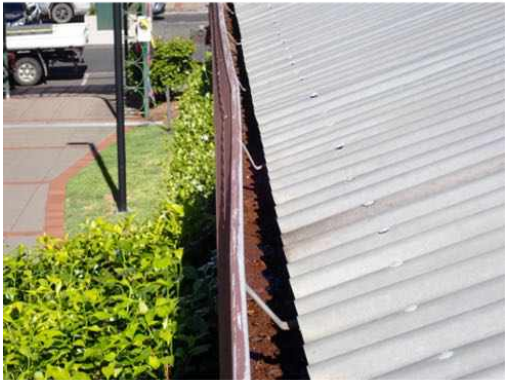
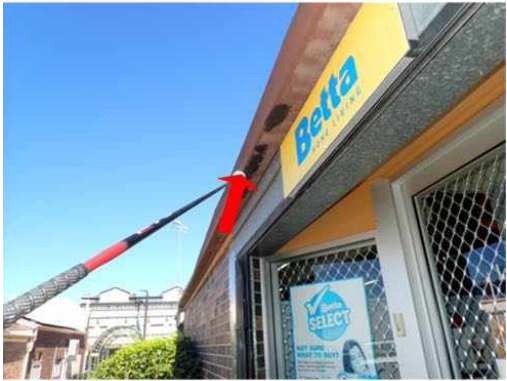
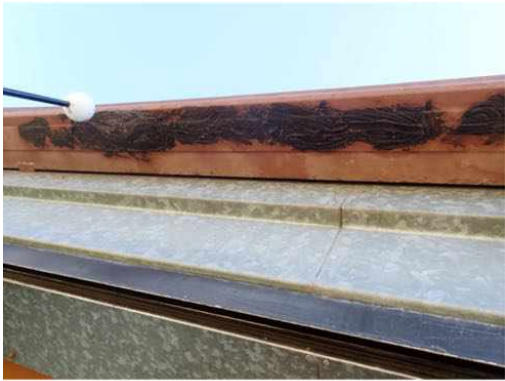
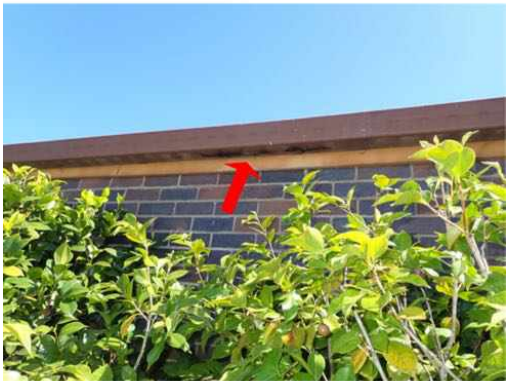
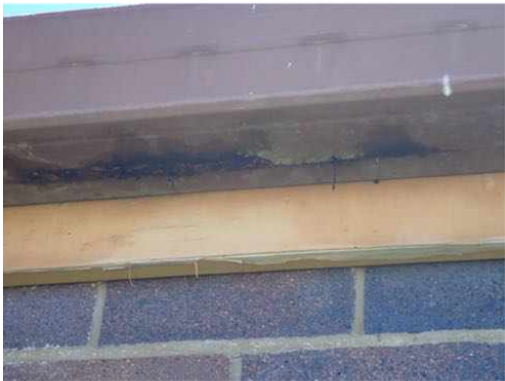
**Finding 2.02**

Building: Main Building  
Location: Right hand side gutter  
Finding: Right-Hand Side Gutter – Rust and Silicone Patching  
Information: Rust was identified to the right-hand side gutter, along with silicone patching to the underside at the time of inspection. This indicates age-related deterioration and previous temporary repairs. If left unaddressed, the gutter may continue to deteriorate and leak, potentially causing water damage to surrounding building materials. It is recommended that a suitably qualified plumber or roofing contractor repair or replace the affected gutter as deemed necessary.

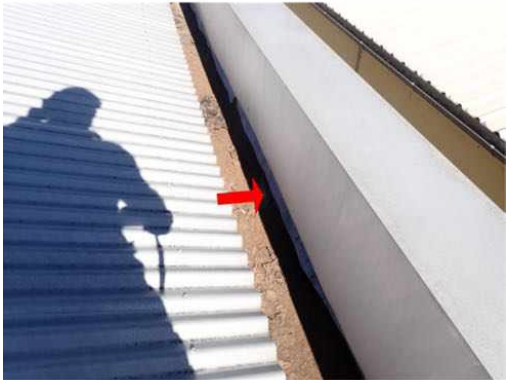
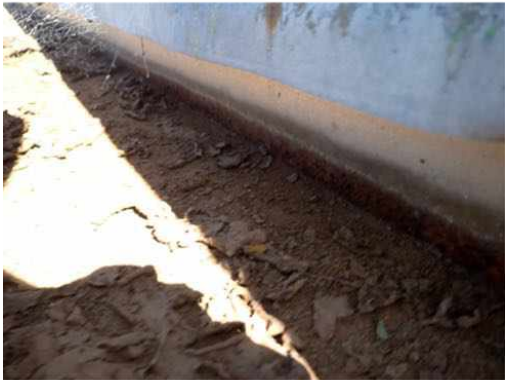
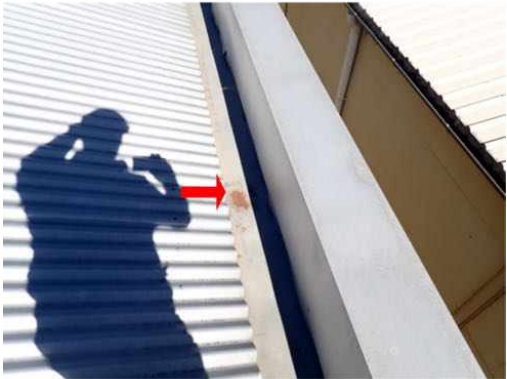
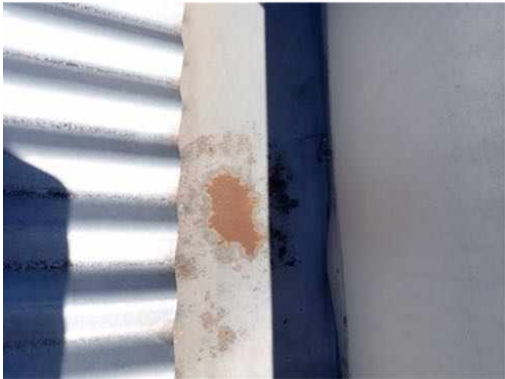
**Finding 2.03**

Building: Main Building  
 Location: Box gutter along left hand side of roof  
 Finding: Box Gutter – Surface Rust to Sections  
 Information: Surface rust was identified to sections along the box gutter at the time of inspection. This indicates age-related deterioration and exposure to weathering. While the rust appeared to be superficial, ongoing corrosion may occur if left unaddressed and could eventually lead to leaks. It is recommended that a suitably qualified roofing contractor clean, treat, and protect the affected areas, or carry out repairs or replacement as deemed necessary to prevent further deterioration.

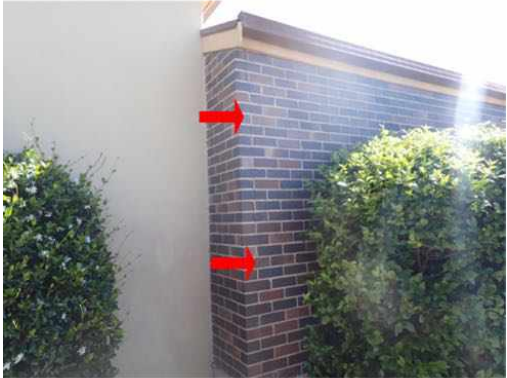
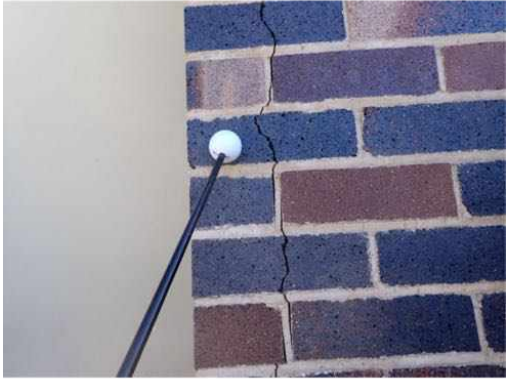
**Finding 2.04**

Building: Main Building  
Location: Right hand side of building  
Finding: Brickwork – Structural Crack Halfway Down Right-Hand Side of Building  
Information: A structural crack was identified in the brickwork approximately halfway down the right-hand side of the building at the time of inspection. This may indicate underlying movement or stress within the building structure. If left unaddressed, further deterioration and potential structural issues may occur. It is recommended that a suitably qualified structural engineer or builder assess the crack and carry out any necessary remedial works as deemed necessary.

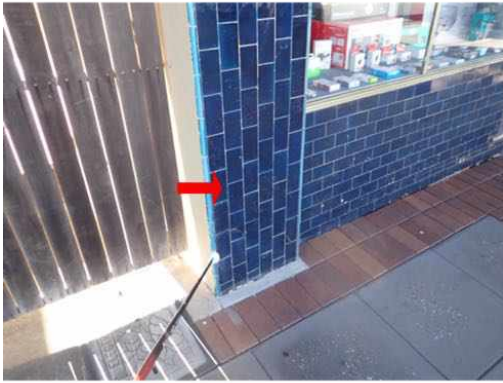
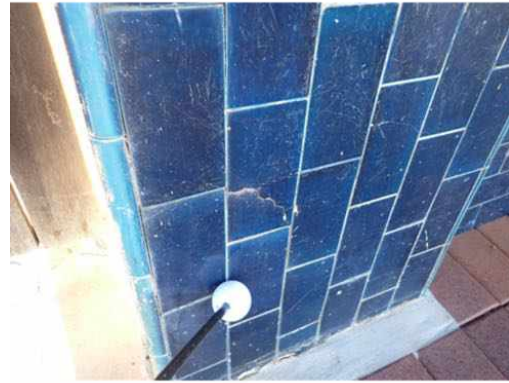
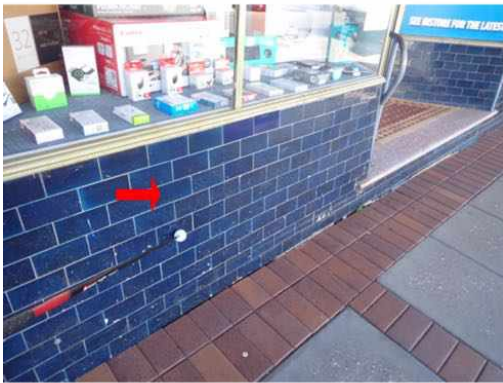
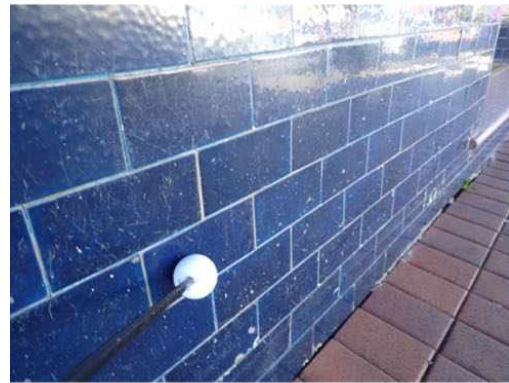
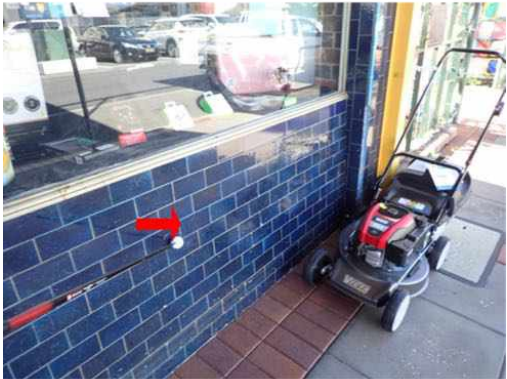
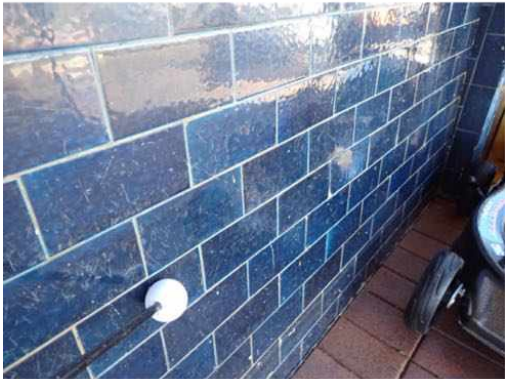
### Finding 3.01

Building: Main Building

Location: Front elevation

Finding: Shop Front Tiles – Age-Related Damage

Information: Age-related damage was identified to the shop front tiles at the time of inspection. This is consistent with general wear and exposure over time. If left unaddressed, the condition may continue to deteriorate and affect the appearance and durability of the tiled surface. It is recommended that a suitably qualified tiler or general handyman repair or replace the affected tiles as deemed necessary.

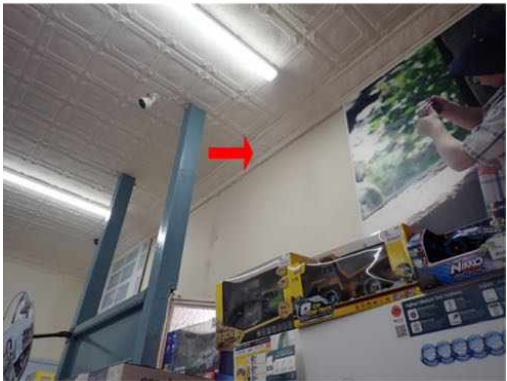
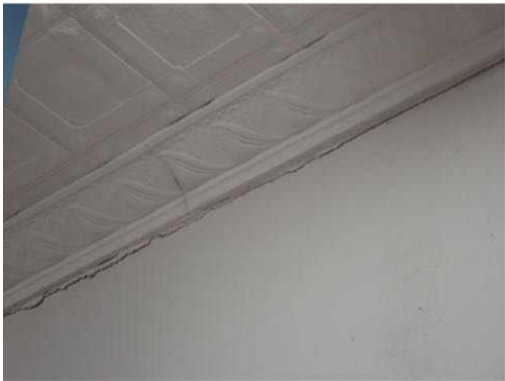
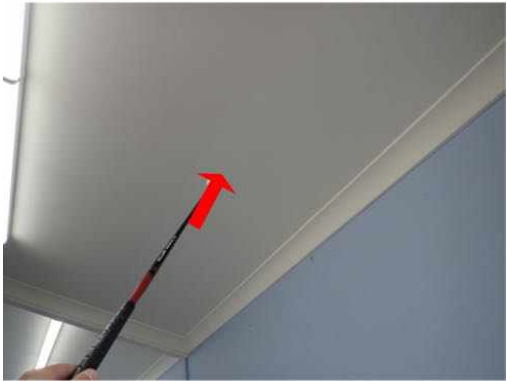
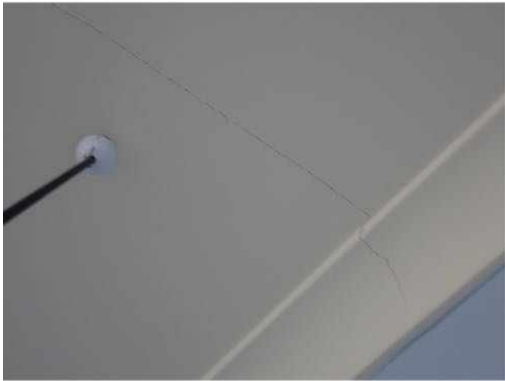
**Finding 3.02**

Building: Main Building  
Location: Ceiling  
Finding: Ceiling Lining – Minor Age-Related Cracks  
Information: Minor age-related cracks were identified to the ceiling lining at the time of inspection. These appear consistent with general movement and normal wear over time. While not considered structurally significant, it is recommended that the cracks be repaired and monitored as deemed necessary by a suitably qualified tradesperson to maintain the condition and appearance of the ceiling.

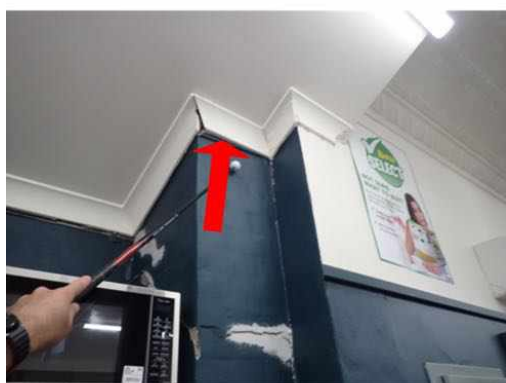
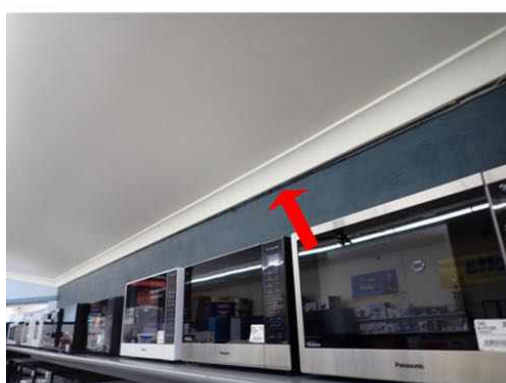
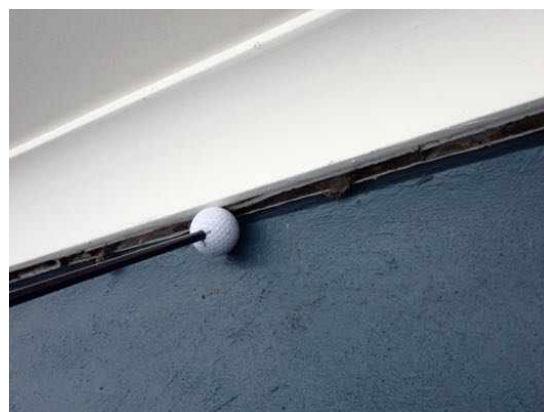
**Finding 3.03**

Building:	Main Building
Location:	Right hand side of show room approximately half way down
Finding:	Damaged — cornice
Information:	Cornice – damage (Showroom Right-Hand Side)

Damage was identified to the cornice at this location at the time of inspection. This may be due to general wear, minor movement, or impact damage. If left unaddressed, the condition may continue to deteriorate and affect the appearance of the area. It is recommended that a suitably qualified tradesperson repair or replace the damaged cornice as deemed necessary.

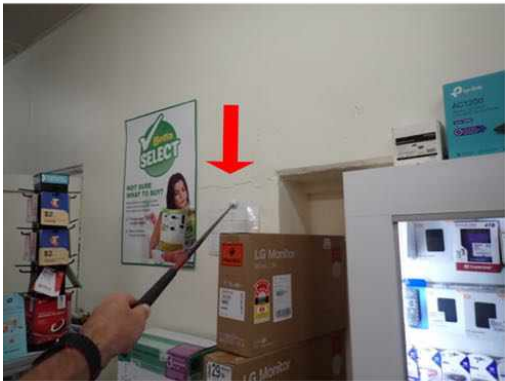
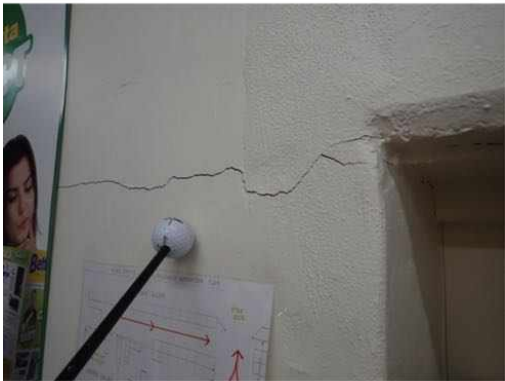
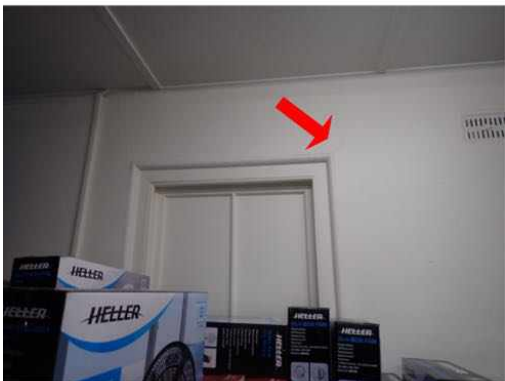
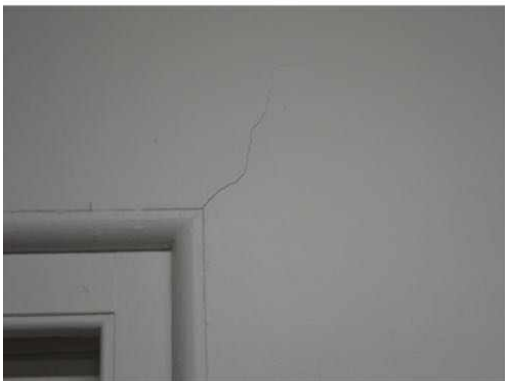
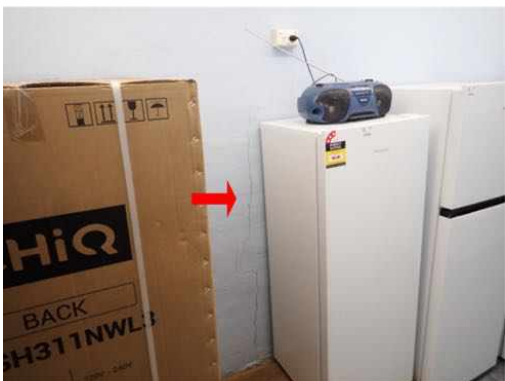
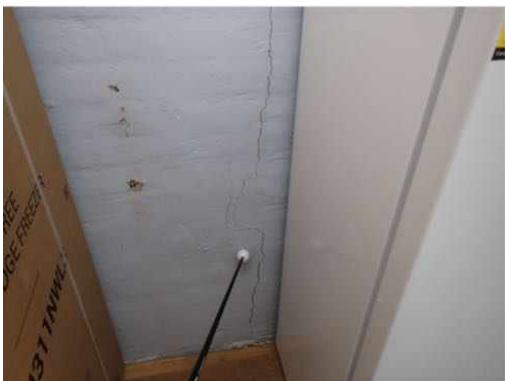
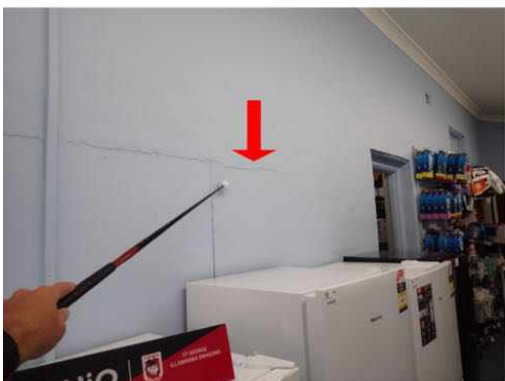
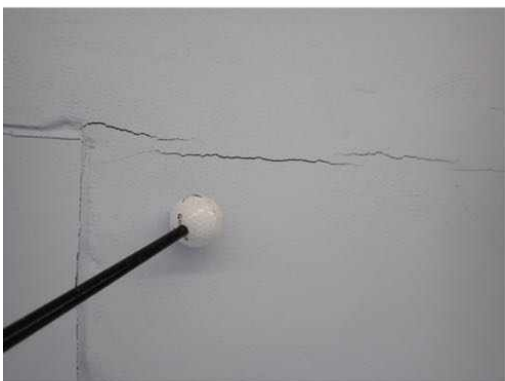
### Finding 3.04

Building:	Main Building
Location:	Rendered brick wall towards the end of the showroom
Finding:	Rendered Walls – Cracks Towards the Rear of the Showroom
Information:	Cracks were identified in the rendered walls towards the back of the showroom at the time of inspection. These may be due to building movement, age-related settlement, or thermal expansion and contraction. If left unaddressed, further deterioration may occur. It is recommended that a suitably qualified builder or tradesperson assess and carry out repairs as deemed necessary to maintain the condition of the walls.

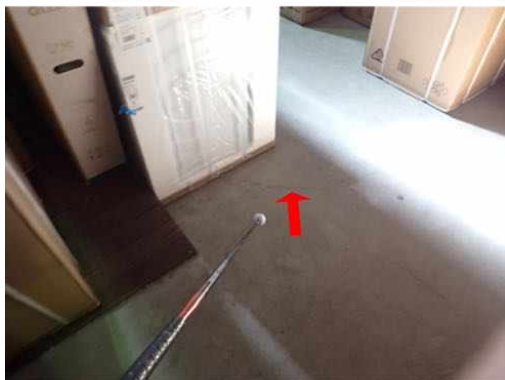
**Finding 3.05**

Building: Main Building  
Location: Warehouse floor  
Finding: Warehouse Concrete Floor – Several Minor Cracks  
Information: Several minor cracks were identified in the warehouse concrete floor at the time of inspection. These appear consistent with general shrinkage, age-related movement, or minor settlement. While not considered structurally significant, ongoing movement may lead to further deterioration if left unaddressed. It is recommended that the cracks be monitored and repaired as deemed necessary by a suitably qualified tradesperson to help prevent future damage.

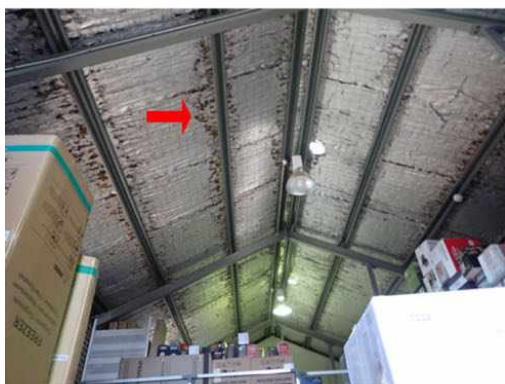
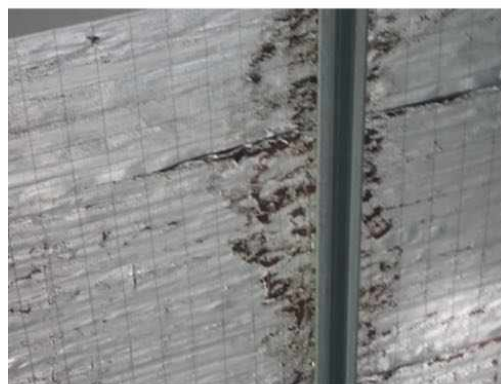
### Finding 3.06

Building:	Main Building
Location:	Warehouse ceiling
Finding:	Warehouse Roof – Deteriorated Sarking
Information:	The sarking to the warehouse roof was found to be deteriorated at the time of inspection. This may reduce its effectiveness in providing weather protection and could allow moisture ingress into the roof space. If left unaddressed, further deterioration may occur. It is recommended that a suitably qualified roofing contractor assess and repair or replace the sarking as deemed necessary to maintain the integrity of the roof system.

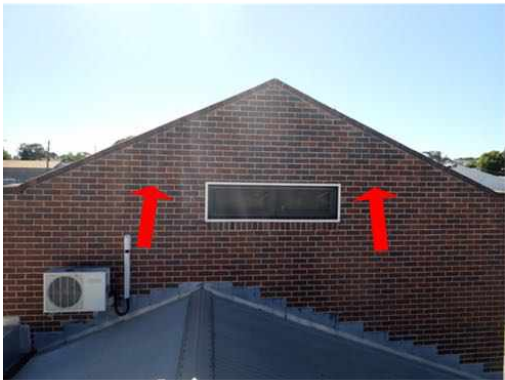
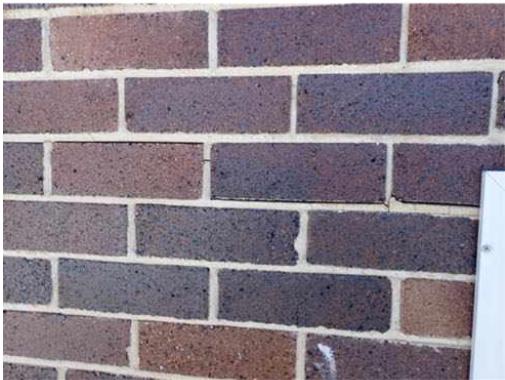
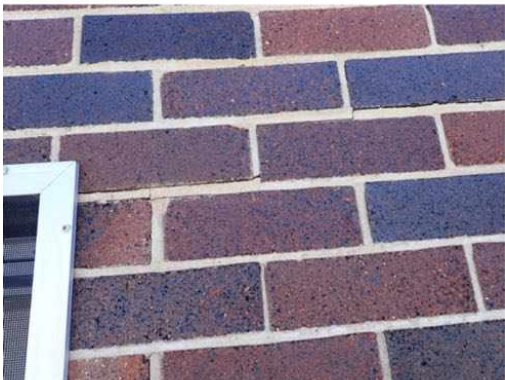
### Finding 3.07

Building:	Main Building
Location:	Brick wall above roof
Finding:	Brickwork Above Roof – Minor Cracks
Information:	Minor cracks were identified in the brickwork above the roof at the time of inspection. These appear consistent with general movement and age-related settlement. While not considered structurally significant at this stage, it is recommended that the cracks be monitored and repaired as deemed necessary by a suitably qualified tradesperson to prevent further deterioration.

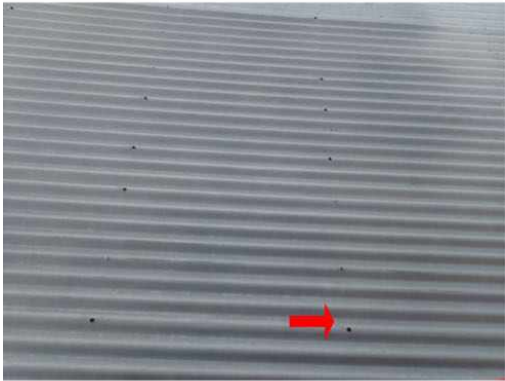
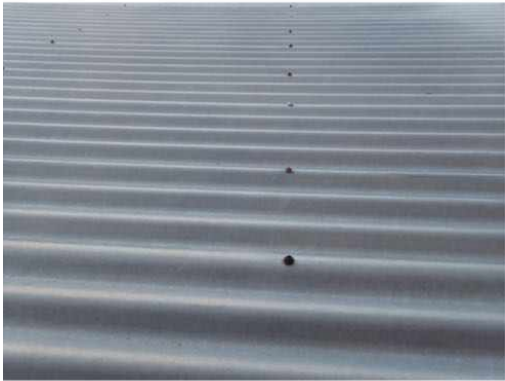
**Finding 3.08**

Building: Main Building  
Location: Roof toward end of the showroom  
Finding: Roof – Rusted Screws Towards the End of the Showroom  
Information: Rusted screws were identified to the roof towards the end of the showroom at the time of inspection. This indicates age-related deterioration and exposure to weathering. If left unaddressed, the fasteners may continue to corrode and affect the integrity of the roof cladding. It is recommended that a suitably qualified roofing contractor replace the affected screws and carry out any necessary remedial works as deemed necessary.

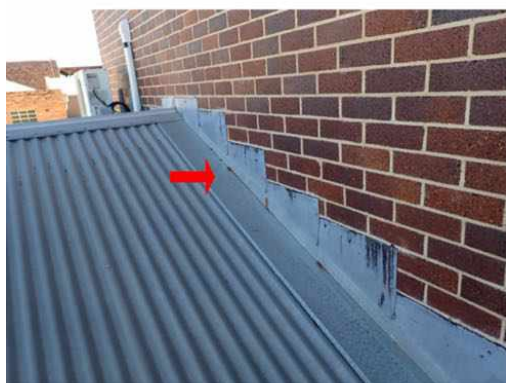
### Finding 3.09

Building:	Main Building
Location:	Roof were it meets the warehouse wall
Finding:	Brickwork / Roof Flashing – Minor Surface Rust at Warehouse Wall Junction
Information:	Minor surface rust was identified to the brickwork and roof flashing where the roof meets the warehouse brick wall at the time of inspection. This is consistent with age-related deterioration and exposure to weathering. While the rust appeared to be superficial, ongoing corrosion may occur if left unaddressed. It is recommended that a suitably qualified tradesperson clean, treat, and protect the affected areas as deemed necessary to prevent further deterioration.

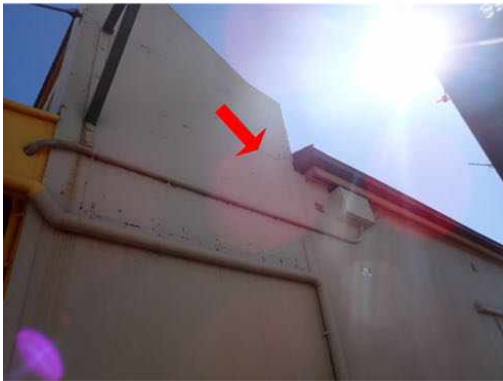
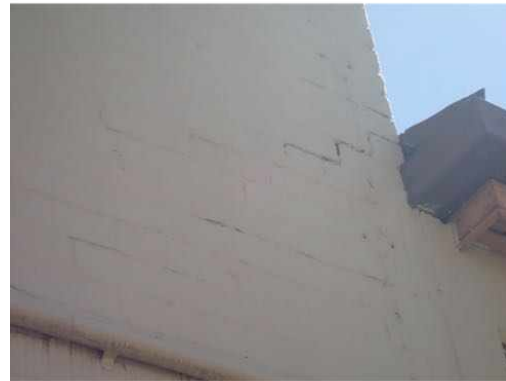
### Finding 3.12

Building:	Main Building
Location:	Right hand side of building
Finding:	Front Parapet – Minor Step Cracking to Brickwork (Right-Hand Side)
Information:	Minor step cracking was identified in the brickwork to the right-hand front side of the parapet at the time of inspection. This appears consistent with minor movement and age-related settlement. While not considered structurally significant at this stage, further movement may lead to increased cracking over time. It is recommended that the area be monitored and repaired as deemed necessary by a suitably qualified tradesperson to prevent further deterioration.

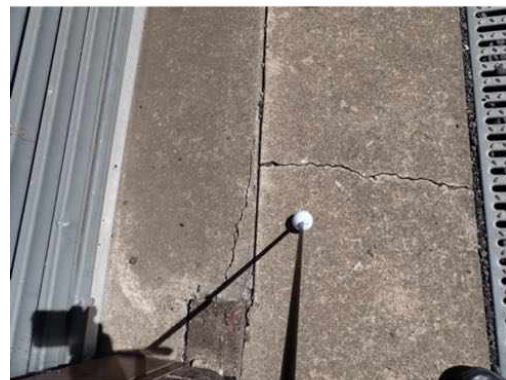
### Finding 3.13

Building:	Main Building
Location:	Rear of warehouse
Finding:	Warehouse Concrete Entry – Minor Cracks
Information:	Minor cracks were identified in the concrete entry area of the warehouse at the time of inspection. These appear consistent with general shrinkage, age-related movement, or minor settlement. While not considered structurally significant, it is recommended that the cracks be monitored and repaired as deemed necessary by a suitably qualified tradesperson to help prevent further deterioration.

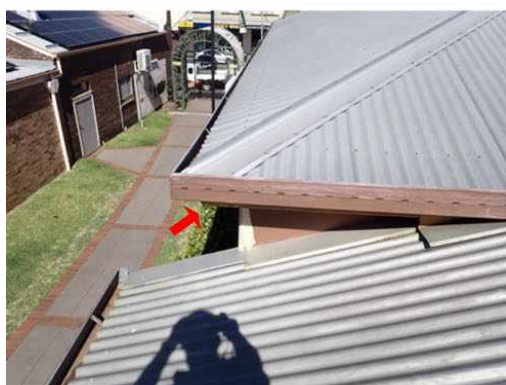
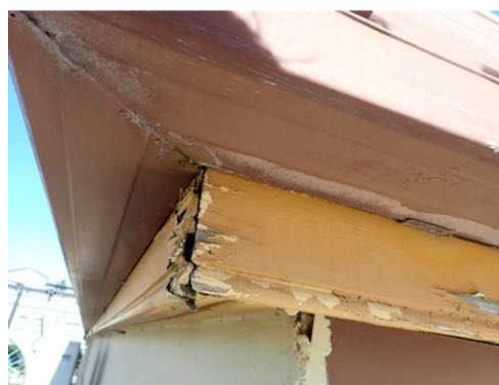
### Finding 7.01

Building:	Main Building
Location:	Fascia half way down right hand side of building
Finding:	Fascia – Wood Rot Halfway Down Right-Hand Side of Building
Information:	Wood rot was identified to the fascia approximately halfway down the right-hand side of the building at the time of inspection. This is likely due to prolonged exposure to moisture and weathering. If left unaddressed, the deterioration may lead to further damage to the roof edge and associated building materials. It is recommended that a suitably qualified carpenter or builder repair or replace the affected fascia as deemed necessary to prevent further deterioration.
