Building and Timber Pest Inspection Report

Inspection Date: Tue, 10 Mar 2026

Property Address: 63 Christy Dr, SCHOFIELDS, NSW, 2762,
Australia

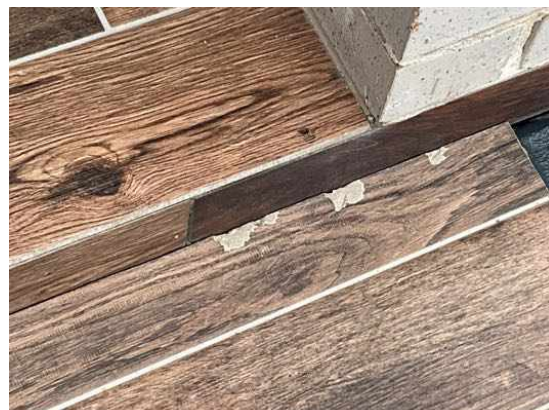
Building: Main Building
Location: Front porch
Finding: Floor Tile Damaged
Information: A floor tile is visibly damaged, showing a chipped/broken section on the surface.

The damaged tile presents a trip hazard, may lead to cuts if stepped on barefoot, and can allow moisture ingress into the substrate, which may cause further deterioration or loosening of adjacent tiles. It also affects the overall appearance of the floor.

A licensed tiler should be engaged to remove the damaged tile and install a matching replacement. If spare tiles are unavailable, additional remedial work may be required to blend the repair with surrounding finishes.

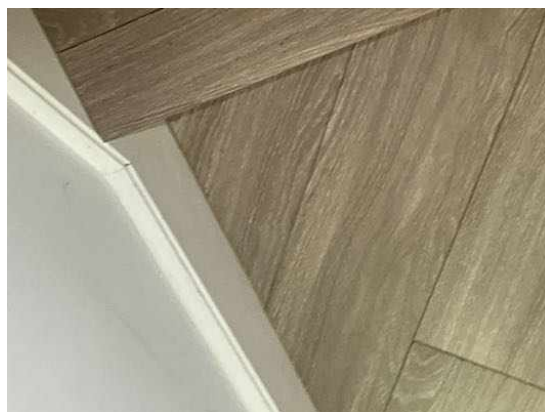
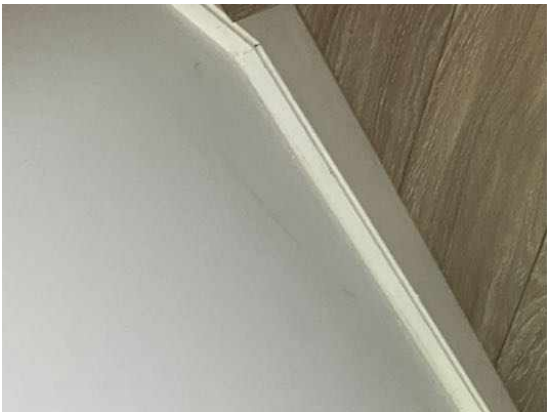
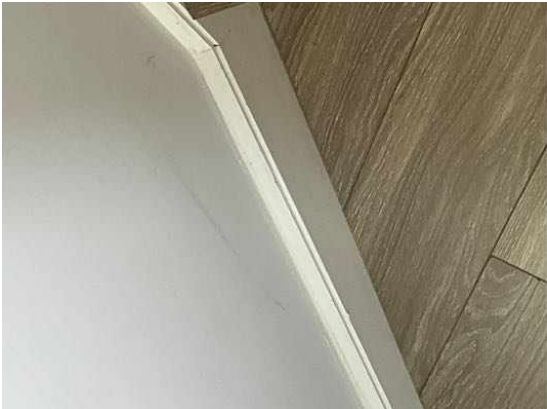
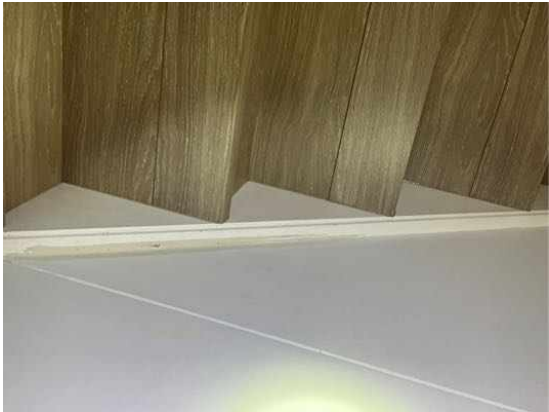
Finding 3.02

Building:	Main Building
Location:	All Areas
Finding:	Paint surface deteriorated
Information:	Sections of the paint in this area was found to have bubble and deteriorated. Paint bubbling is generally an indication of excessive moisture in the area that is currently hidden by the painted surface.

The presence of excessive moisture can have major implications on associated building elements if left unattended. While only seemingly minor at this stage, the damage cannot be determined due to the paint, obstructing any further inspection of the damage.

It is highly advised that the affected paint to be cleaned to allow a further, more invasive inspection by a licensed builder/painter. Failure to act on this defect may necessitate major works in the future.

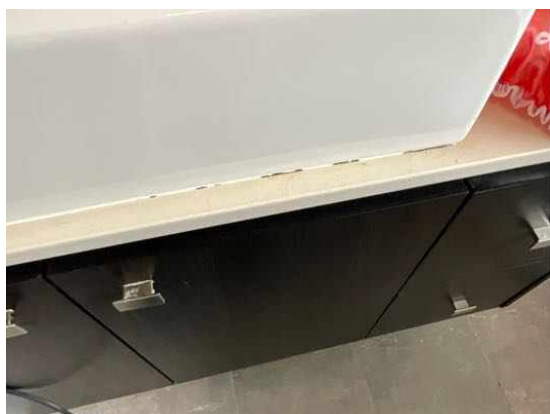
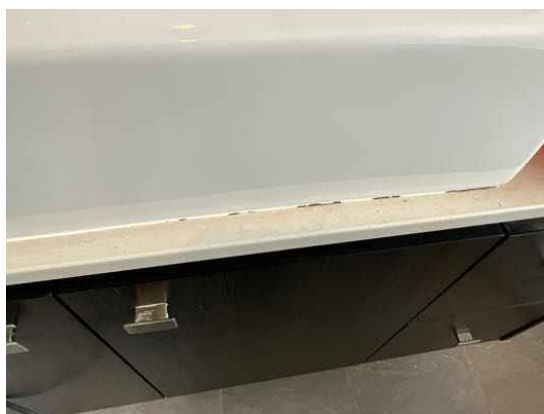
Finding 3.03

Building: Main Building
 Location: Bathroom
 Finding: Silicone Sealant - Detoriated Around Basin
 Information: The silicone seal around the basin has deteriorated, with visible gaps and discolouration noted along the edges.

Water penetration through the deteriorated seal may cause damage to surrounding surfaces, promote mould growth, and lead to deterioration of adjacent materials.

A licensed plumber or qualified handyman should remove the old sealant and reapply a sanitary-grade silicone to ensure watertight protection.

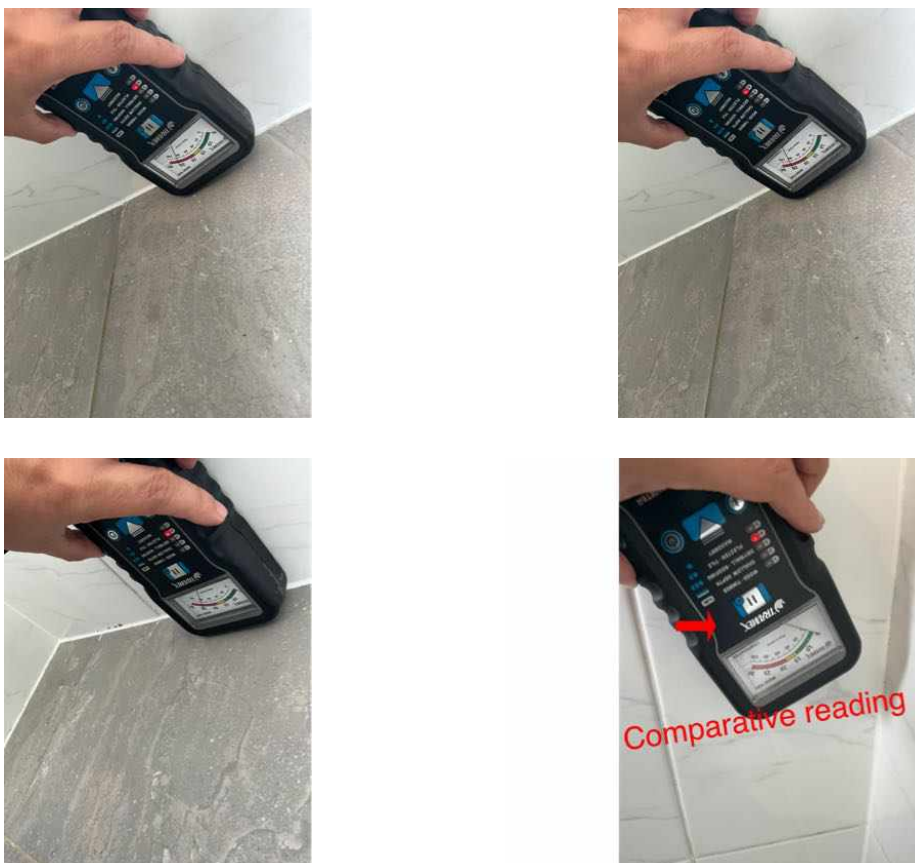
Finding 3.04

Building: Main Building
 Location: Bathroom
 Finding: Shower - Damp
 Information: Damp is evident to the lower 300mm of wall to the shower alcove. This defect is quite common, and is suspected to have been caused by moisture permeating through the

grouting in this area, which shows evidence of deterioration. Leaking pipes within the adjoining wall is also a possible cause.

Unmanaged damp in the shower recess is likely to facilitate the formation and development of mould and fungi growth, decaying associated building materials and compromising their structural integrity. It is important to address damp conditions, as the World Health Organisation notes that excess moisture leads - on almost all indoor materials - to growth of microbes such as moulds, fungi and bacteria, which subsequently emit spores and other matter into the indoor air. Exposure to these contaminants is associated with a wide range of respiratory and other health-related problems.

Consultation with a qualified plumber or bathroom specialist is advised immediately to identify the cause of damp and to perform remedial works as required. Where excessive mould growth is present, further inspection by a specialist environmental health inspector should also be considered.

Always ensure that sealant and grout is in good condition to prevent any moisture issues occurring in the future.

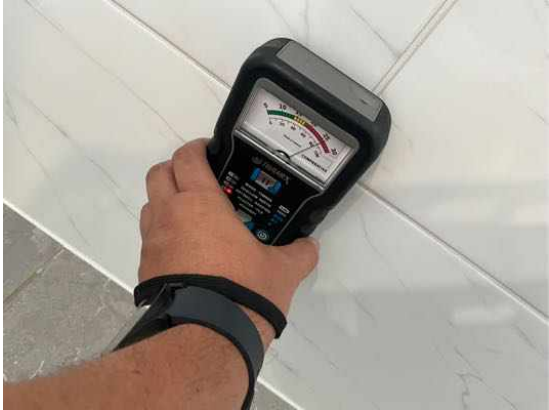
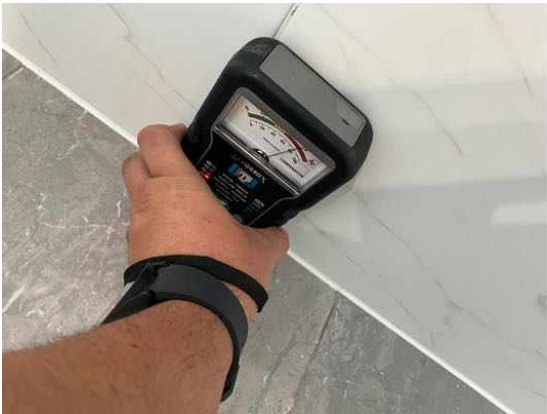
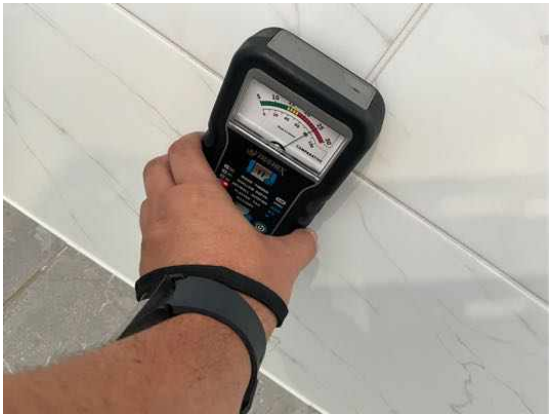
Finding 3.05

Building:	Main Building
Location:	Ensuite
Finding:	Shower - Damp
Information:	Damp is evident to the lower 300mm of wall to the shower alcove. This defect is quite common, and is suspected to have been caused by moisture permeating through the grouting in this area, which shows evidence of deterioration. Leaking pipes within the adjoining wall is also a possible cause.

Unmanaged damp in the shower recess is likely to facilitate the formation and development of mould and fungi growth, decaying associated building materials and compromising their structural integrity. It is important to address damp conditions, as the World Health Organisation notes that excess moisture leads - on almost all indoor materials - to growth of microbes such as moulds, fungi and bacteria, which subsequently emit spores and other matter into the indoor air. Exposure to these contaminants is associated with a wide range of respiratory and other health-related problems.

Consultation with a qualified plumber or bathroom specialist is advised immediately to identify the cause of damp and to perform remedial works as required. Where excessive mould growth is present, further inspection by a specialist environmental health inspector should also be considered.

Always ensure that sealant and grout is in good condition to prevent any moisture issues occurring in the future.

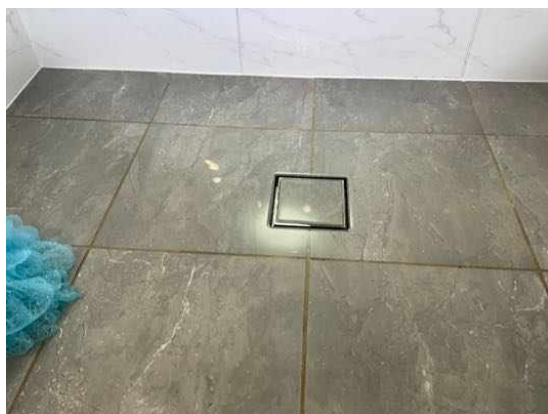
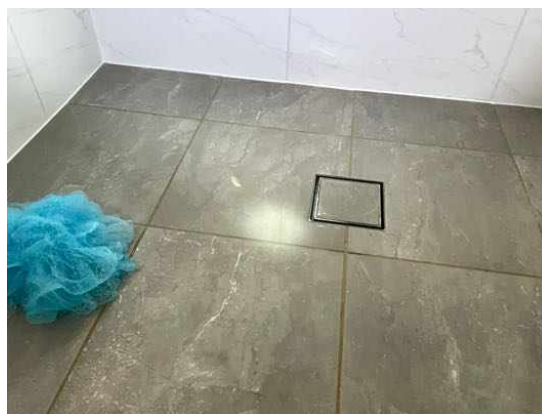
Finding 3.06

Building:	Main Building
Location:	Ensuite
Finding:	Shower base - Water pooling
Information:	Evidence of water pooling around the floor waste in the shower recess was noticed at the time of inspection. It is suspected that this excessive moisture is attributed to insufficient fall in the shower floor tiles.

This pooling is minor overall but is still considered unsatisfactory, as standard tiling practices would not permit this situation to occur. Pooling water around floor wastes can create a slip hazard in extreme cases and create conditions that are conducive to mould growth over time. Where left unmanaged, the degradation of sealant and grouting is also likely to occur, possibly necessitating further repair works.

Remedial works may involve some sections of tiling and flooring repair and replacement. A tiling contractor or bathroom specialist should be appointed to provide further advice on reparation options and to perform works as necessary.

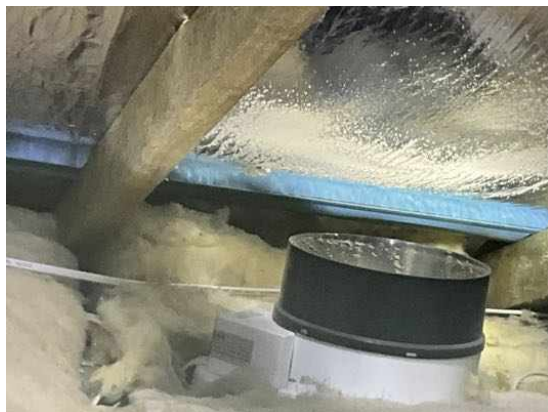
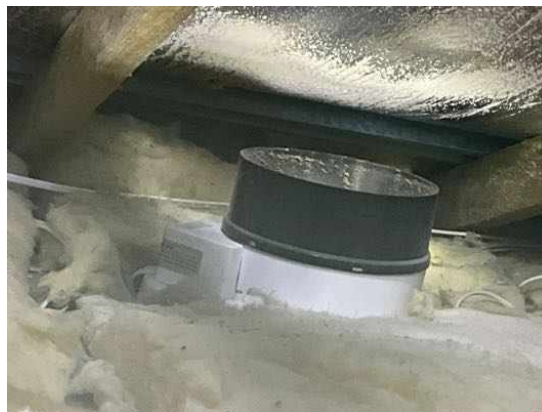
Finding 3.07

Building: Main Building
 Location: Roof Void
 Finding: Exhaust fan not vented out
 Information: The exhaust fan located within the roof void is not appropriately ducted to the external atmosphere and is currently discharging moist air directly into the roof space. This is considered a defect under AS 4349.1, as it does not meet the minimum standard of residential building performance expected under normal residential building practices.

This condition may lead to excessive condensation within the roof void, increasing the risk of mould growth, deterioration of insulation, timber decay, and overall reduced durability of building elements. It may also result in poor indoor air quality, potentially affecting occupant health.

It is recommended that the exhaust fan be modified by a licensed HVAC contractor or qualified builder, ensuring it is properly ducted to discharge externally in accordance with manufacturer specifications, the National Construction Code (NCC), and applicable Australian Standards.

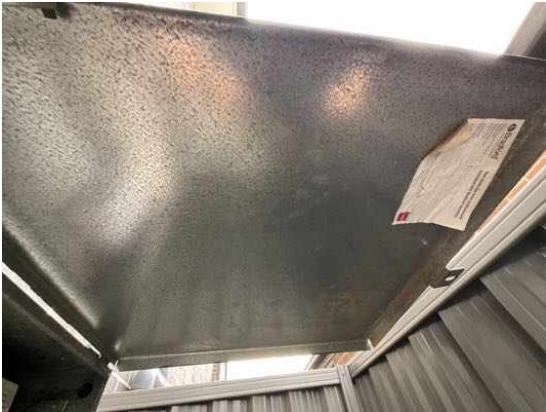
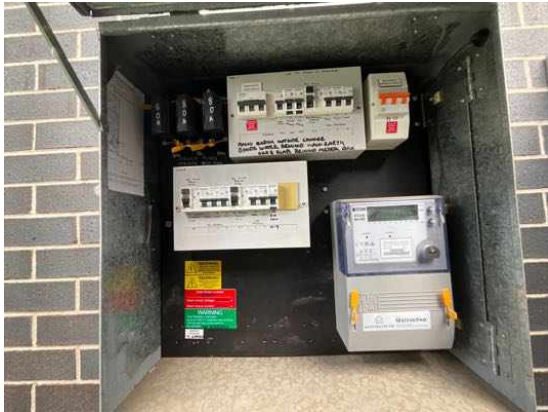
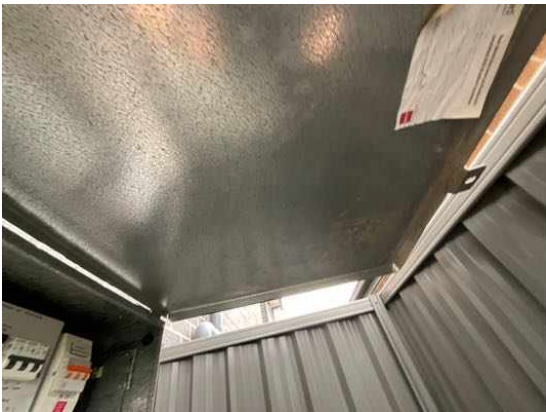
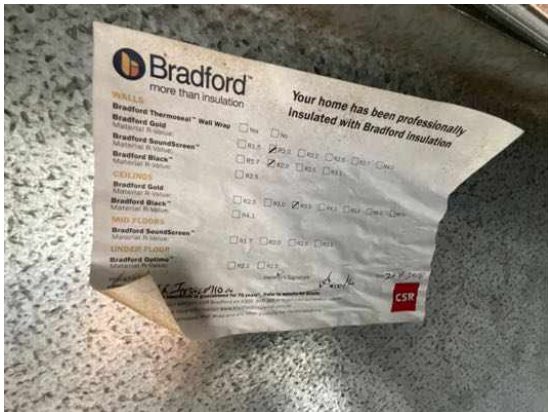
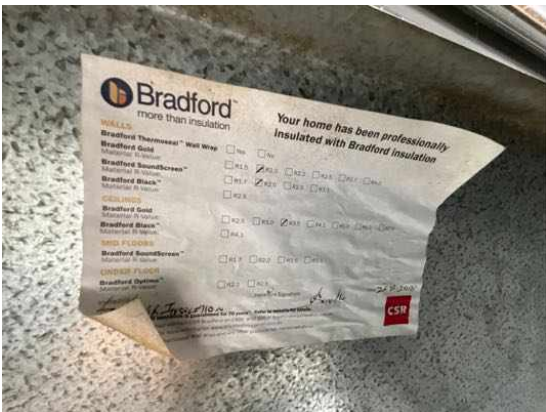
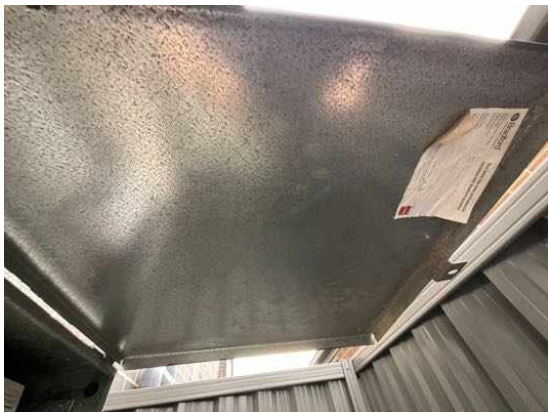
Building:	Main Building
Location:	Exterior walls - right side
Finding:	No Evidence of Termite Management System - Durable notice / Legible Sticker
Information:	The application of a pre & post-construction chemical termite barrier is highly recommended for all properties. Such barriers are highly effective in preventing termite attack on any timber building elements throughout the property.

A durable notice was not placed in the switchboard unit to indicate current termite barriers is legible at the time of inspection.

Client must seek further information from the vendor or real estate agent if the conditions of termite management systems were maintained.

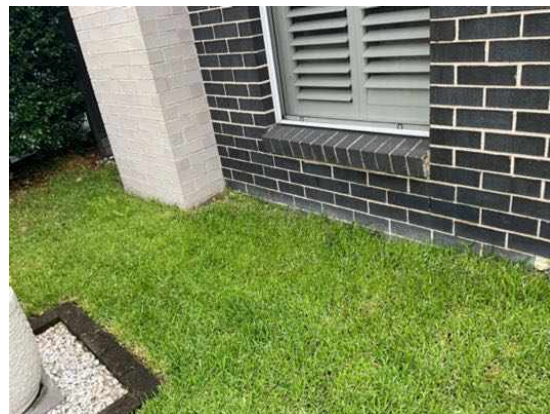
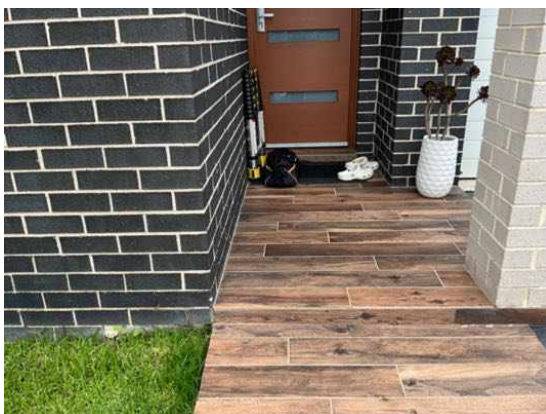
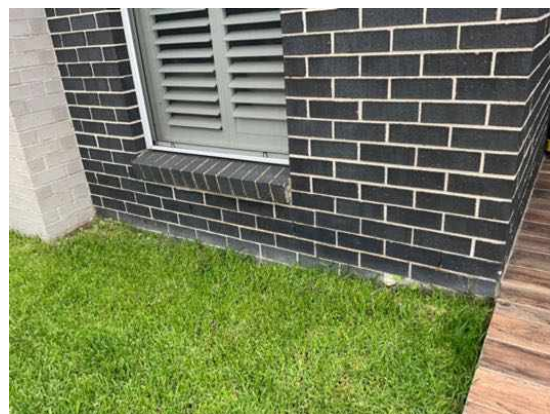
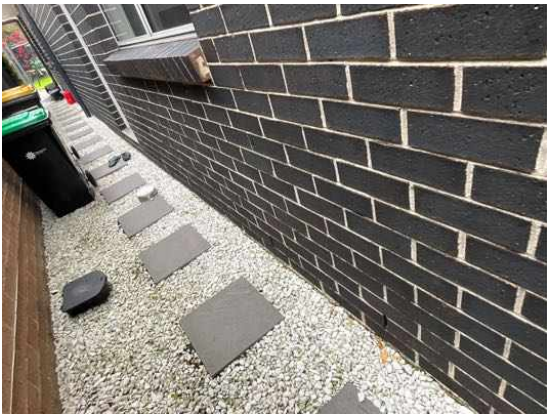
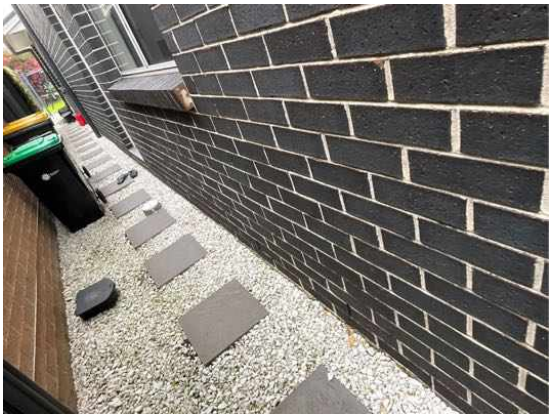
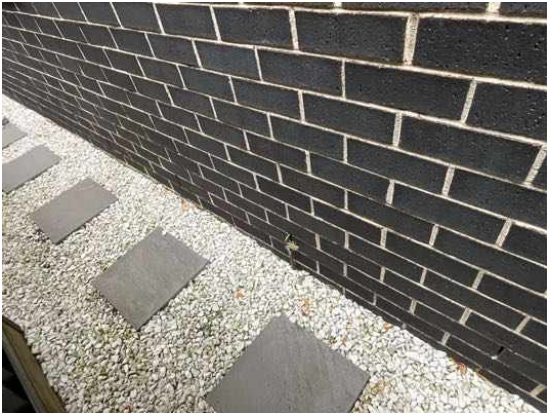
Finding 6.02

Building: Main Building
Location: All Areas
Finding: Slab Edge - Exposure
Information: An inspection zone of at least 75mm in relation to the exposed slab edge, between the bottom brick and the perimeter pavement, is required. This inspection zone should be maintained in order to force termites into the open where they can be detected more readily during regular inspections. The slab edge should not be concealed by anything that may prevent inspection of the area, including render, landscaping, soil, turf, paving, concrete cladding or other structures.

If the slab edge is not properly exposed there is a high risk of termite attack. Sometimes, in order to determine the type of slab, a suitably qualified person such as an architect or builder may be required to consult the construction plans.

Where the slab edge cannot be properly inspected, it is highly recommended that termite or timber pest inspections be carried out every 6-12 months to aid protection of the property against infestation.

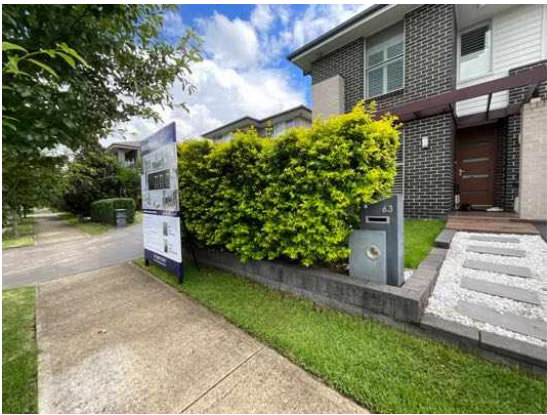
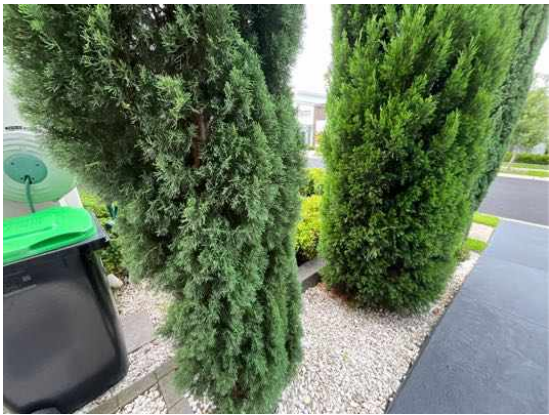
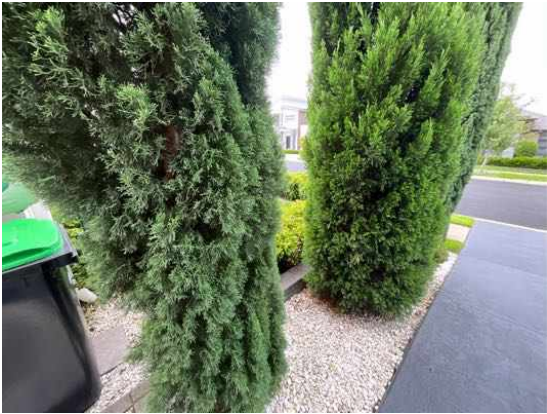
Finding 6.03

Building: Main Building
Location: All Areas
Finding: Dense vegetation around a property can increase the risk of termite infestation
Information: The presence of dense vegetation around a property can increase the risk of termite infestation, as it provides a conducive environment for them. To address this, consider maintaining a clear space between the vegetation and your home. If you suspect a termite issue, it's advisable to consult with a licensed pest control professional for inspection and treatment.

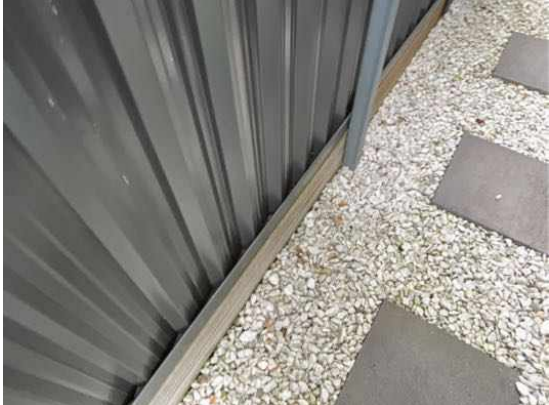
Finding 6.04

Building: Main Building
Location: All Areas
Finding: Timber on ground / conducive conditions to termite damage
Information: Timber on the ground is indeed conducive to termite damage. Termites are known to thrive in moist environments, and wood in contact with soil or moisture is more susceptible to infestation.

To prevent this, it's important to keep timber elevated and away from direct ground contact. Regular inspections and proper termite control measures are also essential to protect your wooden structures from termite damage.

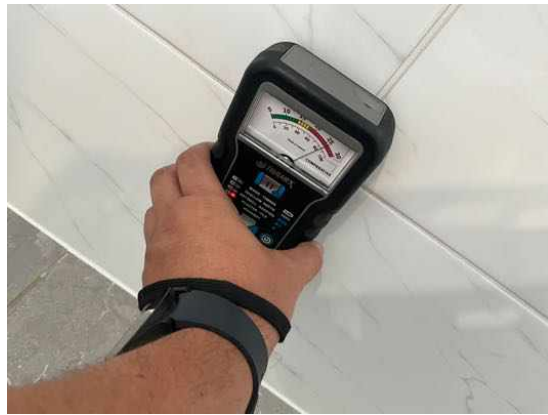
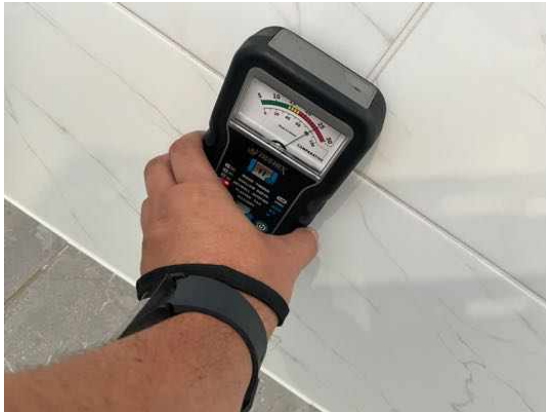
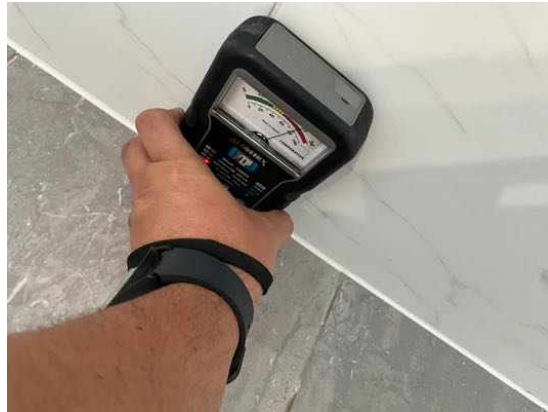
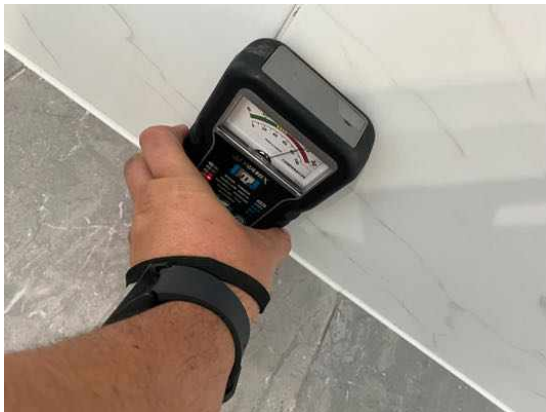
Building:	Main Building
Location:	Ensuite
Finding:	Excessive moisture - Conducive to Timber pest
Information:	Excessive moisture can attract termites and produce conditions that promote fungal growth and wood decay.

Excessive moisture is generally caused by deteriorated inadequate or missing roof drainage leaking plumbing pipes or fixtures poorly plumbed HWS overflows or condenser units and poor site drainage.

Prior to any remedial works being performed a qualified plumber should be appointed to further inspect the property and to identify the cause of the excessive moisture. Works to remove affected building elements may then be necessary and should be performed by an appropriate tradesperson.
