Building and Timber Pest Inspection Report VR

Inspection Date: Tue, 20 Jan 2026

Property Address: 3 Gower Cl, Wetherill Park NSW 2164,
Australia

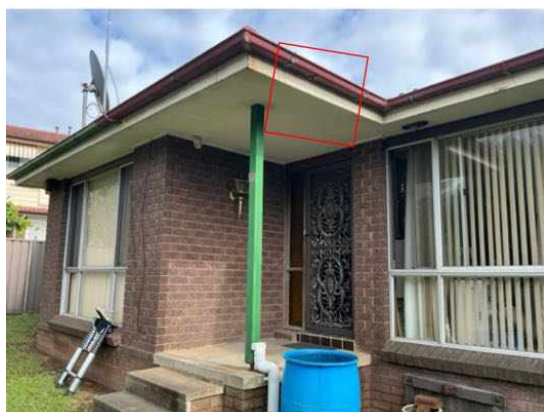
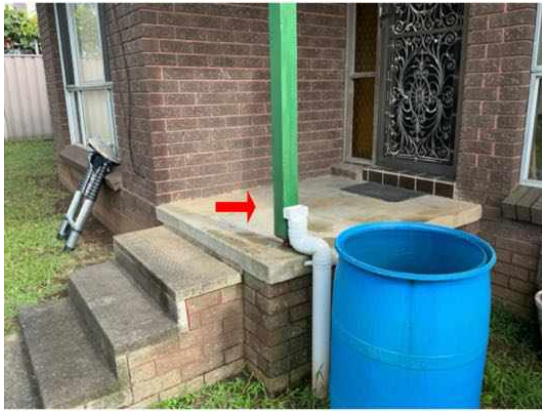
Where roof plumbing doesn't drain adequately, the area at the base perimeter can become excessively damp, potentially creating an environment that is susceptible to rust and corrosion of surrounding building elements, as well as attracting termites and other pests.

It is highly recommended that a plumber be appointed to further inspect the area and to install adequate drainage equipment where necessary.

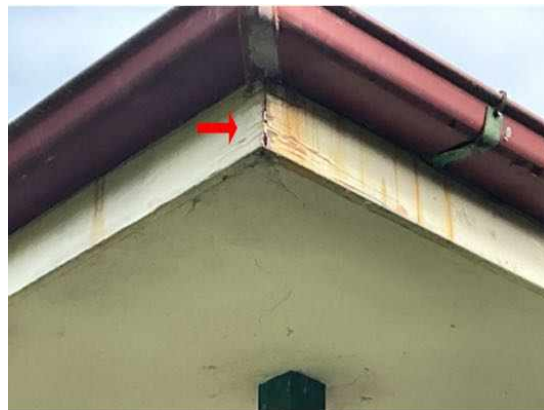
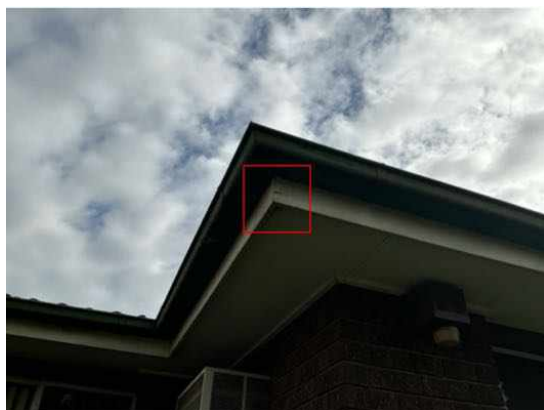
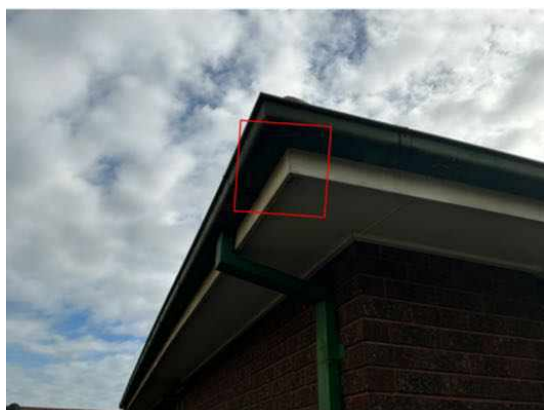
Finding 3.02

Building:	Main Building
Location:	All External Areas
Finding:	External Timber - Weathered
Information:	External timber elements around the property were observed to be showing signs of general wear and tear, including surface deterioration, fading, and early signs of weather exposure. These conditions are commonly caused by prolonged exposure to sunlight, moisture, and temperature fluctuations, which can lead to cracking, splitting, or degradation over time if not properly maintained.

It is recommended that all external timber be inspected and maintained to ensure ongoing protection. This may include sanding, sealing, or repainting affected sections. Regular maintenance will help preserve the timber's integrity, extend its lifespan, and prevent more extensive damage in the future.

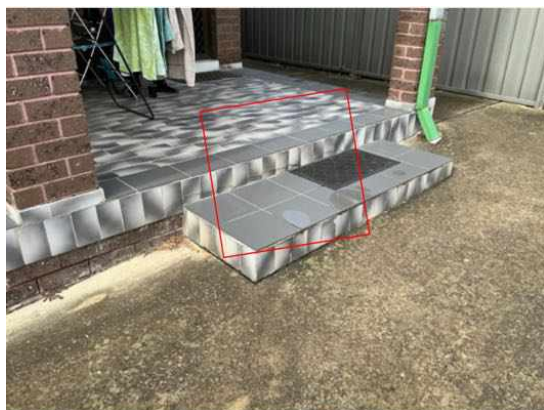
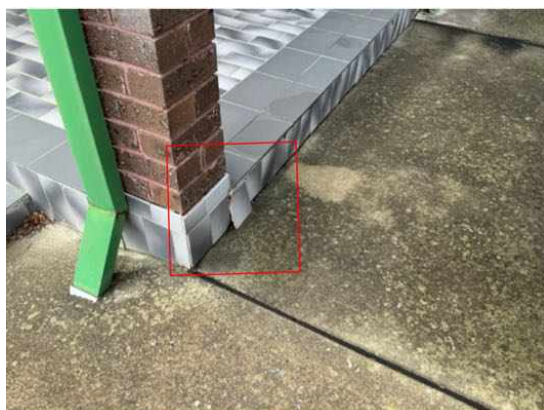
Finding 3.03

Building:	Main Building
Location:	Rear Patio
Finding:	Tiles - Cracked or damaged
Information:	Cracking was evident to the tiling in this area at the time of inspection. While the cracking appears to be minor, this area is frequently exposed to water, allowing potential for water penetration into adjoining sections of of the home.

If left unmanaged, water penetration to these areas may lead to subsequent water damage, which is likely necessitate repair work to affected building elements. This can be seen in the photos.

A tiling contractor should be appointed to ensure that no further water damage occurs. The re-application of silicone and grouting throughout remaining tile work is also advised, to further protect the area against water penetration.

Where water penetration has led to water damage, appointment of a relevant tradesperson may be required to repair damaged building elements.

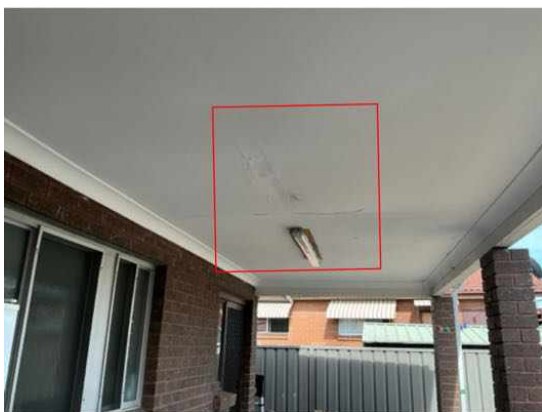
Finding 3.04

Building:	Main Building
Location:	Rear Patio
Finding:	Water staining - Ceiling Previous
Information:	Water staining was evident on parts of the ceiling at the time of inspection. Water staining indicates that surfaces have been exposed to excessive moisture over time. The minerals and other elements in the water lead to staining, which may graduate to deterioration if left unmanaged.

While mostly an appearance defect, water staining can be indicative of more serious defects, which may be currently concealed by other building elements.

Where water staining is active, a licensed plumber must be consulted to identify the cause of the staining and to provide advice on any reparation works that may be required. Replacement of any broken or damaged structures is advised.

Conversely, where water staining is old and inactive, affected building materials may be repaired or replaced at client discretion. A qualified carpenter or registered builder may be appointed to perform these works.

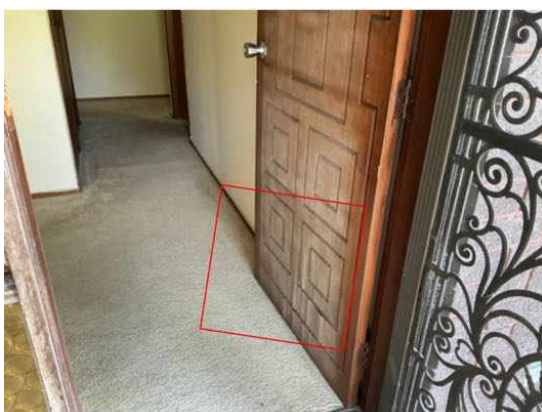
Finding 3.05

Finding: Door - Damaged Delaminating

Information: During the inspection, the entry door was observed to be in poor condition, showing extensive surface wear, swelling, and delamination of the door skin or veneer. This deterioration is likely due to age, moisture exposure, or general wear and tear over time.

Potential for further surface deterioration or structural weakening of the door panels.

A licensed carpenter or competent handyperson should be engaged to assess the affected doors and undertake repairs or replacement as required. Replacement with moisture-resistant or solid-core doors may be appropriate in higher-humidity areas to prevent recurrence.

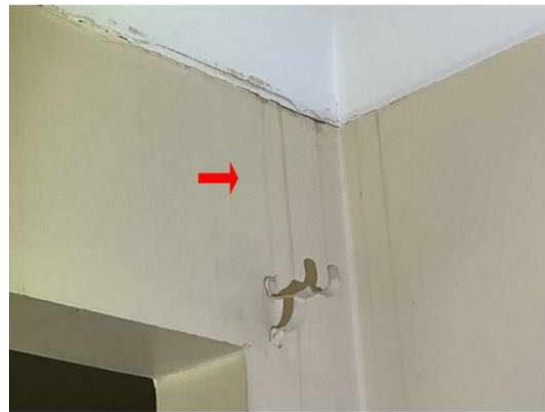
Finding 3.06

Finding: Water staining - Walls

Information: Water staining was evident on parts of the walls at the time of inspection. Water staining indicates that surfaces have been exposed to excessive moisture over time. The minerals and other elements in the water lead to staining, which may graduate to deterioration if left unmanaged.

While mostly an appearance defect, water staining can be indicative of more serious defects, which may be currently concealed by other building elements.

Where water staining is active, a licensed plumber must be consulted to identify the cause of the staining and to provide advice on any reparation works that may be required. Replacement of any broken or damaged structures is advised.

Conversely, where water staining is old and inactive, affected building materials may be repaired or replaced at client discretion. A qualified carpenter or registered builder may be appointed to perform these works.

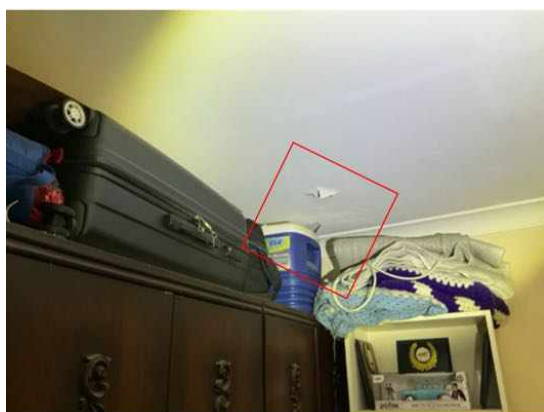
Information: Sections of paint in this area was found to have peeled and deteriorated. Paint peeling and or bubbling is generally an indication of excessive moisture in the area, that is currently hidden by the painted surface.

The presence of excessive moisture can have major implications on associated building elements if left unattended. While only seemingly minor at this stage, the damage cannot be determined due to the paint obstructing any further inspection of the damage.

It is highly advised that the affected paint be cleaned to allow a further, more invasive inspection by a licensed plumber. Failure to act on this defect may necessitate major works in the future.

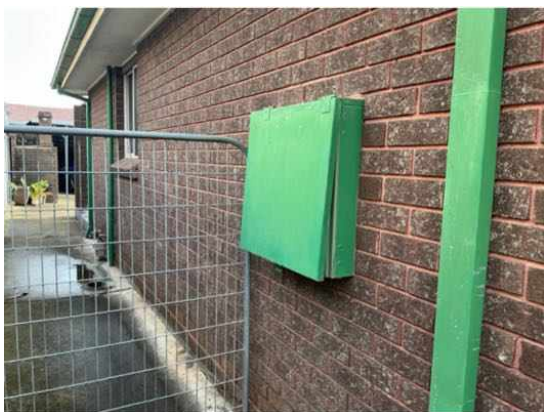
Evidence of this sticker has NOT been located in the meter box. Please see photos attached

Where a Termite Management System has not been identified you should consult a licensed pest inspector immediately to undergo further investigation in what measures would be necessary to maintain a functional pest management system. It is also recommended that a Licensed Pest Controller attend to determine the viability of the current or past treatments

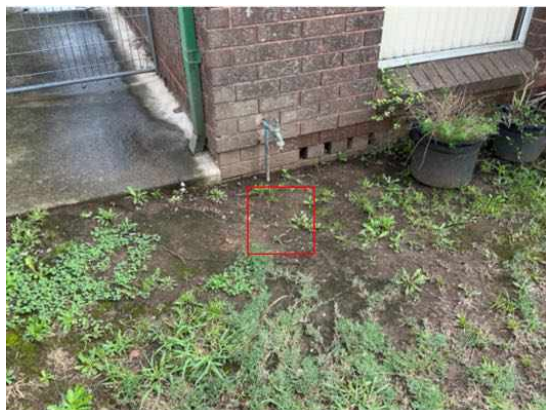
Building:	Main Building
Location:	All External Areas
Finding:	Outdoor Tap - Conducive
Information:	The external garden taps were found to have inadequate drainage at the time of inspection, creating potential for subsequent water damage to associated building elements. In this case the waste is not directly beneath the water tap which poses a significant risk of water pooling around the base of the tap which can result in a series of moisture related problems that could compromise the structural integrity of the property and create an unsafe environment.

Excessive moisture encourages the growth of mould and mildew, which can spread to other areas of the property. This not only affects the aesthetics but can also have serious health implications for occupants particularly those with respiratory conditions or allergies.

Stagnant water around an exterior tap can attract pests such as termites which thrive in moist environments. This creates a pathway for these pest to enter the property and cause extensive damage to wooden structures. The presence of termites can compromise the property structural integrity and lead to costly and invasive repairs if not promptly address.

It is highly recommended that a licensed plumber be engaged to inspect the exterior

tap area comprehensively and determine the best course of action. This may involve the installation of a stormwater drain or other drainage solution designed to redirect water away effectively by taking these measures the property owner or client can significantly reduce the risk of structural damage mould growth and termite attack insuring the property remains safe and well maintained

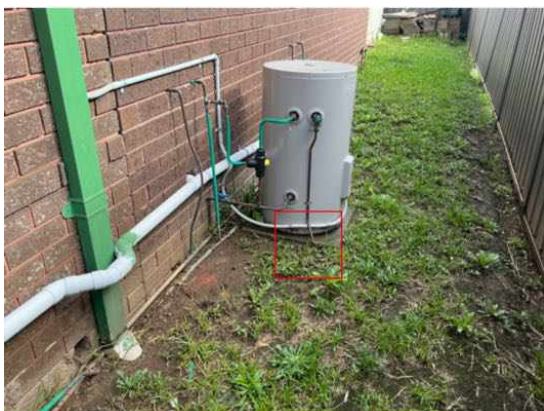
Building: Main Building
 Location: Exterior walls - right side
 Finding: HWS - Disconnected overflow
 Information: The Hot Water System overflow was found NOT to be connected to the storm water drainage and is creating excessive moisture in the surrounding area.

Poorly aligned materials can and will lead to further damage to nearby areas.

It is highly recommended that a licensed plumber be appointed to connect the A/C overflow in order to prevent such an environment from being created. These minor works should be carried out as soon as possible.
