Building and Timber Pest Inspection Report

Inspection Date: Tue, 27 Jan 2026

Property Address: 5 Flemington Pkwy, Box Hill NSW 2765,
Australia

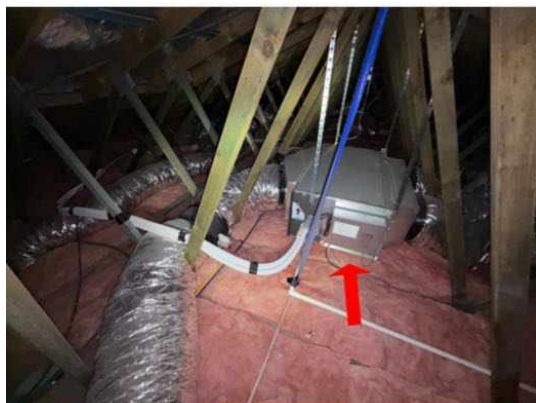
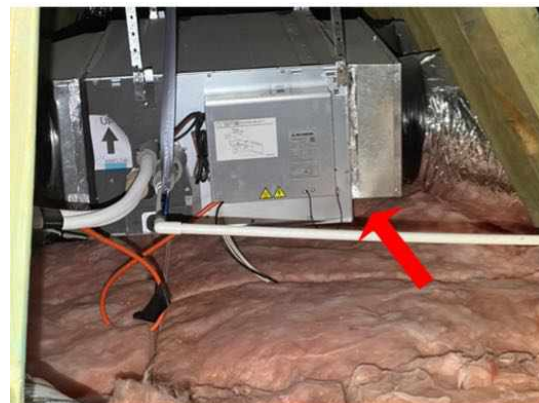
Finding 3.01

Building: Main Building
 Location: Roof Void
 Finding: HWS - Drip tray missing
 Information: The drip tray for the Hot Water System unit is missing, allowing leaks from the unit to affect the surrounding building elements. Generally, a drip tray will be installed to catch expected leaks from the unit, and allow them to evaporate without creating excessive moisture in the area.

Without a drip tray, the leaks from the HWS unit are creating conditions in the area that is likely to develop in the rust, corrosion, or wood rot of associated building elements. Additionally, excessive moisture creates an environment that is conducive to termite and timber pest activity, creating potential for further secondary damage.

It is highly advised that a licensed plumber be appointed to install the necessary drip tray in order to prevent any secondary damage.

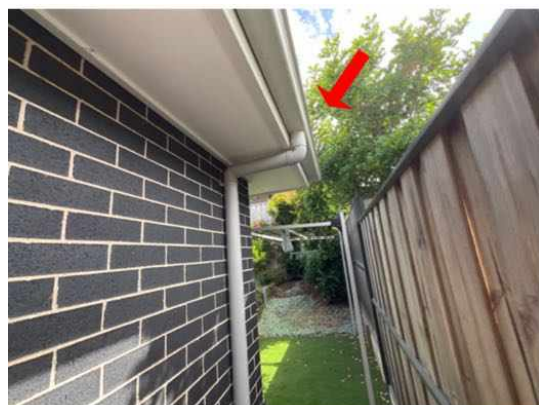
Finding 3.02

Building: Main Building
 Location: Roof Exterior

Finding: Trees - Overhanging and filling gutters
 Information: Overhanging trees often result in excessive amounts of leaf debris accumulating in gutters.

Gutters are a critical part of the building's management of storm water and rain. It is therefore important that they be kept clear to prevent secondary damage to associated building elements, including exterior and interior walls, ceiling linings and any adjoining building elements. Where gutters are blocked, pooling of rainwater is likely to occur, fast-tracking rust and corrosion of the roof plumbing elements.

It is highly advised that all overhanging tree branches be removed as soon as possible to prevent any further damage. Repair and/or replacement of sections of damaged guttering may also be required where the extent of the damage necessitates.

Such works should be performed by the homeowner; however, appointment of a landscape contractor or an arborist may be required. Consultation with a licensed roof plumber is required where guttering has been damaged.

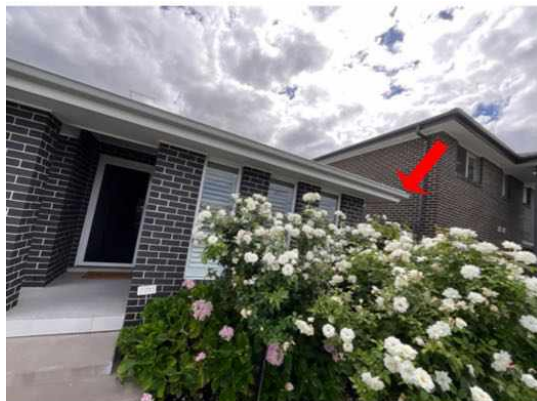
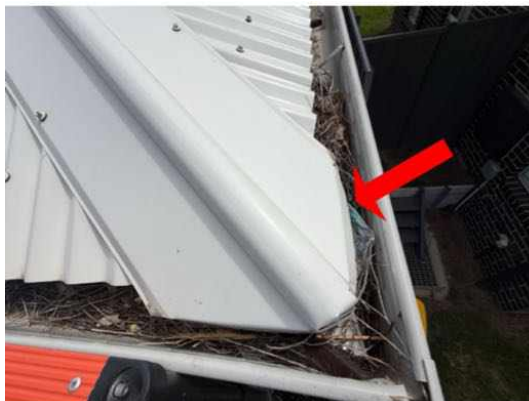
Finding 3.03

Building: Main Building
 Location: Gutters >
 Finding: Gutters - Debris
 Information: Roof plumbing structures, such as guttering and downpipes, should be free of all debris to prevent blockages. Blockages of the guttering and downpipes will lead to pooling and accumulated water overflows, which is likely to subsequently flood eaves and exterior walls.

Blocked gutters are likely to lead to high levels of moisture in the affected areas. Such moisture will not only cause rust and decay of the associated building materials, but can also provide conditions that are conducive to termite and timber pest activity. Blockages in gutters should therefore be removed immediately to ensure dry

conditions are maintained.

Consult a Licensed Plumber for further specific advice on remedial works that may be required. In the interim, it is highly advised that blocked gutters be removed by the homeowner or a general handyperson as a matter of urgency.

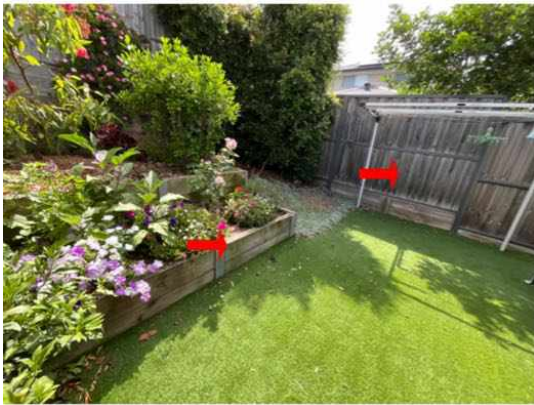
Finding 6.01

Building:	Main Building
Location:	Fencing & Landscaping
Finding:	Building materials in direct ground contact - conducive to termites
Information:	Where timber elements are in direct contact with the ground and consequently moisture or dampness they become conducive to termite activity. Whether timber is used as a building element part of a fencing structure or stored as an unused item they can provide an environment that is attractive to termite infestation.

When met with excessive moisture timber begins to decay and develop wood rot. Any timbers that are in direct contact with external grounds especially if left untreated or non-durable also provide ingress for subterranean termites into that particular element.

The removal of any such materials that may be conducive to termite activity should be removed as soon as possible to minimise the risk of termite attack.

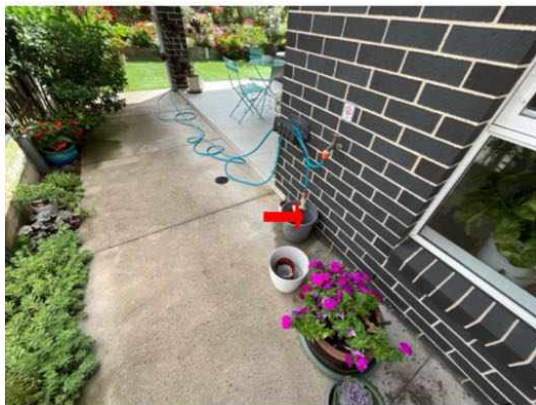
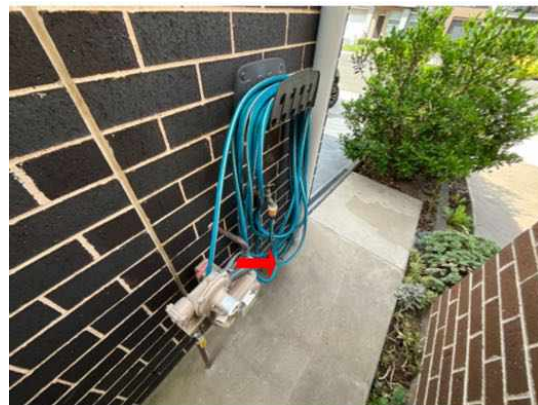
Finding 6.02

Location: External tap

Finding: Tap - No drain

Information: The external tap in this area was noted to have no drain at the time of inspection.

This keeps the surrounding surfaces damp while using the tap, which becomes conducive to termite activity.

A licensed plumber must be appointed to ensure an appropriate drain is installed.

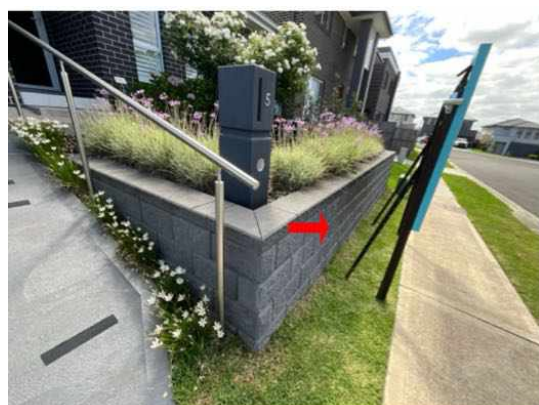
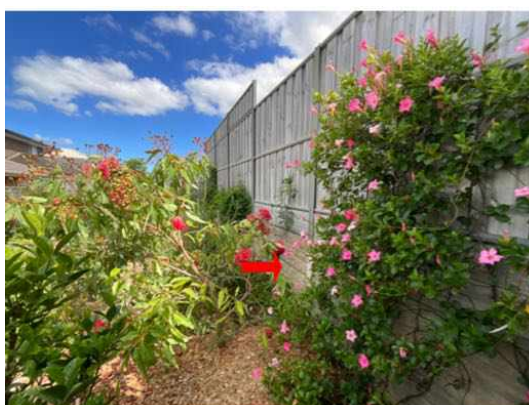
Building: Main Building
 Location: Retaining walls
 Finding: Retaining walls
 Information: At the time of inspection the retaining walls were checked and no defects were observed other than those which May have been mentioned earlier in this report.

AS4349.1-2007 requires all retaining walls in excess of 700mm to be inspected by a licensed and practicing structural engineer.

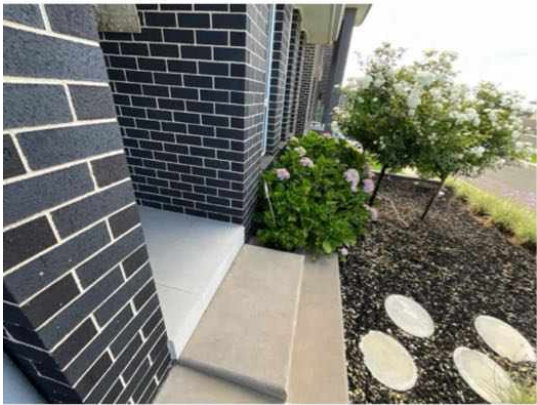
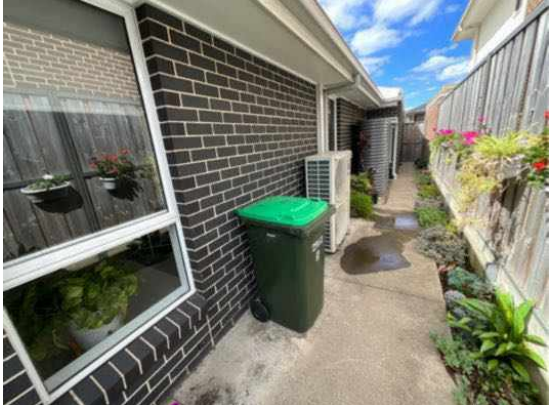
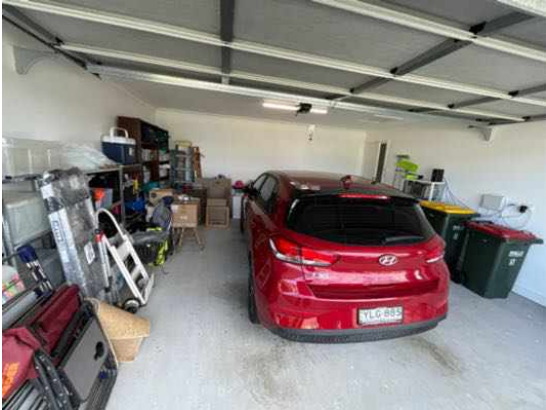
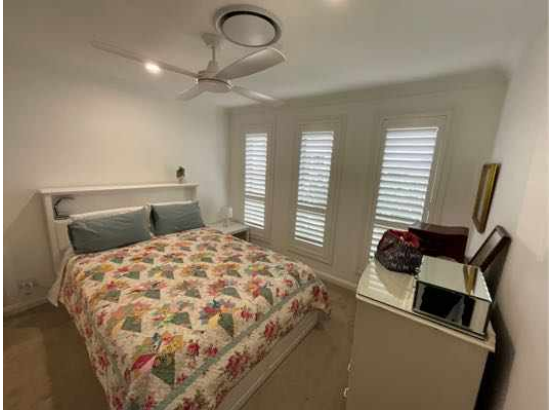
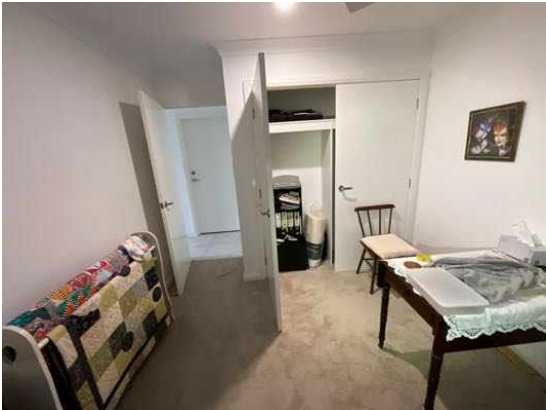
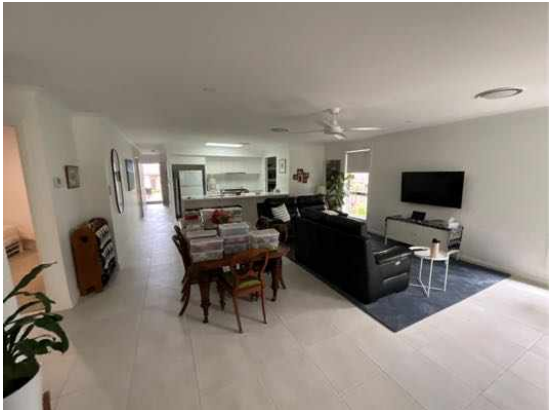
Building: Main Building
 Location: All Areas
 Finding: Additional Photos - Obstructions and Limitations
 Information:

These photographs are an indication of the obstructions and limitations which impeded full inspection of the property at the time of inspection. These obstructions can hide an array of defects and should be removed to allow full inspection to be carried out. A re-inspection is recommended once the areas are made accessible.

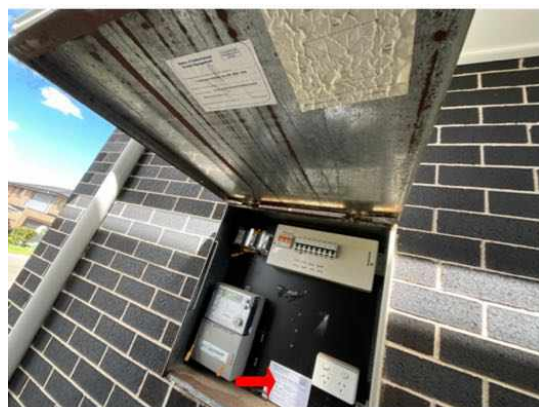
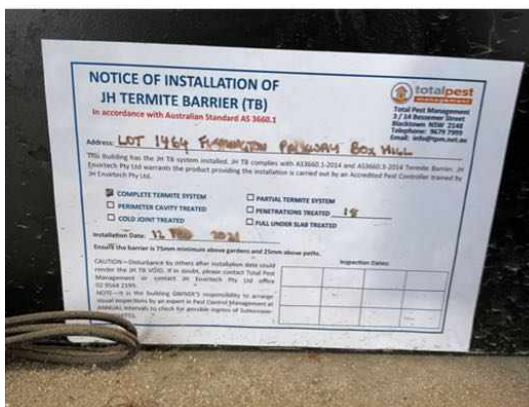
Building: Main Building
 Location: Meterbox
 Finding: Evidence of a previous termite management system was identified
 Information: There are a number of factors which indicate the presence of a previously installed or applied termite barrier. The most common are a durable notice (to the inside of your meter box) observable physical barriers installed to building perimeter and in ground reticulation systems.

Where a Termite Management System has been identified you should refer to the type of barrier date of installation warranty conditions and any documentation provided by a builder or past owner. Consult the company who installed the barrier to confirm whether the system is still under warranty.
