Building Inspection Report

Inspection Date: Mon, 16 Mar 2026

Property Address: 7/267 Princes Hwy, Corrimal NSW 2518,
Australia

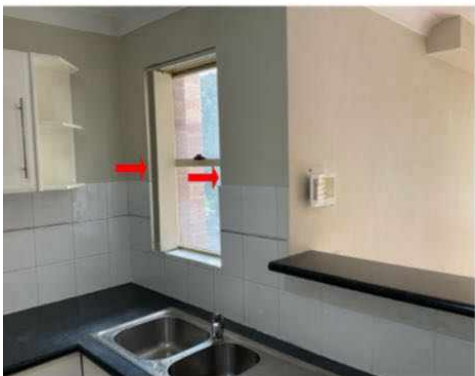
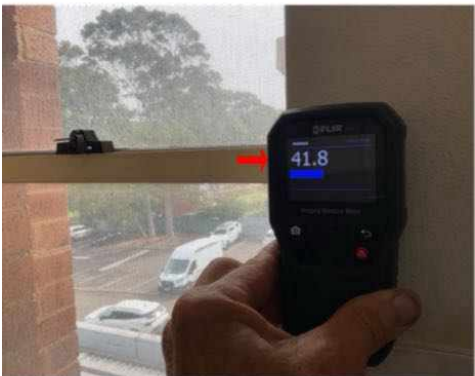
Defects 3.01

| Finding: | Evidence of excessive moisture was present at the time of inspection |

The following medium to high readings were found -

The kitchen fridge area is thought to be caused by a leak from the bathroom. In other areas the moisture ingress appears to be from the external wall areas.

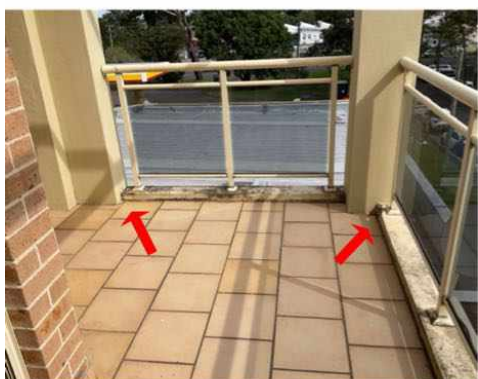
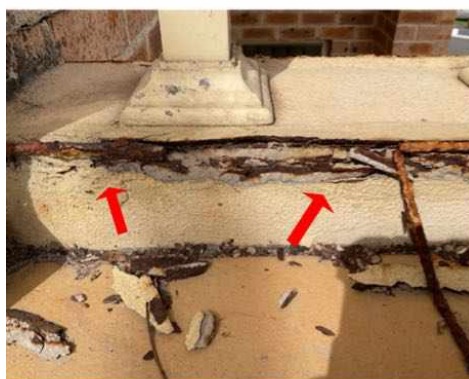
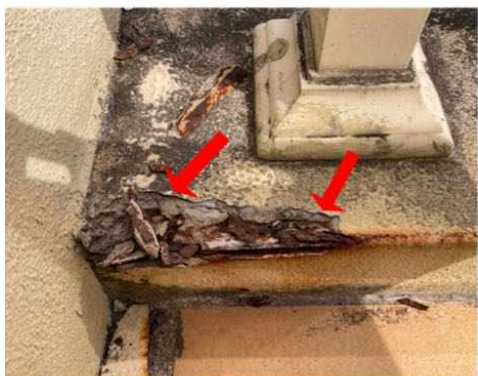
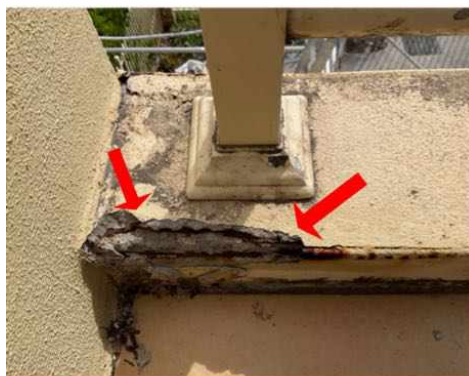
Defects 3.02

Building: Main Building
 Location: Many balconies
 Finding: Concrete spalling
 Information: These verandahs has suffered Concrete Spalling. This is the breakdown of concrete via natural weathering and/or chemical reaction that results in sections of cement chipping off the main body – often resulting in fractured, compromised concrete. Spalling looks like pitted acne scarring and breaks off in flecks which can expose rebar.

A concreting contractor can provide advice on repairs of this damaged concrete when convenient. Due to the number of balconies this appears to affect, the repairs appear to be very costly.

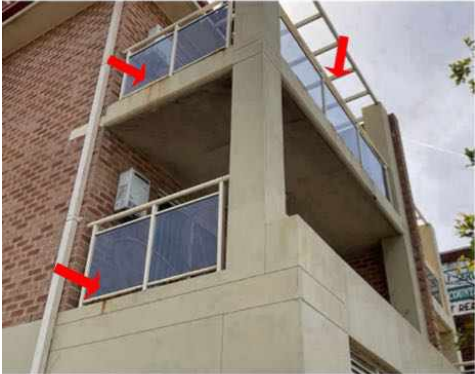
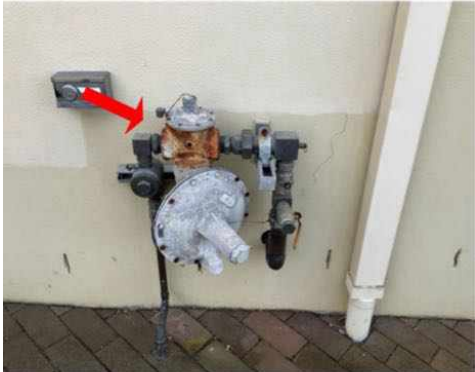
Defects 3.03

Building: Main Building
 Location: Exterior verandahs & vanity
 Finding: Areas rusted or corroded
 Information: These balconies and vanity area shows evidence of rusting and corrosion, which is likely to have developed as a result of excessive exposure to moisture and or inadequate coatings.

As surface rust provides no protection to the underlying iron, the deteriorating

condition is likely to worsen if not addressed in the short-term future.

Rusting and corrosion should be managed by ideally removing or limiting the affected surface from exposure to moisture. Many of these balcony areas will be, or may already be affected by concrete spalling like in unit 7 if these balcony areas are not sealed in the very near future.

The rusted vanity legs will also require replacement .

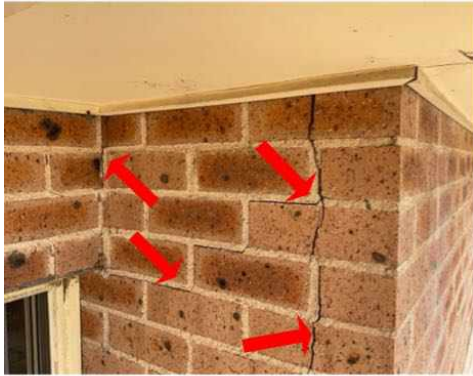
Defects 3.04

| Finding: | Brickwork - Step cracking (appears up to 3mm) |
| Information: | Step cracking of 2-3mm was identified to the brickwork 2 floors high in this northwest corner area at the time of inspection. Step cracking, which is similar to other forms of cracking, has a variety of possible causes. However, the most common is the subsidence of adjacent footings. |

Where step cracking is extensive or severe, the client is advised to consult a structural engineer. This minor step cracking can be used as a warning sign to address factors causing stress to the wall, which can include the effect of surrounding trees, water leaks, soil erosion, or even the presence of reactive soils in the surrounding area.

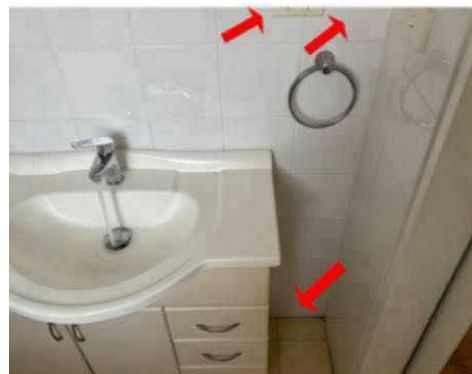
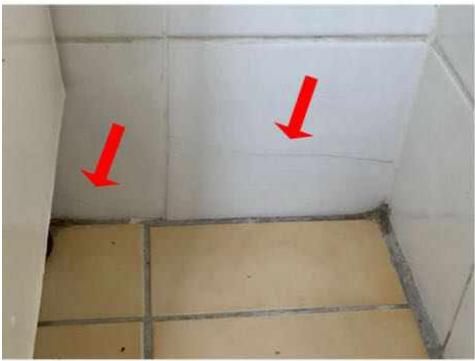
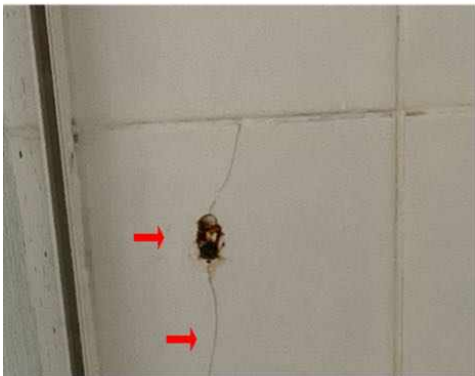
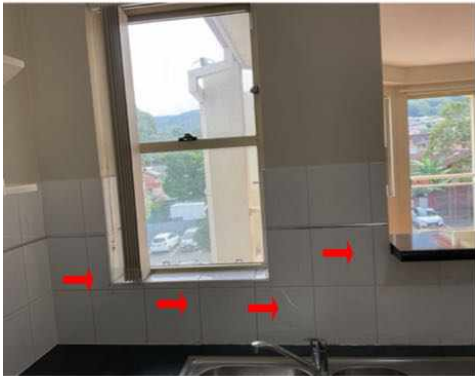
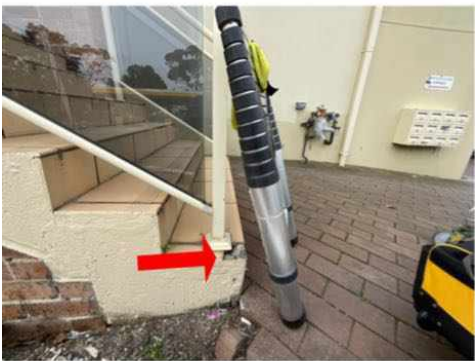
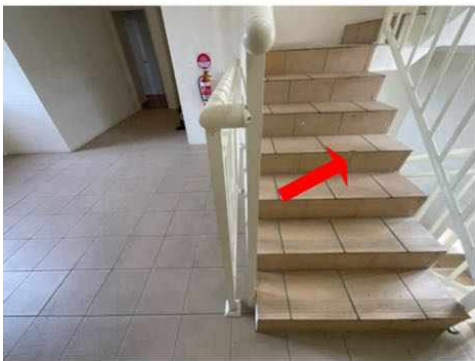
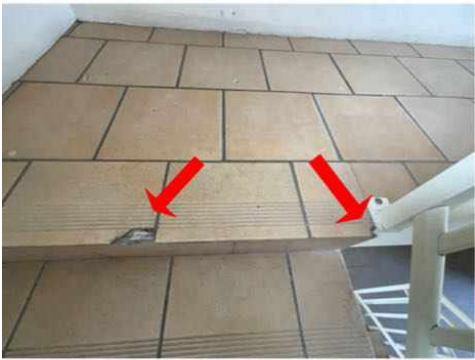
Defects 3.05

| Finding: | Cracked tiles |
| Information: | Cracking in many tiles was evident in these pictured unit and common areas at the time of inspection. It is suspected that this cracking has occurred as a result of settlement and impact damage. Cracked tiles throughout the household detract from the overall appearance of the affected areas however it is unlikely to create or lead to any secondary defects. |

Replacement of cracked floor tiles is recommended at the clients discretion. A tiling contractor may be appointed to perform these works.

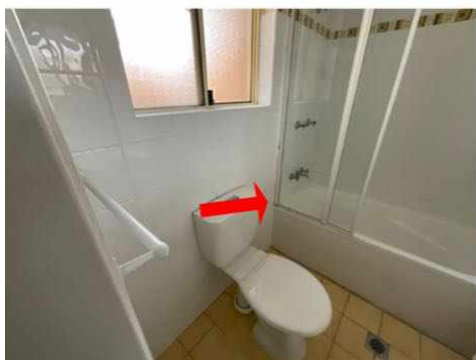
Defects 3.06

| Finding: | Shower screen - Leaking |
| Information: | Leaking was evident to the shower screening at the time of inspection. It is suspected that the leaking has occurred as a result missing sealant. Leaking from the shower , where left unattended, is likely to lead to water damage to adjoining flooring and walls. Such damage can lead to water damage and necessitate extensive remedial works being required. Active water leaks may also create an environment that is susceptible to the formation and development of mould. |

| | Appointment of a sealant expert is required to repair or replace this missing sealant. Such works should be performed as soon as possible to ensure that no further damage occurs. |

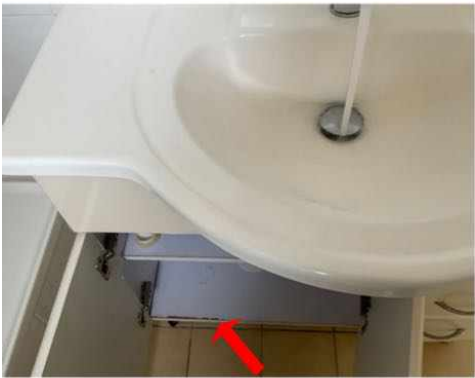
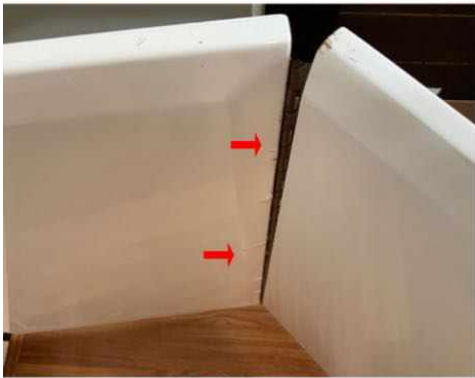
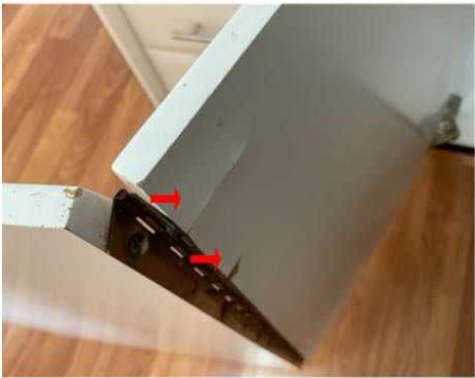
Defects 3.08

Building: Building 1
Location: Bathroom & kitchen cupboards
Finding: Vanity - Swollen and cupboards damaged
Information: Swollen and damaged building elements generally indicate that the building materials have been affected by excessive moisture over a prolonged period of time, and have swollen as a result. The structural integrity of this vanity cannot be guaranteed, and further damage is likely to develop if left unmanaged. Excessive moisture is likely to lead to the development of secondary damage to any associated building elements, which may necessitate major reparation works if left unmanaged. Repair and/or replacement of this vanity and cupboard should be conducted by a cabinetmaker.

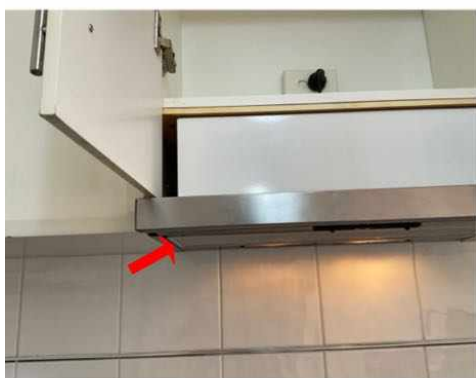
Defects 3.09

Building: Building 1
 Location: Kitchen
 Finding: Rangehood - pull out binding
 Information: While the range hood appears to be working at a satisfactory level, the pull out operation binds on the cupboard and has dents evident.

A electrician can replace rangehood this is required.

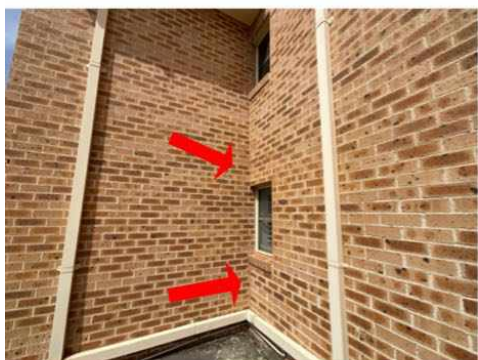
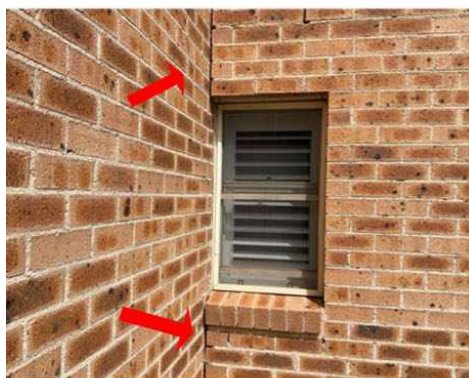
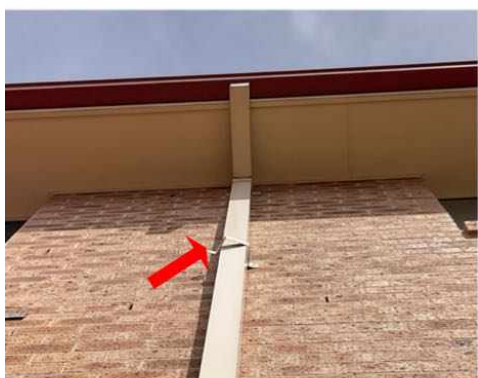
Defects 3.10

Building: Main Building
 Location: External Rear Corner Areas
 Finding: Expansion strip - Missing
 Information: No expansion strips have been installed in the control joints in this area. Although some building elements may seem, irrelevant or unnecessary, all elements play a key role in the operation and function of the overall structure and its performance.

Where expansion strips are missing, an entry point for vermin, termites and other pests is created. Excessive moisture is also likely to accumulate in this area, making the control joint susceptible to water damage.

One gutter bracket is also loose in this area.

Expansion strips should be installed prior to final handover to meet requirements. Failure to install these building elements is non-compliant with AS1720 Timber Structures.

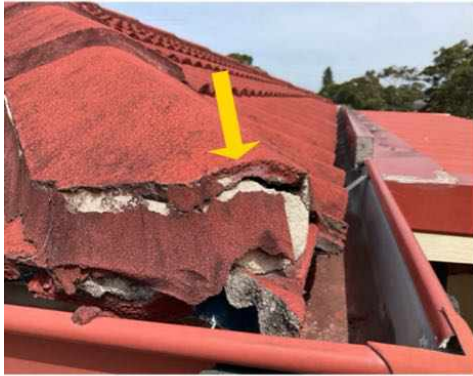
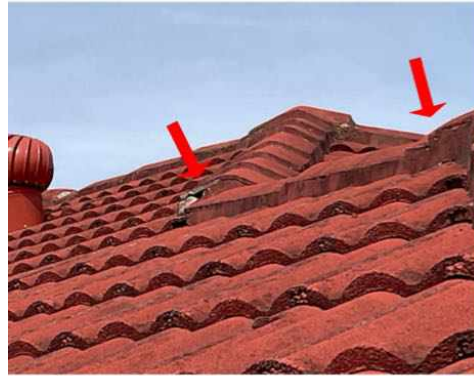
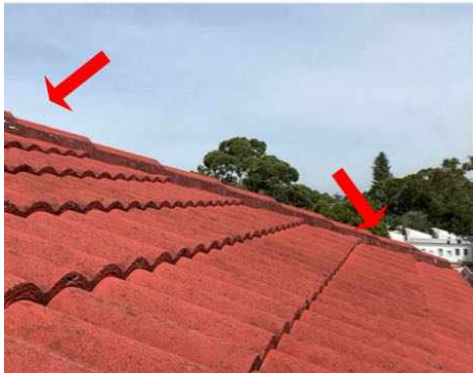
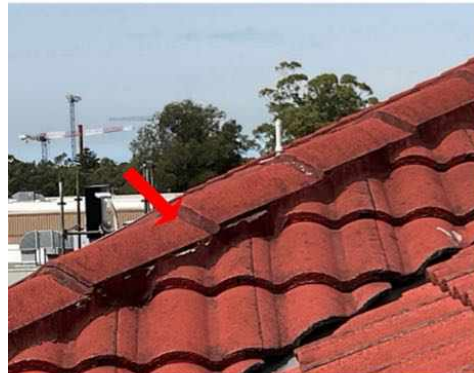
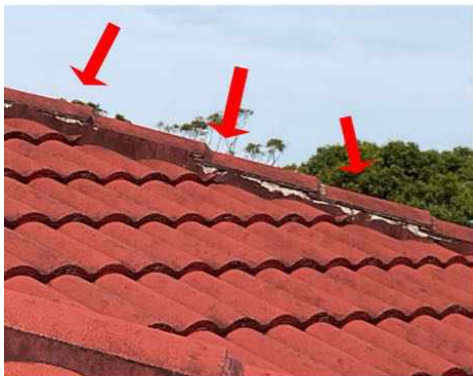
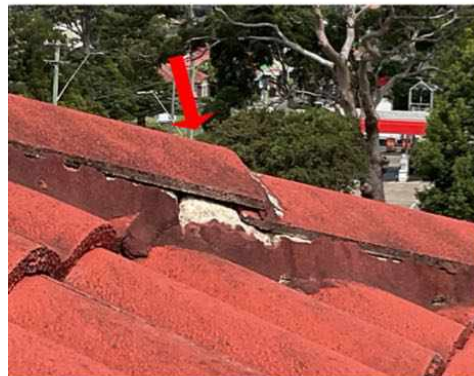
Defects 3.11

| Finding: | Mortar - Deterioration |
| Information: | Mortar, or 'bedding', is the material which fills joints and intersections between tiles and other building elements on the exterior roof covering, such as gable ends, hip capping and valleys. Upon inspection of the exterior roof, it was noted that many sections of the mortar show varying levels of deterioration. |

Mortar generally deteriorates as a result of frequent exposure to weather conditions over a prolonged period of time. Mortar that is deteriorating may allow water ingress into the roof void, putting associated building elements and roofing structures at risk of water damage. Deteriorated mortar also detracts from the functionality of roof tiles and other roofing elements, potentially decreasing weather tightness.

A roofing contractor is required to repair these areas before internal water damage occurs.

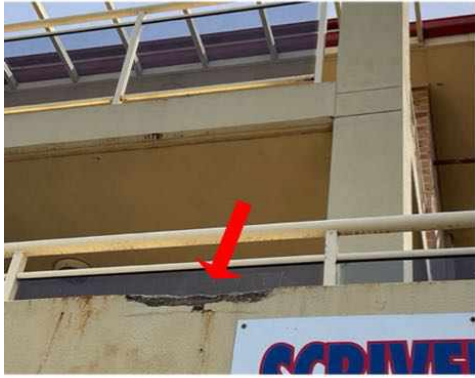
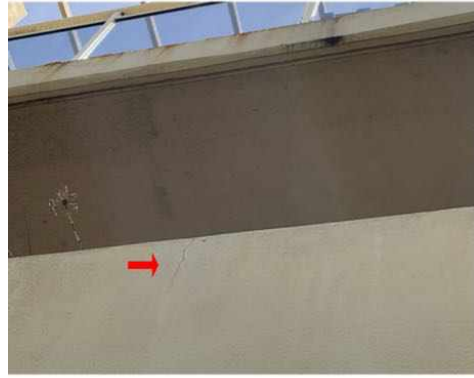
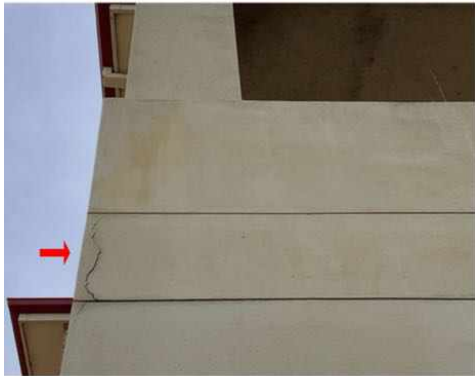
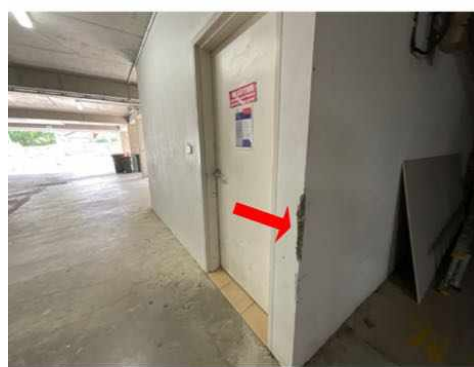
Defects 3.12

| Finding: | Render (external) cracking. |
| Information: | It has been observed that cracking to some external rendered surfaces. The degree of damage is described as noticeable cracks which are easily filled. Cracking of this size are generally less than 5mm in width. |

Always contact your building inspector should cracks widen, lengthen, or become more numerous.

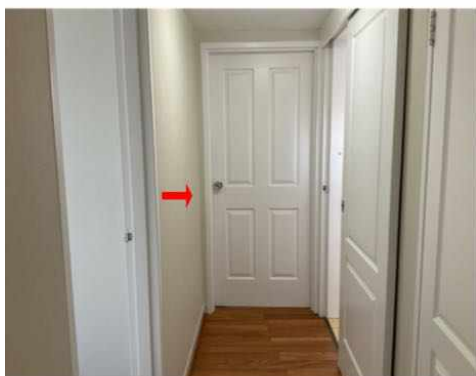
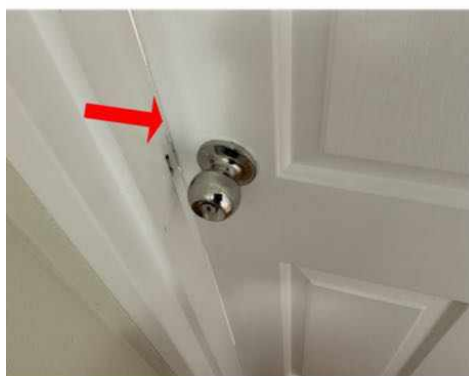
Defects 3.13

| Information: | Binding and/or jamming of this door is evident during standard operation. This defect inhibits the functionality of the affected door as well as creating potential for secondary defects to associated building elements, such as damage to the floor covering. |

A door that binds to flooring or to the associated door frame may have several causes, ranging from minor defects, such as poor installation of the door or deteriorated hinges, through to major structural issues, such as damage to subfloor structures. This door has a slight bow and requires sanding.

For minor causes, a qualified carpenter or general handyperson should be appointed to perform minor rectification works at client discretion.

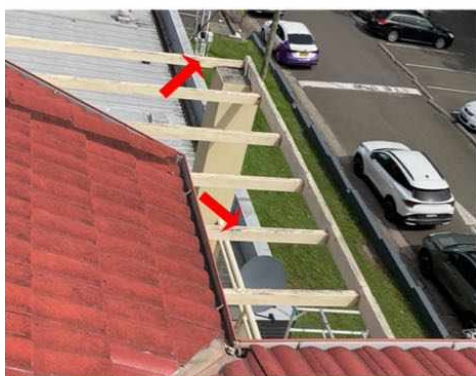
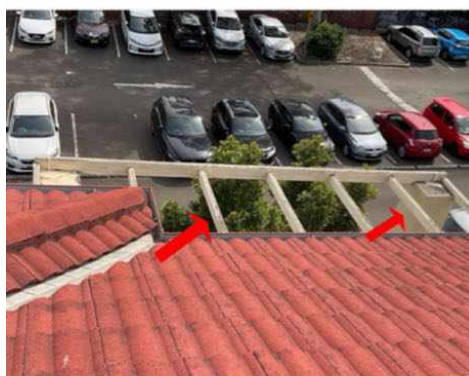
Defects 3.14

Building: Main Building
 Location: Roof pergola
 Finding: External painting deteriorated
 Information: Much of the external paintwork had never been painted or has been neglected and require attention to prepare and paint.

Whilst incomplete or missing paint finish is generally an appearance defect, it can also lead to the development of secondary building defects over time. Incomplete areas of paint finish expose the area to moisture, potentially accelerating the deterioration of underlying building materials.

Degraded paint finishes should be sanded back, filled, leveled and painted, as applicable. Where inadequate or missing paint protection has led to the deterioration of the associated building element, repair and/or replacement of this building element may be required.

A painting contractor should be appointed as soon as possible to perform necessary works to aid the appearance of the affected area and to ensure the area is protected against further deterioration. Alternatively, the homeowner following manufacturer instructions may perform these works.

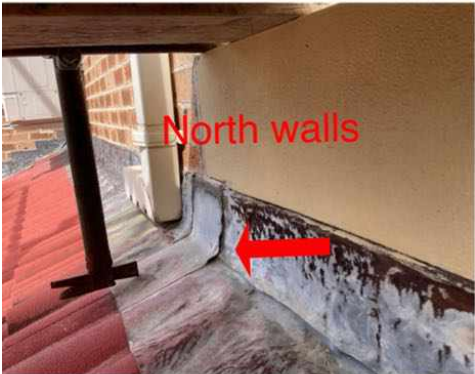
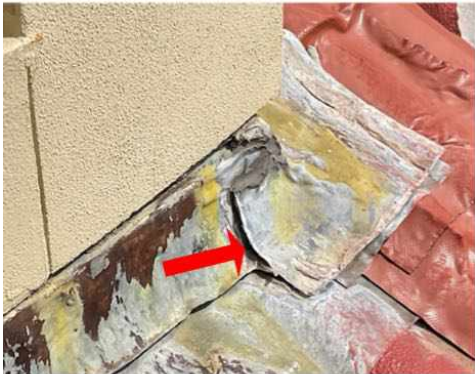
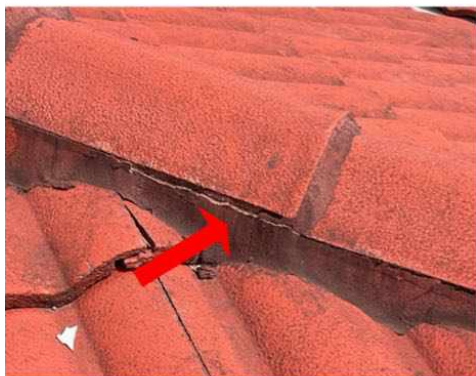
Defects 3.15

Building: Main Building
Location: Roof Exterior
Finding: Sealant (external) - Missing.
Information: It was noted on inspection that areas of external sealant was missing to small areas of the external roof areas.

Flexible sealants should be applied to these affected areas to prevent any subsequent water damage that is likely to occur.

A sealant specialist or skilled handy person should be appointed to complete these works as soon as possible

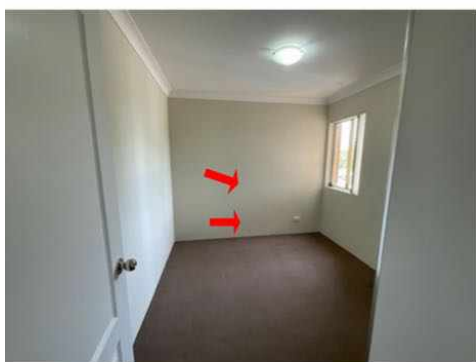
Defects 3.16

Finding: Cracks to internal render - Category 2

Information: It has been observed that cracking to internal rendered surfaces has occurred. The degree of damage falls within Category 2, described as noticeable cracks which are easily filled. Cracking of this size are generally less than 5mm in width.

Category 2 damage is required to be monitored for a period of 12 months. After the monitoring period, a crack rated at Category 2 or above is considered a defect requiring rectification.

Always contact your building inspector should cracks widen, lengthen, or become more numerous.
