# Building and Timber Pest Inspection Report

Inspection Date: Thu, 26 Mar 2026

Property Address: 31 Fairholm Grove, Camberwell VIC 3124,  
Australia

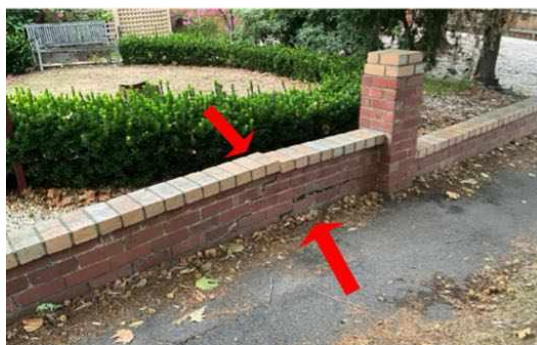
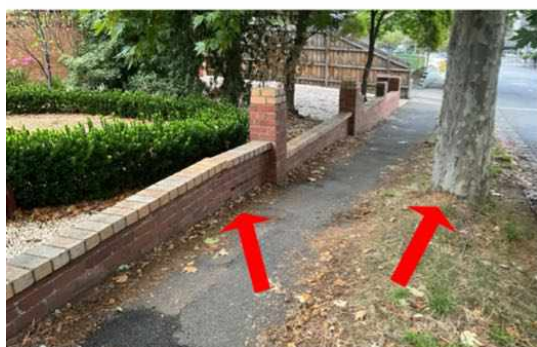
Finding: Brickwork - Step cracking noted within small brick retaining wall

Information: Extensive Step cracking was identified to the brick retaining wall at the time of inspection. This is classified as a major\* defect.

Step cracking, which is similar to other forms of cracking, has a variety of possible causes. However, the most common is the subsidence of adjacent footings, in this instance suspected to be caused by the presence of tree roots in the area.

Mortar failure in the gaps between affected bricks indicates the stresses and tensions affecting the wall.

Please note. As the defect is suspected to have been caused by the tree roots from the tree on council land immediately in front of this area, it is recommended that further enquiries be made to determine whether repairs to the brick wall may be covered by the council.

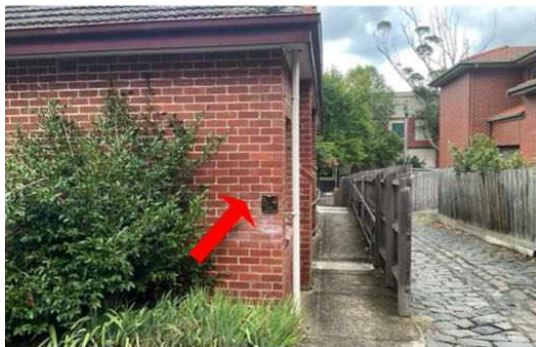
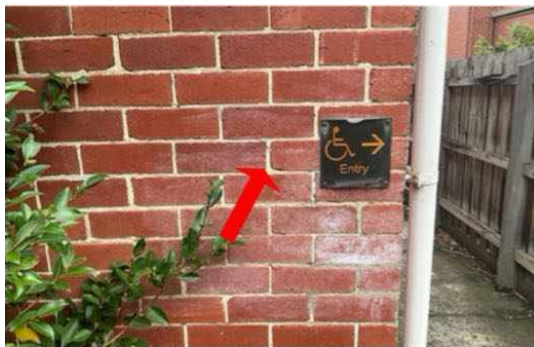
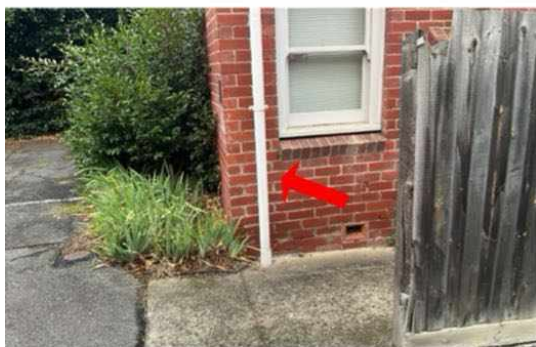
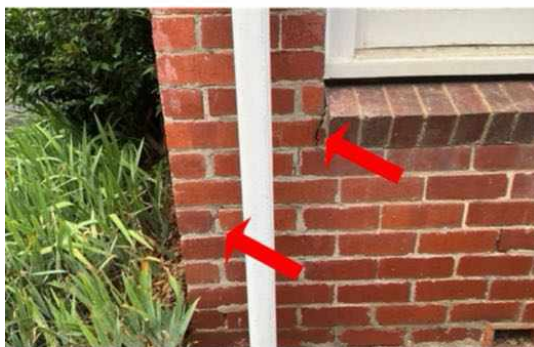
## Finding 2.02

Building:	
Location:	All External Areas
Finding:	Brickwork - Step cracking
Information:	Extensive Step cracking was identified to the brickwork in this area at the time of inspection. Due to the significant amount and the extensive nature of the cracking this is classified as a major defect*.

Step cracking, which is similar to other forms of cracking, has a variety of possible causes. However, the most common is the subsidence of adjacent footings.

Step cracking is a relatively common defect, and is most likely to occur adjacent to windows, doors and other openings. Mortar failure in the gaps between affected bricks indicates the stresses and tensions affecting the wall.

Where step cracking is extensive or severe or is coupled with other formed of cracking to the brickwork ( as noted here) , the client is advised to consult a structural engineer.

It is highly recommended that the cracking be monitored for a period of time e.g. six

months, to determine if there is any further cracking or active movement within the bricks. Should no further cracking or movement occur, the bricks may be patched by qualified bricklayer.

Should cracking increase, a structural engineer should be engaged. In that instance , Underpinning of the foundations may be required to stabilise the area and reduce the cracking.

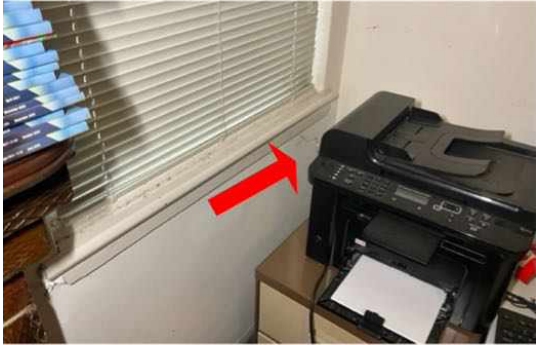
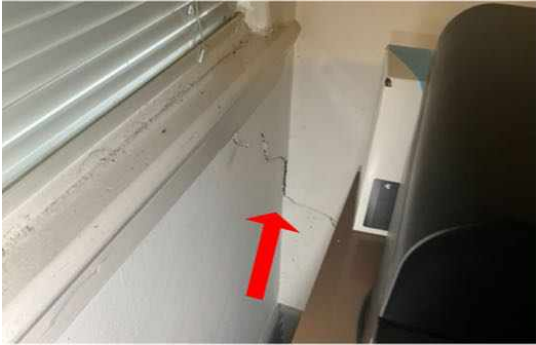
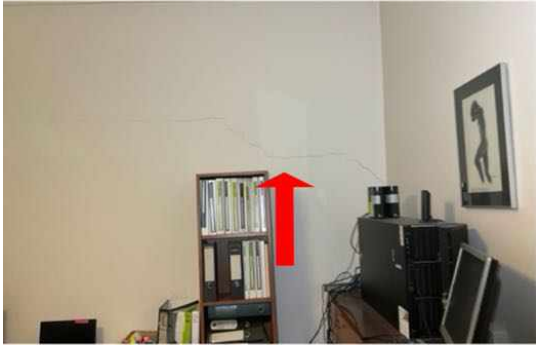
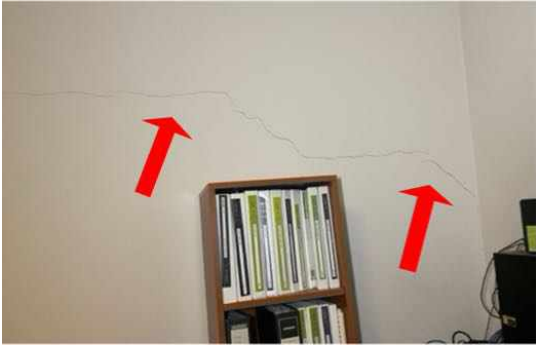
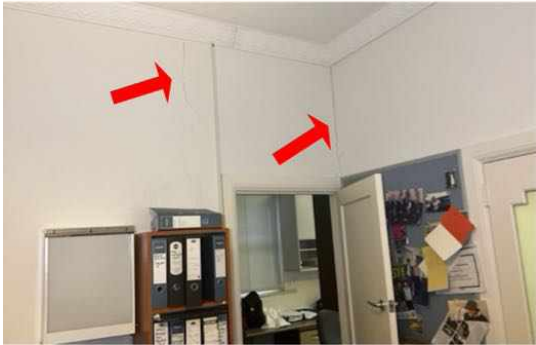
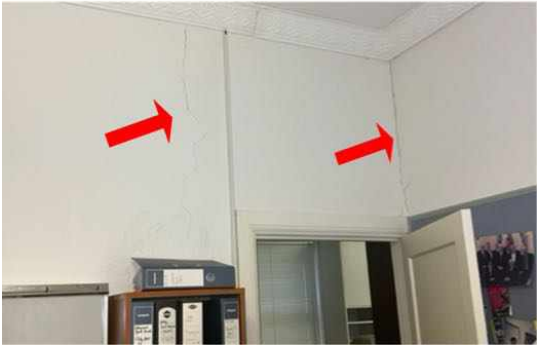
Finding: Cracks to internal solid walls

Information: It has been observed that cracking to some of the solid internal walls has occurred. Whilst some of the cracks may appear minor, a lot of them are extensive and in conjunction with the extensive step cracking to the external brickwork, is classified as a major defect.\*

Generally, the cause of cracking to solid surfaces is indicative of a slight movement of the building

Monitoring of all cracking should be conducted and should no further cracking occur, repairs should be undertaken. Cracking of this nature can generally be repaired with minor sanding, filling and/or repainting. Such works should be performed by a qualified painter or a general handyman.

Always contact a building inspector should cracks widen, lengthen, or become more numerous.

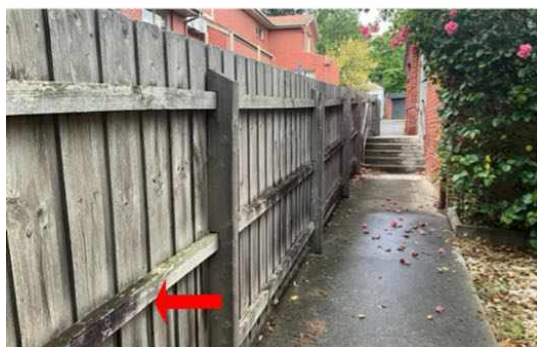
Finding: Fencing - Deteriorated

Information: It was noted at the time of inspection that sections of the fencing throughout the property have deteriorated, with wood rot and splitting of timbers noted. Due to the amount of repairs required, this defect is listed as a major defect\* .

Typically fencing deteriorates due to age and or wear, rot and or rust which is generally expected for a structure of this age, due to prolonged exposure to weather conditions. Sometimes inadequate installation or maintenance can be to blame. Significant wood rot was noted in sections of the fencing.

If left unattended, it is likely that further damage will occur. It is suspected that repair and replacement of several elements of the fencing will be required.

A licensed fencing contractor should be appointed to provide further advice and perform rectification works as necessary.

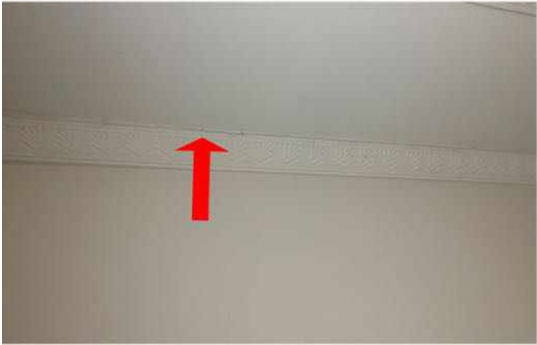
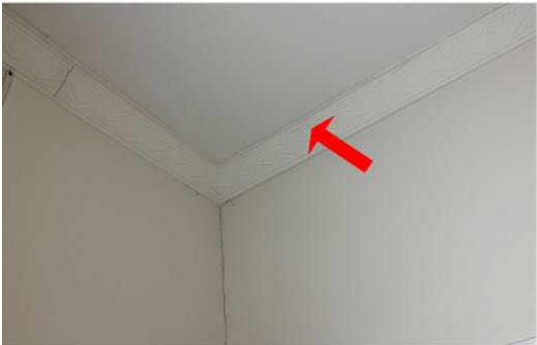
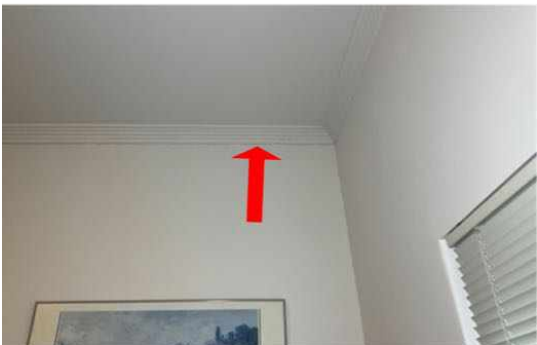
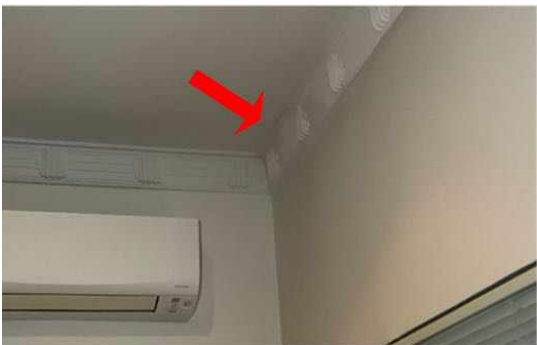
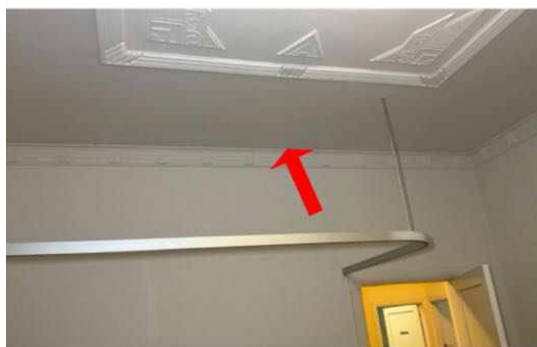
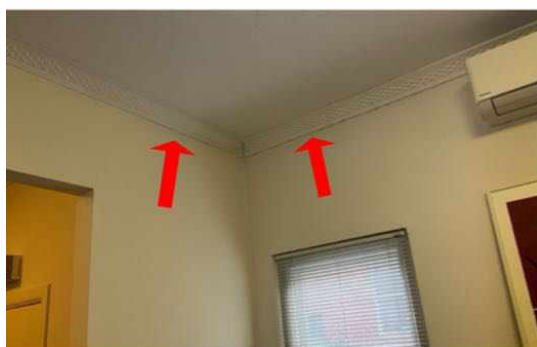
Finding: Cracking - fine

Information: Some fine cracking was noted throughout the property.

Although fine cracks are quite noticeable, they are often only considered to be an appearance defect, and usually do not indicate any structural damage. Generally, the cause of a fine crack is indicative of a separation between building materials and finishes (e.g. paint, plaster, etc.) along joints.

Note: photos included are indicative of fine cracking noted at the the time of inspection. Other fine cracks may be present but not recorded here.

Cracking of this nature can generally be repaired with minor sanding, filling and/or repainting. Such works should be performed by a qualified painter or a general handyman.

Monitoring of all cracking should be conducted frequently. Always contact a building inspector should cracks widen, lengthen, or become more numerous.

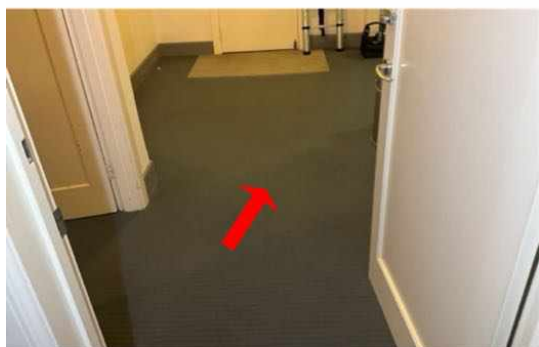
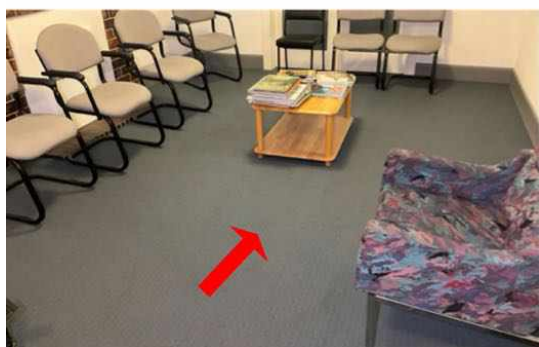
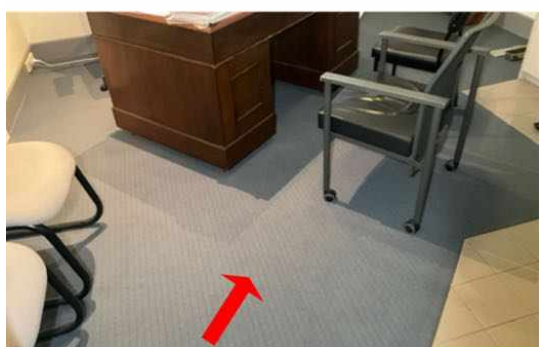
### Finding 3.02

Creaking floors generally indicate that the floorboards or the subfloor structures are coming loose from the supporting structure that they are installed on.

Please note: no access was available to inspect the subfloor. The purchaser should be aware that further defects may be present within the subfloor that cannot be inspected.

The areas should be monitored for any changes or unevenness. Should this occur, consultation with a registered builder should be undertaken to determine the cause. The potential resolution may involve regluing and screwing the floor down through to replacement of subfloor support structures.

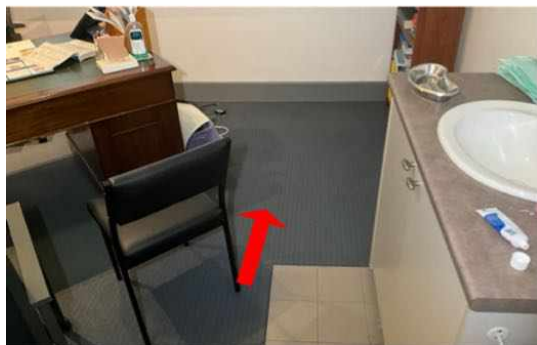
### Finding 3.03

Bouncy floors generally indicate that the floorboards or the subfloor structures are coming loose from the joists that they are installed on. Bouncy flooring may also be the result of gaps between flooring and stumps or joist structures, which require packing.

Please note: as no access was available to inspect the subfloor underneath this area the purchaser should be aware that more significant defects may be present that has caused this bouncing to the floor.

Where necessary, the client is advised to seek quotations for required repairs from a Registered Builder specialising in re-stumping. The potential resolution may range from packing gaps in subfloor structures through to replacement of subfloors stumps and refixing of flooring.

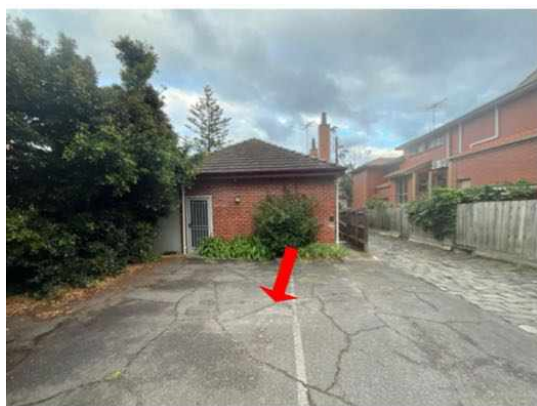
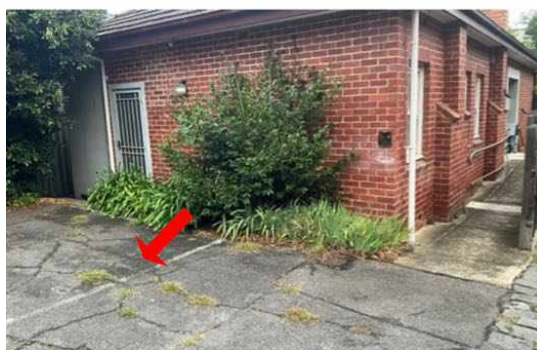
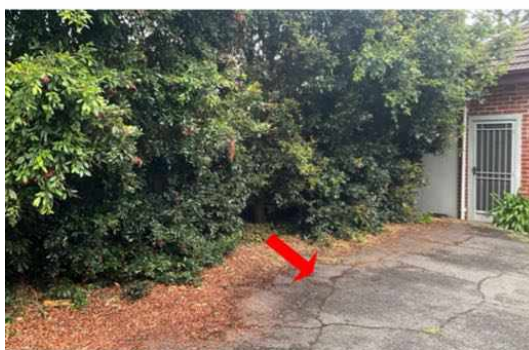
### Finding 3.04

Building: All External Areas  
 Location: All External Areas  
 Finding: Noticeable Cracking - External Concrete Paving  
 Information: Noticeable cracks were identified in the concrete paving at the rear of the property.

General age and expected deterioration of the paved areas is a common cause of this type of cracking. However, expansion and contraction of the concrete may also have occurred due to environmental factors. Such factors include variable moisture and weather conditions, the presence of trees and their roots having a settling or lifting affect on the soil, or the effect of load bearing over a sustained period of time.

Cracking to this degree may also be due to poor original installation of the concrete. Factors such as poor compaction of the sub surface and/or inadequate reinforcing of the slab may create cracking and other secondary defects. Noticeable cracks may also be due to subsidence of soils.

The area should be monitored for any changes that may occur and potentially cause tripping hazards. Should this occur, repair and likely replacement of the concrete paving may be necessary.

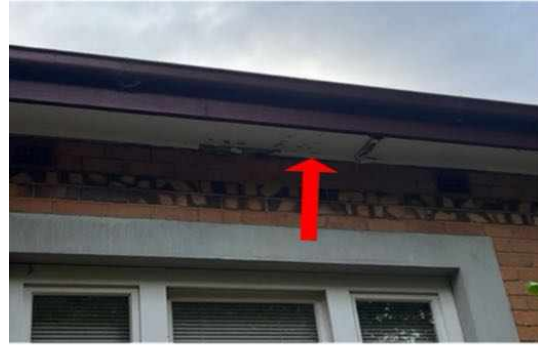
### Finding 3.05

Building:	
Location:	Eaves
Finding:	Eaves - Suspected previous moisture damage
Information:	At the time of inspection bubbling and peeling of the painted surface was noted to the eaves at the front of the property. It is suspected that this has been caused by a failure in the guttering system above creating excessive moisture within the area.

Please note: given the age of the property there is a high chance that the eave sheets may contain asbestos material. It is recommended that prior to any works being carried out on the eaves, an asbestos inspection and sampling be carried out to determine whether this is the case. Your Jim's building consultant can help you with this.

Where bubbling/ peeling is evident, the primary requirement is to identify and rectify the source of the leaking. Where the damage is still active a roofing plumber should be appointed immediately to identify the leak and perform rectification works as necessary, ensuring the moisture damage is restricted.

Once the leak is repaired, consultation with relevant tradespeople, including painters is advised. Rectification works may include replacement of eave lining or minor repainting, depending on the extent of the damage.

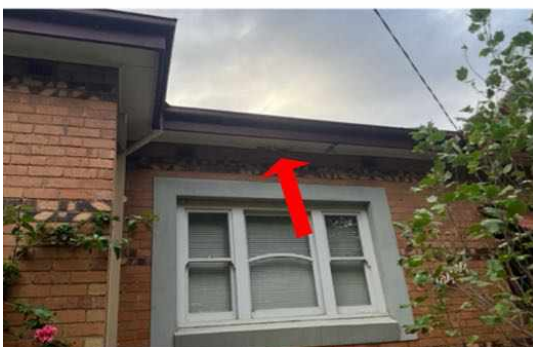
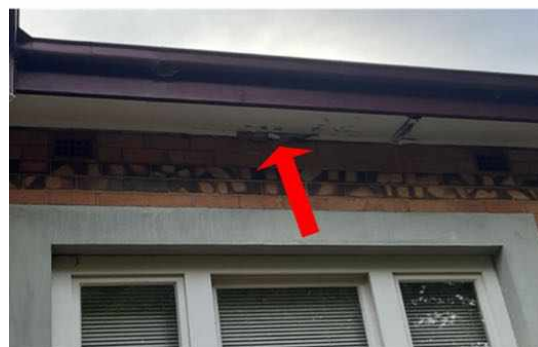
### Finding 3.06

Finding: Beads - Damaged

Information: Beading acts (like cornice or skirtings) to cover the intersection or joins of building materials. It was noted at the time of inspection that beading in this area has come loose. This deterioration is suspected to have been caused by general ageing and frequent exposure to weather, which is expected in a building of this age and condition.

Beading is important in weatherproofing the surrounding building elements and preventing termite or pest ingress. Furthermore, beading works to protect the joins of building materials, which are more susceptible to deterioration and decay.

Repair or replacement of the beading is advised to ensure the protection and longevity of any associated building elements. Such works may be performed by a general handyperson or qualified carpenter.

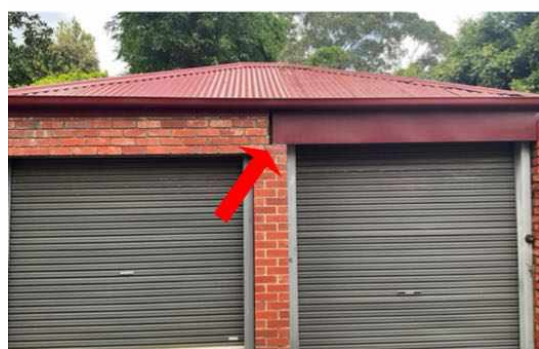
### Finding 3.07

Any gaps to the exterior walls of the building that are larger than 3mm are deemed a defect and require filling, beading or replacement of brickwork to close or cover the gaps. Such gaps create potential for pest ingress, excessive moisture and structural issues, and should therefore be minimised prior to the development of secondary defects.

Works should be carried out by a bricklayer or competent handyman to prevent secondary defects.

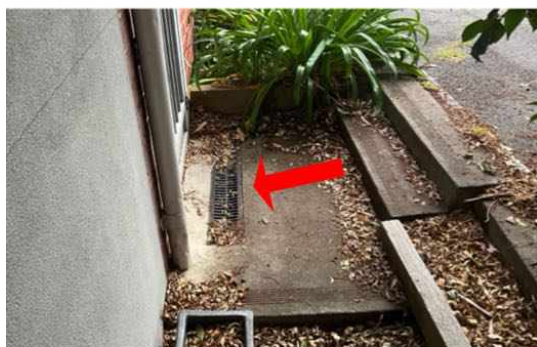
### Finding 3.08

Building: Exterior walls - rear  
 Location: Exterior walls - rear  
 Finding: Channel drain - blocked with leaves  
 Information: The channel drain in the path outside the rear door appeared blocked with leaves at the time of inspection. This has the potential to cause the drain to fail in its purpose of removing water from the area. The drains should be cleared as a matter of urgency to ensure water is channelled away correctly.

Failure to clear the drains of leaf litter may cause the drains to overflow and create moisture ingress issues within the property.

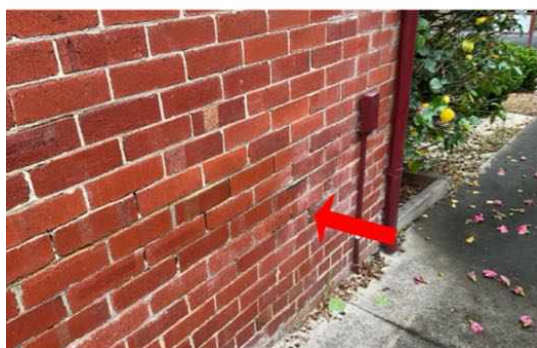
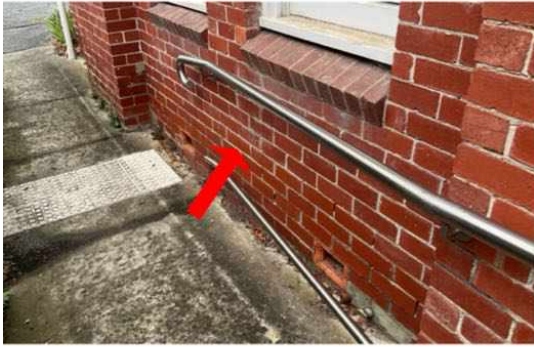
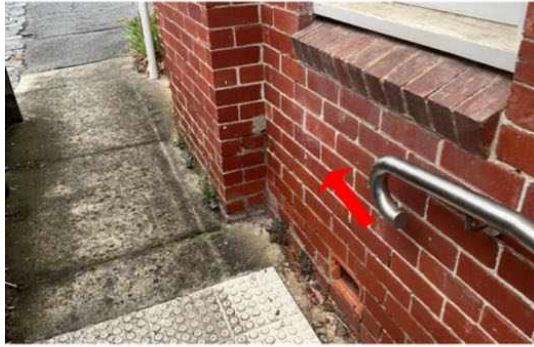
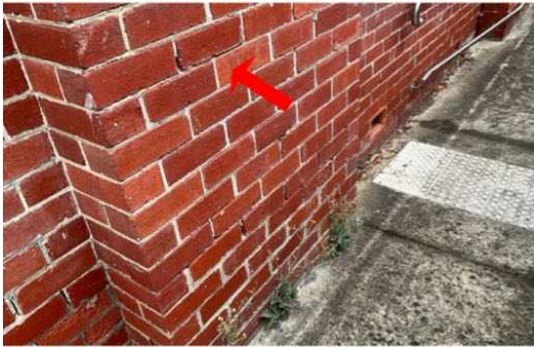
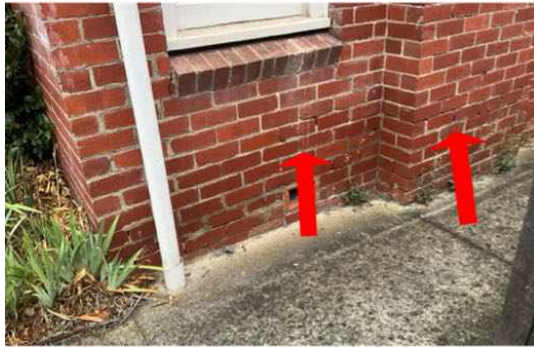
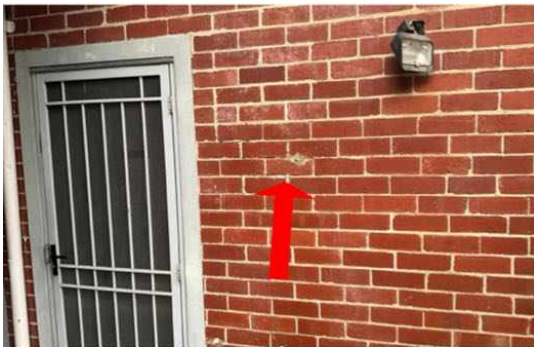
### Finding 3.09

Finding: Brickwork - Deteriorated mortar

Information: Deteriorated or missing mortar was noted around brickwork in this area.

Mortar, or 'bedding', is the material which fills joints and intersections between bricks in masonry walls and structures. Sections of mortar in this brickwork were identified as having deteriorated, which is generally expected for a property of this age and condition.

Mortar may deteriorate as a result of age of building materials, minor movement of bricks, or frequent exposure to weathering. Mortar should be replaced to ensure that bricks remain in their intended location and to prevent gaps, which would allow water or moisture ingress and secondary damage as a result.

Mortar deterioration can be addressed by a bricklayer where areas of deterioration are localised and easily accessible. Alternatively, appointment of a registered builder is advised, to repoint large areas of decaying mortar. Where secondary structural defects have become evident, consultation with a structural engineer may be required.

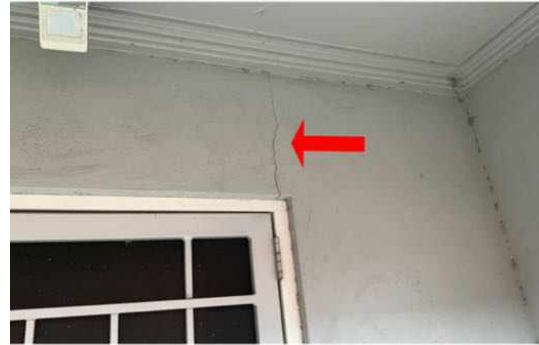
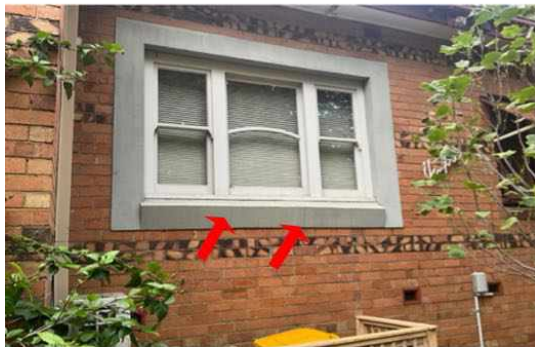
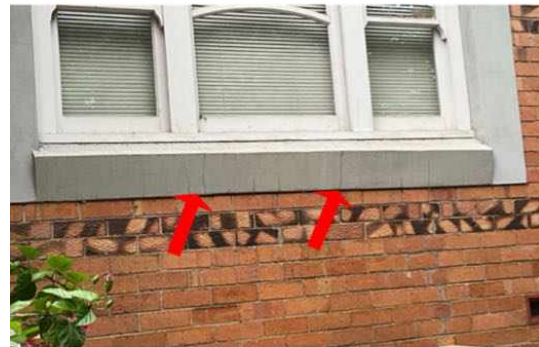
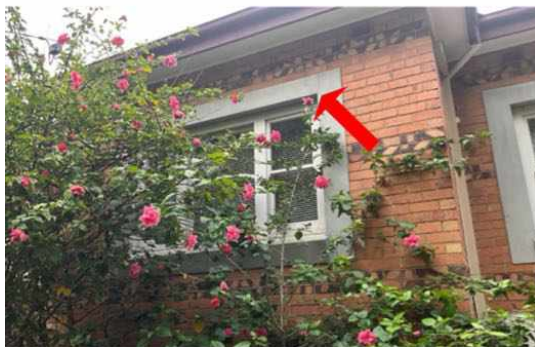
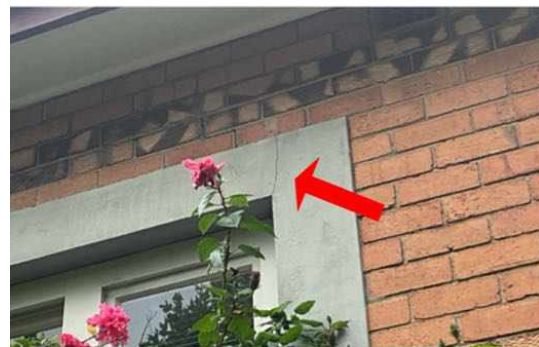
### Finding 3.10

Finding: Rendered exterior wall - minor cracking

Information: Minor cracking to the rendered wall was identified at the time of inspection.

This type of cracking is often consistent with general movement of the foundations of the property and is not considered a major structural defect.

Whilst it is more of an appearance issue, repairs may be required as failure to act may allow moisture to enter the crack and cause secondary damage to other building elements.

Consultation with a suitably qualified renderer should be sought to determine costs involved with any repairs necessary.

Should cracks increase in size or number, speak with your building inspector for further advice.

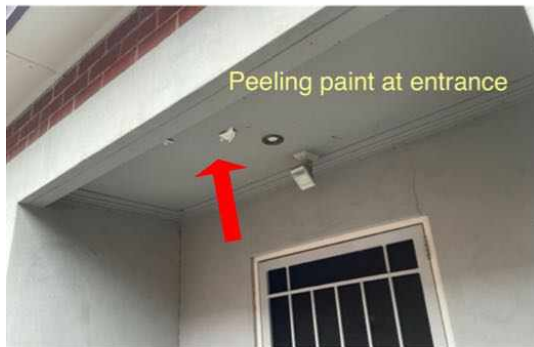
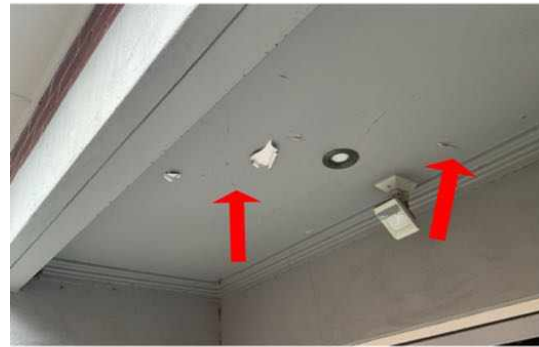
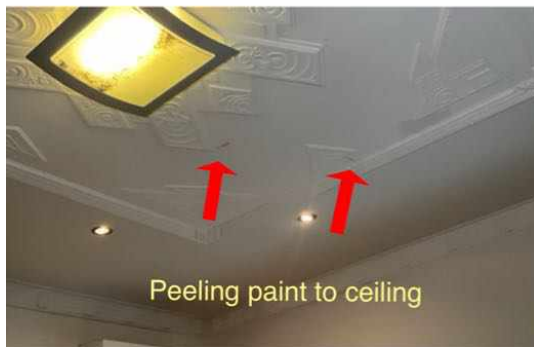
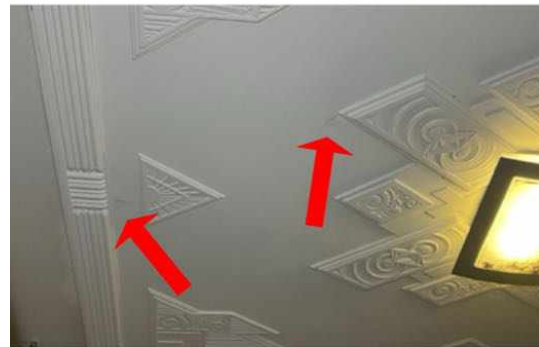
**Finding 3.15**

Building:  
Location: All Areas  
Finding: Additional Photos - minor defects  
Information: Additional photos are provided for your general reference. Arrows have been included where necessary to highlight areas of importance.

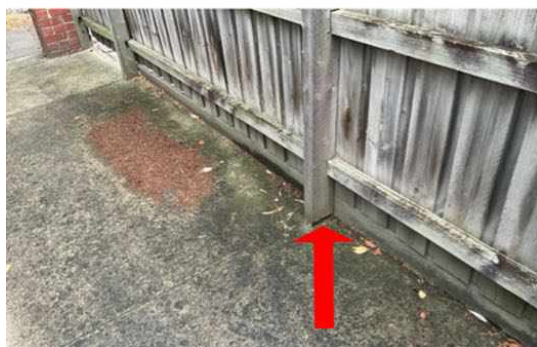
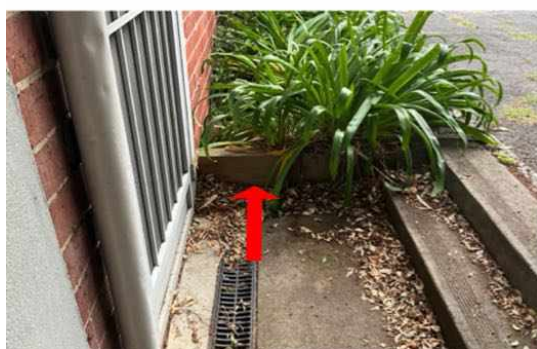
When met with excessive moisture, timber begins to decay and develop wood rot. Any timbers that are in direct contact with external grounds especially if left untreated or non-durable also provide ingress for subterranean termites into that particular element.

Where possible, the removal of any such materials that may be conducive to termite activity should be carried out as soon as possible to minimise the risk of termite attack. Where not possible or practical, regular monitoring of timber elements is recommended. Replacement of any damaged materials should be carried out where necessary.

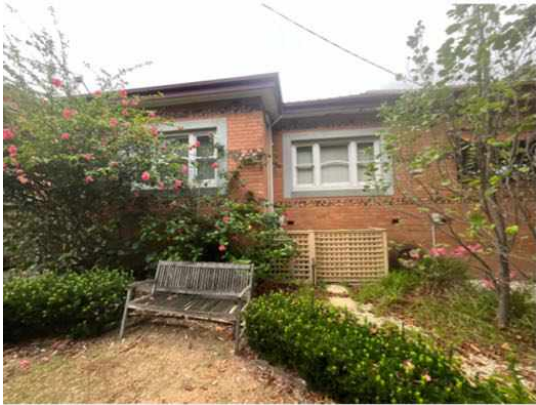
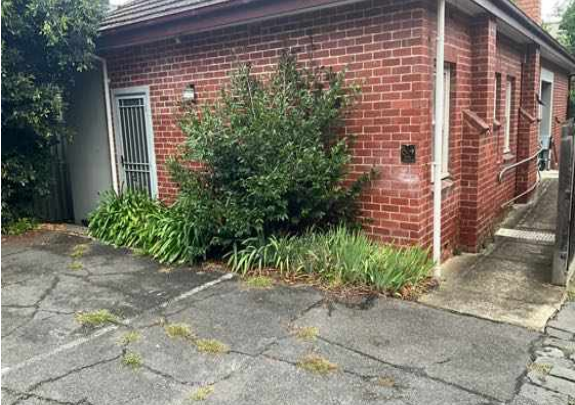
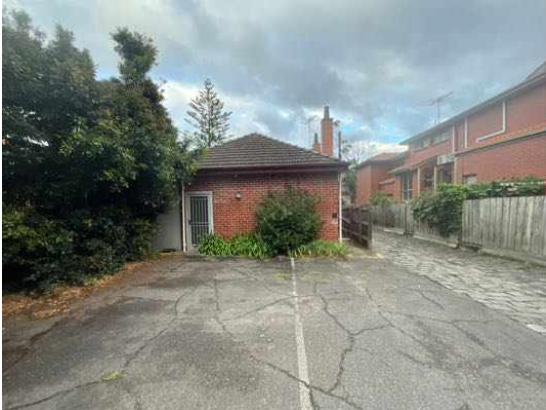
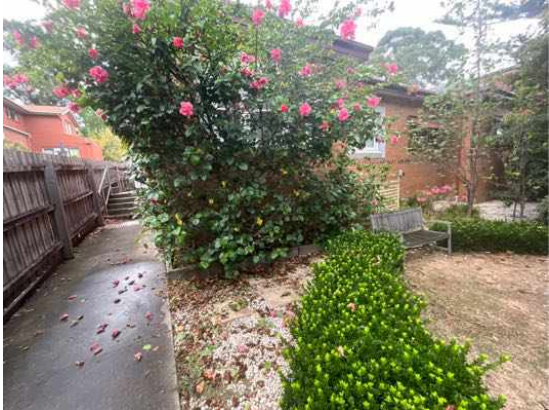
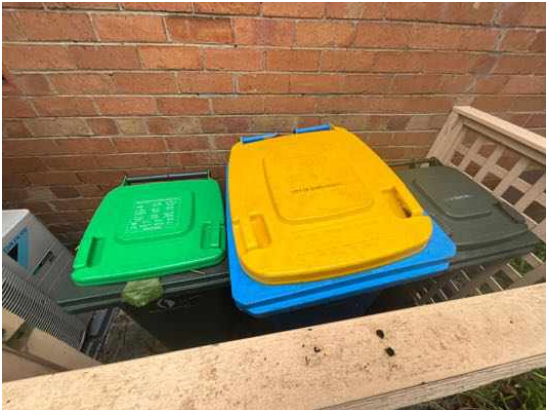
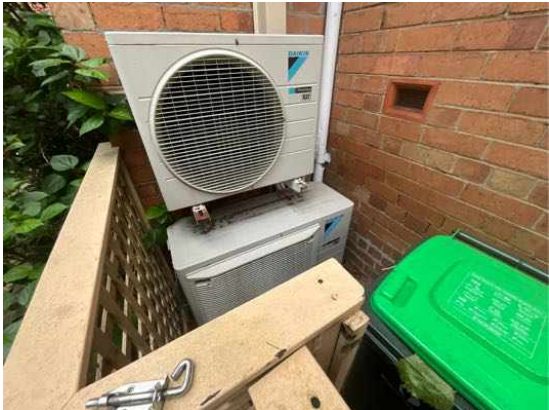
Building:  
Location: All Areas  
Finding: Additional Photos - Obstructions and Limitations  
Information: These photographs are an indication of the obstructions and limitations which impeded full inspection of the property at the time of inspection. These obstructions can hide an array of defects and should be removed to allow full inspection to be carried out. A re-inspection is recommended once the areas are made accessible.
