# Building and Timber Pest Inspection Report

Inspection Date: Thu, 5 Feb 2026

Property Address: 85/21 Leviathan Dr, Mudgeeraba QLD  
4213, Australia

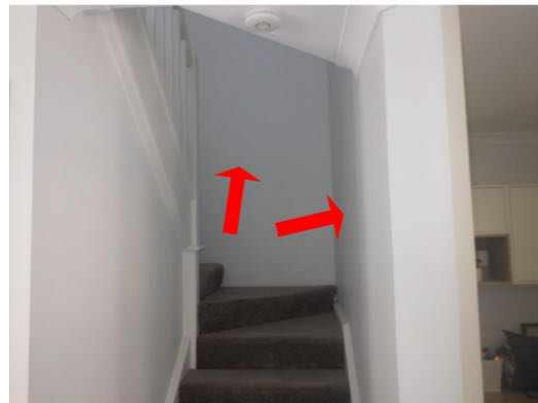
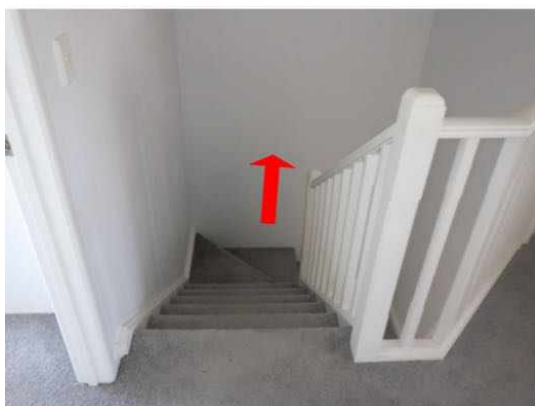
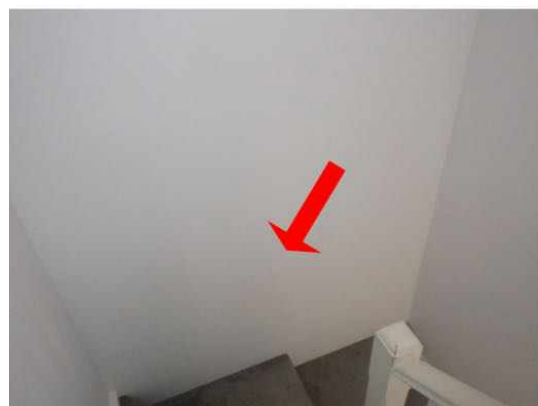
Building: Main Building  
Location: Stairs - Internal > Existing  
Finding: Stairs - Handrail  
Information: At the time of inspection it was noted there was no handrail in the internal stairway. The absence of a handrail in the stairway compromises the safety and accessibility of the stairs for all users.

This is noted as a safety concern and this regulation may not have been in place at the time of construction.

A licensed builder could be consulted for further information on stairway requirements.

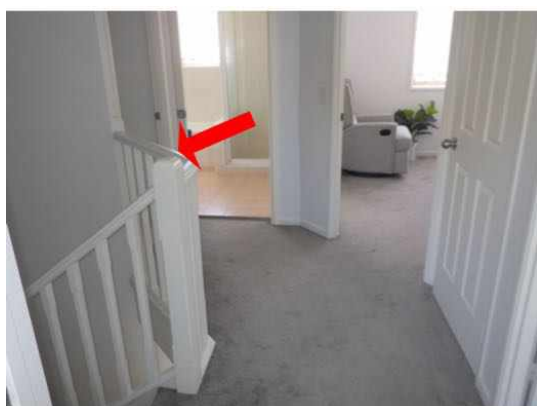
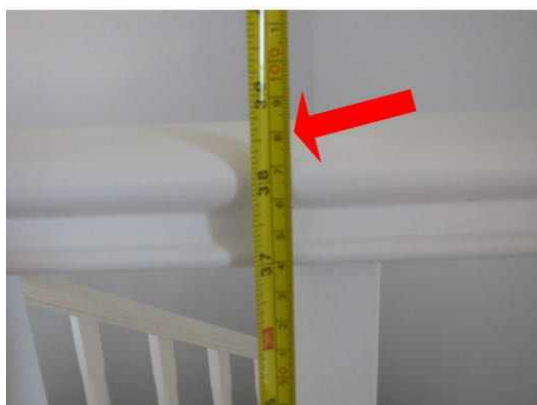
#### Finding 1.02

Building: Main Building  
 Location: Stair Landing > Existing  
 Finding: Balustrade - Suspected Non-Compliance  
 Information: The upper level stair landing area balustrade was measured and found to be (.980mm high) less than the present building regulation requirement of 1000mm high.

A registered builder could be contacted to discuss possible rectification solutions.

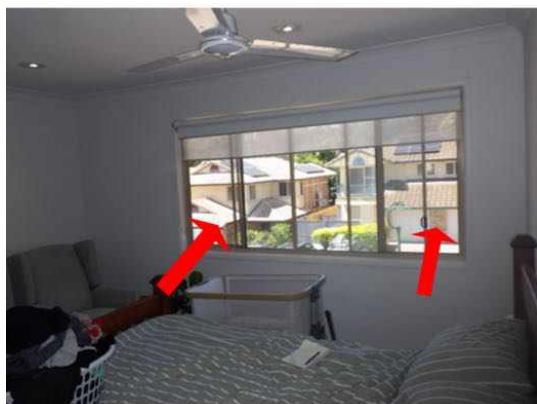
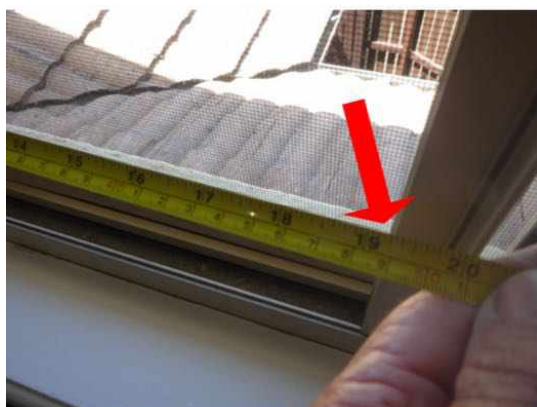
### Finding 1.03

Building: Main Building  
 Location: Main Bedroom > Centre Left  
 Finding: Window safety  
 Information: It was noted that the window of the upper level main bedroom is less than 1.7m from the floor and has a fall greater than 2m on the exterior from the sill and as such are required to only open upto 125mm or have security grills fitted.

This is noted as a safety concern and this regulation may not have been in place at the time of construction.

See NCC Vol2 Part 3.9.2.6 for further detail on this matter.

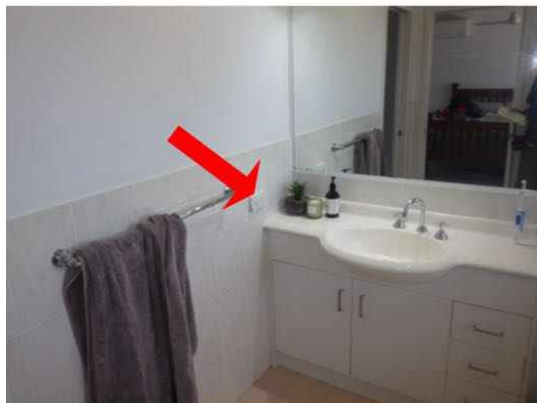
### Finding 1.04

Building: Main Building  
 Location: Bathroom > Rear Left  
 Finding: Electrical Switch  
 Information: At the time of inspection the general power outlet switch in the bathroom area showed signs of damage and/or cracking to the cover plate.

A licensed electrician should be engaged to repair or replace the electrical switch/fitting.

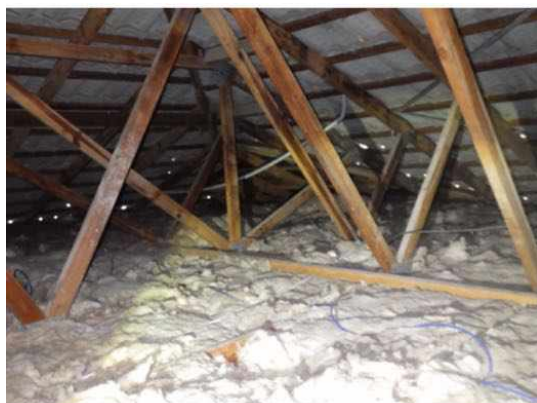
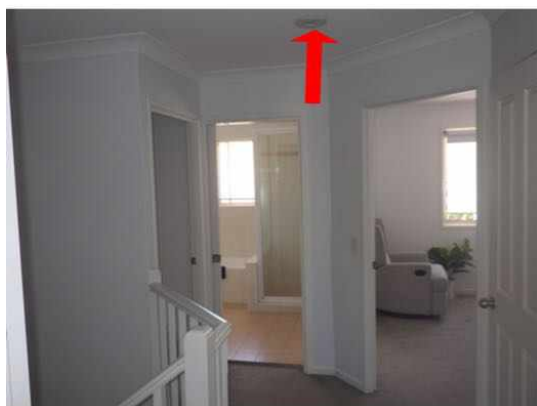
### Finding 1.05

Information: At the time of inspection it was suspected sections of insulation in the roof void may be covering down light fittings (as per example photos). While the down lights appear to be LED style lights the presence of this insulation can create a potential fire hazard.

Downlights with clear markings and supporting documentation showing the appropriate IC-F or IC ratings may be covered with insulation, but is still not recommended by the manufacturers.

The client is advised to engage a licensed electrician to check and/or confirm the IC-F or IC rating of the properties installed down lights.

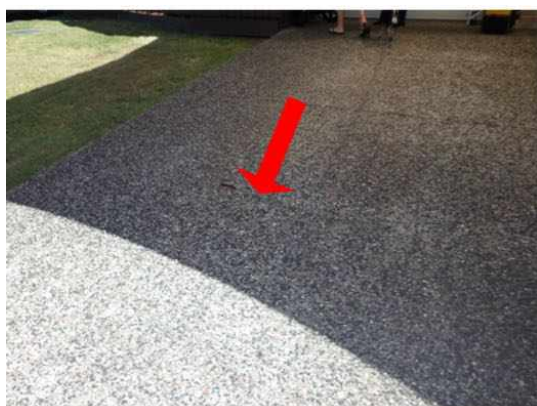
Building: Main Building  
 Location: Driveway > Ground Level  
 Finding: Cracking in concrete slab - Category 1  
 Information: Cracking coded as Category 1 was identified in the driveway and footpaths concrete slab. A Category 1 crack is described as a fine but noticeable crack, with the slab at an otherwise reasonable level.

To be considered Category 1, the approximate width of the crack is less than 1.0mm, or a less than 10mm change in offset when a 3m straight edge is placed over the defect.

Category 1 cracks should be monitored for a period of 12 months. At the end of the monitoring period, identified cracks that are rated greater than Category 2 are considered defects, and require rectification.

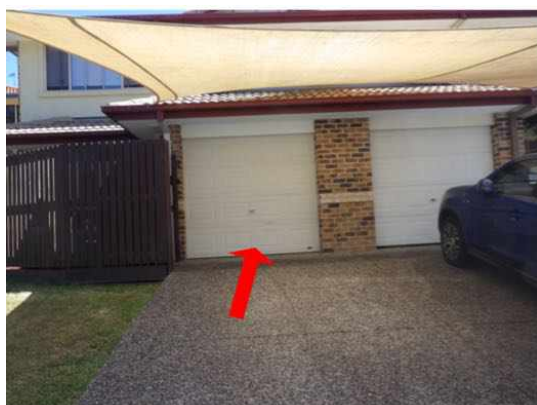
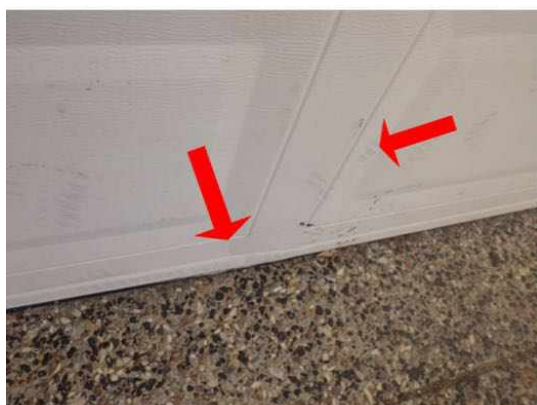
### Finding 3.02

Building:	Main Building
Location:	Garage > Front
Finding:	Garage door - dent
Information:	The garage door has a number of marks and dents likely to have resulted from impact damage be it accidental or deliberate impact at sometime.

Repair and/or replacement of the garage door would improve the condition of the garage but certainly not an urgent item

A qualified sectional door installer or supplier could be engaged to check out the operation and overall condition of the door to determine if repair is an option otherwise replacement may need to be considered.

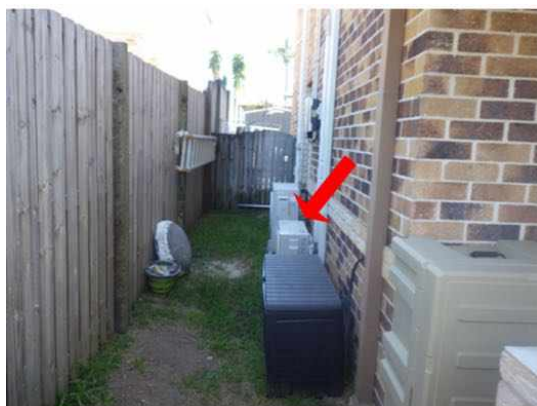
### Finding 3.03

Building:	Main Building
Location:	Exterior walls - left side > Centre Left
Finding:	Pipework - Insulation deteriorated

Information: At the time of inspection sections of the air conditioning unit pipe work insulation showed evidence of damage and deterioration. It is suspected that this deterioration has developed as a result of excessive exposure to weather, including UV exposure in daylight. Deteriorated insulation reduces the effectiveness of the material in helping to maintain the desired temperature and work most efficiently.

If left in an exposed position, it is likely that the deterioration will continue and worsen over time, potentially resulting in secondary building defects as well as a further loss in insulating properties.

Some areas of replacement of pipe insulation is likely to be required. Further preventative measures to remove or protect the material from future exposure are also advisable. Consultation with a licensed air conditioning installer is advised to gain quotes for the repair and/or replacement of deteriorated insulation.

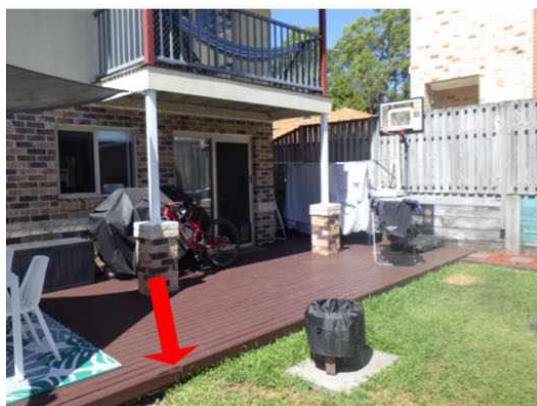
### Finding 3.04

Building: Main Building  
 Location: Deck > Rear Right  
 Finding: Decking Board  
 Information: At the time of inspection there was minor damage to a timber facing board on the front of the deck area at the rear of the property.

A qualified carpenter or general handyman could be engaged to undertake repair work to the affected decking board.

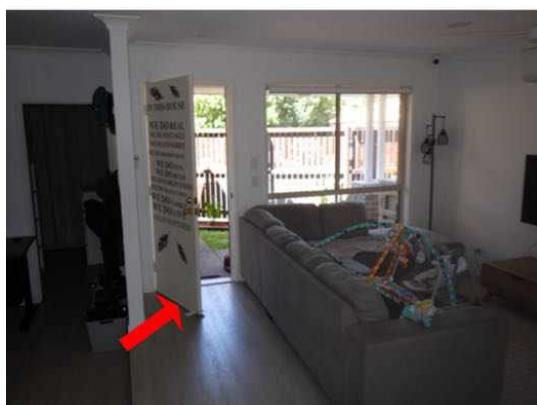
### Finding 3.05

Building: Main Building  
 Location: Entry > Front  
 Finding: Damaged Door  
 Information: It was observed at the time of inspection, the entry door has suffered damage to the bottom edge.

Damage occurs generally when the building materials have aged and decayed, but in this instance the damage appears to be the result of exposure to moisture, possibly from the bottom and/or top edges of the door not being sealed with a suitable paint or sealant at the time of construction.

A qualified carpenter or general handyman could be appointed to repair/replace the door at the clients discretion.

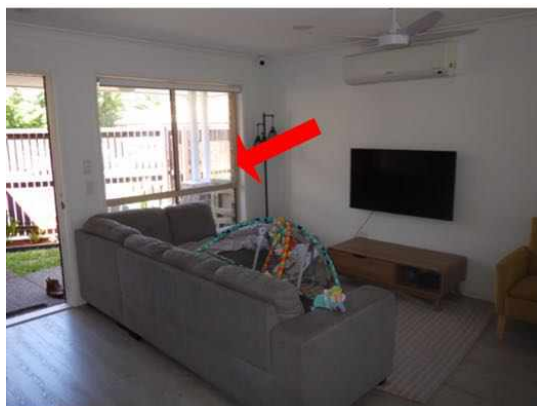
### Finding 3.06

Building: Main Building  
 Location: Living Room > Front  
 Finding: Window - missing latch  
 Information: The window latch to the living room area aluminium sliding window was found to be missing at the time of inspection. Breakage occurs generally when the building

materials have aged and decayed.

Replacement of the missing window catch is advised to improve the operational state of the associated window.

An aluminium window service agent or general handyman should be appointed to replace the window latch at the client's discretion.

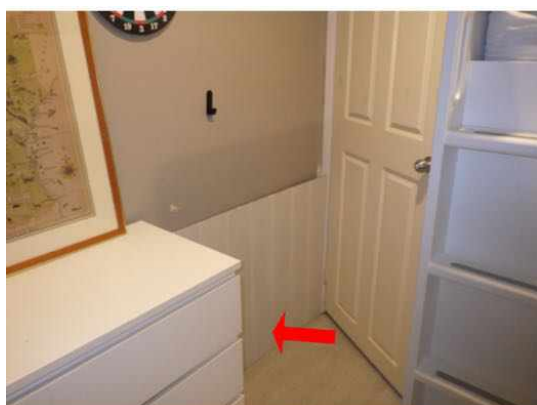
### Finding 3.07

Building: Main Building  
 Location: Utilities Room > Front  
 Finding: Door stop - Missing  
 Information: The utilities room door stop is missing or is inadequate to stop the door handle from damaging the wall.

Re-installation or replacement of the door stop is advised to prevent any subsequent damage to the wall linings or associated structures.

A general handyman may be appointed to perform these works at client discretion.

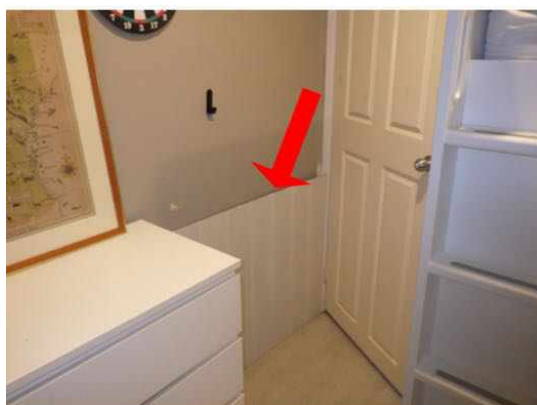
### Finding 3.08

Location: Utilities Room > Front Right  
 Finding: Wall Paneling - Deteriorated  
 Information: It was noted at the time of inspection that a section of the interior wall paneling to the utilities room area of the property have detached. Typically wall paneling deteriorates due to age and or wear which is generally expected for a structure of this age. Sometimes inadequate installation or maintenance can be to blame.

If left unattended, it is unlikely that further damage will occur. It is suspected that repair of several sections of the wall cladding may be required.

A licensed carpenter or general handyman could be engaged to undertake repair work.

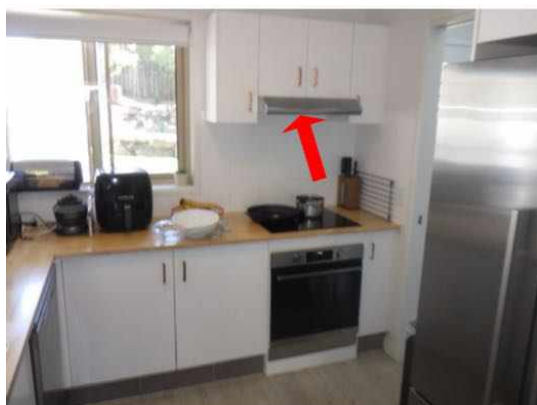
### Finding 3.09

Building: Main Building  
 Location: Kitchen > Rear Right  
 Finding: Rangehood - Light  
 Information: The kitchen range hood light was not working at the time of inspection. It is advised to replace the bulb first - if still not functioning, a licensed electrician could be appointed to repair or replace the range hood to restore it to a fully operational state.

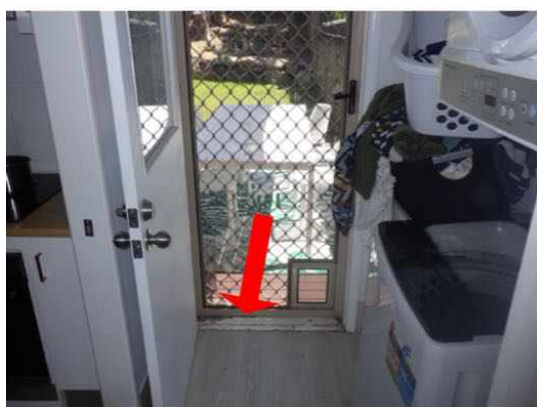
### Finding 3.10

Building: Main Building  
 Location: Laundry > Centre Left  
 Finding: Timber - exposed to weather  
 Information: At the time of inspection the laundry area exterior door timber sill showed evidence of weathering.

External timbers that are frequently exposed to harsh weather conditions require adequate protection in order to maintain their condition. Where timbers have not been painted or treated adequately, general deterioration is likely to occur at an accelerated rate.

Adequate treatment of the timber door sill is required as soon as possible by a painting contractor or general handyman.

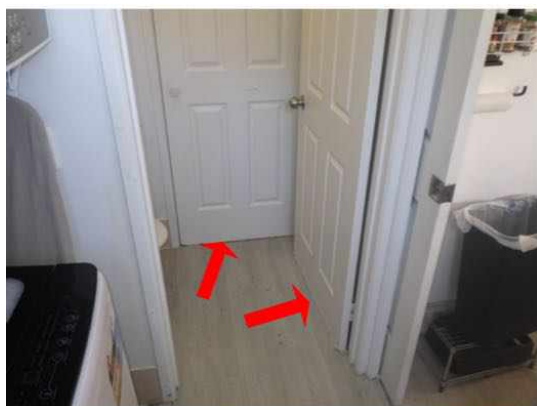
### Finding 3.11

Building: Main Building  
 Location: Toilet (WC) > Front  
 Finding: Damaged Door  
 Information: The doors leading into the ground floor WC and under stair storage area have suffered damage to the bottom edges.

Damage occurs generally when the building materials have aged and decayed, but in this instance the damage appears to be the result of exposure to moisture, possibly from the bottom edges of the doors not being sealed with a suitable paint or sealant at the time of construction.

A qualified carpenter or general handyman could be appointed to repair/replace the door at the clients discretion.

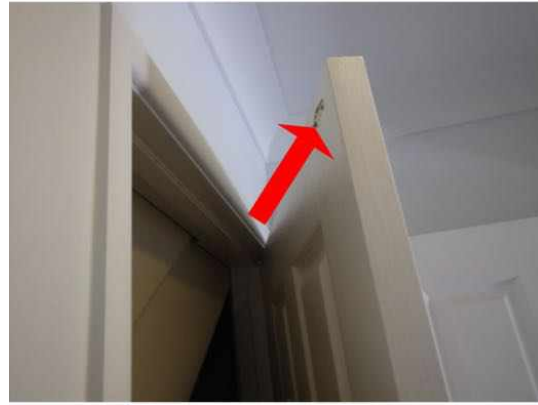
### Finding 3.12

Building: Main Building  
 Location: Under Stair Void or Storeroom > Front  
 Finding: Door - Broken latch  
 Information: The door latch to the under stair cupboard door was found to be broken at the time of inspection. Breakage occurs generally when the building materials have aged and decayed, but may be indicative of impact damage (accidental or deliberate).

Replacement of the broken door catch is advised to improve the operational state of the associated door.

A general handyman could be appointed to replace the door latch at the client's discretion.

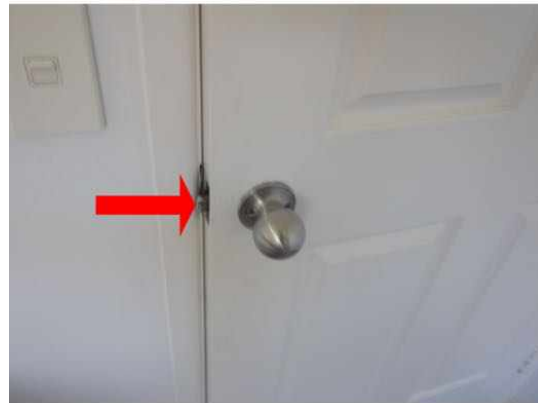
### Finding 3.13

Building: Main Building  
 Location: Bedroom 3 > Front  
 Finding: Door - Not latching  
 Information: The door to bedroom 3 was found to be not latching at the time of inspection. Breakage occurs generally when the building materials have aged and decayed.

A qualified carpenter or general handyman could be appointed to adjust the door handle striker plate at the client's discretion.

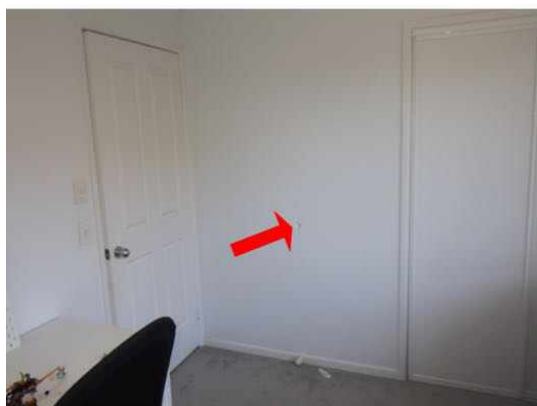
### Finding 3.14

Building: Main Building  
 Location: Bedroom 3 > Front Left  
 Finding: Internal walls - Hole  
 Information: A hole was identified in the bedroom 3 left hand side wall section. It is suspected the hole is caused from the door handle impact.

All excessive holes, gaps or cracks should be adequately filled by a suitable sealant to prevent any further damage. Such works may be conducted by a general handyperson or licensed painter.

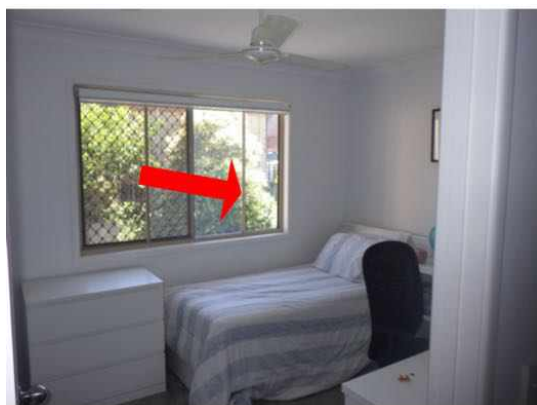
### Finding 3.15

Building: Main Building  
 Location: Bedroom 3 > Centre,Rear  
 Finding: Window - missing latch  
 Information: The window latch to the bedroom 3 area aluminium sliding window was found to be missing at the time of inspection. Breakage occurs generally when the building materials have aged and decayed.

Replacement of the missing window catch is advised to improve the operational state of the associated window.

An aluminium window service agent or general handyman should be appointed to replace the window latch at the client's discretion.

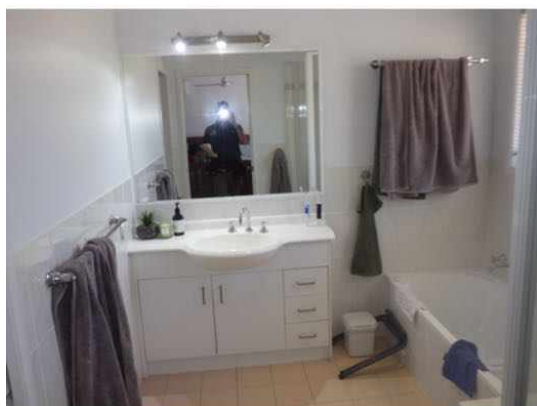
Building:	Main Building
Location:	Bathroom > Existing
Finding:	Cabinetry - Deterioration
Information:	At the time of inspection the bathroom cabinetry showed signs of minor deterioration (as per example photos). The level of damage appears consistent with exposure to moisture or general wear and tear.

A qualified cabinet maker or general handyman could be engaged to undertake repair works at the clients discretion.

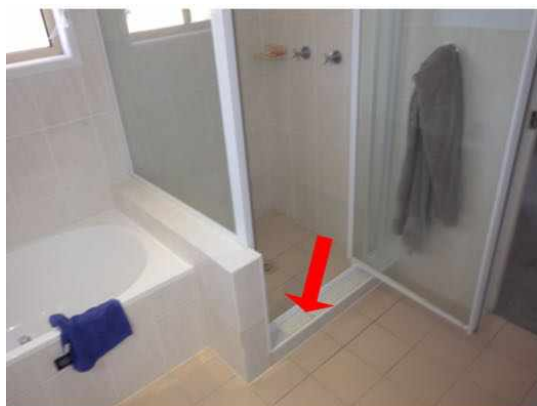
### Finding 3.21

Building: Main Building  
 Location: Bathroom > Front Left  
 Finding: Tile - Cracked  
 Information: Cracked tiles to the bathroom shower door sill area was identified at the time of inspection. Such defects are generally caused by impact. Cracked or broken tiled areas may also be a direct result of poor workmanship during the construction process.

A tiling contractor should be appointed to perform repair works.

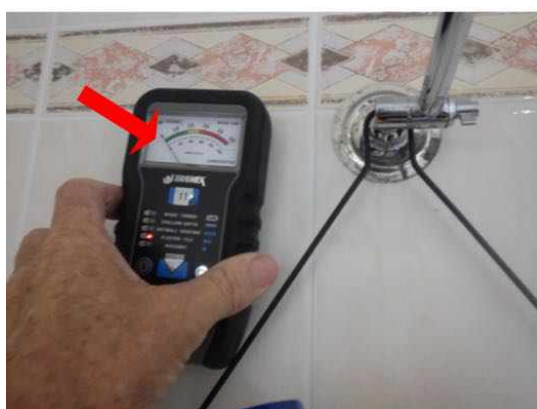
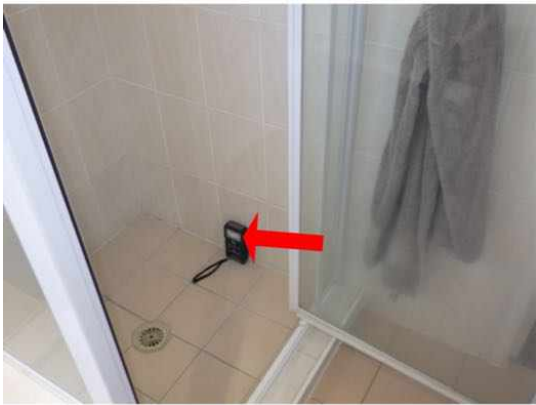
### Finding 3.22

Building:	Main Building
Location:	Bathroom > Rear Right
Finding:	Shower - Monitor
Information:	Elevated moisture level readings were recorded to the lower 200mm of wall to the bathroom shower alcove at the time of inspection. There was no elevated moisture level readings around the tap area, and no elevated readings transferring outside the shower cubicle or to the other side of the wall in the areas where moisture readings were able to be obtained. Both sealant and grout appear in fair condition at present.

This defect is quite common, and is suspected to have been caused by moisture permeating or leaching through the grouting and perhaps gaps in the sealant.

Monitoring the area is advised and if any visual signs of excessive moisture appear (peeling paint, mould) then consultation with a qualified plumber or bathroom specialist would be advised to identify the cause of damp and to perform remedial works as required.

Always ensure that sealant and grout is in good condition to prevent any moisture issues occurring in the future.

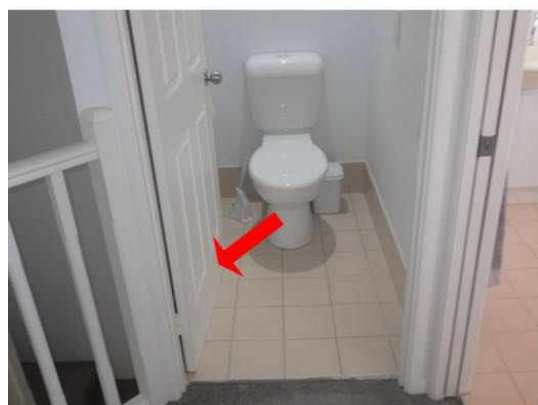
Finding 3.23

Building: Main Building  
 Location: Toilet (WC) - 2 > Front  
 Finding: Damaged Door  
 Information: The door leading into the upper level WC has suffered damage to the bottom edge.

Damage occurs generally when the building materials have aged and decayed, but in this instance the damage appears to be the result of exposure to moisture, possibly from the bottom edge of the door not being sealed with a suitable paint or sealant at the time of construction.

A qualified carpenter or general handyman could be appointed to repair/replace the door at the clients discretion.

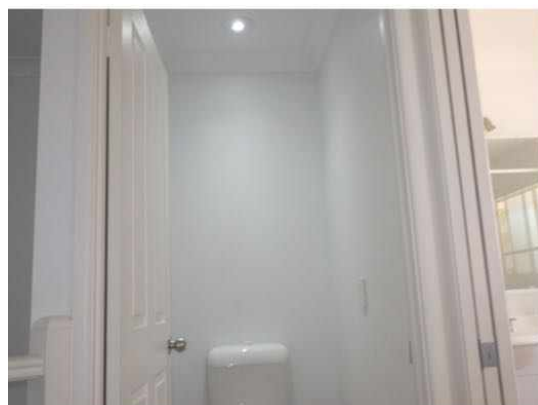
### Finding 3.24

Building: Main Building  
 Location: Toilet (WC) - 2 > Front  
 Finding: Tile - Cracked  
 Information: Cracked tiles to the upper level WC floor area were identified at the time of inspection. Such defects are generally caused by impact. Cracked or broken tiled areas may also be a direct result of poor workmanship during the construction process.

A tiling contractor could be appointed to perform repair works at the clients discretion.

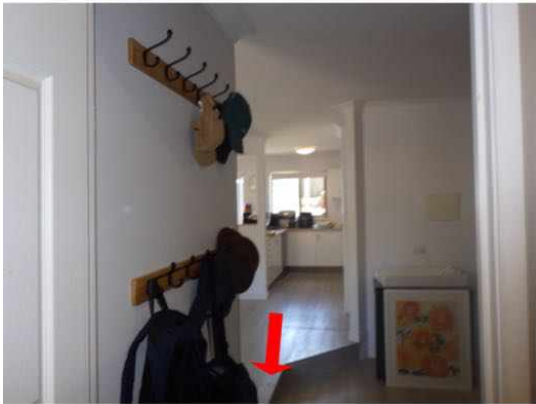
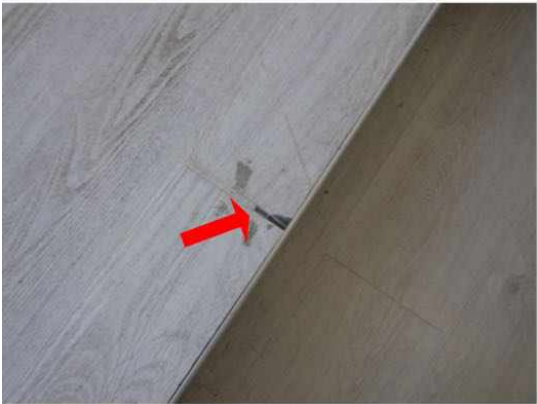
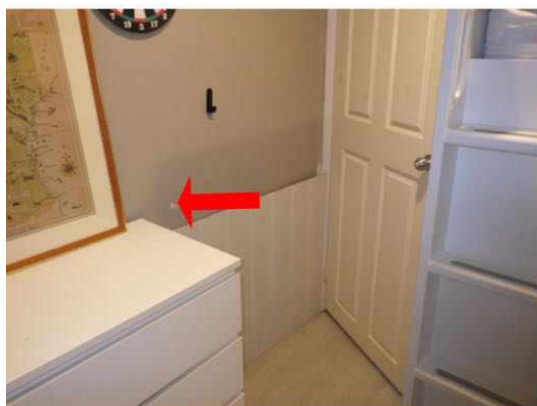
**Finding 3.25**

Building: Main Building  
Location: Internal Areas > Existing  
Finding: Wear and Tear  
Information: At the time of inspection the building interior showed signs of minor cracking and/or scuffing to floors, walls, ceilings and cornices (as per example photos).

The level of damage appears consistent with general deterioration and/or wear and tear.

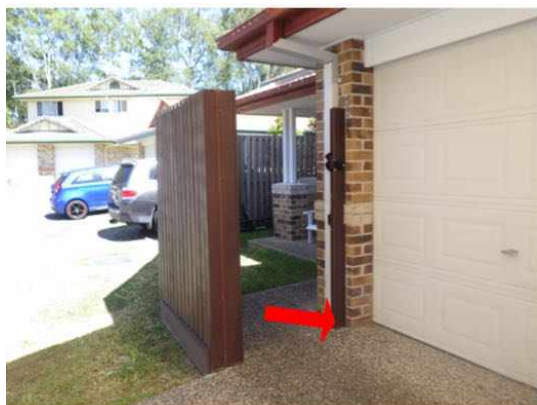
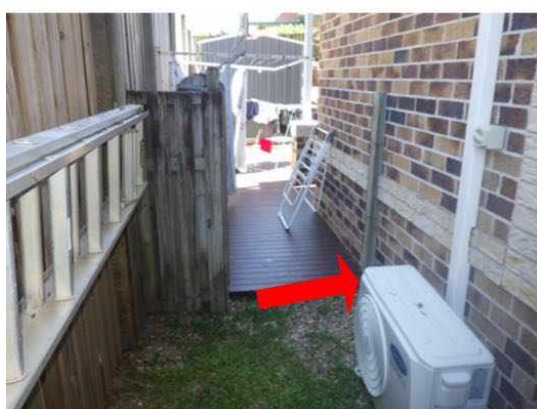
## Finding 6.02

Building:	Main Building
Location:	Exterior walls - front & left side > Front Left, Centre Left
Finding:	In ground contact
Information:	The timber gate posts fixed to the exterior wall brickwork are in direct contact with the footpath concrete slab or finished ground surface.

Frequent pest inspections are advised to readily identify any termite activity in these areas.

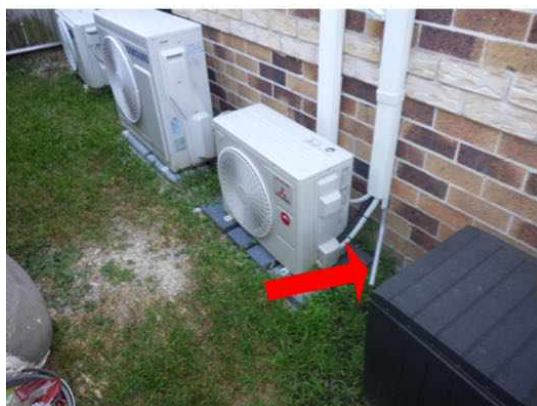
### Finding 6.03

Building:	Main Building
Location:	Exterior walls - left side > Centre Left
Finding:	Overflow - Not plumbed for drainage
Information:	The air conditioning unit overflows are not plumbed or connected to suitable drainage, which can result in the surrounding areas becoming excessively damp. These damp conditions can lead to secondary defects such as rot, rust or corrosion of associated building elements, the formation of fungal decay, or even the creation of potential slip hazards. When coupled with poor site drainage, pooling of water may also attract termite activity to this area. It is highly recommended that a qualified plumber be appointed to install adequate drainage to the overflows. These works will ensure that the areas remain dry and free of any secondary defects.

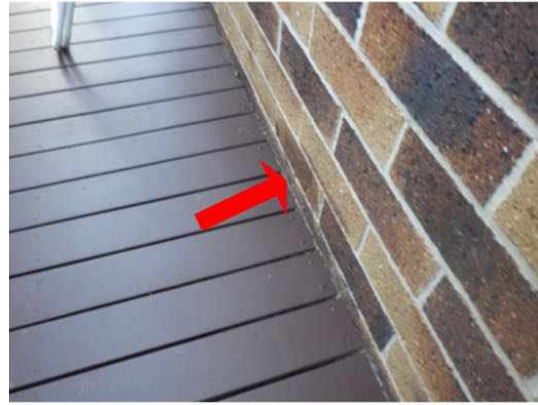
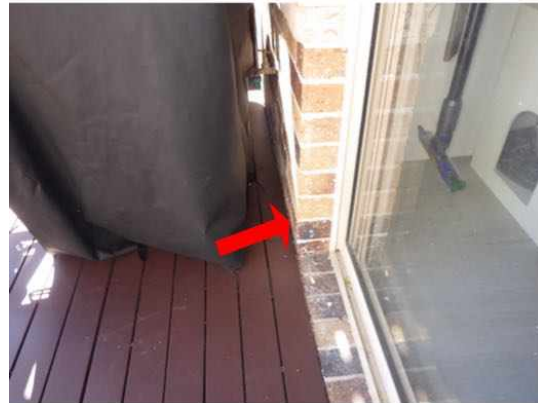
### Finding 6.04

Building:	Main Building
Location:	Exterior walls - rear > Rear Left
Finding:	Inspection Zone Exposure
Information:	At the time of inspection the timber deck at the rear of the property finished tight against the exterior wall brickwork.

It is highly recommended that timber termite pest inspections be carried out every 3 - 6 months to aid protection of the property against infestation.

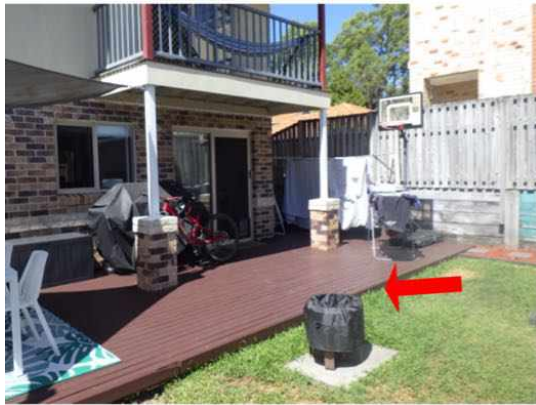
### Finding 6.05

Building: Main Building  
 Location: Deck > Rear  
 Finding: Deck - In ground contact  
 Information: At the time of inspection it was noted the timber deck area to the left side and rear of the property is in direct contact with the finished ground level.

Frequent pest inspections are highly advised to readily identify any termite activity in these areas.
