Building and Timber Pest Inspection Report

Inspection Date: Thu, 19 Mar 2026

Property Address: 25 Wentworth St, Randwick NSW 2031,
Australia

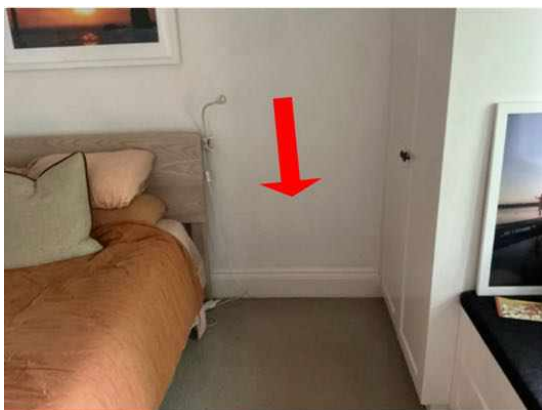
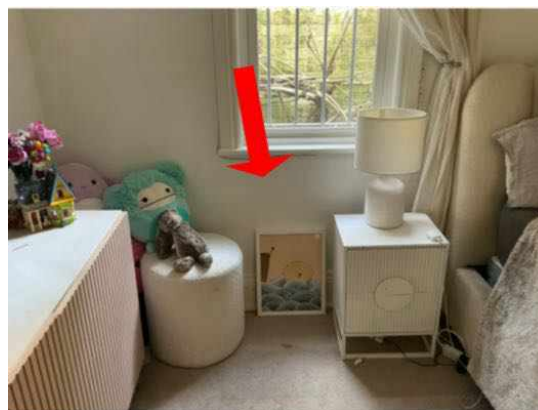
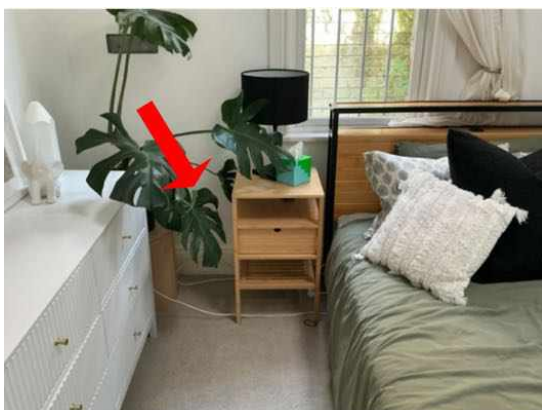
Rising damp is generally managed by the installation of a damp proof course during construction. A Damp Proof Course (DPC) is an impermeable barrier at the base of the wall above ground level. However, many 19th Century buildings have no damp course installed, or the materials have failed. The DPC may have been omitted as a consequence of poor workmanship, or it may have been bridged where materials built up against the side of the house allow moisture ingress above the DPC level.

Rising damp may lead to issues on some building elements, including wall finishes like paint and plasterwork.

The first step in addressing rising damp is to diagnose the cause. Further consultation with a damp specialist is highly advised to identify the cause of the damp and perform remedial works as required.

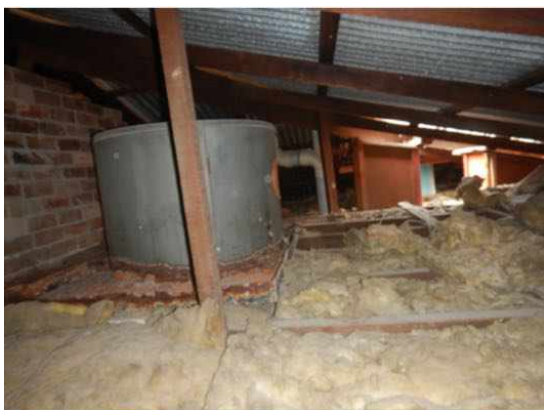
Finding 3.02

| Information: | It was noted at the time of inspection that a disconnected gravity-fed hot water system (HWS) remains in this area. |

Despite this plumbing structure being unused, the HWS can rust and may also make the area susceptible to termite or timber pest activity. However, if the structure is not causing any issues it can remain in place until a renovation take place on the roof area.

Further consultation with a licensed plumber is required to gain further advice on removal of the structure.

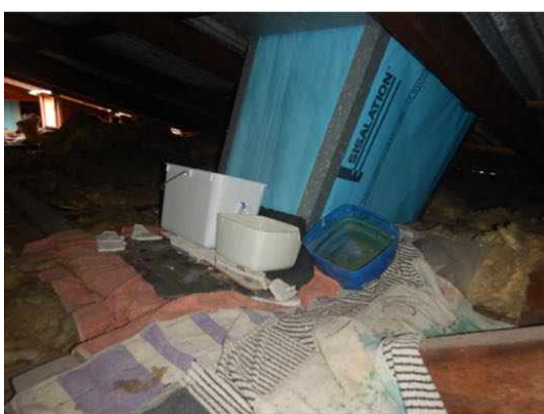
Finding 3.03

| Finding: | Suspected Roof Leak |
| Information: | A roof is suspected in this area evidenced by buckets in the roof void. Leaks such as this may have been caused by damaging a flashing or skylight. |

Where water leaks are active, rain penetration is likely to cause water damage to associated structures and building elements in this area, which can have a range of implications. If left unmanaged, further damage to associated structures may occur.

A roof plumber should be appointed as soon as possible to primarily identify the cause of the leak, determine if the issues is ongoing, and to provide subsequent repair works as necessary.

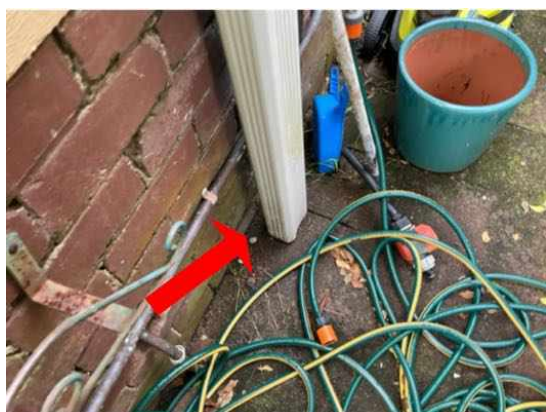
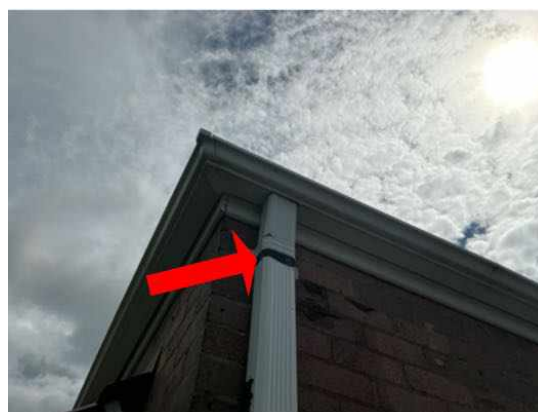
Finding 3.04

Information: A stormwater downpipe at the front right-hand side of the house was observed to be disconnected from the stormwater drainage system. An additional downpipe at the rear of the house also does not appear to be adequately connected. As a result, rainwater is discharging directly onto the ground adjacent to the building.

Excess water flow in these areas may allow moisture to accumulate around the footings and under the house, which may contribute to dampness noted to the walls on the right-hand side of the property.

It is recommended that a licensed plumber be consulted to properly connect the downpipes to the stormwater drainage system to ensure water is directed away from the building and to reduce the risk of ongoing moisture penetration.

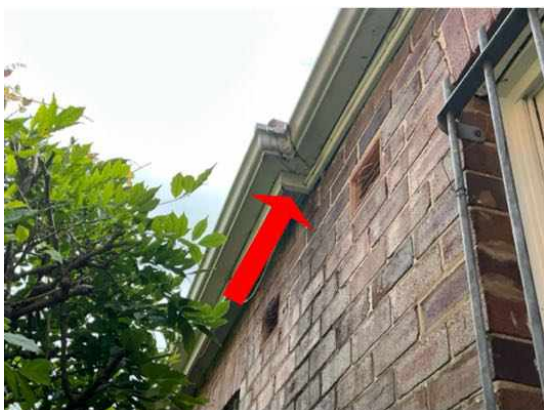
Finding 3.05

Building: Main Building
 Location: Exterior walls - right side
 Finding: Gutter - Leaking
 Information: Evidence of a leak was showing in the guttering at the time of inspection. Leaks can have a number of causes, including deterioration of plumbing fixtures and fittings, or substandard original installation or blockage or damage to gutter.

Where water leaks are active, moisture is likely to cause water damage to associated structures and building elements in this area, which can have a range of implications.

A roof plumber should be appointed as soon as possible to primarily identify the cause of the leak, and to provide subsequent repair works if necessary.

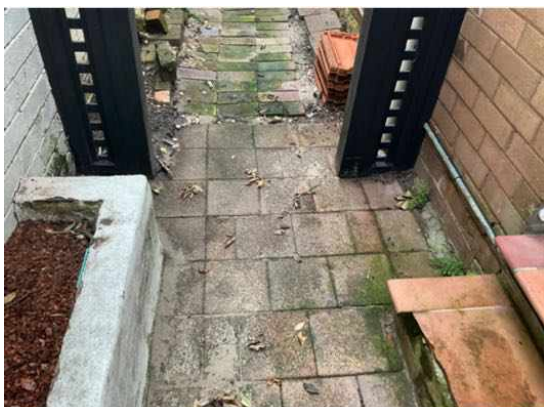
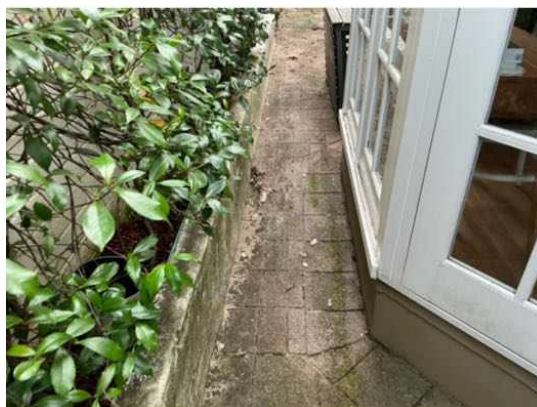
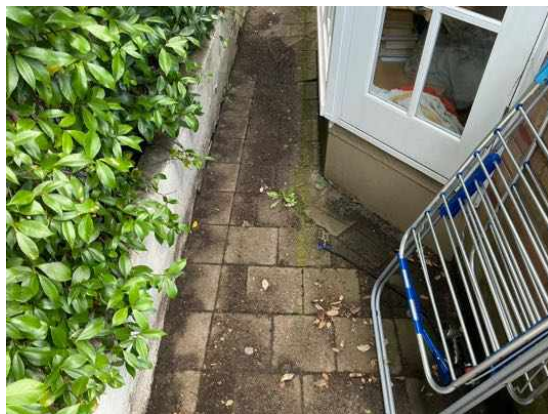
Finding 3.06

| Finding: | Site drainage - Inadequate |
| Information: | The site drainage in side and rear of the house was found to be inadequate at the time of inspection, creating potential for subsequent water damage to associated building elements. |

It is important that water does not lie against the base of walls; surrounding paths and ground levels should be sloped to drain water away from walls. Stormwater should be carried away by large, regularly cleaned drains.

Where site drainage is inadequate, installation of additional drainage may be required. A qualified plumber should be appointed to further inspect the property and perform any remedial works as necessary. Water damage and secondary defects are likely to occur if left unmanaged.

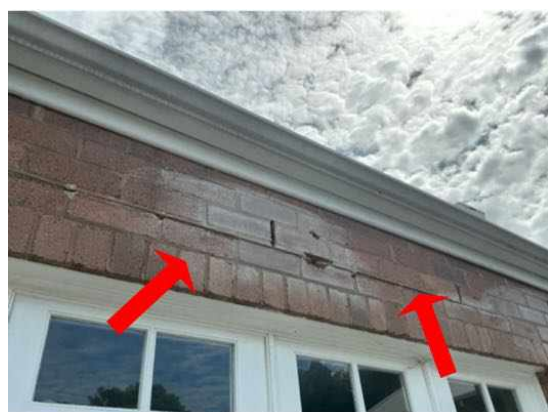
Finding 3.07

| Finding: | Brickwork - Cracking noticeable |
| Information: | There were several cracks evident to external brick pier and porch. |

Noticeable cracks are a common occurrence in external brickwork and are a likely result of age expected building movement, general expansion, and/or contraction of building materials in different weather conditions. Noticeable cracks in brickwork may develop if left unattended.

It is advised that a qualified bricklayer be appointed to provide necessary works to cracked brickwork to prevent any further damage.

Always monitor these cracks and contact a building inspector should cracks widen, lengthen, or become more numerous.

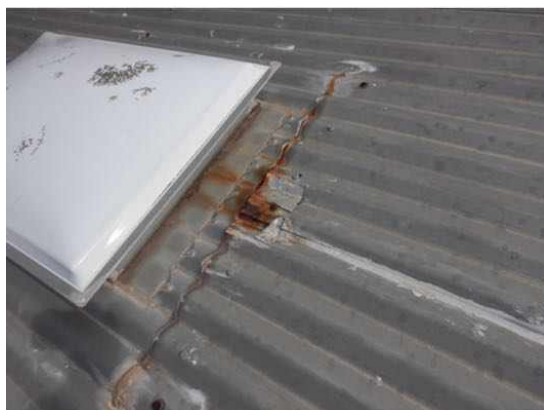
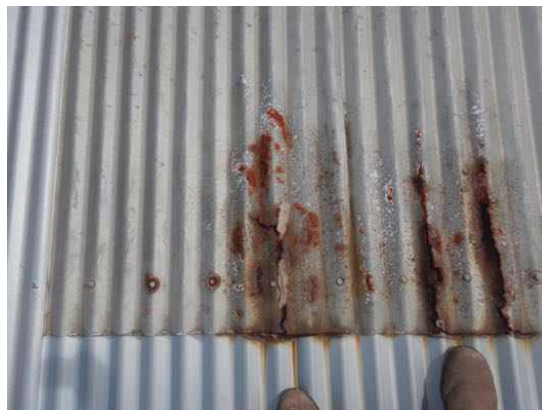
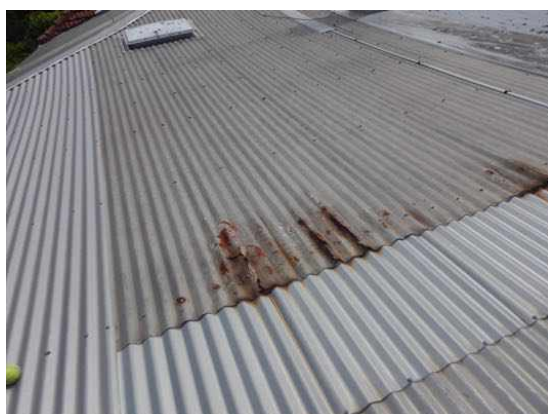
Finding 3.08

| Finding: | Roof sheets - Rusted |
| Information: | Upon inspection of the exterior roofing structure, evidence of rust was identified. |

If left unmanaged, these degrading can allow water ingress to the internal roofing structures, potentially leading to secondary damage of building elements. Accelerated deterioration of the roofing sheets and any associated building elements is also likely to occur.

A roofing contractor should be appointed immediately to assess the damage to the roofing sheets and to perform remedial works as necessary. Works may include replacement of severely affected roofing sheets or minor works such as the application of rust-retardant surface protectors.

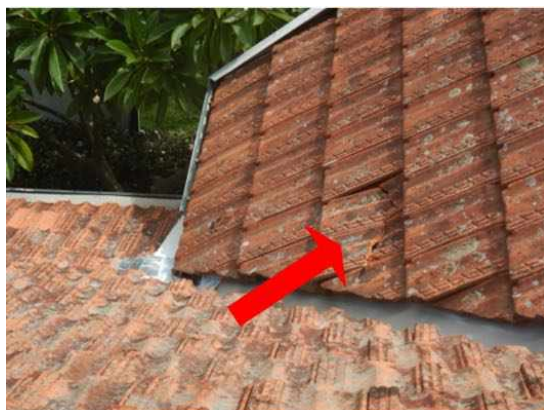
Finding 3.09

| Finding: | Roof tiles - Broken |
| Information: | <p>Upon inspection of the exterior roof covering, a broken roofing tile was identified. Broken and friable roof tiles are generally the result of ageing and weathering of what is essentially a porous material. If left to further deteriorate, broken and brittle roof tiles are likely to lead to water penetration via the roof into the ceiling space, causing secondary damage to ceiling linings, insulation and roof structures. Broken roof tiles are also likely to detract from the effectiveness of the roof drainage system, creating potential for secondary damage to the exterior roof covering and roof plumbing.</p> |

Replacement of broken tiles is required and should be performed by a roofing contractor as soon as possible.

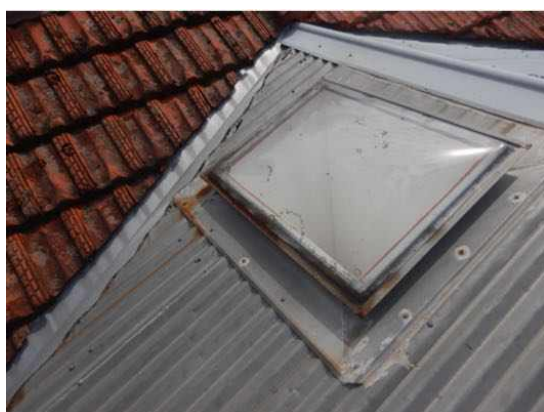
Finding 3.10

| Finding: | Skylight - Rusted or corroded |
| Information: | This skylight shows evidence of rusting and corrosion, which is likely to have developed as a result of excessive exposure to moisture and or inadequate coatings. As surface rust provides no protection to the underlying iron, the deteriorating condition may lead to leaks in the roof interior. Where possible, the use of galvanized (treated) metals or aluminium coated metals aid in rust prevention, as does regular general maintenance. A registered builder or roofing specialist may be appointed to replace any building elements that have been severely affected by rust or water damage. |

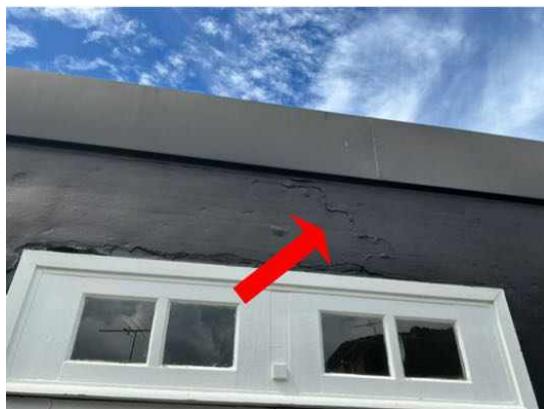
Finding 3.11

| Finding: | Brickwork - Cracking [Fine] |
| Information: | Although fine cracks are quite noticeable, they are often only considered to be an |

appearance defect and usually do not indicate any structural damage. Generally, the cause of a fine crack is indicative of a separation between brickwork and mortar throughout the structure, but single bricks may also show cracks of this nature.

Cracking of this nature can generally be repaired with minor filling and should be conducted by a qualified bricklayer.

Always contact a building inspector should cracks widen lengthen or become more numerous.

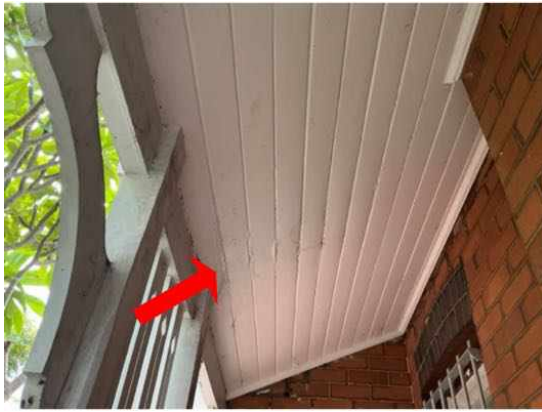
Finding 3.12

| Finding: | Ceiling - Water stained |
| Information: | Water staining to ceiling linings in this area was evident at the time of inspection. Water staining indicates that surfaces have been exposed to excessive moisture over time. |

While mostly an appearance defect, water staining can be indicative of more serious defects such as leak form the roof exterior.

Where water staining is active, a licensed plumber must be consulted to identify the cause of the staining and to provide advice on any reparation works that may be required. Replacement of any damaged structures is advised.

Conversely, where water staining is old and inactive, affected building materials may be repaired or replaced at client discretion.

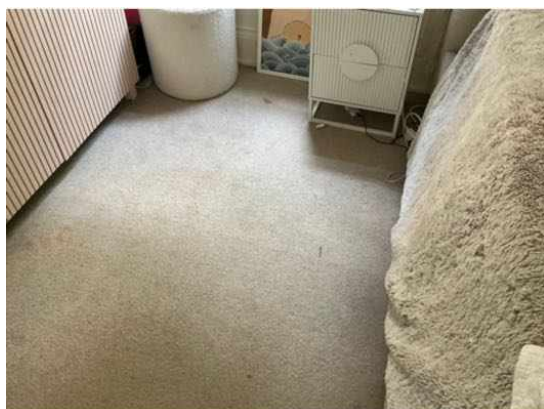
Bouncy flooring generally indicate that the boards or the subfloor structures are coming loose from the joists that they are installed on. Bouncy flooring may also be the result of deterioration of the subfloor timbers or piers.

The potential resolution may range from packing gaps in structures through to replacement of subfloors piers, repair of damaged or deteriorated timbers and refixing of boards. A carpenter or builder can be appointed as soon as possible to carry out repairs as required.
