## Building Inspection Report

Inspection Date: Fri, 13 Feb 2026

Property Address: 20/213 Normanby Rd, Notting Hill VIC  
3168, Australia

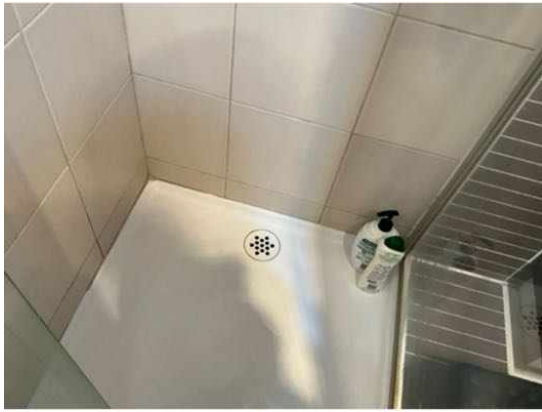
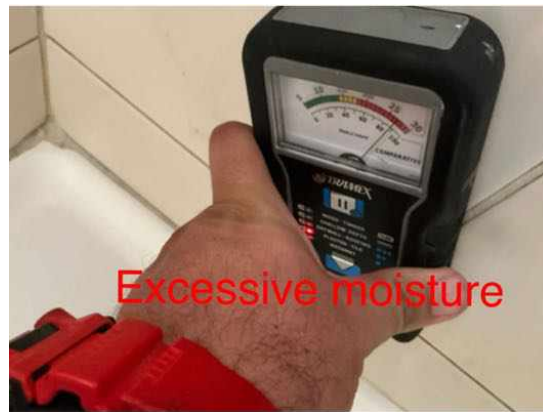
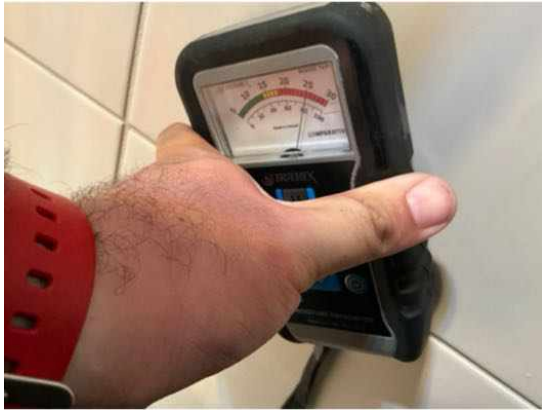
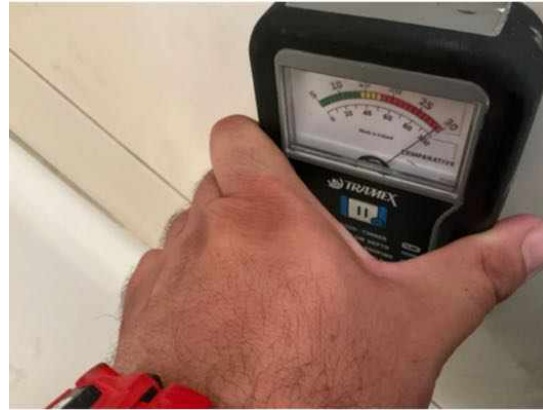
#### Defects 3.01

Building:	Main Building
Location:	Bathroom
Finding:	Shower - Damp
Information:	Damp is evident to the lower 300mm of wall to the shower alcove. This defect is quite common, and is suspected to have been caused by moisture permeating through the grouting in this area, which shows evidence of deterioration. Leaking pipes within the adjoining wall is also a possible cause.

Damp (or structural damp) refers to the presence of unwanted moisture in the structure of a building, either as the result of intrusion from outside, or condensation from within the structure. In the shower area, internal water leaks or other sources of excessive moisture are generally the cause of damp.

Unmanaged damp in the shower recess is likely to facilitate the formation and development of mould and fungi growth, decaying associated building materials and compromising their structural integrity. It is important to address damp conditions, as the World Health Organisation notes that excess moisture leads - on almost all indoor materials - to growth of microbes such as moulds, fungi and bacteria, which subsequently emit spores and other matter into the indoor air. Exposure to these contaminants is associated with a wide range of respiratory and other health-related problems.

Consultation with a qualified plumber or bathroom specialist is advised immediately to identify the cause of damp and to perform remedial works as required. Where excessive mould growth is present, further inspection by a specialist environmental health inspector should also be considered.

Always ensure that sealant and grout is in good condition to prevent any moisture issues occurring in the future.

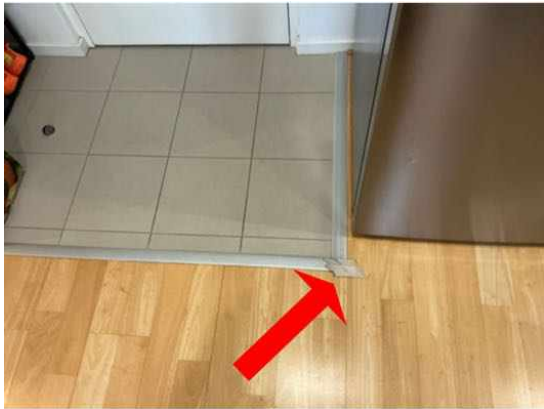
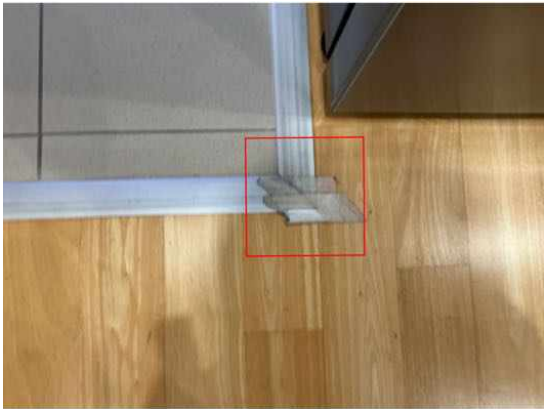
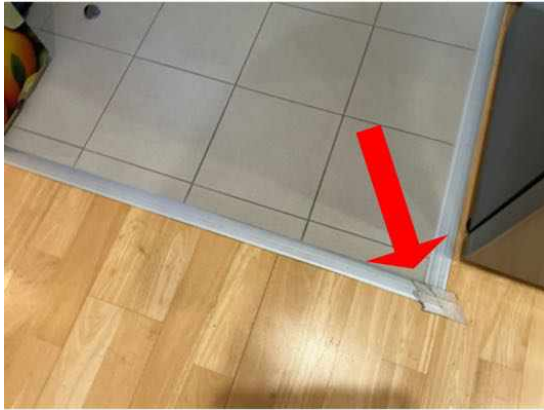
### Defects 3.02

Building:	Main Building
Location:	Entry
Finding:	Detached Floor Trim to Entrance Area
Information:	The floor trim at the entry area was observed to be detached from its fixing. Temporary adhesive tape appears to have been used to hold the trim in place at the time of inspection.

This condition is considered poor workmanship and may present a minor trip hazard if left unsecured. Temporary fixing methods are not considered an acceptable permanent solution.

The client is to arrange for a qualified flooring specialist or suitably skilled handyman to properly re-fix or replace the floor trim using appropriate mechanical fixings or approved adhesive to ensure it is securely installed and finished to an acceptable standard.

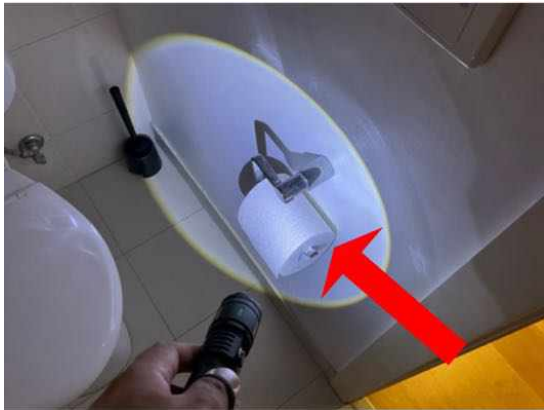
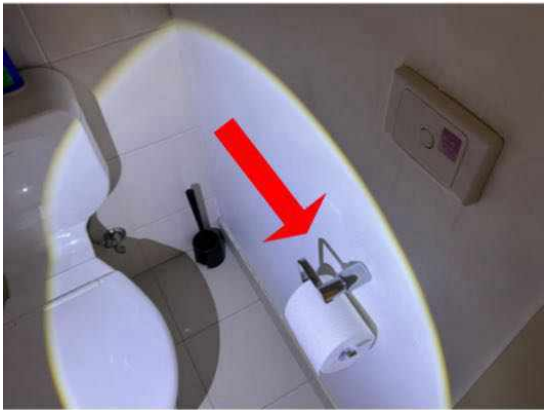
**Defects 3.03**

Building: Main Building  
Location: Bathroom  
Finding: Toilet roll holder - Loose  
Information: The toilet roll holder was found to be loose at the time of inspection. While not a major operational defect, function can deteriorate if the problem is left unmanaged.

It is advised that the homeowner performs remedial works to re-attach the toilet roll holder to its original fixing. A general handyperson may be required to perform these works.

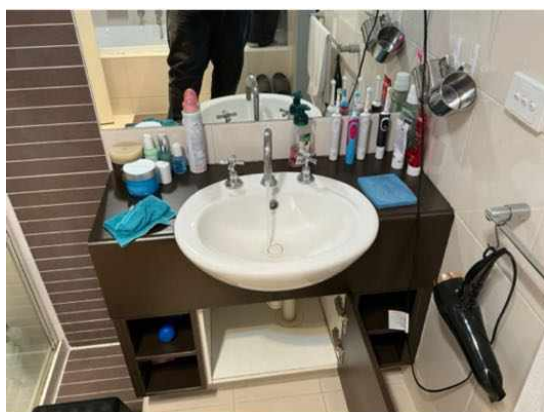
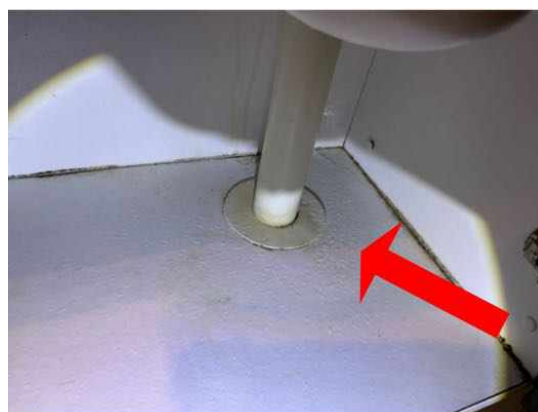
## Defects 3.04

Building:	Main Building
Location:	Bathroom
Finding:	Bathroom Sink plumbing pipe - Leaking
Information:	The plumbing pipes in the bathroom were found to be leaking at the time of inspection.

This is a common defect that is consistent with general ageing of the building element. However, it may be indicative of substandard plumbing workmanship if the tap is relatively new.

While this defect only seems minor, if left unmanaged, it is likely to result in the development of rust, water damage and/or extensive water usage.

It is advised that a licensed plumber be appointed to perform remedial works on the affected tap. Such works should be performed prior to the development of secondary defects to ensure adequate functionality of all associated building elements

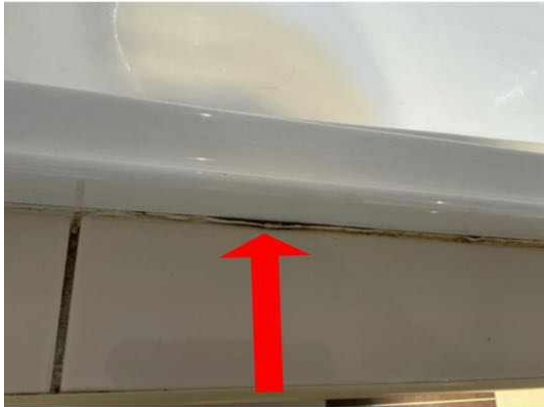
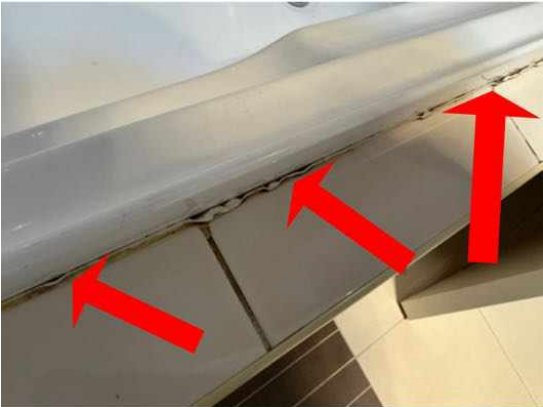
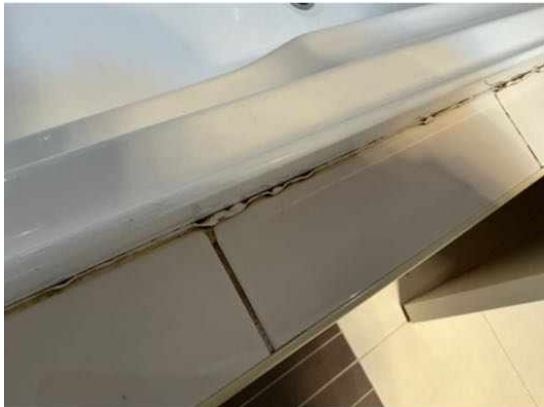
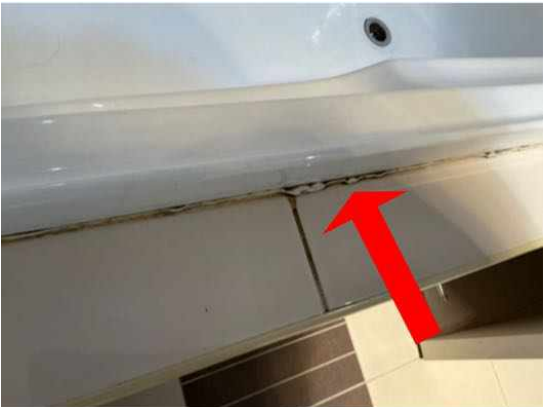
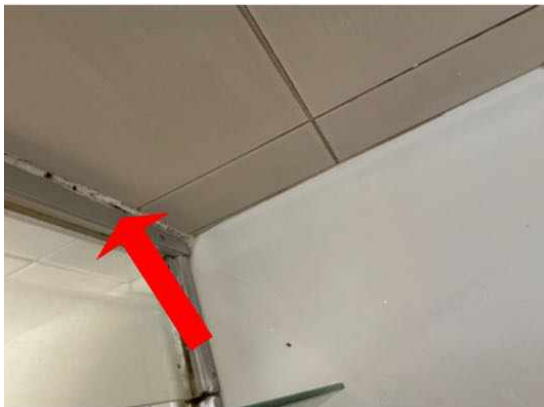
## Defects 3.05

Building:	Main Building
Location:	Bathroom
Finding:	Sealant and grouting - Deteriorated
Information:	It was noted on inspection that sealant or grout is degraded to the tiled shower alcove and or other areas of the bathroom.

Different materials and floor areas move at different rates, generally causing cracking to grout or sealant at this point. A flexible sealant is required to allow for expected expansion and contraction, while keeping the joint water tight and protective of all associated building materials.

Flexible and mould resistant materials should be applied to affected areas to prevent any subsequent water damage that is likely to occur. Regular maintenance and

replacement of damage or missing or damaged sealant and grout is highly recommended to the wet areas, as this is a regular wear and tear defect. Sealant and grouting in areas that come into regular contact with water should be maintained for the long term care of your property.

A sealant specialist or tiling contractor should be appointed to complete these works as soon as possible

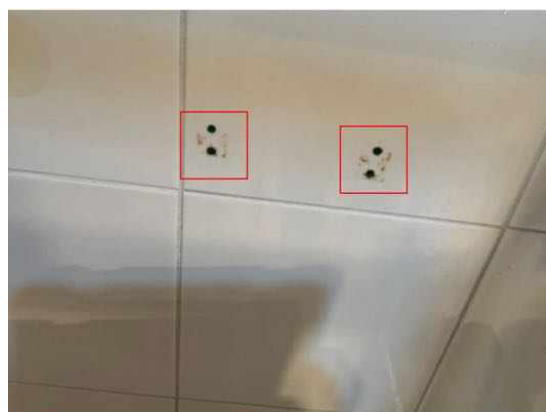
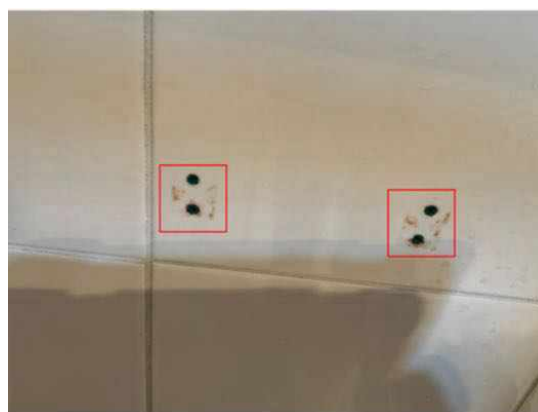
**Defects 3.06**

**Finding:** Wall Tile Penetrations with Remaining Plugs  
**Information:** Wall tiles were observed to contain previous screw penetrations, likely from removed fixtures such as hooks or hangers. Plastic wall plugs remain embedded within the tiled surface at the time of inspection.

These penetrations compromise the integrity of the tiled finish and may allow moisture ingress behind the tiles, potentially leading to substrate deterioration, loss of adhesion, or water damage if located within a wet area.

The client is to arrange for a qualified tiler to remove the affected tiles and replace them with new tiles, ensuring the wall surface is properly sealed and finished to maintain the waterproof integrity of the area.

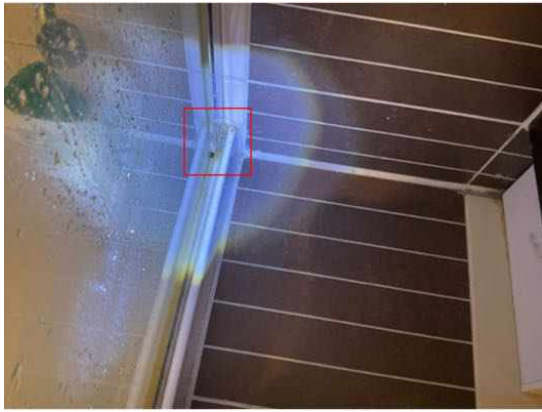
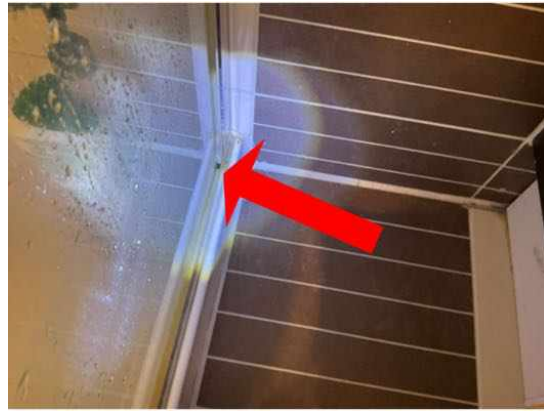
### Defects 3.07

**Building:** Main Building  
**Location:** Bathroom  
**Finding:** Shower screen - Leaking  
**Information:** Leaking was evident to the bathroom's shower screen at the time of inspection. It is suspected that the leaking has occurred as a result of deteriorated or missing caulking to the shower or general ageing of the building elements.

Leaking from the shower where left unattended, is likely to lead to water damage to adjoining flooring and walls. Such damage can lead to water damage and necessitate extensive remedial works being required. Active water leaks may also create an environment that is susceptible to the formation and development of mould.

Appointment of a caulking contractor is required to repair or replace the caulking to the shower area. Such works should be performed as soon as possible to ensure that no further damage occurs.

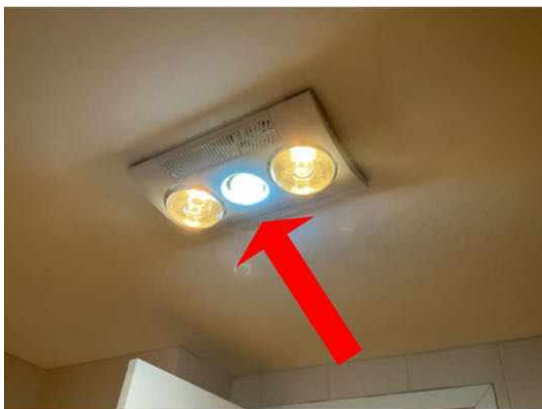
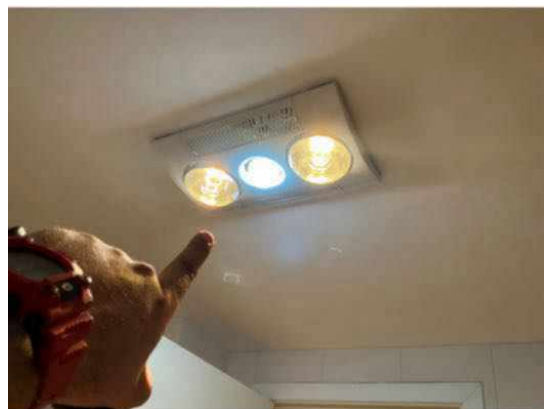
### Defects 3.08

This issue may reduce the efficiency of the exhaust fan, leading to inadequate ventilation in the en-suite, which could contribute to moisture buildup and potential issues such as mold or mildew growth. A noisy fan is also generally less effective at expelling humid air, which could affect the overall air quality and comfort of the space.

It is recommended that a qualified technician inspect and service the exhaust fan to determine the cause of the noise. If necessary, the fan should be repaired or replaced to restore proper ventilation and ensure the en-suite remains well-ventilated and free of excess moisture.

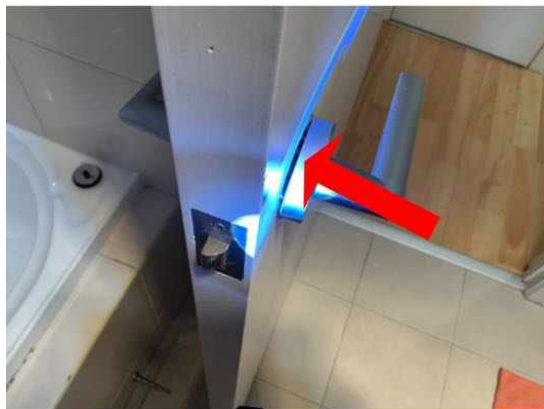
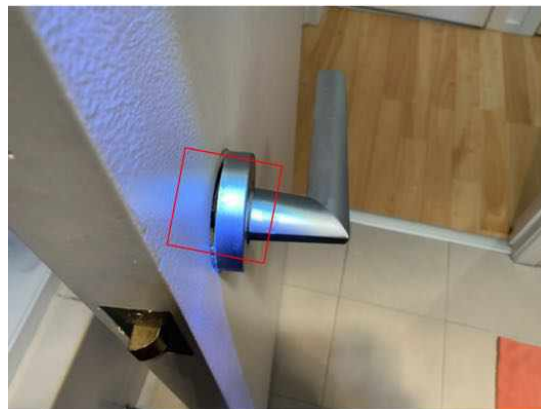
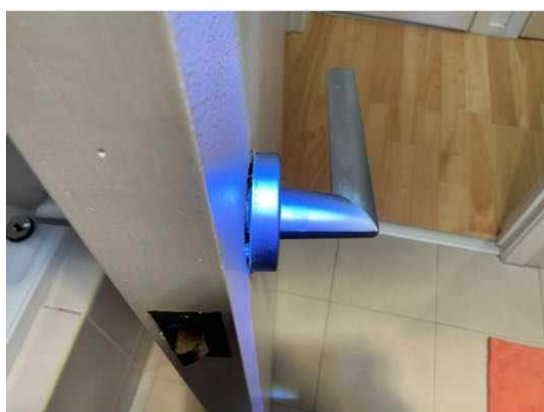
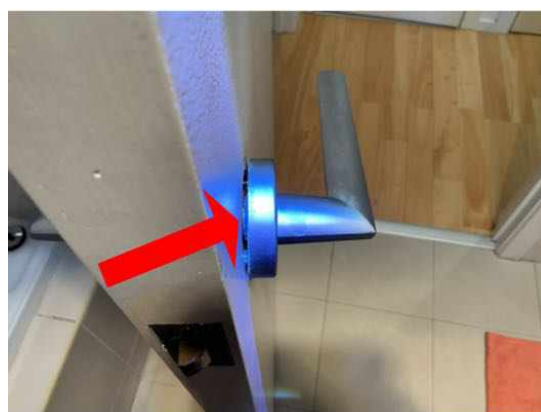
### Defects 3.09

Finding: Loose Door Handle – bathroom door  
 Information: Upon visual inspection, we found that the bathroom door handle was slightly loose and exhibited some movement when operated from both the interior and exterior sides. This condition may worsen over time with continued use, potentially leading to difficulty in operating the door or further mechanical failure. We recommend that a licensed carpenter or handyman be engaged to tighten or adjust the door handle to ensure secure and reliable operation.

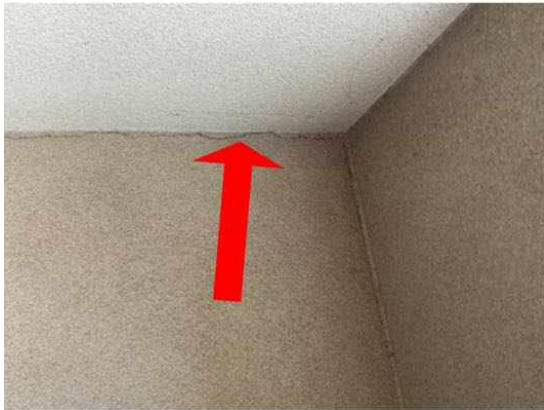
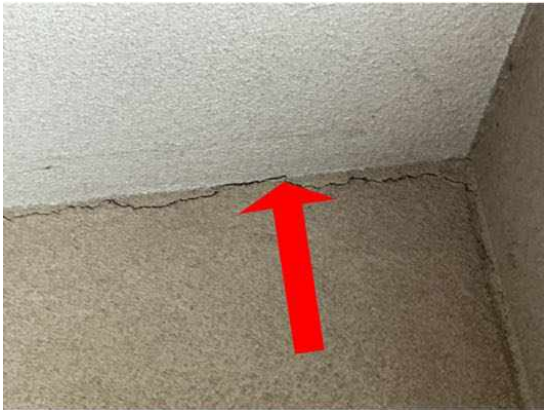
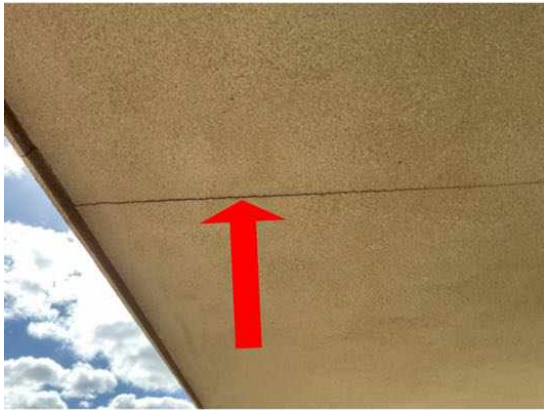
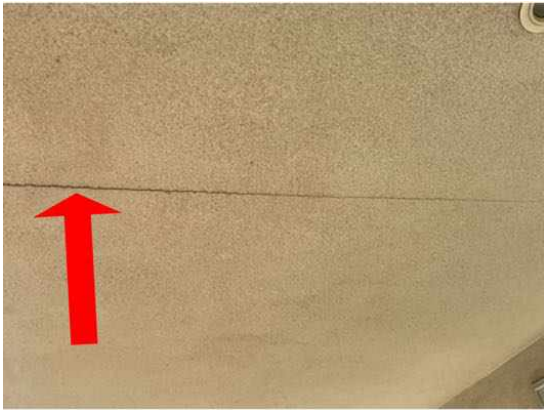
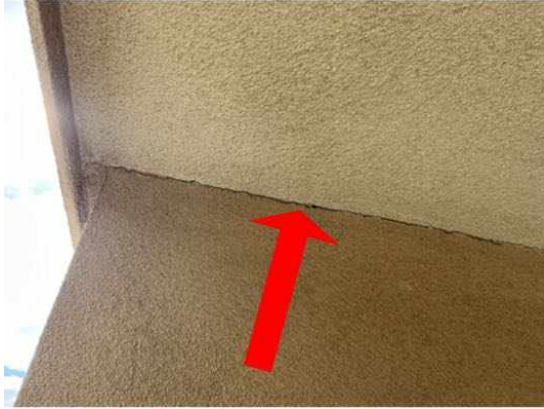
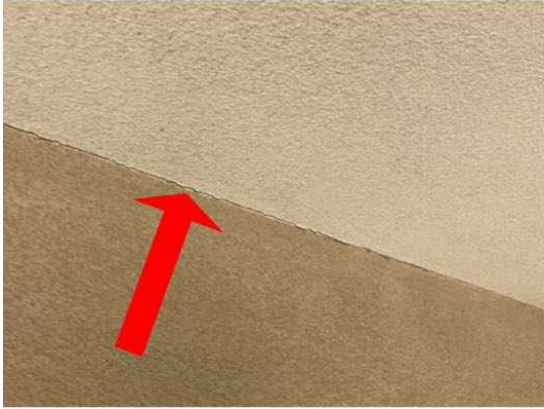
### Defects 3.10

Building: Main Building  
 Location: Balcony  
 Finding: Cracks to internal render - Category 2  
 Information: It has been observed that cracking to internal rendered surfaces in the balcony has occurred. The degree of damage falls within Category 2, described as noticeable cracks which are easily filled. Cracking of this size are generally less than 5mm in width.

Category 2 damage is required to be monitored for a period of 12 months. After the monitoring period, a crack rated at Category 2 or above is considered a defect requiring rectification.

Always contact your building inspector should cracks widen, lengthen, or become

more numerous.

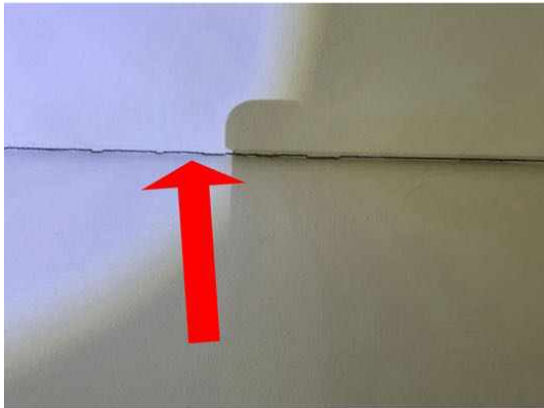
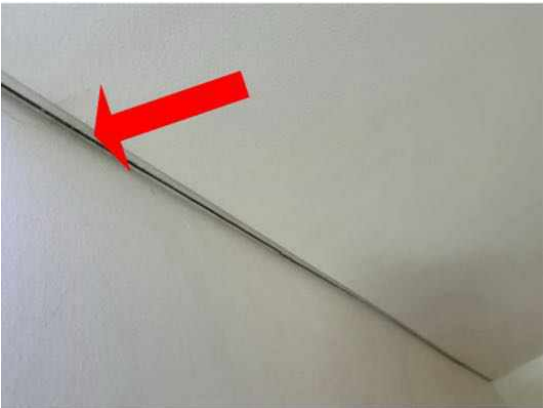
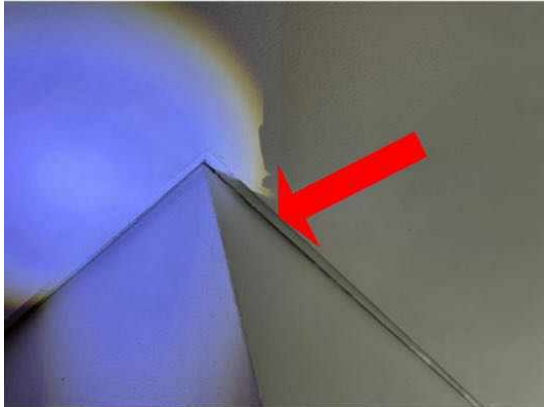
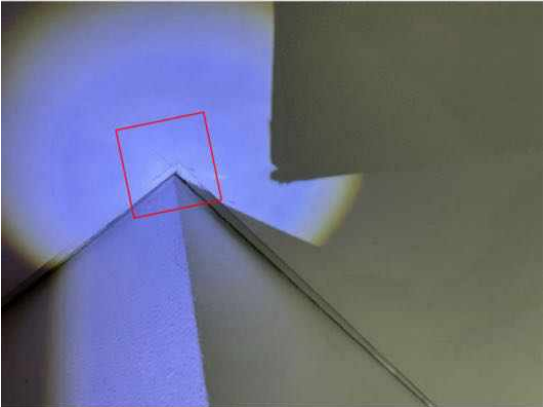
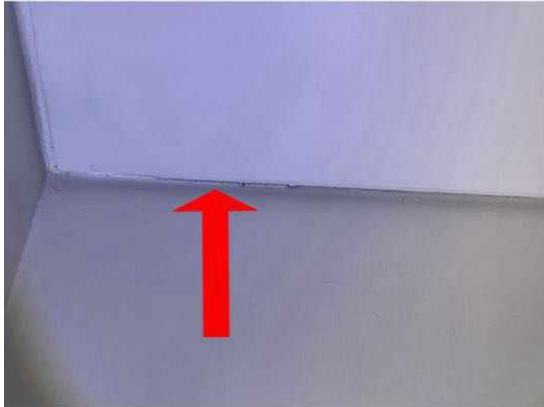
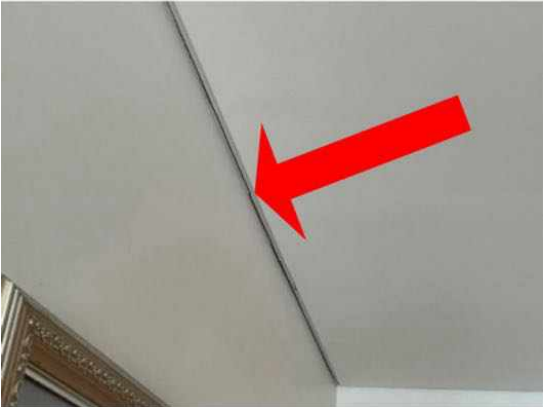
**Defects 3.11**

Building: Main Building  
Location: Bedroom  
Finding: Ceiling Cracking – Bedrooms  
Information:

Noticeable cracking was observed to the ceiling linings in multiple bedroom areas. The cracks appear consistent with minor movement and normal settlement, and no significant separation or structural distortion was evident at the time of inspection.

Although the cracking is considered minor in nature, untreated ceiling cracks may worsen over time due to continued movement and may allow joint compound deterioration, resulting in further surface defects and cosmetic decline.

The client is to arrange for a qualified plasterer to properly prepare the affected areas, including opening and cleaning the cracks as required, applying suitable jointing compound, sanding smooth, and repainting to achieve a uniform finish consistent with surrounding ceiling surfaces.

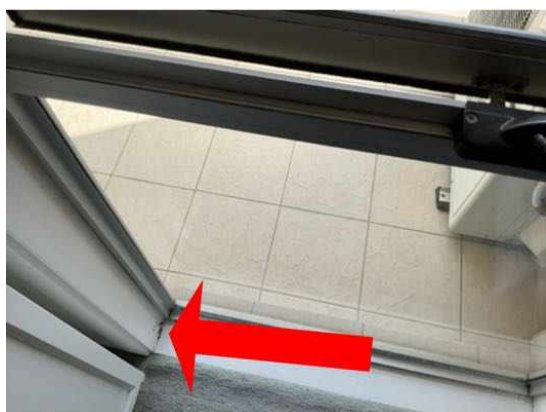
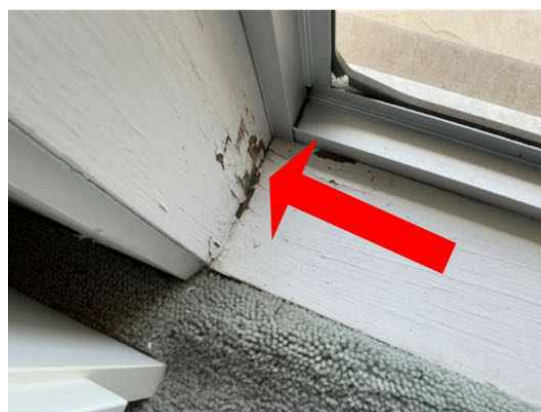
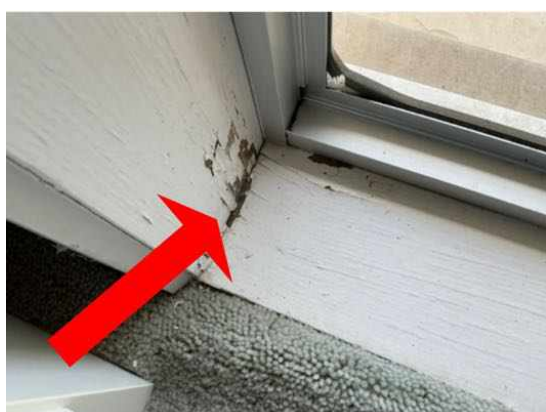
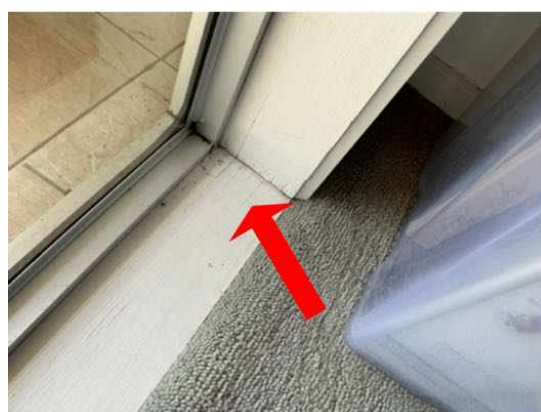
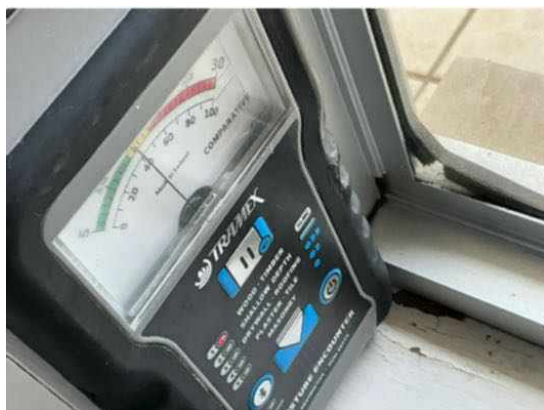
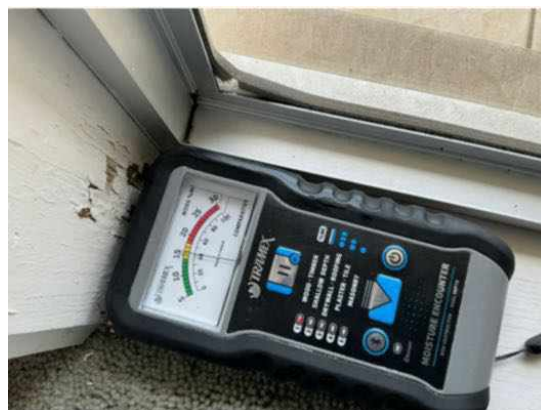
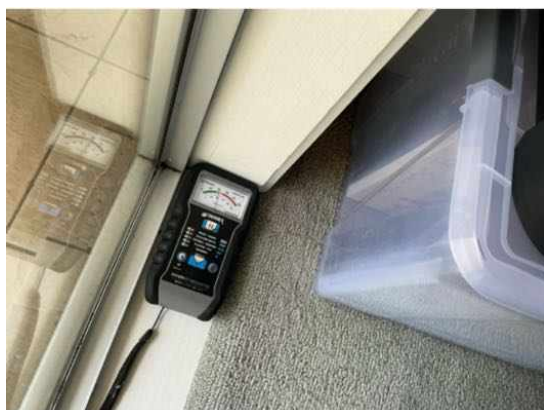
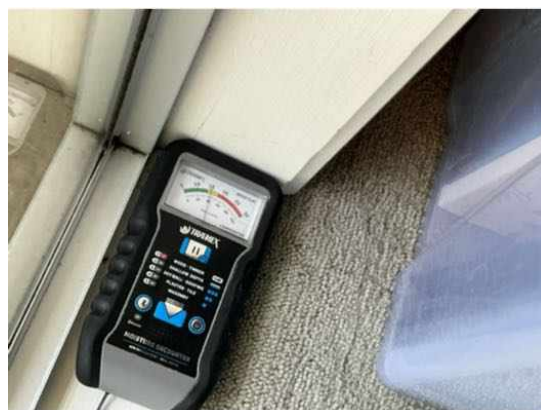
**Defects 3.12**

Location: Bedrooms  
Finding: Water Damage to Timber Window Sills – Bedrooms  
Information:

The timber window sills within the master bedroom and second bedroom were observed to exhibit water staining and signs consistent with previous moisture exposure. Localised surface deterioration and possible minor timber decay were noted; however, moisture meter testing at the time of inspection did not detect elevated moisture levels, indicating the damage appears historic rather than active.

If left unaddressed, deteriorated timber may progressively decay and compromise the integrity of the sill, and failure to maintain adequate external sealing may result in future moisture ingress and recurrence of damage.

A qualified carpenter is to assess the affected window sills and remove any decayed timber, repair or splice affected sections as required, and make good. A qualified painter is to prepare, fill, sand, prime, and repaint the surfaces. Additionally, a suitably qualified tradesperson is to inspect and re-seal the external window perimeters as necessary to ensure the openings are properly weatherproofed and protected against future water ingress.

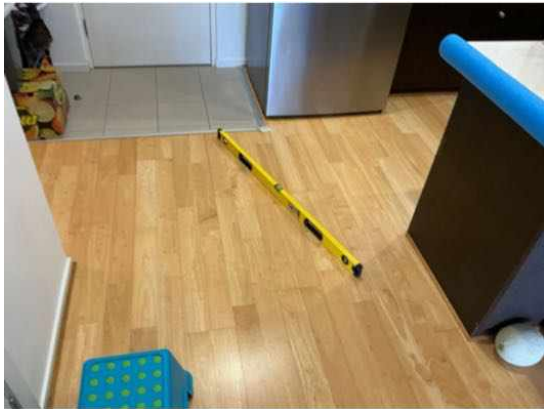
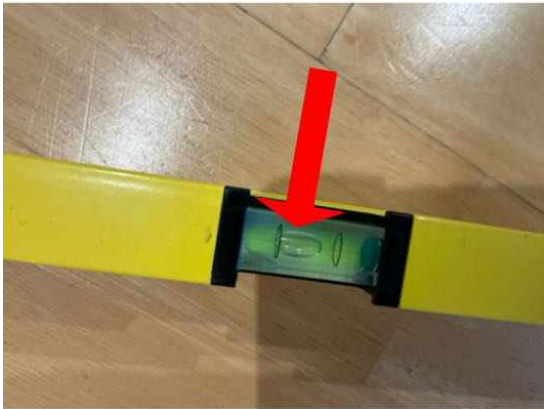
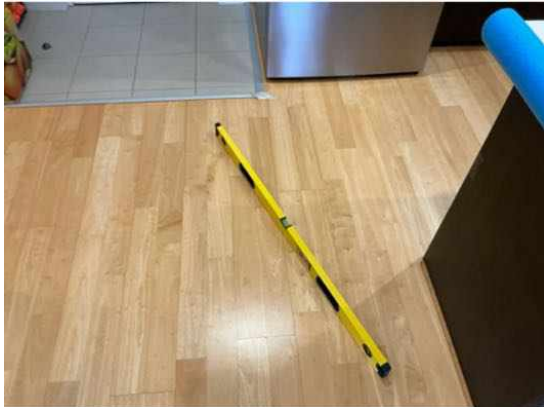
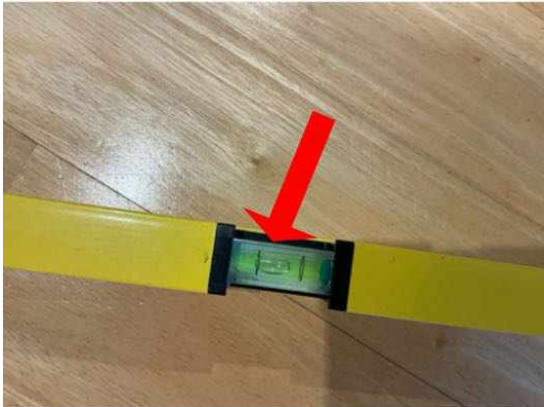
### Defects 3.13

Information: The internal flooring in the entry area is out of level and uneven. Uneven flooring is likely to indicate minor defects such as expected movement of the foundations of the property, but may also indicate poor workmanship during initial floor installation.

It is advised that the flooring be closely monitored to identify any further movement. Where flooring remains relatively unchanged for an extended period of time (i.e. several months), it is likely that this defect has been caused by expected movement of the foundations of the property.

However, where flooring is uneven further, potentially invasive inspection of the subfloor structures and stumps in this area is required. In this case, works to repair are likely to be required, and would be carried out by a registered builder.

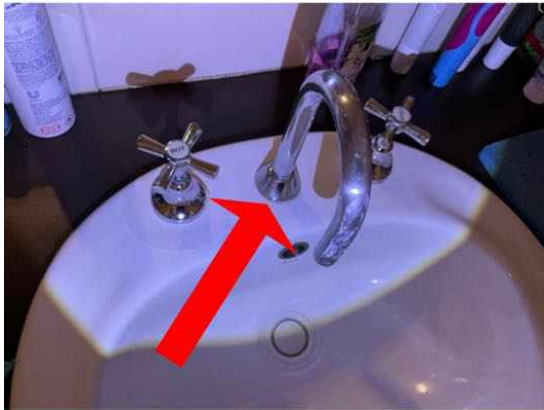
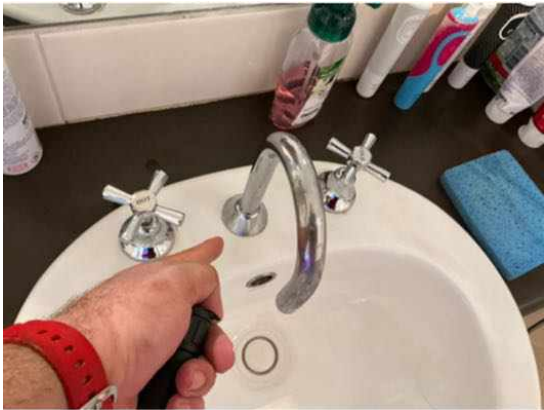
**Defects 3.14**

Building: Main Building  
Location: Bathroom  
Finding: Tap - Loose  
Information: The tap in the bathroom has not been installed correctly, or has deteriorated with age, and is consequently loose. This tap being loose creates potential for water leaks and subsequent water damage to the surrounding area.

Where taps or spouts are loose, a qualified plumber should be appointed to re-fix the plumbing fitting.

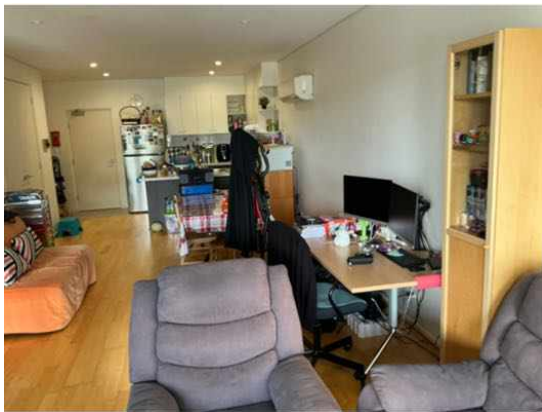
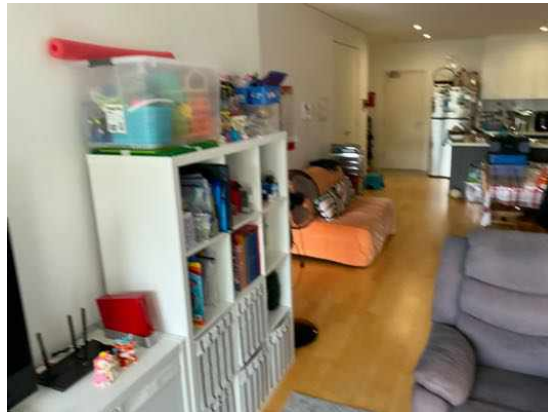
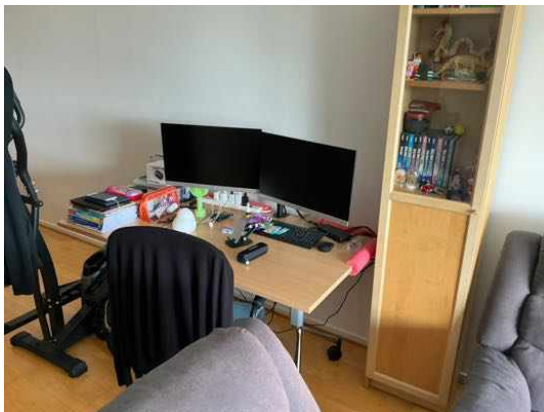
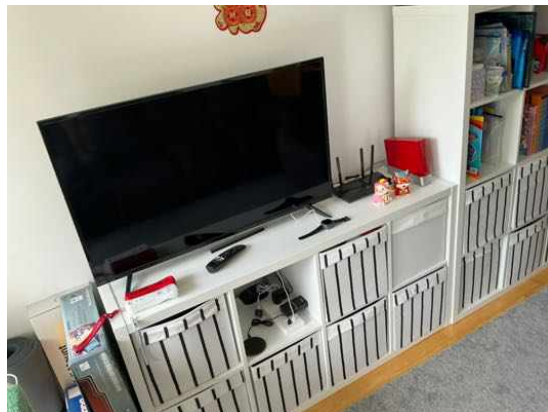
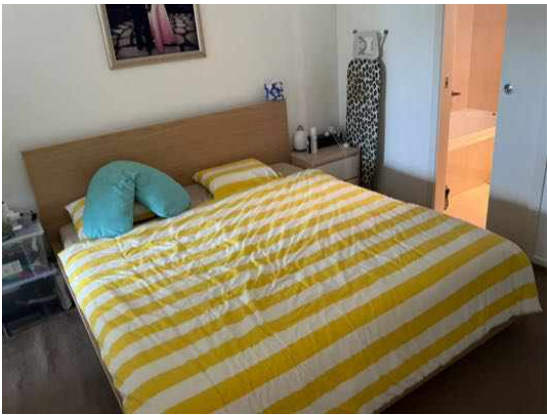
#### Noted Item

Building: Main Building  
Location: All Internal Areas  
Finding: Obstructions and Limitations - Interior  
Information: These photographs are an indication of the obstructions and limitations which impeded the inspection of the internal areas of the property at the time of inspection. These obstructions can hide an array of defects and should be removed to allow full inspection to be carried out. A re-inspection is recommended once the areas are made accessible.

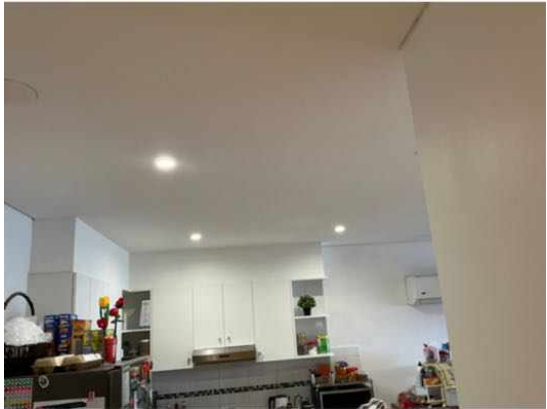
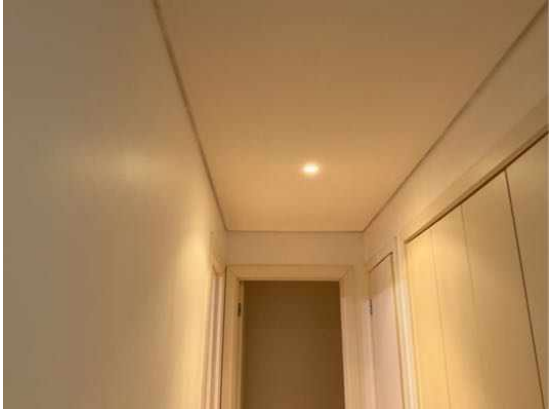
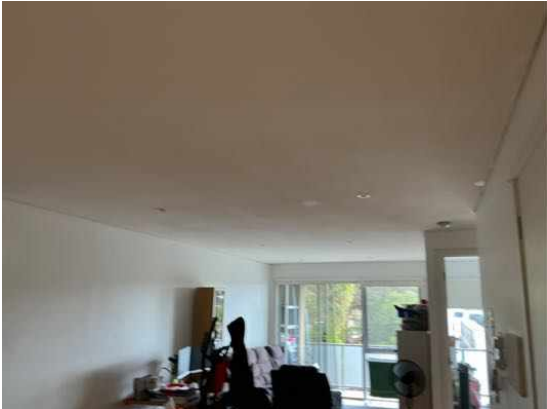
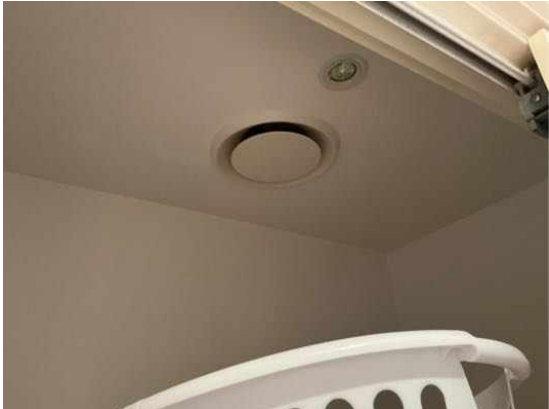
**Noted Item**

Building: Main Building  
Location: Roof Void  
Finding: Obstructions and Limitations - Roof Cavity No access  
Information: The roof cavity was inaccessible at the time of the inspection due to no appropriate access which impeded the inspection of the roof cavity of the main building at the time of inspection. These obstructions can hide an array of defects and should be removed to allow full inspection to be carried out. A re-inspection is recommended once the areas are made accessible.
