Building and Timber Pest Inspection Report

Inspection Date: Wed, 25 Mar 2026

Property Address: 34 Pauline Dr, Surrey Downs SA 5126,
Australia

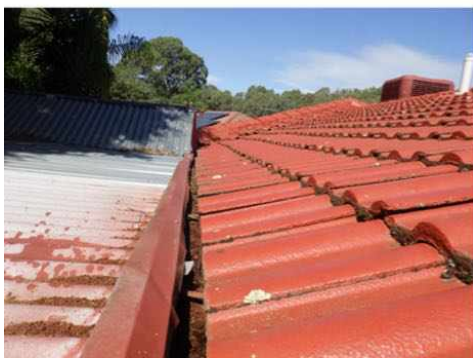
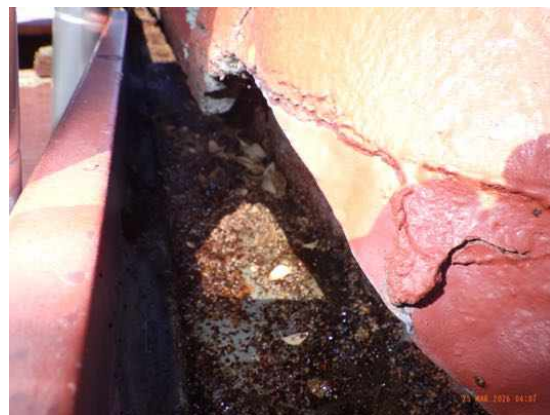
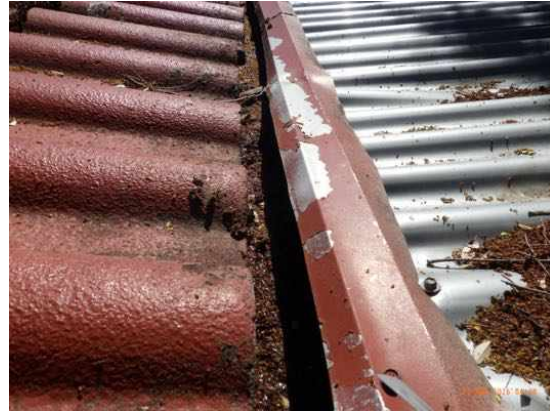
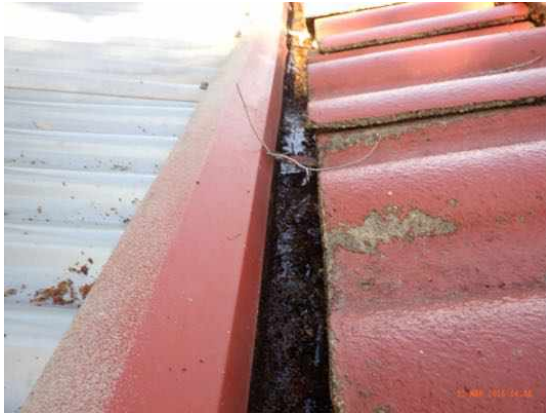
Finding 2.01

Blocked gutters are likely to lead to high levels of moisture in the affected areas. Such moisture will not only cause rust and decay of the associated building materials, but can also provide conditions that are conducive to termite and timber pest activity. Blockages in gutters should therefore be removed immediately to ensure dry conditions are maintained.

Consult a Licensed Plumber for further specific advice on remedial works that may be required. In the interim, it is highly advised that blocked gutters be removed by the homeowner or a general handyperson as a matter of urgency.

Removal of debris may expose currently concealed defects.

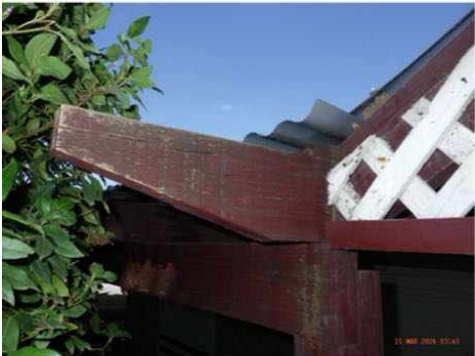
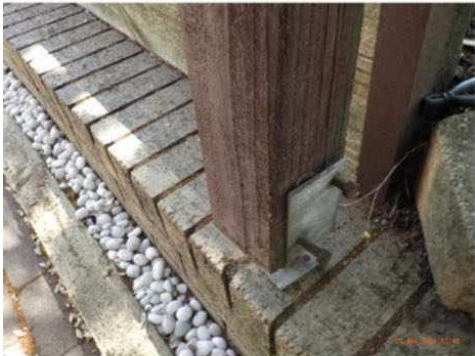
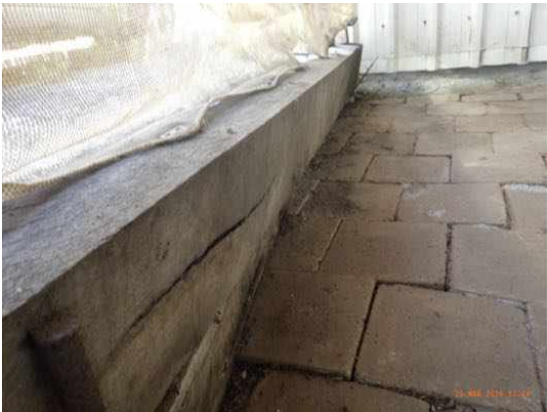
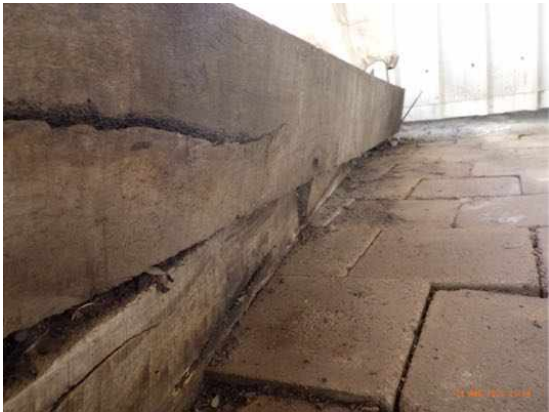
Finding 3.01

Building:	Building 1
Location:	Front Elevation
Finding:	Structure - Old and non-compliant
Information:	The pergola structure, whilst appearing to provide adequate structural support, does not comply with contemporary building practices and current Australian Standards. This is not a requirement in older homes and is merely noted for your information that there are several minor issues relating to this area.

This includes the lack of guttering to remove the stormwater from the area and the deterioration to the timber elements and a post has become dislodged from the sleeper beneath.

Without repair it is likely that the area could become further deteriorated and as such should be addressed in the short to mid term.

It is advised that this structure be inspected by a registered builder to ensure that the structure remains in a serviceable condition.

Repair front pergola post and drainage

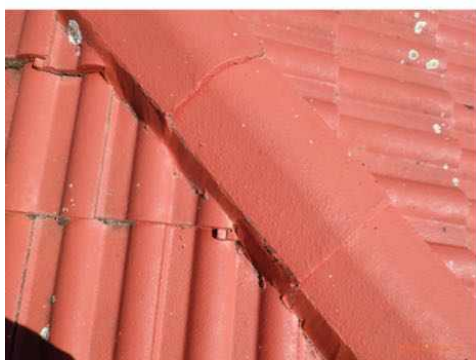
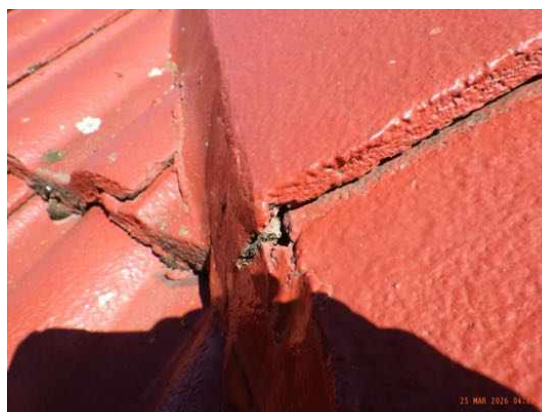
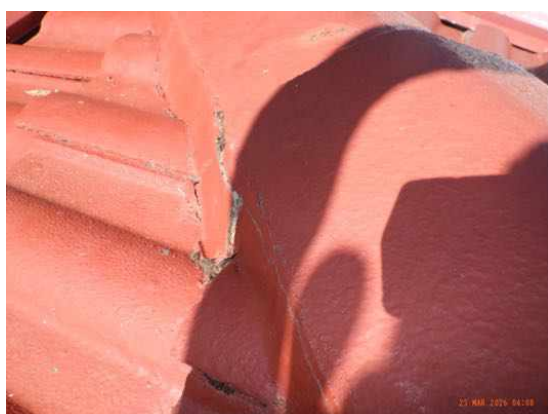
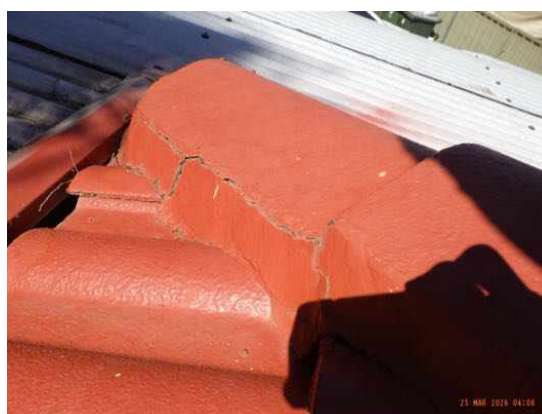
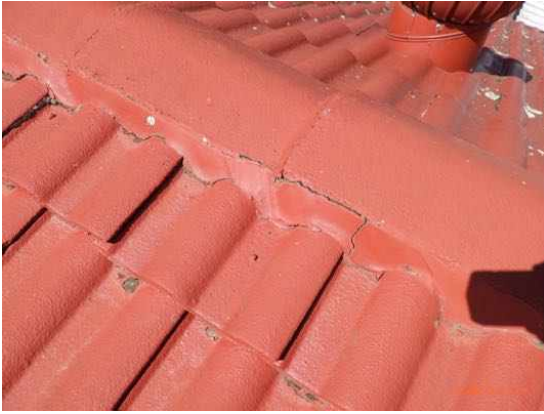
Finding 3.02

Building:	Building 1
Location:	Roof Exterior
Finding:	Mortar - Deterioration
Information:	Mortar, or 'bedding', is the material which fills joints and intersections between tiles and other building elements on the exterior roof covering, such as gable ends, hip capping and valleys. Upon inspection of the exterior roof, it was noted that sections of the mortar show varying levels of deterioration.

Mortar generally deteriorates as a result of frequent exposure to weather conditions over a prolonged period of time. Mortar that is deteriorating may allow water ingress into the roof void, putting associated building elements and roofing structures at risk of water damage.

Deteriorated mortar also detracts from the functionality of roof tiles and other roofing elements, potentially decreasing weather tightness and roof drainage.

Mortar deterioration can be attended to by a handyperson where areas of deterioration are localised and easily accessible. Otherwise, consultation with a roofing contractor is advised where greater works are required.

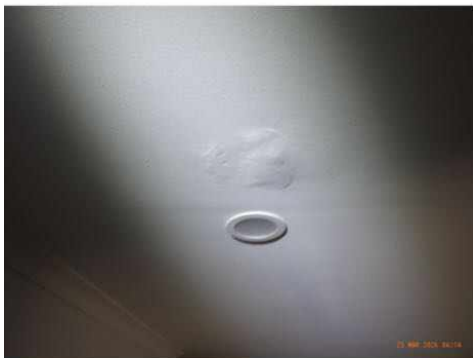
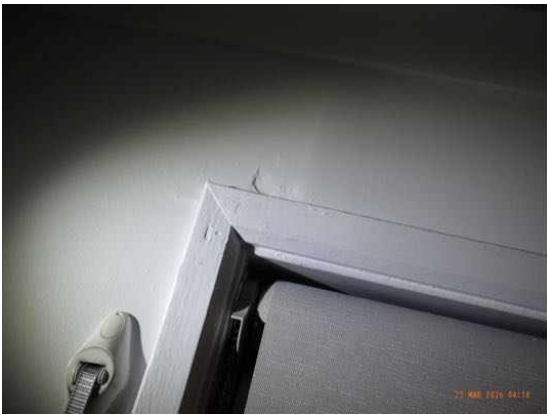
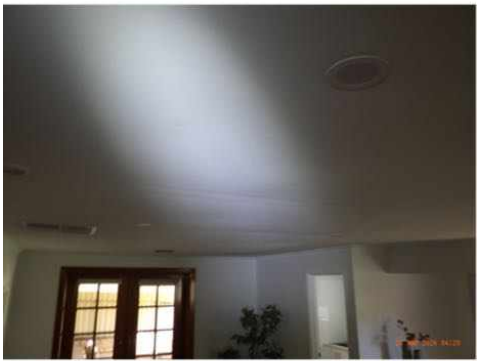
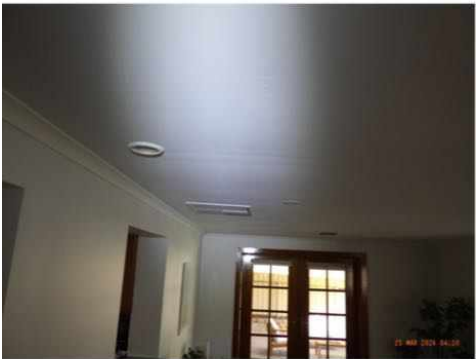
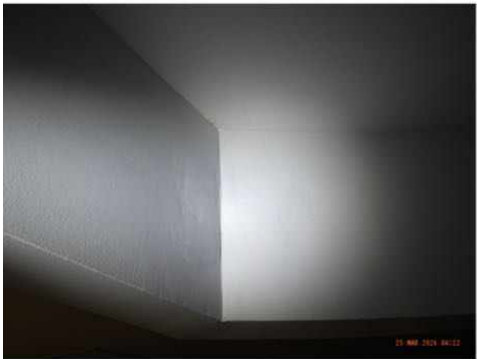
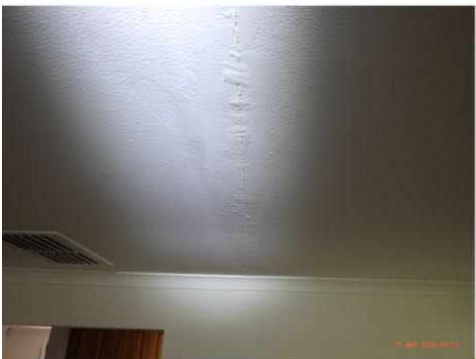
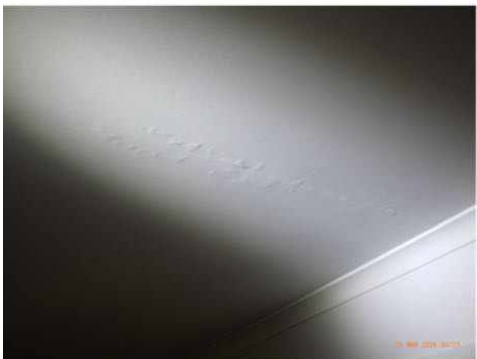
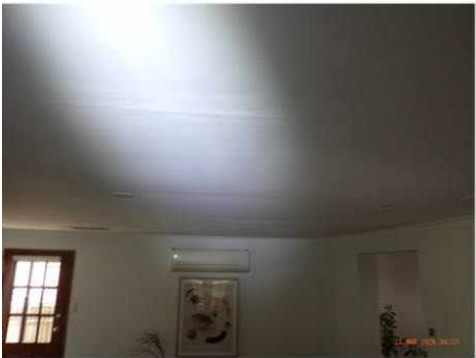
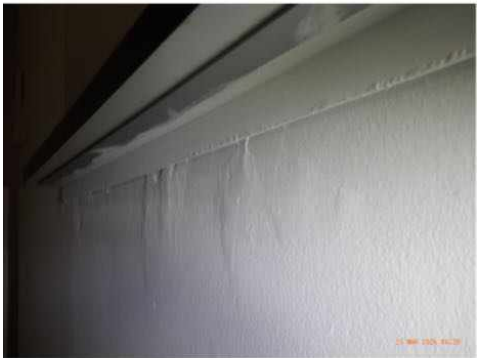
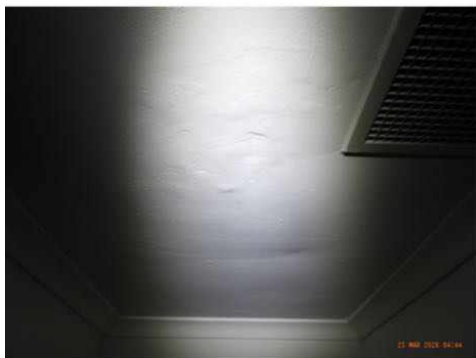
Finding 3.03

Building:	Building 1
Location:	All Internal Areas
Finding:	Cracking and repairs, Walls and ceilings (minor)
Information:	Several cracks and or crack repairs were evident throughout the internal walls and ceilings of the property.

Although fine cracks are quite noticeable, they are often only considered to be an appearance defect and usually do not indicate any structural damage. Generally, the cause of a fine crack is indicative of minor expected movement of a structure of this age however as repairs have been carried out, it is impossible to know the extent of any cracking.

Cracking of this nature can generally be repaired with minor filling and should be conducted by a qualified painting contractor

Always contact a building inspector should cracks widen lengthen or become more numerous.

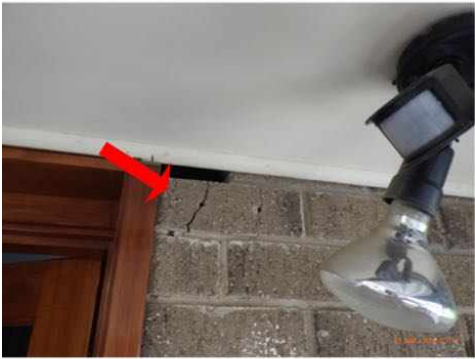
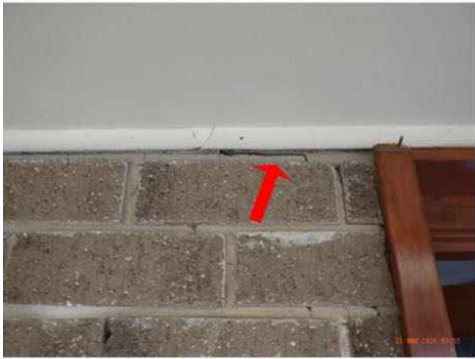
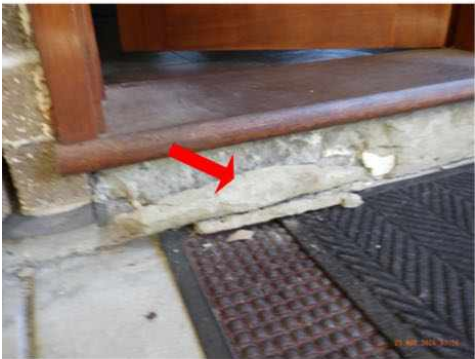
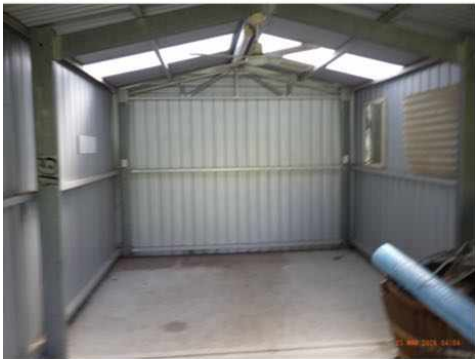
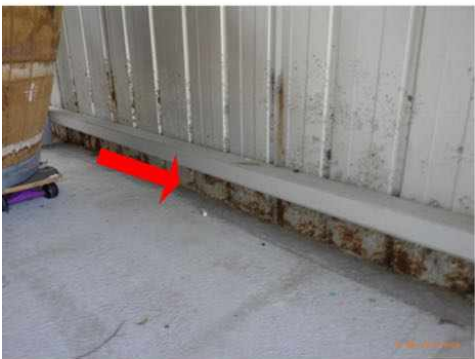
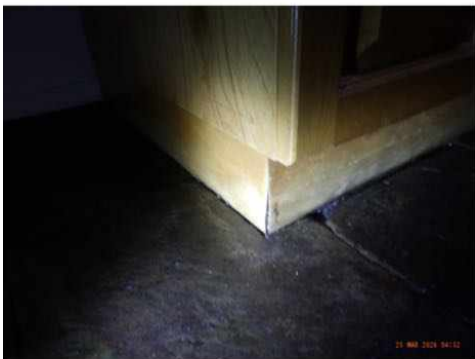
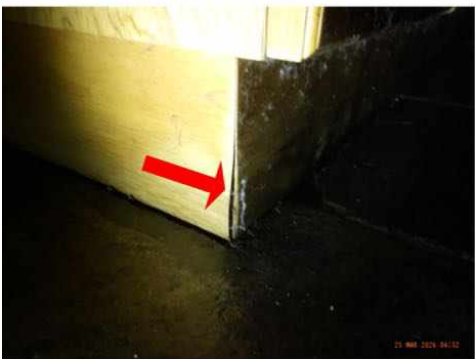
Finding 3.04

Building:	Building 1
Location:	All Areas
Finding:	Minor defects present
Information:	Minor defects were evident throughout the dwelling at the time of inspection, which are consistent with normal wear and tear and considered appropriate for a property of this age.

These defects are typical of ongoing material ageing, settlement, and general use over time, and include, but are not limited to:

- Minor cracking to bricks above rumpus door
- Minor deteriorated to concrete below rumpus door
- Rust to shed wall iron
- Swelling evident to kitchen kicker and bathroom door
- Heater not operating at the time of inspection

While these defects are not considered structurally significant at present, they should be addressed as part of routine and ongoing property maintenance to prevent further deterioration. Repairs and maintenance works should be carried out by appropriately licensed and qualified tradespeople to ensure the continued serviceability and longevity of the dwelling.

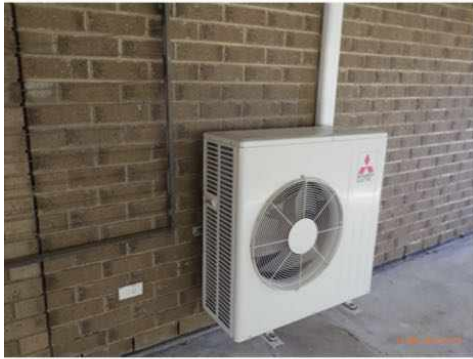
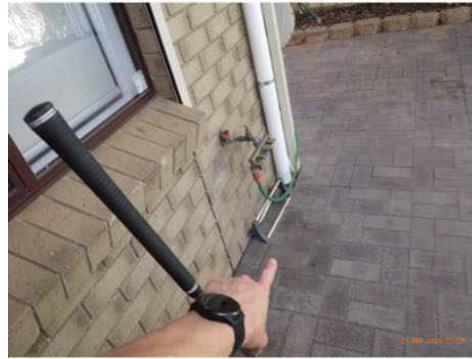
Finding 6.01

Building:	Building 1
Location:	All External Areas
Finding:	Air conditioner and/ or external tap. No drainage
Information:	Moisture around the perimeter of the building should be minimised to ensure that the area is kept dry and stable which in turn reduces the risk of water damage and termite infestation.

There appears to be no drainage points set up to the air conditioning unit, and or the external tap. While this is not a legal requirement it is recommended to reduce the risk of moisture related issues and the creation of an environment conducive to termite activity.

It is recommended that a licensed plumber be appointed to set up drainage in order to prevent such an environment from being created.

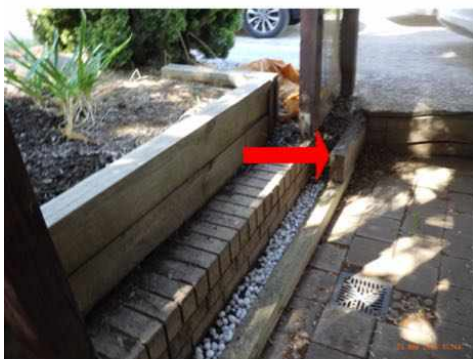
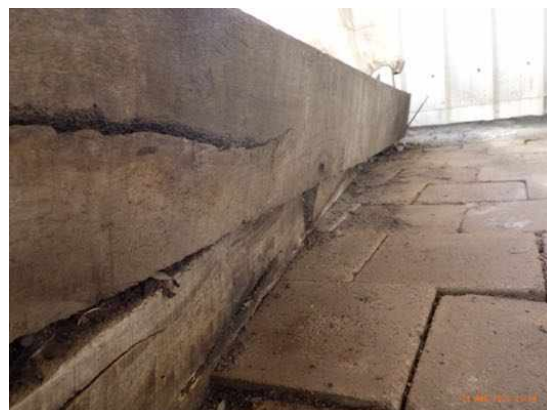
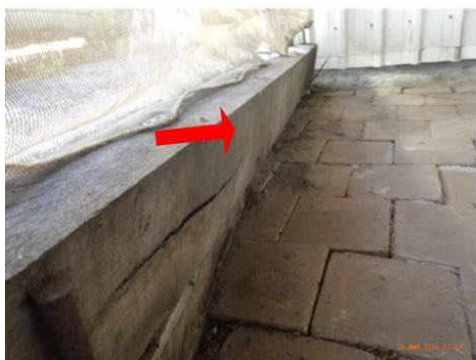
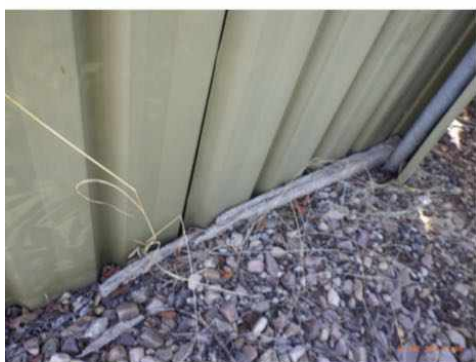
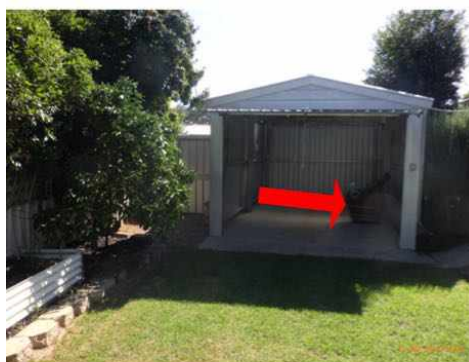
Finding 6.02

Building:	Building 1
Location:	All External Areas
Finding:	Untreated or non-durable timbers in a hazardous environment
Information:	To reduce the risk of timber pest attack it is essential that timber used in a hazardous environment (e.g. in direct contact with the ground or frequently exposed to damp conditions) is of sufficient durability and/or is adequately preservative treated. Additionally any timber lying around or timber stumps should be removed.

Untreated timbers in direct contact with the ground are likely to develop severe wood rot and/or fungal decay if left unattended creating attraction for subterranean termites to infest the timbers from surrounding areas.

If untreated or non-durable timbers are found to be in a hazardous environment it is highly advised that replacement of these building elements be performed as soon as possible to aid the protection of the property against termite / timber pest attack. Failing this close monitoring is recommended in an attempt to identify termite infestation at an early stage.

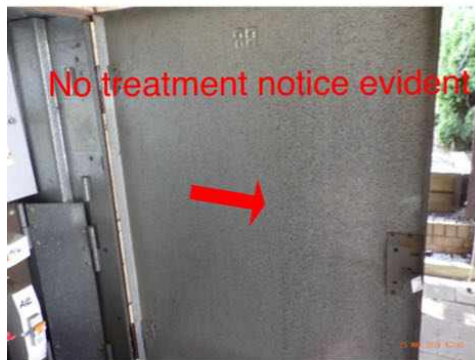
Finding 6.03

Building:	Building 1
Location:	All Areas
Finding:	Termite Management System - no evidence of a chemical installation
Information:	The application of a post-construction chemical termite barrier is highly recommended for all properties, particularly if live termite activity has been found on the site previously. Such barriers are highly effective in preventing termite attack on any timber building elements throughout the property.

At the time of inspection, it appeared as though no termite management system has been installed, with no evidence to suggest preventative works taking place.

The client may consider gaining further advice from a pest controller as to the costs and procedures involved with this application. It is recommended that obtaining such advice be a short-term priority.

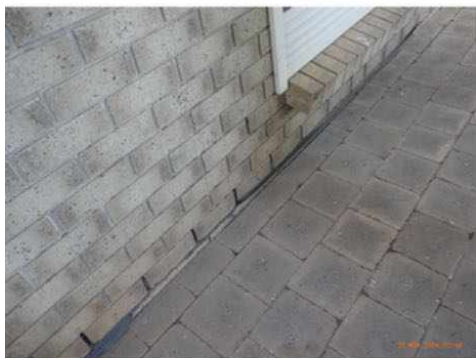
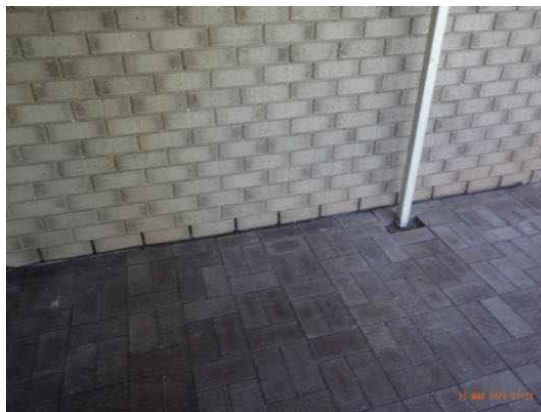
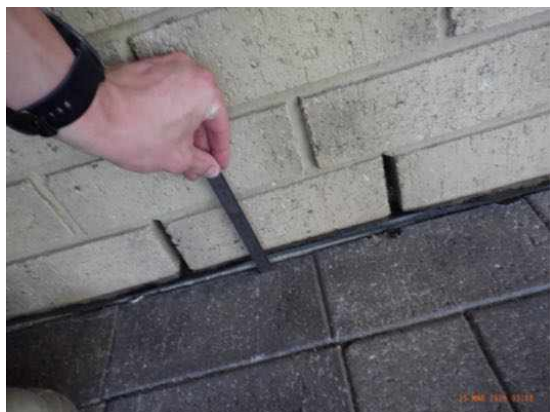
Finding 6.04

Building:	Building 1
Location:	All External Areas
Finding:	Slab Edge - Exposure
Information:	An inspection zone of at least 75mm in relation to the exposed slab edge, between the bottom brick and the perimeter pavement, is required. This inspection zone should be maintained in order to force termites into the open where they can be detected more readily during regular inspections. The slab edge should not be concealed by anything that may prevent inspection of the area, including render, landscaping, soil, turf, paving, concrete cladding or other structures.

Where the slab edge cannot be properly inspected, it is highly recommended that termite or timber pest inspections be carried out every 6-12 months to aid protection of the property against infestation.

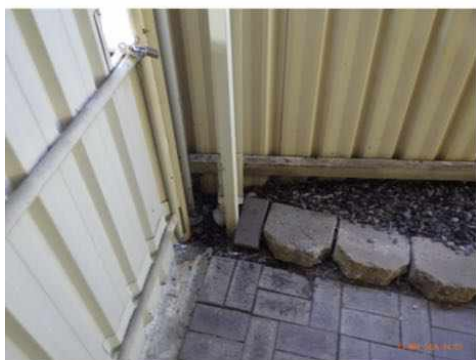
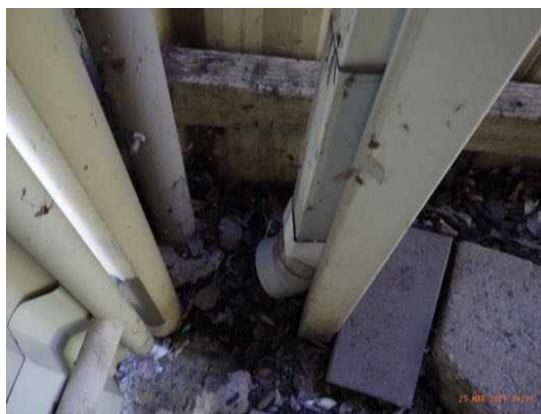
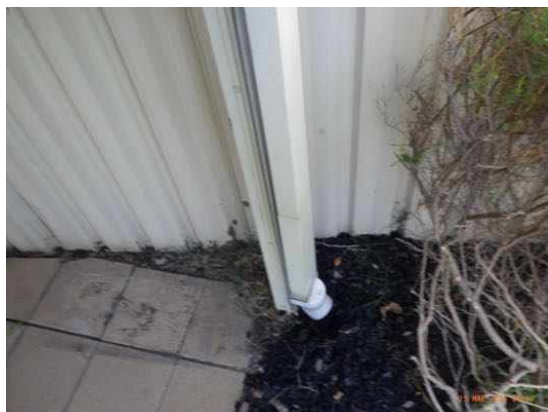
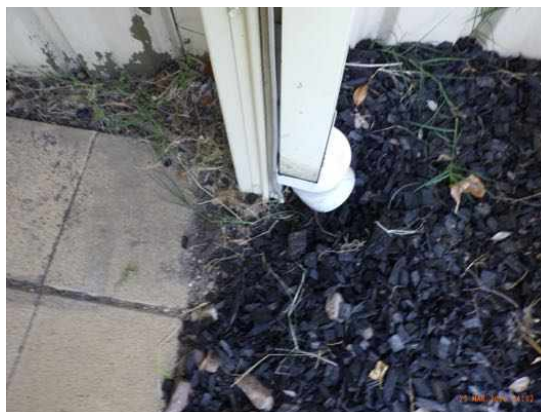
Finding 6.05

Building:	Building 1
Location:	Yard - Back
Finding:	Stormwater drain - Not connected
Information:	The roof plumbing is not adequately connected to stormwater drainage on the site. This disconnection negatively impacts the functional capacity of the roof plumbing.

Where roof plumbing doesn't drain adequately, the area at the base perimeter can become excessively damp, potentially creating an environment that is susceptible to rust and corrosion of surrounding building elements, as well as attracting termites and other pests.

It is highly recommended that a plumber be appointed to further inspect the area and to install adequate drainage equipment where necessary.

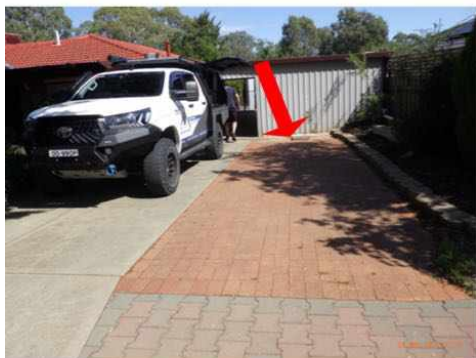
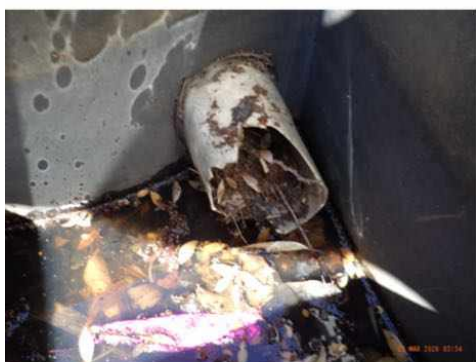
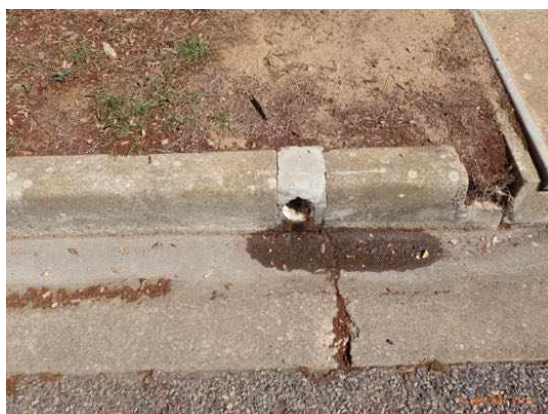
Finding 6.06

Building:	Building 1
Location:	Driveway
Finding:	Site drainage - Inadequate
Information:	The site drainage to the front driveway was found to be inadequate with blockages evident at the time of inspection, creating potential for subsequent water damage to associated building elements.

It is important that water does not lie against the base of walls; surrounding paths and ground levels should be sloped to drain water away from walls. Downpipes should not discharge stormwater onto lower walls or plinths. Stormwater should be carried away by large, regularly cleaned drains.

Where site drainage is inadequate, installation of additional drainage may be required. A qualified plumber should be appointed to further inspect the property to ensure the sump functionality and perform any remedial works as necessary. Water damage and secondary defects are likely to occur if left unmanaged.

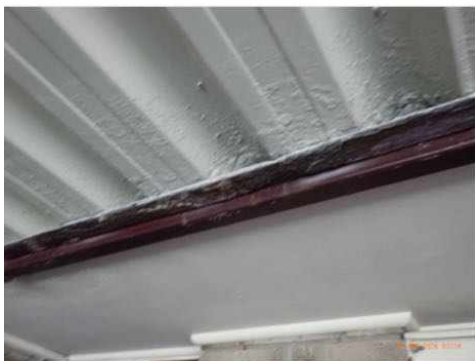
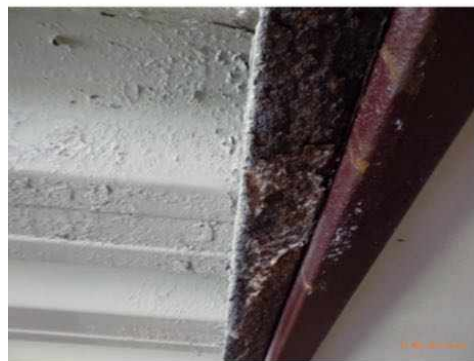
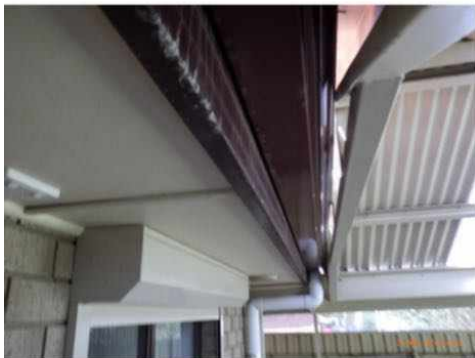
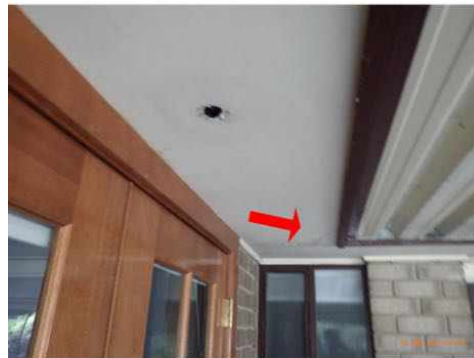
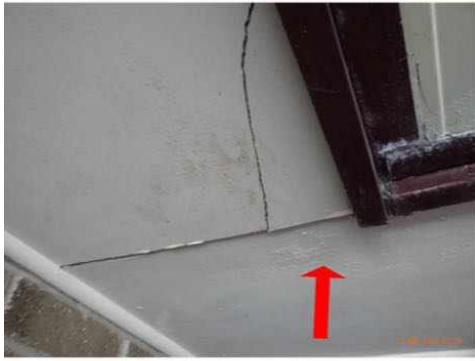
Finding 6.07

Building:	Building 1
Location:	Verandah
Finding:	Roof plumbing - Rusted or corroded
Information:	The roof plumbing has areas of rust and corrosion. It is suspected that this has been caused by blockages, resulting in pooling or standing water, that have prematurely rusted elements of the roof plumbing. There was also some minor damage to the eaves adjacent to this area.

Rusted roof plumbing will generally develop holes and leaks that can affect other building elements with poor drainage of storm water.

Poorly drained roof areas will also lead to damp conditions surrounding the base perimeter of the building which, if left unmanaged, can lead to a range of secondary building defects.

Repair and/or replacement of rusted roof plumbing is highly required in order to reinstate the roof drainage system to a fully operational level.

To further maintain these areas, gutters should be cleaned frequently, allowing the avoidance of any partial blockages.

A licensed plumber or specialist roof restoration company should be appointed to undertake these works. It is advised that such works be completed as soon as possible to prevent any further damage and deterioration.

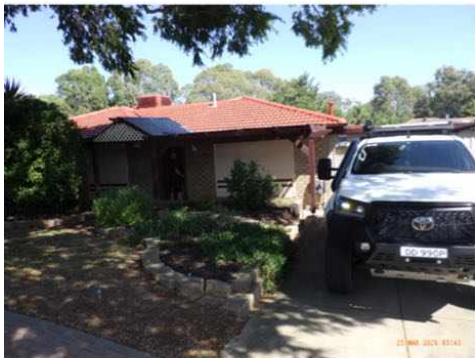
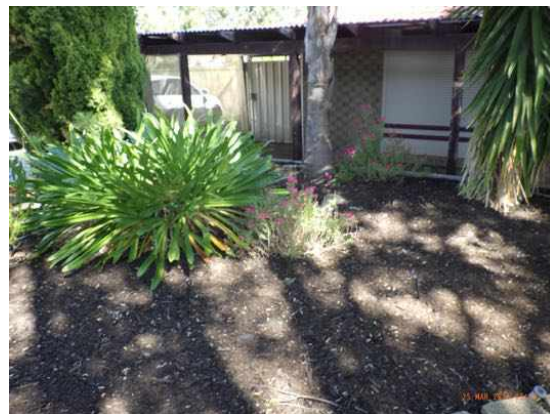
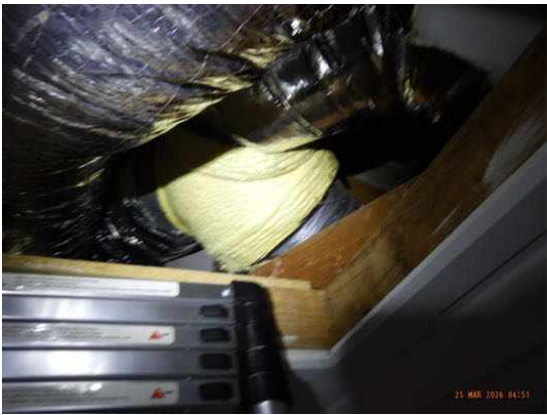
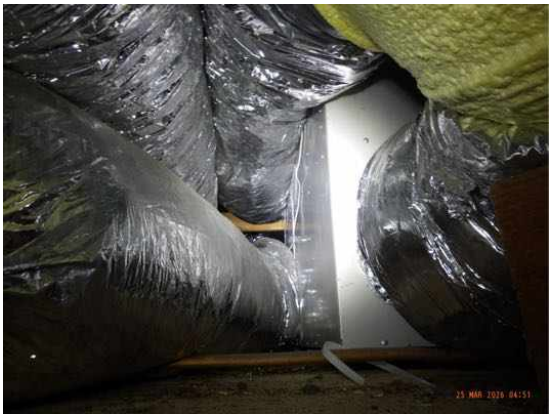
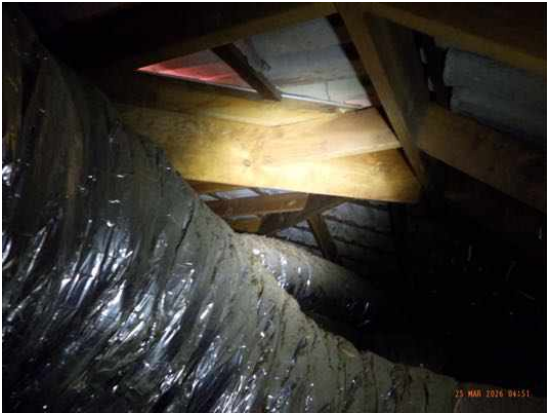
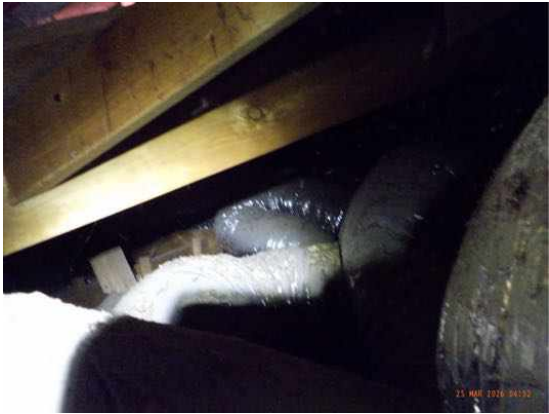
Noted Item

Building: Building 1
 Location: All Areas
 Finding: Additional Photos - Obstructions and Limitations
 Information: These photographs are an indication of the obstructions and limitations which impeded full inspection of the property at the time of inspection. These obstructions can hide an array of defects and should be removed to allow full inspection to be carried out. Reinspection is recommended once access is provided.

Please note access to the roof void was pretty much non-existent due to multiple ducts crossing over the manhole.
