Building Inspection Report

Inspection Date: Tue, 27 Jan 2026

Property Address: 410/7 Hinchcliffe Pl, Zetland NSW 2017,
Australia

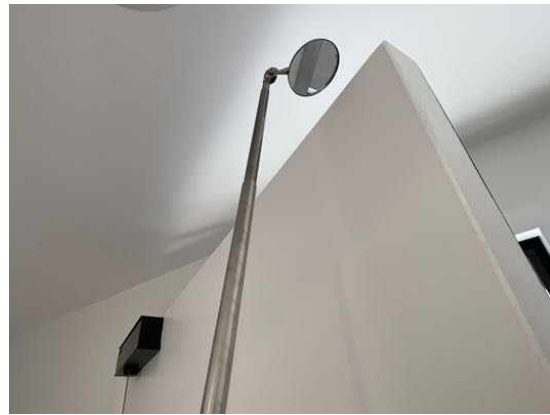
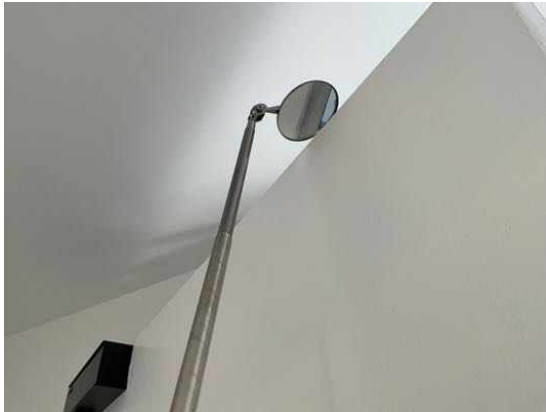
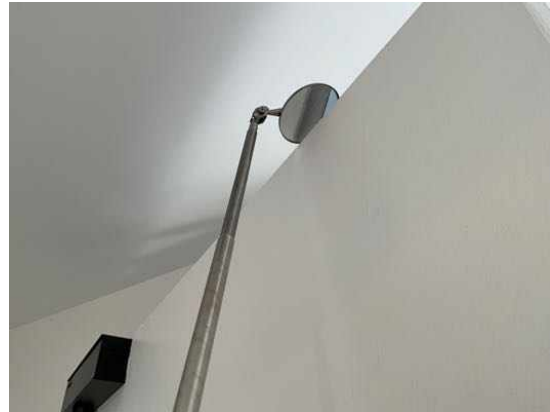
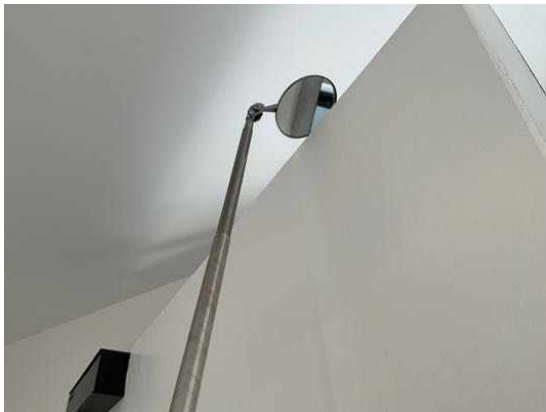
Defects 3.01

Building:	Main Building
Location:	All Areas
Finding:	Incomplete Painting of Doors
Information:	The paintwork on the doors throughout the building is incomplete, failing to meet the requirements specified by Australian Guides and Tolerances.

- ****Coverage:**** Incomplete paint coverage on the doors, with visible areas left unpainted or thinly coated.
- ****Edges and Corners:**** Edges and corners of the doors are inadequately painted, showing bare or poorly covered areas.

The doors must be repainted to meet the standards outlined in the Guide to Standards and Tolerances. This includes:

- Ensuring complete and consistent paint coverage on all surfaces of the doors.
- Achieving a smooth and even finish without visible defects such as brush marks, drips, or streaks.
- Proper surface preparation to ensure good paint adhesion and prevent peeling or flaking.
- Thoroughly painting edges and corners to achieve a uniform appearance.

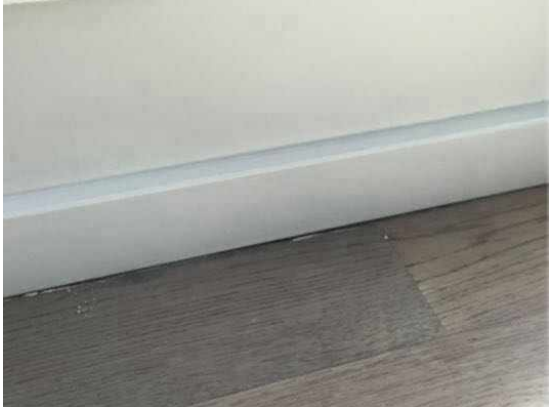
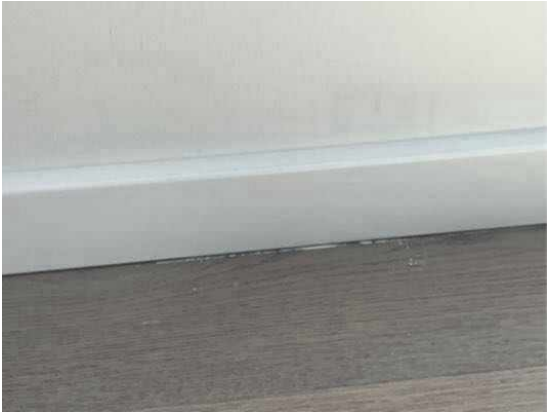
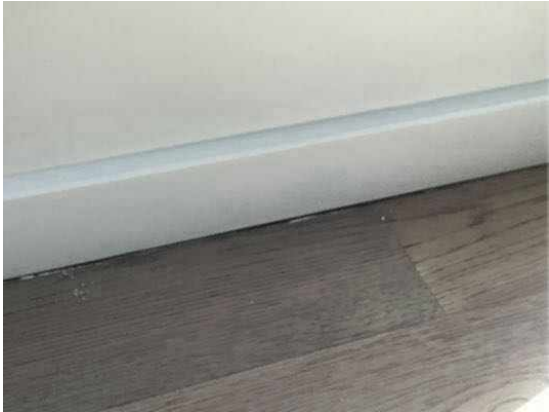
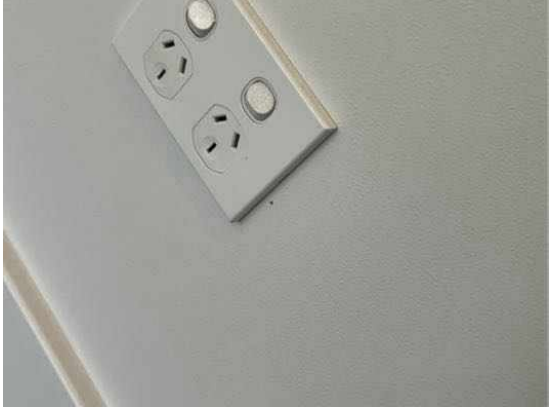
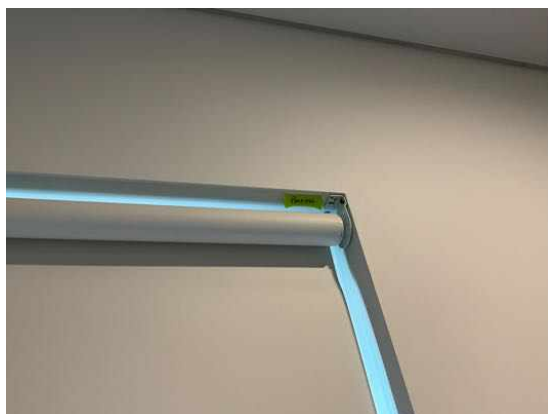
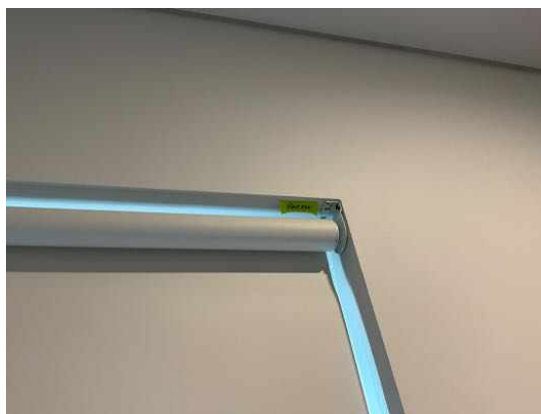
Defects 3.02

Building:	Main Building
Location:	All Areas
Finding:	Paint - Substandard
Information:	Areas were identified where the surface finish of the painting is substandard and this is considered a defect.

Any irregularity in the surface which is visible from a normal viewing position is considered a defect. Marks may also be a result of fault by other tradespeople throughout the construction process.

Defective surface finish of paintwork is marked with an arrow to the below photos in

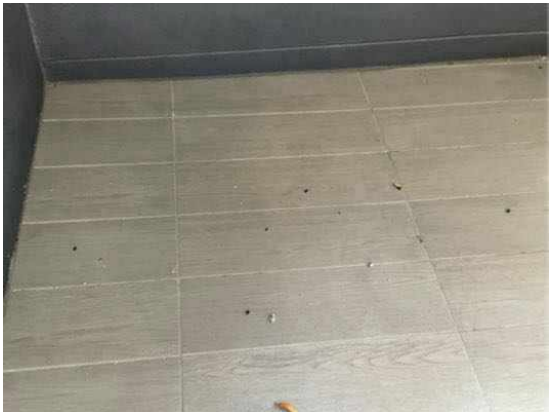
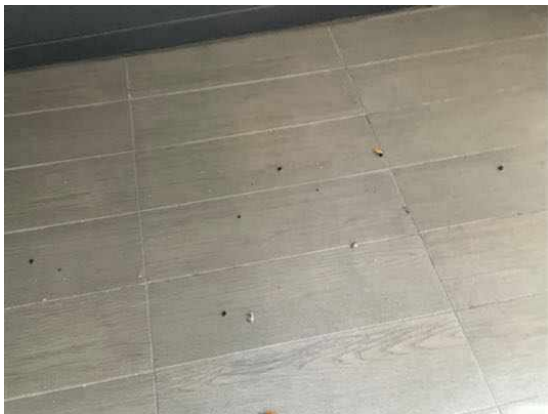
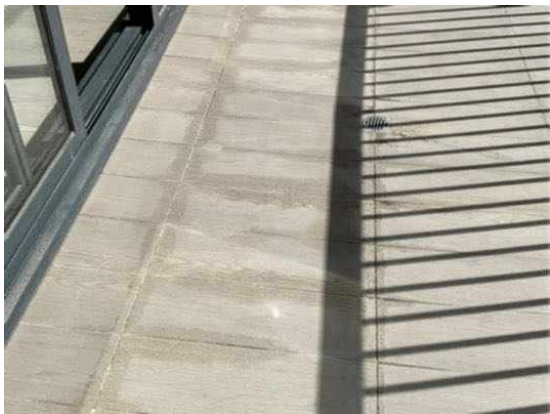
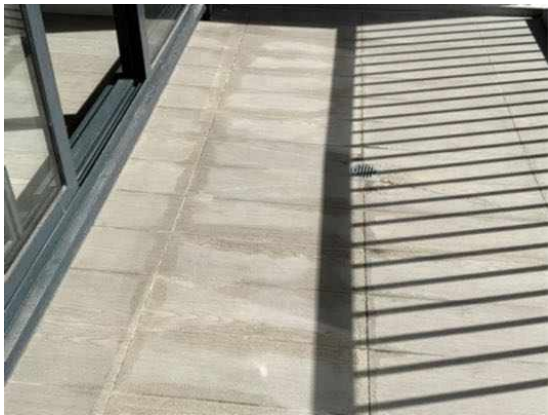
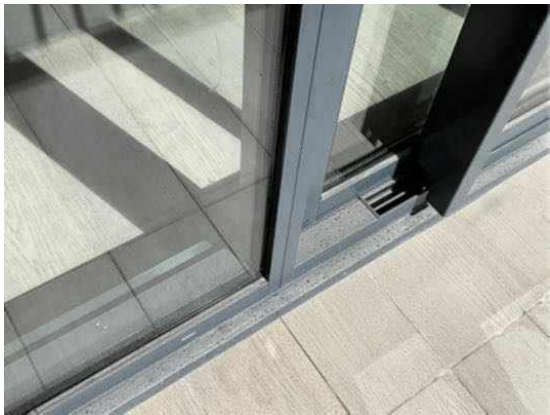
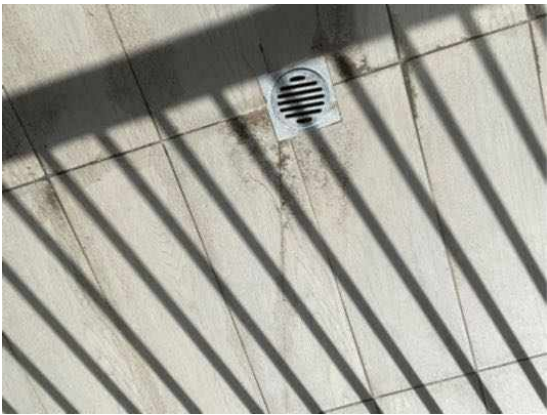
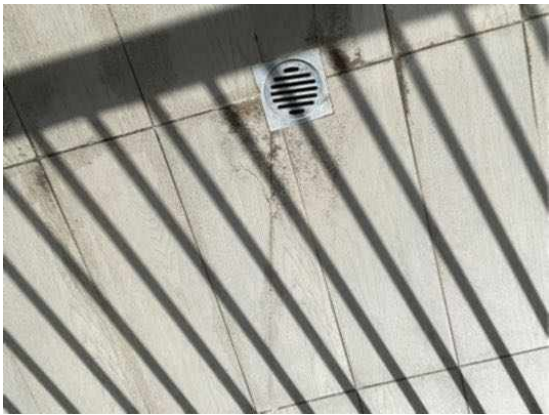
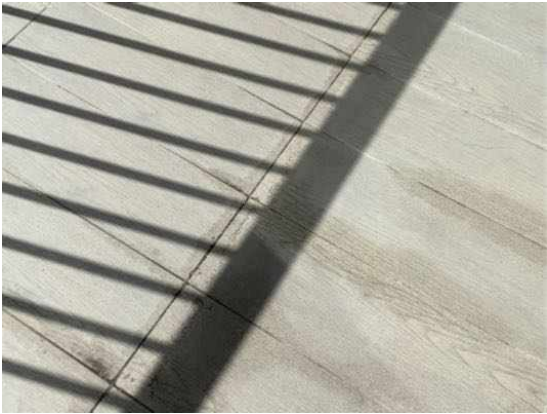
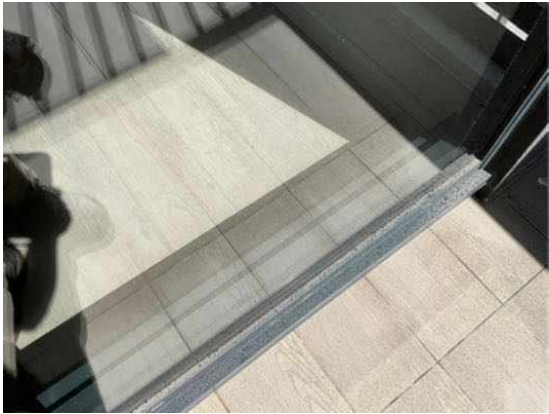
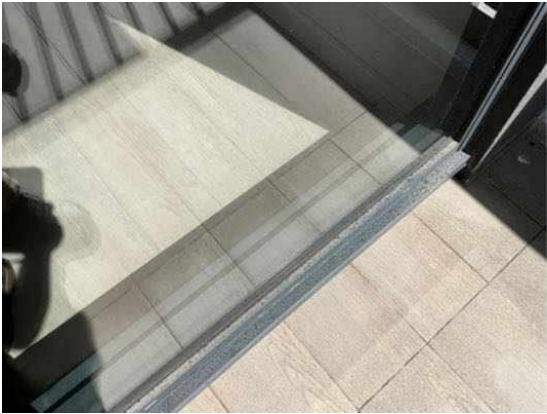
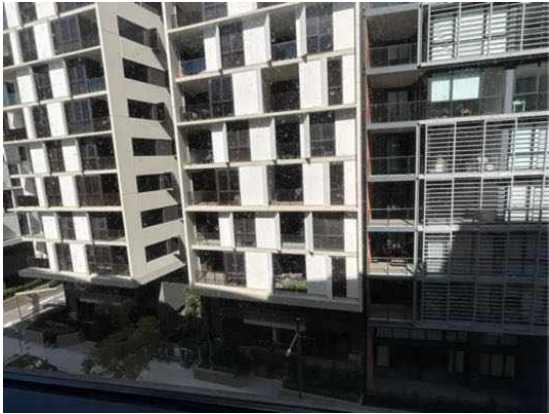
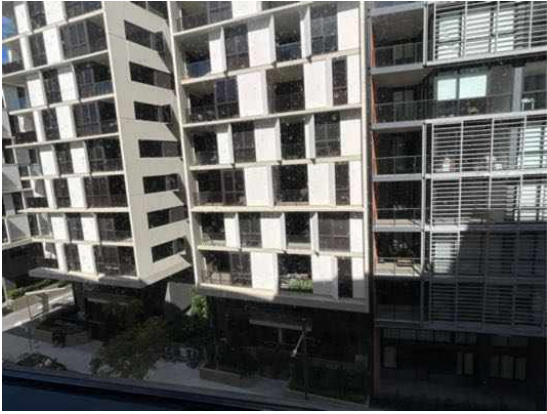
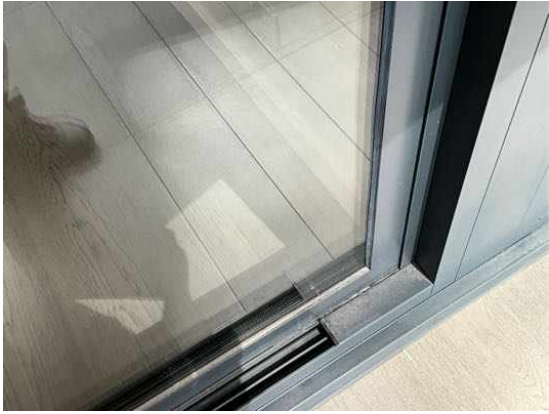
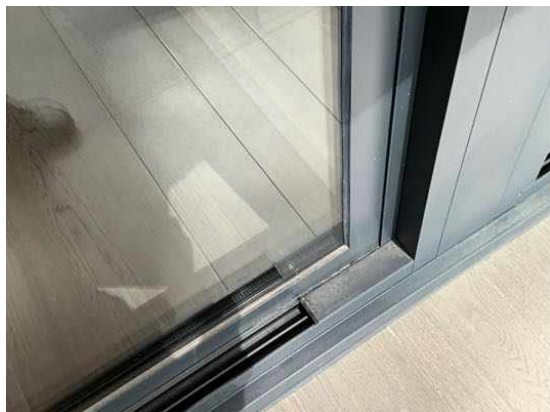
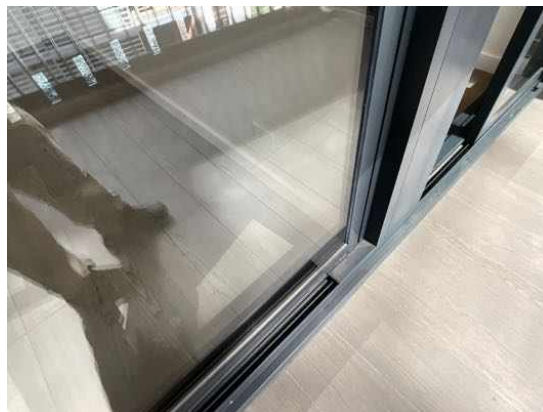
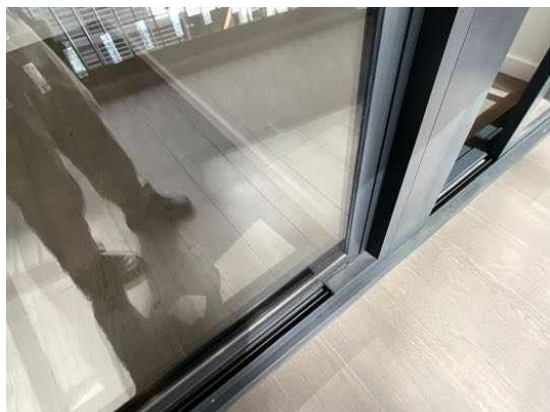
Defects 3.03

Building:	Main Building
Location:	All Areas
Finding:	Cleaning required
Information:	It was observed that the house requires cleaning.

Works are defective where windows are not clean, floors are not swept, mopped or vacuumed as appropriate, tiles, sinks, basins, baths, windows or any other area throughout the property are not cleaned, and shelving, drawers and cupboards are not ready for use not cleaned and ready for use at handover.

This is to be referenced against the Australian Standards & Tolerances clause 19.8 Cleaning.

This is to be addressed prior to handover.

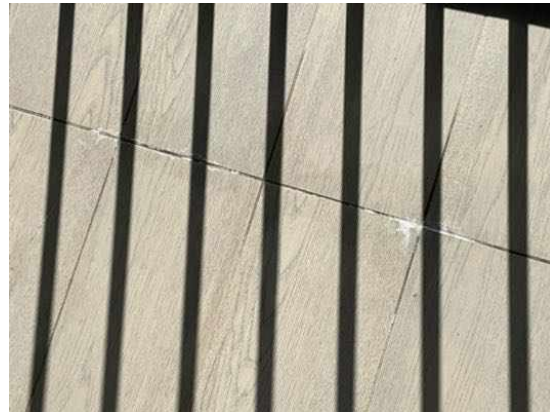
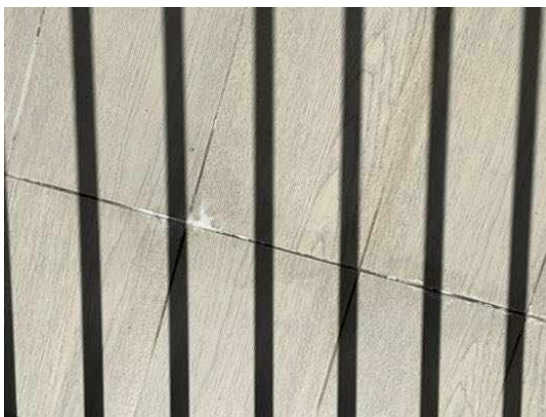
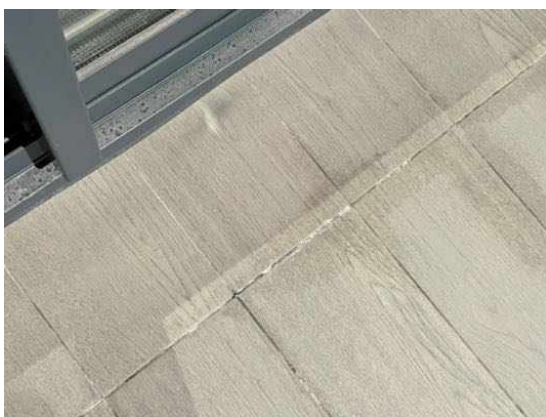
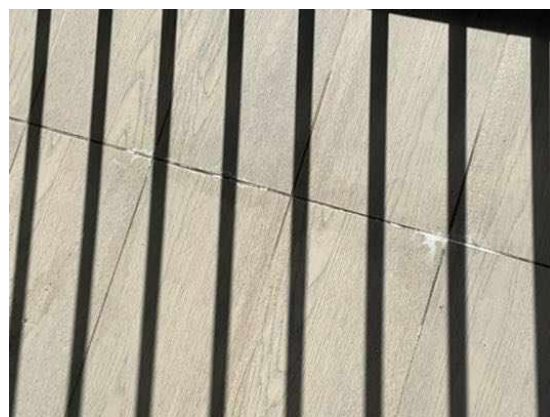
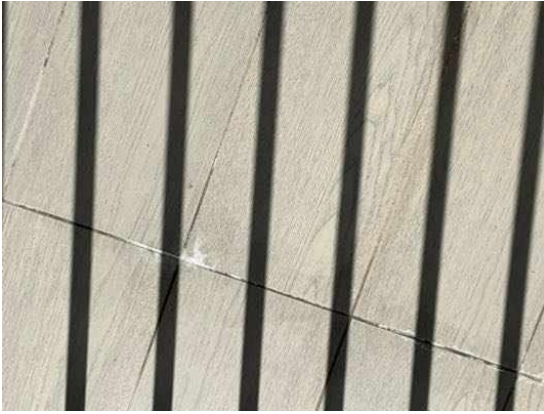
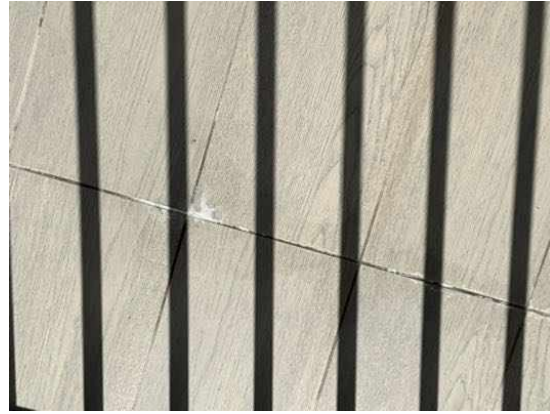
Defects 3.04

Building:	Main Building
Location:	All Areas
Finding:	Balcony - Efflorescence and Moisture Staining to External Tiled Floor
Information:	White crystalline deposits (efflorescence) and visible moisture staining were observed across grout lines and tile surfaces. This condition is commonly associated with the movement of moisture through the tile bed or substrate, which dissolves soluble salts and deposits them on the surface as water evaporates.

- Indicates potential waterproofing failure or inadequate drainage.
- May lead to tile delamination, deterioration of grout and adhesive, and long-term moisture damage to the substructure.
- In severe or persistent cases, dampness may migrate into internal areas, potentially leading to mould growth or structural deterioration.
- Surface may become slippery, increasing the risk of slips and falls.

- Engage a licensed waterproofing contractor to conduct moisture testing and assess

the integrity of the waterproofing membrane.

- If failure is confirmed, rectification may require tile removal and reapplication of a compliant waterproofing system, followed by re-tiling by a qualified tiler.
- If moisture ingress is suspected to affect internal structural components, an invasive inspection by a registered building consultant or structural engineer is recommended.

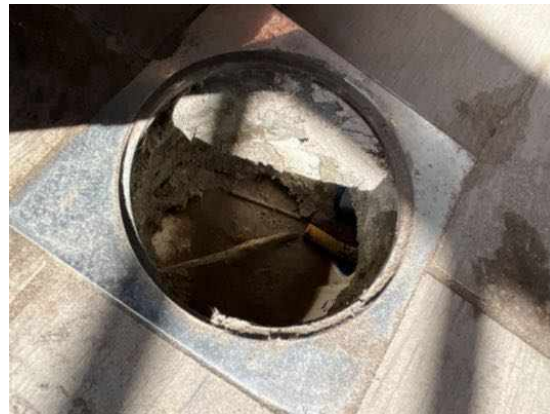
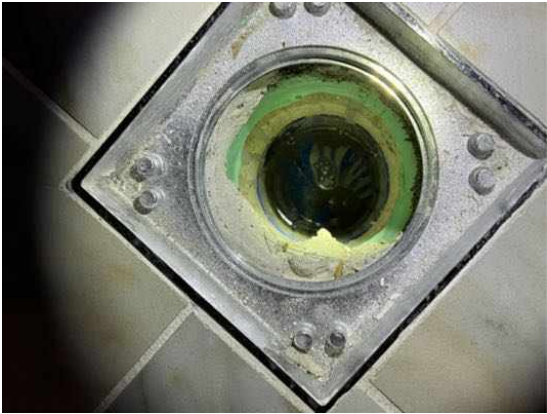
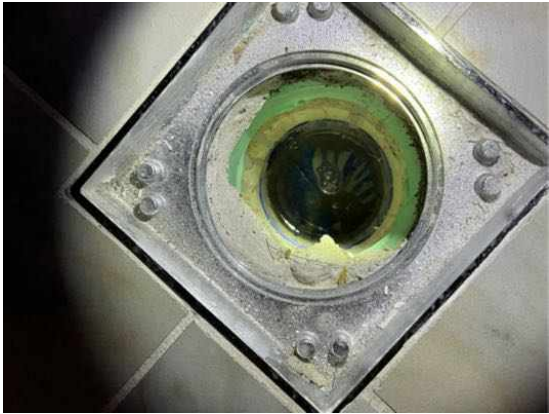
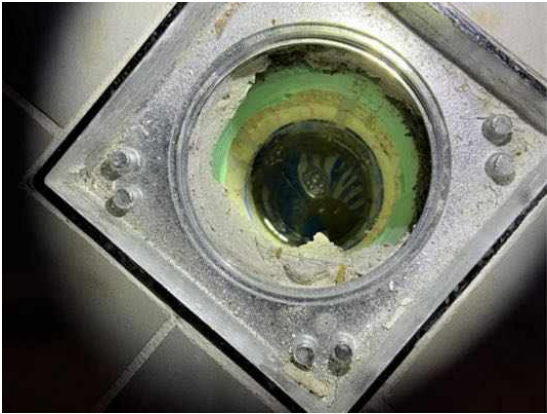
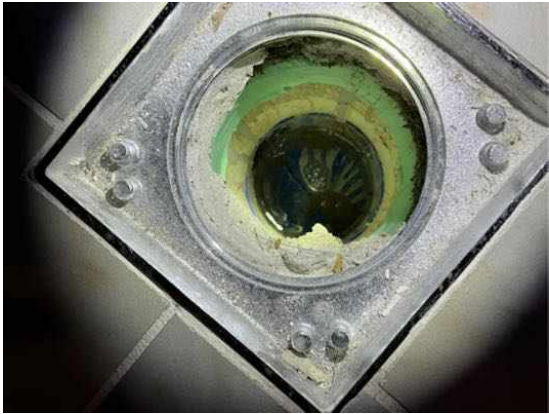
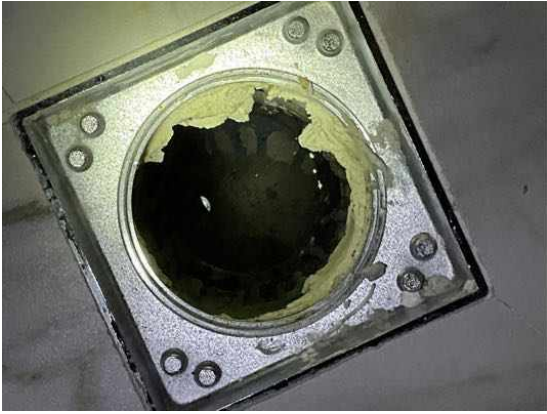
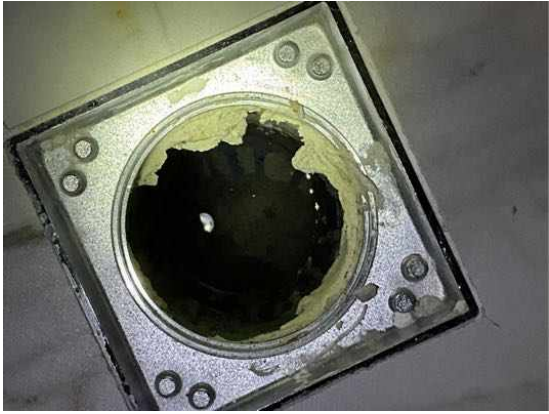
Defects 3.05

Building:	Main Building
Location:	All Areas
Finding:	Floor waste Debris
Information:	It was noted that there is builder debris in the floor waste drainage. Debris in the plumbing system may lead to blockages in the future.

This is referenced against the Australian Standards and Tolerances clause 19.8 Cleaning - Owners are entitled to expect that the building site and works are clean and tidy on completion.

Building sites are defective if they are not clear of building debris. All floor wastes need to be checked and cleared prior to handover.

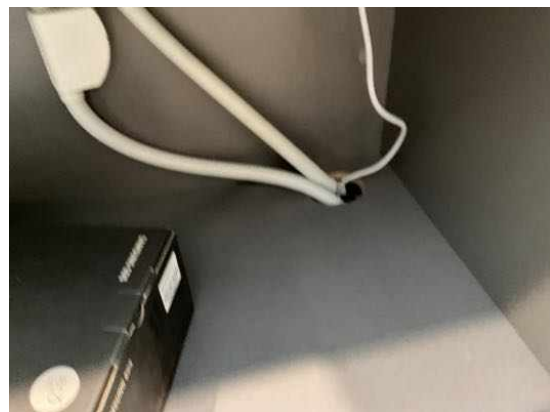
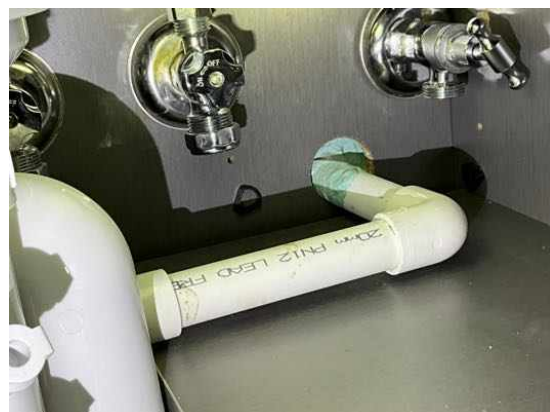
Defects 3.06

Building: Main Building
 Location: All Areas
 Finding: Pipe Penetrations - caps required
 Information: It was noted that at the time of the inspection the pipe penetrations were defective as stated in the Australian Standards and Tolerances 7.3.

7.3 Pipe penetrations through external walls and inside cupboards

Plumbing holes are defective if they are not:

- properly grouted as appropriate
- fitted through neat minimal size penetrations (in the case of cabinet network)
- fitted with tight fitting cover plates or collars with penetrations kept to the smallest size practicable.

This is to be rectified prior to handover.

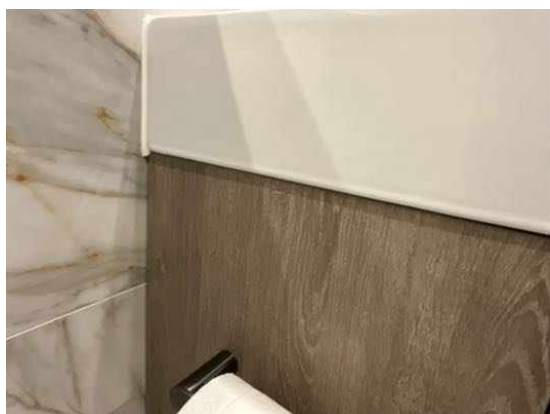
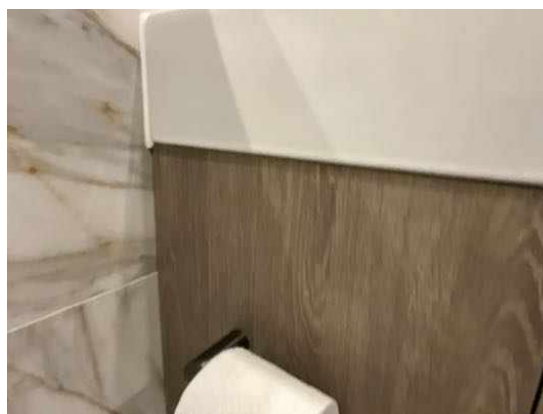
Defects 3.07

Building: Main Building
 Location: All Areas
 Finding: Silicone- Missing Sealant Around Basin

No silicone sealant was observed around the perimeter of the vessel basin where it meets the benchtop surface. This is considered non-compliant with good building practice and may allow moisture ingress, leading to potential swelling, mould growth, and damage to cabinetry and surrounding finishes.

In accordance with the NCC and the Guide to Standards and Tolerances 2017, joints between sanitary fixtures (such as basins) and adjoining surfaces must be properly sealed with a flexible waterproof sealant to ensure water resistance and durability.

It is recommended that a qualified tradesperson apply a continuous bead of mould-resistant, sanitary-grade silicone sealant to all exposed joints to prevent future water damage and ensure compliance with standards.

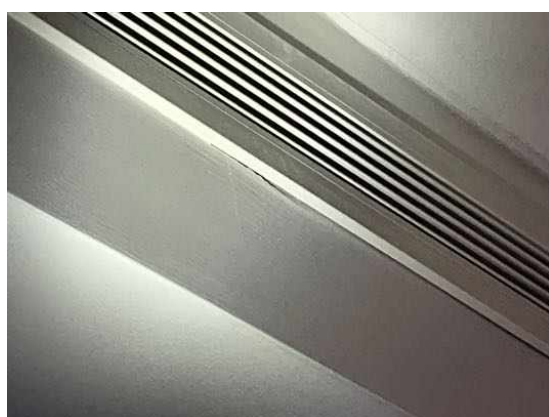
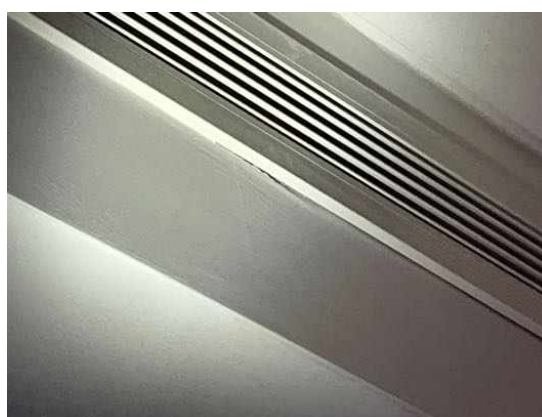
Defects 3.08

Building:	Main Building
Location:	Living Room
Finding:	Cracking - Damage Category 0 - Hairline (less than 1mm)
Information:	Hairline cracks are very minor in nature and generally are only ever an appearance defect. While such cracking may be noticeable in some cases, it is quite common and does not indicate any structural damage.

Cracking of this nature can generally be repaired with minor sanding, filling and/or repainting. Such works should be performed by a qualified painter or a general handyman.

Monitoring of all cracking should be conducted frequently. Always contact a building inspector should cracks widen, lengthen, or become more numerous.

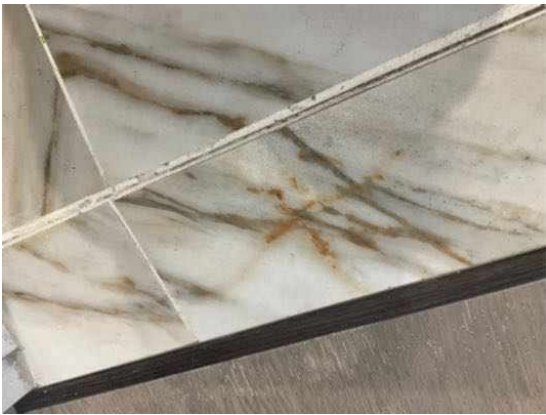
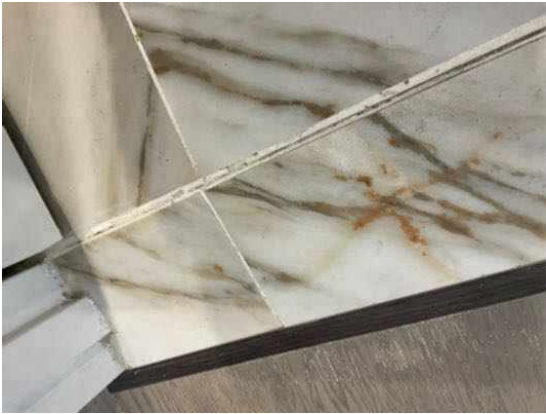
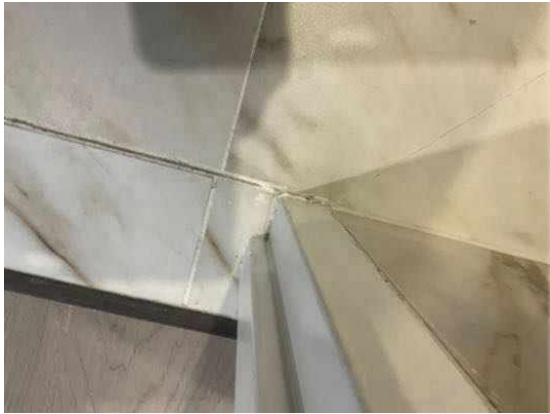
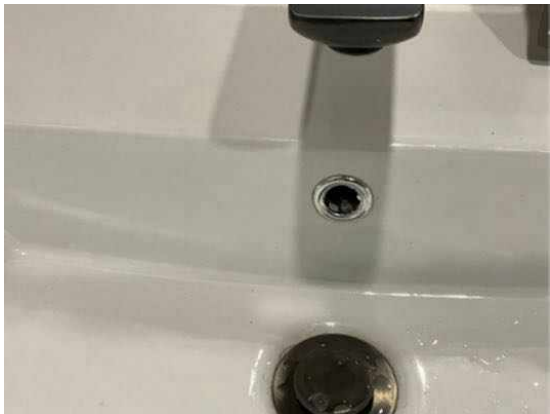
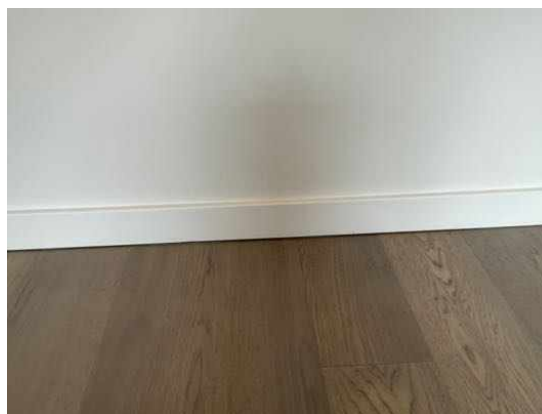
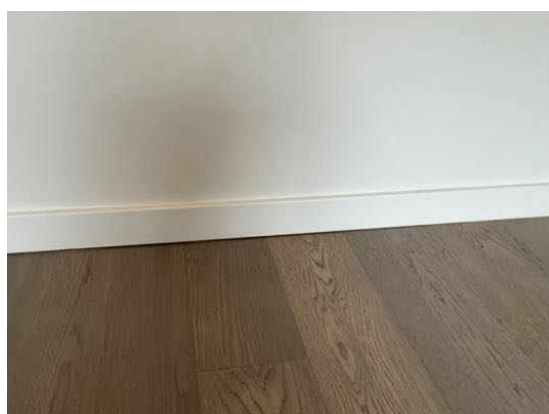
Defects 3.09

Building:	Main Building
Location:	All Areas
Finding:	Substandard Work- Various Areas of the Building
Information:	Substandard work has been identified in multiple areas throughout the building, failing to meet the requirements specified by Australian Guides and Tolerances.

- ****Paint Application:**** Inconsistent and incomplete paint coverage on walls, ceilings, and downpipes, with visible brush marks, drips, and streaks.
- ****Surface Preparation:**** Poor surface preparation resulting in inadequate paint adhesion.
- ****Flooring:**** Uneven flooring with dips and bumps exceeding allowable tolerances.

- **Plasterwork:** Cracks in plaster exceeding the acceptable width as specified in the Guide to Standards and Tolerances.

- **Fixtures and Fittings:** Misaligned or improperly installed fixtures and fittings, not meeting the standard requirements for level and alignment.

All identified areas of substandard work must be rectified to meet the standards outlined in the Guide to Standards and Tolerances. This includes:

- Repainting surfaces with proper surface preparation and uniform application.
- Correcting uneven flooring to meet the specified tolerances.
- Repairing or replacing cracked plaster to ensure compliance with acceptable standards.
- Realigning and properly installing fixtures and fittings.
